**Susitna-Watana Hydroelectric Project  
(FERC No. 14241)**

**Thermal Infrared Remote Sensing Pilot Test**

URS Corporation  
Watershed Sciences Inc.

February 2013

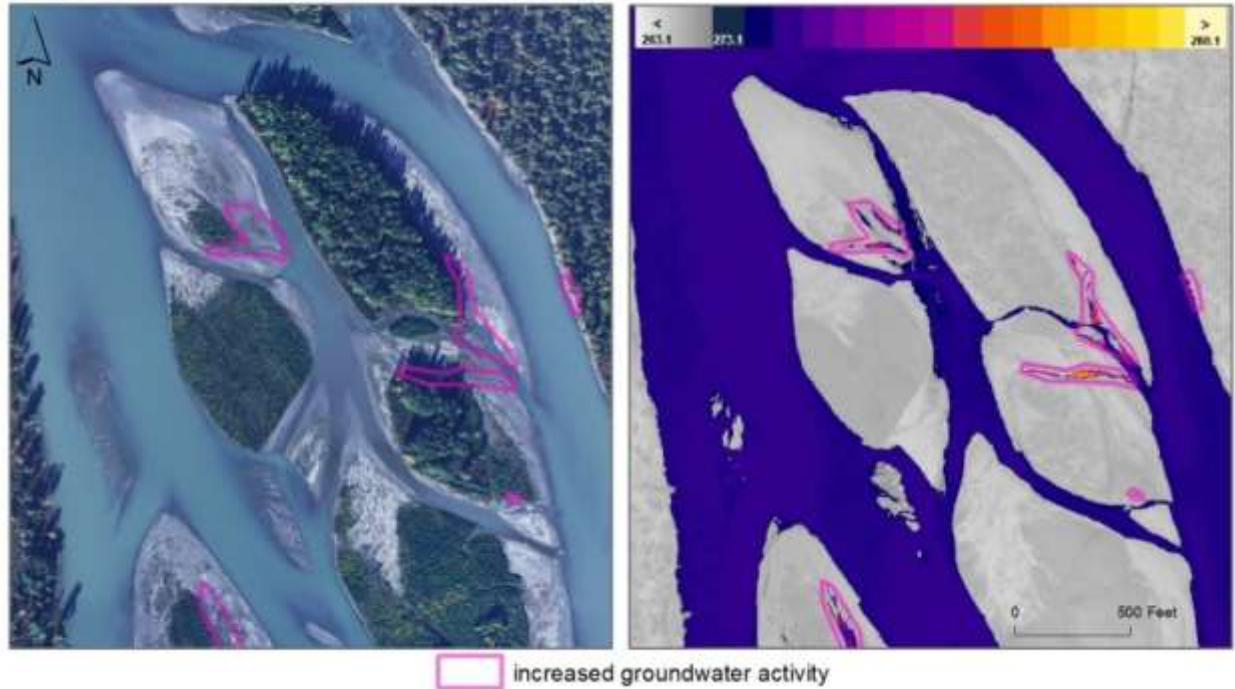
**Figure 7. TIR/True Color Image Comparison.**

The TIR/true color image pair above shows an example of the small hyporheic seeps that were detected in the thermal imagery, particularly in the exposed gravel beds.
