Susitna-Watana Hydroelectric Project Document

Susitna-Watana Hydroelectric Project (FERC No. 14241)

Riparian Vegetation Study Downstream of the Proposed Susitna-Watana Dam

ABR, Inc.—Environmental Research & Services

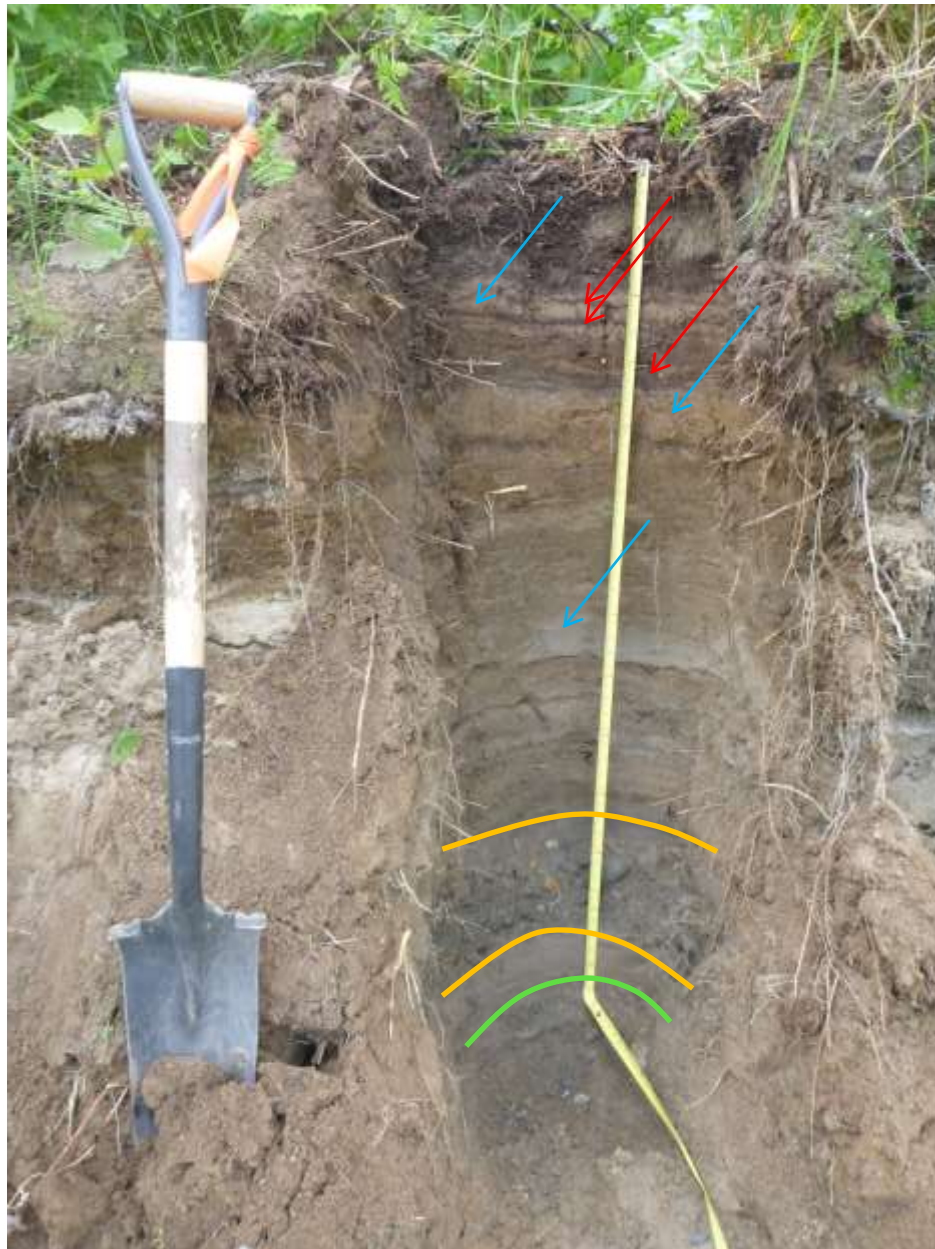
Figure 5. Typical Cryofluvents at a river bank exposure, Riparian Vegetation Study area, Susitna River floodplain, Alaska, 2012.

Dark horizontal lines (red arrows) indicate layers of organic material buried by periodic past sedimentation events. Orange and grayish layers (blue arrows) are riverine sands and silts. Cobbly/gravelly layer (between orange lines) indicates historic large, powerful flood event. The cobbly layer at the bottom of the pit represents the original cobble bar surface (below green line). Shovel in photo is approximately 1 meter (3.3 feet) tall.

A total of 15 soil subgroups (Soil Survey Staff 2010) were sampled during the 2012 field survey. The most common types were Typic Cryofluvents ($n=19$ occurrences; Figure 5), Oxyaquic Cryofluvents ($n=12$), Typic Cryorthents ($n=5$), Aquic Cryofluvents ($n=4$), and Oxyaquic Cryorthents ($n=4$; Figure 6). Definitions of common soil subgroups found in the study area are provided in Table 3.

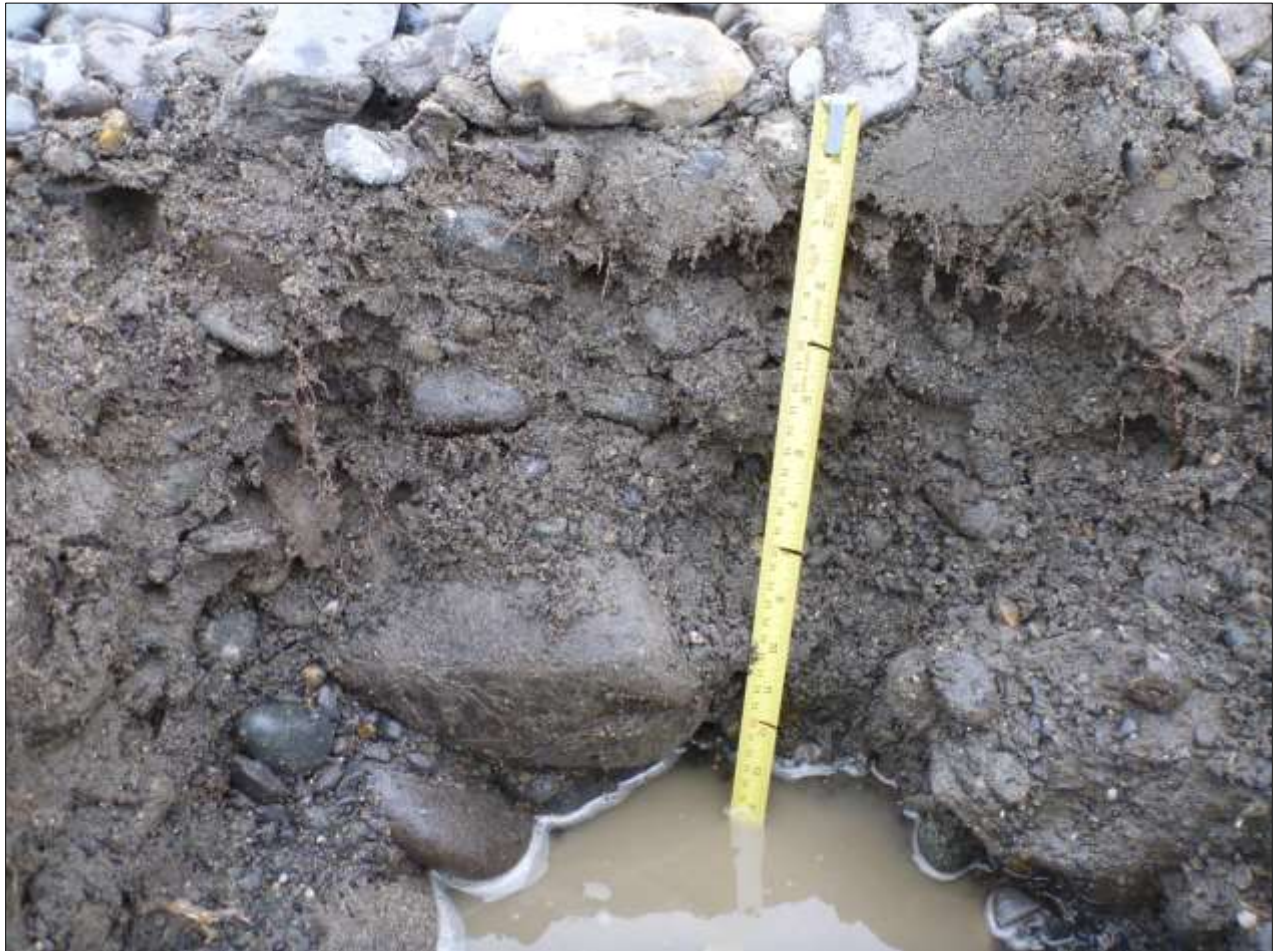
Figure 6. Oxyaquic Cryorthents on an active cobble bar showing water table at 35 centimeter (14 inches) below soil surface, Riparian Vegetation Study area, Susitna River floodplain, Alaska, 2012.

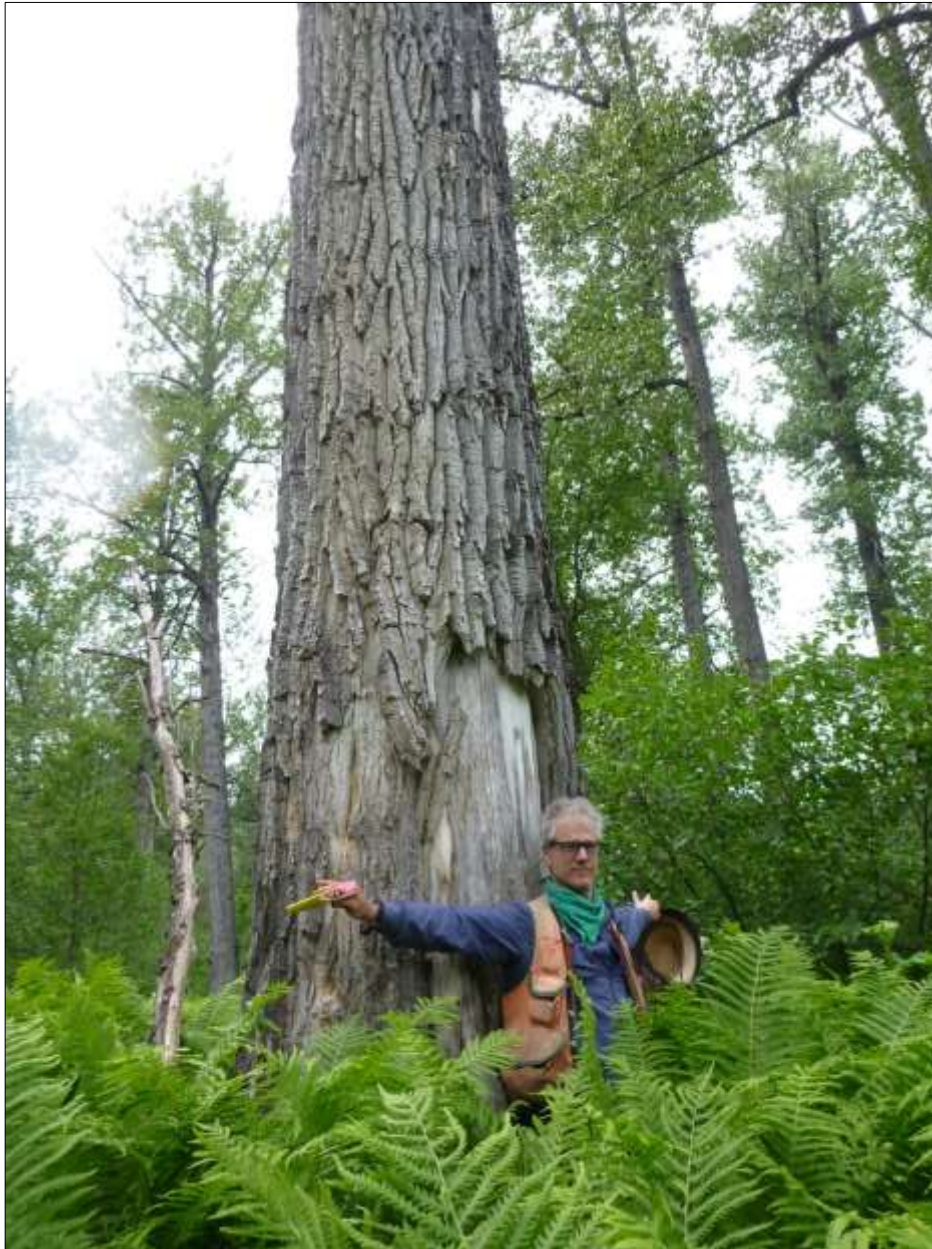
Figure 7. Ice scar on balsam poplar, Riparian Vegetation Study area, Susitna River floodplain, Alaska. Scientist in photo is ~1.9 meter (6.2 feet) tall.

Evidence of ice processes was common throughout the study area, including tree-bole scarring (up to 4–6 meter [13–20 feet] above ground level on the upstream side of trees; Figure 7), ice gouging and “bull-dozing” along banks and gravel bars (Figure 8), large displaced stones, and “mowing” of vegetation.

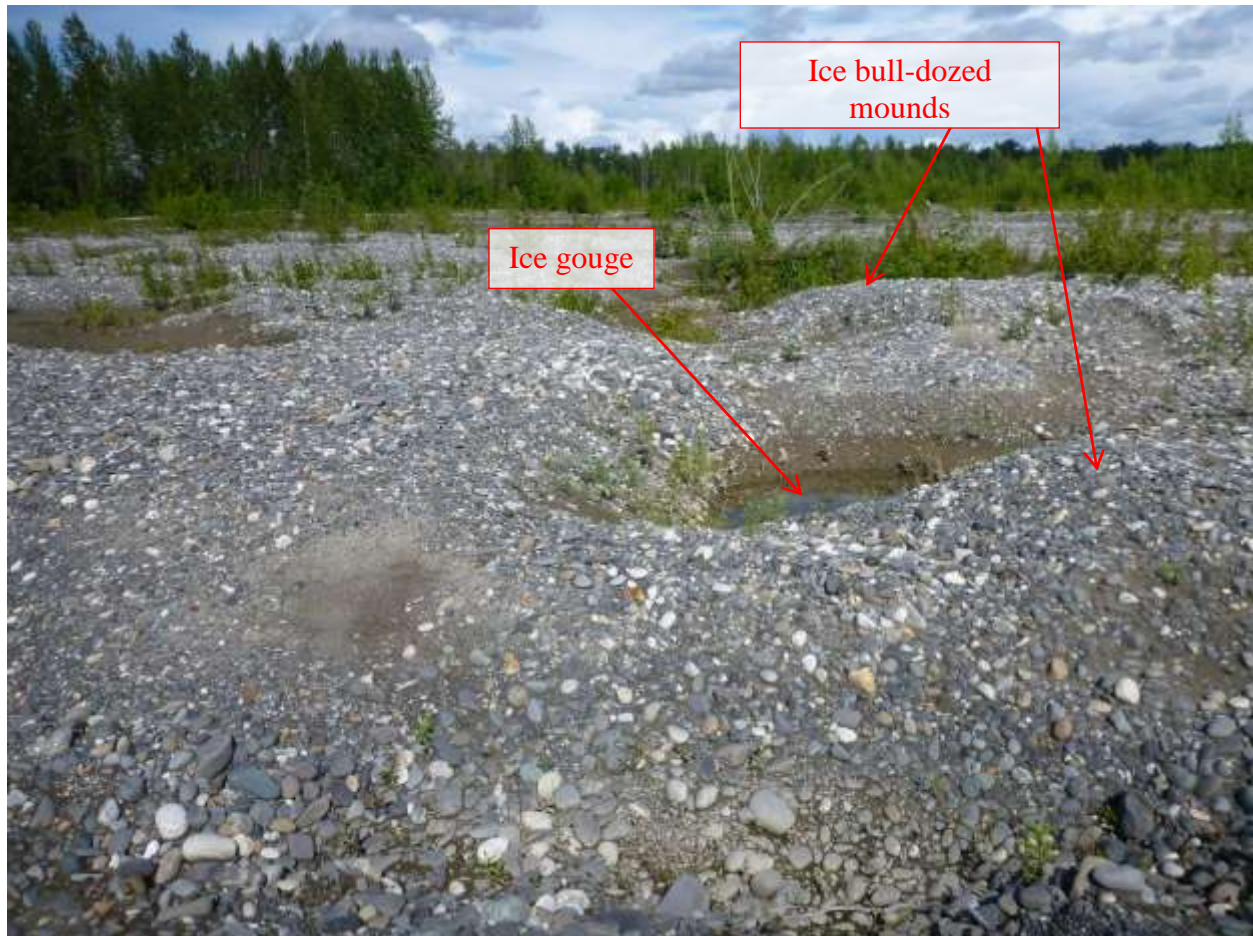
Figure 8. Recent ice gouging and ice bull-dozing on a mid-river gravel bar, Riparian Vegetation Study area, Susitna River, Alaska, 2012.

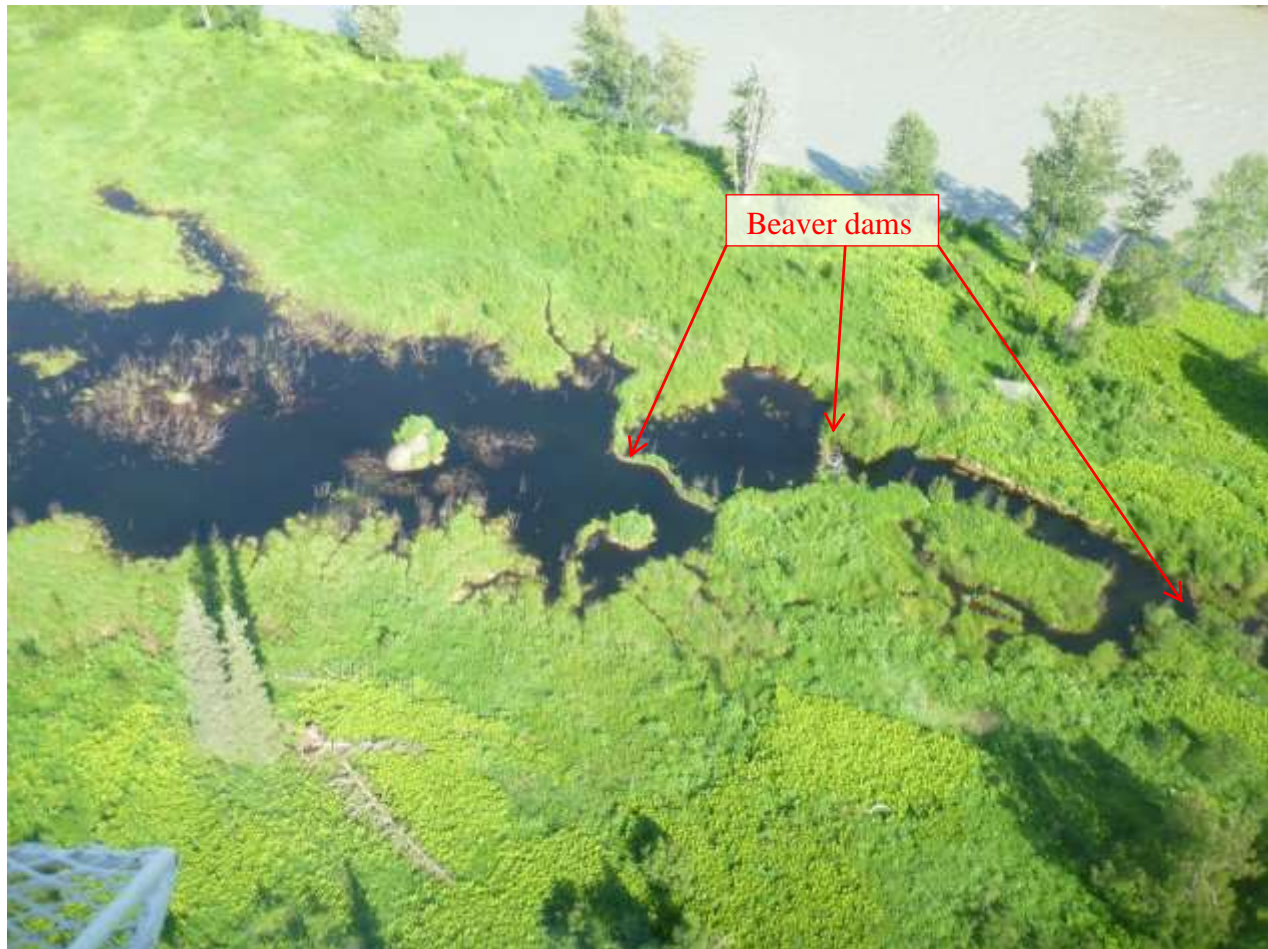
Figure 9. Aerial view of beaver pond complex, Riparian Vegetation Study area, Susitna River floodplain, Alaska, 2012.

Signs of beaver activity were observed throughout the study area, particularly in the Middle River and Lower River – Middle Susitna River segments where beavers often formed dams in inactive side channels and sloughs of the river (Figure 9). Observations of beaver activity included chewed and felled trees and shrubs, dams and lodges, and impoundments. Several older, large (10–30 meters [33–98 feet] across, and 1–2 meters [3.3–6.6 feet] high) vegetated beaver dams were also observed that showed evidence of recent maintenance by beavers (Figure 10).

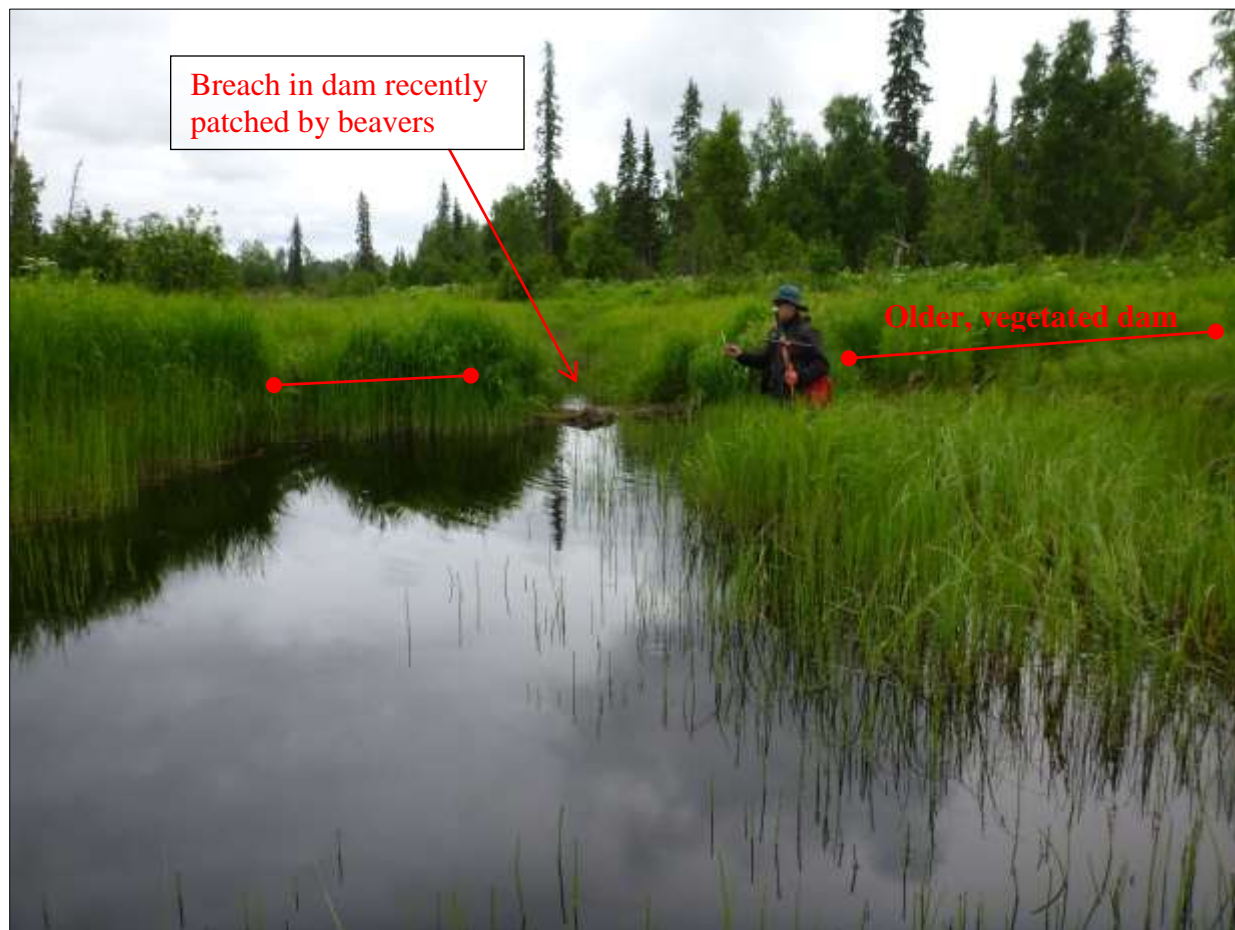
Figure 10. Beaver impoundment showing older, vegetated dam with breach recently maintained by beavers, Riparian Vegetation Study area, Susitna River floodplain, Alaska, 2012.
