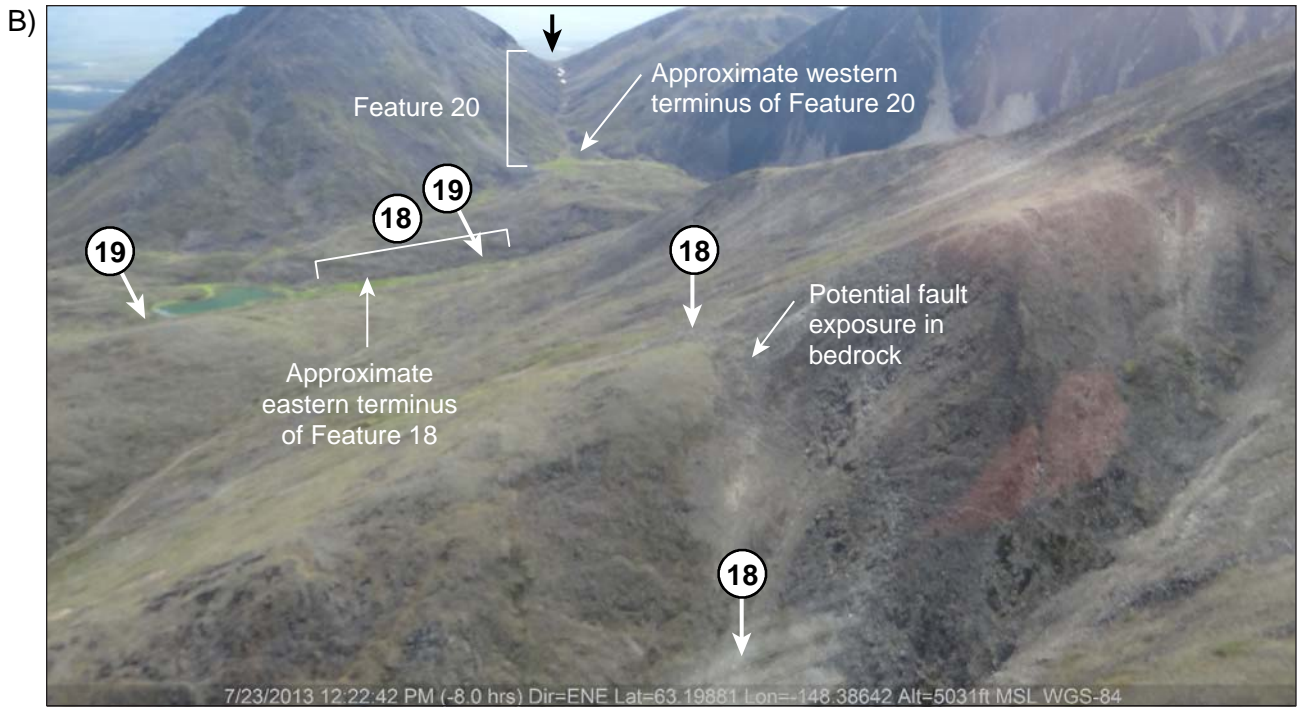
View looking southeast from photograph location B. Arrows and brackets indicated the projected trace of lineaments 18, 19, and 20.

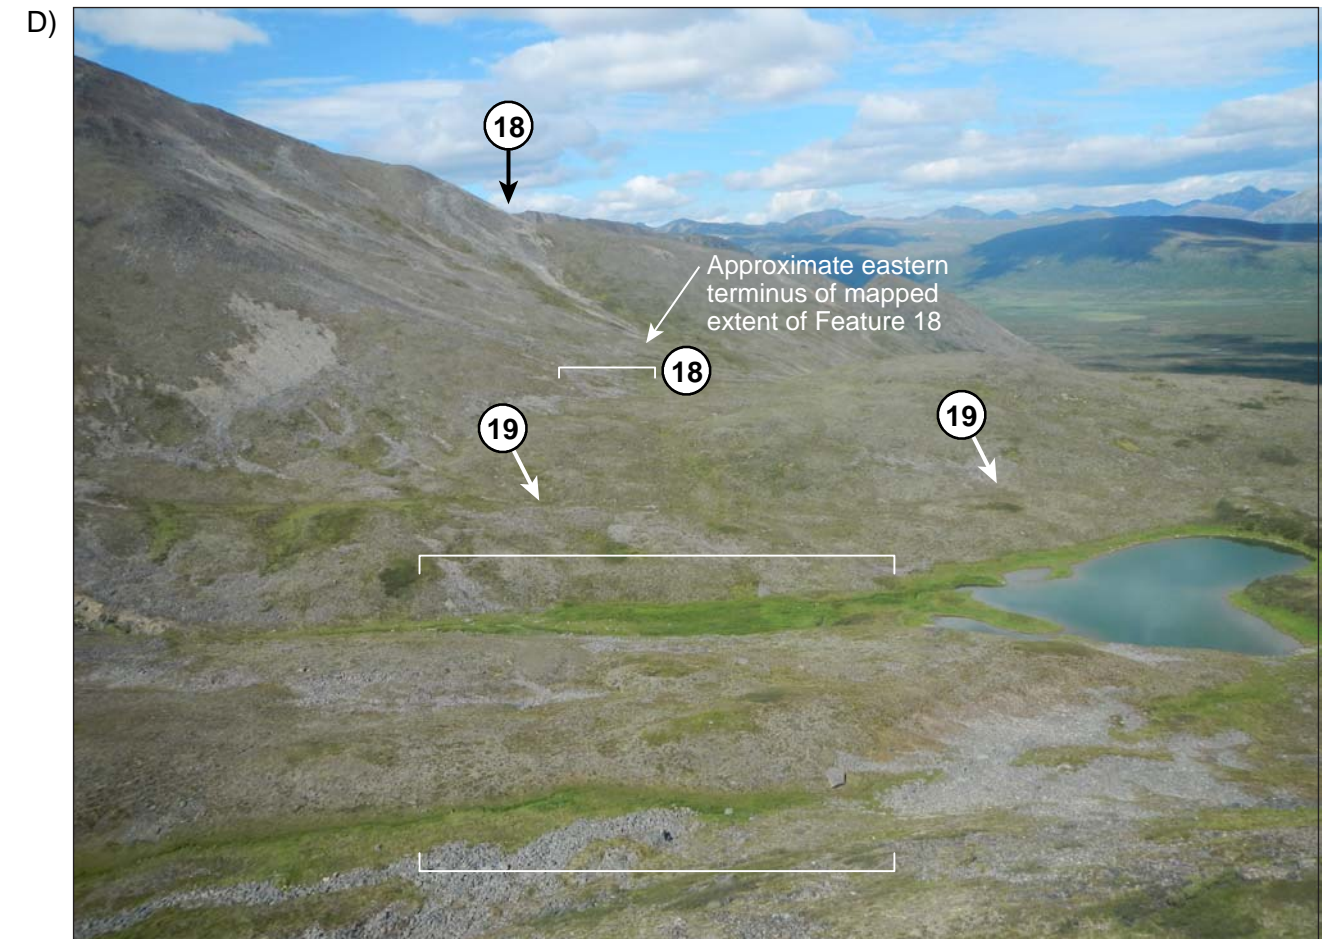
View looking northwest from photograph location D. Arrows show the mapped trace of Features 18 and 19. Note absence of lineaments or apparent deformation in Quaternary deposits between brackets in lower middle portion of photograph.

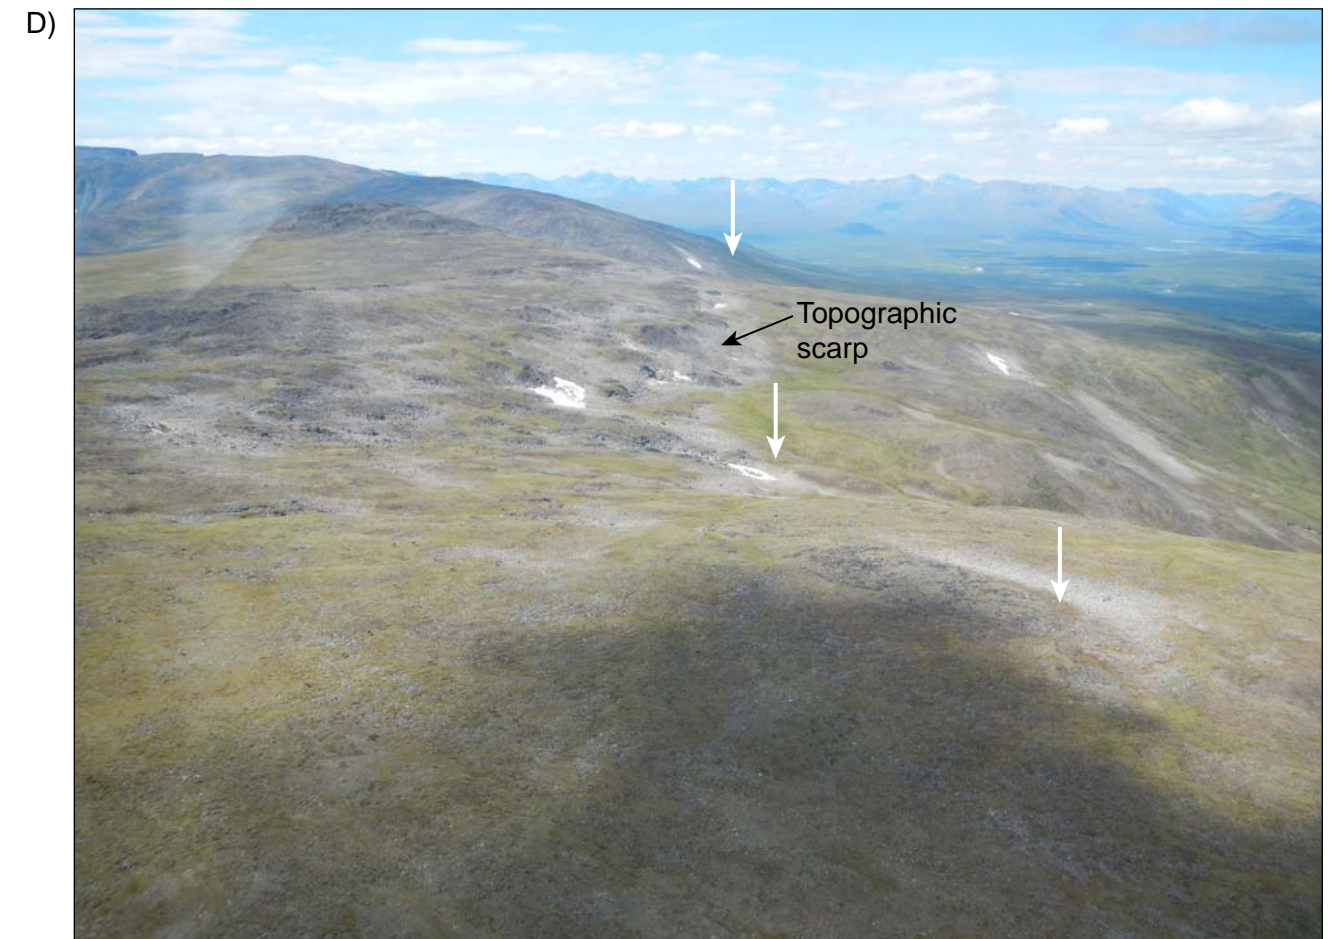
View looking west from photograph location C. Arrows show the projected trace of the Feature 22 lineament. Note topographic scarp in Photograph D is not proportional to minor scarps associated with solifluction in Photograph C.

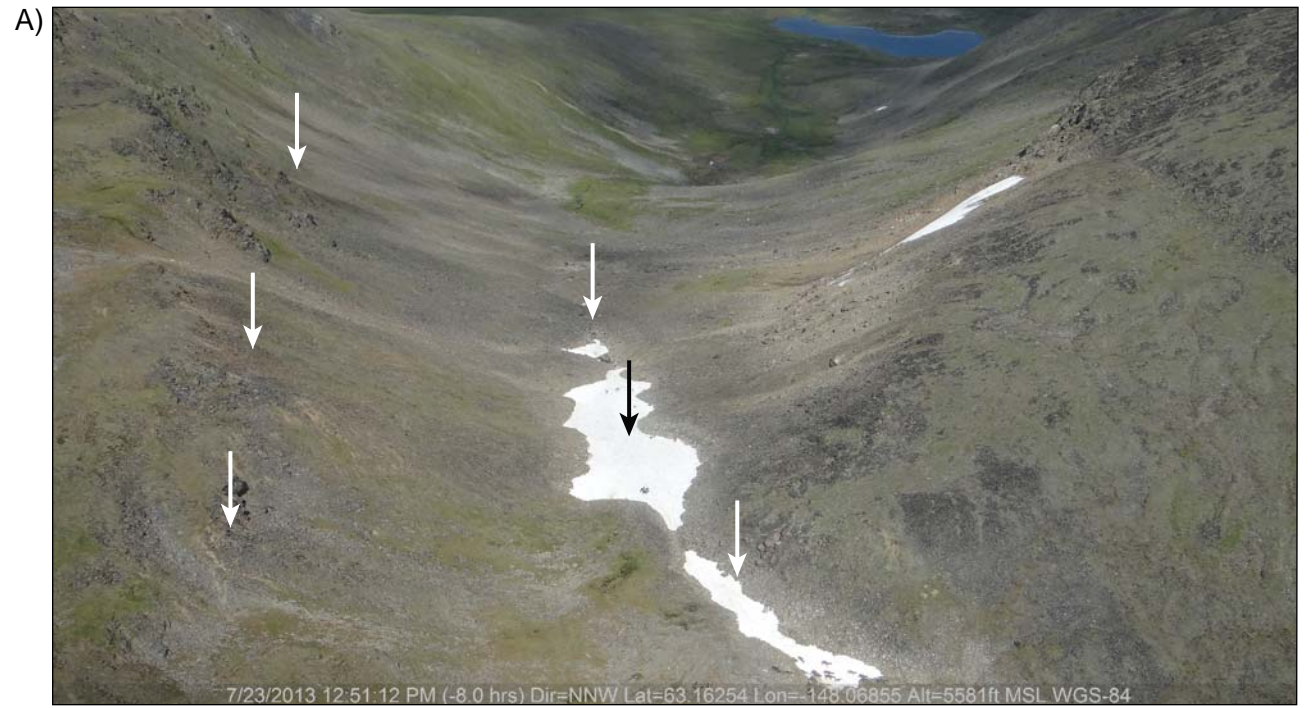
View looking west from photograph location C. Arrows indicate the projected path of the Feature 24 lineament.

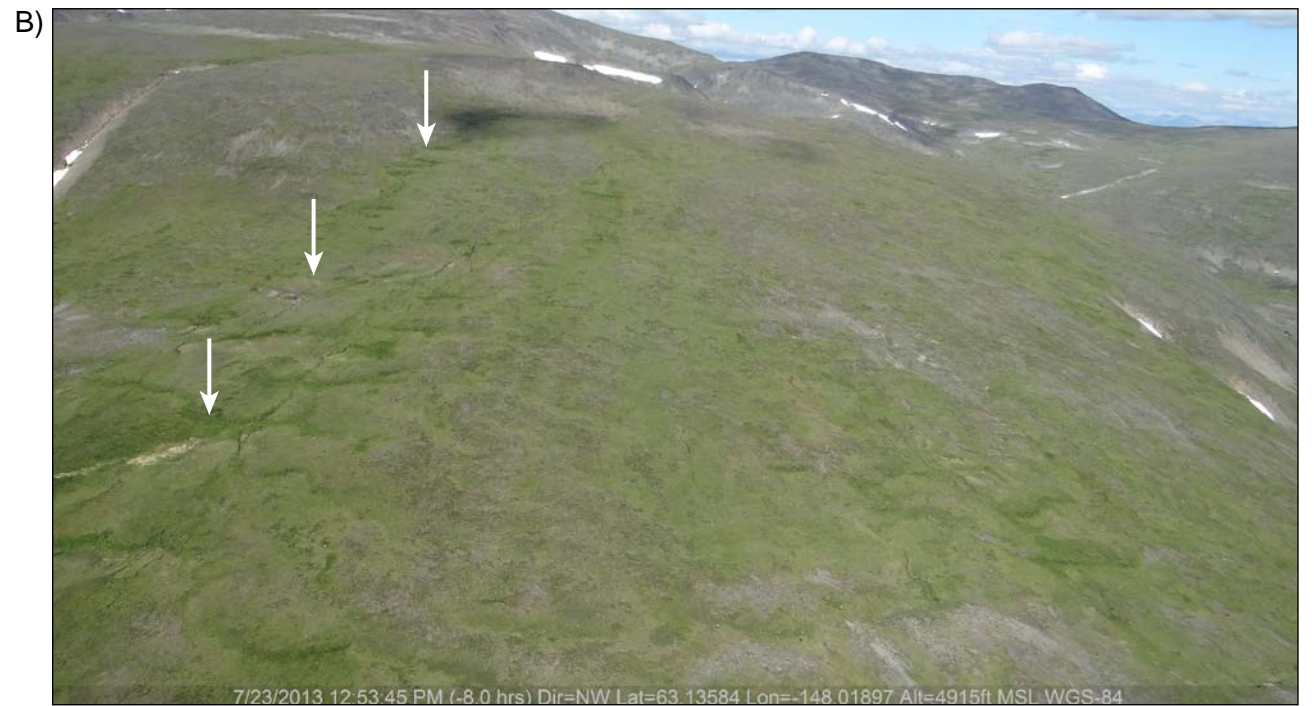
View looking west from photograph location C. Arrows indicate the projected path of the Feature 25 lineament.
