**Appendix A:**  
**Strip Maps and Photographic Documentation**  
**of Lineament Data Presented in FCL (2013)**

<p>FUGRO Date 01/06/14</p> <p>STATE OF ALASKA ALASKA ENERGY AUTHORITY <b>ALASKA</b> ENERGY AUTHORITY</p> <p>SUSITNA-WATANA HYDROELECTRIC PROJECT STRIP MAPS EXPLANATION 2 OF 4</p> <p>FIGURE A0.3</p>

**SUSITNA-WATANA HYDROELECTRIC PROJECT**

**LINEAMENT GROUP 6**

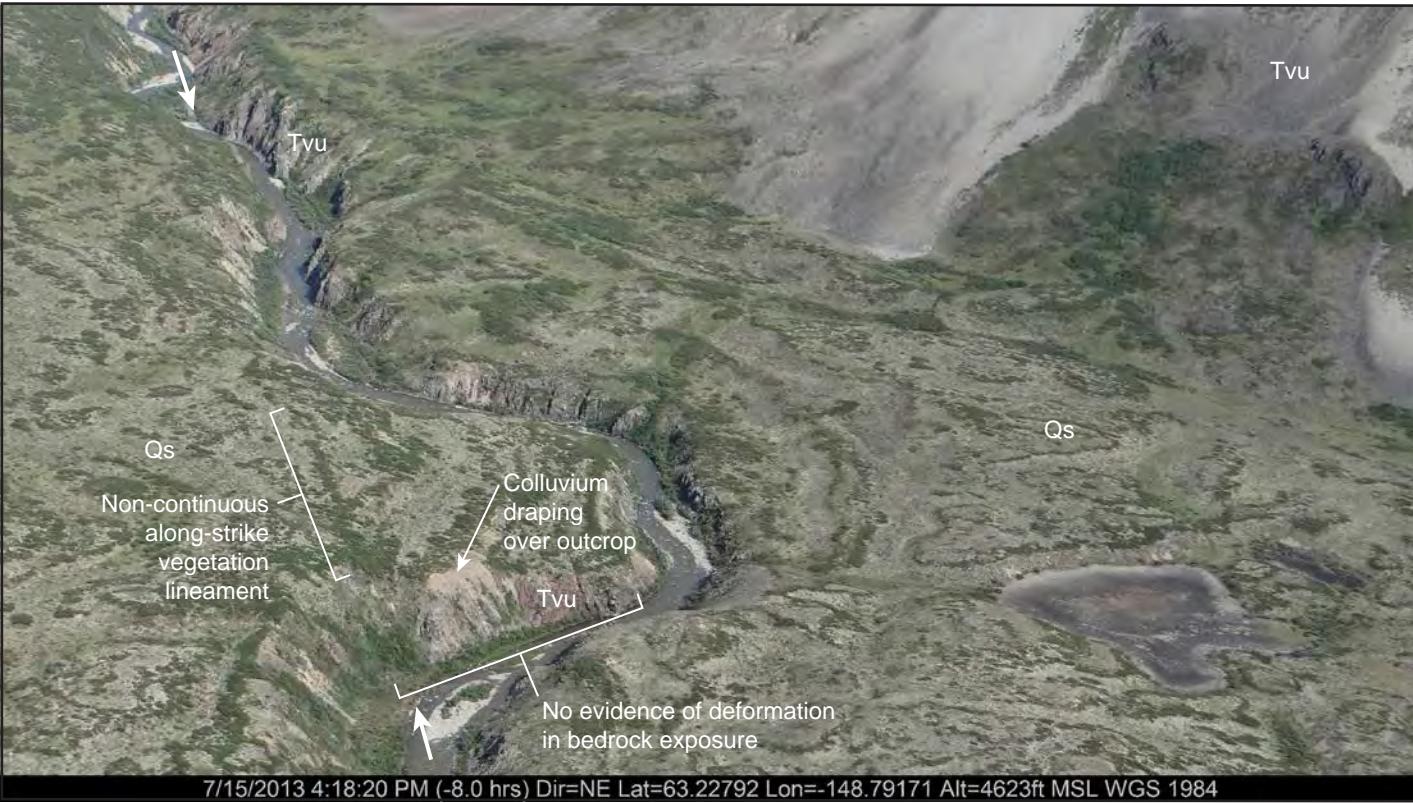
Photograph taken from location A looking east-northeast. Arrows show the alignment of FCL-mapped lineament. Note lack of apparent deformation in bedrock exposure along Jack River.

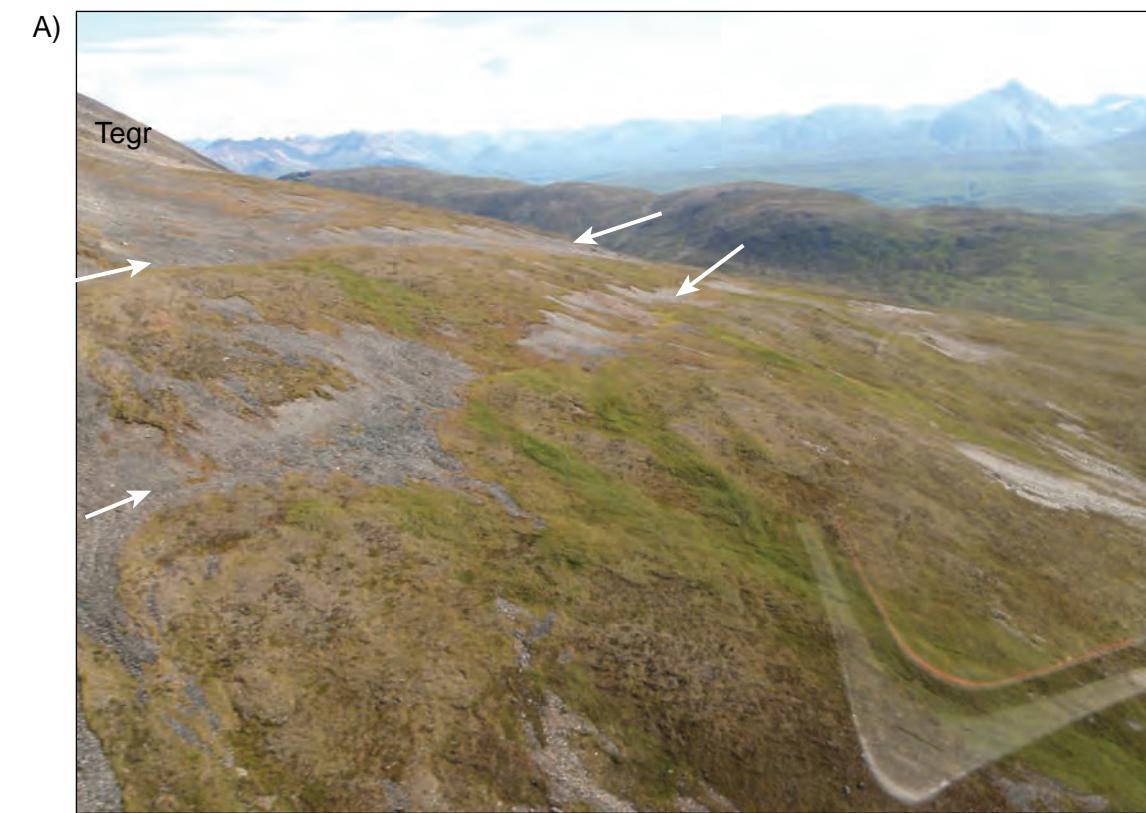
View looking east at likely solifluction-related scars on hillside that correspond with mapped lineaments. Large arrows point along lineaments.

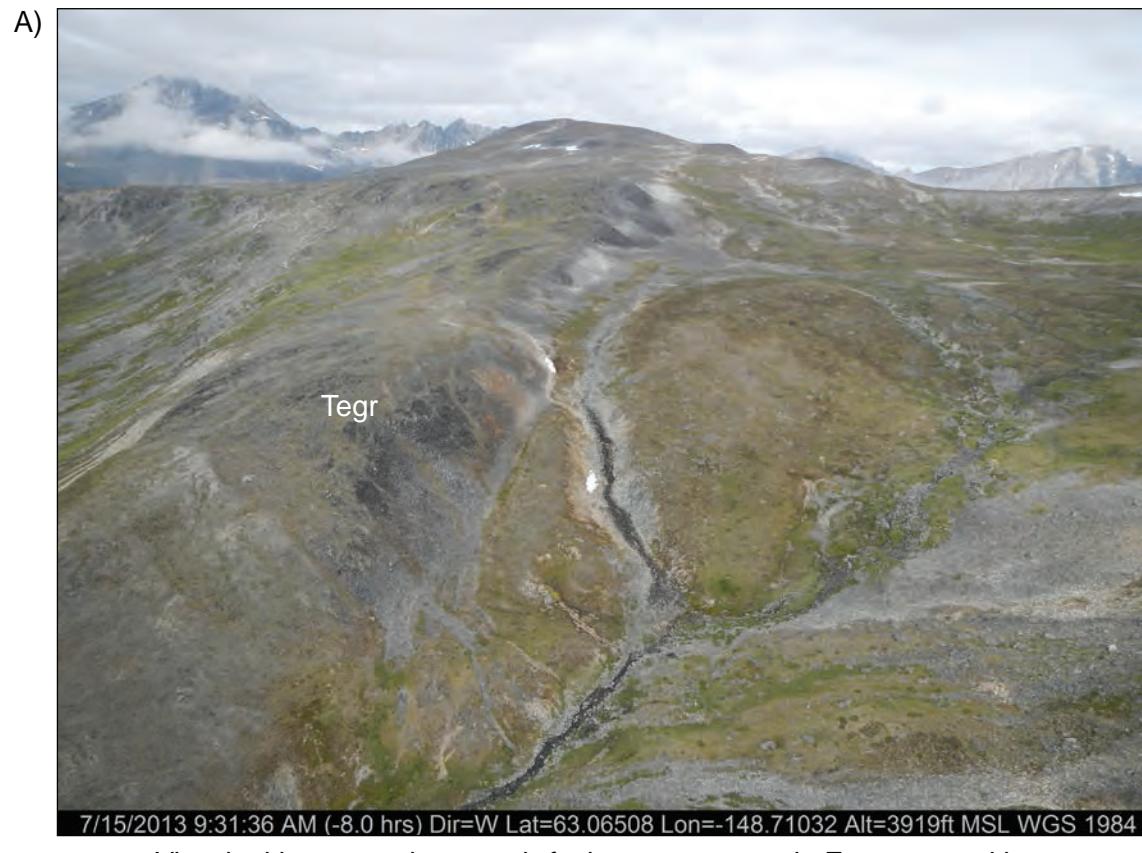
View looking west along north-facing escarpment in Eocene granitics.

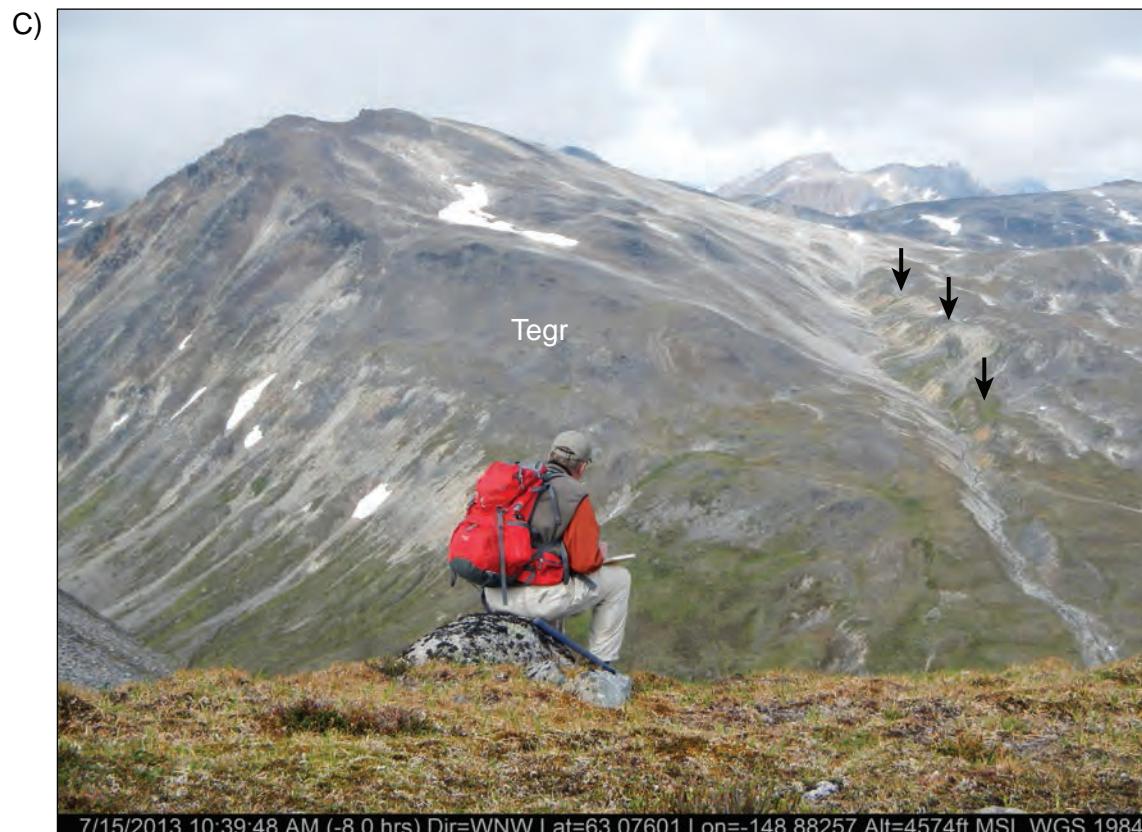
View looking west along lineament 3b projection. South-facing escarpment indicates a reversal in kinematic morphology.

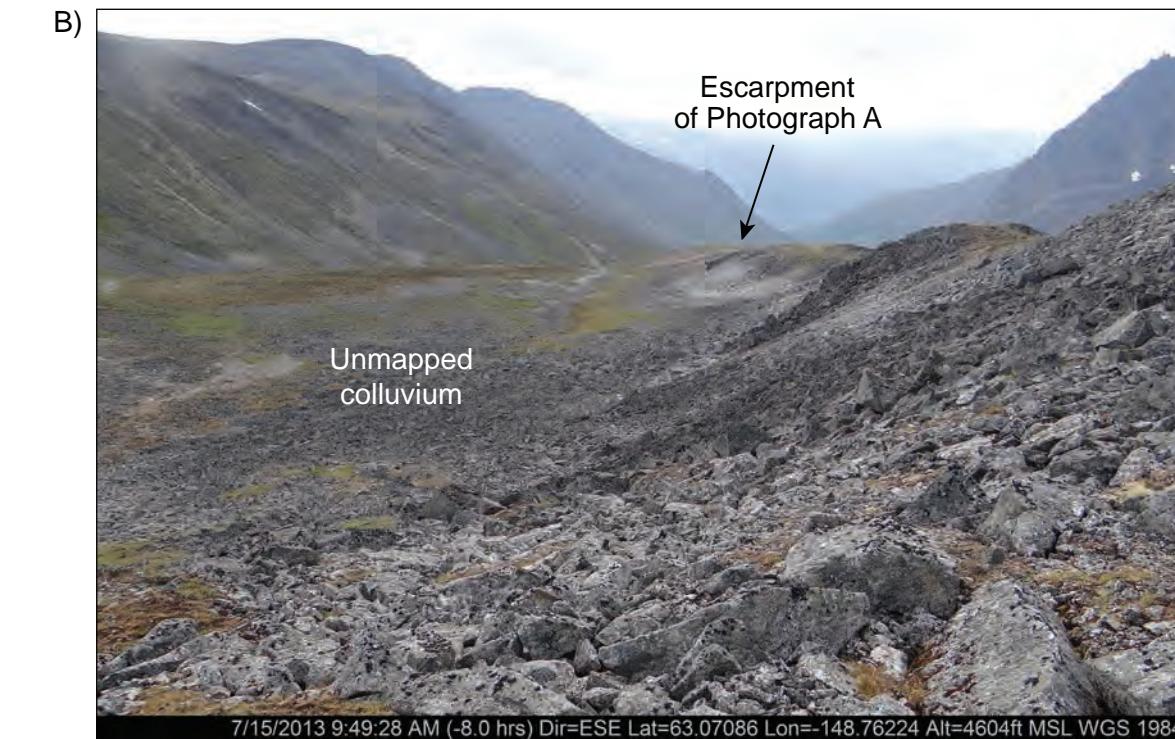
View looking east along lower talus scree field that shows decreasing relief at west end of lineament 3b.

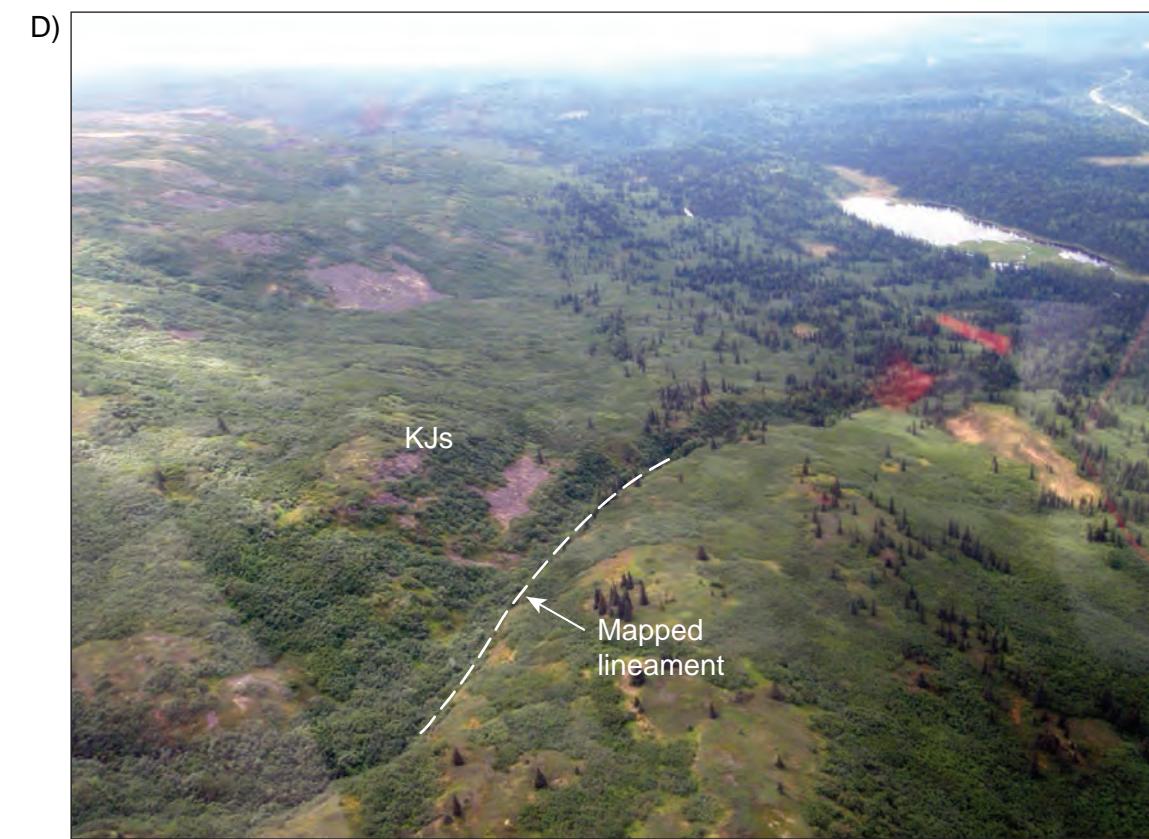
View of drainage with mapped lineament approximately shown.

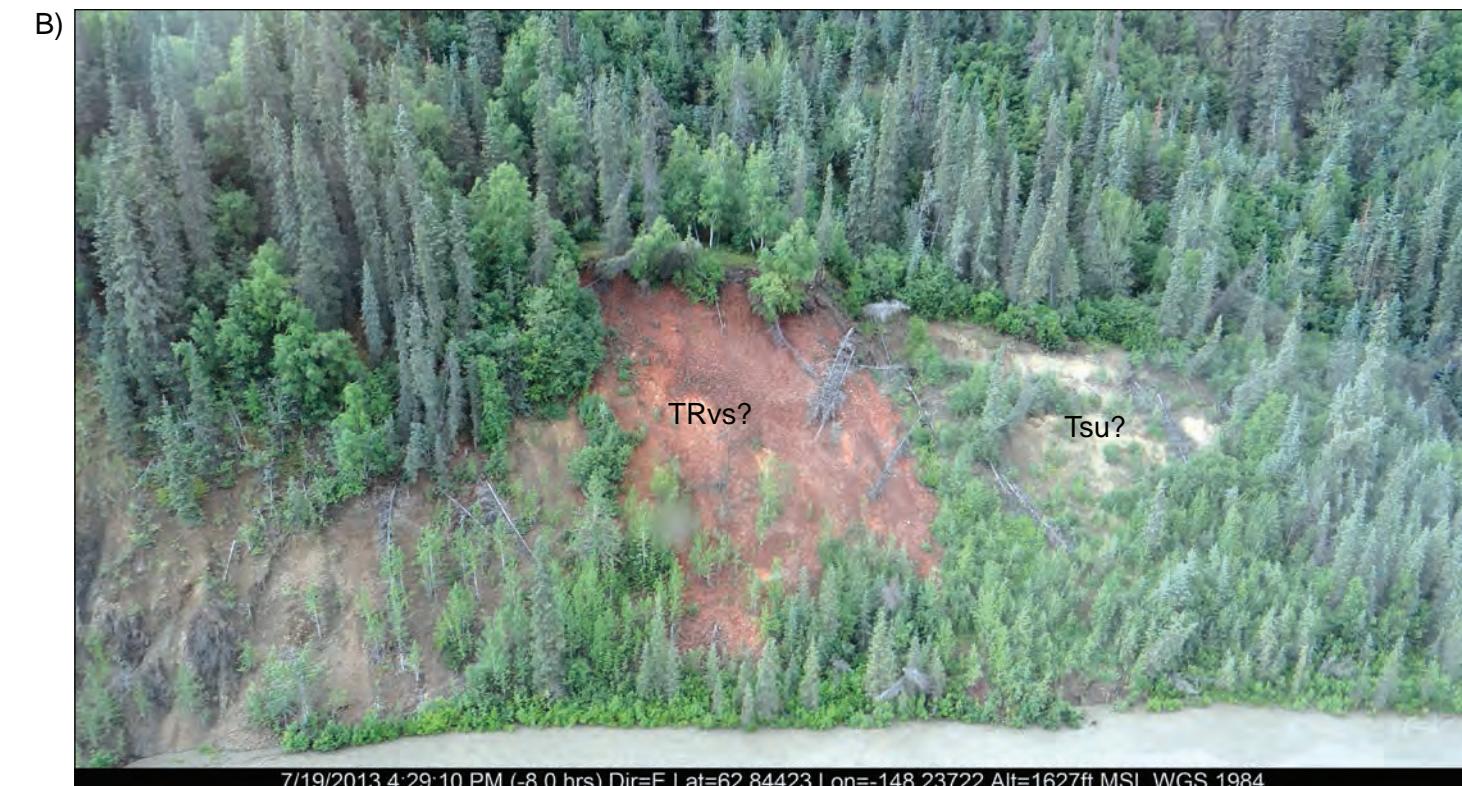
View looking east along lower river bank at apparent alternation zone distinguished by color contrast, possible juxtaposition of Triassic metabasalts and undifferentiated Tertiary sediments. This location is east of the mapped projections of the Talkeetna fault.

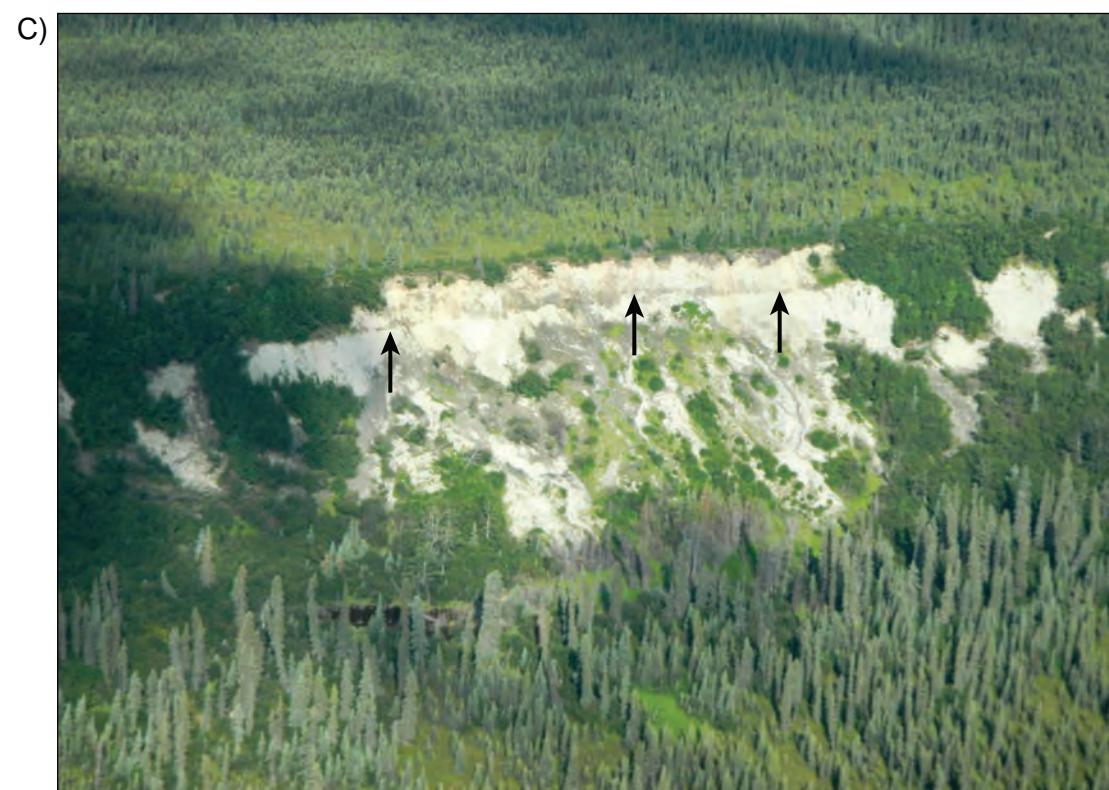
View looking east at apparent flat-lying contact between Quaternary lake sediments (above) and Quaternary till (below). Arrows point to contact.

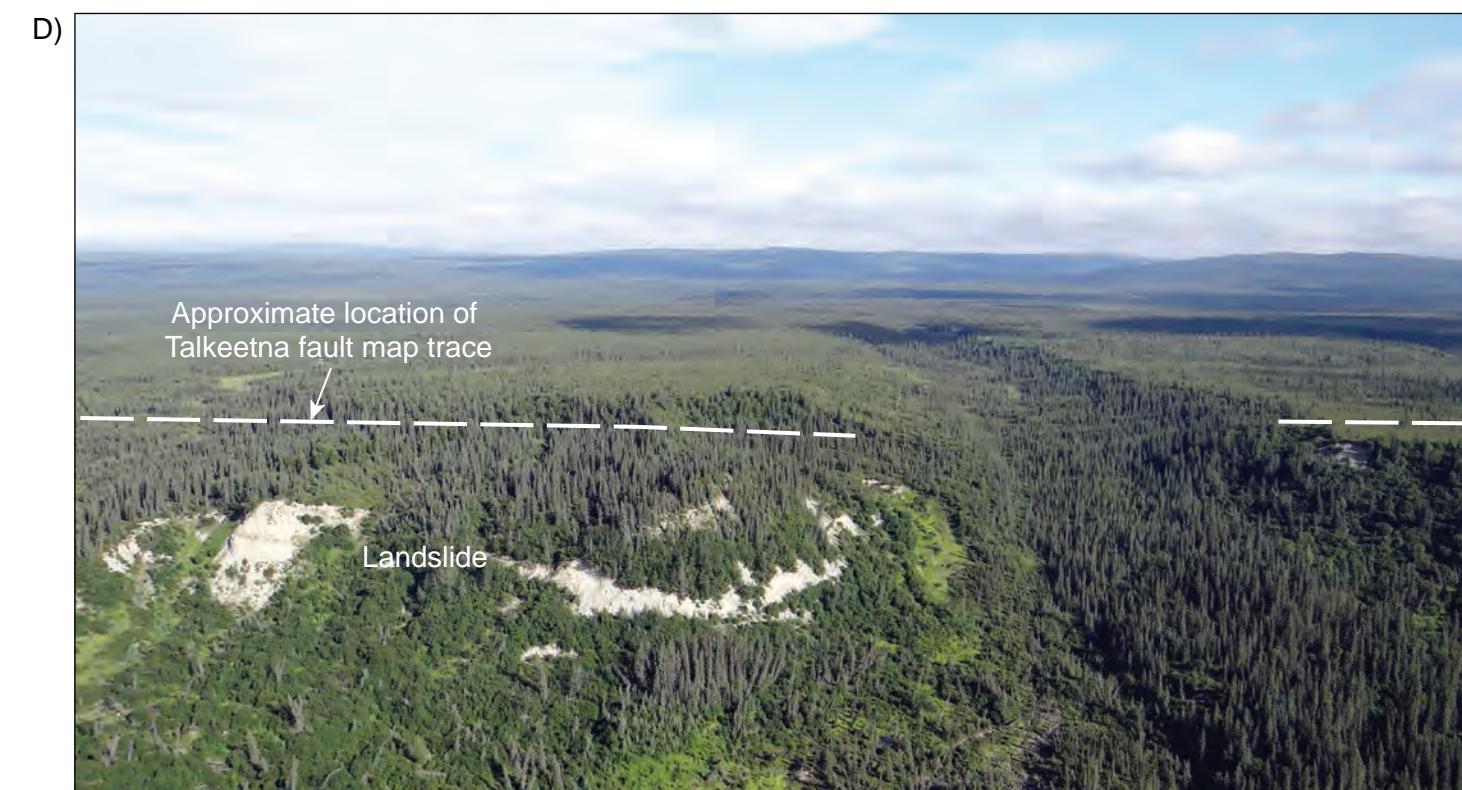
View looking west at projected trace of Talkeetna fault whose ground expression is absent in Quaternary surface.

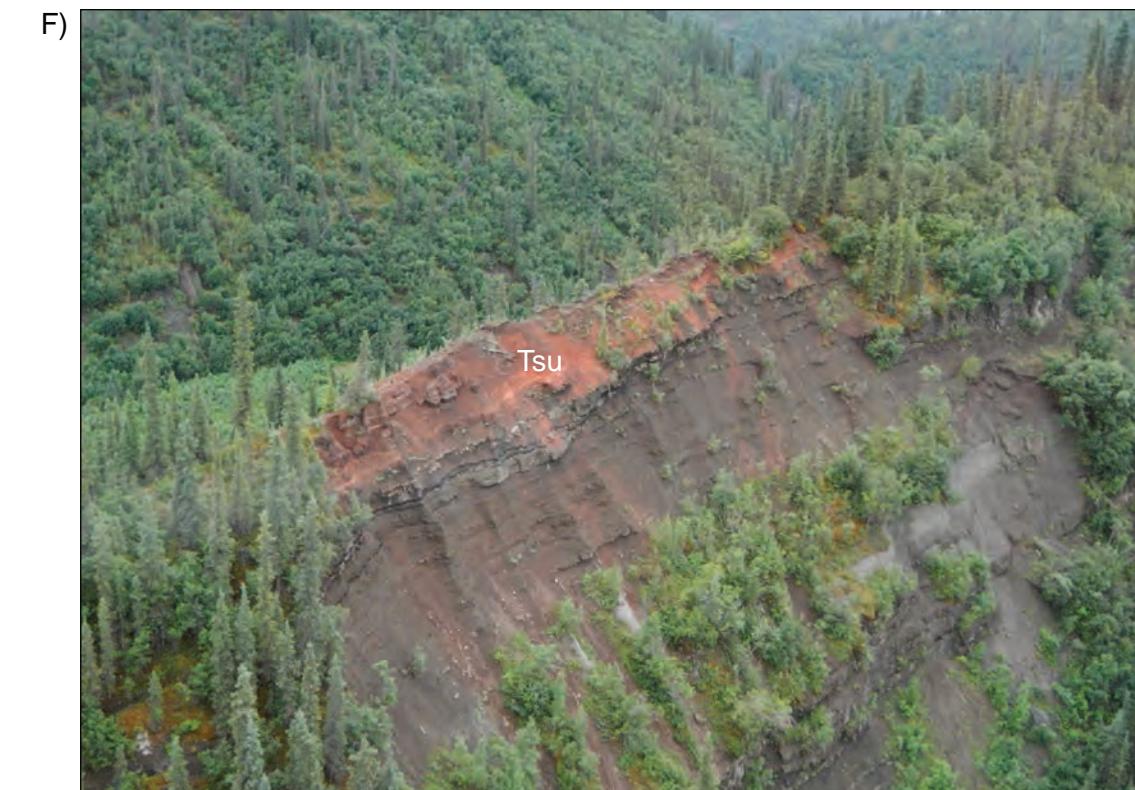
View looking west at apparently northwest-dipping beds in Tertiary sediments, relatively consistent with northwest dips measured by WCC (1982) in Tertiary sediments along west bank Watana Creek.

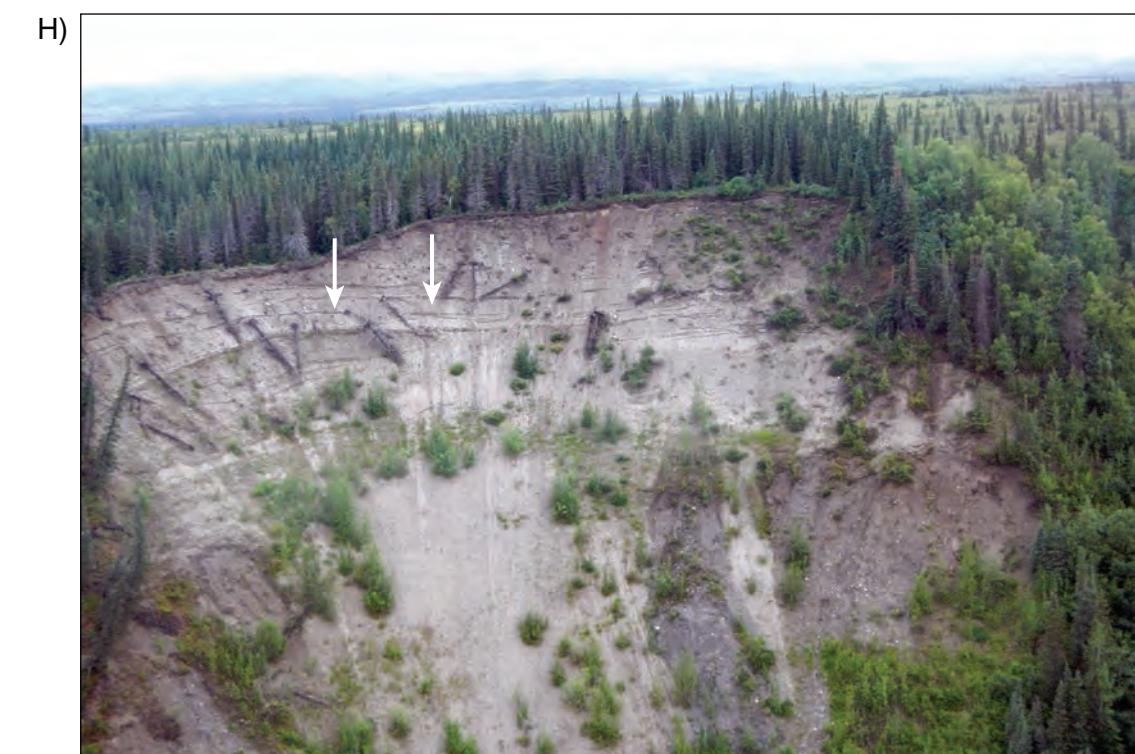
View looking west at bedded (lake?) stratigraphy exposed in eroding bluff. Beds appear relatively horizontal, but may have a sense of non-planar geometry because of semi-circular outcrop. Note fallen trees that indicate erosion/slope movement.

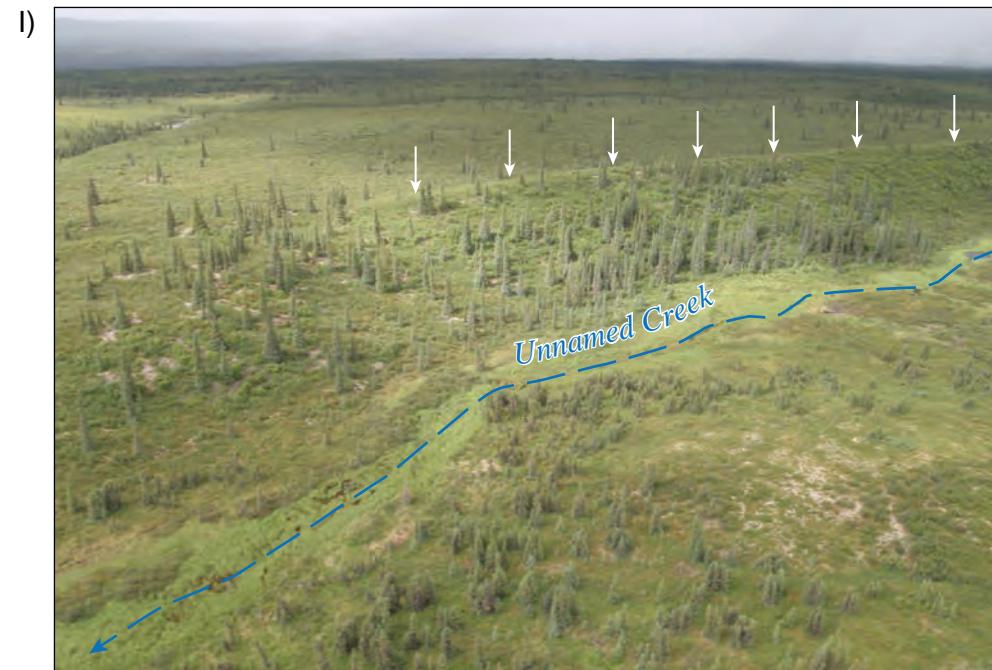
View looking north at linear esker nearly coincident with map projection of Talkeetna fault. See Figure A6.1 for location. Arrows point to esker crest.

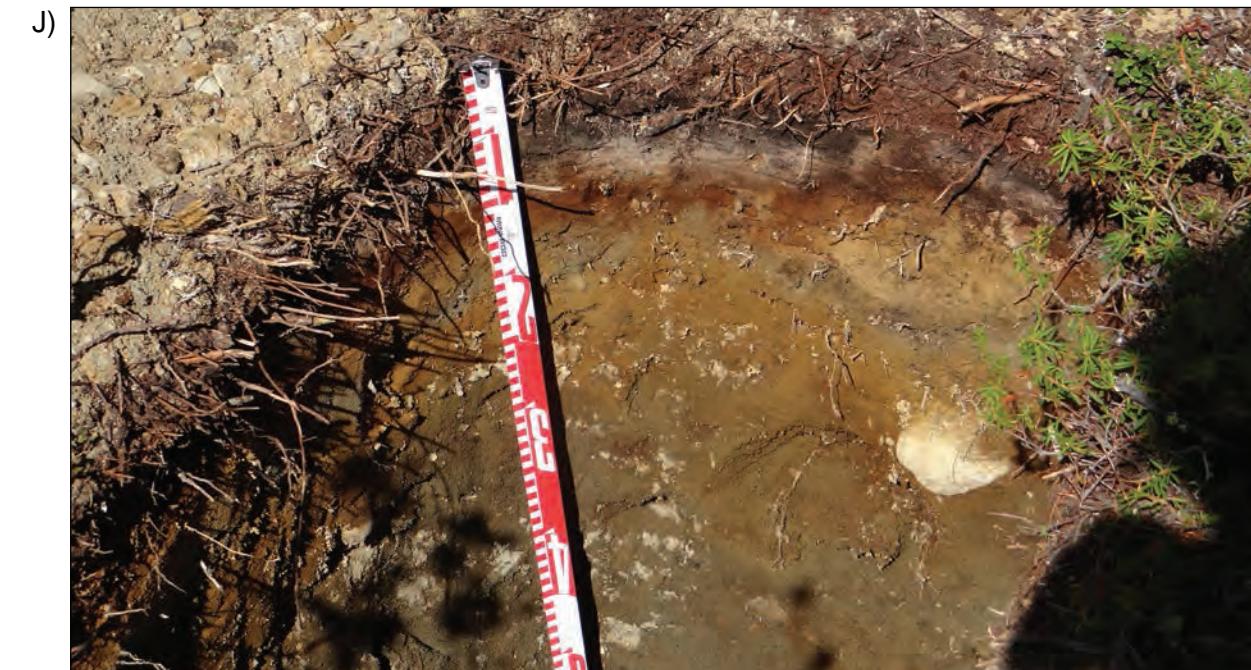
View looking at shallow soil pit dug in esker crest. Upper black, gray, and reddish soil layers are Holocene tephras. Scale is in centimeters; the upper 45 centimeters of the pit are in view.

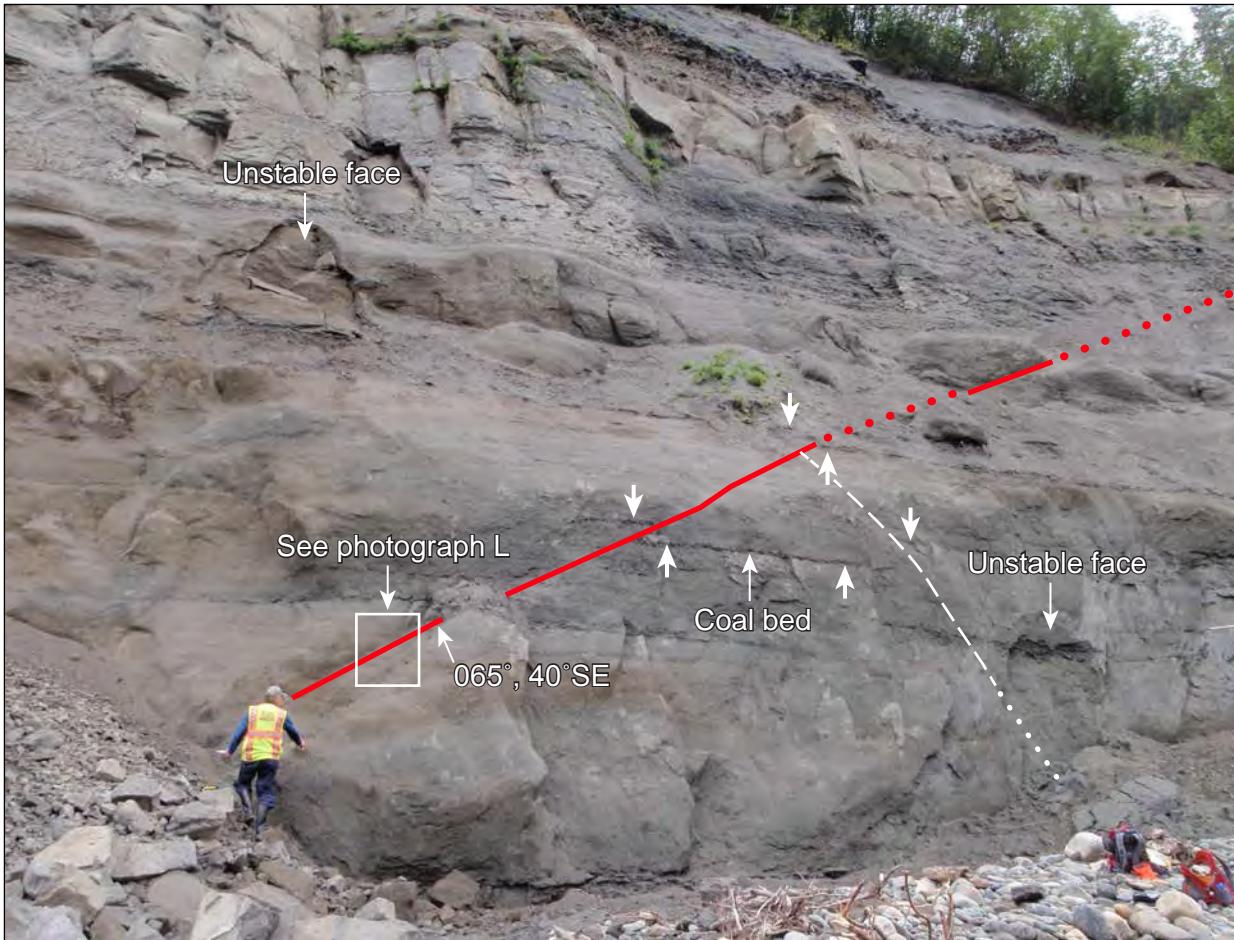
K)

Photograph of faulted outcrop with coal bed. Visually estimated 60-80 cm of separation along the fault plane. Second fault appears to terminate against primary fault (065, 40°SE) extends across the outcrop.

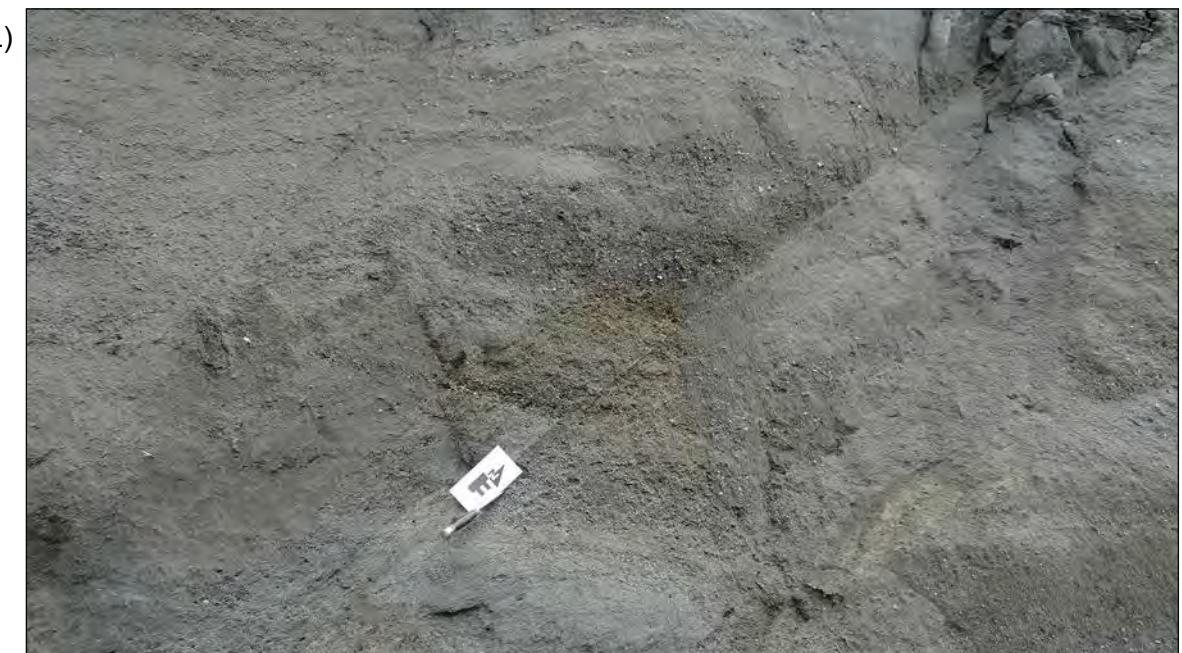
L)

Detail of fault plane. Placard is 6 inches (15 cm) in length; fault plane is approximately 1 cm wide.

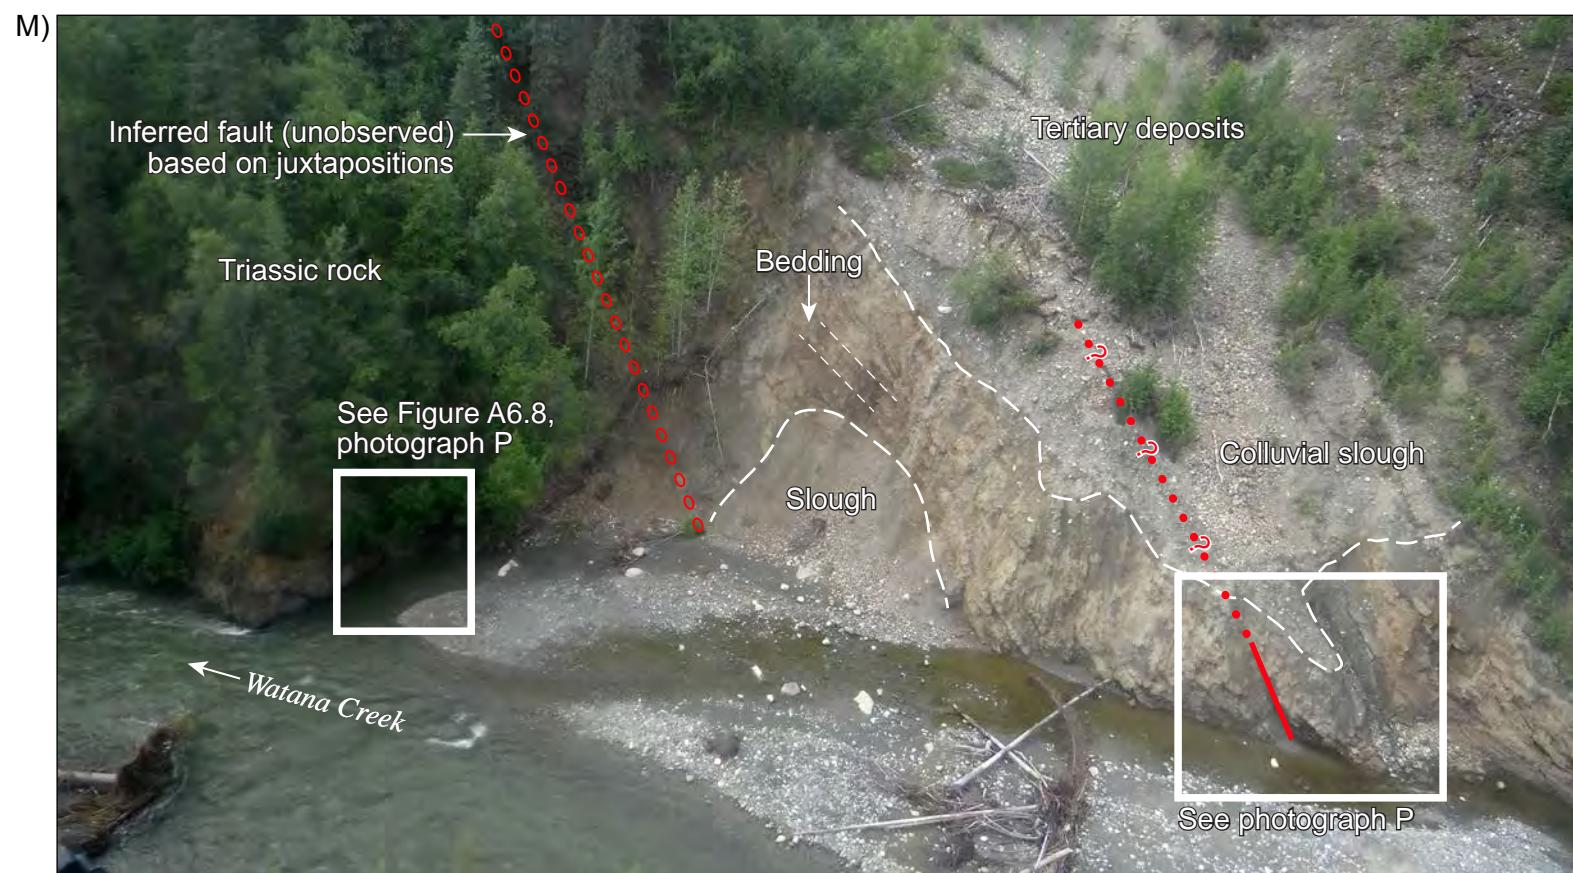
Aerial view looking approximately south-southwest. Triassic rocks are densely vegetated.

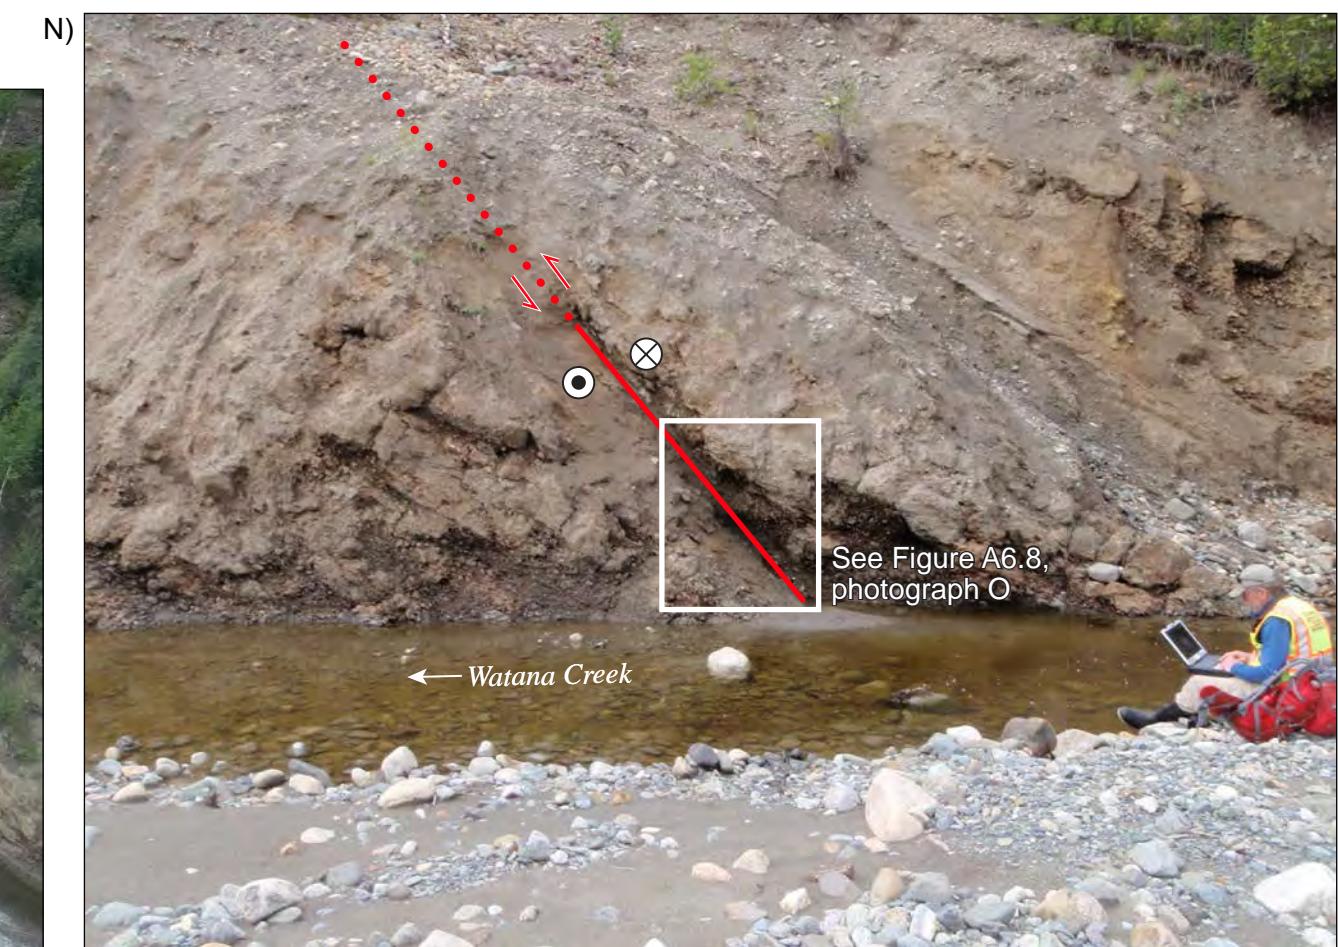
View looking west at lower part of Tertiary deposit toward uncleared exposure of fault (065-080° strike; 65°N dip). Left-lateral oblique relative movement.

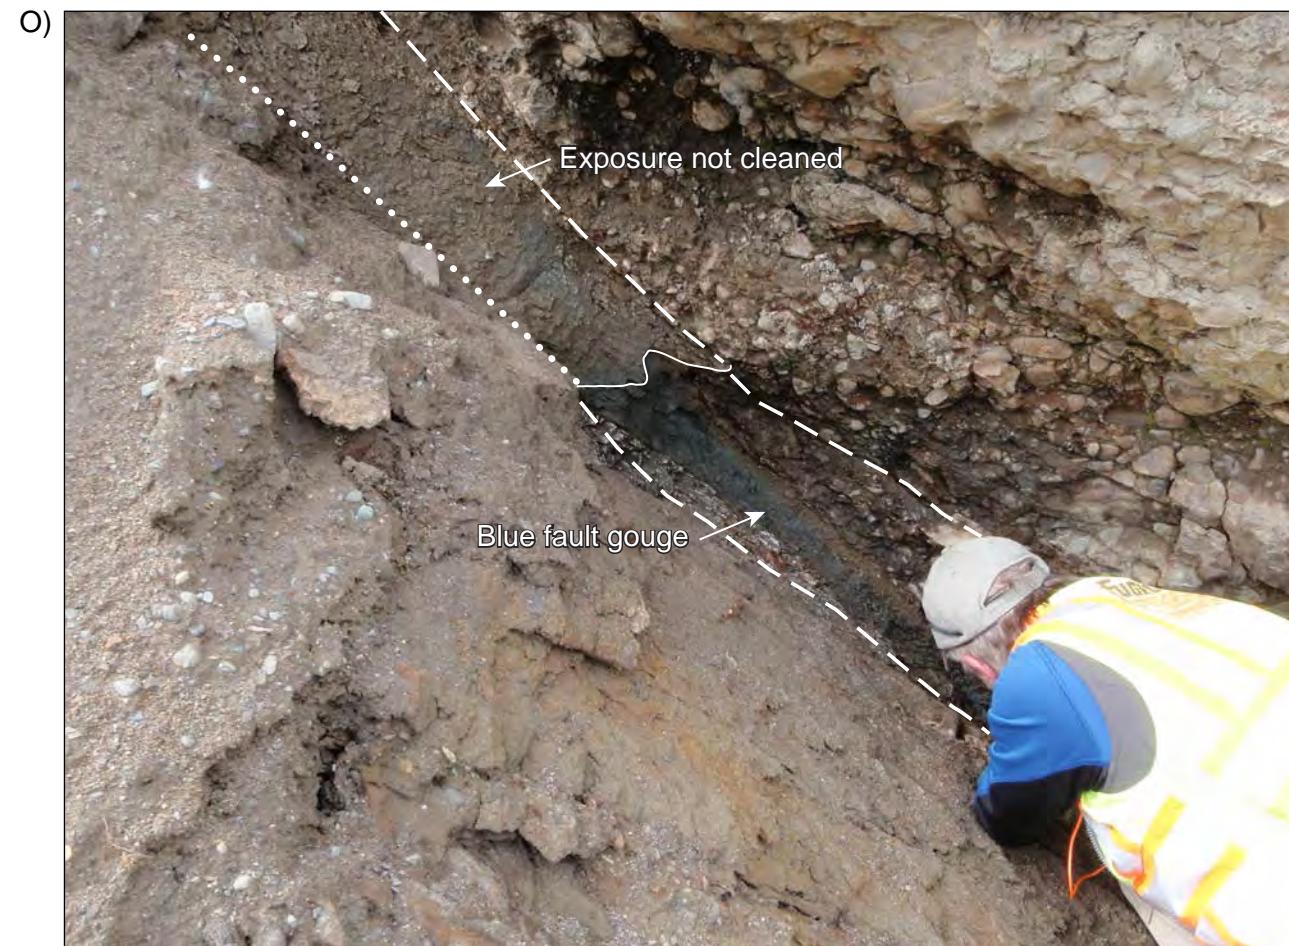
Close up of fault in cobble-rich Tertiary deposit.

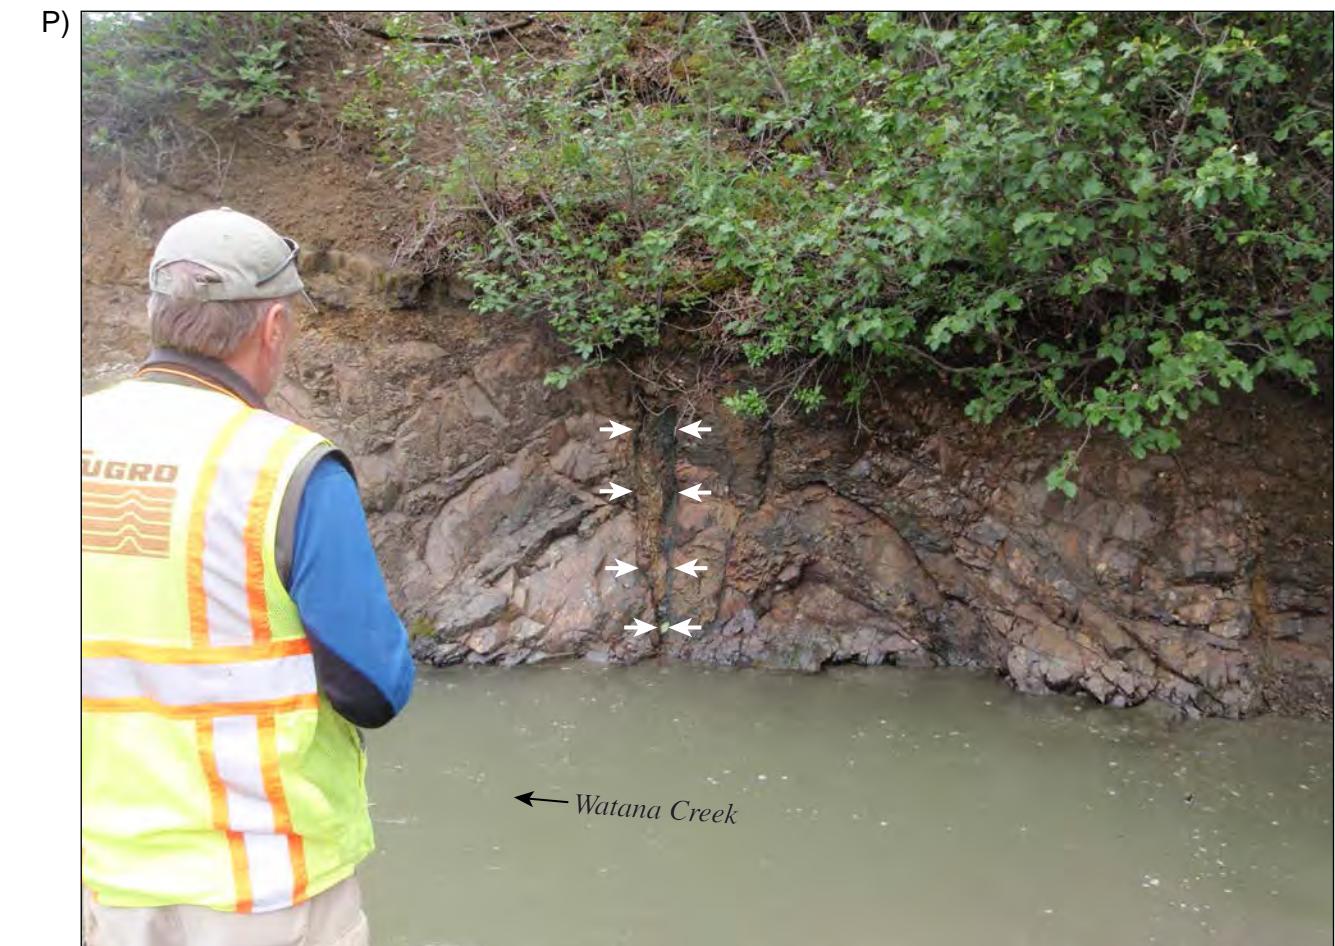
View looking south at vertical fault in Triassic rocks; visually estimated apparent strike is northeast.

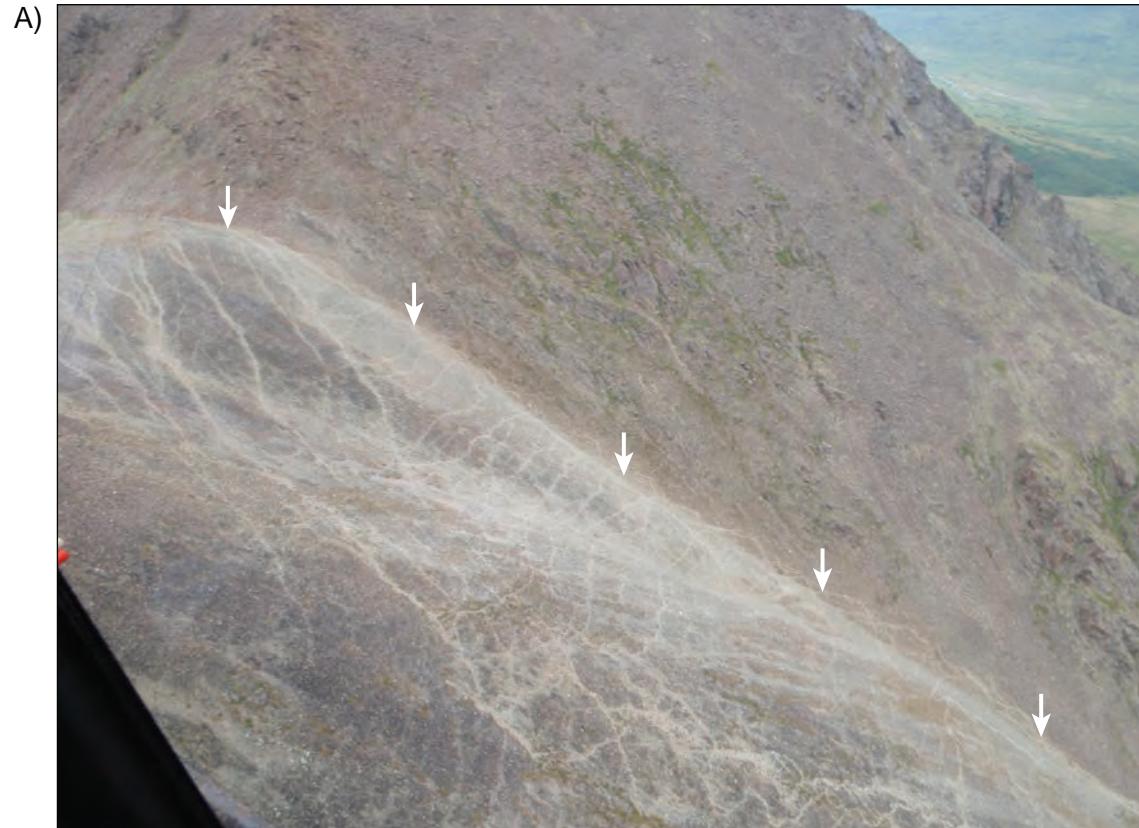
View looking at color contrast at previously mapped bedrock fault.

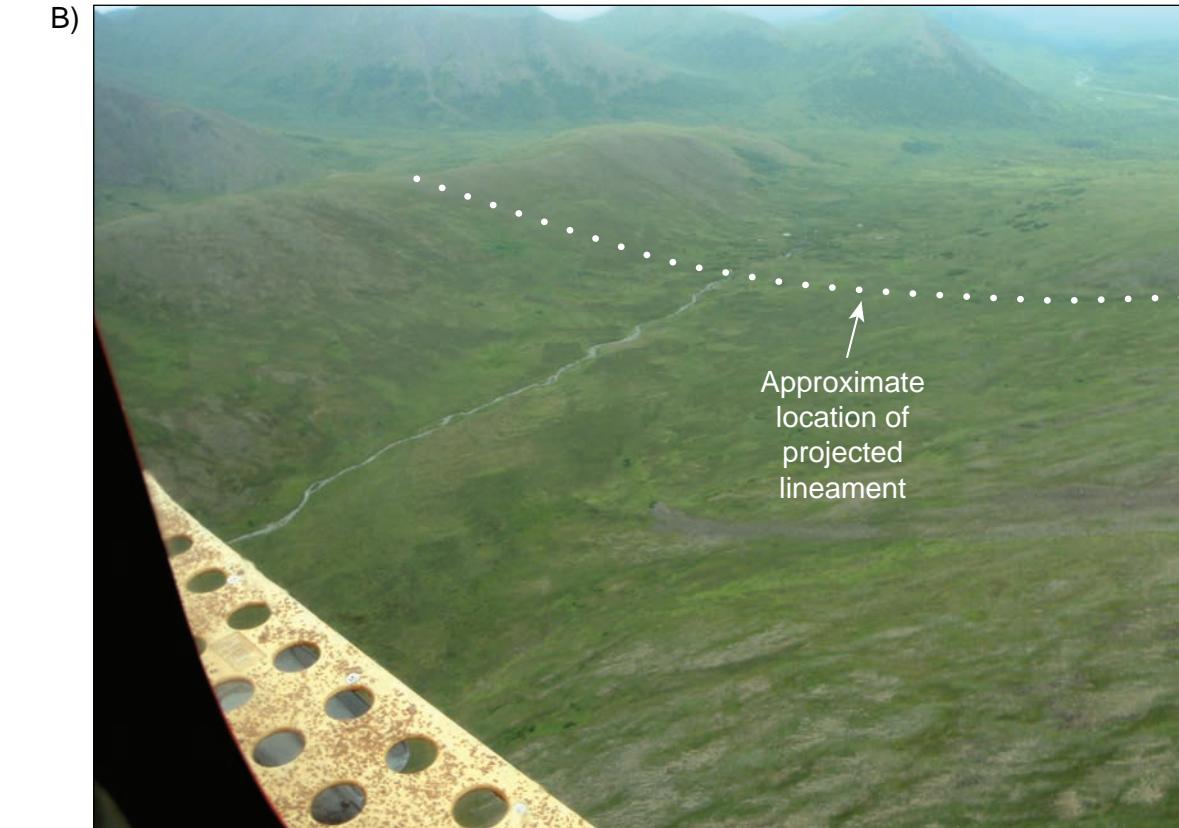
View looking west down-valley at apparent undeformed glacial sediments.

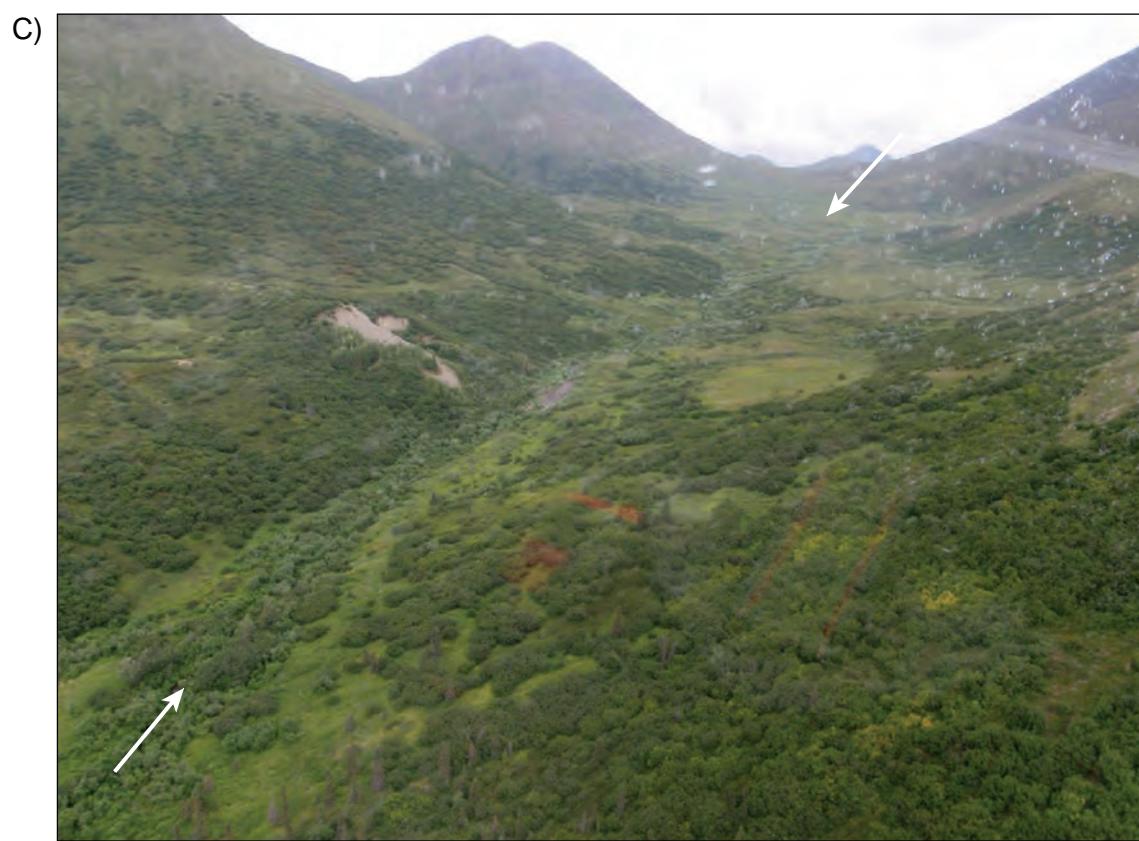
View looking up-valley at incised drainage that coincides with mapped lineament and previously mapped fault.
