**Appendix A:**  
**Strip Maps and Photographic Documentation**  
**of Lineament Data Presented in FCL (2013)**

<p>FUGRO Date 01/06/14</p> <p>STATE OF ALASKA ALASKA ENERGY AUTHORITY <b>ALASKA</b> ENERGY AUTHORITY</p> <p>SUSITNA-WATANA HYDROELECTRIC PROJECT STRIP MAPS EXPLANATION 2 OF 4</p> <p>FIGURE A0.3</p>

**SUSITNA-WATANA HYDROELECTRIC PROJECT**

**LINEAMENT GROUP 6**

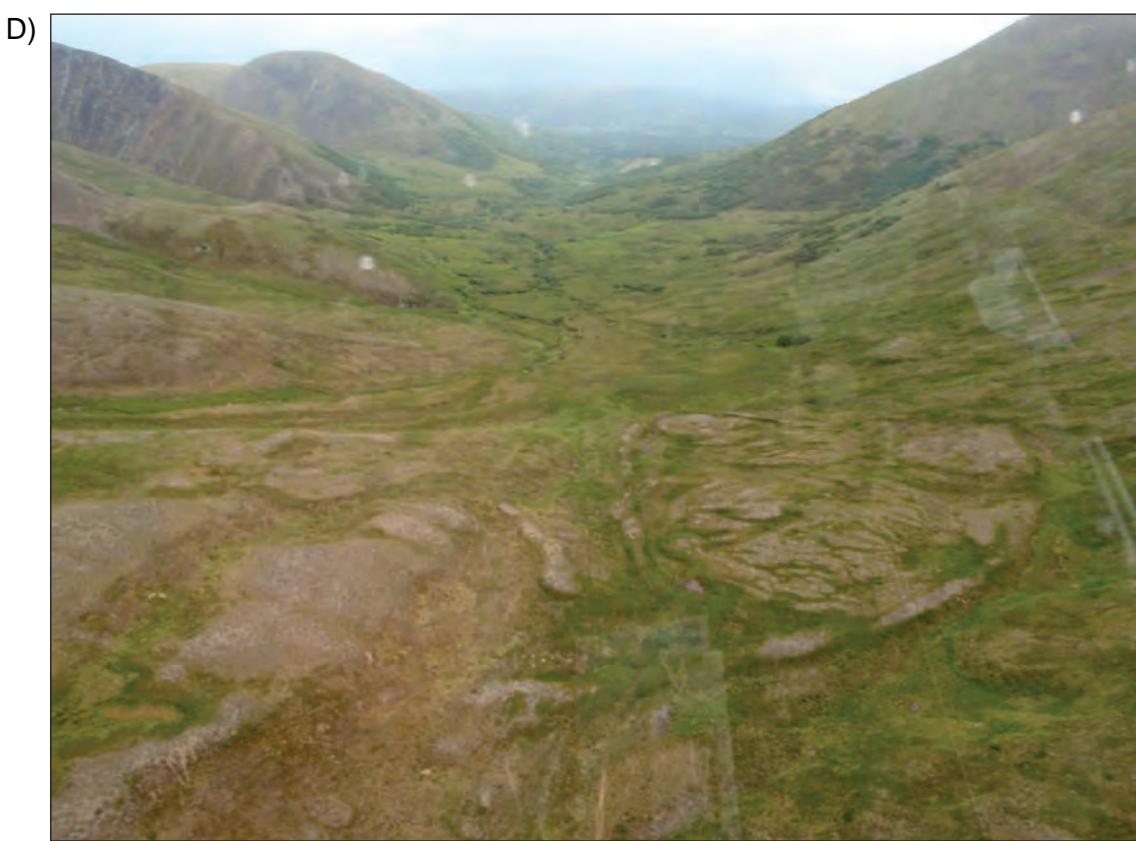
View looking down-valley from the top of the drainage seen in Photograph C.

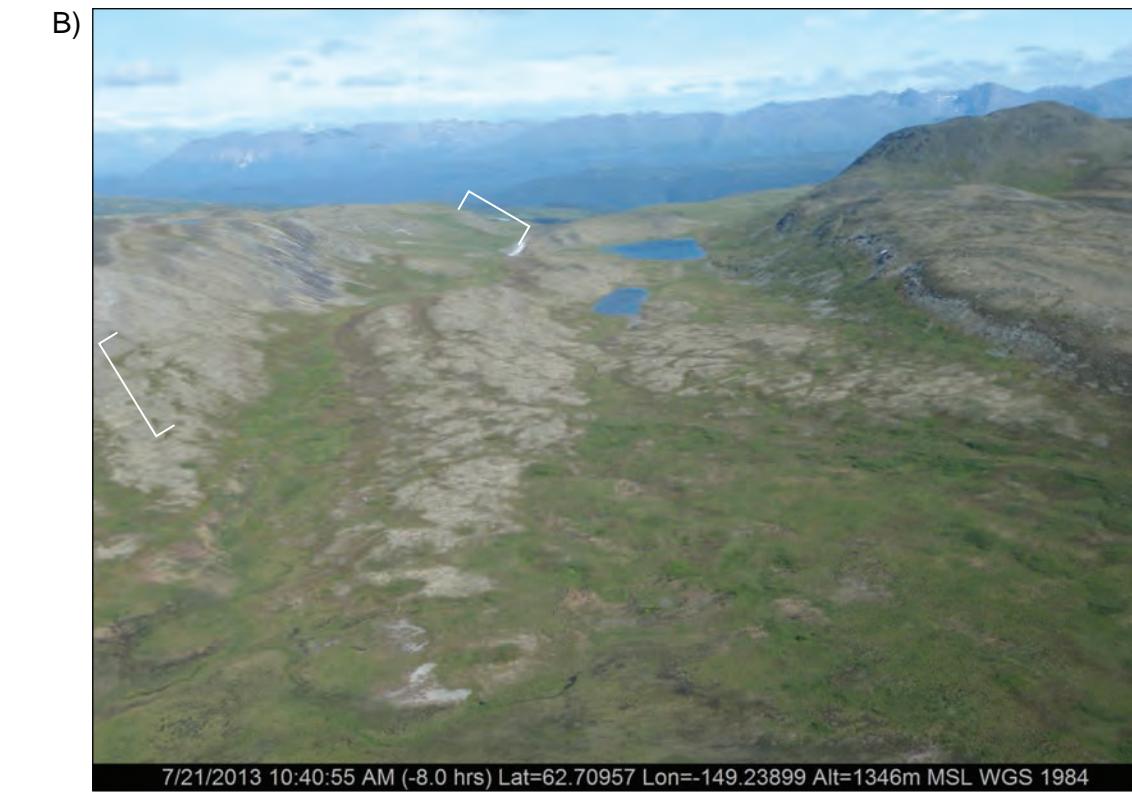
Close up view of saddle area shown in Photograph A. Brackets, again, show position of fault but note that no geomorphic expression of faulting is readily apparent.

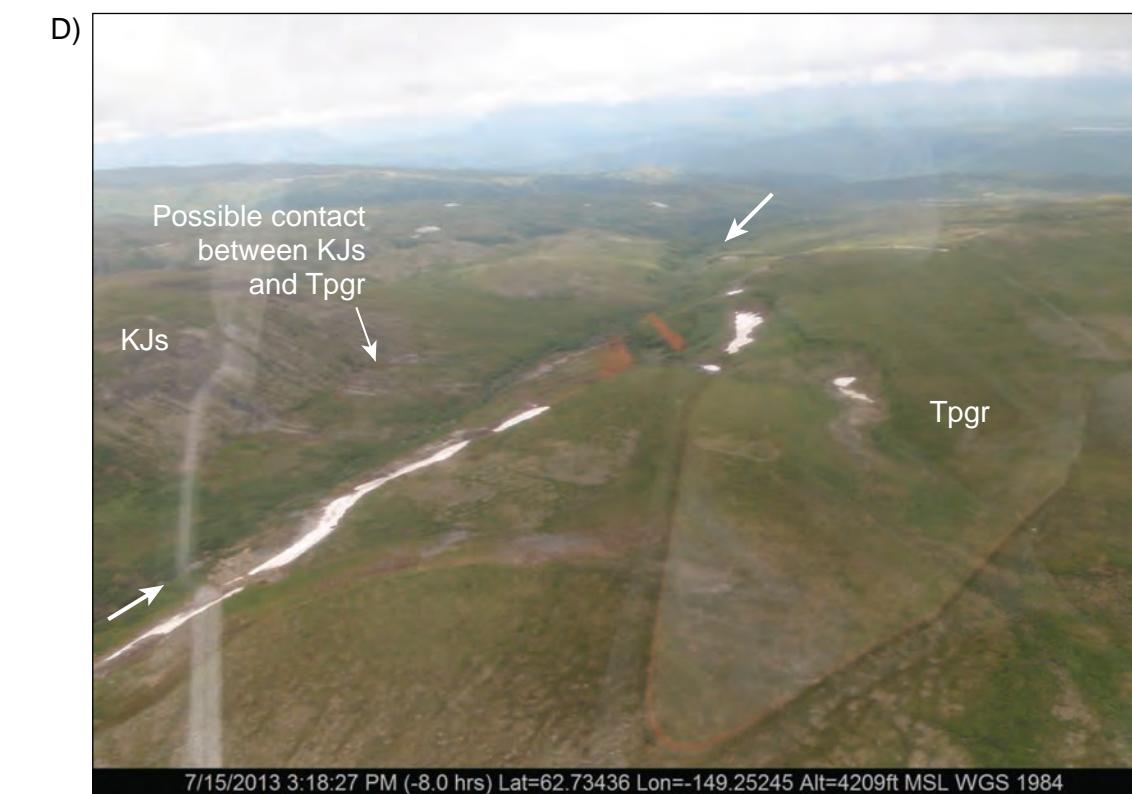
View looking north down the prominent, deeply incised linear drainage. Mapped fault runs between large arrows.

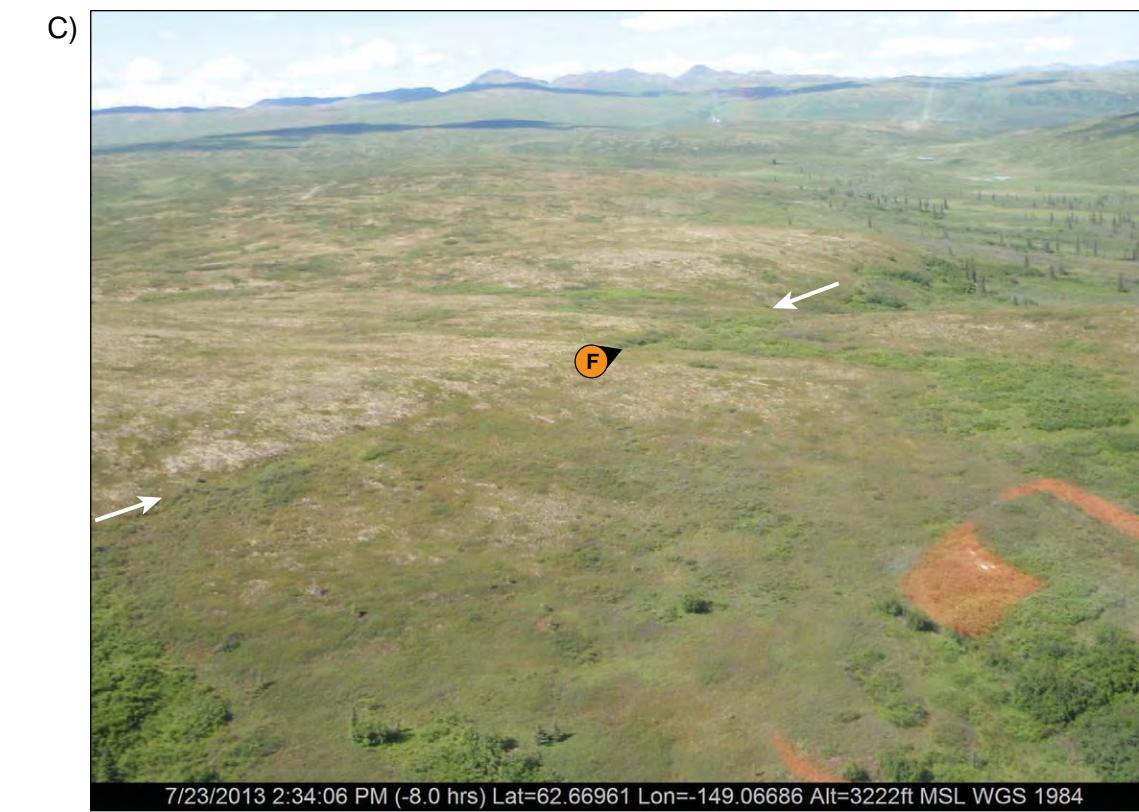
Photograph 3 of 5 looking northwest. Large arrows point along lineament.

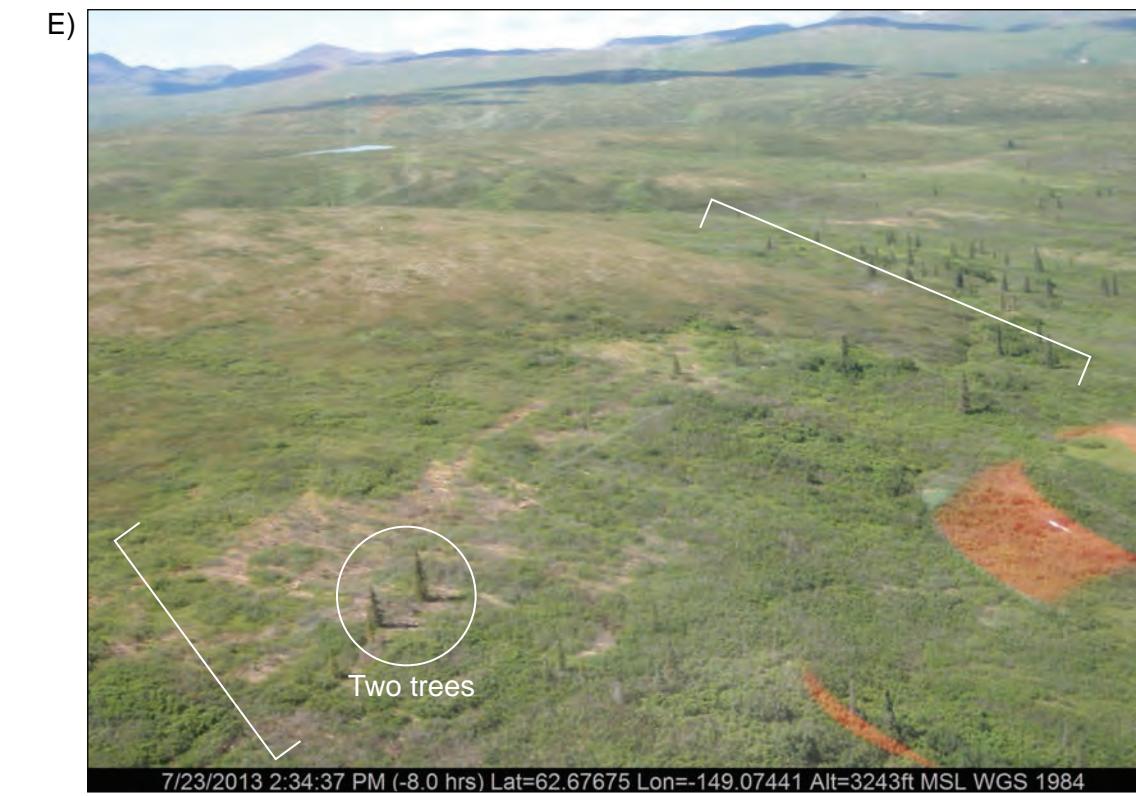
Photograph 5 of 5 with view looking northwest. Note that lineament expression has died out and brackets bound the location of its projection.

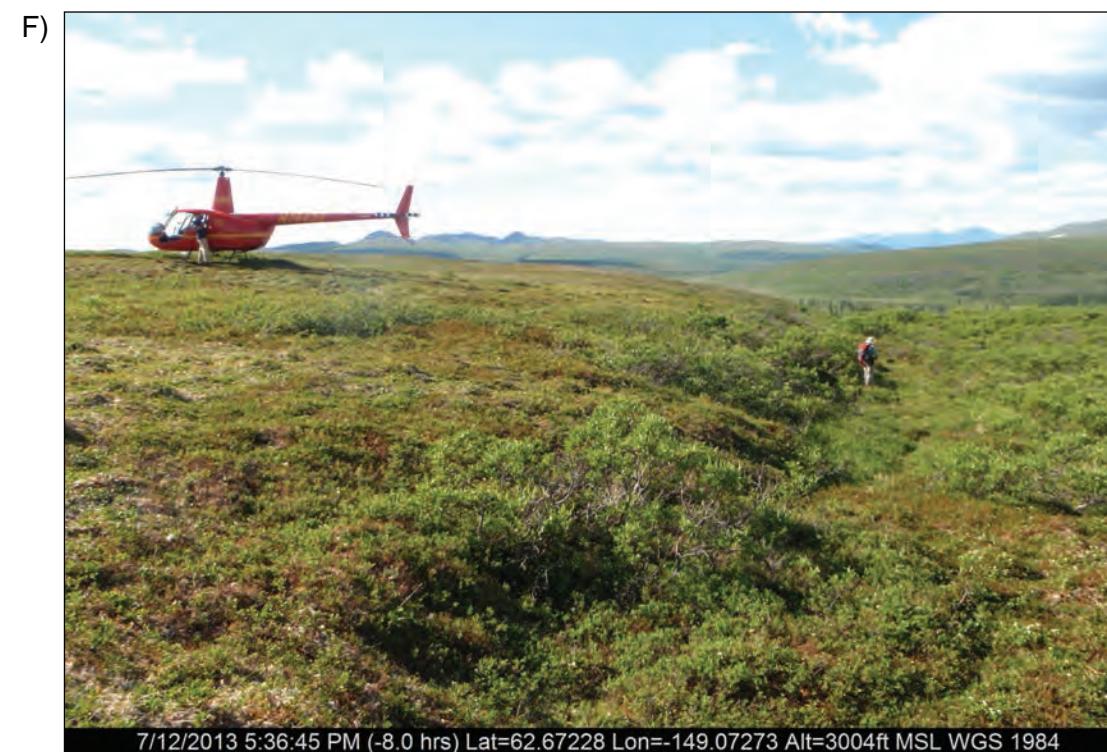
View looking north from location F. Geologist at base of east-facing break-in-slope is 170 cm tall.

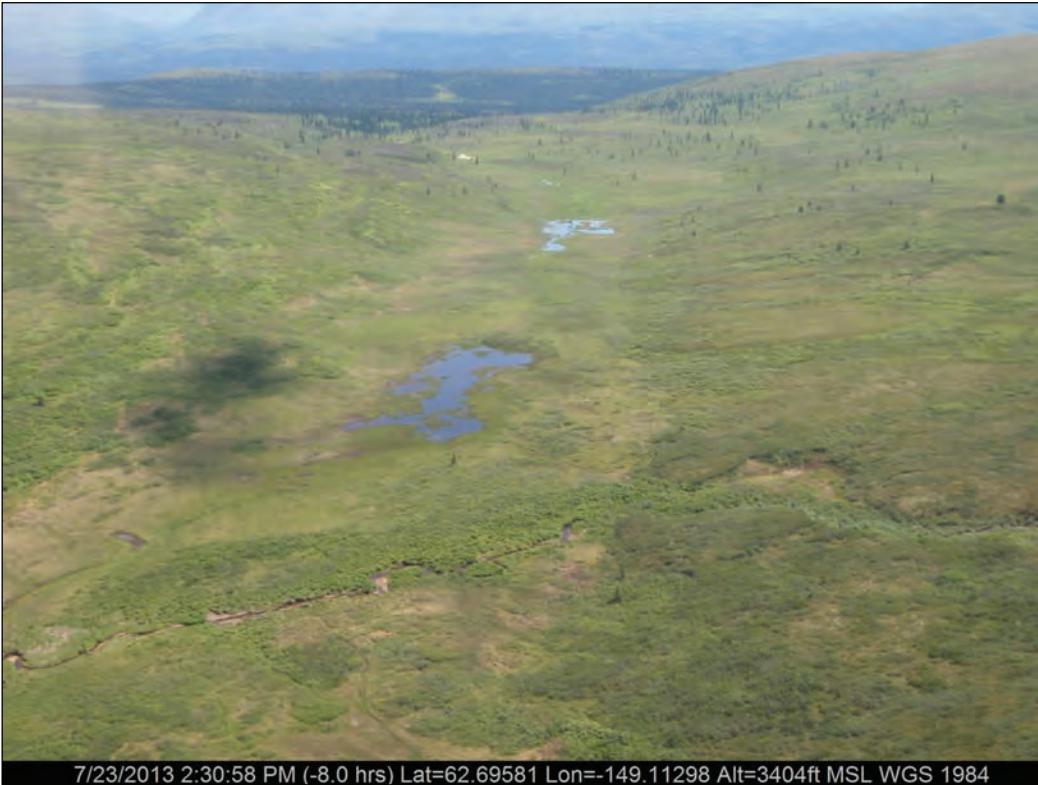
H)

View looking south from location I across area within WCC's segment 3. Note the lack of expression of any lineaments in the broad depression.

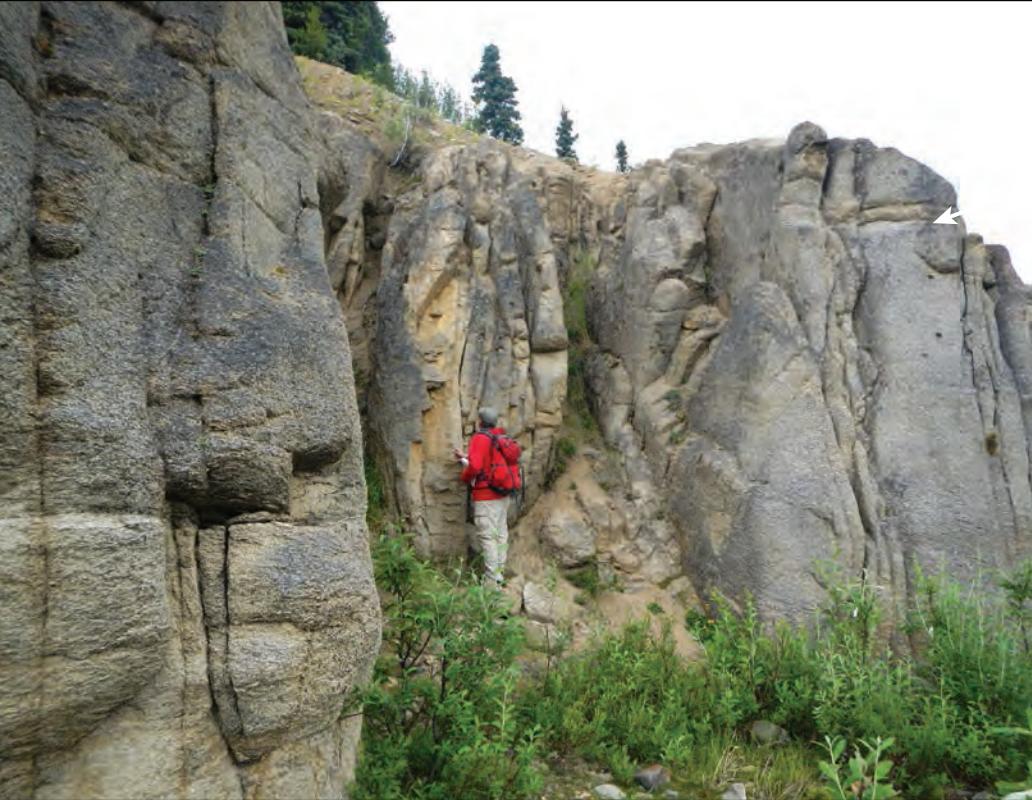
I)

Exposures of widespread granodiorite in unnamed creek near GPS waypoint 176 in terrain mapped as flysch (map unit KJs) by Wilson et al. (2009). The geologist is approximately 175 cm tall.

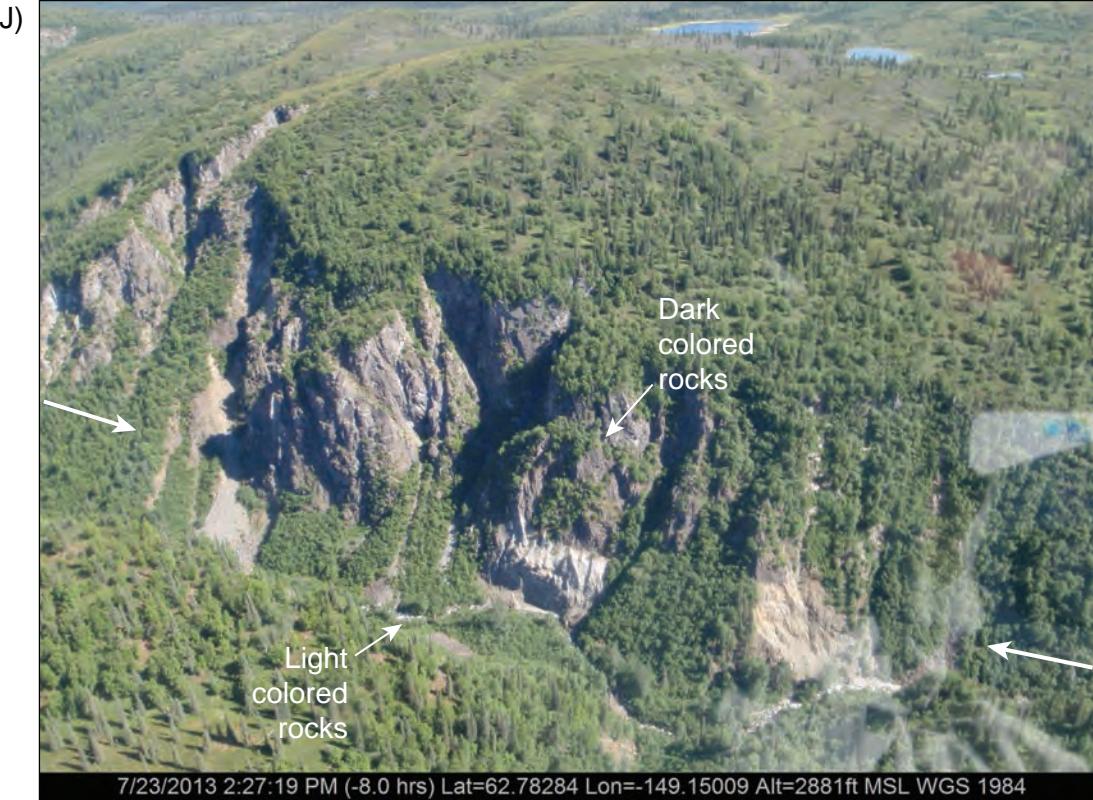
J)

View looking northeast at right wall of linear v-shaped canyon. Large arrows point along apparent bedrock type contrast.

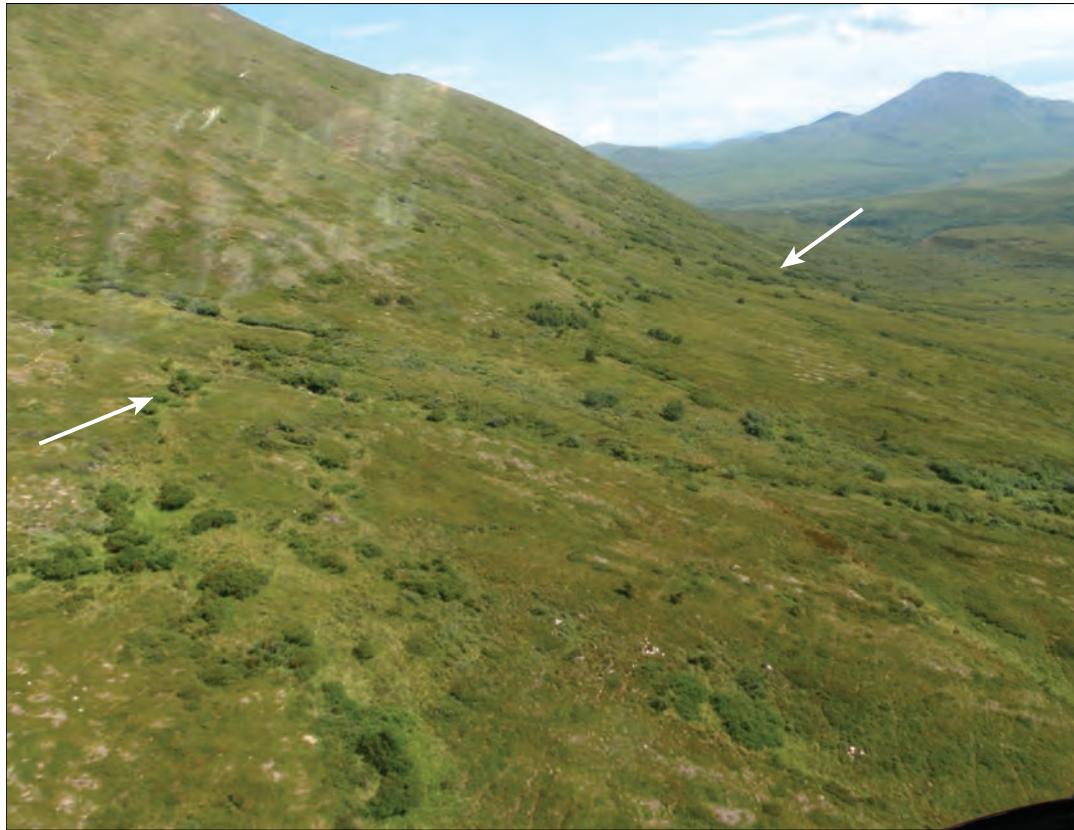
A)

View looking northeasterly along lineaments. Arrows point along trend and position of lineaments.

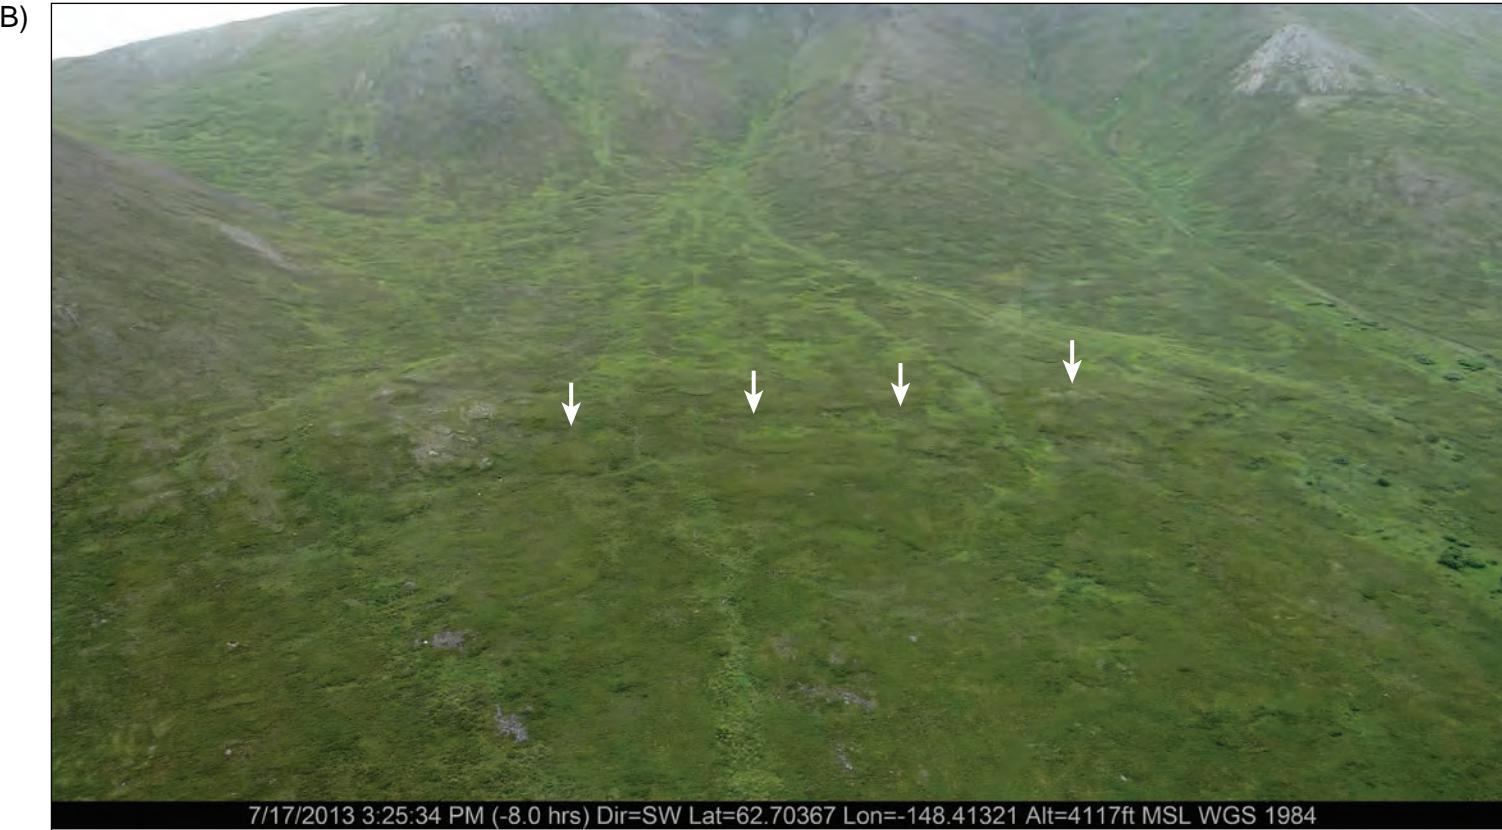
B)

View of lineaments expressed in Quaternary sediment.

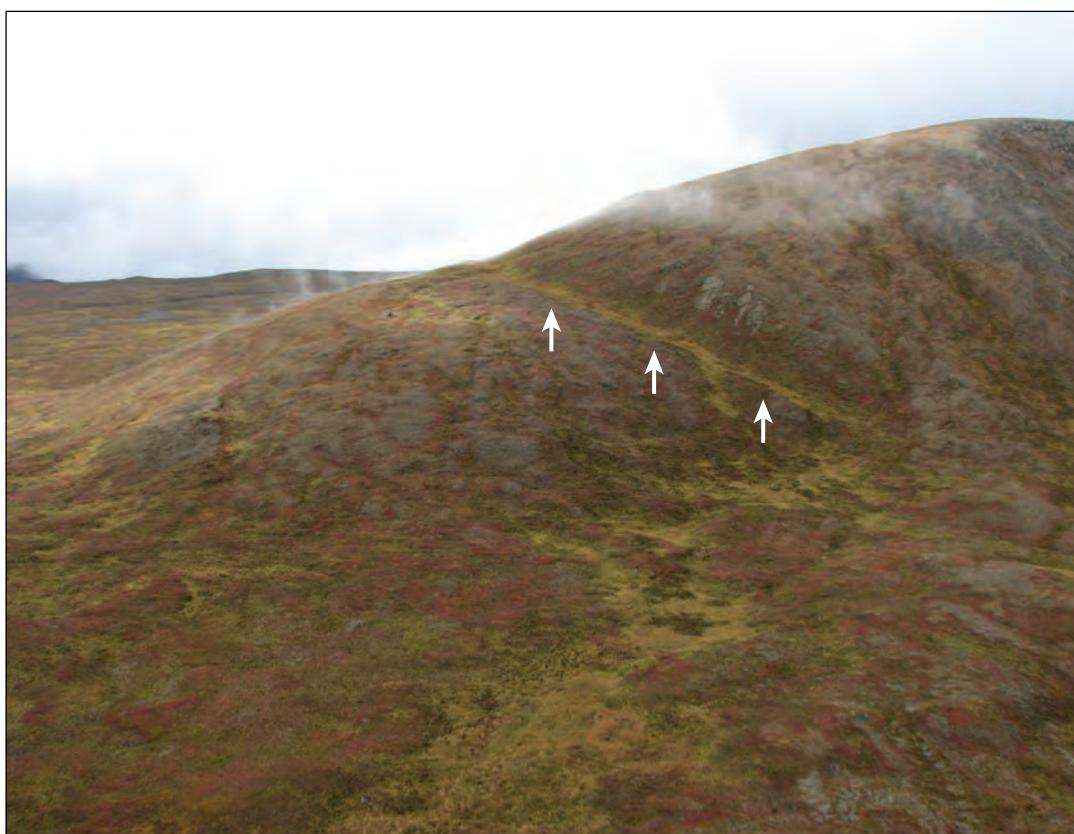
C)

View looking at notch in bedrock with expression of apparent northwesterly dip.

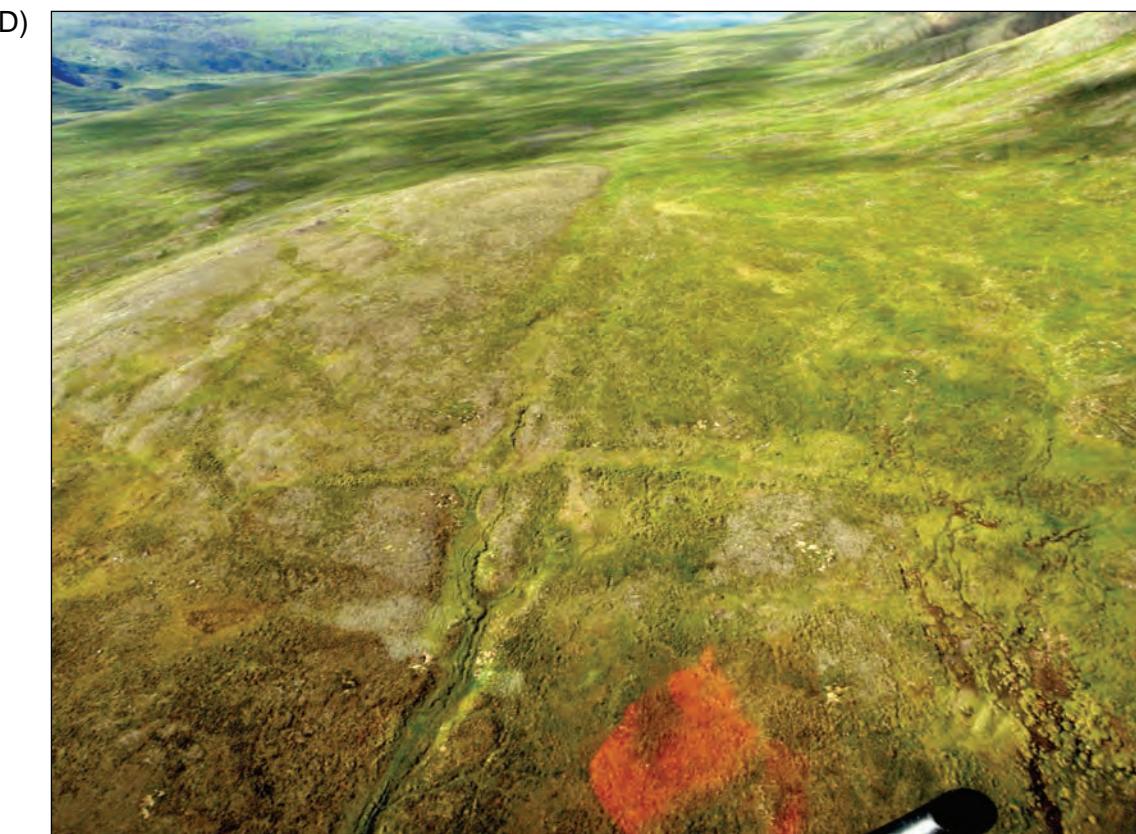
D)

View looking southwesterly along glacially scoured surface.

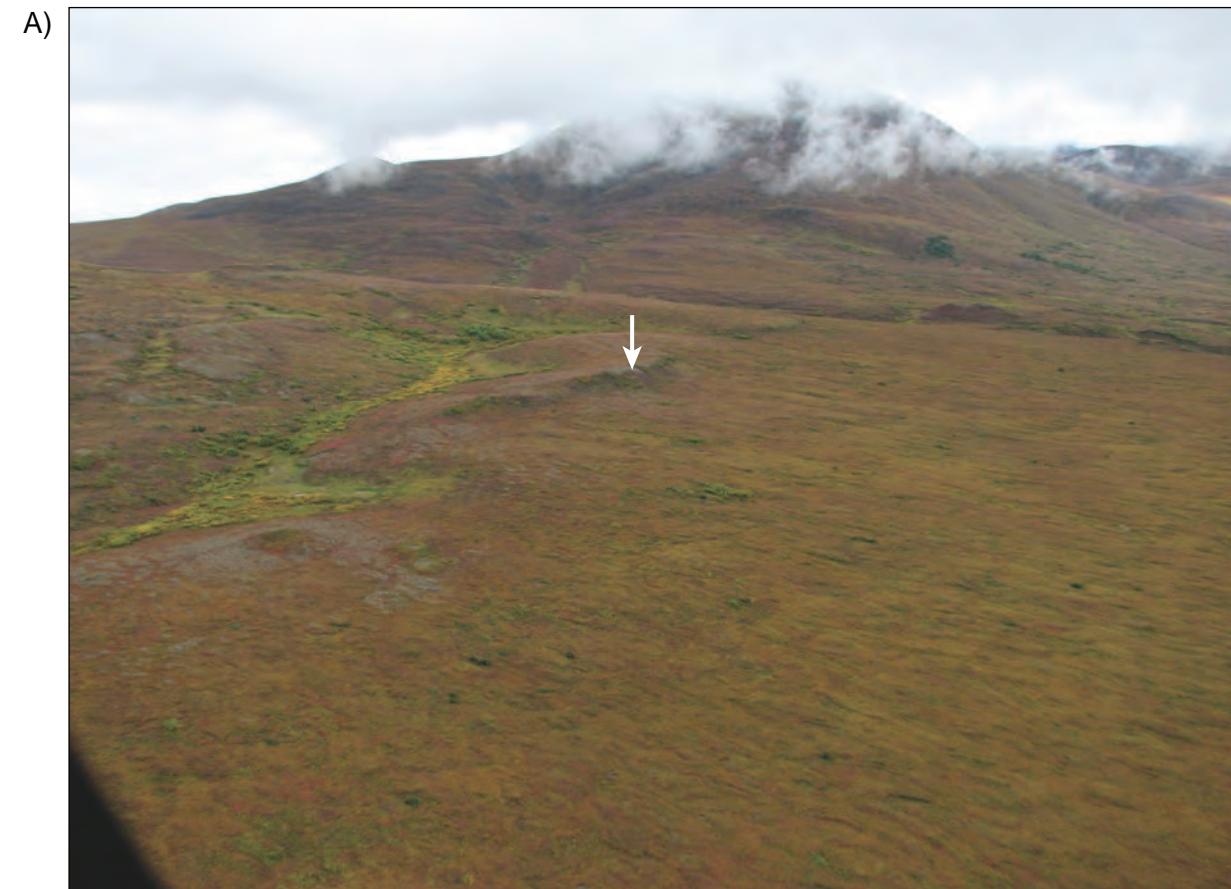
View looking northeast at erosional break-in-slope mapped as an individual lineament. Feature is absent in the background along projection of strike.

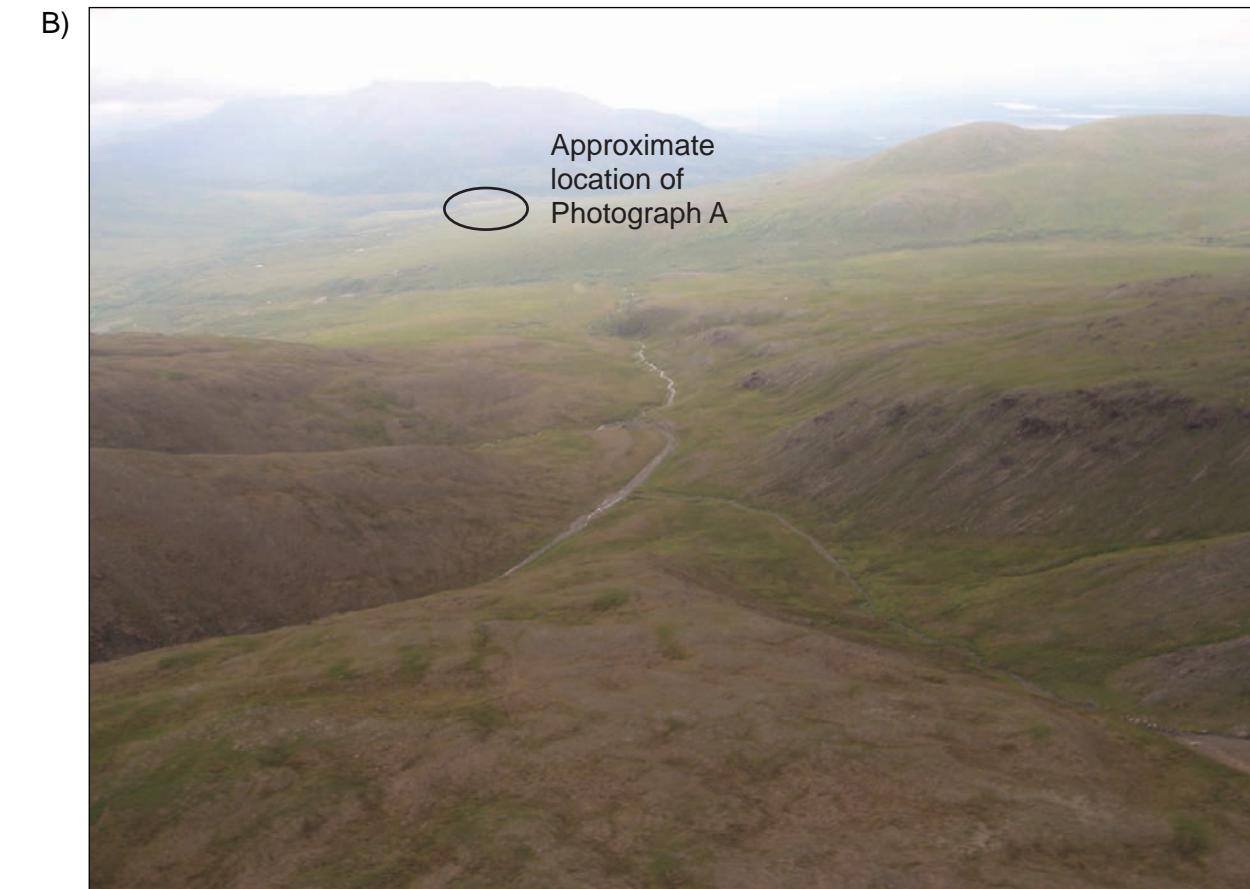
View looking southwest down-valley along lineament geomorphically expressed as linear valley. Very little alluvium has accumulated in the drainage, and glacially sculpted bedrock is shallow.

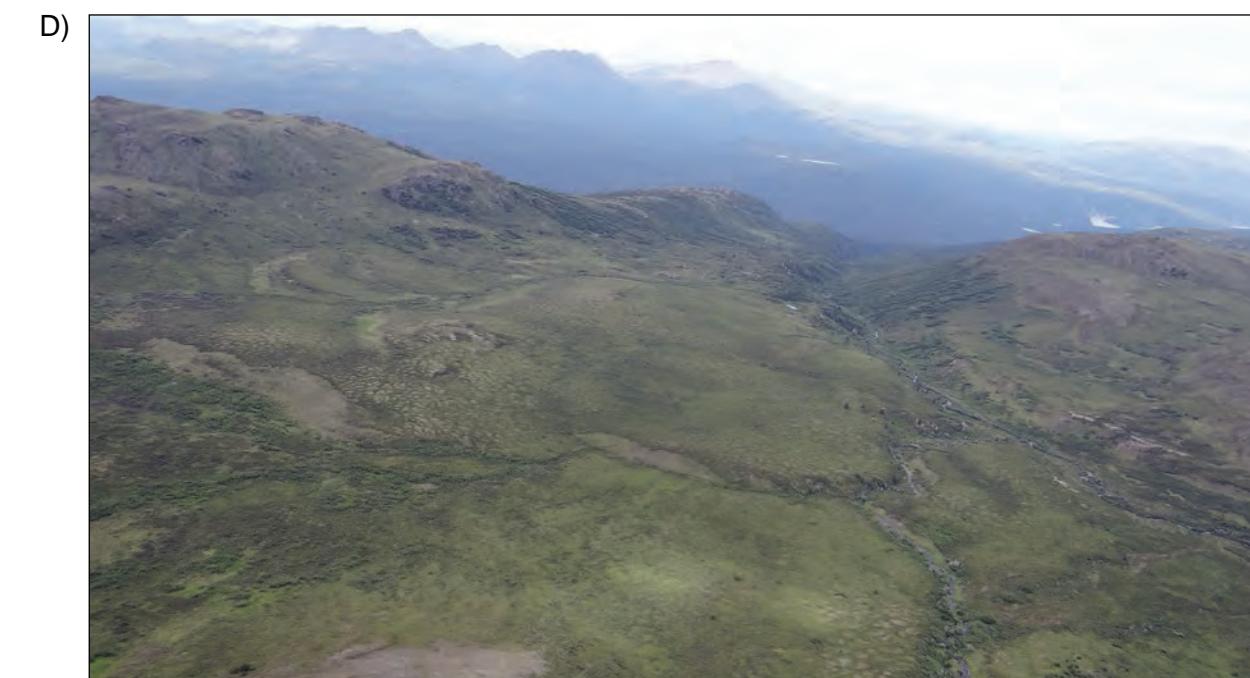
View northerly down-valley along lineaments geomorphically expressed as linear drainage. Thin cover of unconsolidated surficial sediment mantles the Paleozoic rocks.

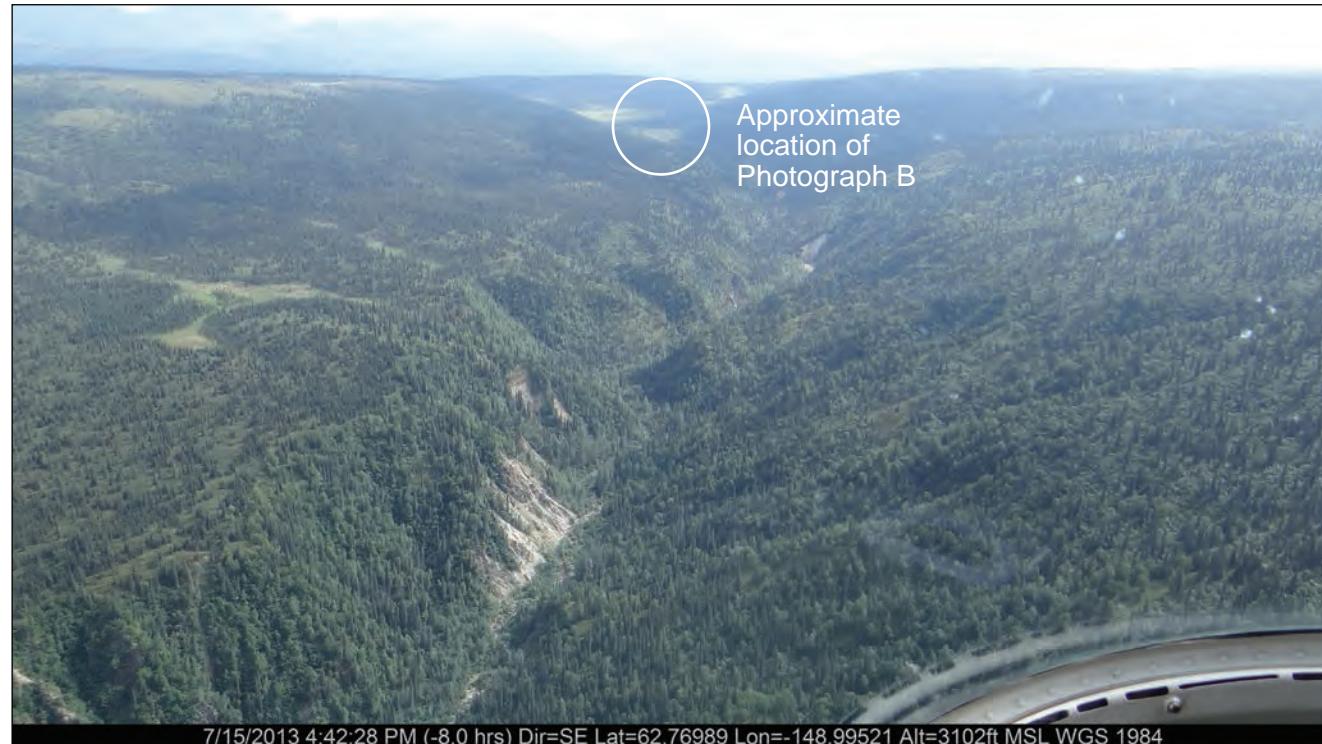
A)

View looking south at linear canyon that is tributary to the Susitna River. Canyon bottom and creek drainage have sinuosity not apparent at smaller scales.

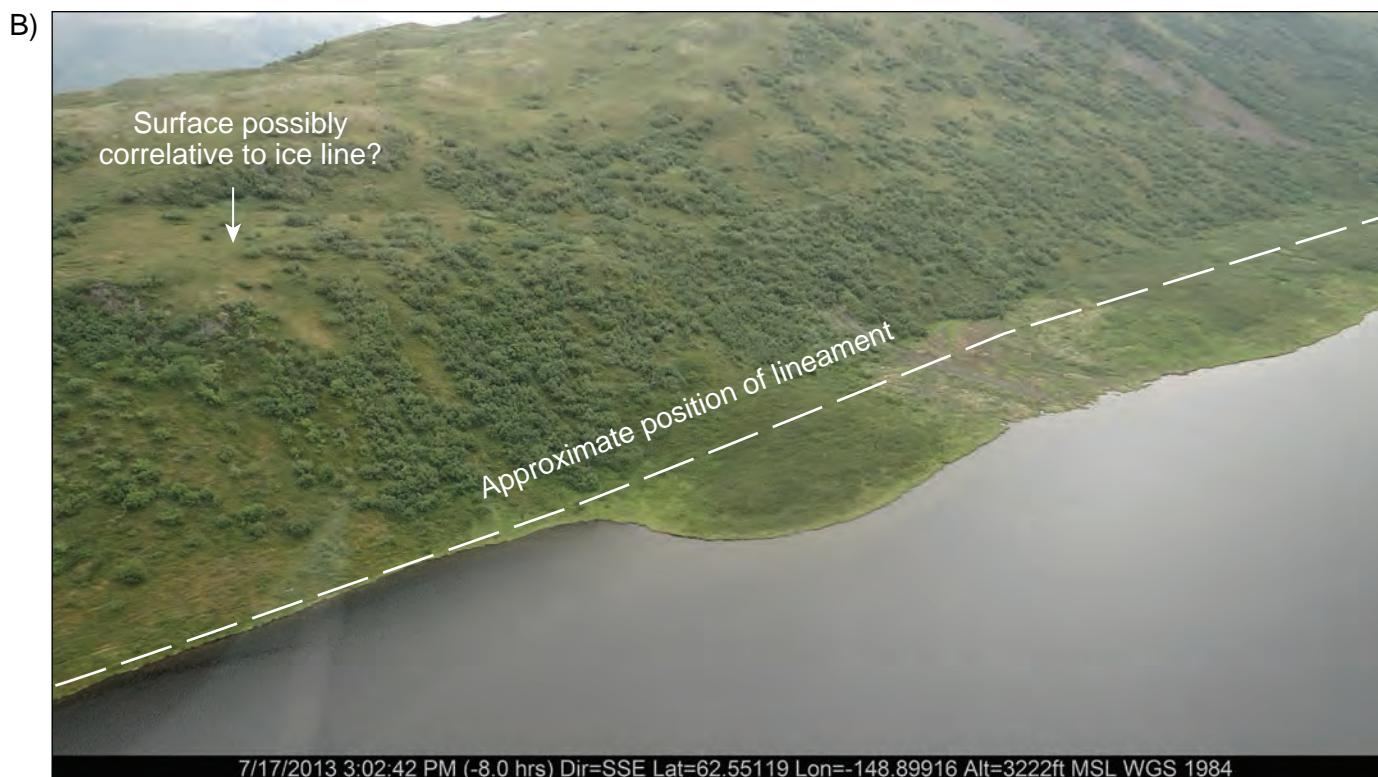
View looking south southwest at lake margin of glacial valley. Lineament was mapped at base of slope, and is not expressed as a scarp-type feature. Apparent colluvium along projection of lineament does not appear offset.

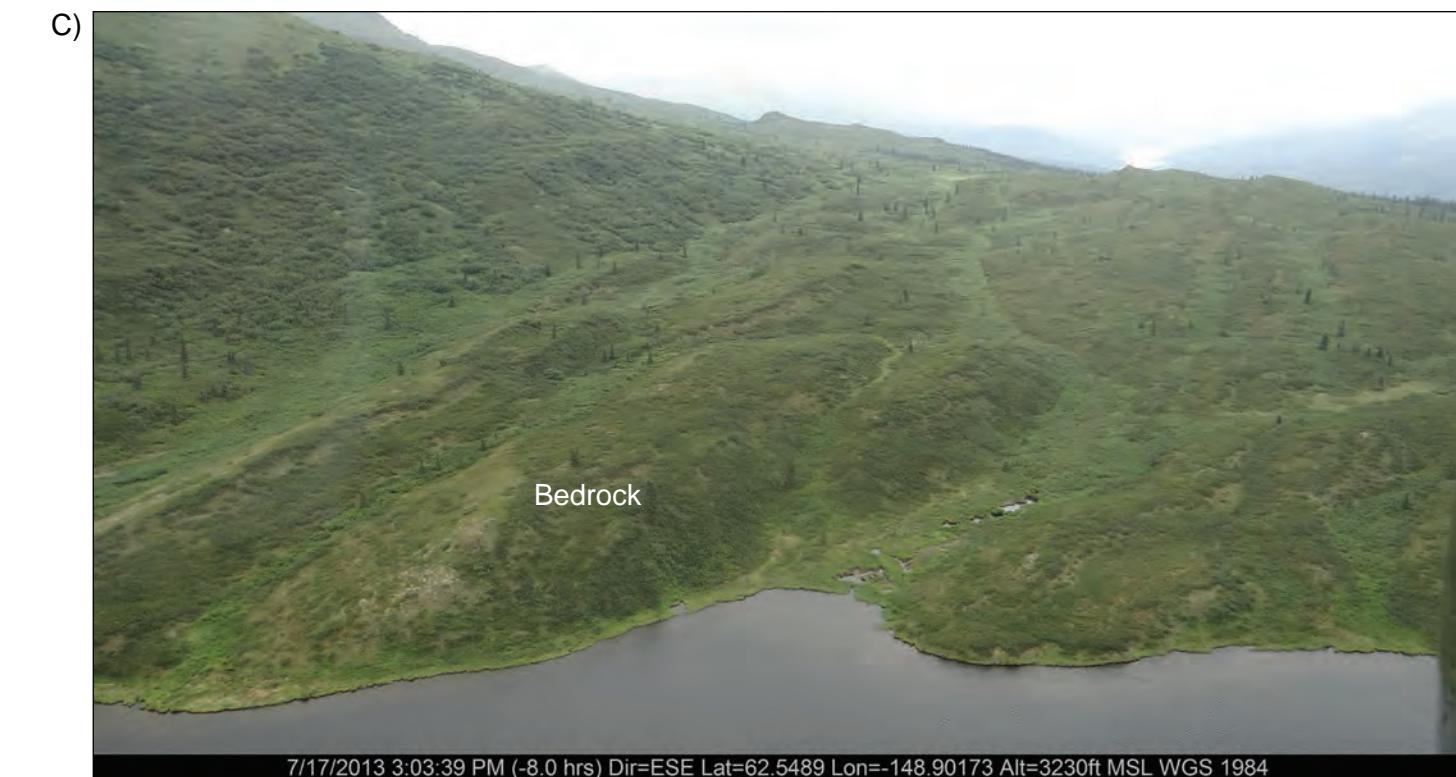
View looking south southeast along glacially-sculpted terrain along which Csejtey (1974) has inferred a fault within the glacial sediment that mantles the bedrock knolls (Figure A17b.1).

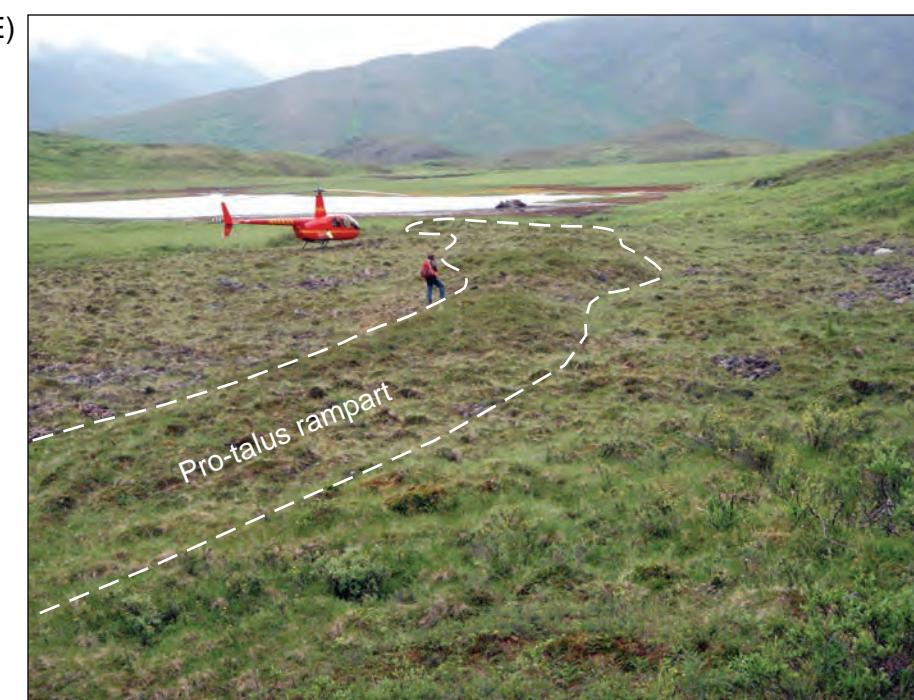
View looking south at pro-talus rampart and GPS waypoint 15. Note lateral distance between base of slope to crest of rampart. Geologist for scale is about 180 cm tall.

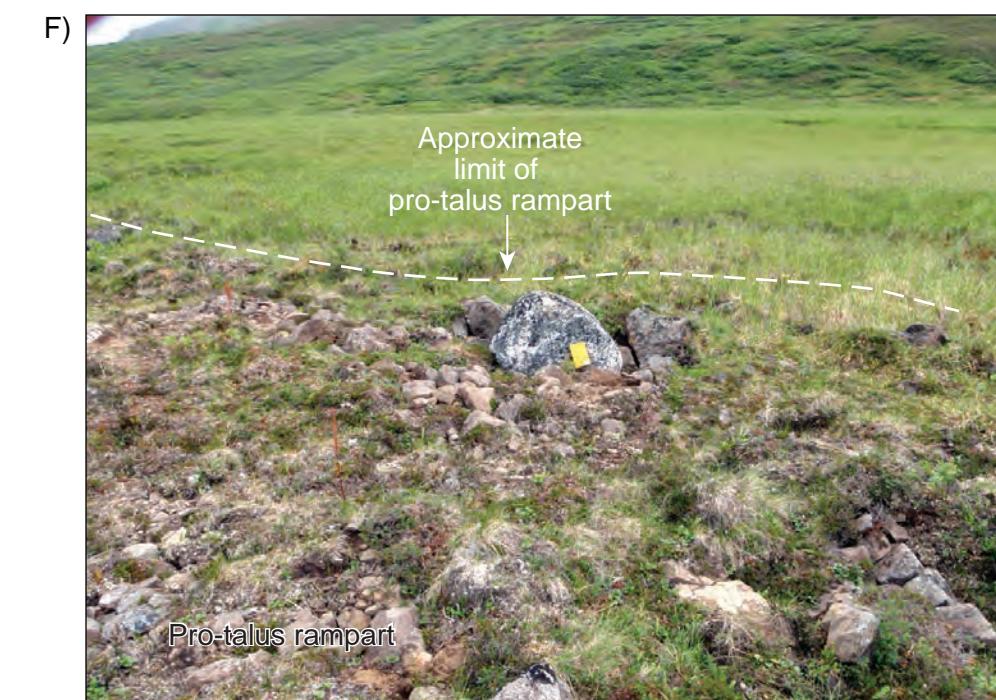
Pro-talus rampart constructed from blocky, frost-shattered volcanic rocks. Photograph is centered on more sub-rounded glacial erratic (granitic) that is not similar to any of the local hillside lithologies. Field notebook is 19 cm tall.

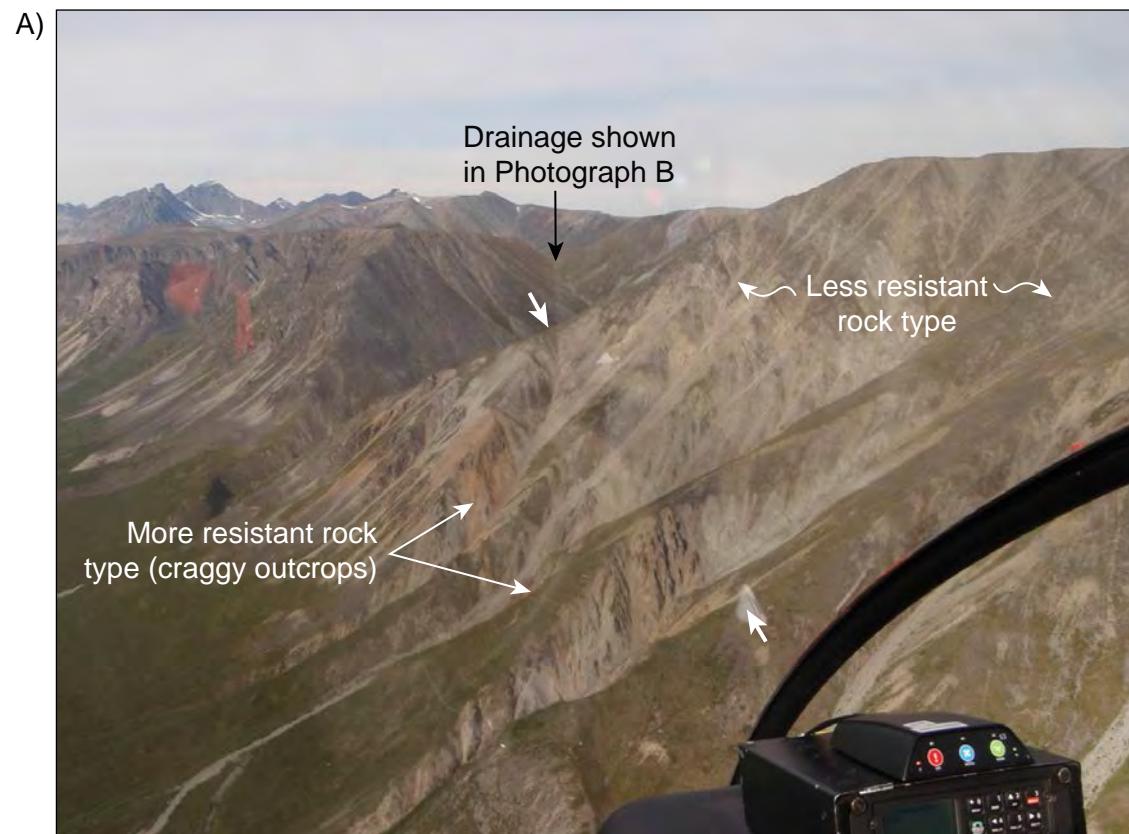
Photograph taken from location A looking southwest along apparent rock type contrast (contact?) and towards mapped lineaments in steep-walled, v-shaped, linear drainage. Arrows point along apparent contact between less-resistant rock on the north and more resistant and craggy outcrops on the south.

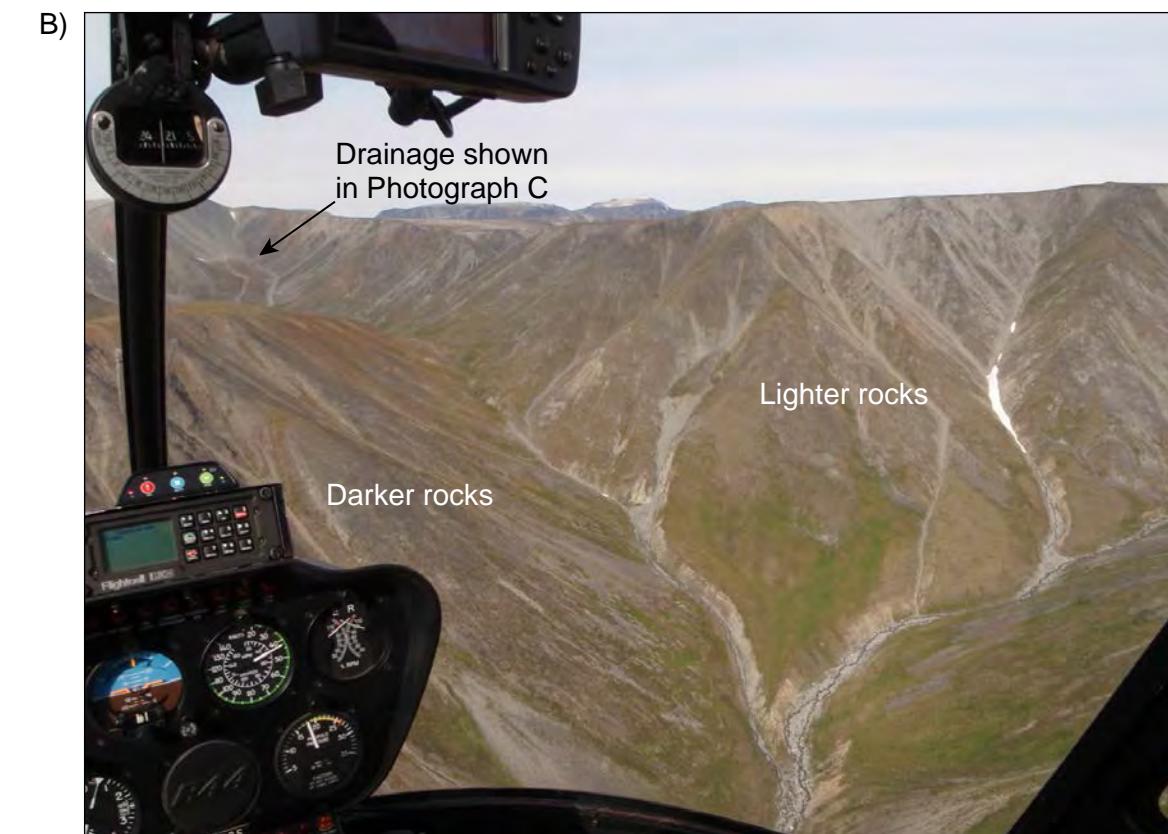
Photograph taken from location B looking west along mapped lineaments and apparent rock contact in steep-walled, v-shaped, linear drainages.
