**Appendix A:**  
**Strip Maps and Photographic Documentation**  
**of Lineament Data Presented in FCL (2013)**

<p>FUGRO Date 01/06/14</p> <p>STATE OF ALASKA ALASKA ENERGY AUTHORITY <b>ALASKA</b> ENERGY AUTHORITY</p> <p>SUSITNA-WATANA HYDROELECTRIC PROJECT STRIP MAPS EXPLANATION 2 OF 4</p> <p>FIGURE A0.3</p>

**SUSITNA-WATANA HYDROELECTRIC PROJECT**

**LINEAMENT GROUP 6**

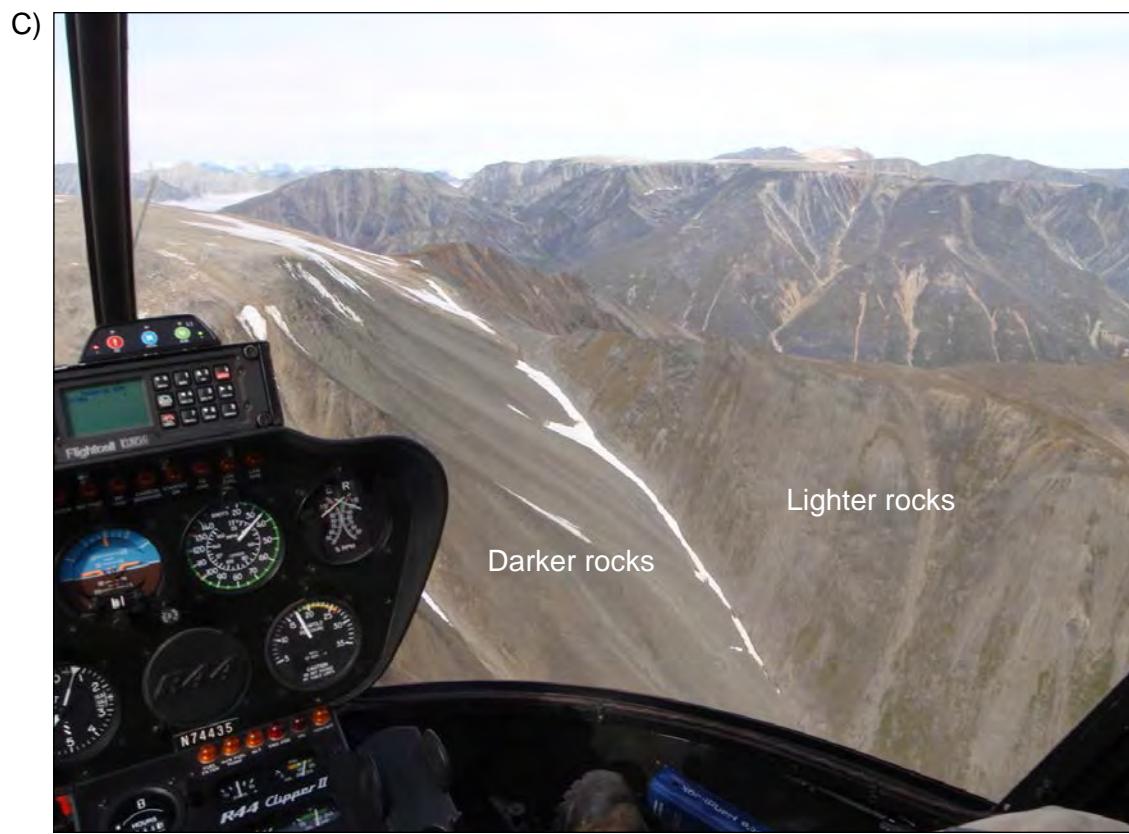
Photograph taken from location C looking west at head of steep-walled, v-shaped, linear drainage where mapped lineaments correspond to apparent rock contact.

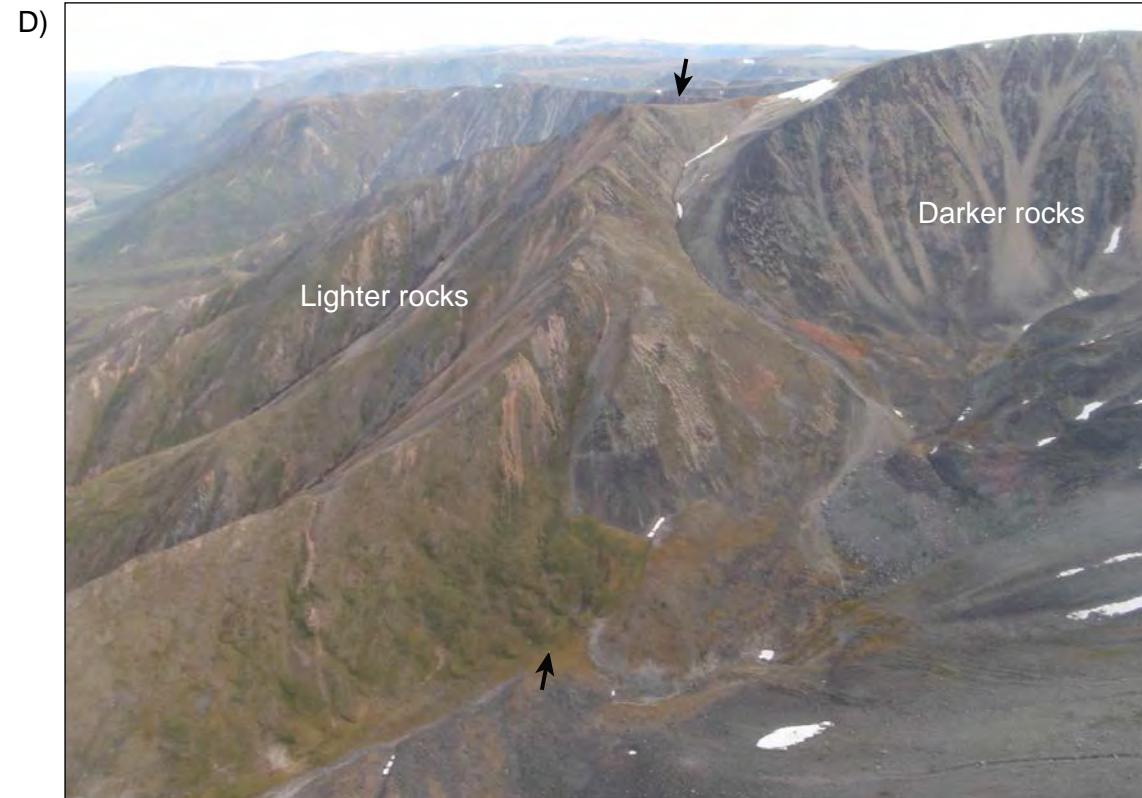
Photograph looking northeast from location D along the western continuation of the apparent rock type contrast shown in Photographs A, B, and C. Arrows point along apparent contact.

Photograph from location E looking southwest down the ridgeline shown in Photograph D. View is 180 degrees from that in Photograph D. Note presence of rock glacier and glacial deposits in valley bottom. Arrows point along apparent contact.

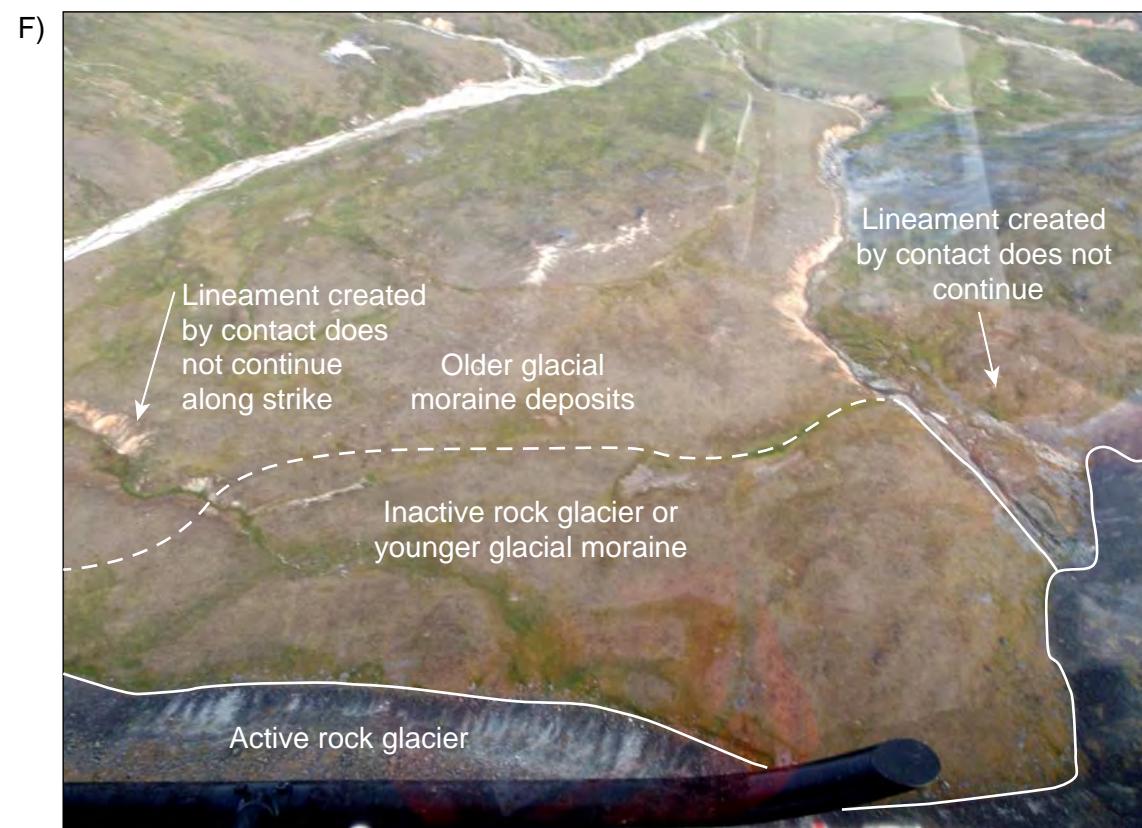
Photograph looking northwest from location F showing apparently undeformed rock glacier and/or glacial deposits along strike of the mapped lineaments and apparent rock contact shown in Photographs A through D.

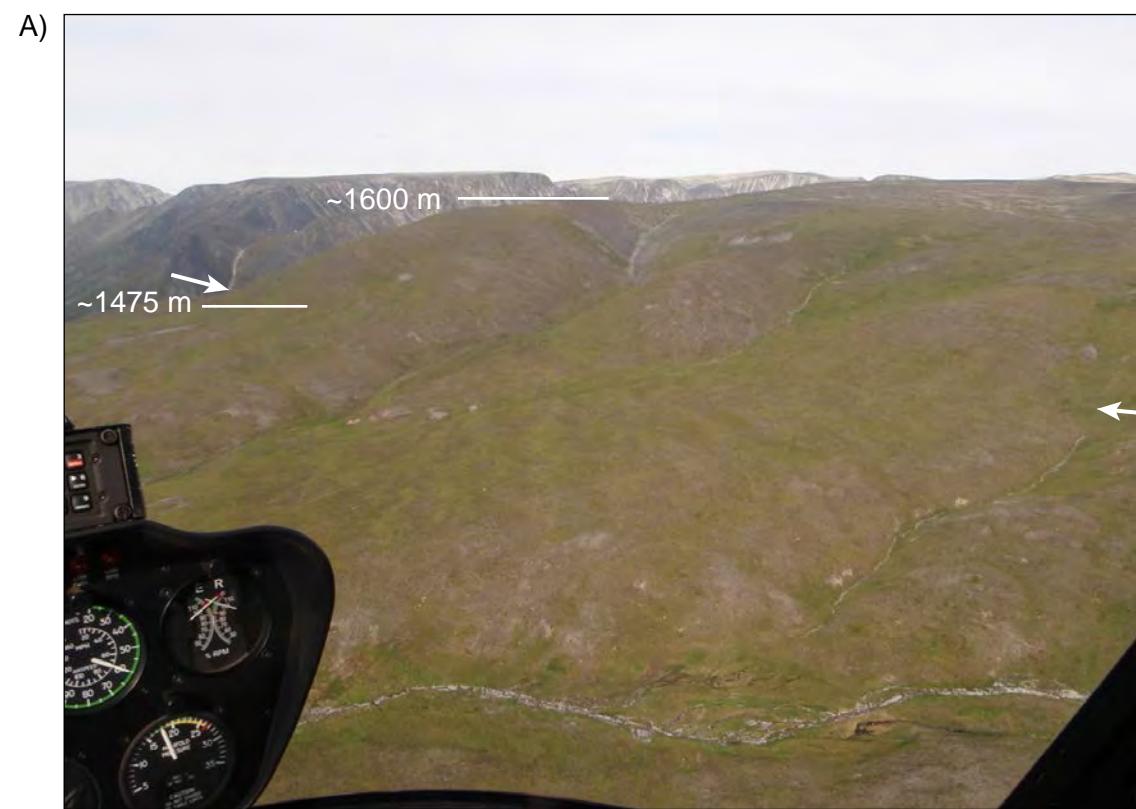
Photograph taken from location A looking west. Arrows point along trend of mapped lineaments along southwest-facing aligned break-in-slope. Note the rounded and subdued nature of break-in-slope. Relief across break-in-slope is ~125 m.

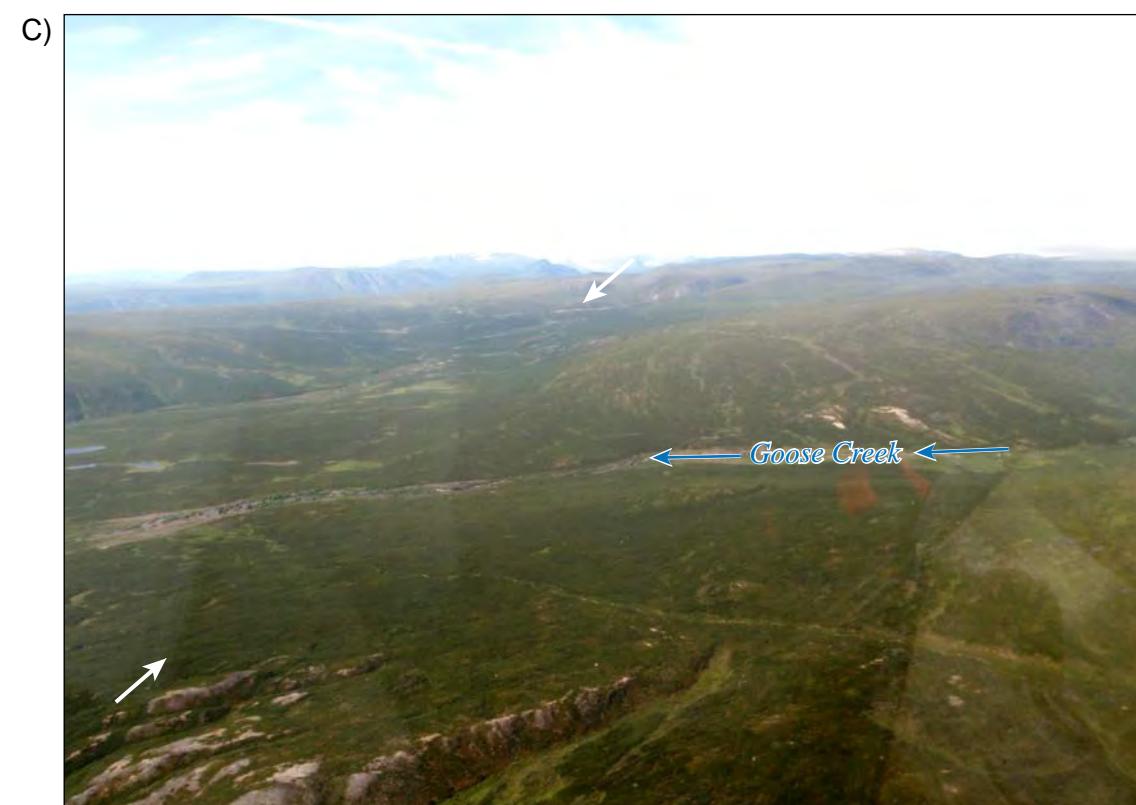
Overview photograph looking southwest from location C along alignment of mapped lineaments. Arrows point along trend of lineament group 19. Note absence of expression of lineaments within the landscape across the Goose Creek portion of the lineament group.

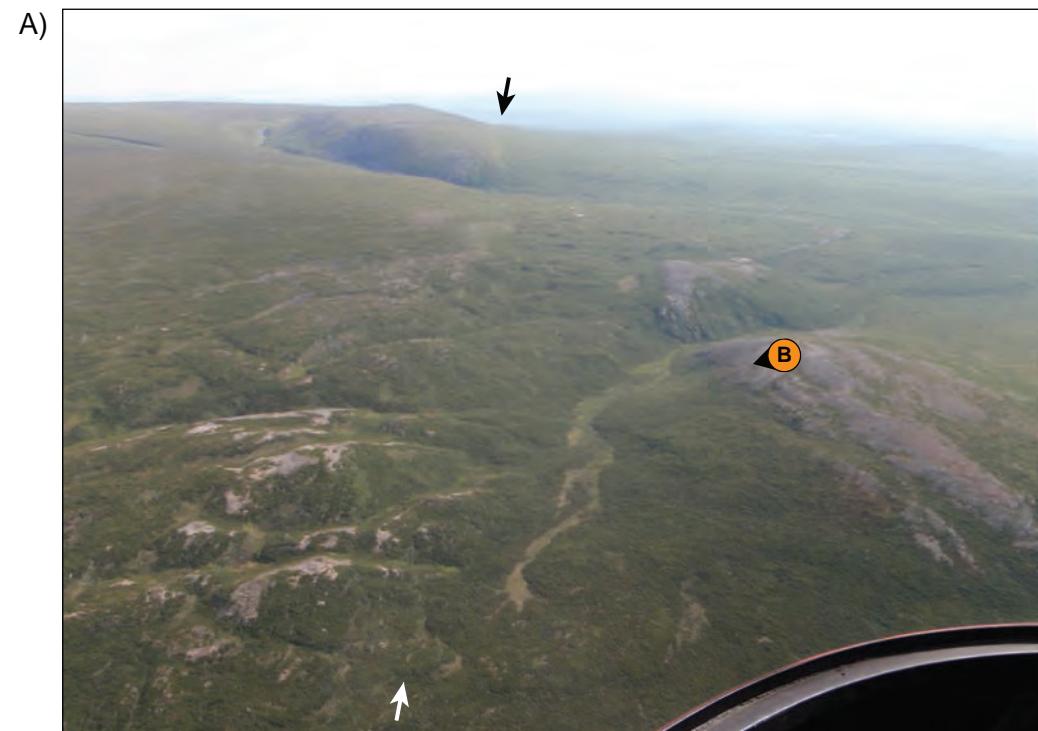
Photograph looking north-northeast from location A along the east-facing break-in-slope that defines the northeast portion of LG 19. Arrows point along alignment of mapped lineaments.

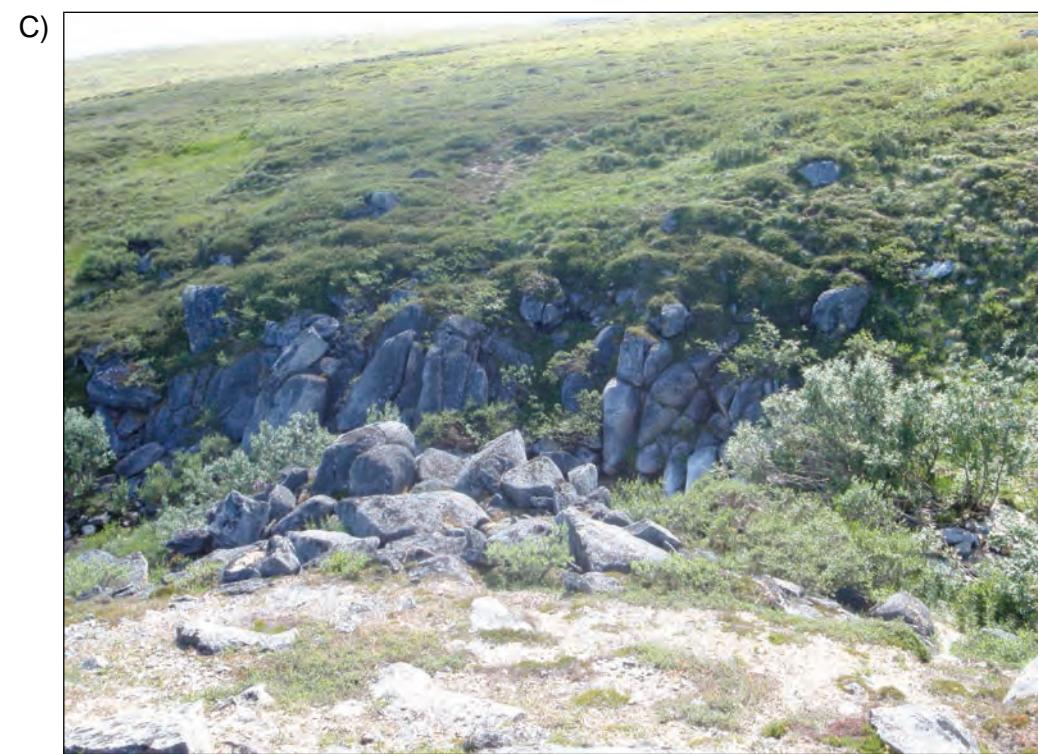
Photograph looking south-southwest from location C at widely spaced, near vertical, well-developed joints in trondhjemite (aka tonalite) bedrock. Joint spacing is 1 to 1.5 meters. Predominant orientations of joints are 042/80SE, 012/85SE, and 082/85SE but other orientations exist. Joint faces have clean surfaces with relief of minerals of 1 to 3 mm. No gouge or mineralization observed on joint surfaces, nor any sense of movement indicators (striae or mullions).

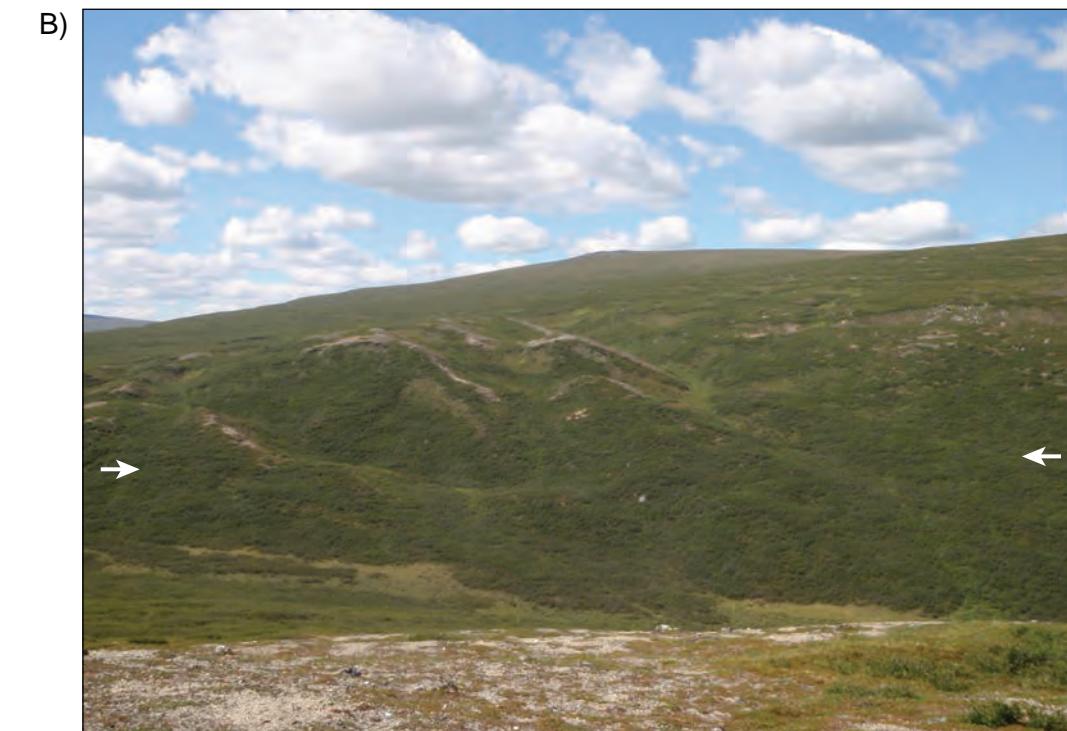
Photograph looking northwest from location B at sub-ice fluvially-eroded channels. Arrows point along the trend of mapped lineaments that make up group 19.

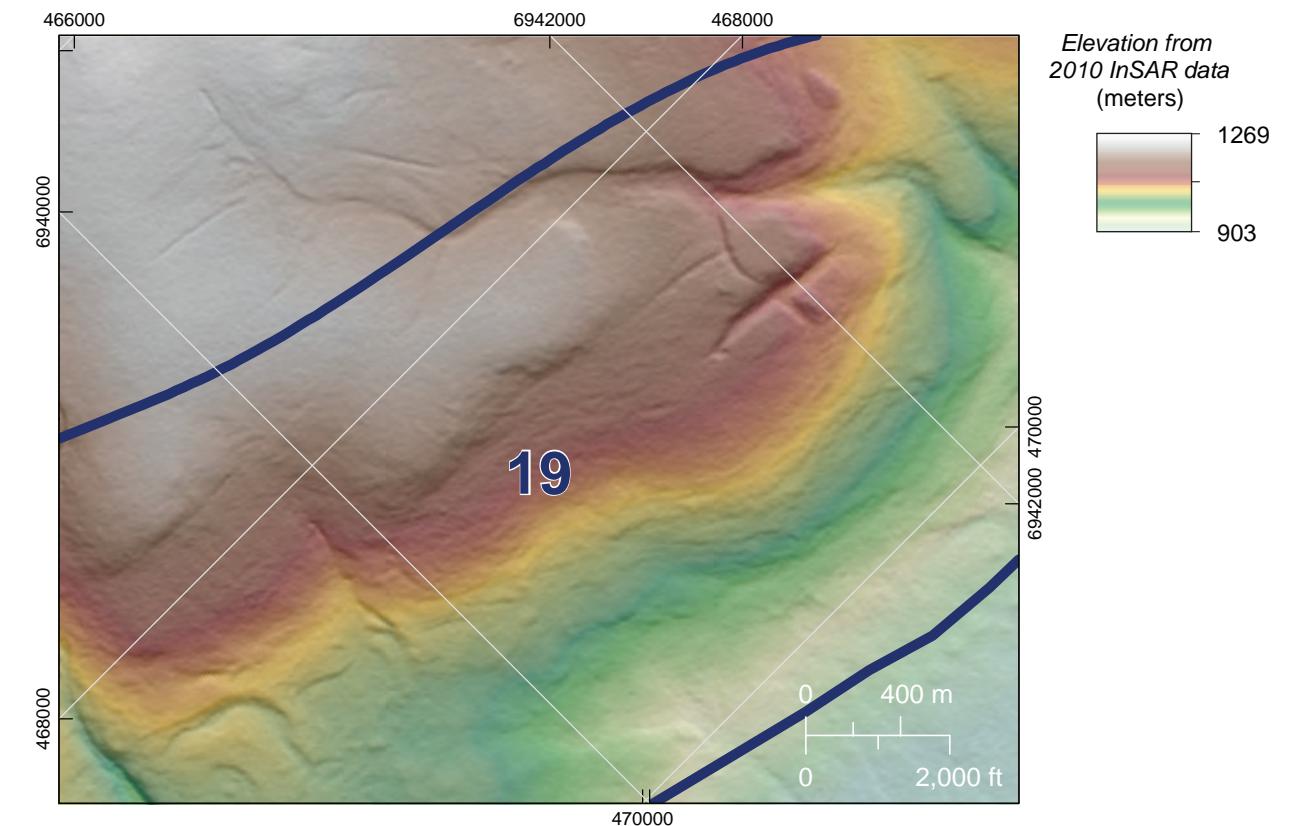
Detailed DEM showing orthogonal joint sets at northeast end of group 19.
