**Appendix B:  
Strip Maps and Photographic Documentation  
of Lineament Data for Lineaments Mapped by Reger et al. (1990)**

Project: **Susitna-Watana Dam, AK**  
Scientist: **Dean Ostenaa, Fugro Consultants**

**Preliminary Luminescence Age Report**

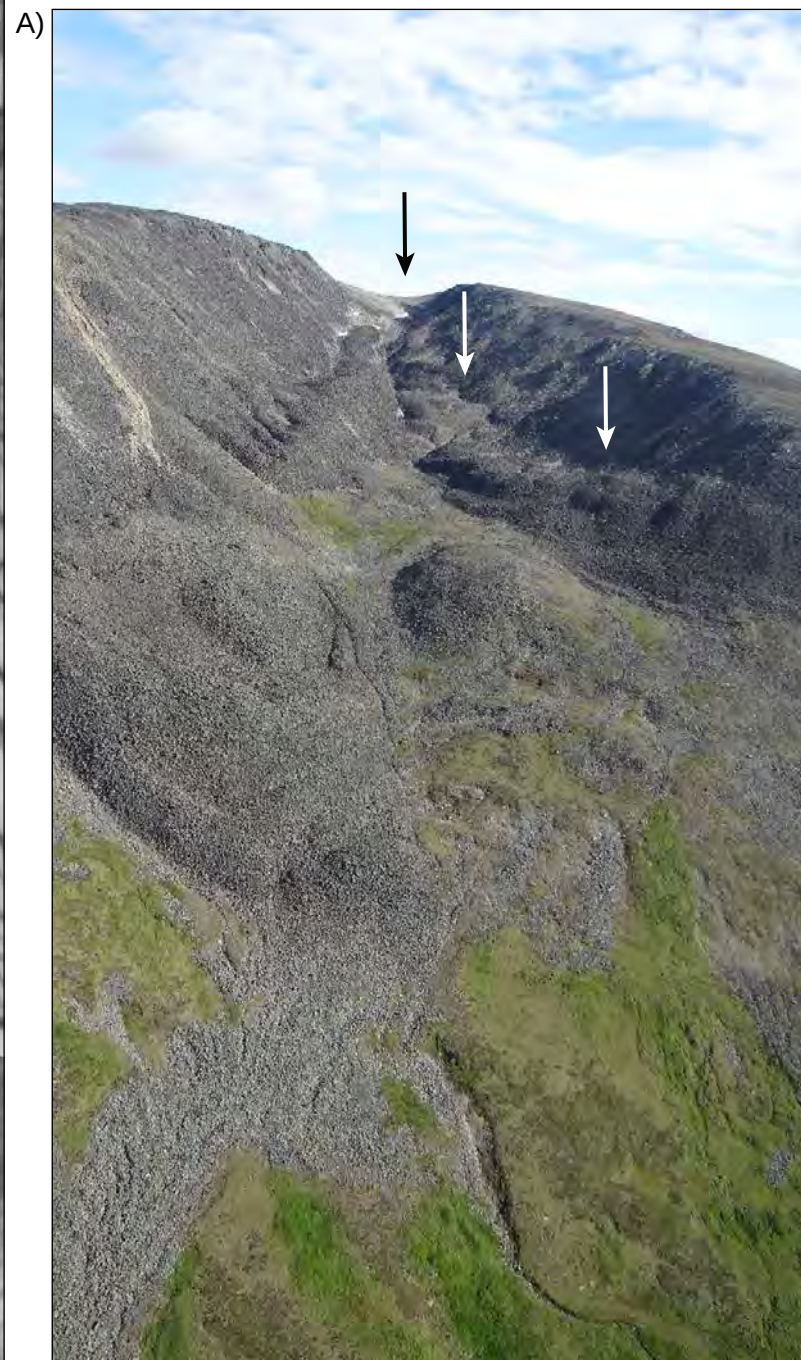
View looking northeast from location A. Arrows show location of mapped trace of lineament.

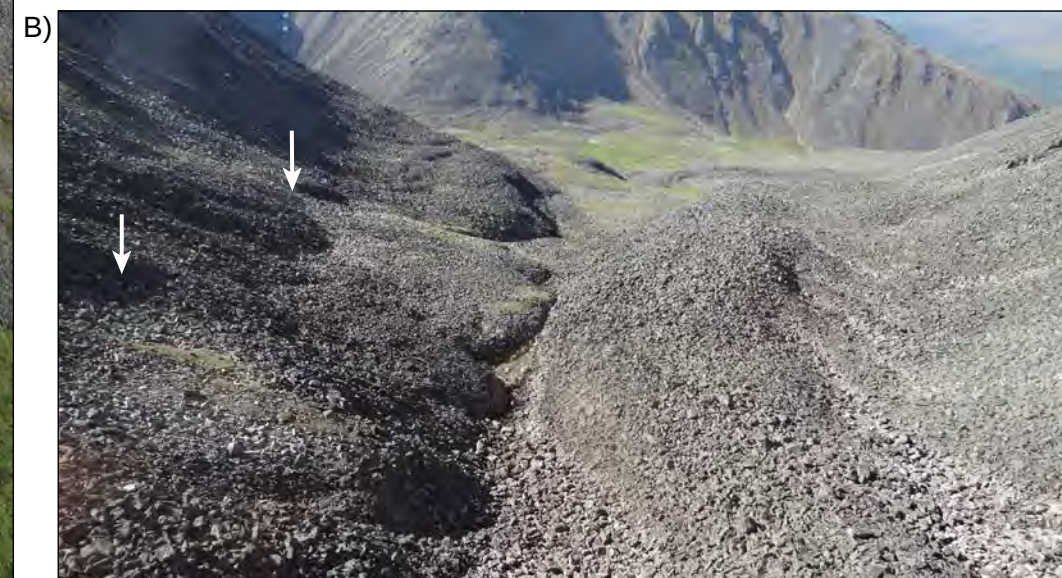
View looking southwest from location B. Arrows show the location of lineament. Note the semi-linear and lobate toe of talus deposit.

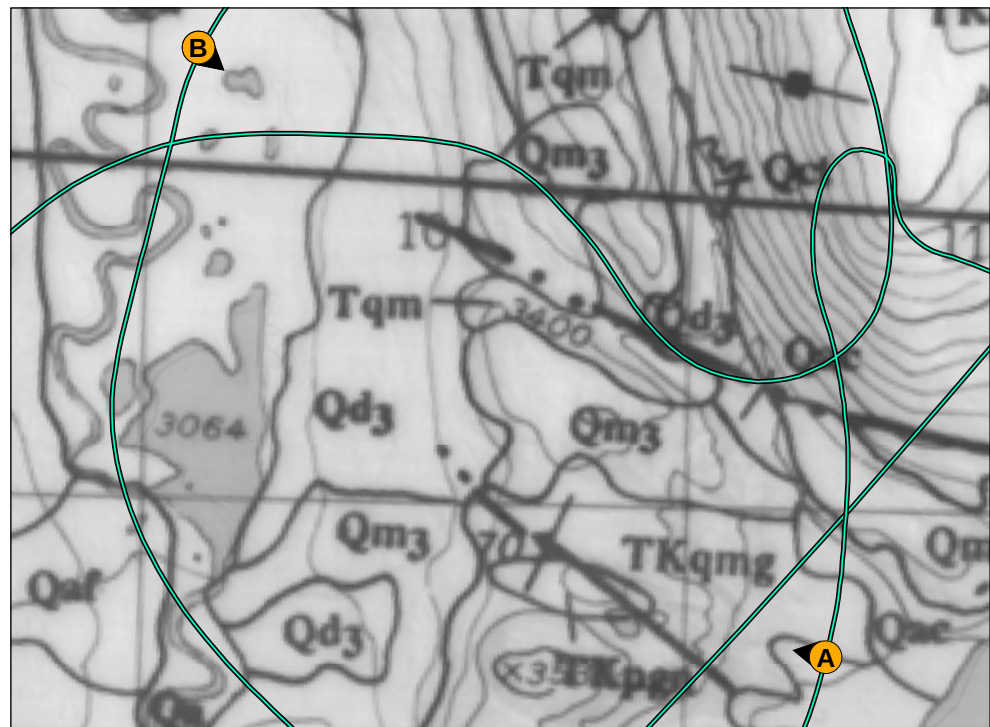
View looking northwest from location A. Arrows and brackets show projected trace of lineament. Note absence of continuous lineament across projected trace.

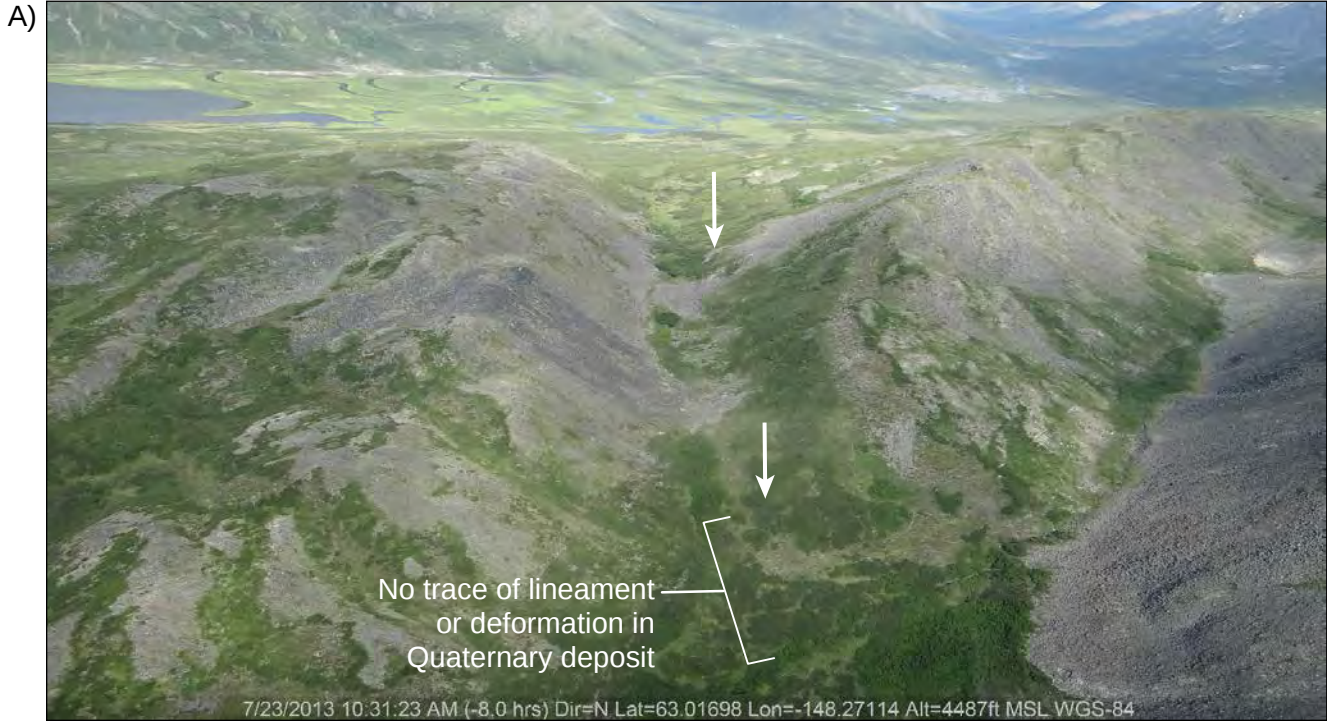
View looking northwest from location A. Arrows show the projected trace of lineament. Note absence of lineament or deformation in Quaternary deposits.

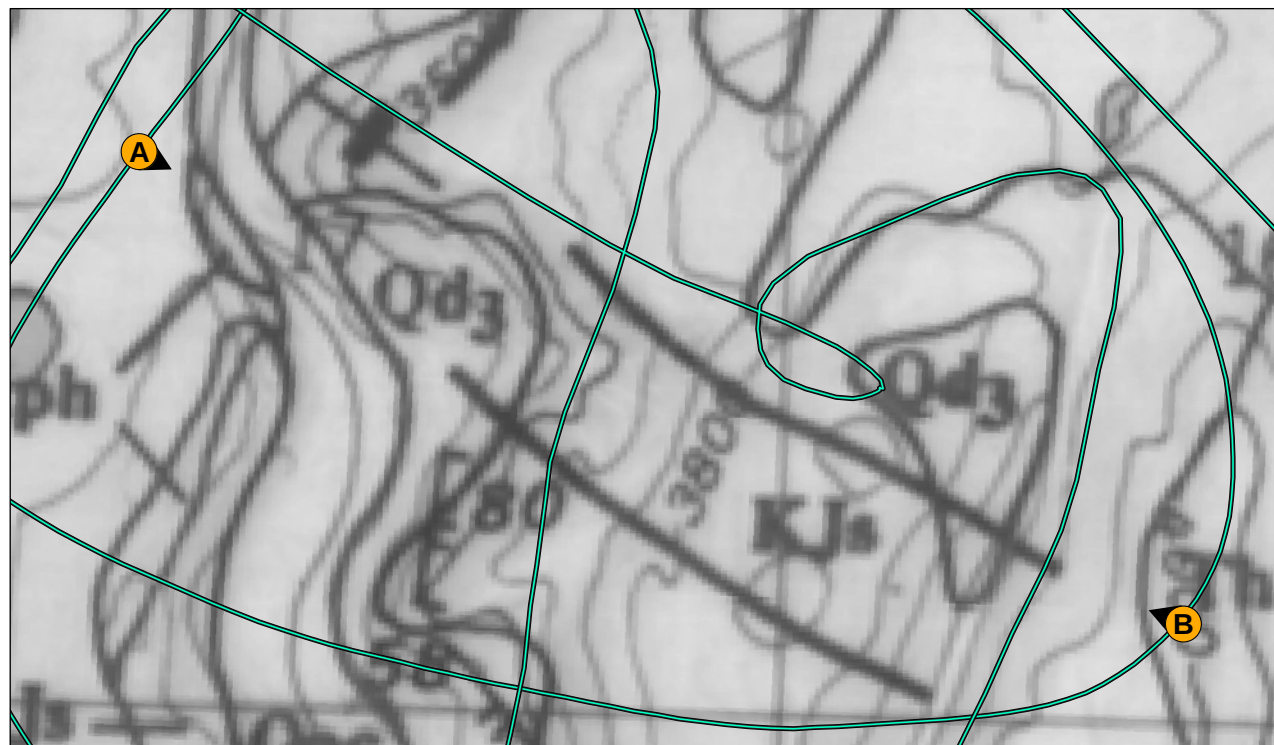
View looking southeast from location A. Arrows show the projected traces of Features 4 and 5. Note absence of lineament or deformation in Quaternary deposits in foreground.

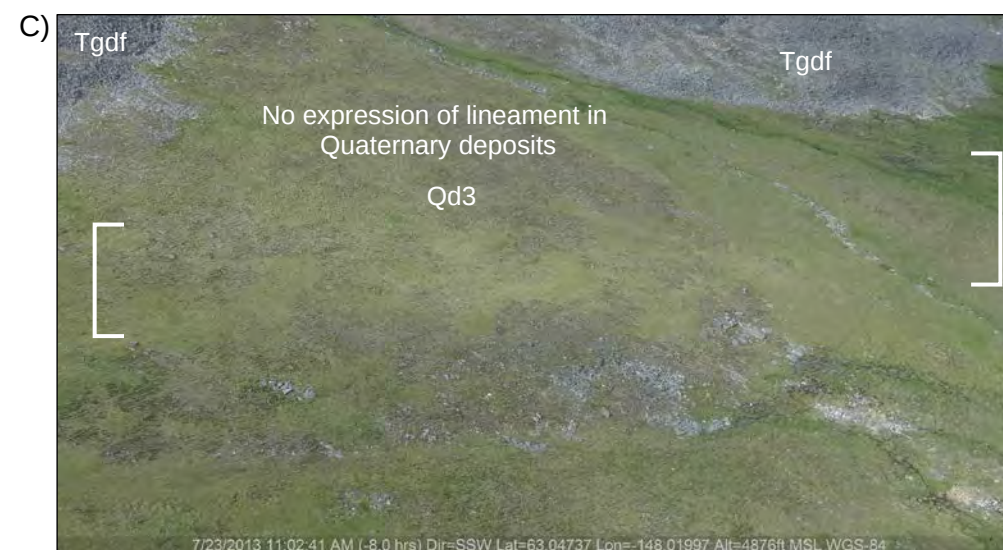
View looking west from location C. Brackets indicate the projected trace of lineament. Note absence of lineament or deformation in Quaternary deposits.

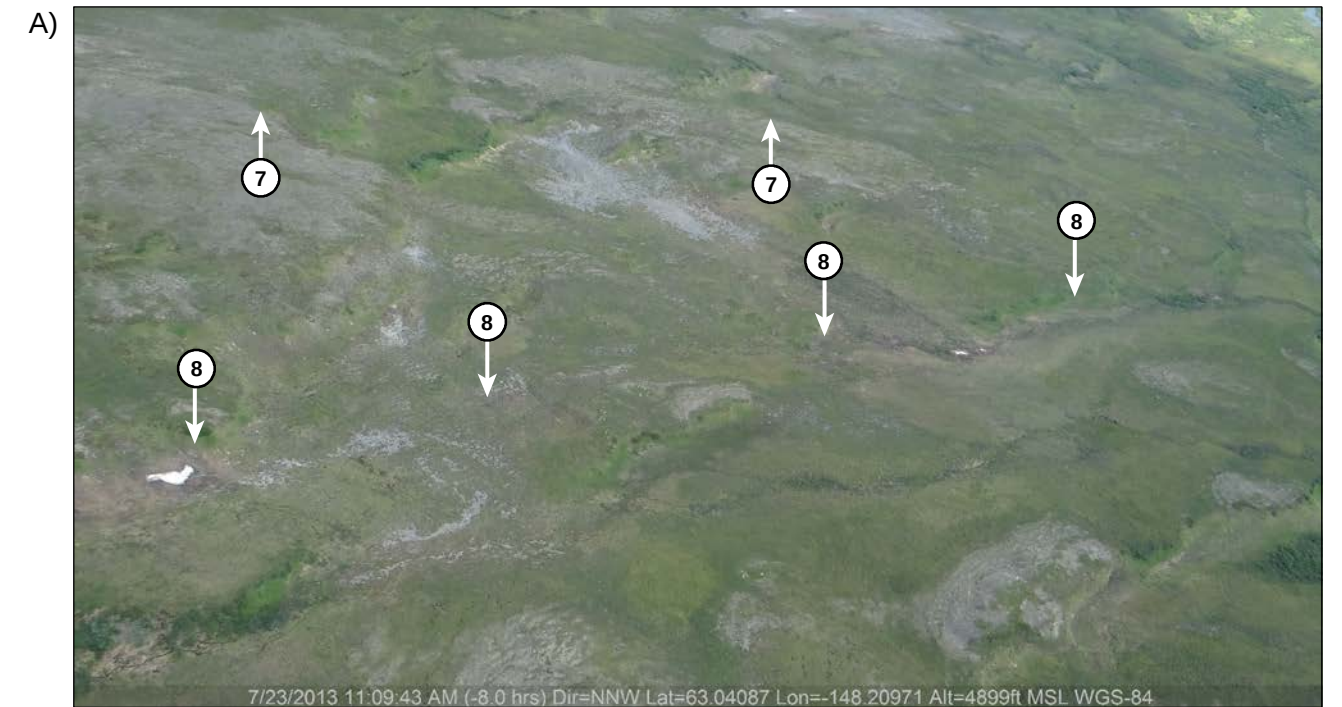
View looking northeast at lineaments 7 and 8 from photograph location A.

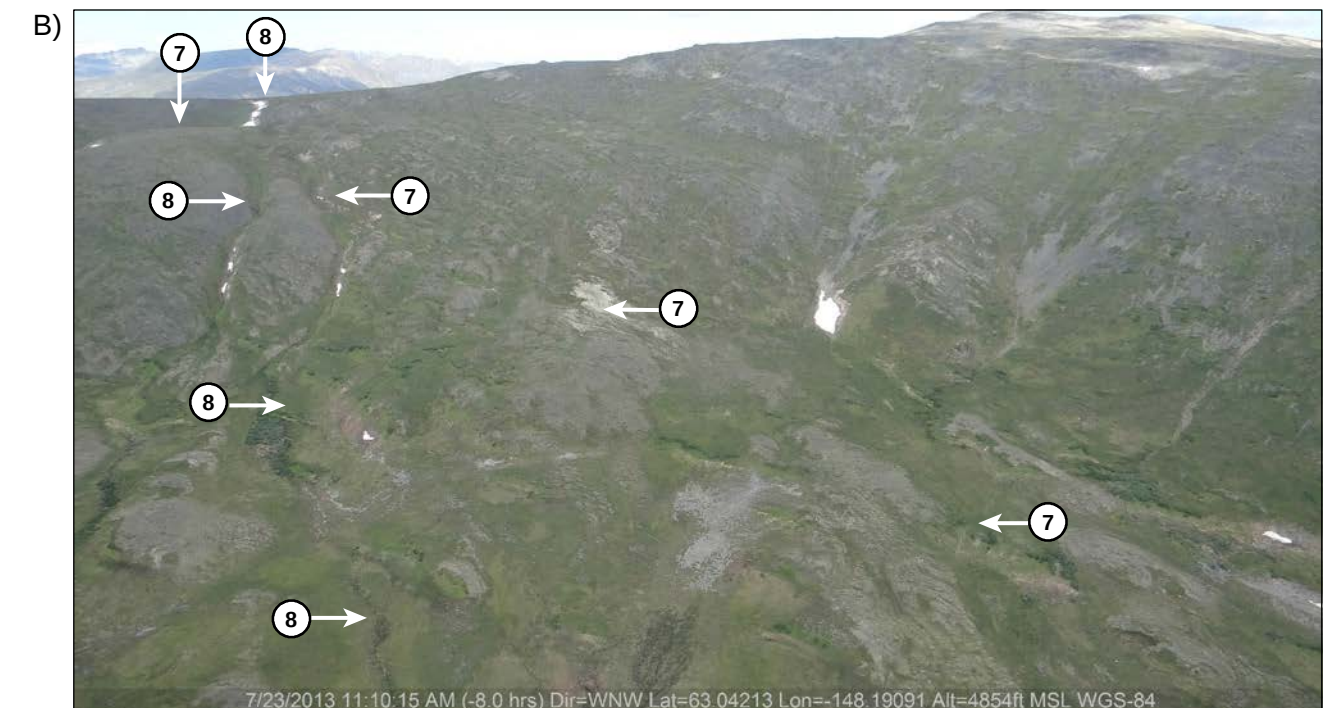
View looking west at lineaments 7 and 8 from photograph location B. Note that lineament 7 is a linear series of unrelated features.

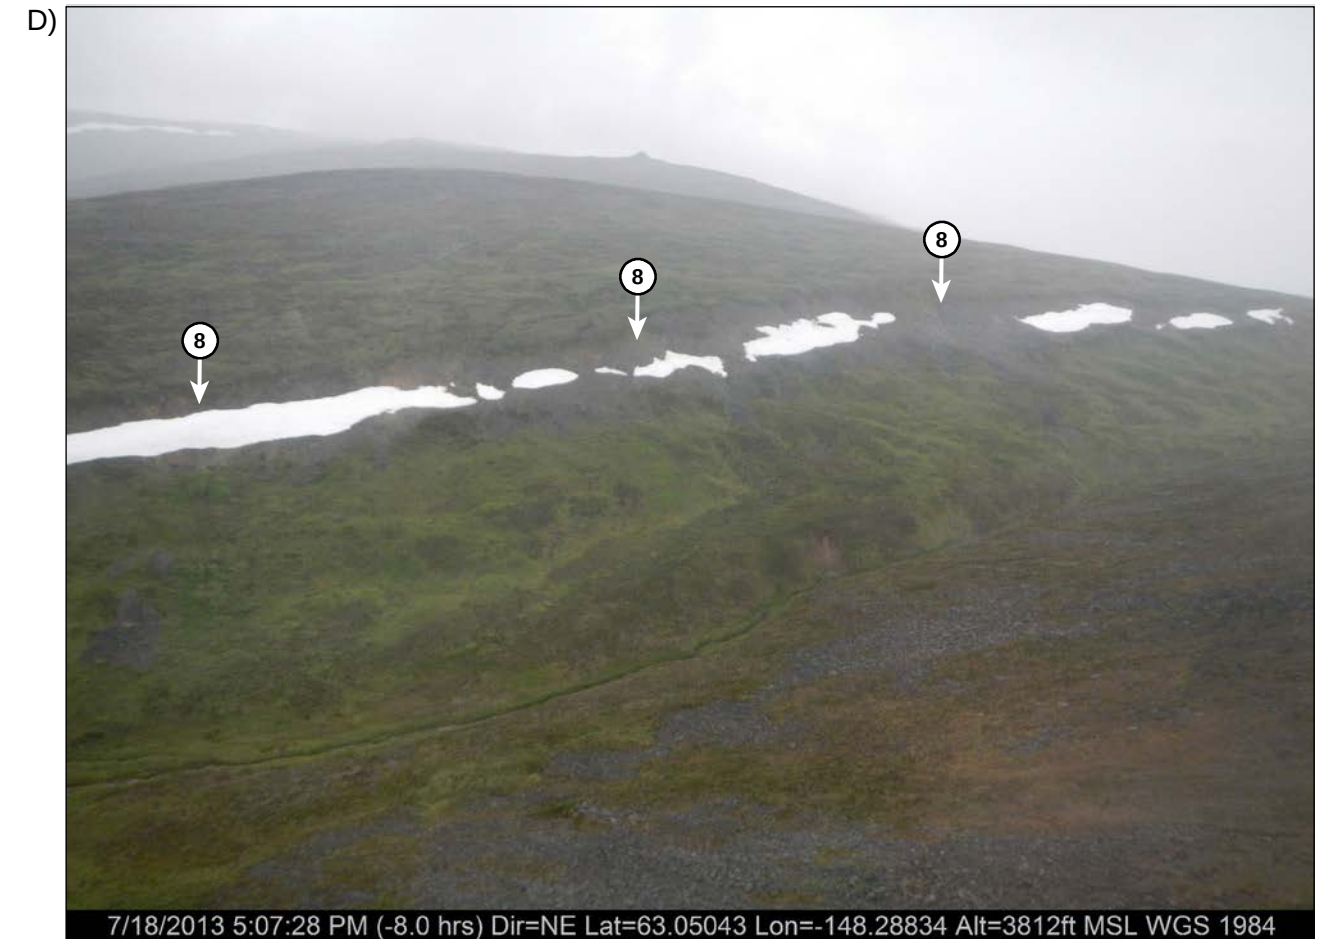
View looking northeast at lineament 7 from photograph location D.

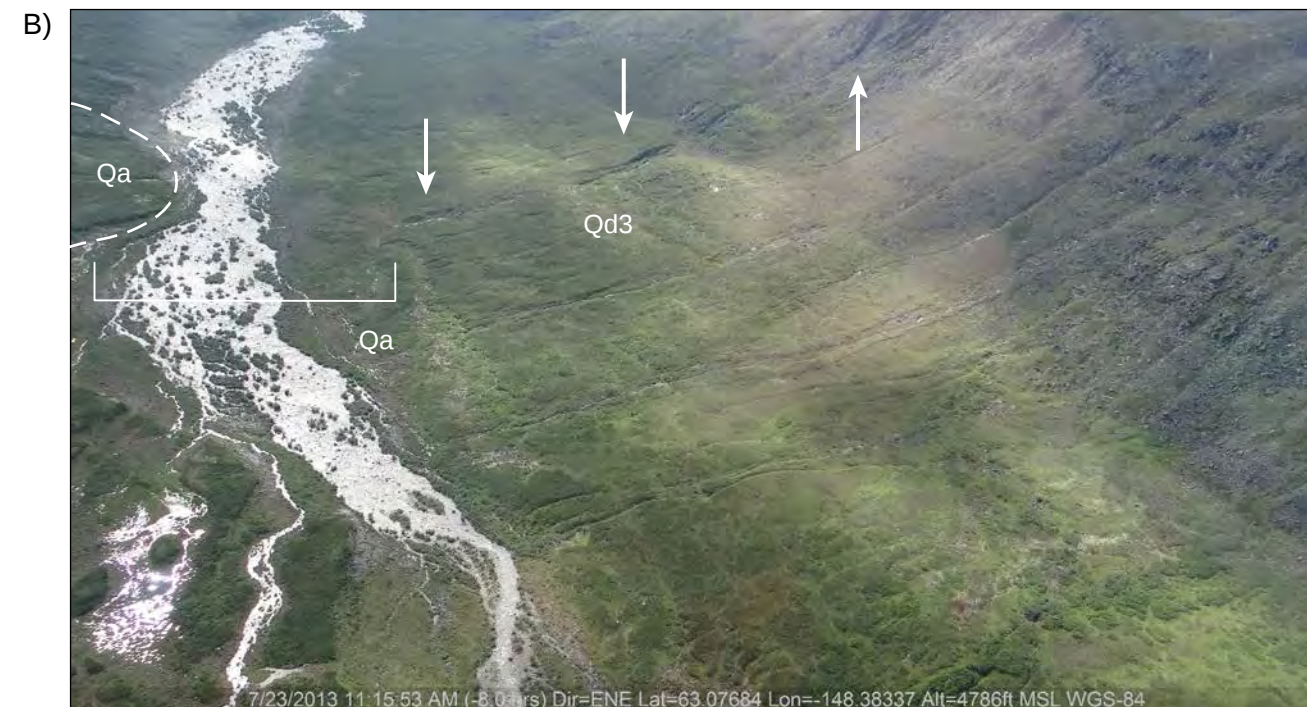
View looking south from photograph location B. Arrows show the projected trace of lineament. In Qd3 (till) the lineament is coincident with linear drainage in till deposit. Note absence of lineament in Qa deposit.

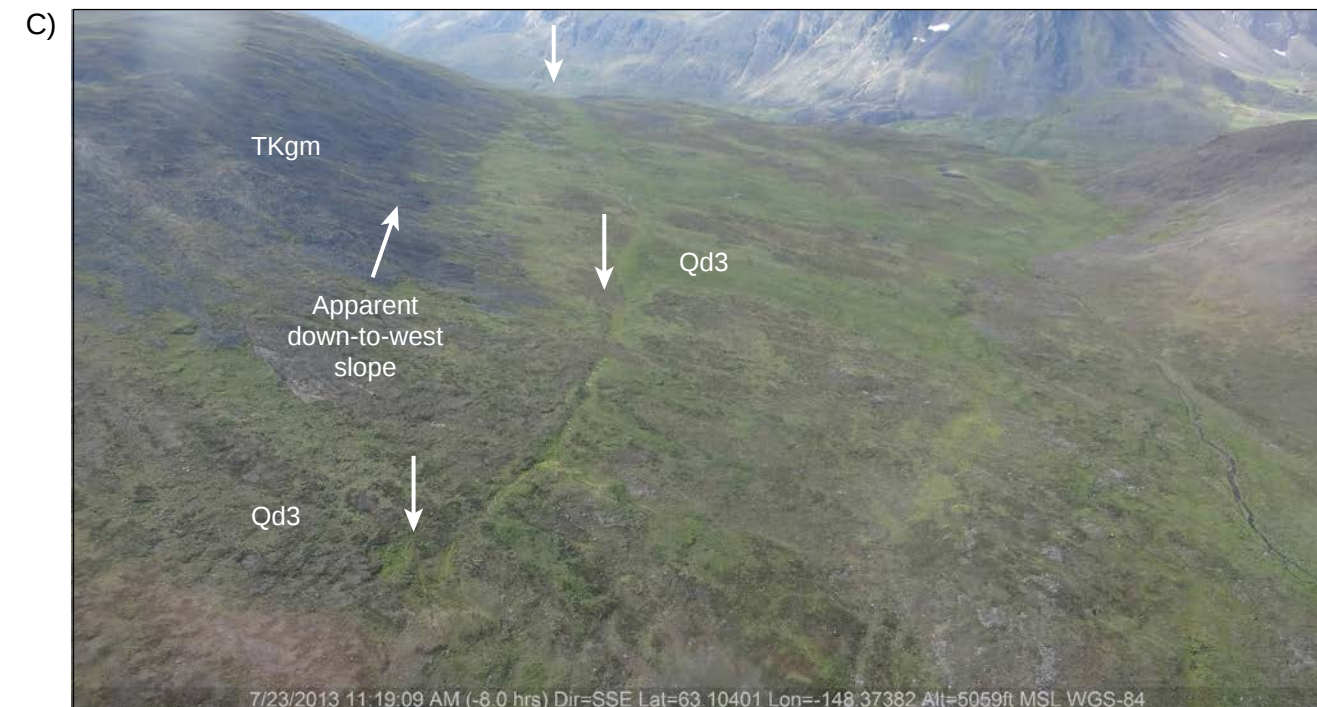
View looking south from photograph location C. Arrows show the projected trace of lineament. Note lineament is coincident with a linear drainage in this view.

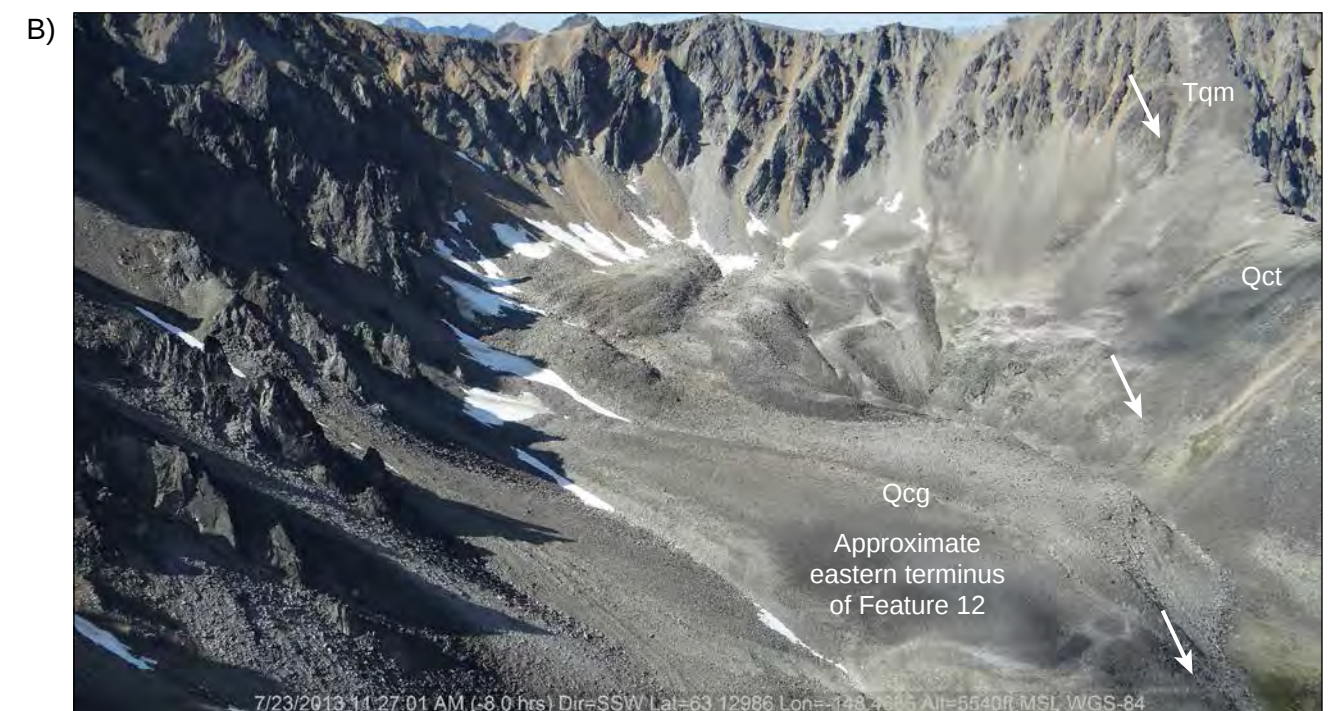
View looking west from location A. Brackets show projected trace of Feature 12 lineament. Note the trace of the lineament is a collection of unrelated features rather than a through-going feature.

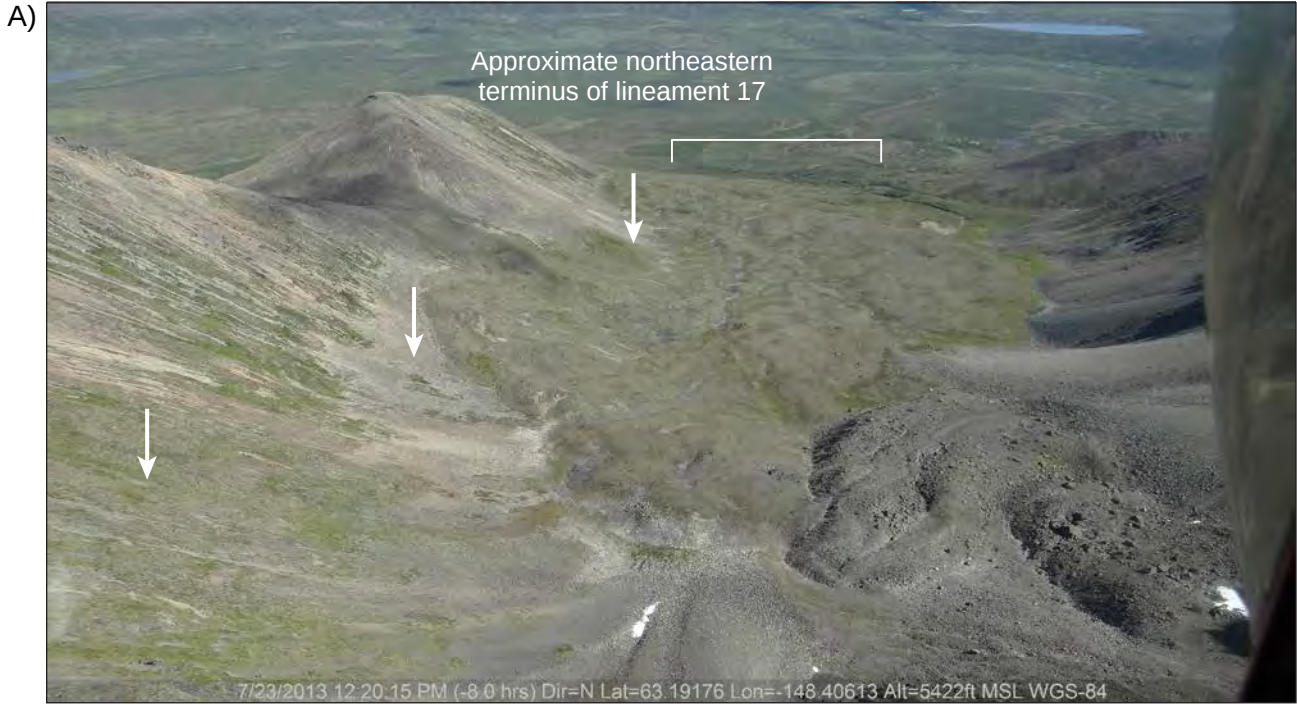
View looking northeast from location A. Arrows and brackets show projected trace of lineament 17.

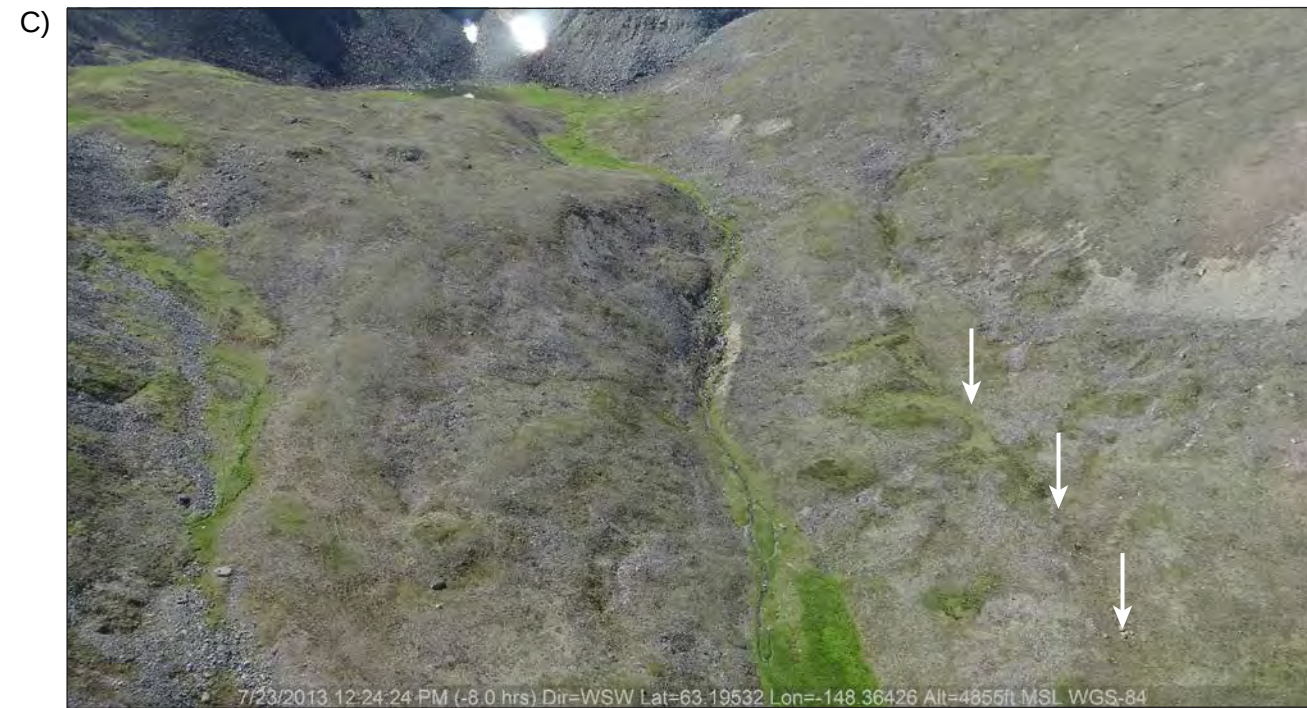
View looking southwest from photograph location C. The arrows indicate the projected path of Feature 19 lineament.

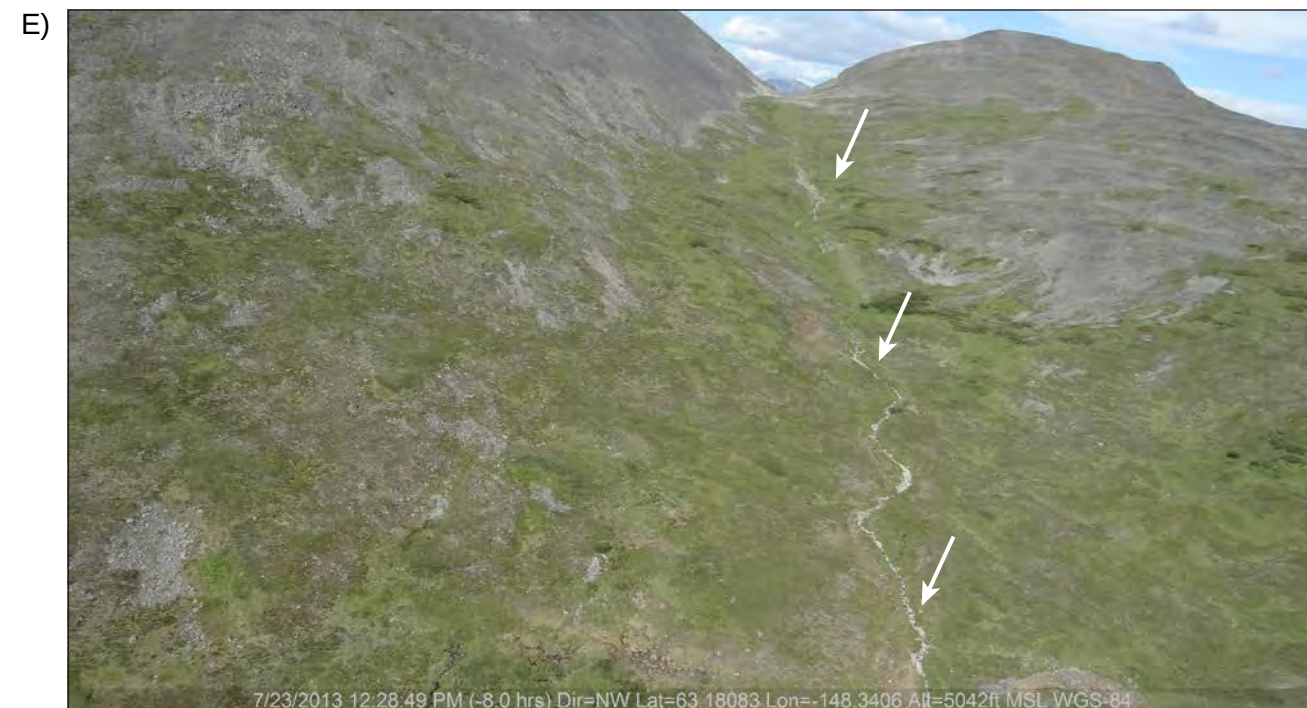
View looking northwest from photograph location E. Arrows show the mapped trace of Feature 20 lineament. Note mapped trace of Feature 20 is coincident with linear drainage.

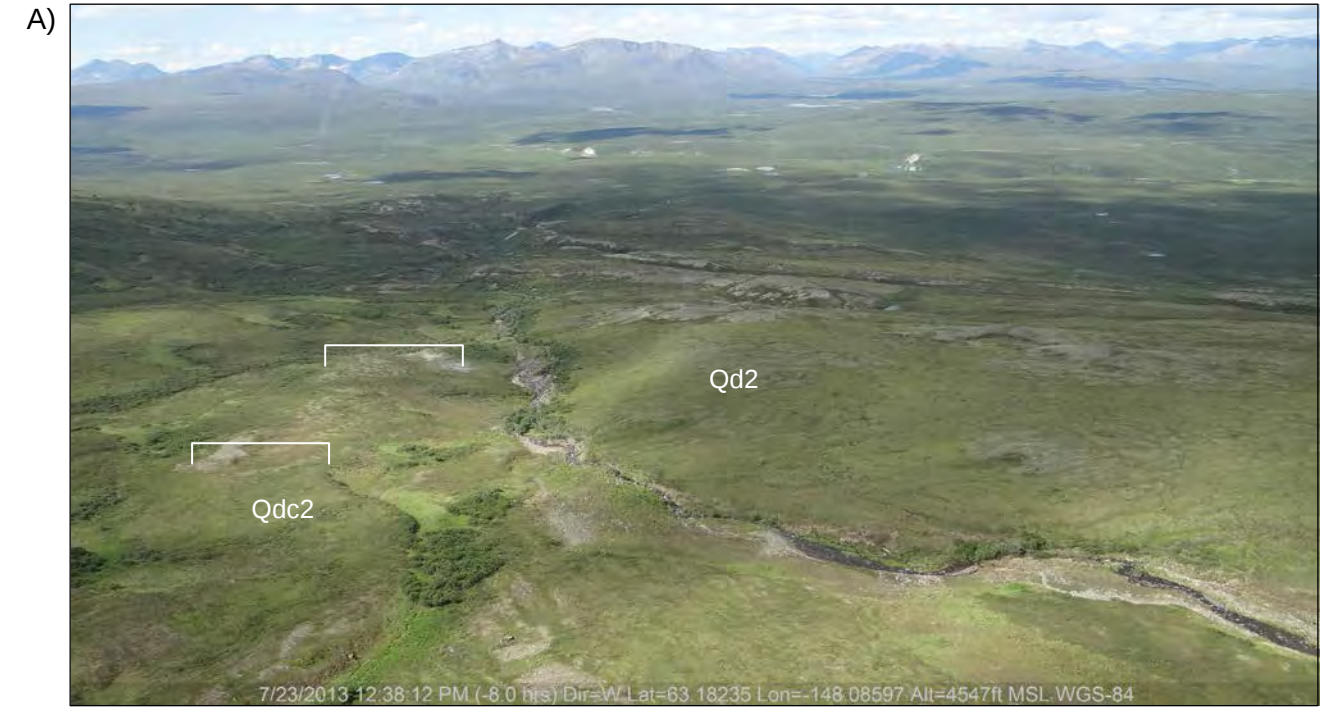
View looking west from photograph location A. Brackets show the projected trace of Feature 22. Note the absence of a continuous lineament along the projected trace and exposed till on low relief ridge crest between drainages.

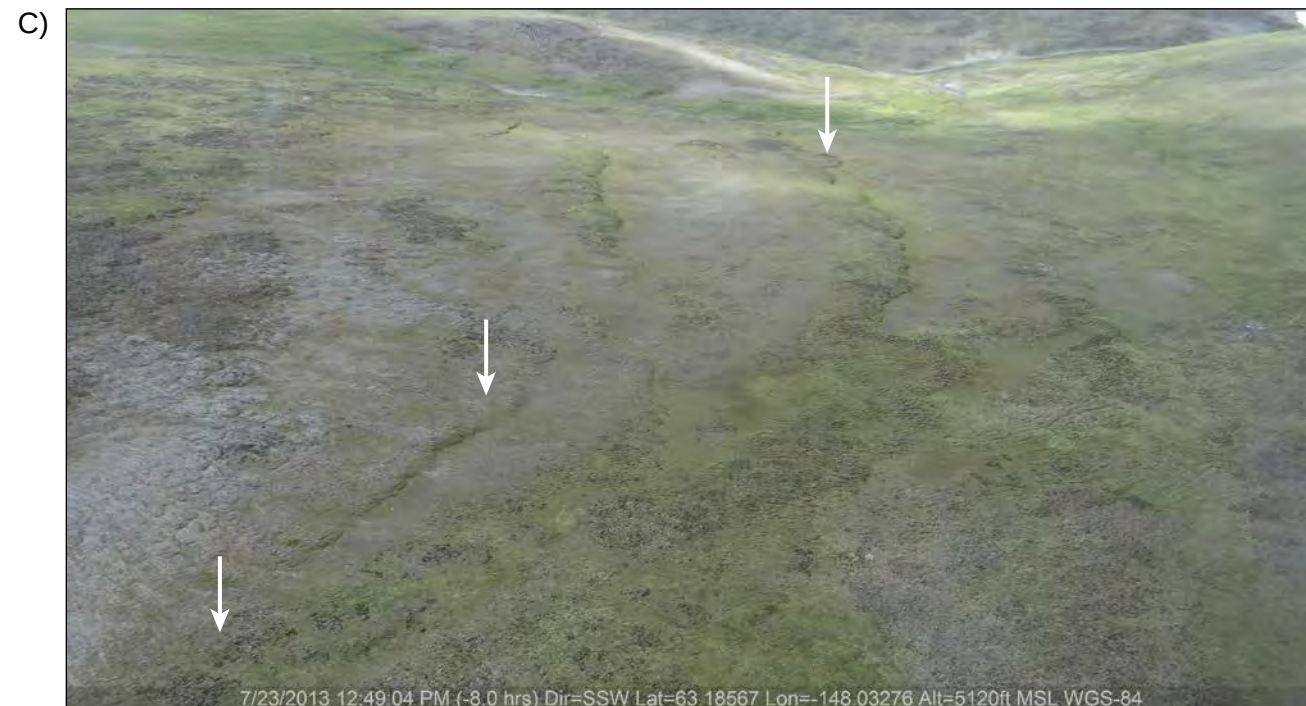
View looking west from photograph location C. Arrows show the projected trace of the Feature 22 lineament. Note linear expression is coincident with solifluction lobes and not continuous.

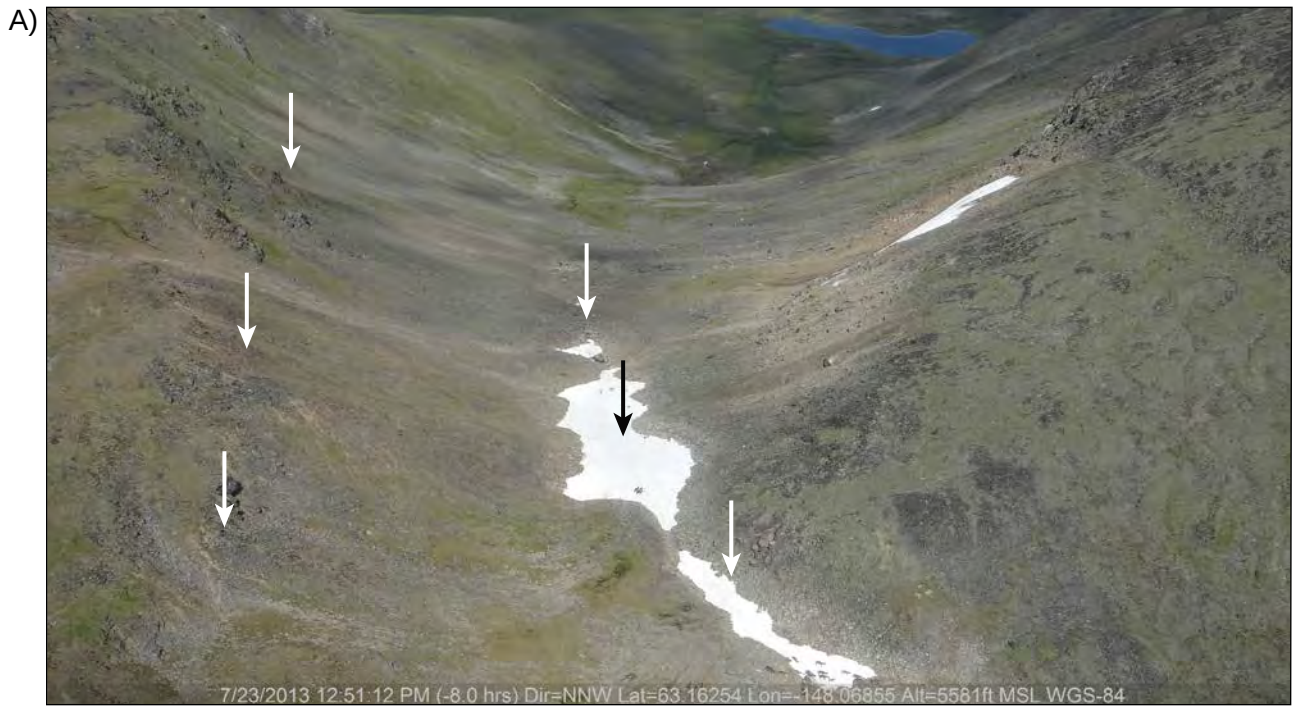
View looking west from photograph location C. Arrows indicate the projected path of the Feature 24 lineament.

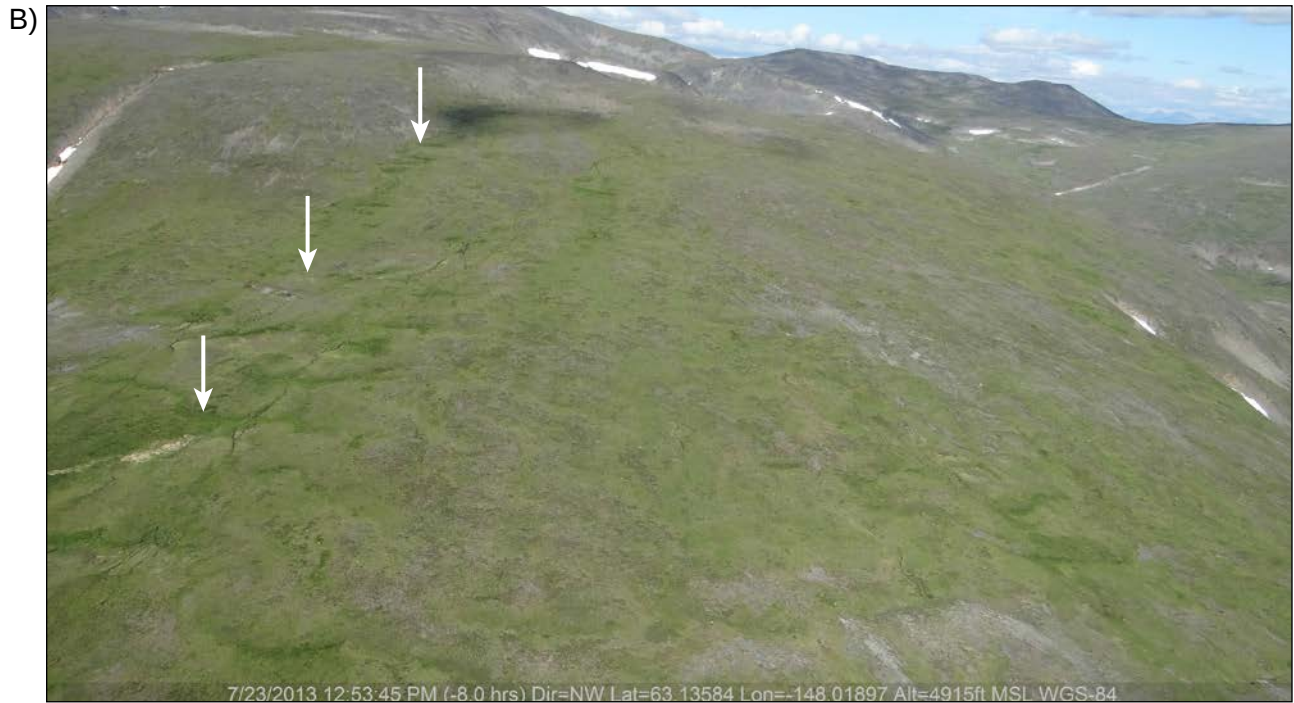
View looking west from photograph location C. Arrows indicate the projected path of the Feature 25 lineament.

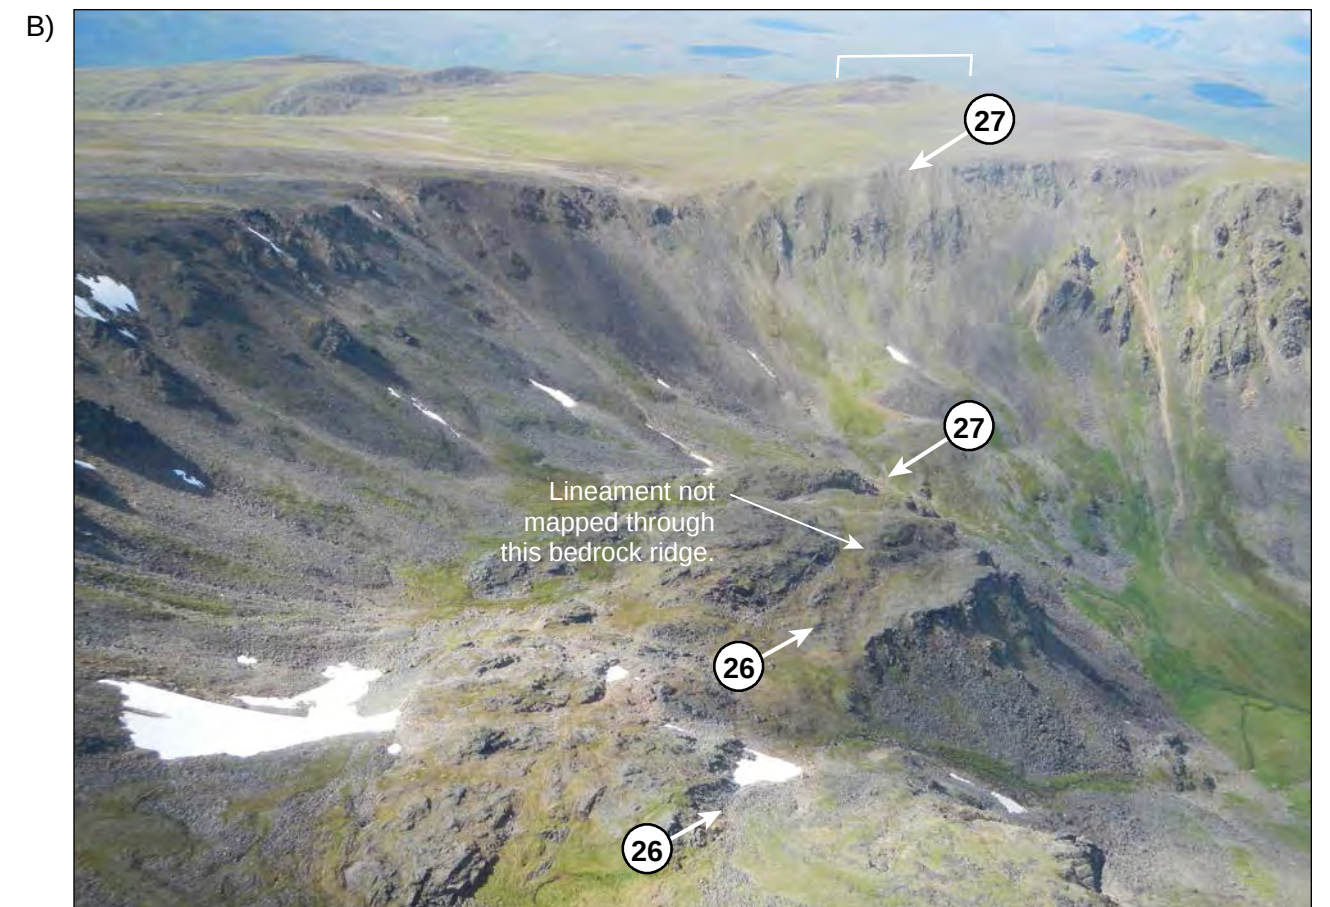
View looking east from photograph location B. Arrows and brackets indicate the projected path of Feature 26 and 27 lineaments. Note the absence of a continuous and clear lineament along projected traces.

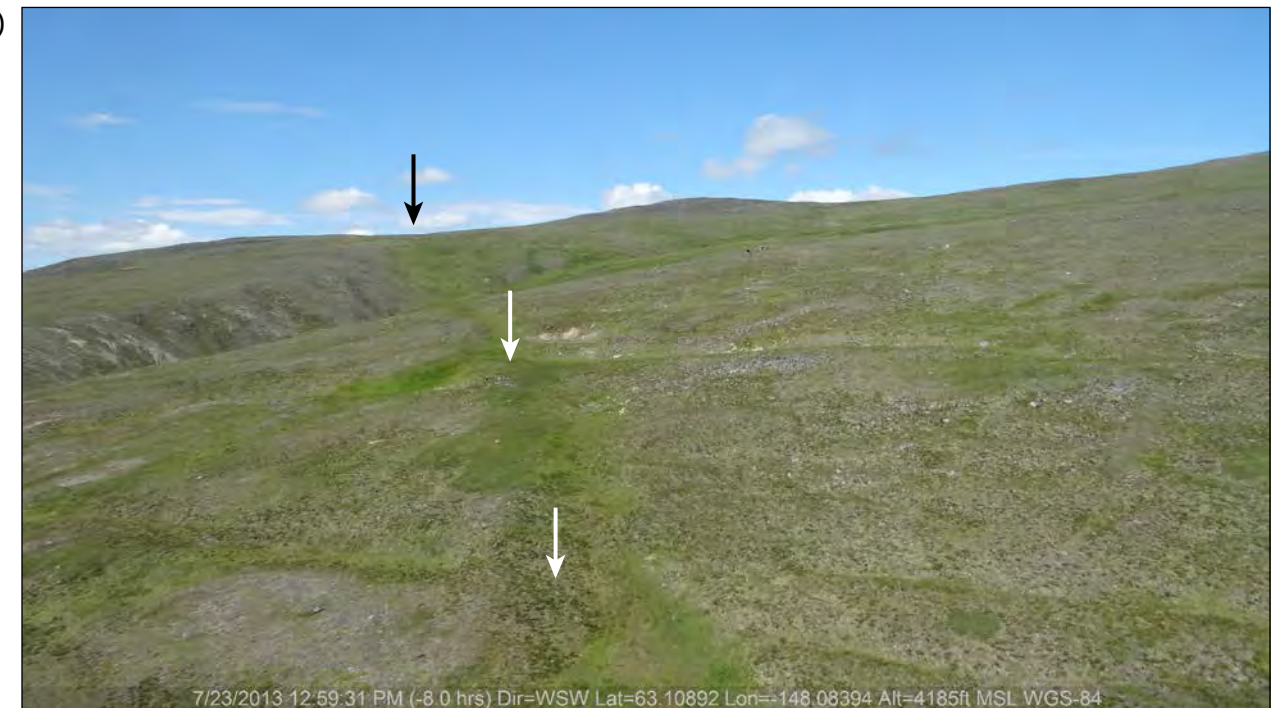
A)

View looking west-northwest from photograph location A. Arrows show mapped trace of Feature 28. Note lineament corresponds to subtle linear trough and linear vegetation trend.
