Susitna-Watana Hydroelectric Project (FERC No. 14241)

Ice Processes in the Susitna River Study (7.6)

Appendix A Detailed Ice Observations and Lower River HEC-RAS Modeling

Initial Study Report

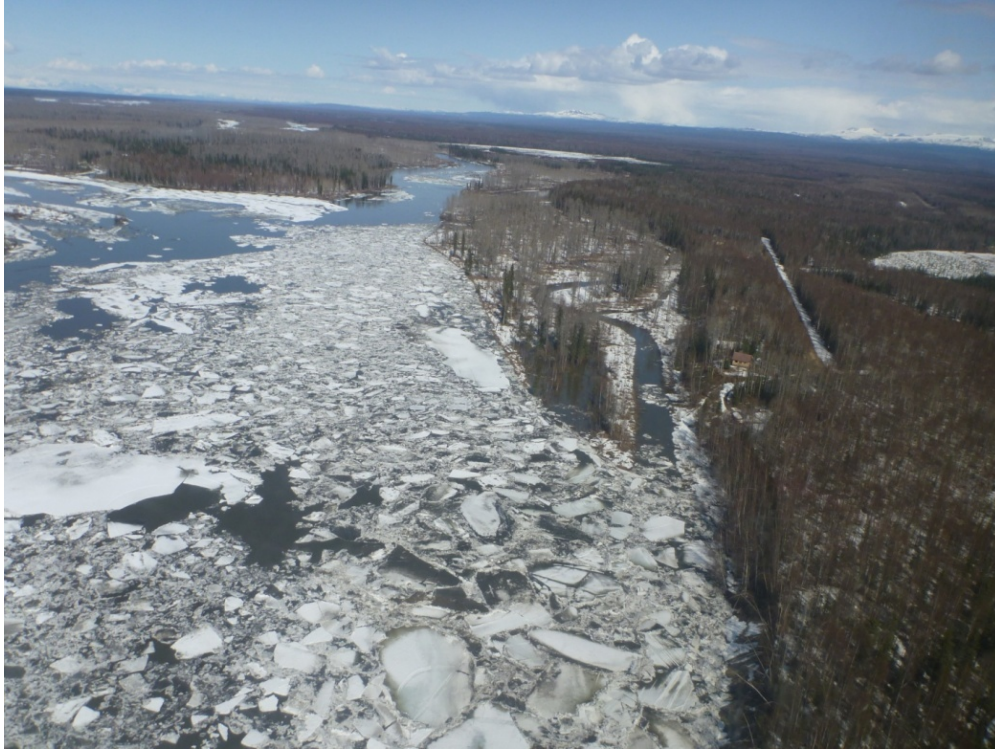
Figure 1.1-1. PRM 101.8 (RM 98)- A large ice jam at the confluence of the Susitna and Chulitna Rivers was back watering the side channel towards Billion Slough, April 30, 2012. Flow is from top to bottom in this photo.

April 30th: The confluence of the Chulitna and Susitna Rivers has a large ice jam that was causing some backwatering into a nearby slough. There was less snow and ice on the banks and bars compared to April 27th, 2012. Generally, this section was snow and ice free; however, between PRM 72 (RM 68) and PRM 90 (RM 86) there was more snow and ice compared to the rest of this section. Similar open water conditions exist from the mouth to PRM 22 (RM 18) as observed on April 27th, 2012. There was an ice floe from PRM 10 (RM 5) to PRM 15 (RM 10).

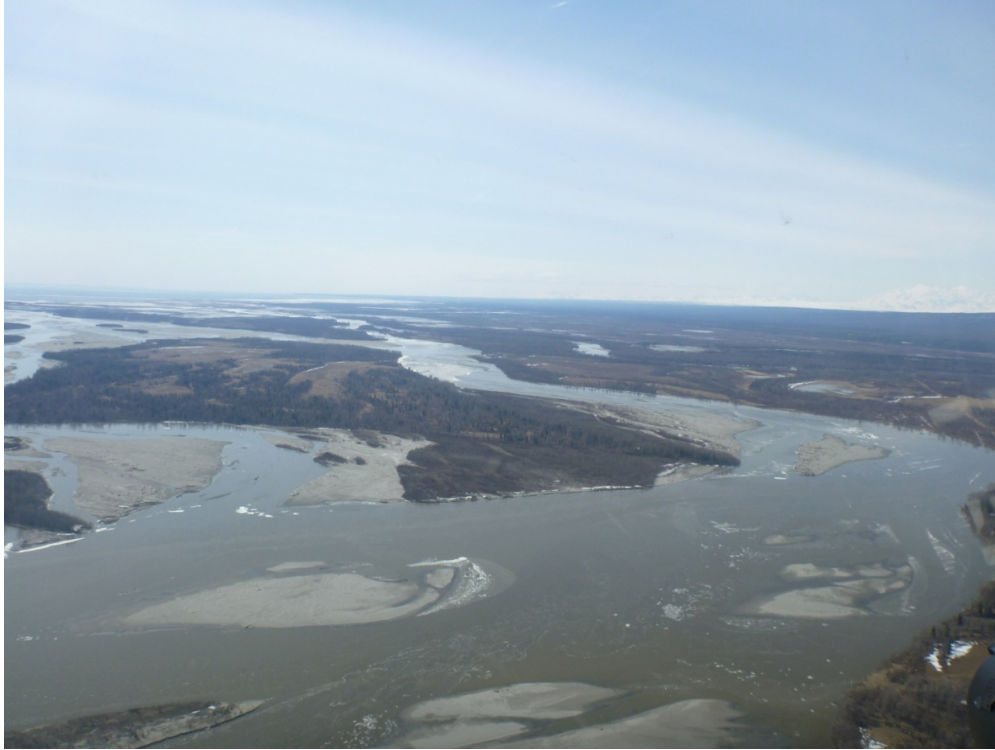
Figure 1.1-2. PRM 14.9 (RM 10)- Minimal mainstem and side channel ice present, May 2, 2012. Flow is from left to right in this photo.

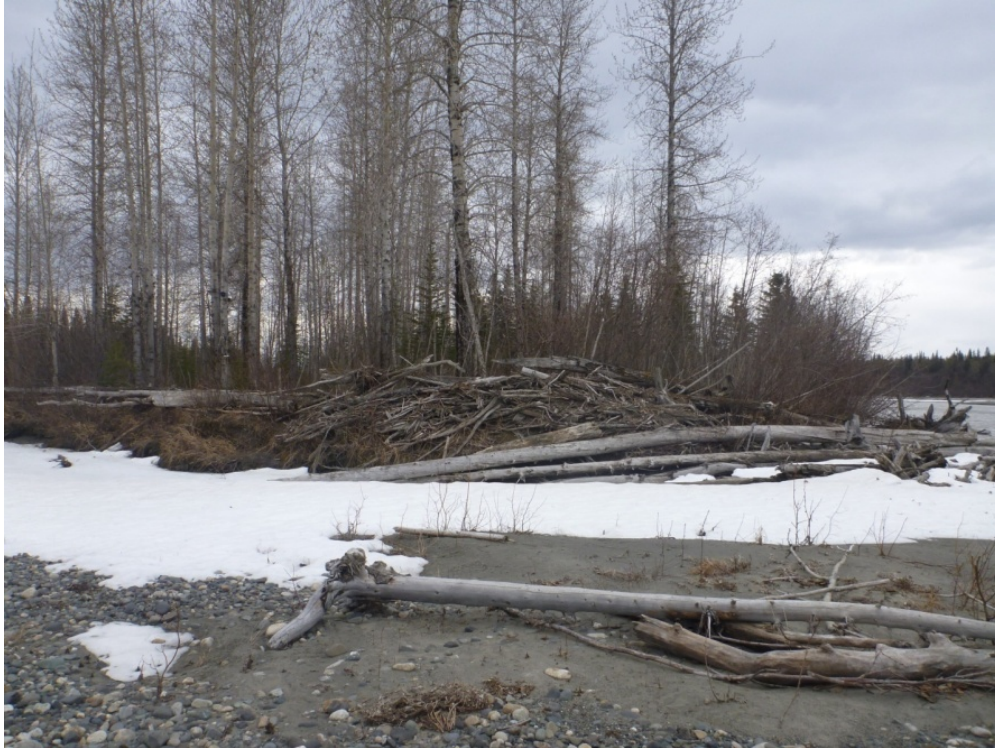
Figure 1.1-3. Birch Creek Slough (PRM 92 [RM 88.6])- Large old woody debris pile on the upstream side of the island on May 10, 2012. No sign of ice-vegetation interactions this year.

May 10th: Camera site at Birch Creek (PRM 91.4 [RM 88]): The upstream point of this island has very large woody debris mats from old ice-vegetation interactions. This debris pile was over 15 feet high. There were no signs of ice-vegetation interactions at this location this year.

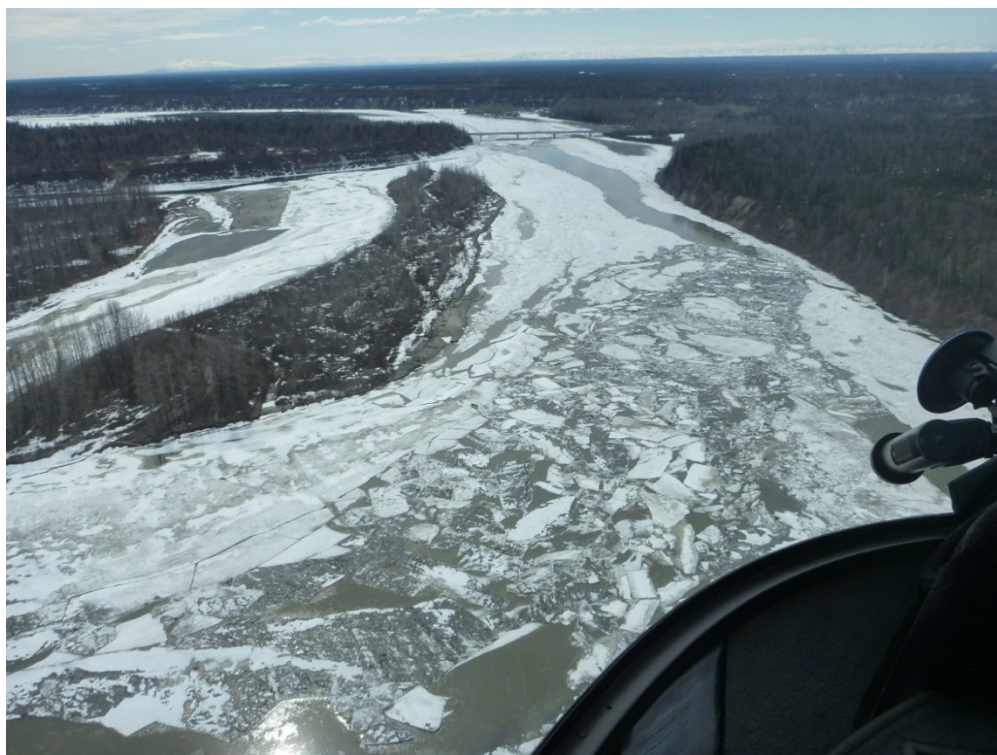
Figure 1.1-6. PRM 89.3 (RM 85.4) - Ice jam upstream of Sunshine Bridge, photo looking downstream. Ice became increasingly broken up upstream. May 14th, 2013.

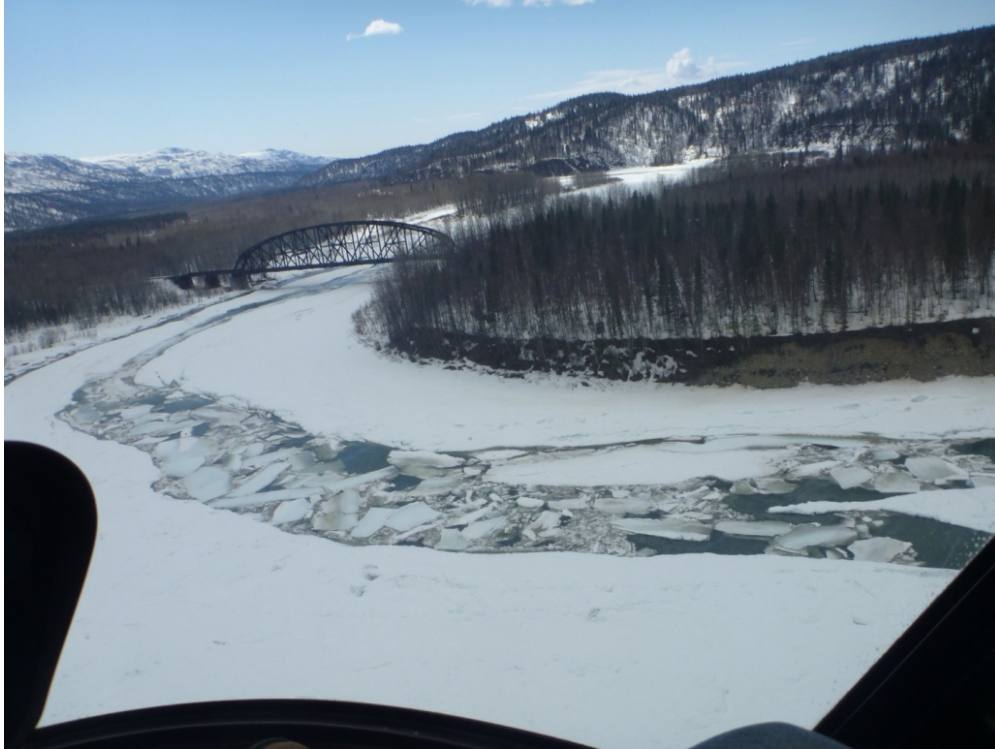
Figure 1.1-7. PRM 140.4 (RM 137)- A small jam in a middle river velocity lead. Flow is from right to left in this photo. April 19, 2012.

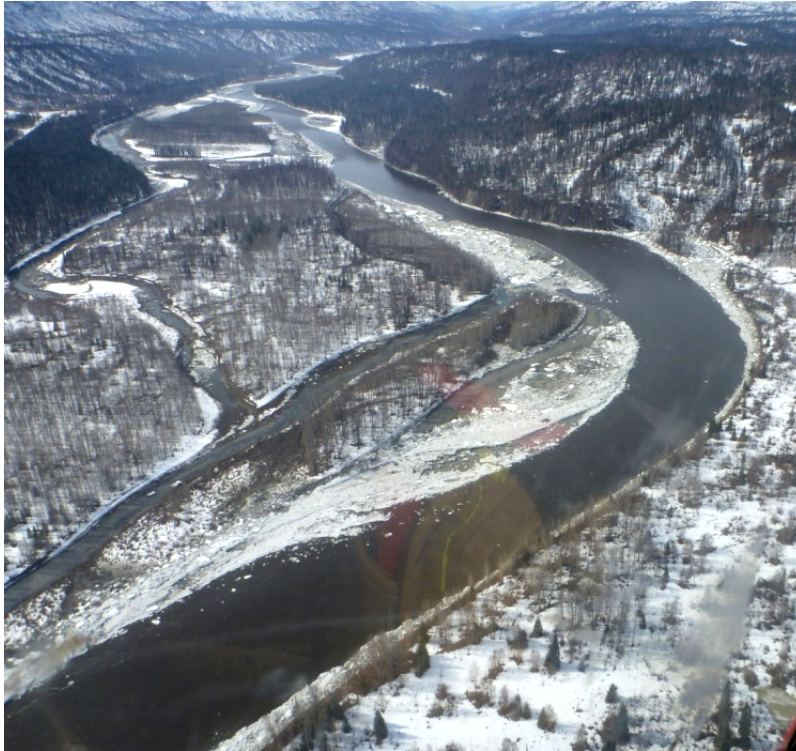
Figure 1.1-8. PRM 139.4 (RM 136)- and Slough 11 after the ice jam collapsed and moved downstream, May 2nd, 2012.

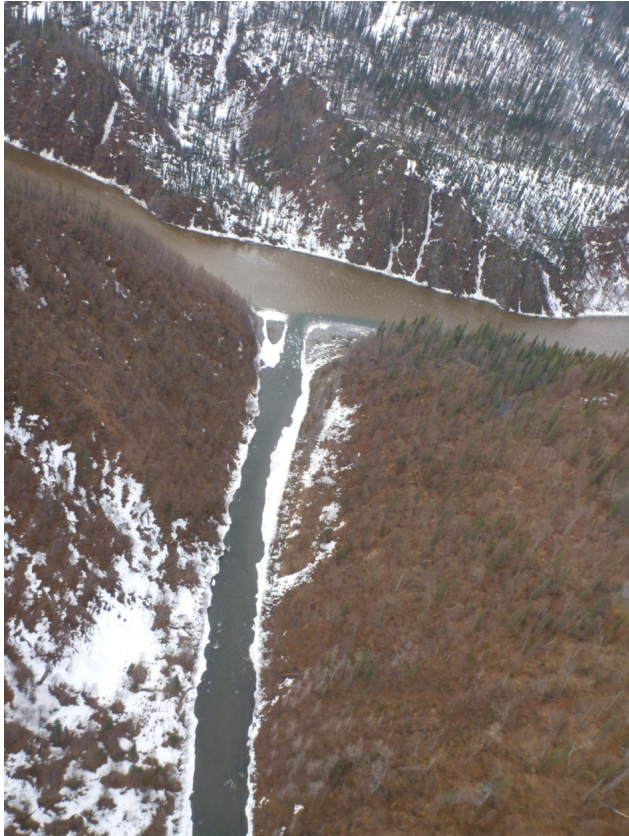
Figure 1.1-9. (PRM 152.3 [RM 148.8])- The confluence of Portage Creek (flowing from the bottom of the photo) and the Susitna River (flowing from the left of the photo) showing the increased sediment being carried in the Susitna River. May 10, 2012.

May 10th: At the confluence of Portage Creek and the Susitna River the water colors indicate the increased sediment being carried in the Susitna River on May 10th. Camera site at FA-151 (Portage Creek) was on the gravel point on the downstream side of the confluence. No ice-vegetation interaction was observed; however some sediment deposition was observed. The observed sediment deposition appears to be sediment that was carried in the ice and deposited when the ice melted in place.

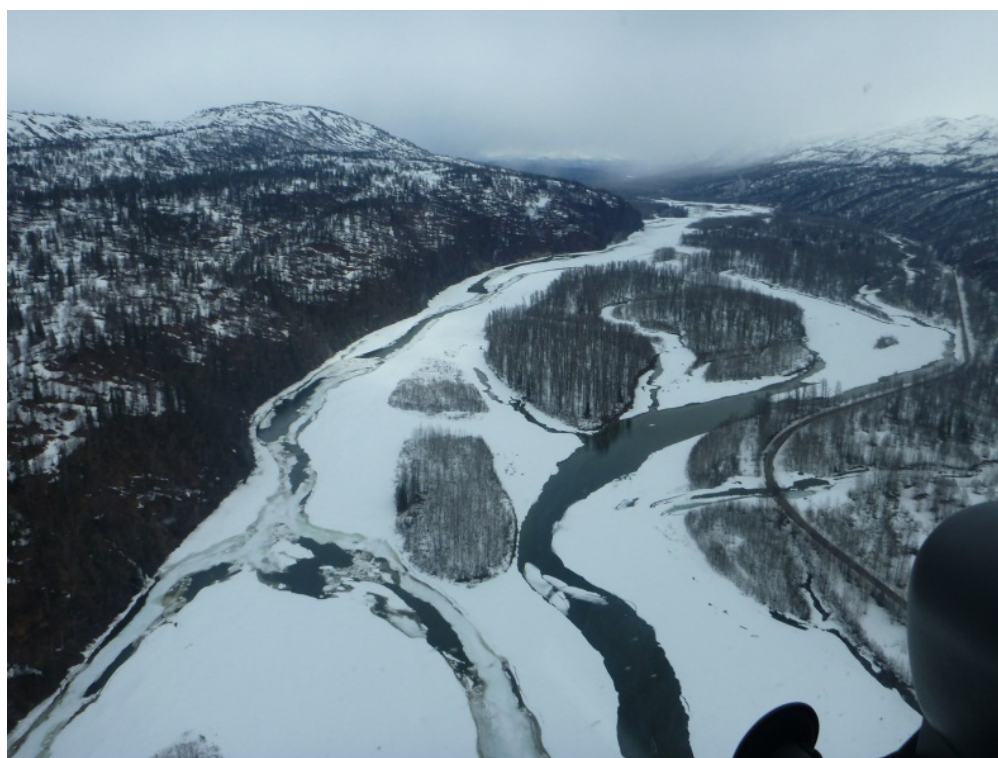
Figure 1.1-11. FA-128 (Slough 8A) (PRM 127.9 [RM 124]) – Ice jams forming. May 15th, 2013

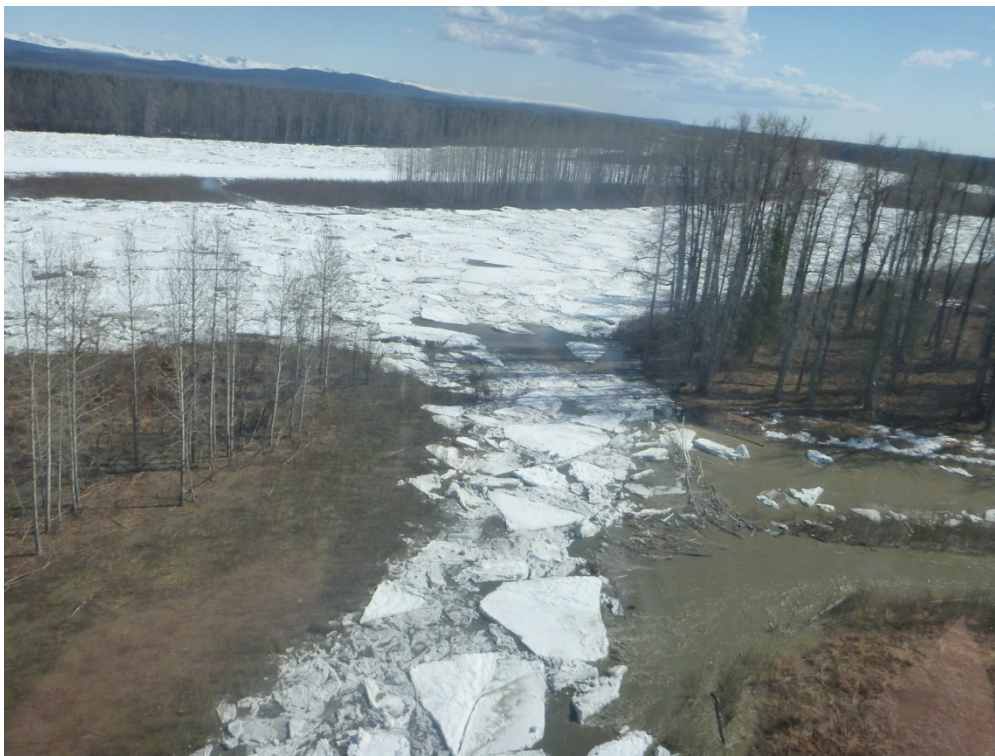
Figure 1.1-12. (PRM 105.4 [RM 101.5]) - Ice jams at Whiskers Slough flooding the slough. May 25th, 2013.

May 25th: A large jam formed just downstream of Whiskers Slough (PRM 104.9 [RM 101]) and was backing up water and ice and flooding the slough and mouth of Whiskers Creek. There were various ice jams along the Middle River up to Devils Canyon. Ice bridges remained at the mouth of Portage Creek. Fast, turbulent flow in Devils Canyon was breaking apart ice from the Upper River and leaving only slush and small chunks downstream. Few jams remain in the canyon. Ice was broken up and rapidly moving downstream upstream of Devils Canyon. Tsusena Creek continued to open and was at 20 percent during this survey.

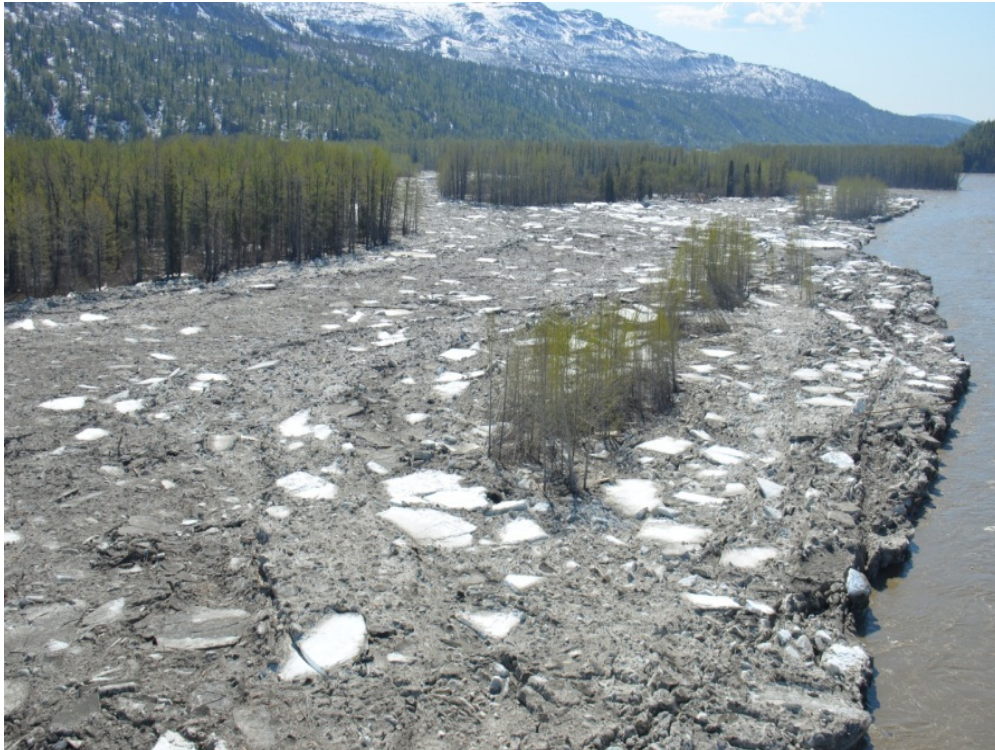
Figure 1.1-13. PRM 132.4 (RM 129) - Ice deposited in Slough 9. May 29th, 2013.

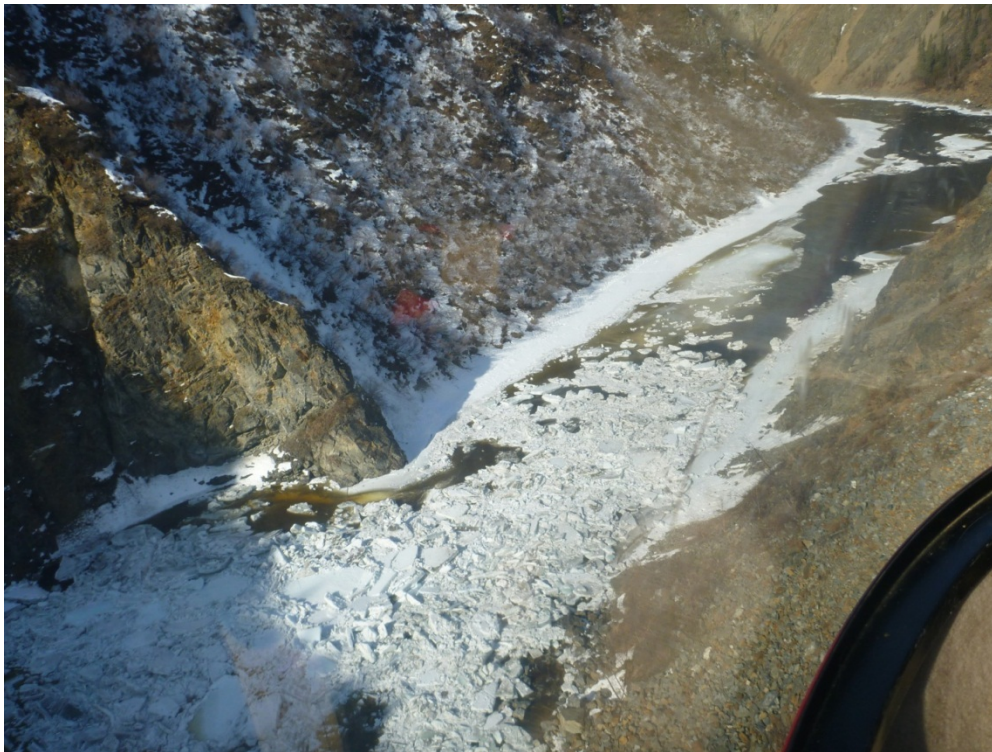
Figure 1.1-14. PRM 223.4 (RM 221.5) - Ice jam in Vee Canyon. April 27th, 2012.

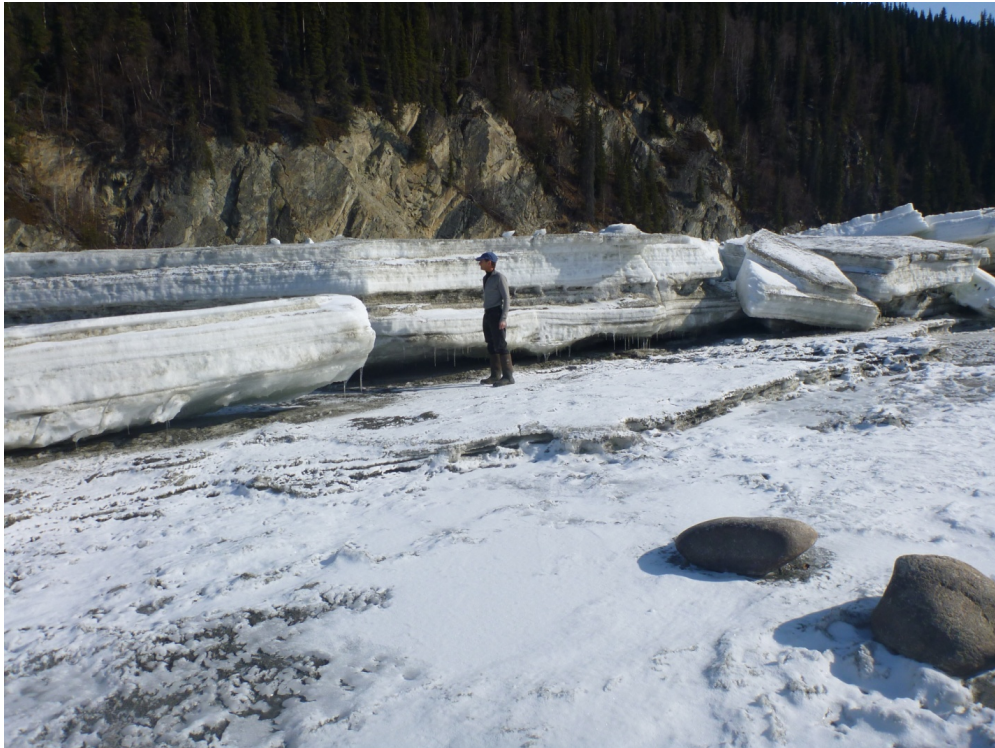
Figure 1.1-15. PRM 222.9 (RM 221) - Remnant ice slabs downstream of Vee Canyon. May 2nd, 2012.

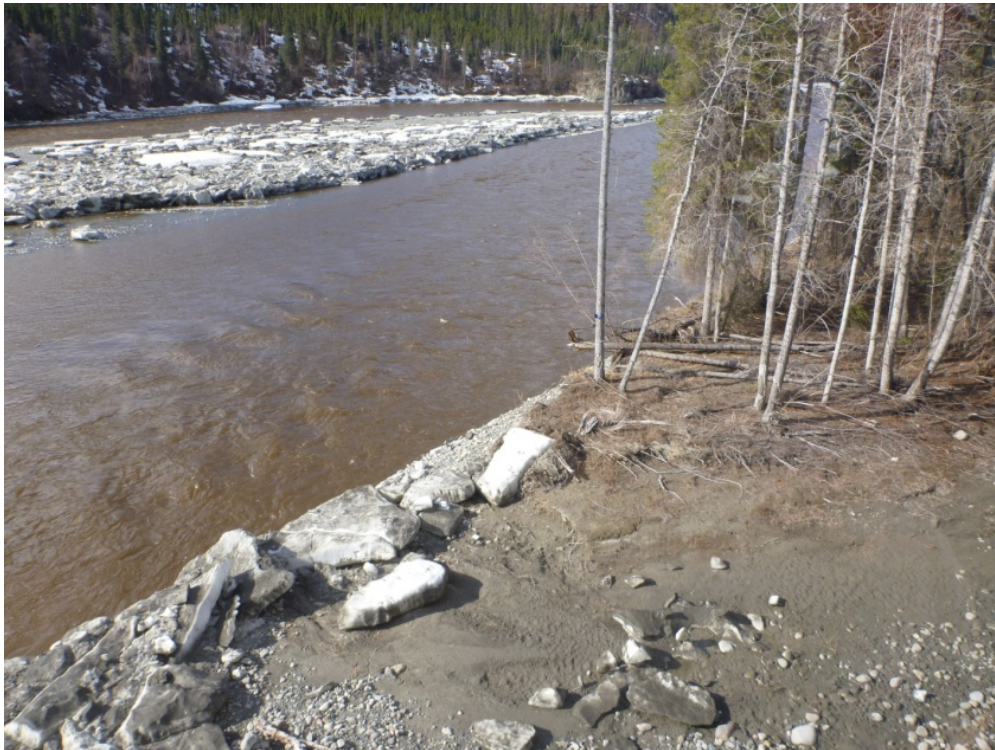
Figure 1.1-16. PRM 181.2 (RM 184)- Time-lapse camera location. This photo documents both ice-vegetation and ice-sediment interactions on the upstream point of this island. Flow is from left to right. May 10th, 2012

May 10th: FA-184 (Watana Dam) (PRM 186.8 [RM 184]): Ice-vegetation and ice-sediment interactions were observed at this location. There was both ice-vegetation and ice-sediment interactions on the upstream point of this island. There was some evidence of scouring, but no large material clearing was observed. Several old ice scars were observed at this site and two old ice scars were seen on large trees on the mainstem side of the island as evidence of old ice-vegetation interactions; however, no new ice scars were observed. Floating ice landed on the shore-edge of the island, but was not pushed to cause recent undercutting of the bank. There was white ice downstream on the island that was melting in place and showed no ice-vegetation or ice-sediment interactions.

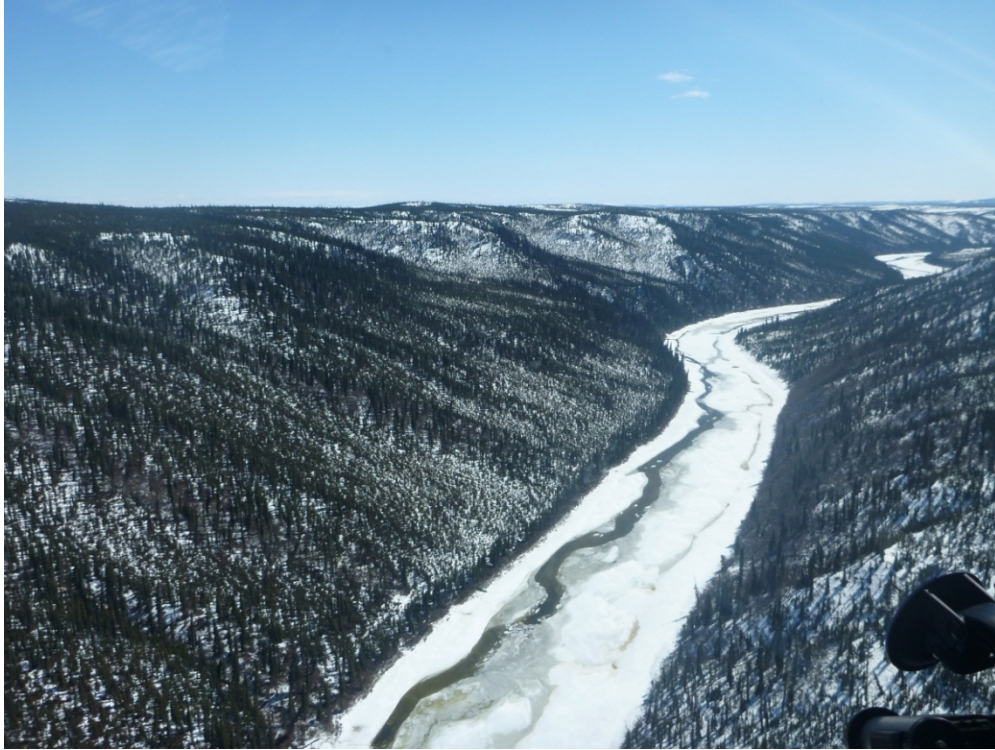
Figure 1.1-18. PRM 228 (RM 226) - Open lead on the upper river. May 19th, 2013.

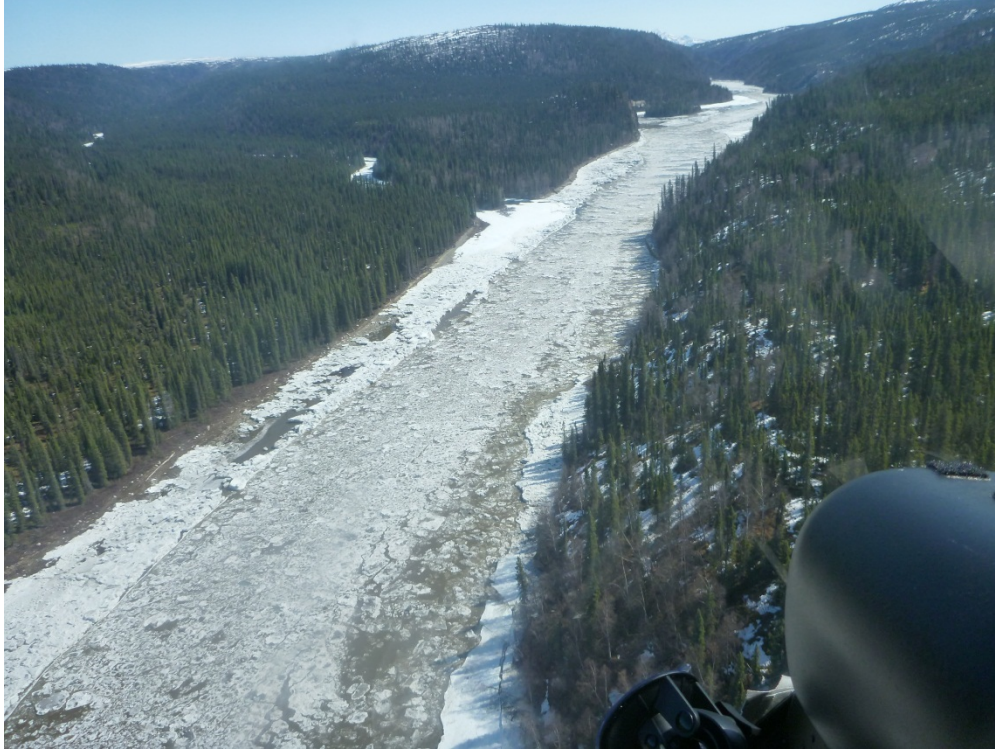
Figure 1.1-19. PRM 196.8 (RM 194.1) - Broken but extensive ice cover. May 25th, 2013.

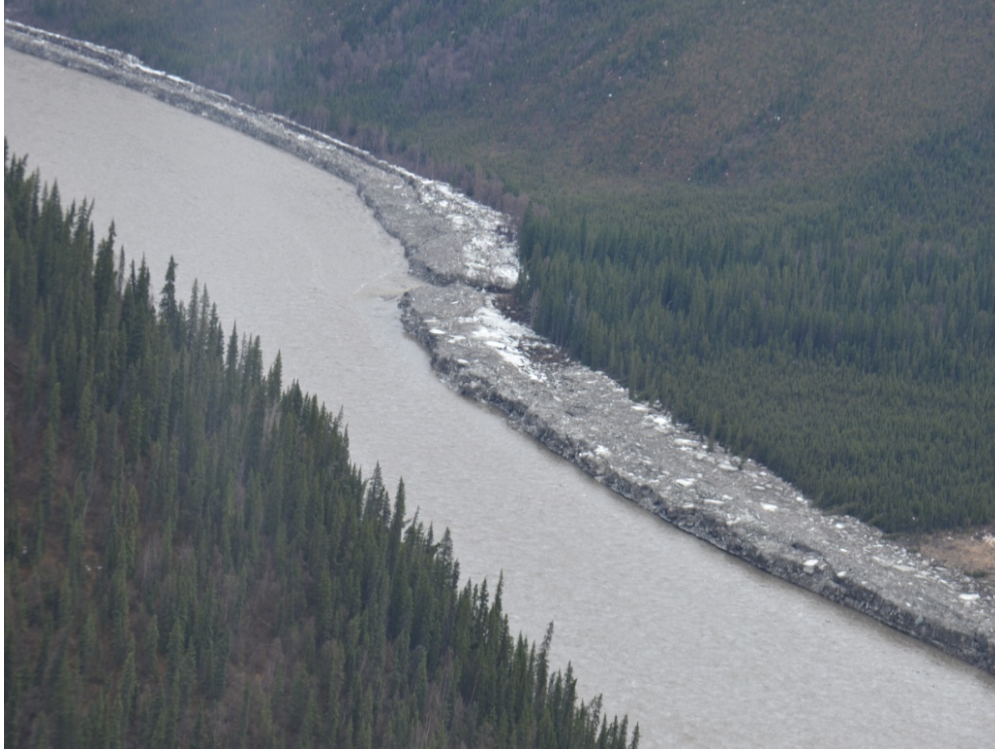
Figure 1.1-20. PRM 222 (RM 220.1) - Remnants of ice shelves and stranded ice on the Upper River. May 29th, 2013.

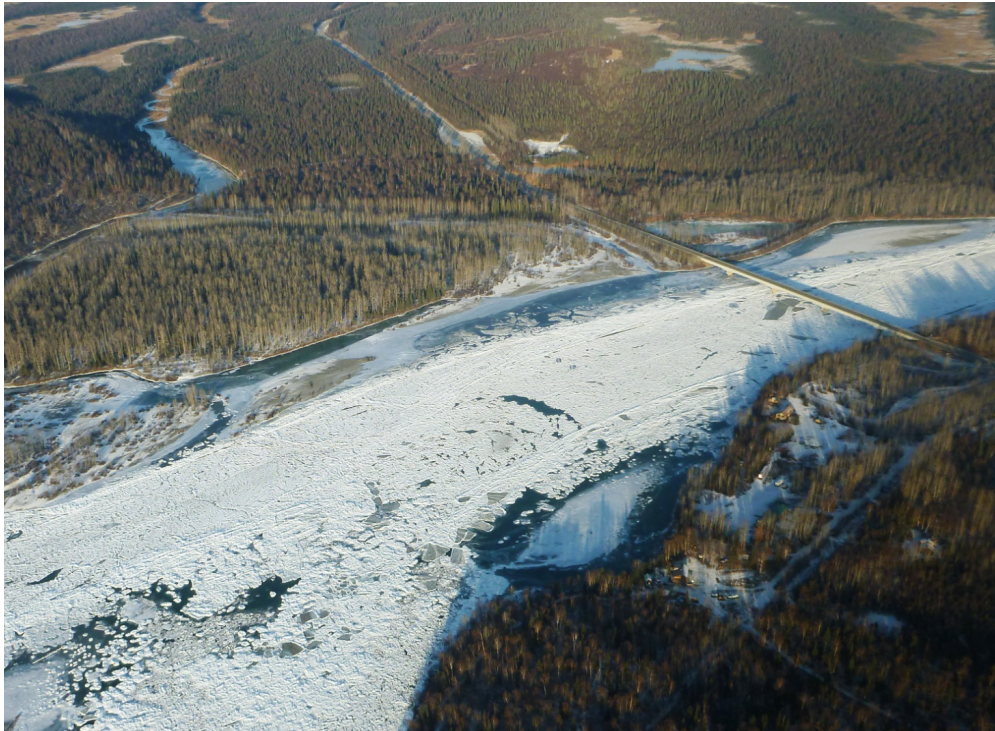
Figure 2.1-2. PRM 88 (RM 84) - Parks Highway Bridge after ice cover progression. Note flooded gravel bars on both sides of the river. November 7th, 2013.

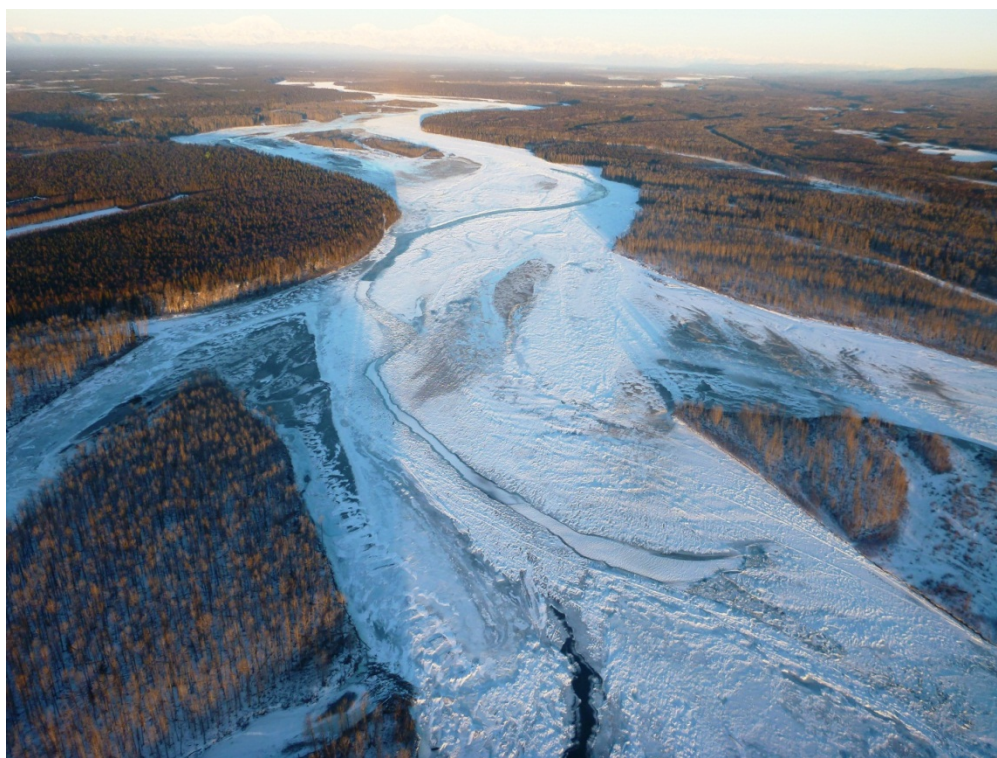
Figure 2.1-3. PRM 78 (RM 74.3) - Looking upstream. Velocity lead in main channel filling in from bottom with frazil ice. December 3rd, 2013.

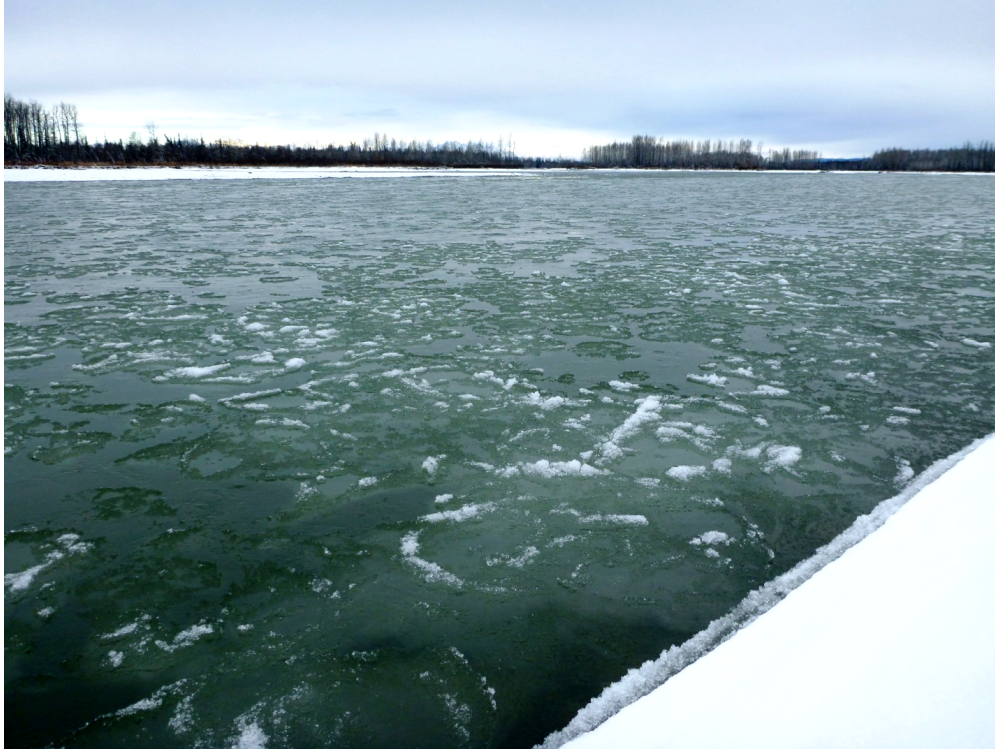
Figure 2.1-5. PRM 103.8 (RM 100) - Frazil ice pans flowing past on the Middle River. October 16th, 2012.

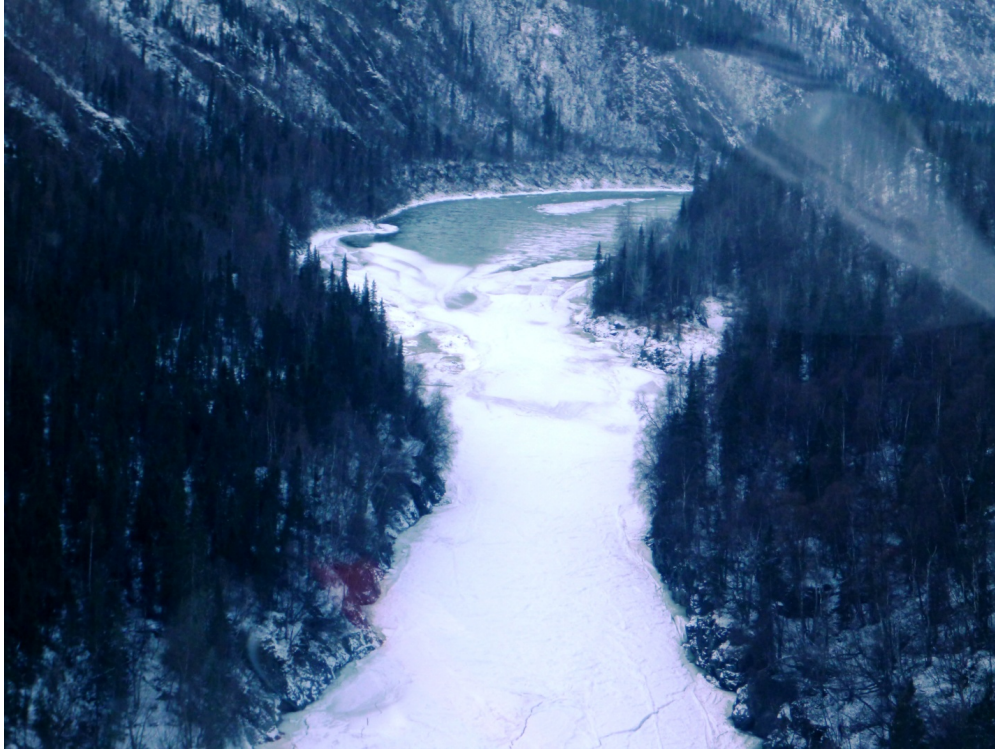
Figure 2.1.2-6. PRM 154.7 (RM 151) - Ice bridge in Devil Canyon, flow is from bottom to top. October 22nd, 2012.

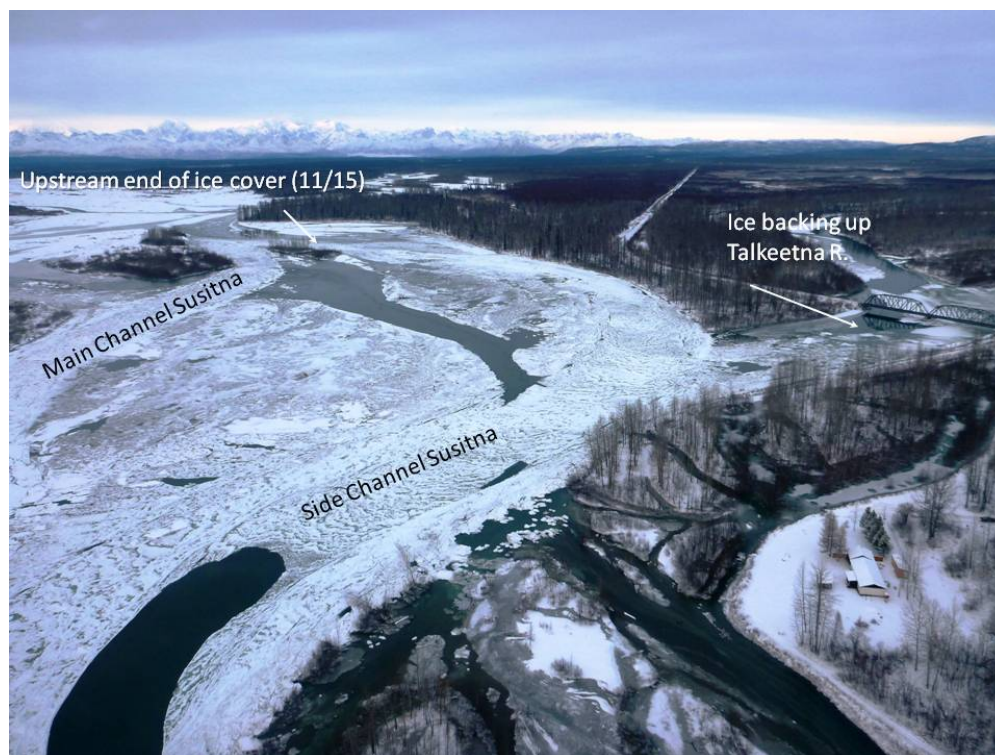
Figure 2.1-7. PRM 100-102 (RM 96.6-98.2) - Ice cover configuration and flooded channels at Talkeetna. November 15th, 2012.

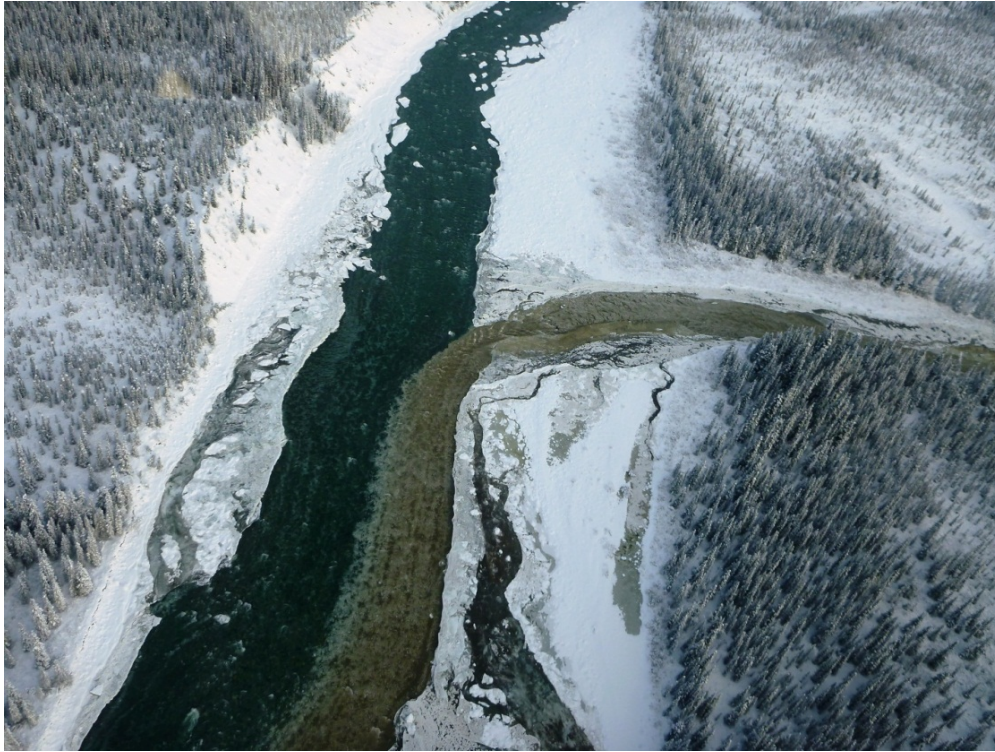
Figure 2.1-9. RM 235 (RM 233.4) - Oshetna River confluence and apparent ice-jam breakout flood (brown water coming from Oshetna River). November 15th, 2012.

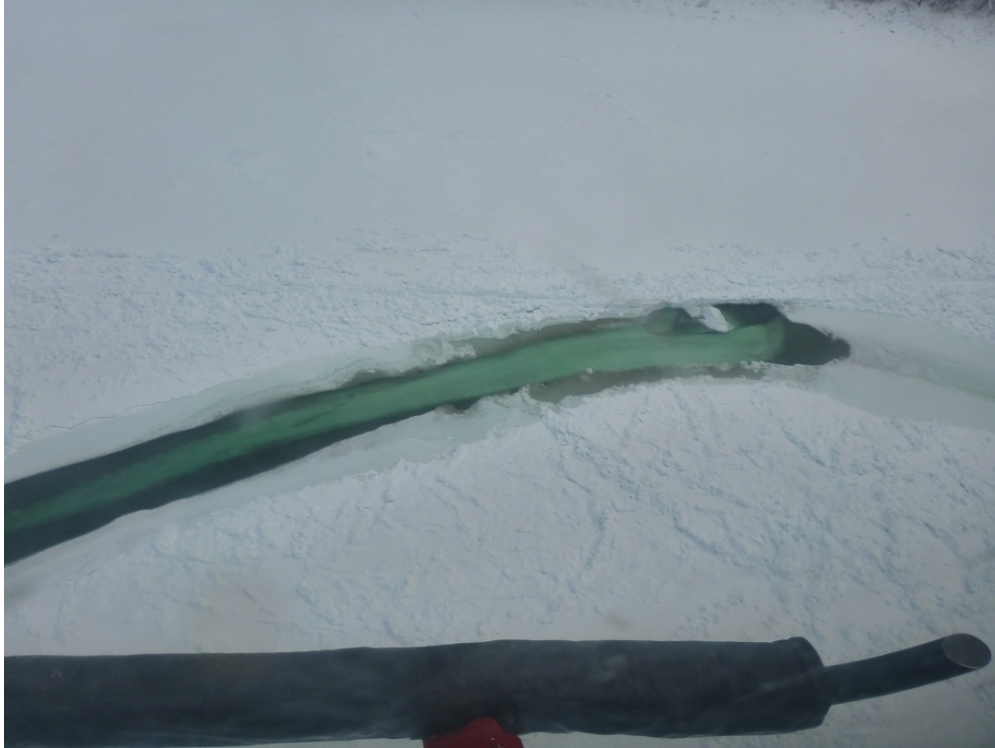
Figure 2.1-10. PRM 217 (RM 214.9) - Anchor ice. January 9th, 2012.

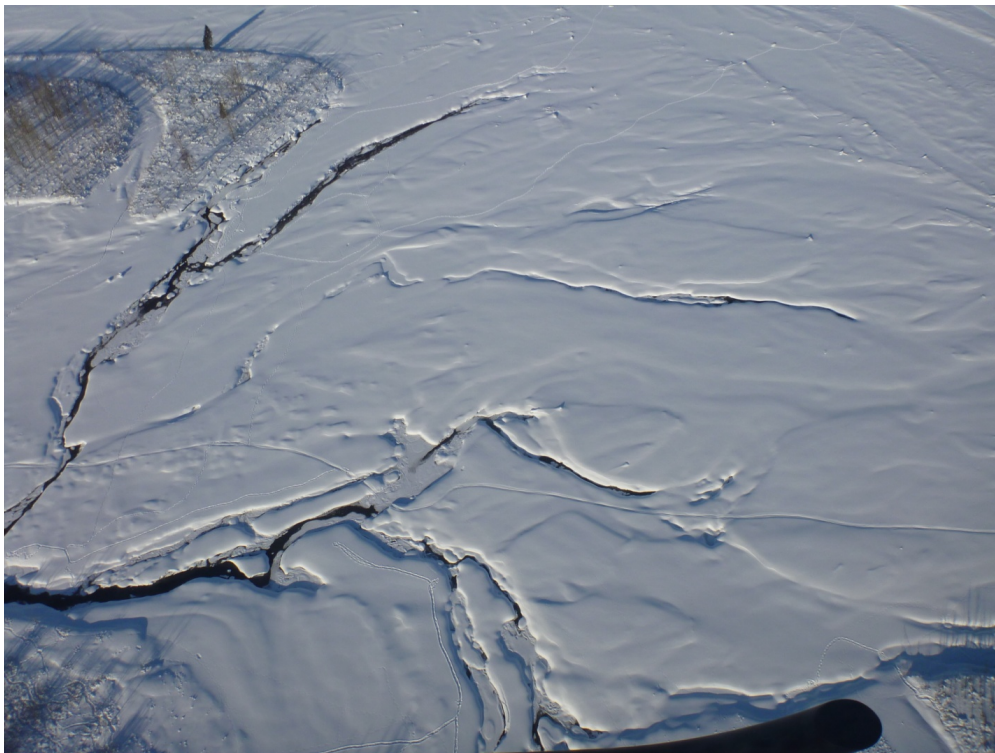
Figure 3.1-1. PRM 49 (RM54) - Photo of threaded pattern of open water thermal leads on the Susitna River. Flow is from right to left in this photo. March 21st, 2012.

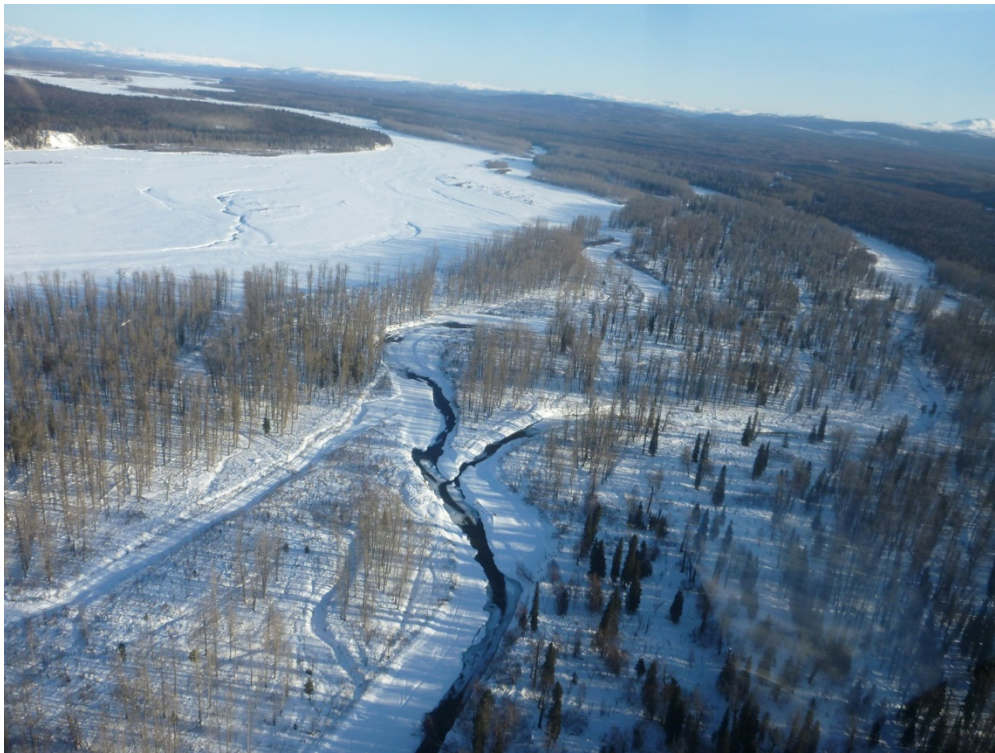
Figure 3.1-2. PRM 89 (RM 85.3) – Thermal lead in Sunshine Slough. March 12th, 2013.

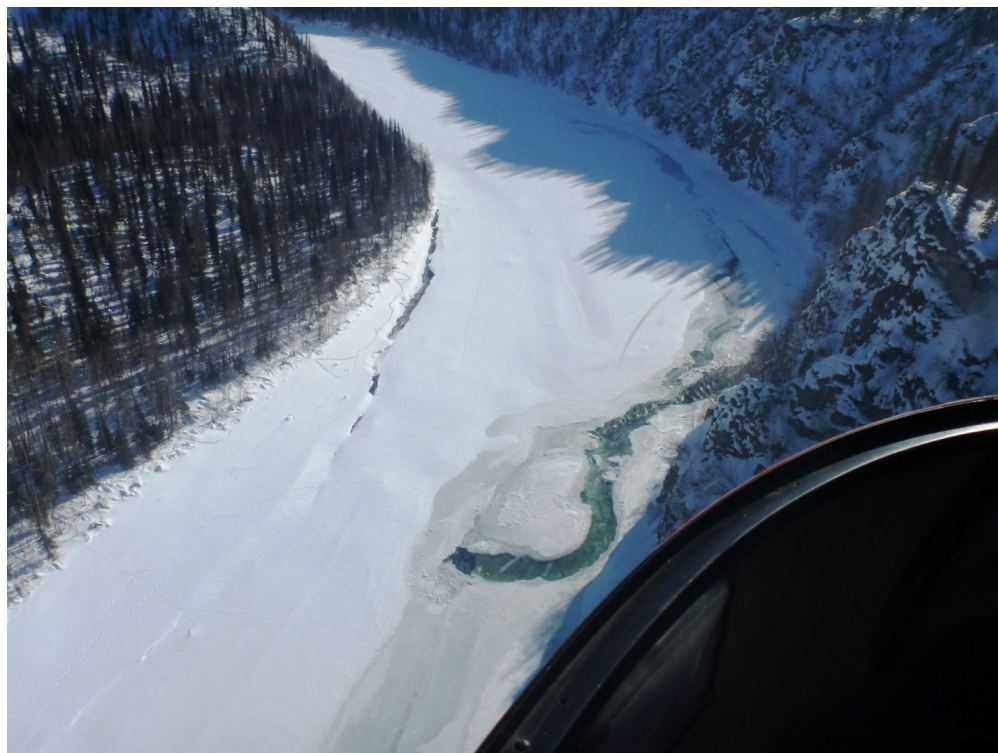
Figure 3.2-1. PRM 149.4 (RM146) - Thermal lead on river right and a velocity lead on river left near Susitna. Note that flow is from top to bottom in this photo and river right and river left are with respect to flow. March 22nd, 2012.

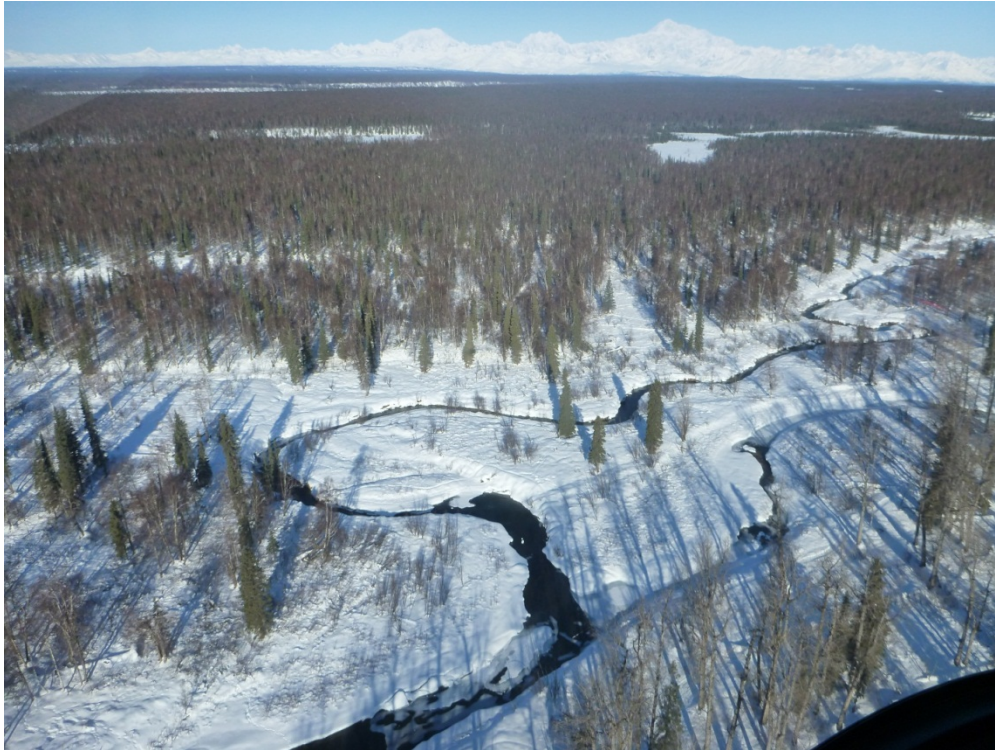
Figure 3.2-2. PRM 105.5 (RM 101.6) - Thermal leads in Whiskers Creek where it joins Whiskers Slough. March 12th, 2013.

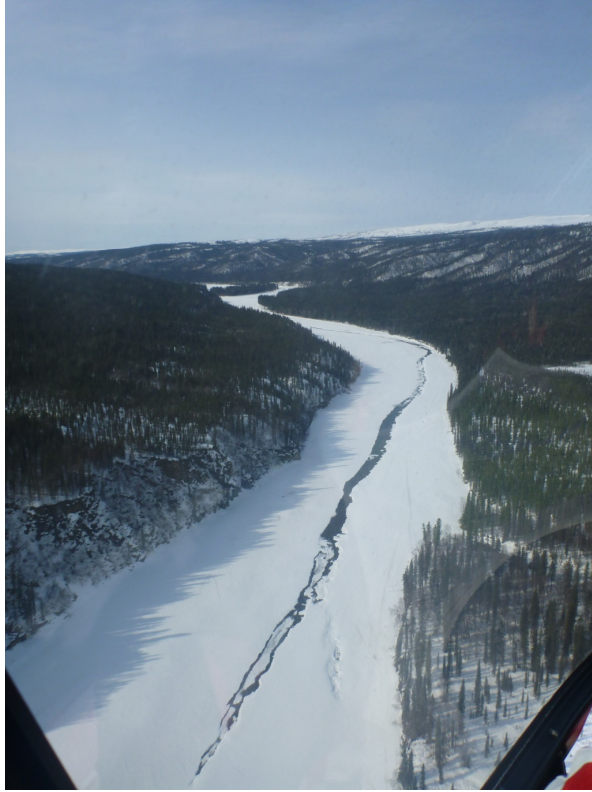
Figure 3.3-1. PRM 184.7 (RM 182) - A long velocity lead on the Susitna River. Flow is from bottom to top in this photo. April 4th, 2012.

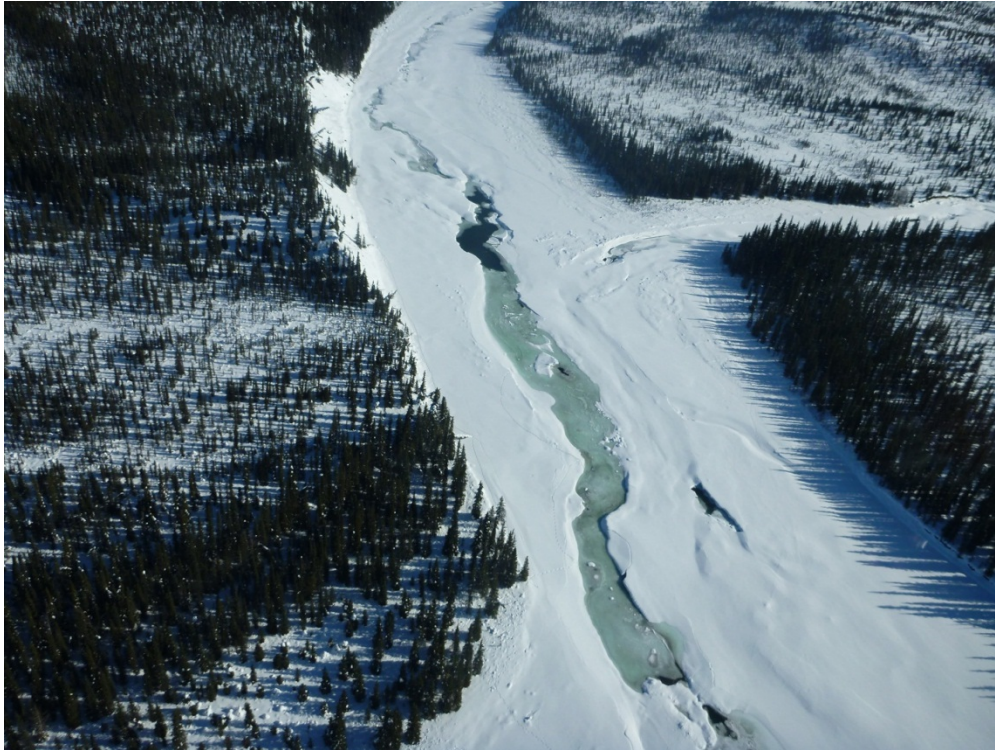
Figure 3.3-2. PRM 236 (RM 234.7) - Velocity leads at the Oshetna River confluence. March 12th, 2013.
