Susitna-Watana Hydroelectric Project (FERC No. 14241)

Ice Processes in the Susitna River Study (7.6)

Appendix A Detailed Ice Observations and Lower River HEC-RAS Modeling

Initial Study Report

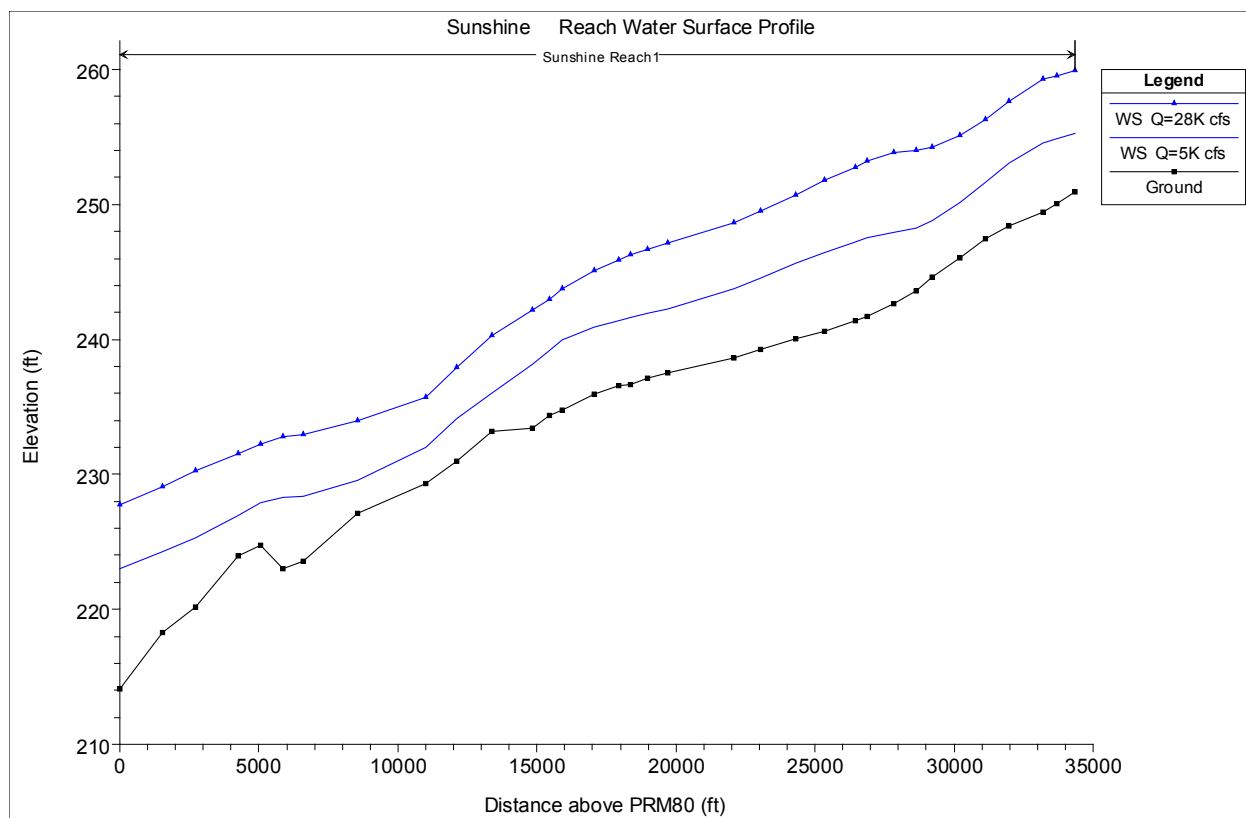
Figure 4.2-1. HEC-RAS profile plot of the modeled reach near Sunshine at the start of the freeze-up period at discharge levels of 5,000 and 28,000 cfs.

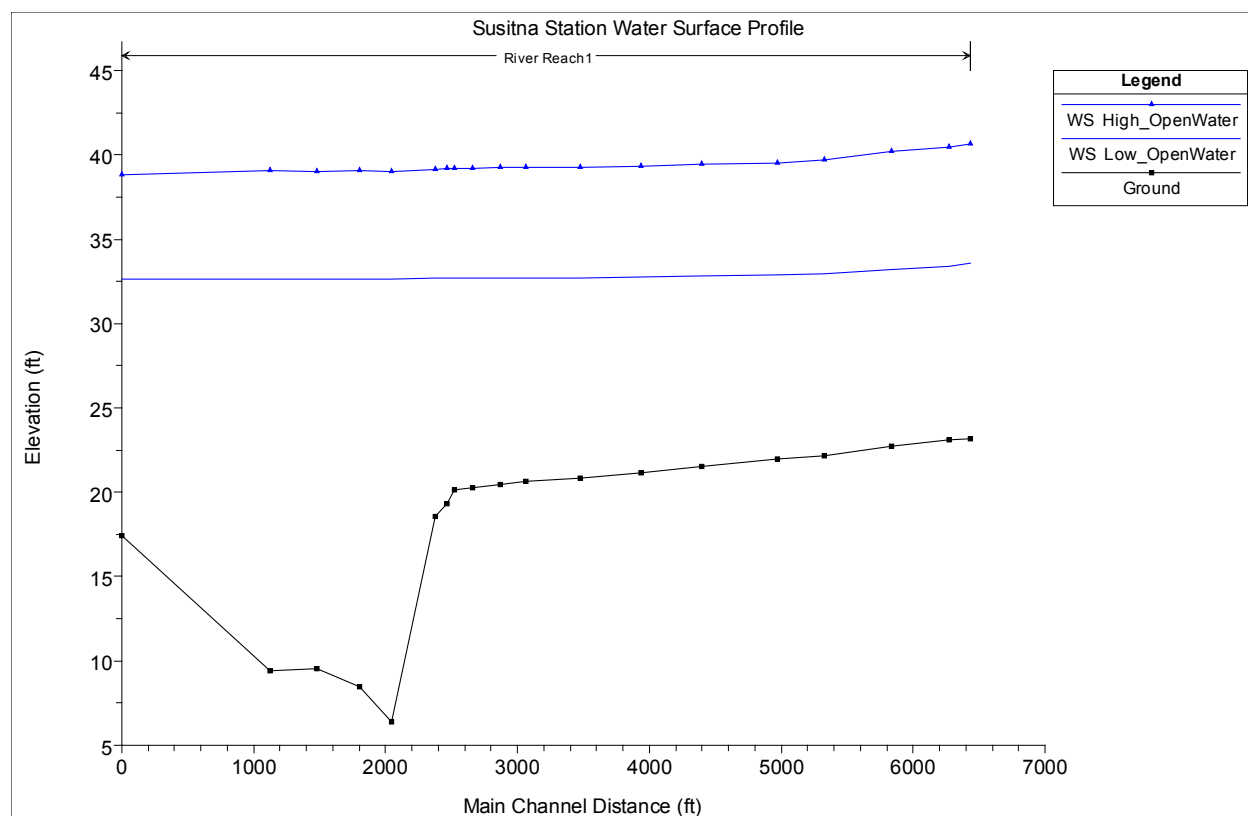
Figure 4.3-1. HEC-RAS profile plot of the modeled reach at Susitna Station at the start of the freeze-up period at discharge levels of 11,000 and 58,000 cfs.

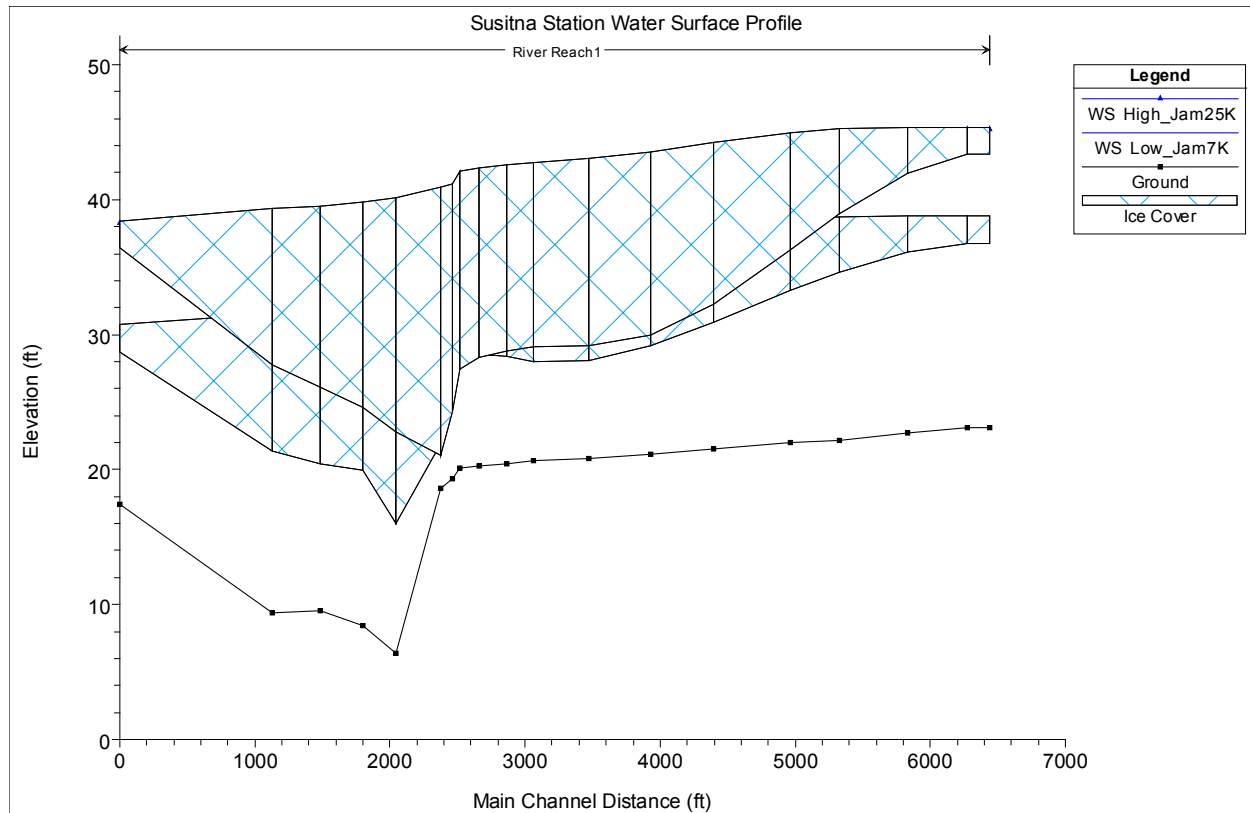
Figure 4.3-2. HEC-RAS profile plot of the modeled reach at Susitna Station at the completion of the freeze-up period at discharge levels of 7,000 to 25,000 cfs.

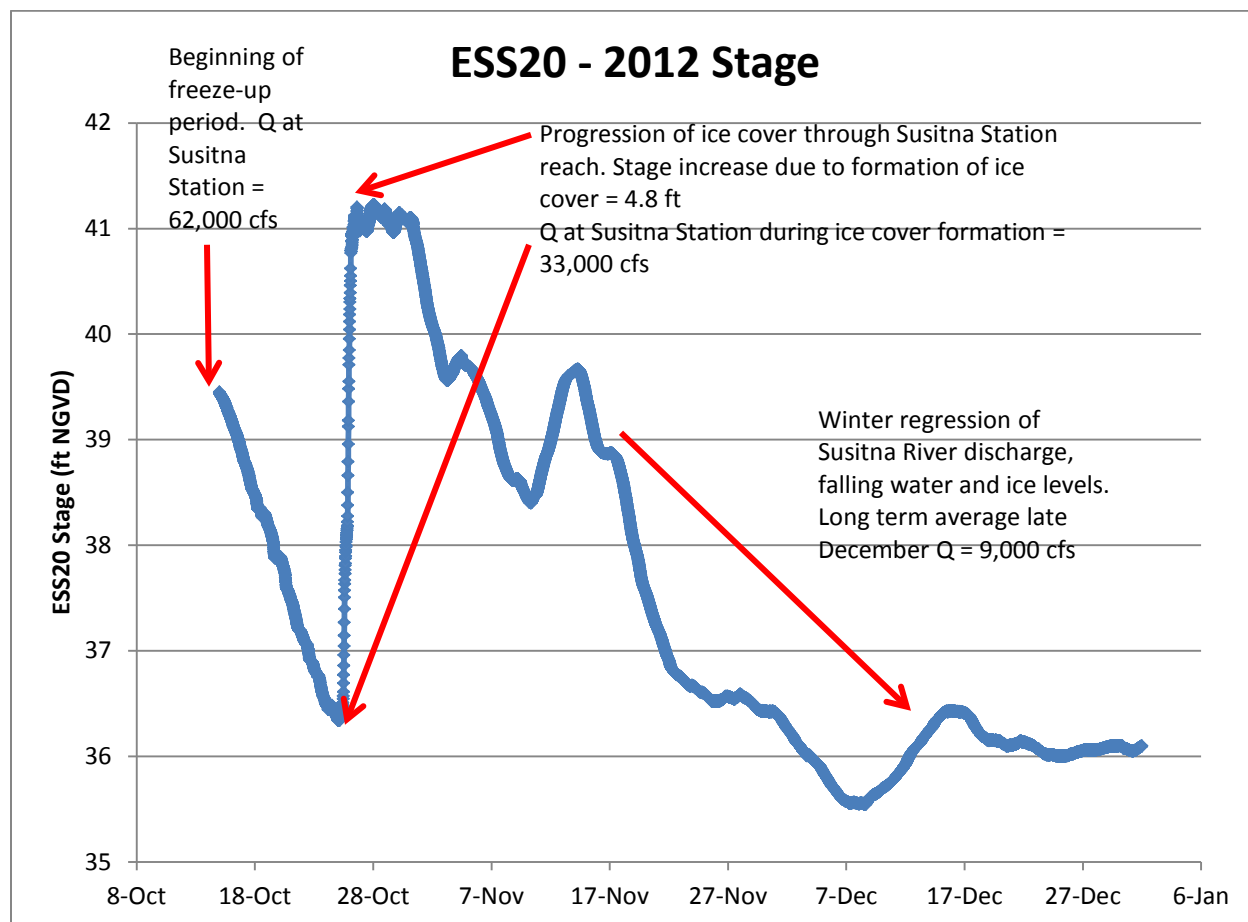
Figure 4.3-4. Hydrograph of ESS20 during the freeze-up period in 2012 with discharge at various times annotated.

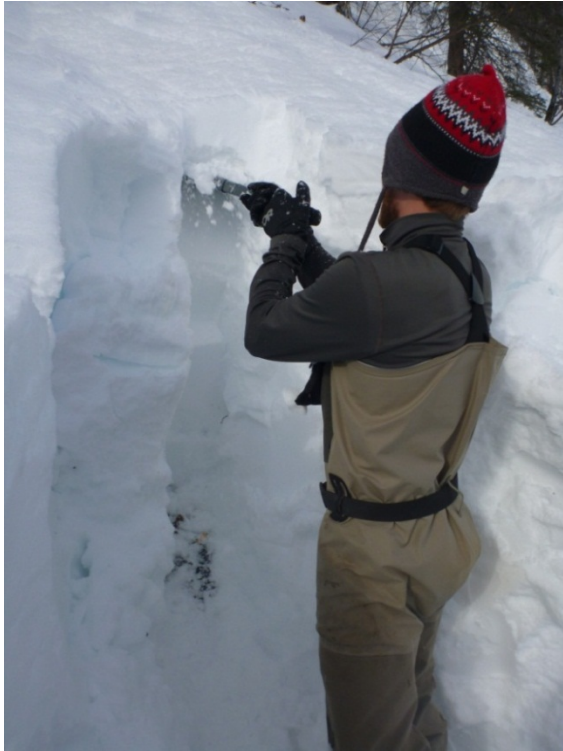
Figure 4.1-1. Locating TBM2 at ESS50 (PRM 124.4 [RM 121]) (HDR Alaska).

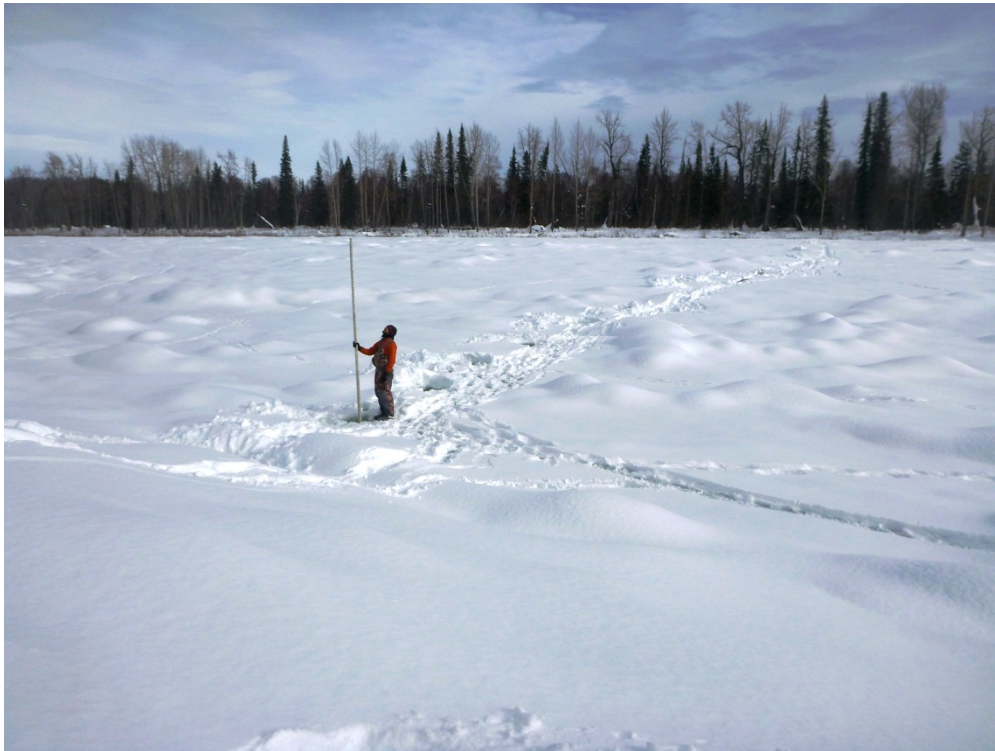
Figure 4.1-2. Surveying ice elevation at ESS40 (PRM 106.8 [RM 103]) (HDR Alaska).

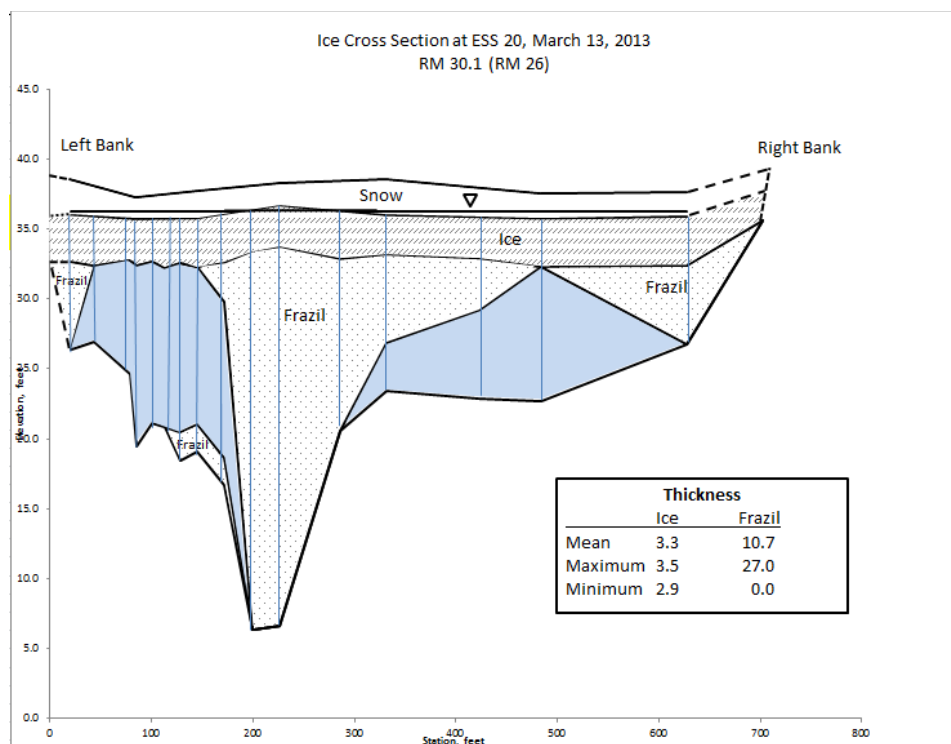
Figure 5.1-1. Cross Sectional Diagram of ESS20. HDR Alaska.

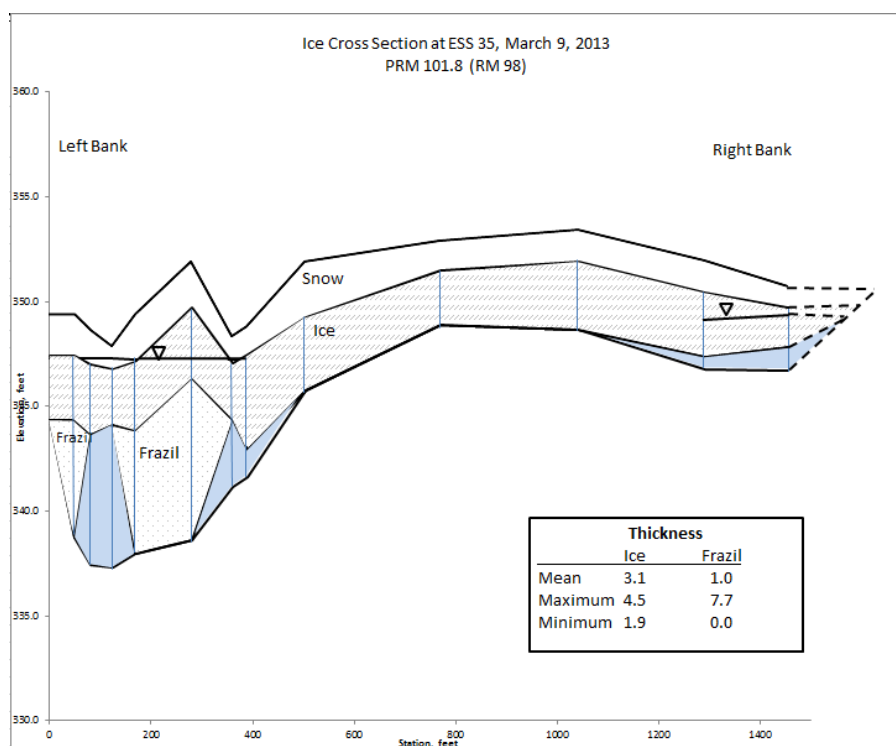
Figure 5.1-2. Cross Sectional Diagram of ESS35. HDR Alaska.

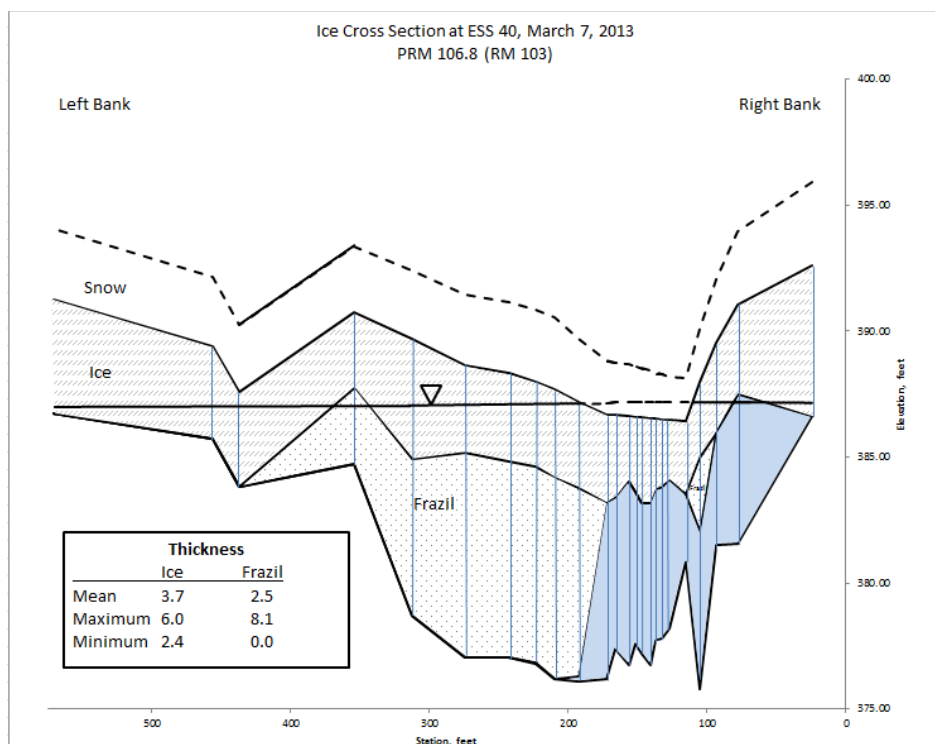
Figure 5.1-3. Cross Sectional Diagram of ESS40. HDR Alaska.

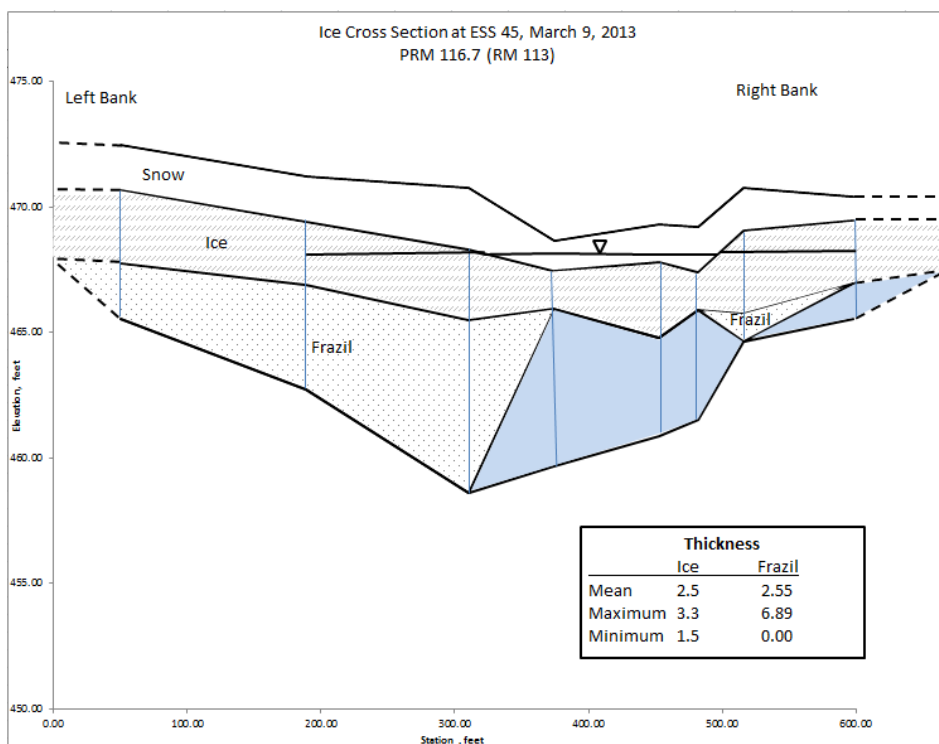
Figure 5.1-4. Cross Sectional Diagram of ESS45. HDR Alaska.

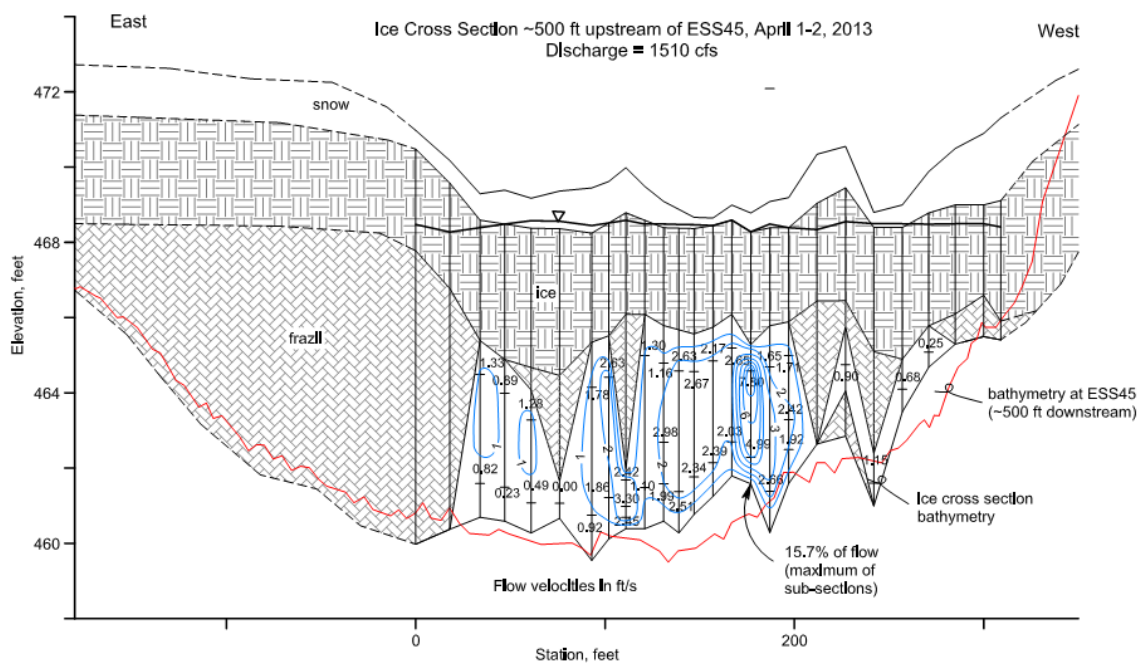
Figure 5.1-5. Cross Sectional Diagram of ESS45. Brailey Hydrologic.

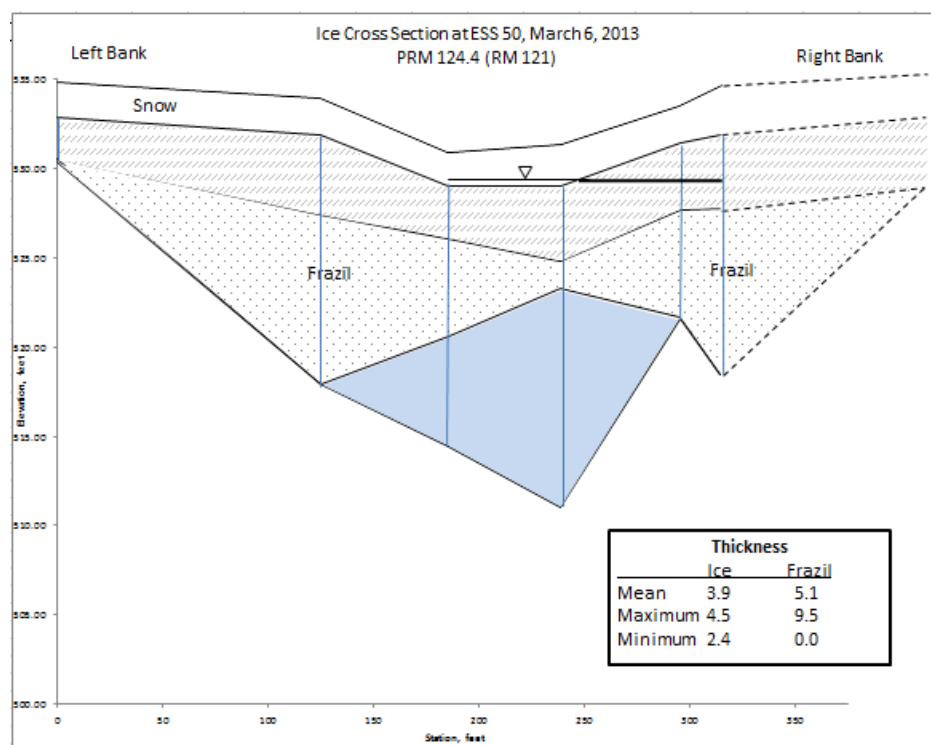
Figure 5.1-6. Cross Sectional Diagram of ESS50. HDR Alaska.

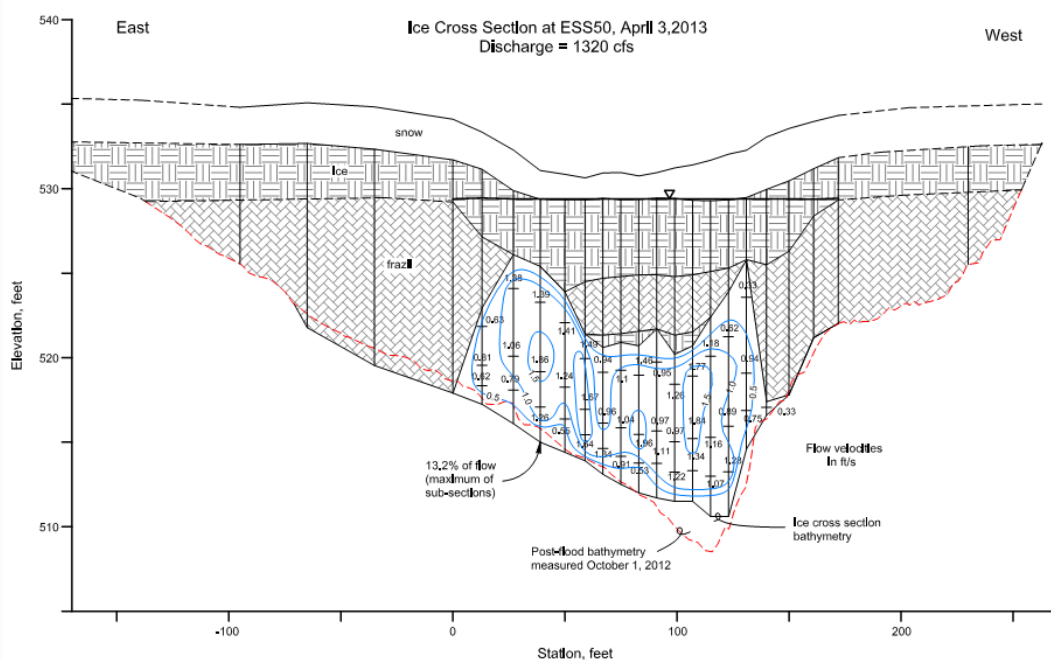
Figure 5.1-7. Cross Sectional Diagram of ESS50. Brailey Hydrologic.

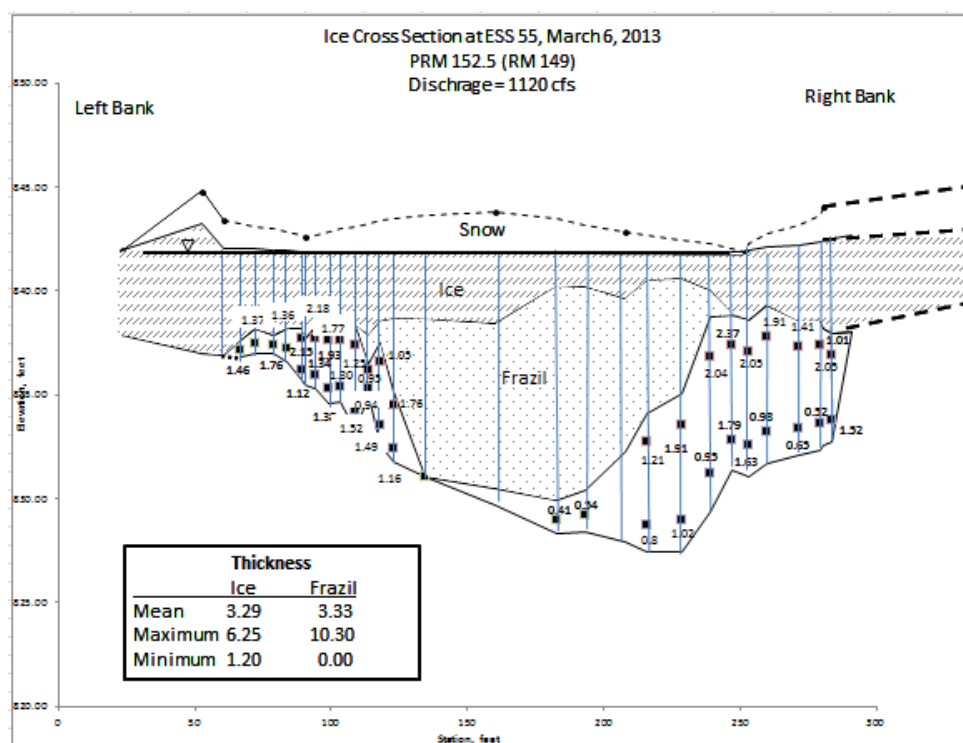
Figure 5.1-8. Cross Sectional Diagram of ESS55. HDR Alaska.

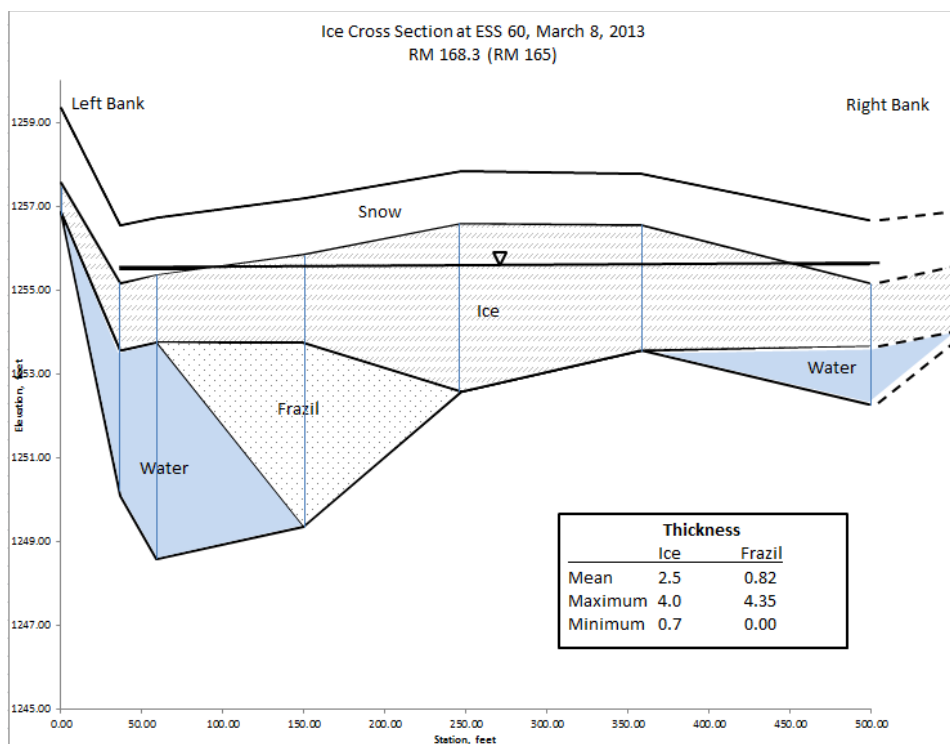
Figure 5.1-9. Cross Sectional Diagram of ESS60. HDR Alaska.

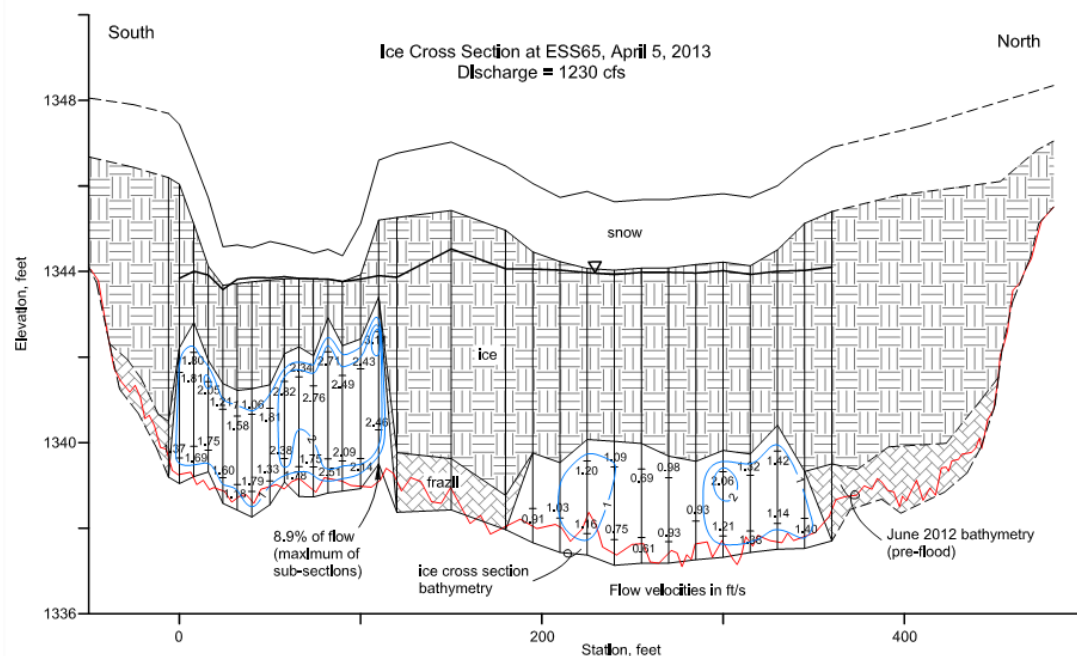
Figure 5.1-12: Cross Sectional Diagram of ESS65. Brailey Hydrologic.

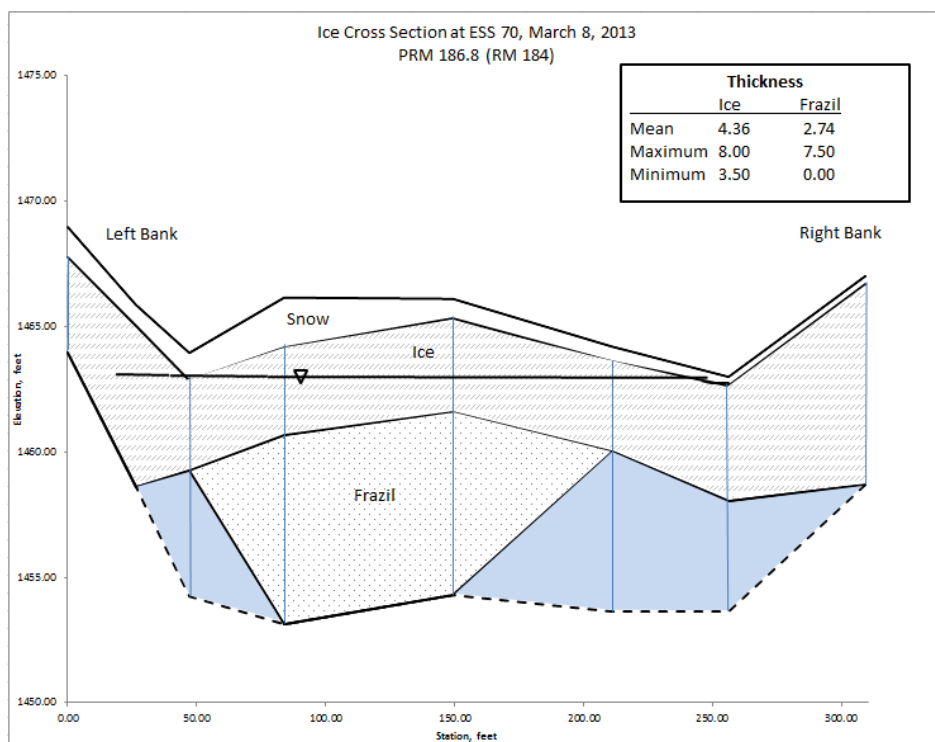
Figure 5.1-13. Cross Sectional Diagram of ESS70. HDR Alaska.

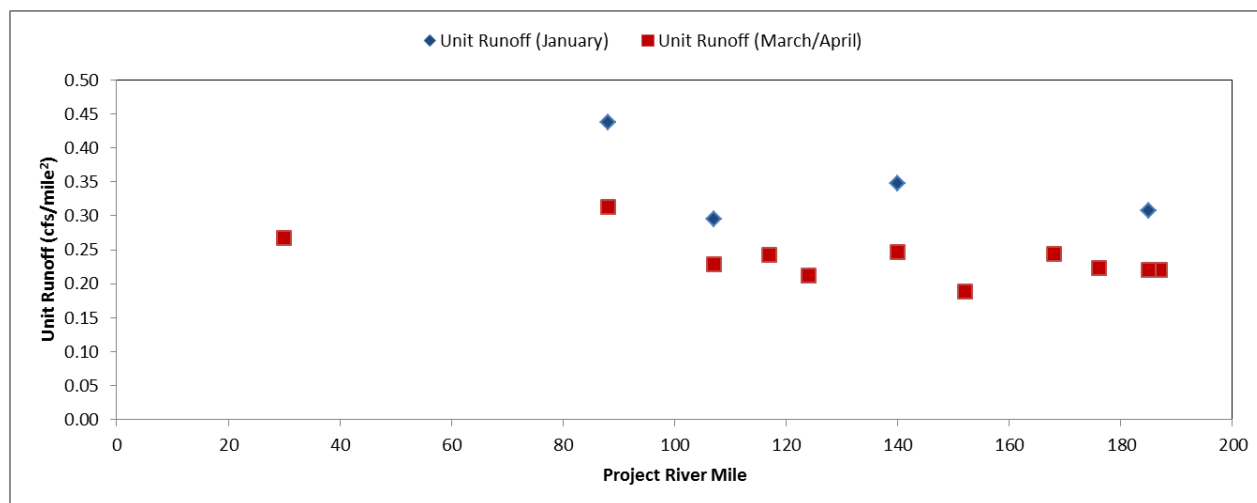
Figure 5.1-15. Unit Runoff Plotted Against Project River Mile for the January and March/April Field Events
