**SURVEY AND EVALUATION OF THE IDITAROD TRAIL
AND CONNECTING TRAILS IN THE CHUGACH NATIONAL FOREST**

DRAFT TECHNICAL REPORT

VOLUME 2: NATIONAL REGISTER EVALUATION FORMS

1. Name of Property: Monarch/Jewell Mining District
2. Location: Section 16, T.11N-R.2E, Seward Meridian.
Anchorage A-6 Quadrangle.
3. Classification:
 - Ownership: Public-federal
 - Category of Property: District
 - Number of Resources within Property:
 - Contributing: 23 structures
 - Non-Contributing: 0
 - Number of Contributing Resources previously listed: 0
 - Name of related multiple property listing: Gold Mining
on the Chugach National Forest, 1895-1940.
6. Function or Use:
 - Historic Functions: Industry/Extractive Facility
 - Current Functions: Recreation and Culture/Outdoor
Recreation/Hiking Trail, Commemorative Marker.

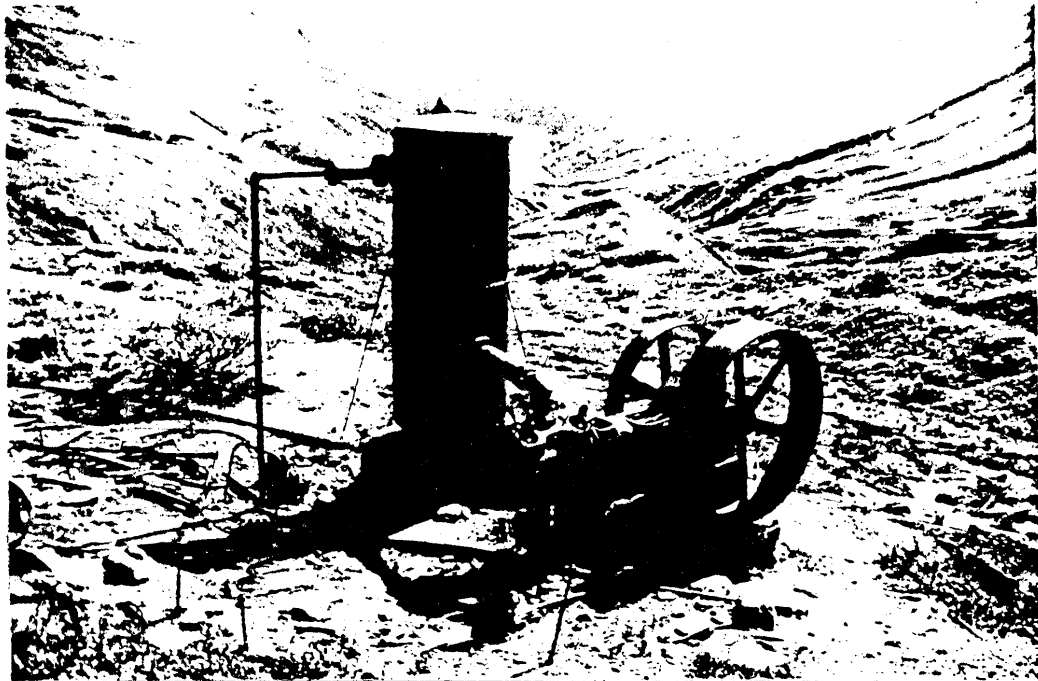
the head of the tailings pile. Feature 1 appears to be in two levels; the upper level contains the stamp mill remains, and the lower area contains the remains of a compressor. The compressor engine and attached reservoir are mounted on poured concrete foundations. The slopes of the Feature have slumped considerably, making definition difficult for dimensions of former structures. This feature was reportedly built in 1931 as a landing/base for a small mill and compressor (U.S.G.S. Bulletin 849 G).

Feature 1, Compressor Remains, View South

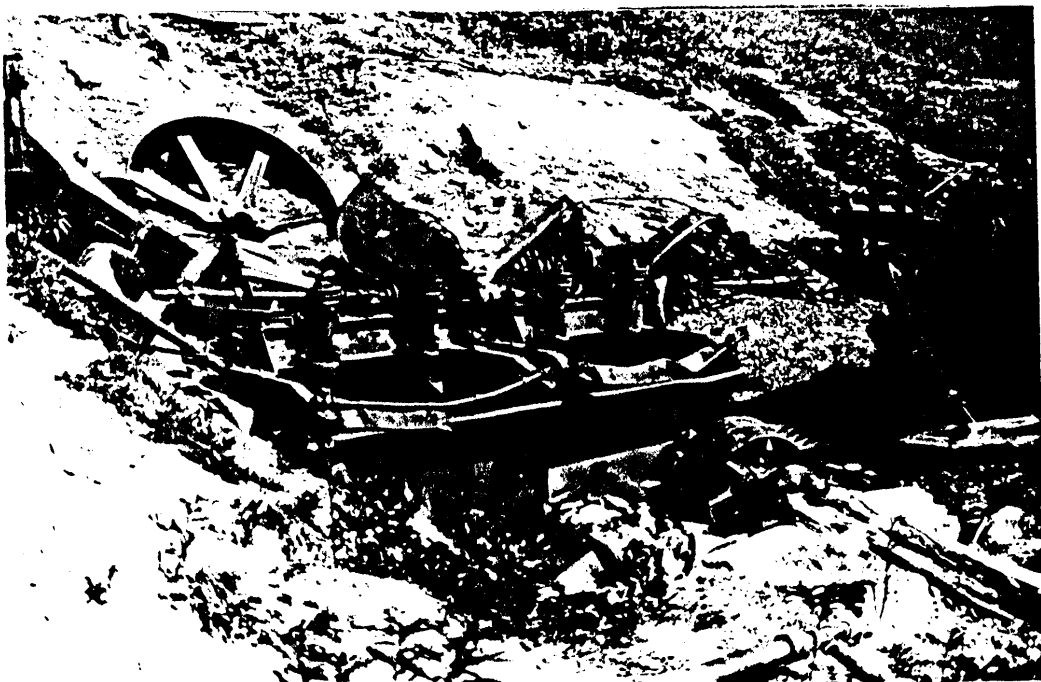
Locus 1 is the headquarters/mill location for the Monarch Mine. This locus contains 14 historic structural features and extensive mining and milling equipment remains. Feature 1 is a rectangular pit containing remains of a stamp mill, a compressor and various other machinery. The pit is banked into a northeast hill slope. A tailings pile of fine ground stone extends about 9 meters to the north-northwest from the northwest corner of the Feature. The tailings pile extends from a cribbed log structure which is about 2 meters square and curbed into the hill slope at

Feature 1, Mill Remains, View East

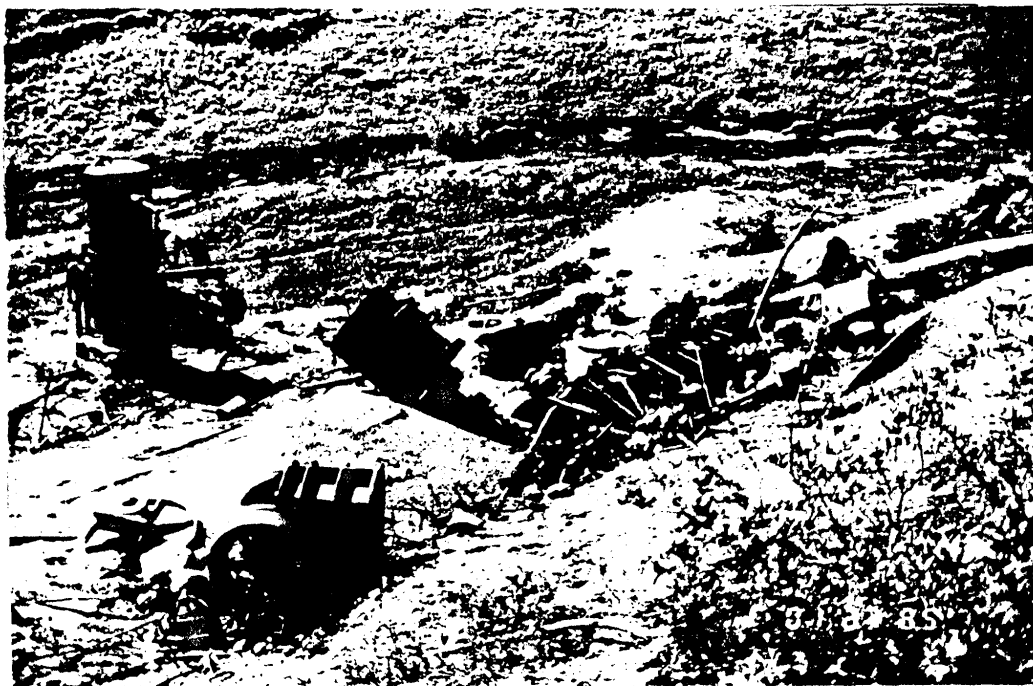
Feature 1, Mill Equipment, View to SE

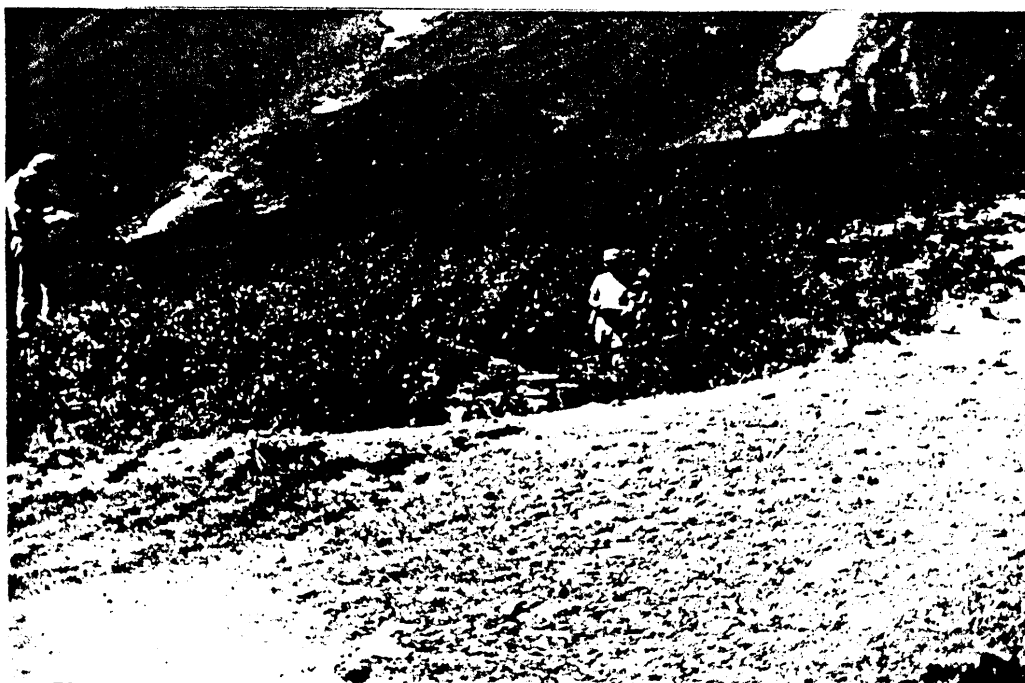
Feature 3, Building Depression, View to East

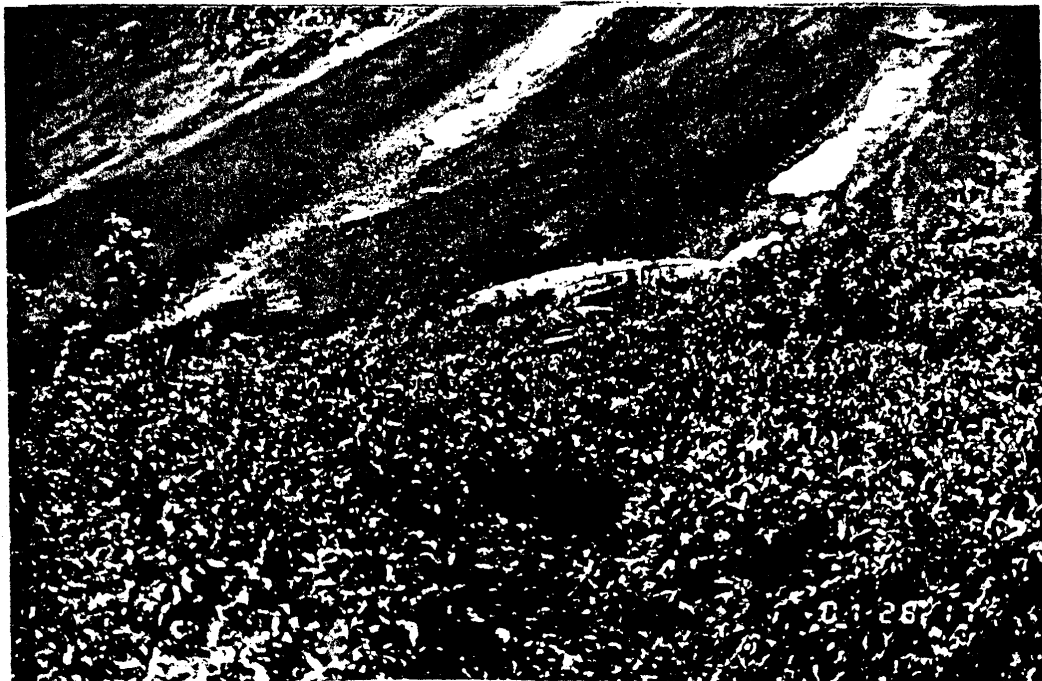
Feature 5, Intact Cart Track, View to West

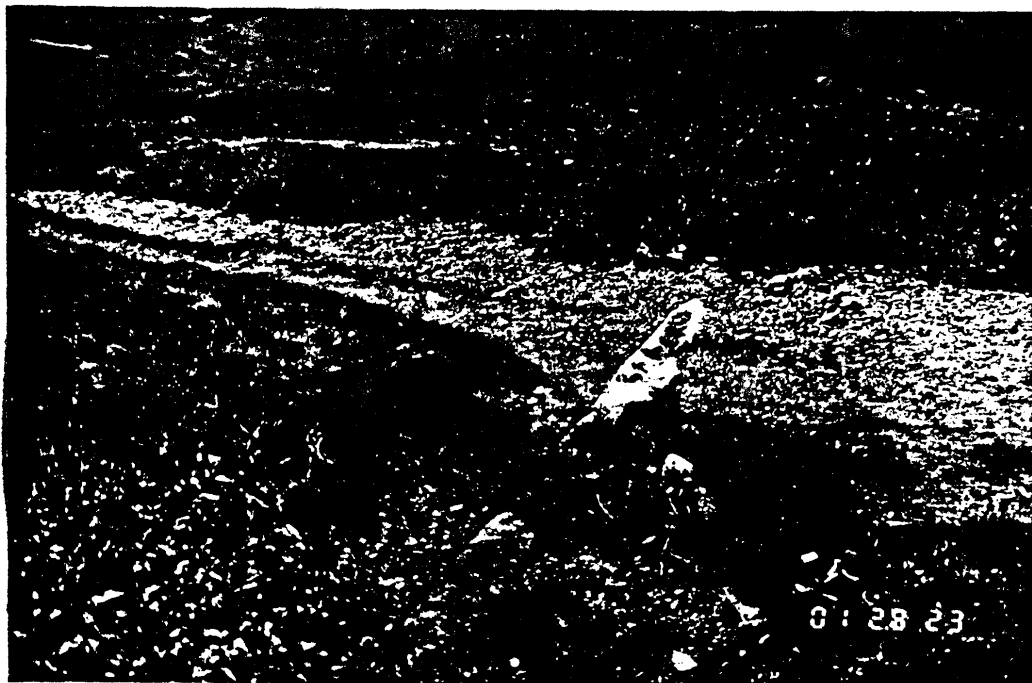
Feature 7 is two buried pipelines, one about 30 centimeters in diameter and the other about 5 centimeters in diameter. Both pipes run parallel to Feature 6, about 3.5 meters up slope (to the northwest) from Feature 6. The pipelines continue for an unknown distance from the southwest edge of the trail to the northeast, past the mine mouth; above the mine mouth the pipelines are covered with earth and vegetation. Feature 8 is a storage pile of cart rails and ties. Feature 9 is a large cellar of dry laid rubble and stones of various sizes. The depression for the structure is banked into a west-facing hill slope. The rectangular foundation/cellar has a small foundation partition in the southeast corner, and a deeper, stone-lined depression is in the northwest corner. The cellar is partially filled with foundation stones and is up to 2 meters deep. At the approximate center of the foundation/cellar is an upright pole, about 15 centimeters in diameter, banked with large rocks, and containing wire nails.

Feature 7, Buried Pipelines, View to SW

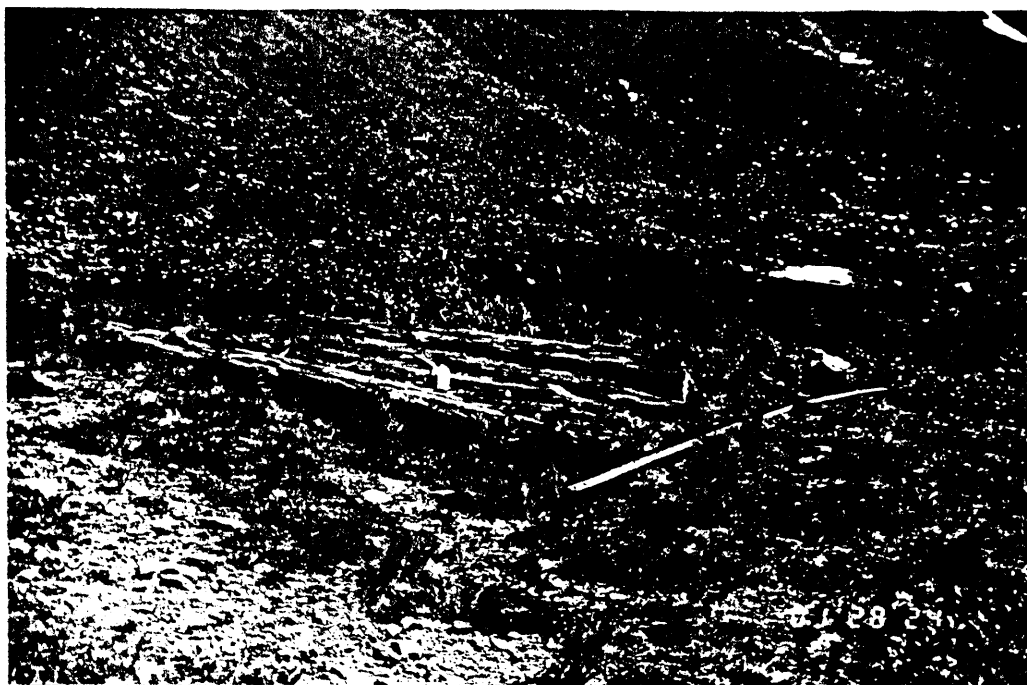
Feature 8, Rail and Timber Cache, View to East

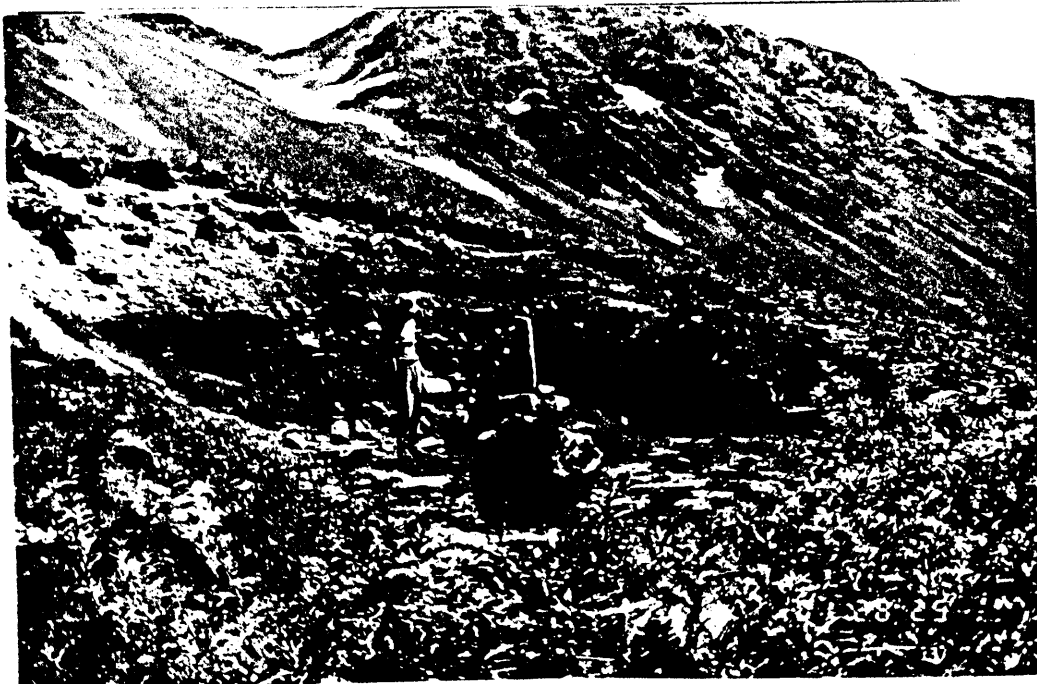
Feature 9, Foundation/Basement, View to East

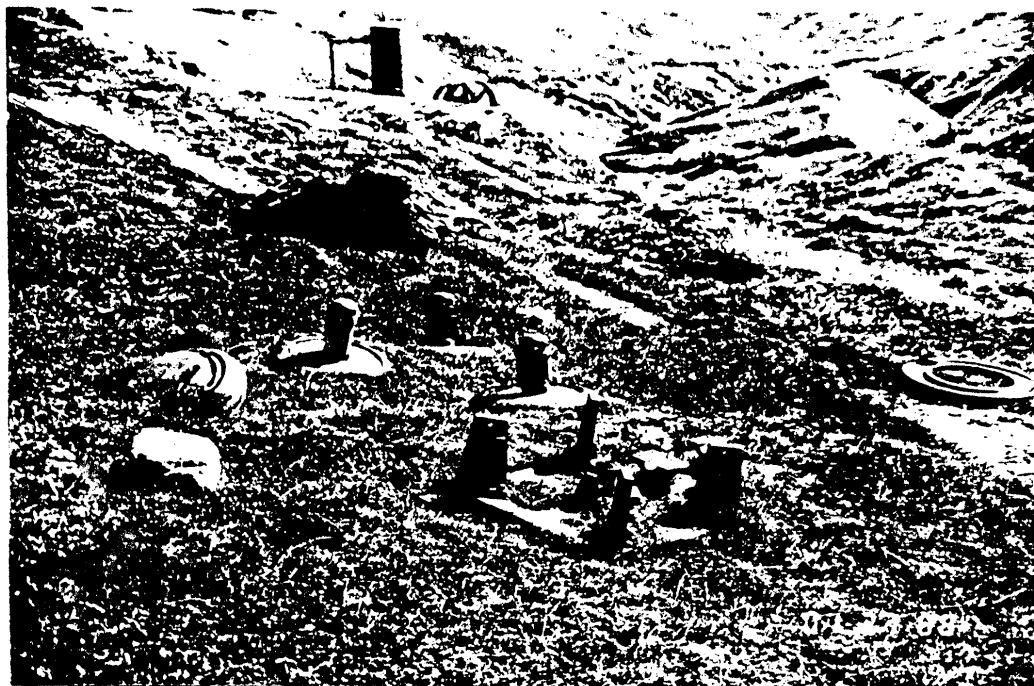
Feature 10 is a small concentration (approximately 4.5 meters in diameter) of large metal rollers used in the ore milling process. Observed within the concentration were 4 rollers and a mounting assembly in the concentration and one small enameled metal bowl. Down slope to the south of the Feature are two large metal tracks in which the crusher/mixers ran. Feature 11 is a former building pad down slope to the south from Feature 1. The pad is roughly rectangular and has an earthen berm along the south and west down slope sides. The pad contains an 8" diameter pole, a large wooden beam with threaded bolts, a metal mining drill screw, stove parts, sheet metal, and a heavy iron door.

Feature 10, Mill Rollers, View to SE

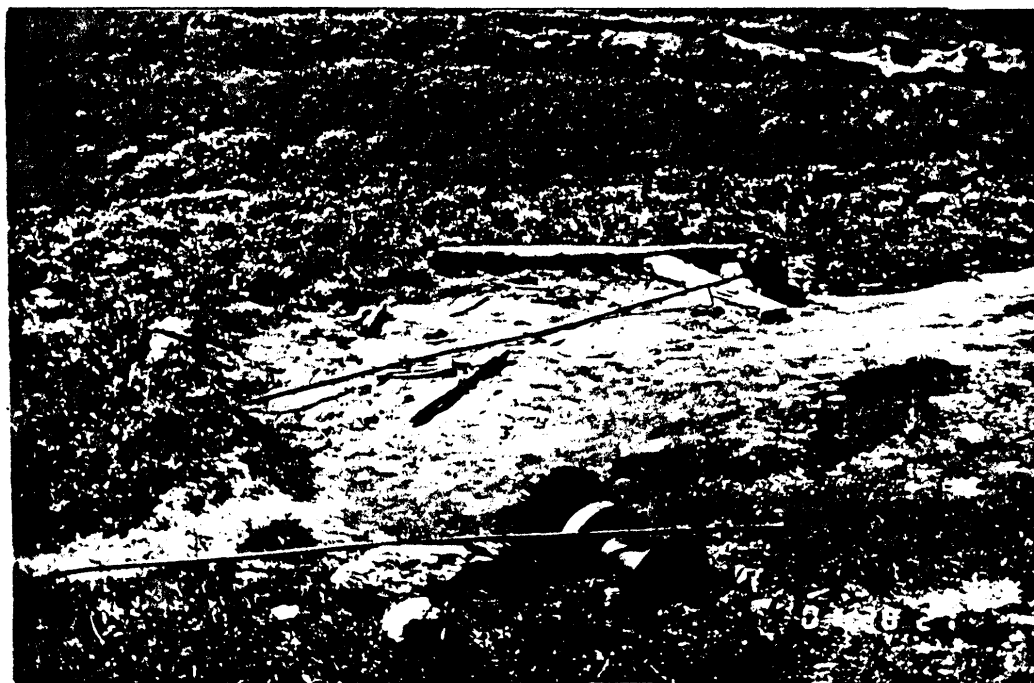
Feature 11, Building Pad and Machinery, View to West

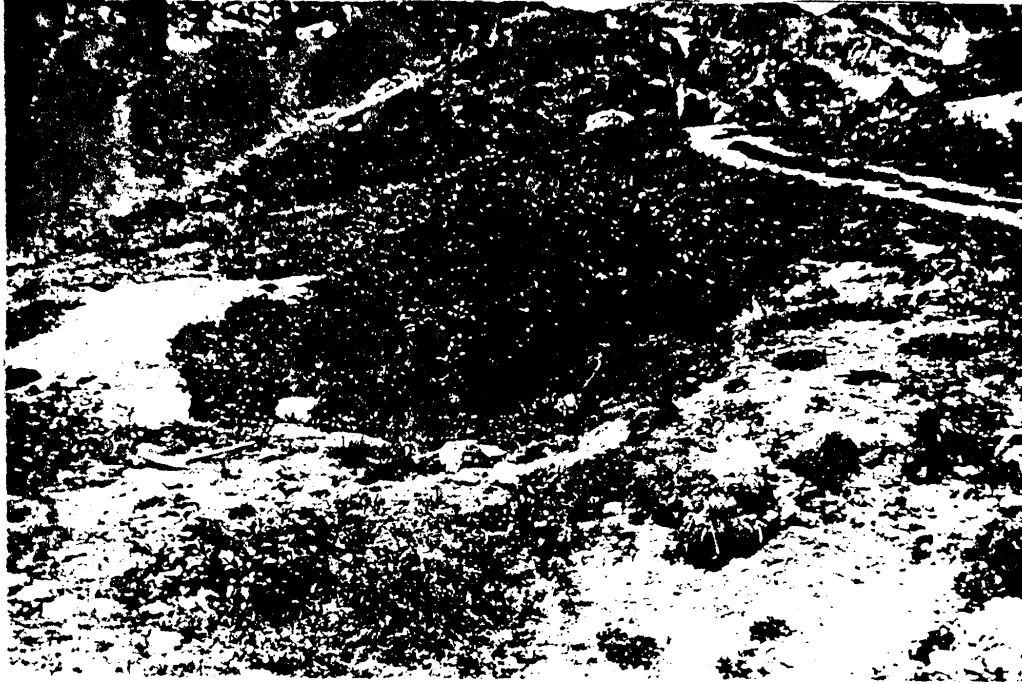
Feature 12 is a depression excavated into the south-facing slope. The depression opens onto the wagon road to the southwest and is about 2 meters deep below the slope level at the north extent. The Feature contains ore stones, a wood beam, and sheet metal. Feature 13 is a series of 4 cellar depressions and/or prospect pits. The depressions are aligned north-south and excavated materials have been thrown up on the west side. The depressions contain round wire nails, buckets, cans, sheet metal, shoe leather, milled lumber, a portion of a 12" diameter post, and an enamel cup. One depression has a partial stone foundation on the north and east sides. Feature 14 is a large rectangular, flat excavation into an east-facing hill

Feature 12, Building Depression, View to NW

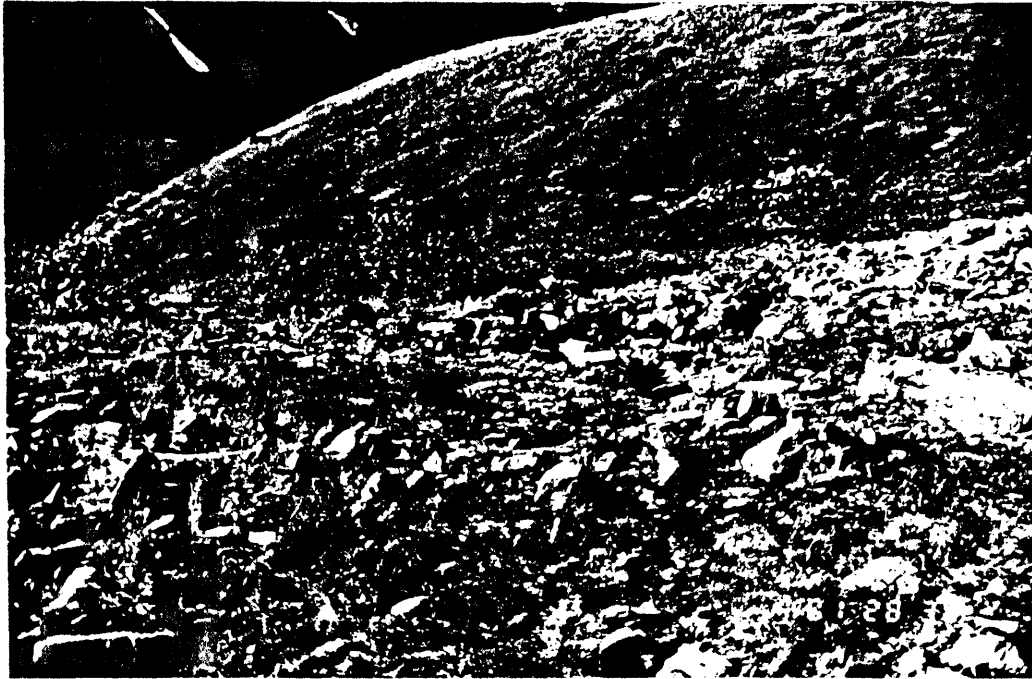
Feature 18 is 110 degrees, 1.2 meters from the southeast corner of Feature 16. Feature 18 is a building pad levelled into the east-facing slope and built up with rock on the west or up slope side. The building pad is about 7.3 meters by 5.5 meters and contains green and clear bottle glass, milled lumber, a bed frame, can metal, round wire nails, plaster, rubber, and wire. To the immediate west of the feature is remains of an ore car.

Feature 18, Building Pad, View to NW
