Iditarod National Historic Trail Office  
Bureau of Land Management

Name of Site <u>CATTLE LANDING # 4.</u>	AHRS Number	Site Number
--	-------------	-------------

Type of Inspection  
On Site   x     JULY 14, 80   Aerial

Inventory Work Sheet

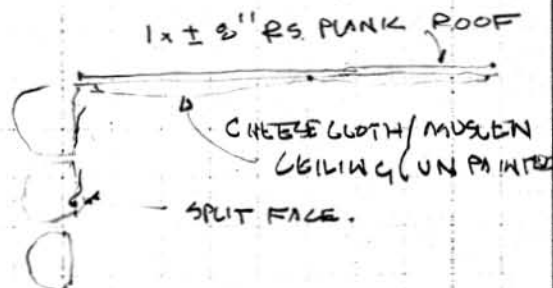
Structural System, Framing

Log - 1 SIDED

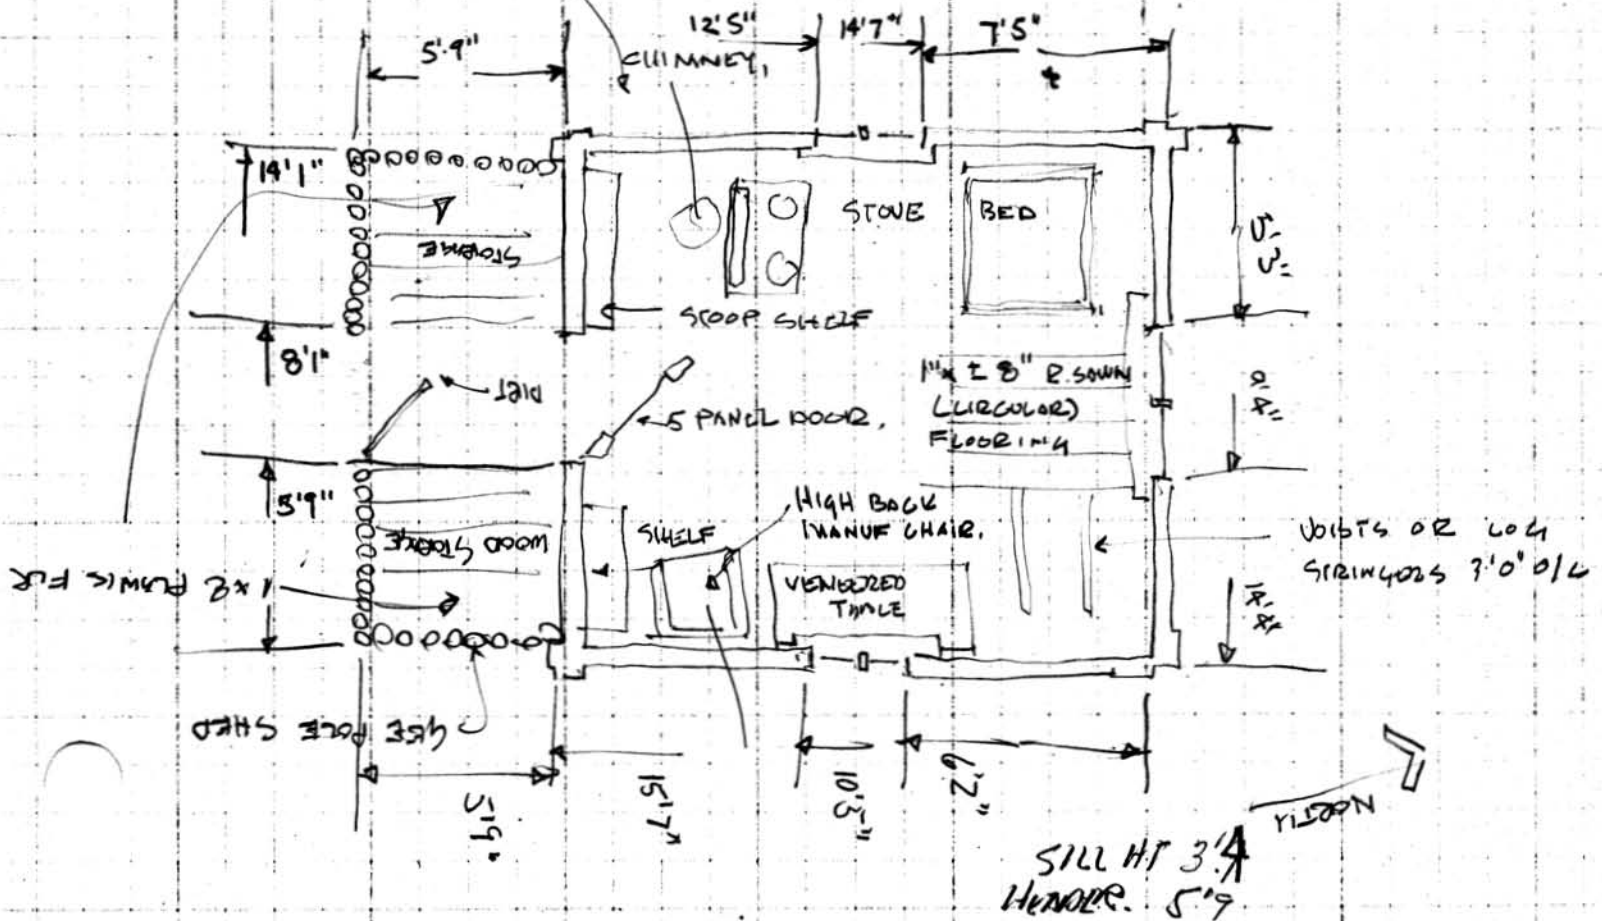
Floor Plans (by floors)

SEEMS MATERIALS MAY HAVE COME FROM PIKE.  
STRUCTURE IE: WALLS, FLOOR, WINDOWS,

SOIL BANKED - AROUND MAIN CHAIN

SEE PLAN
