# Erosion and Sedimentation in the Kenai River, Alaska

GEOLOGICAL SURVEY PROFESSIONAL PAPER 1235

By KEVIN M. SCOTT

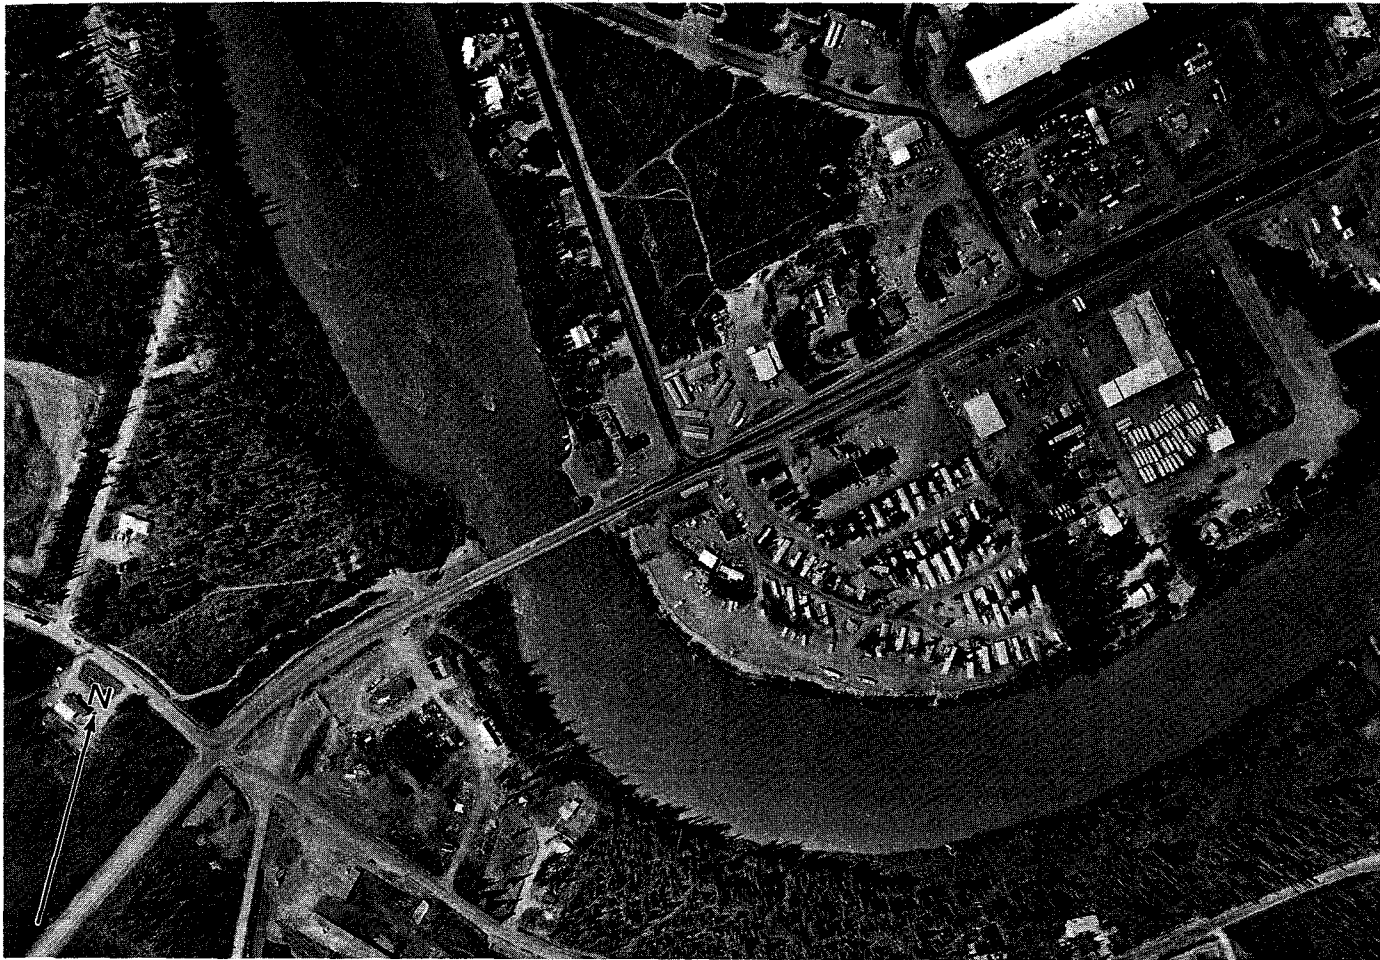
FIGURE 4.—Kenai River at the Soldotna bridge. The river is entrenched 30 to 40 ft below the Soldotna terrace, upon which part of the town of Soldotna is visible here. Wakes in the river are caused by large boulders, the presence of which is characteristic of the entrenched section of the stream. Direction of flow is toward upper left. Reach visible in photograph extends from approximately river miles 21.5 to 20.7. Scale, 1:4,800, or 1 in. = 400 ft. Photograph credit: U.S. Army Corps of Engineers.

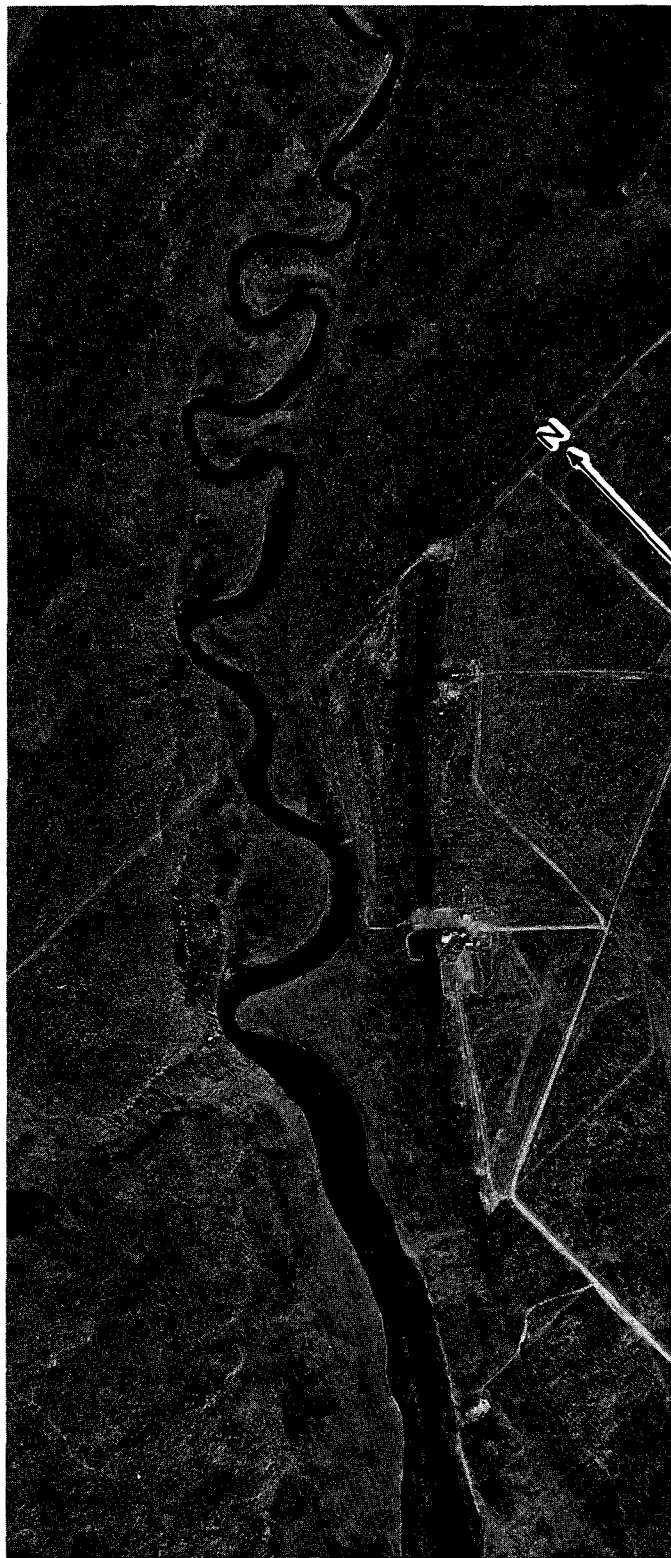
FIGURE 7.—Moose River channel between 1.3 and 2.6 mi upstream from its junction with the Kenai River—a striking example of confined meanders occurring within a large sinuous paleochannel. Flow is toward bottom of photograph. Downstream change in pattern of present channel from meandering to straight is in response to entrenchment of the Kenai River. Scale, 1:12,000, or 1 in. = 1,000 ft. Photograph credit: U.S. Army Corps of Engineers.

Figure 7 illustrates the channel of the Moose River a short distance upstream from its junction with the Kenai River. The underfit condition is pronounced. The present channel is approximately 80 ft wide where it meanders within a paleochannel 600 to 700 ft wide. The Moose River paleochannel appears to be a natural upstream extension of the lower part of the Kenai River, from both the similarity in pattern and the trends of the two channels at their junction.

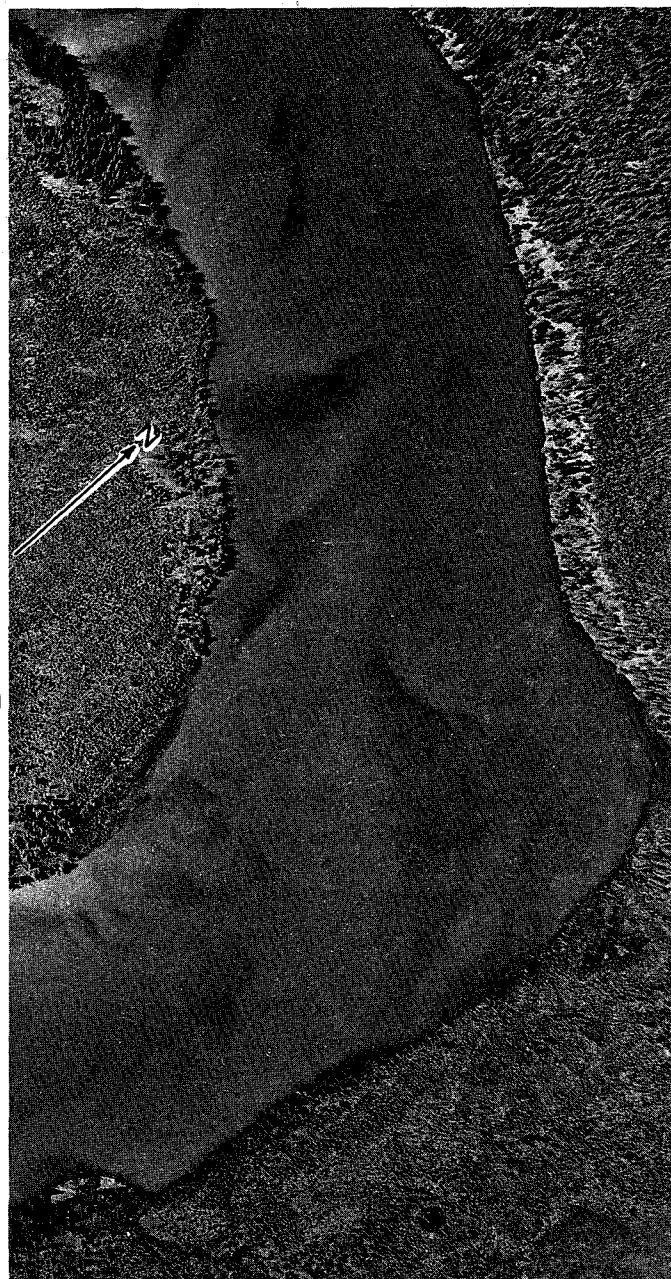
FIGURE 12.—Kenai River between approximate river miles 47.5 and 46.9. Crests of large crescentic gravel dunes appear just below water surface as darker areas. Flow is from bottom of photograph toward top. Scale 1:4,800 or 1 in. = 400 ft. Date: July 11, 1977. Photograph credit: U.S. Army Corps of Engineers.

Features of comparable coarseness and scale have been reported to result from an exceptional flood discharge, such as a surge from a dam failure (Scott and Gravlee, 1968, fig. 18), but in these unusual instances the features are not subsequently active. The gravel dunes of the Kenai River were examined with aerial photography taken in 1950, 1972, and 1977 to determine the degree of their activity. Where best developed, between river miles 48.5 and 46.5, the dunes

show a surprising and remarkable similarity in position. Resolution is relatively poor on the 1950 photographs, but the positions of the major forms are clearly the same as those in 1972 and 1977. Striking comparisons of the 1972 and 1977 photographs show that even the small irregularities of dune morphology did not change in that interval, one that included a major flood

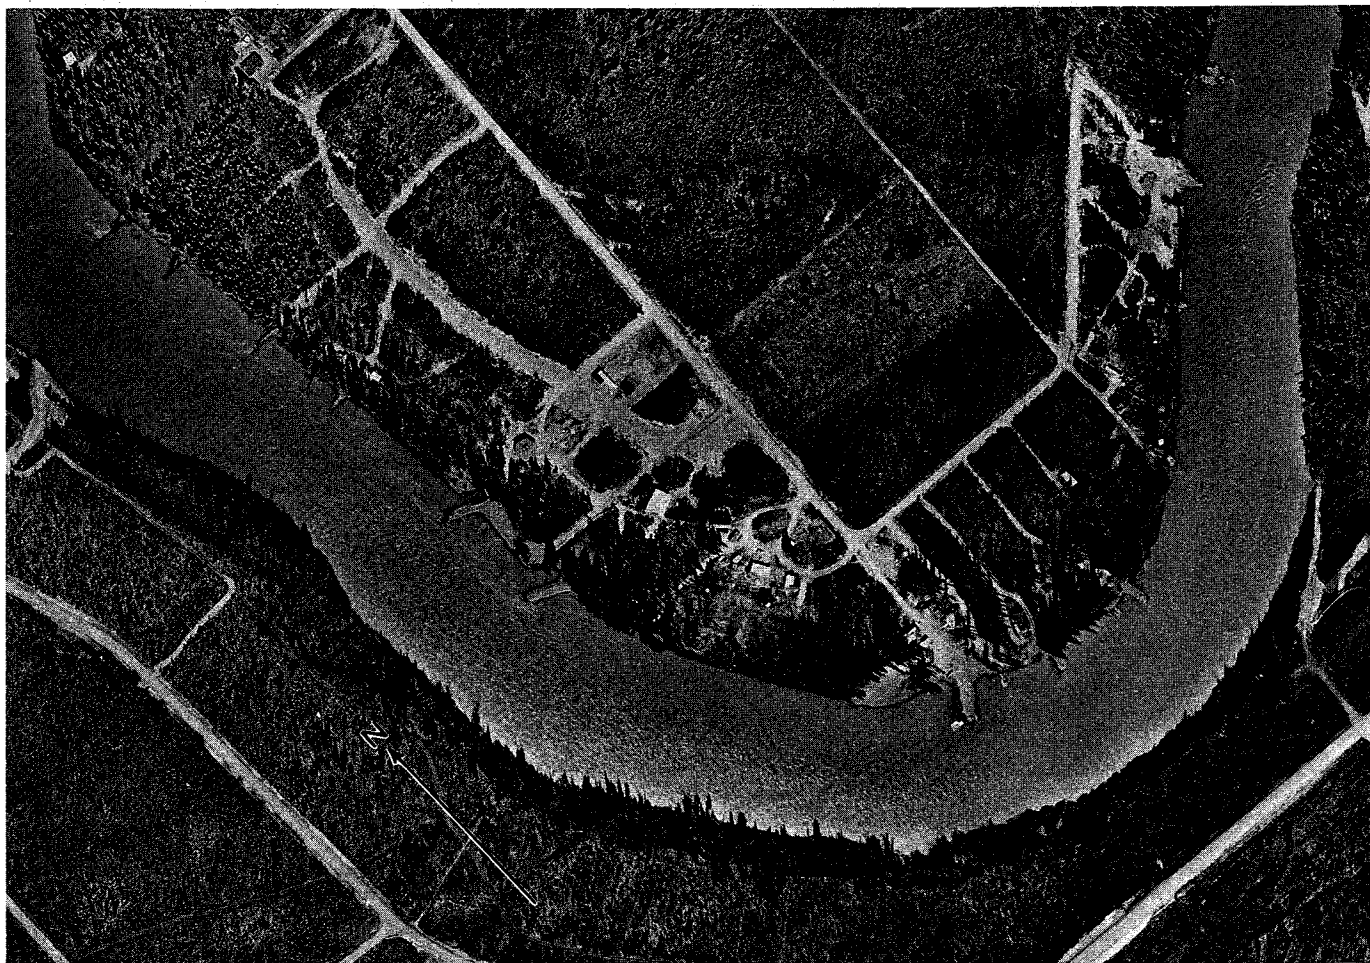
FIGURE 18.—Kenai River between approximate river miles 38.2 and 37.0. Flow is from right to left. Scale, 1:4,800, or 1 in. = 400 ft. Date: July 11, 1977. Photograph credit: U.S. Army Corps of Engineers.

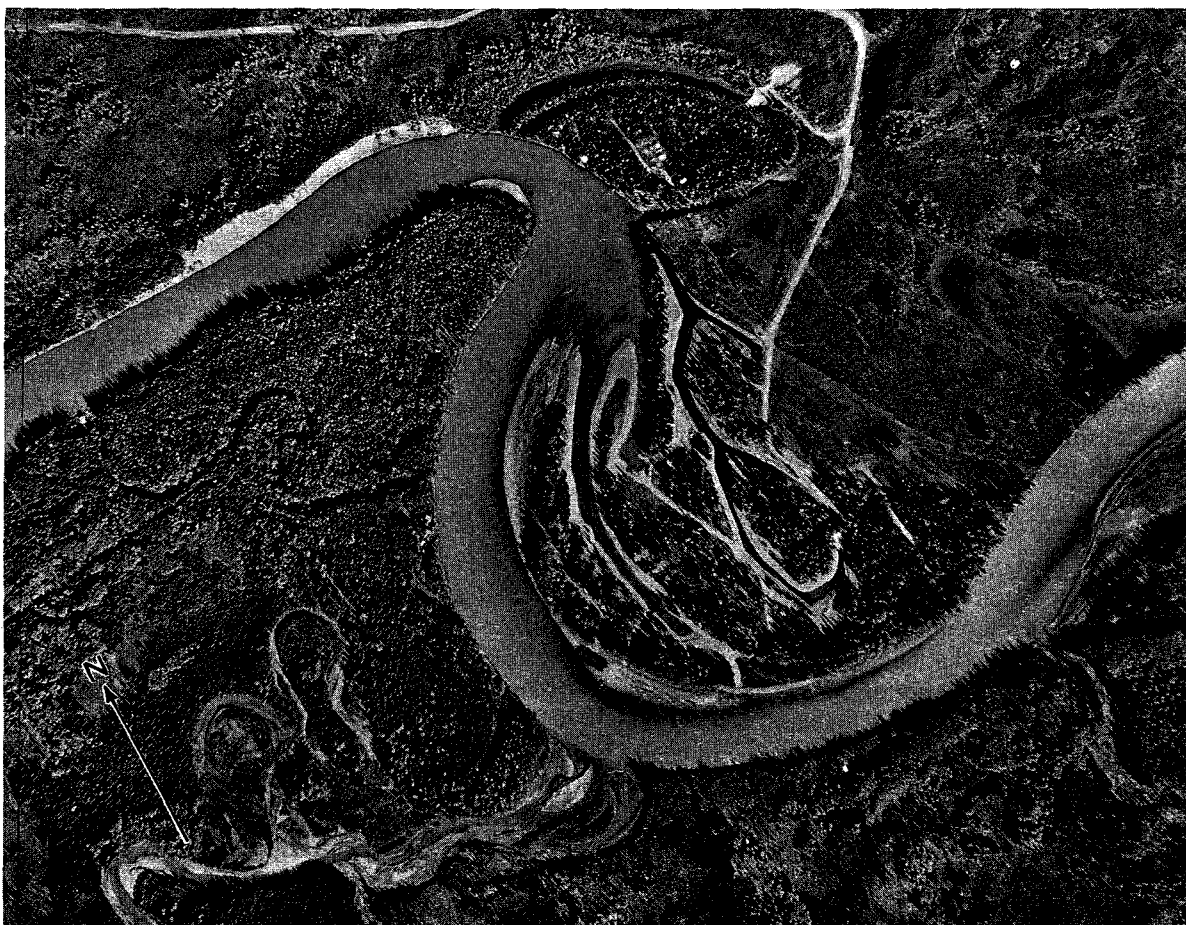
FIGURE 19.—Kenai River between approximate river miles 44.8 and 42.9. Interior of meander loop has been developed with canals. Note natural channels across neck of meander; one channel has been partly excavated to form a canal. The Killey River enters from bottom of photograph. Flow direction is from right to left. Scale, 1:12,000, or 1 in. = 1,000 ft. Date: September 24, 1972. Photograph credit: U.S. Army Corps of Engineers.
