CRREL Report 81-1

Analysis of ice jams and their meteorological indicators for three winters on the Ottauquechee River, Vermont

Roy E. Bates and Mary-Lynn Brown

February 1981

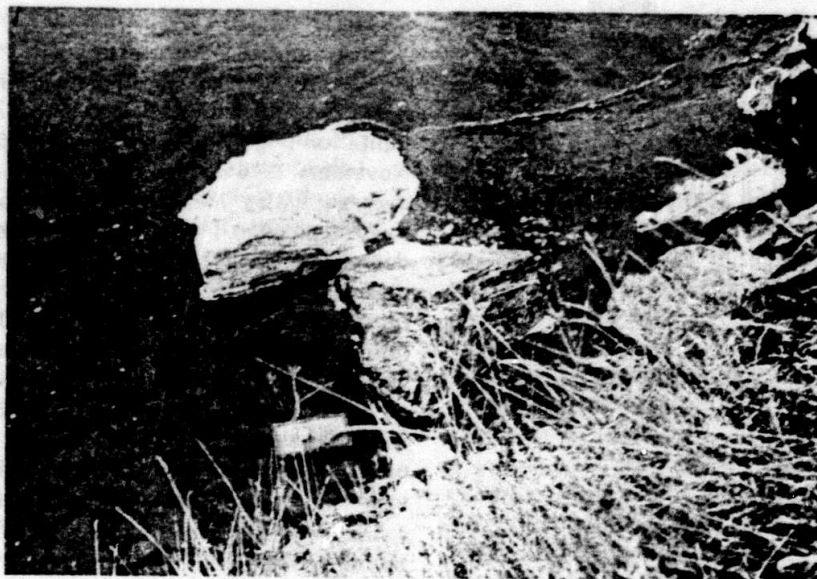
Figure 6. Water temperature measurement device near the Woodstock Sewage Treatment Plant.

was installed on the Ottauquechee River. Temperatures, precipitation, and wind (speed and direction) were recorded on a daily basis. In addition, water temperatures were electronically monitored at two sites: one near the Woodstock Sewage Treatment Plant (Fig. 6) and the other near Quechee at the Yankee Musket Shop (Fig. 1). Because of recorder and thermistor cable difficulties, only one site (the Woodstock Sewage Treatment Plant) continuously recorded water temperatures in January 1978.

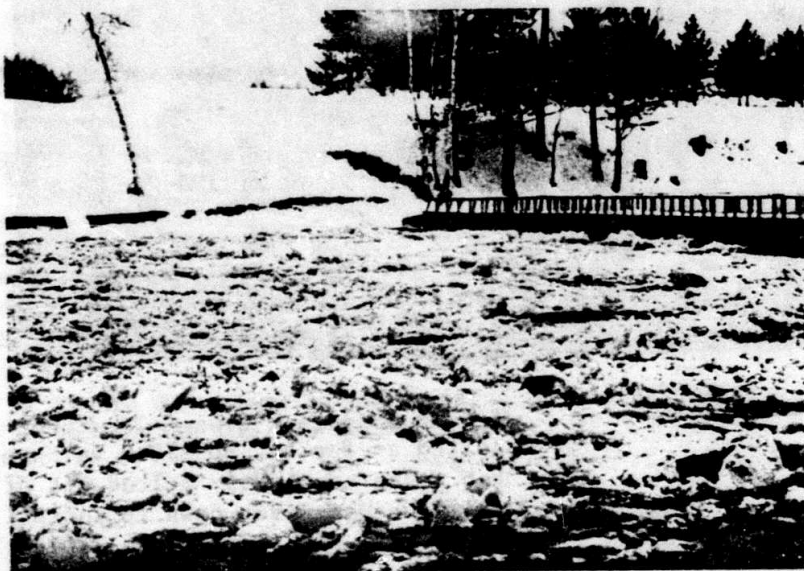
Figure B1. Ice jam at Quechee Golf Course bridge, 26-28 January 1976.

Coinciding with the rapid increase in temperature was heavy rainfall which accounted for over one-half of January's precipitation¹. The combination of temperatures above freezing and heavy precipitation on an already high water-equivalent snow cover^{7*} caused extensive flooding and jamming of ice on the Ottawa-Quebec River (Fig. B1).

DATE	ICE THICKNESS (cm)	ICE CONDITIONS AND REMARKS
	61-64	Woodstock Sewage Treatment Plant: Two holes drilled 6 m apart. Ice measures 61 to 64 cm. Water temperature 0.05°C. At outfall pipe opening in ice ≈61 cm downstream, water temperature 2.45°C. 8 m below pipe water temperature 0°C. (For last three weeks ice surface consists of small soft snow hillocks 1 to 4 cm deep below which is ice and soft slush.)
26-28 Jan -----		High air temperature coupled with heavy precipitation caused heavy flooding and severe ice jamming along the Ottawa-Quebec River. High water caused by over 6 cm of rain in a three-day period. Air temperature rose as high as 8°C (Fig. B1).

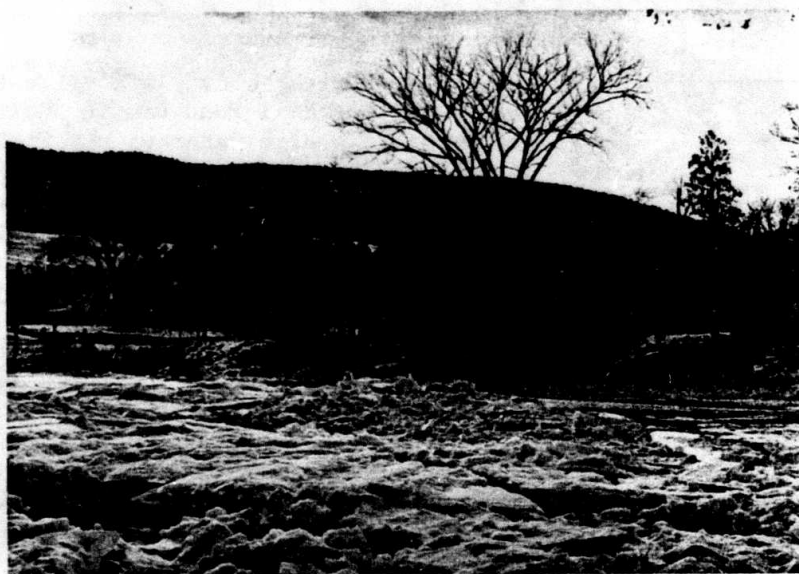
Figure B2. Jamming and rafting of ice behind the Taftsville Dam, 16 December 1976.

<u>DATE</u>	<u>ICE THICKNESS (cm)</u>	<u>ICE CONDITIONS AND REMARKS</u>
30 Nov	-----	Freeze-over of Taftsville Pond.
1 Dec	-----	Solid ice cover on Taftsville Pond.
11-12 Dec	-----	Ice jam on Taftsville Pond caused by warmer weather and rain.
16 Dec	-----	Ice jam area rafted along eastern shore of Ottauquechee River, 120-150 cm high (Fig. B2).

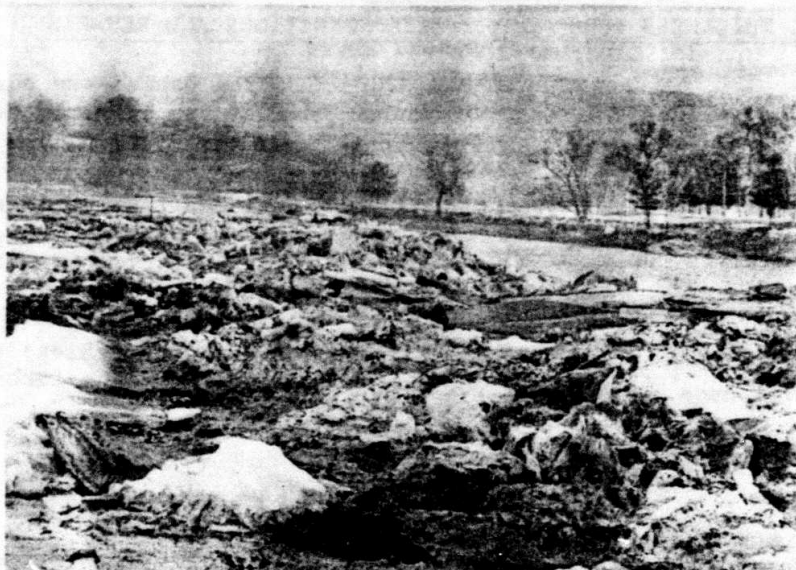
Figure B4. Ice rafted on Quechee Golf Course, 15 March 1977.

that water overflowed all low areas. Ice rafted and flowed over many areas of golf course (Fig. B4). Ice blocks 91-151 cm thick onshore (Fig. B5).

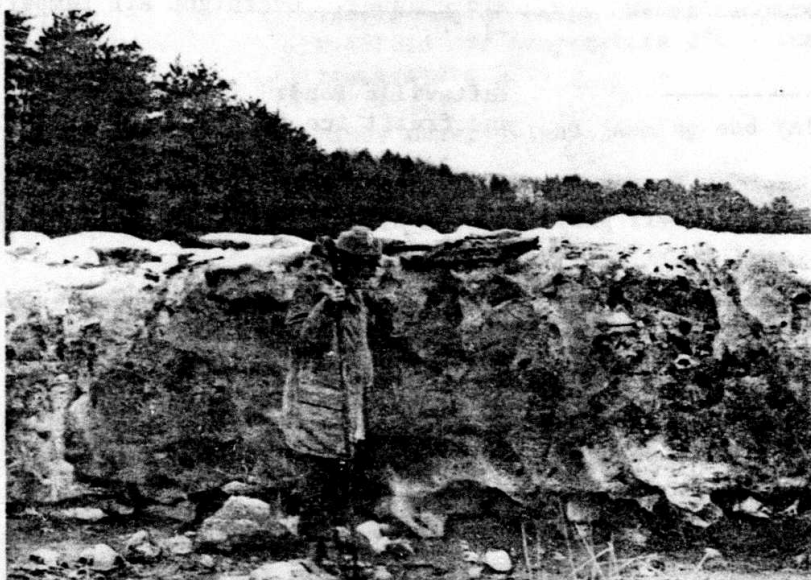
Figure B5. Ice blocks, 91-151 cm on shore of Ottauquechee River, 15 March 1977.

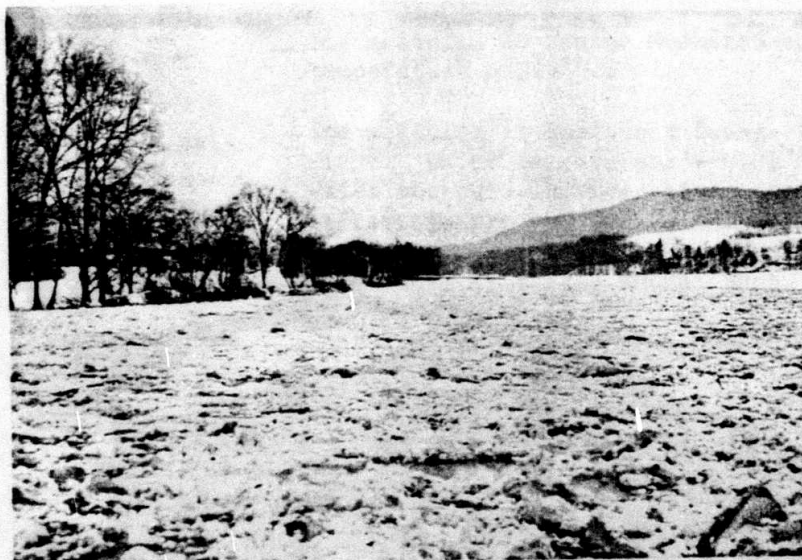
Figure B6. Ice jam at Woodstock, east of Sewage Treatment Plant, 26 January 1978.

Two minor thaws occurred in January 1978 (4-9 January, 24-26 January), causing slight jamming and rafting of the ice (App. B). The second thaw was the more serious one. According to the observational report: "thaw and heavy rain caused flooding and a new ice jam at Woodstock" (Fig. B6).

<u>DATE</u>	<u>ICE THICKNESS (cm)</u>	<u>ICE CONDITIONS AND REMARKS</u>
25-26 Jan -----		Thaw and heavy rain caused flooding and a new ice jam in Woodstock (Fig. B6). Solid ice remained in Quechee Lakes Mill Pond and Taftsville Pond. Ice jam extends from just below Woodstock Sewage Treatment Plant upstream to Woodstock Union High School.
9 Feb	25-38	New ice formation. Ice rafted and jammed at Woodstock and Quechee.
7 Mar	56	Water temperature at bridge near Yankee Musket Shop 0°C or slightly below. Water samples appear silty. Snow depth on ice 30 cm. Ice same thickness 3 m from shore and in center of river at shop. 51 cm water beneath ice in center of river; 66 cm water near sensor.
	71	Woodstock Sewage Treatment Plant: 3 m beyond temperature sensor, water samples nearly clear, 33 cm water beneath ice. Water temperature 0°C. (See Fig. B7 and B8.)
	74	6 m from shore: 3 m water beneath ice, water temperature 0°C.

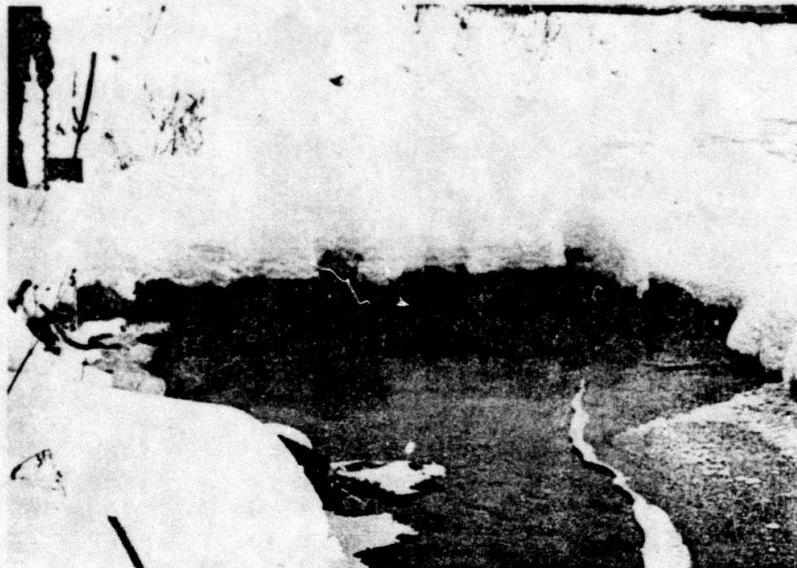
Figure B8. Effect of sewage effluent at Woodstock Sewage Treatment Plant (looking downstream).
