Long-Term Habitat and Biological Changes on Disturbances at Oil and Gas Exploration and Development Sites in Arctic Alaska:

**Report on Field Studies, 1984–91,
the National Petroleum Reserve in Alaska,
Sagavanirktok River Valley,
and Prudhoe Bay Oil Field**

BP Exploration (Alaska) Inc.

January 1994

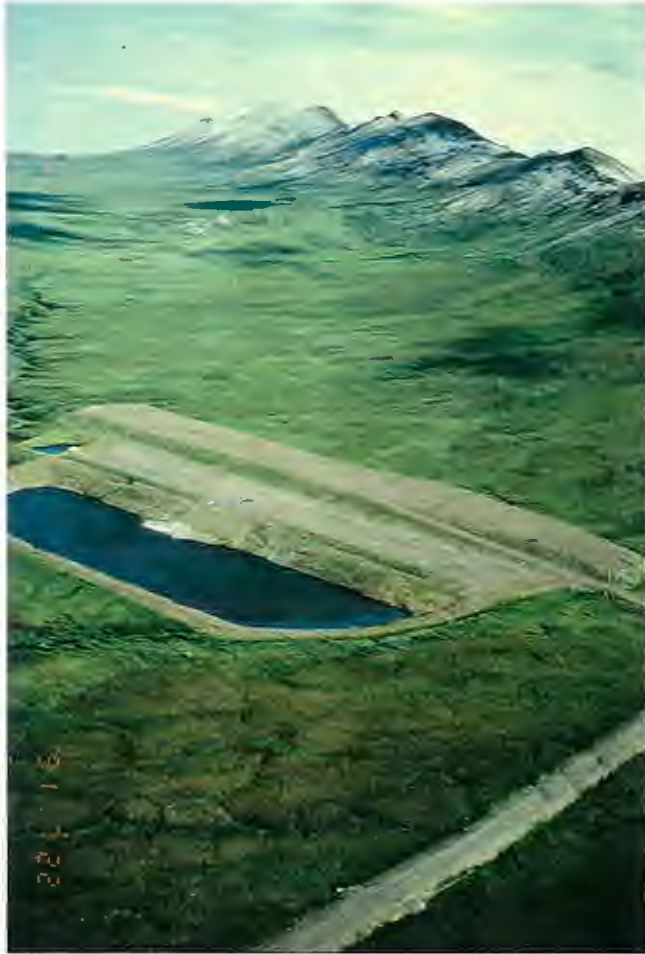
Figure 4. Aerial oblique of the Lisburne drilling site, which is situated on a north facing slope among the Ivotuk Hills (22 July 1991).

During the second exploration of the NPRA, the Lisburne Test Well No. 1 was drilled to explore formations at the southernmost point in NPRA. At this location, a gravel pad was constructed on a 6–7 percent north-facing slope above a small stream in the Ivtok Hills (Fig. 4). The area was surveyed during the summer of 1978 (ONPRA 1978b). That winter, staging began in December at Lake Betty, 32 km to the west. On February 21, 1979, workers began construction at the Lisburne location. Material for pad, road, and airstrip construction came from the Otuk Creek floodplain, about 915 m west of the drilling pad (Brooks and Mitchell 1983). Gravel used for the site construction was more coarse and angular than any other found on sites examined in our study in the NPRA. Gravel removal occurred during the winter of 1978–79, and the disturbed material site areas were seeded and fertilized during the summer of 1979. When examined in 1984, the material site seedings were in their fifth growing season. In 1991, they were in their twelfth growing season.

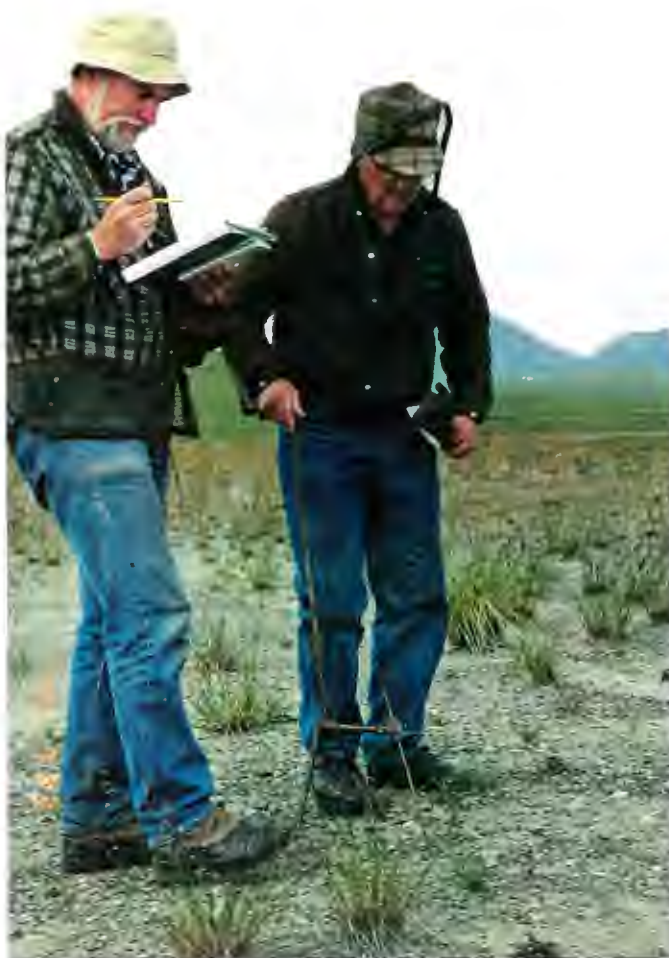
Figure 6. Collecting walking point data on the insulated portion of Lisburne drilling pad, 23 July 1991.

Botanical species composition and basal cover were obtained from walking-point data (Owensby 1973) at three NPRA locations sampled in 1991 and on the gravel trail in the Sagavanirktok River delta in 1987. Areas of the NPRA drilling sites sampled were insulated and non-insulated pad surfaces and the pad slopes. Areas beyond the gravel fill were not sampled with the walking-point method. Observers walked transects across representative areas sampled. At every pace or every other pace, depending on the size of the area to be sampled, the legs of the pointer were positioned on the ground in front of the observer, without looking to anticipate the placement, and the pointer lowered to touch the surface of the ground (Fig. 6). If

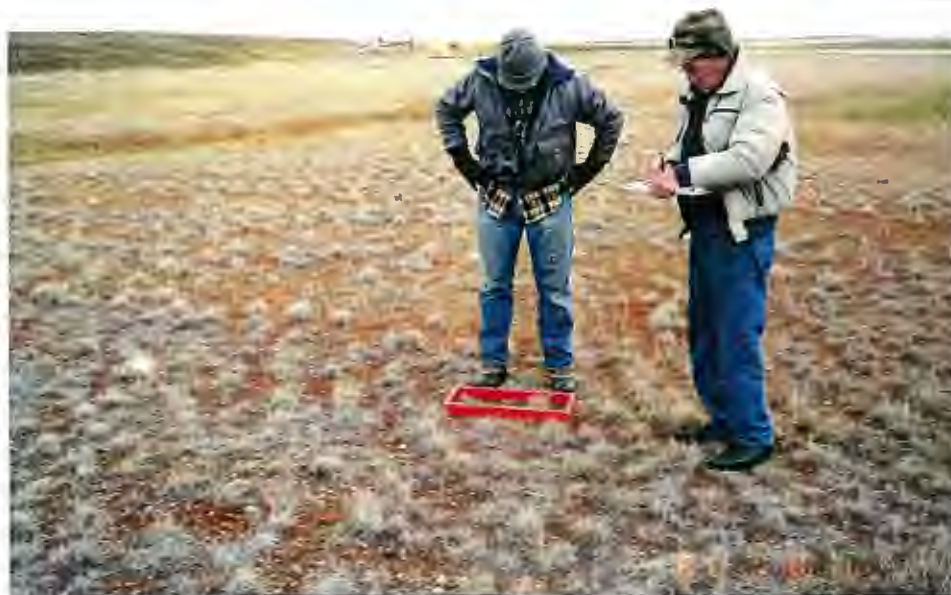
Figure 7. Collecting Daubenmire plot cover data on the non-insulated portion of Inigok drilling pad (18 July 1991).

Canopy cover provides an index to the dominance of various plant lifeforms; and as with botanical species composition, it indicates relative importance among categories of plants. We used it to compare among gravel-fill habitats within and among locations. Canopy cover was measured on gravel fill at the three NPRA wellsites examined during the 1991 field season. It was measured using a 20-by-50-cm rectangular plot frame (Fig. 7). This is commonly referred to as the Daubenmire method (Daubenmire, 1959). An observer placed the plot frame at random locations on the surfaces of various portions of the gravel pad, i.e., insulated and non-insulated pad surfaces and pad slopes. The area defined by the plot frame was examined. Graminoid, forb, shrub, moss, lichen, dead plants, feces, rock and bare ground were each given class ratings that corresponded with cover percentage ranges. These data were recorded on field sheets. In the laboratory, these data were entered into computer spreadsheets, and the corresponding cover percentages totalled for each cover class. This total was divided by the number of plots sampled at the site to obtain a final percentage for each cover class.

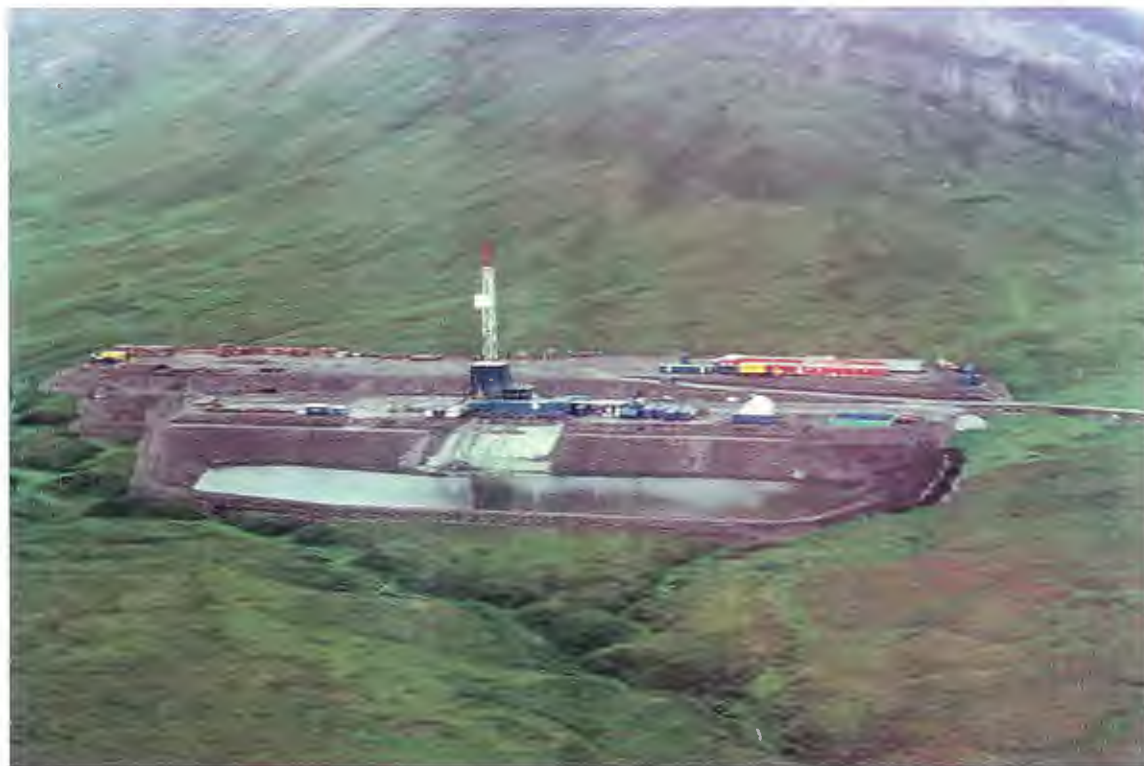
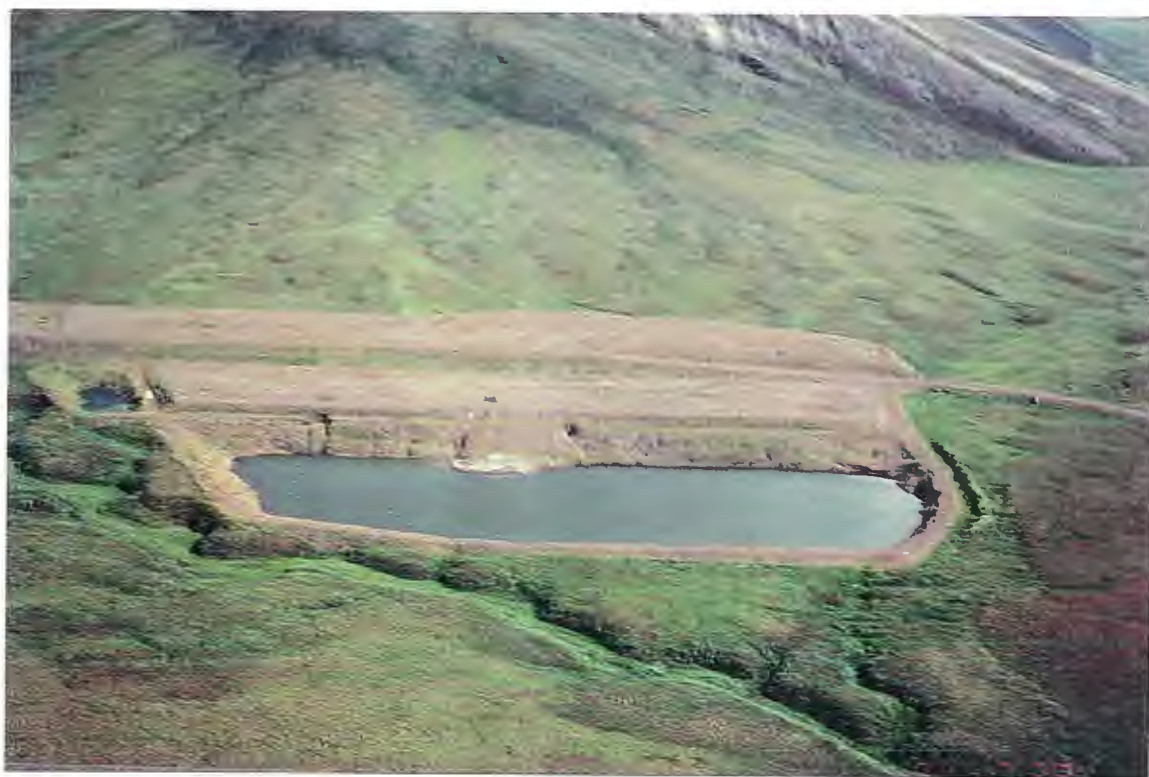
Figure 16. Aerial oblique of the Lisburne drilling site. The upper photo was taken on 8 August 1979; the lower on 22 July 1991.

At some locations, camera points of photos taken during previous years were relocated. Figures 12 through 14 are examples of current ground-level photos and those of a previous visit. Some oblique aerial views also provide useful information about changes that occurred at these sites over time. Figures 15 and 16 are examples of aerial oblique views that attempted to repeat the perspective of a previous photo.

Various kinds of information can be obtained from photopoints. Comparing the 1984 and 1991 views of the Inigok drilling site (Figs. 12 and 15) revealed that the water level in the reserve pit dropped and the vegetation aspect changed as the seeding on the pad aged. Figure 16 illustrates the Lisburne drilling site during drilling with the pad 12 years later. Photo records of recovery of vegetation on gravel source areas, such as the pad slopes in Figures 13 and 14, will possibly provide some of the most useful information on long-term aspect changes.

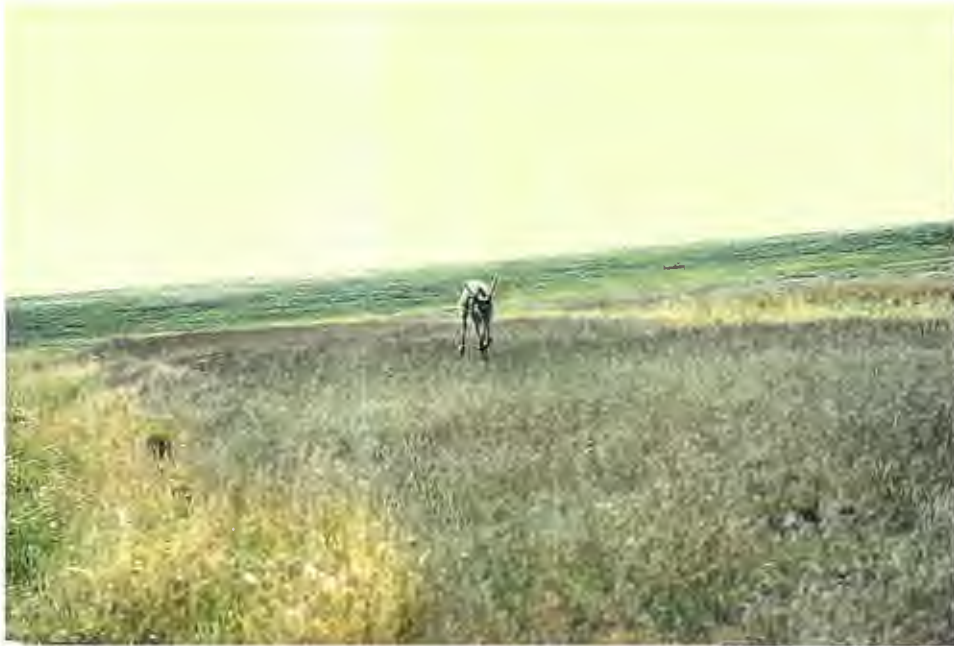
Figure 17. Caribou using the trail on the road between the Tunalik airstrip and drilling pad (25 July 1991).

Single caribou, as well as groups of 15 or more, moved through the area and across the pad during the site visit in 1991. The caribou made, and were observed using, a trail on the road (Fig. 17). Even though people were in sight, the caribou were often reluctant to leave the road or drilling pad. The reason for this could have been that those features were elevated and provided some insect relief for the animals (Curatola and Murphy 1983, Johnson and Lawhead 1989). Due to warm weather, insect populations were quite high during the 1991 visit.

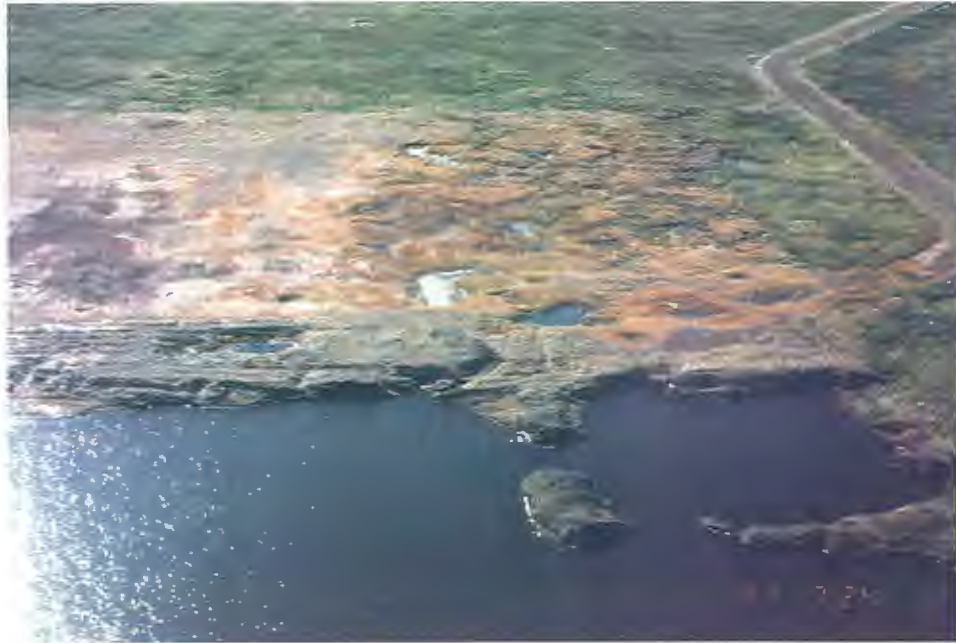
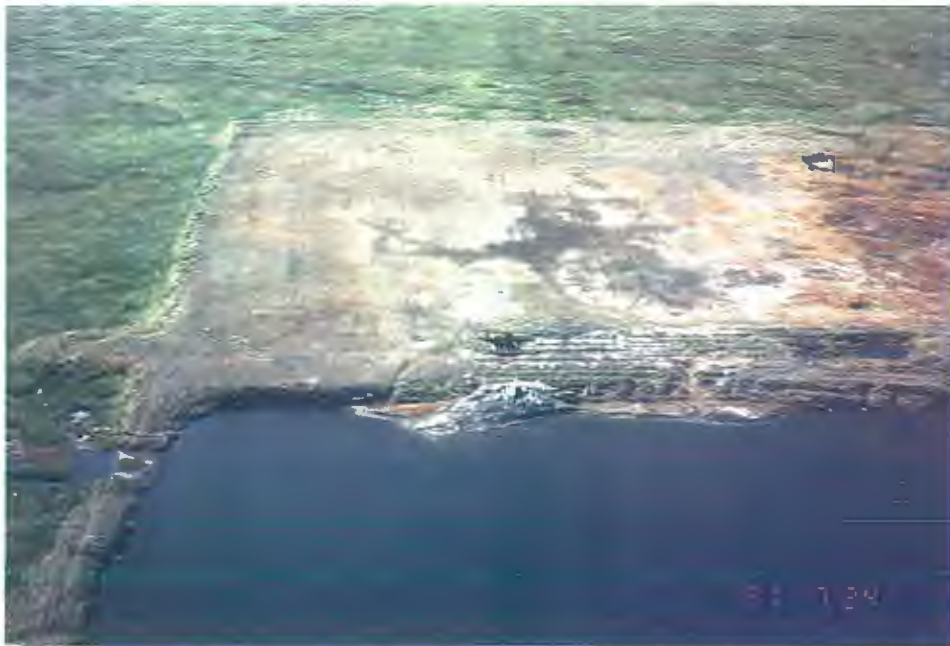
Figure 20. Aerial oblique view of non-insulated (upper) and insulated (lower) portions of the Tunalik drilling pad on 24 July 1991.

Insulation used between the gravel fill and underlying tundra to help maintain thermal stability and physical strength of some pads markedly affected the kinds of plant communities forming after the NPRA sites were abandoned. The non-insulated portions of pads developed thermokarst depressions which were subsequently invaded by moss and indigenous vascular plants. This is illustrated in Figure 20, which shows the insulated and non-insulated portions of the Tunalik pad. These thermokarst depressions were also attractive to lemmings, which developed colonies during the winter and fed on the seeded and volunteer vegetation. These plants produced shoots that probably were more succulent than those produced on the drier, insulated portions of the pads. Higher moss cover was also found on the non-insulated portions of the NPRA pads than the insulated portions.

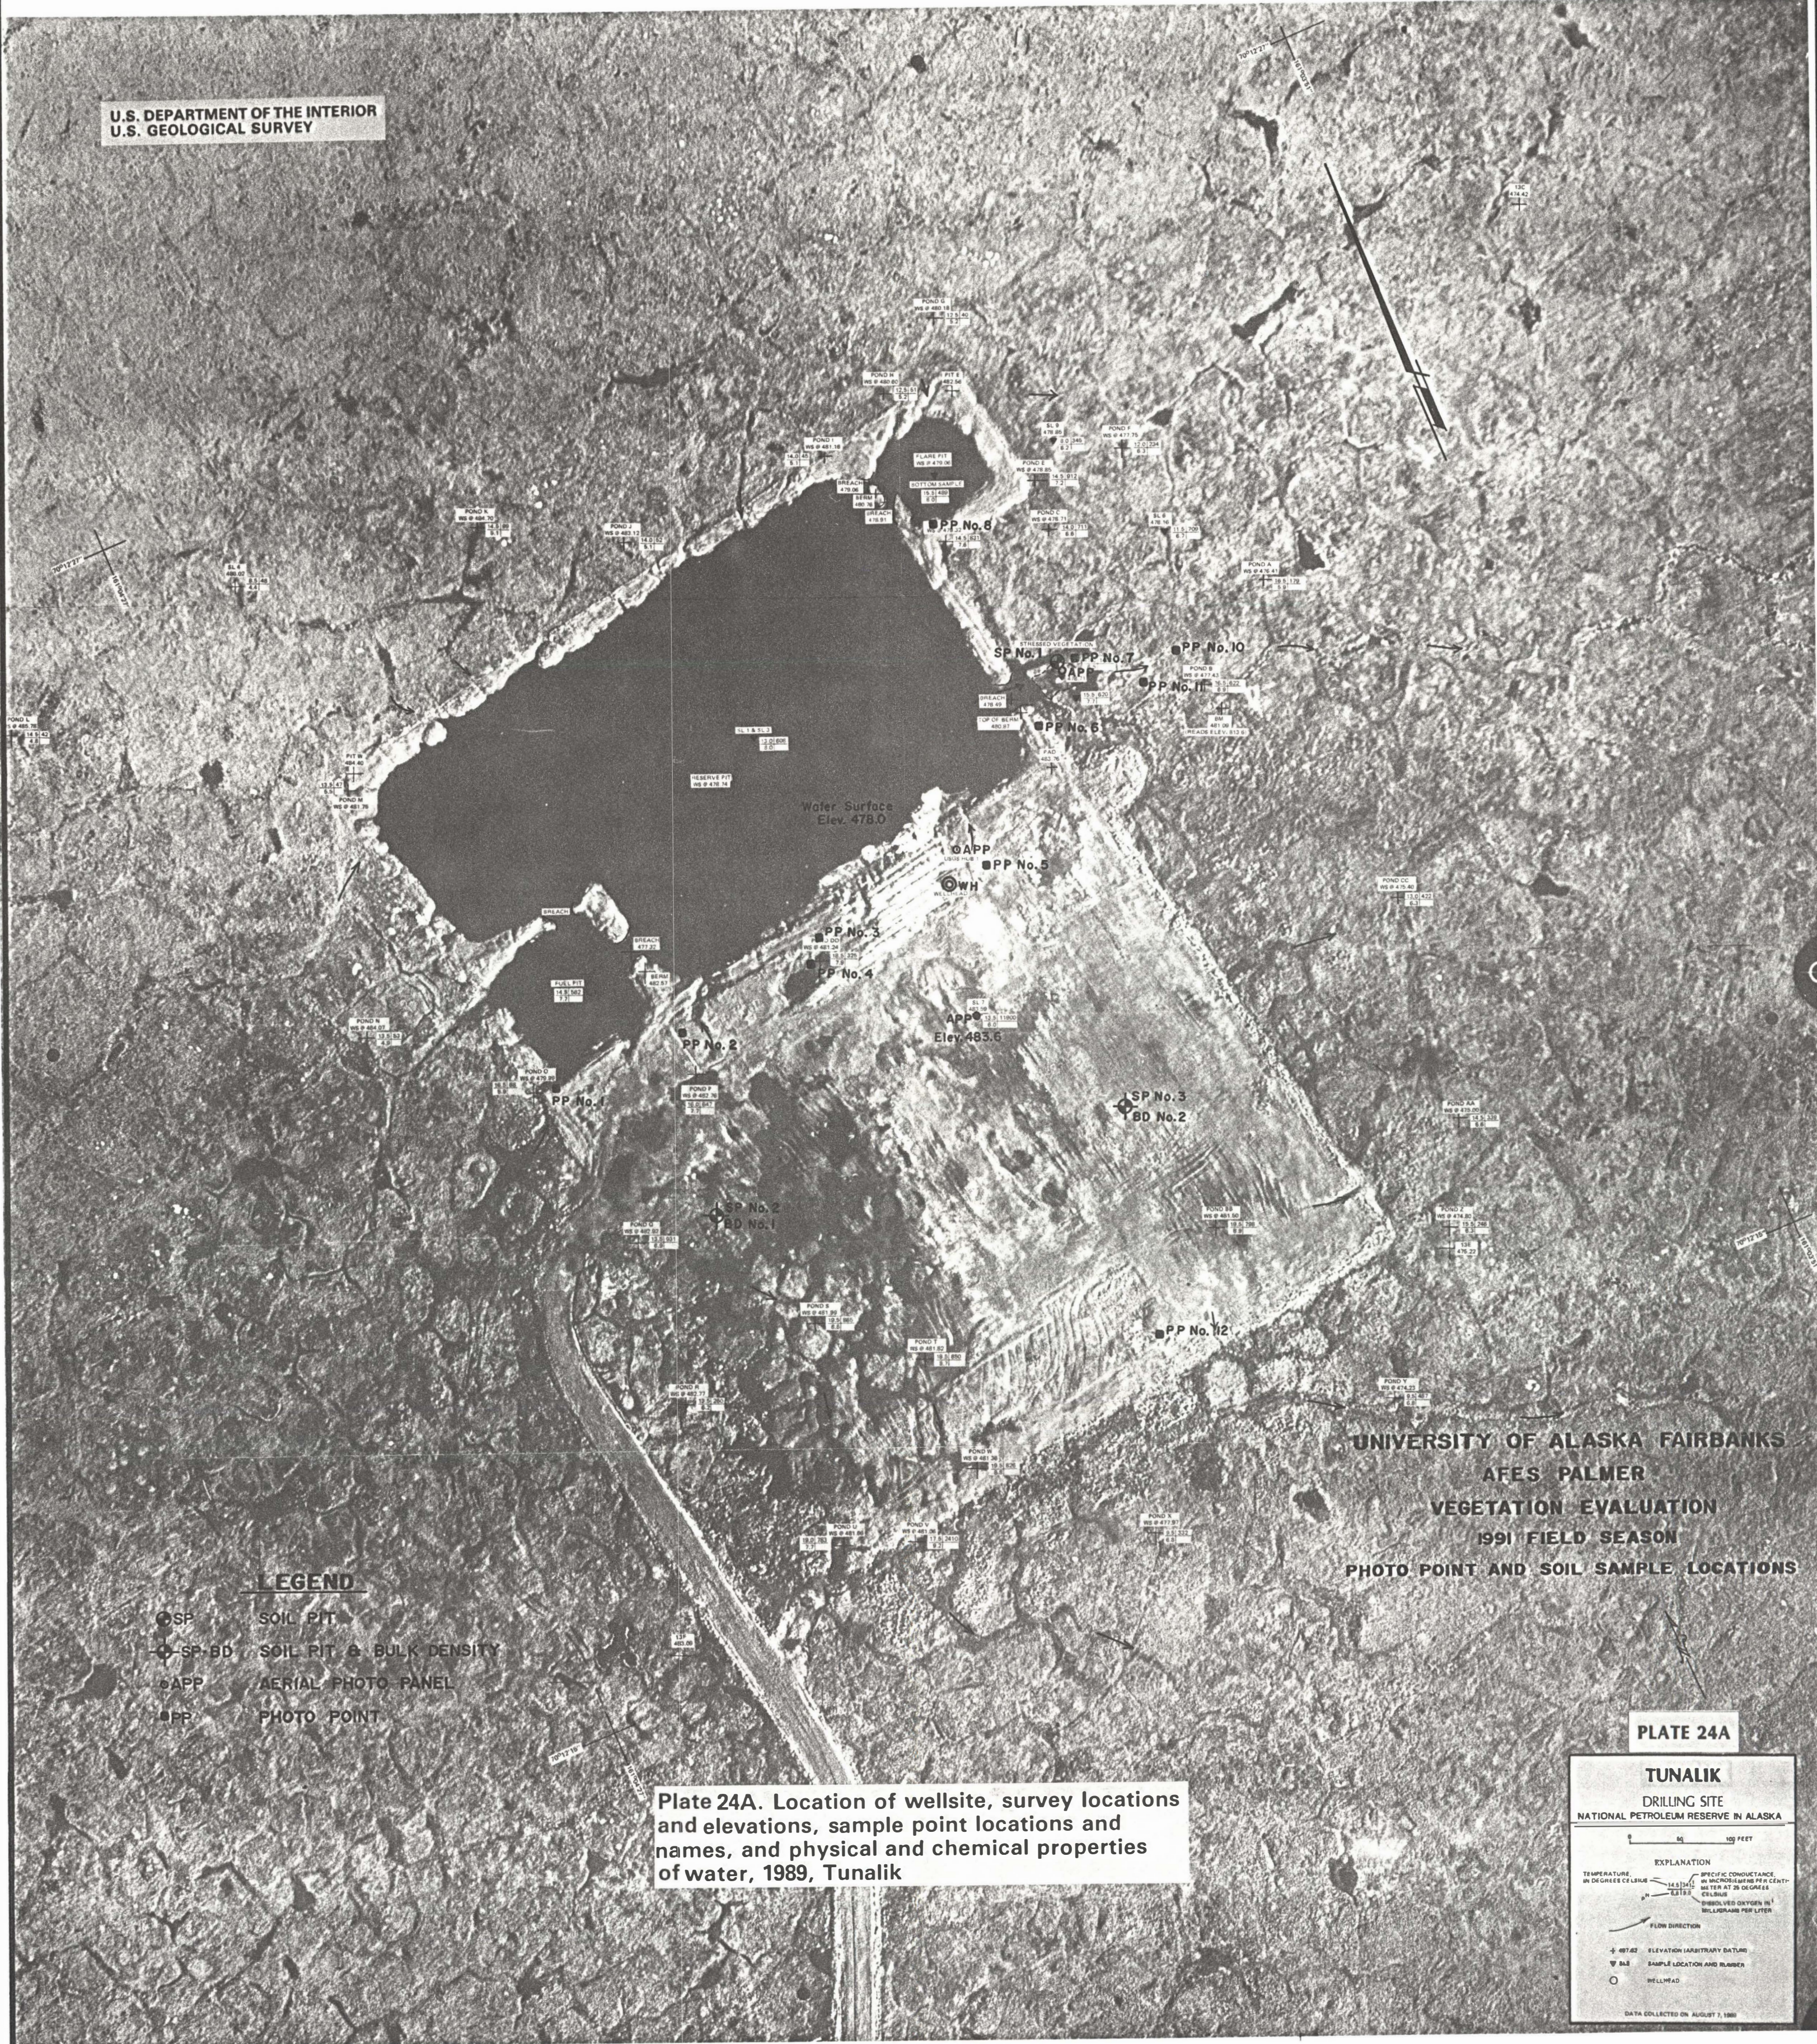
UNIVERSITY OF ALASKA FAIRBANKS
AFES PALMER
VEGETATION EVALUATION
1991 FIELD SEASON
PHOTO POINT AND SOIL SAMPLE LOCATIONS
