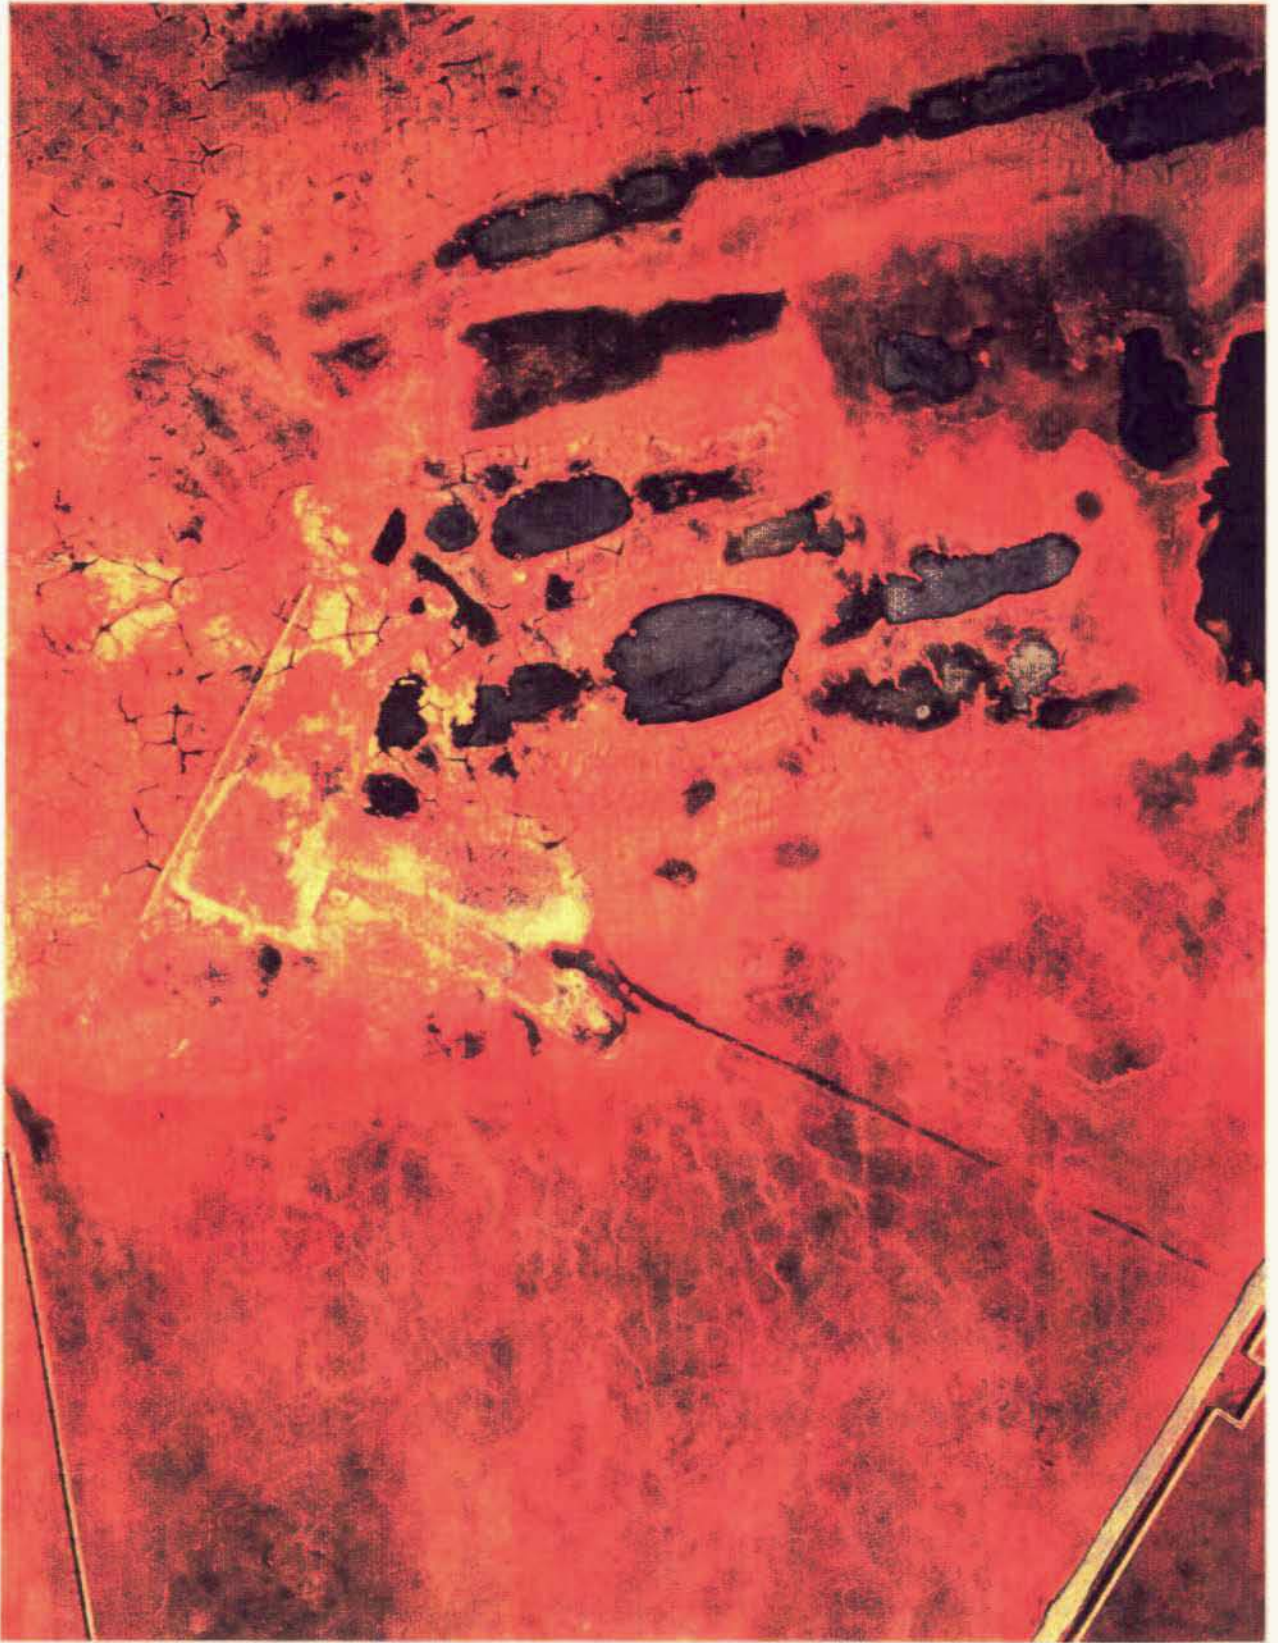
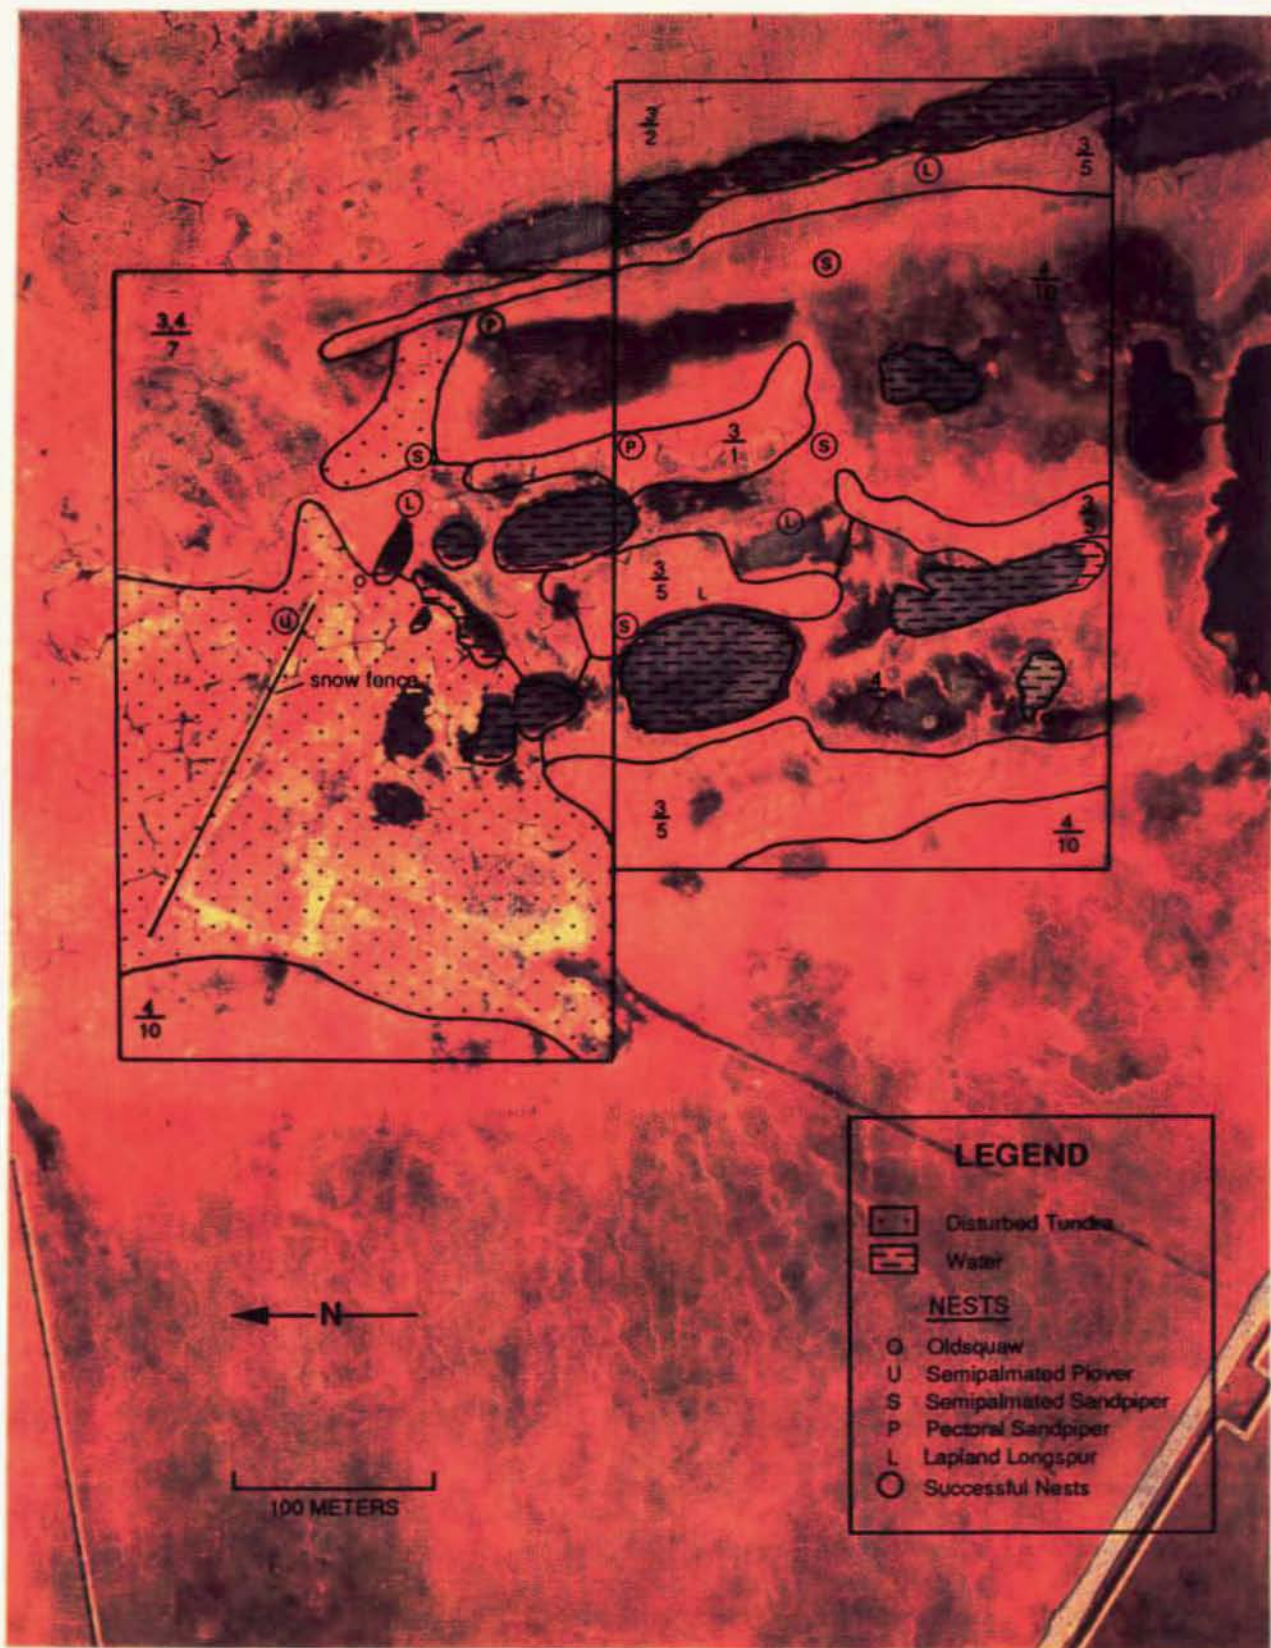
Fig. A-8. Gravel disturbance, nest locations, and geobotanical types of tundra patches on disturbed and undisturbed study plots, Put River 22-33-11-13, Prudhoe Bay, Alaska, 1990.

Put River 22-33-11-13 ("BP Pad") (Fig. A-8) is located in the Prudhoe Bay Unit in Sec. 33, T11N, R13E. It is approximately 0.5 km west of Y Pad. There is no road access to the site, but it can be reached in about 5 min by foot from Y Pad.

This site is the object of an experimental rehabilitation project being undertaken by BPX. Most of the gravel was removed from this site to within six inches of the original grade in May 1989. Some additional gravel was removed in April 1990. Overburden was placed over the area of gravel removal. The area was fertilized and planted with *Poa glauca*, *Festuca rubra*, and *Arctagrostis latifolia* in May 1989. It was fertilized again after the first growing season in September 1989. A wooden snow fence was installed north of the gravel site just prior to gravel removal. The purpose of this fence is to attempt to accumulate drifting snow as a source of water for the cultivars. The cultivars were doing well during the 1990 field season. The cultivated area includes most of the area designated as "disturbed tundra" on the site map (Fig. A-8). The smaller portion of disturbed tundra showed signs of disturbance such as sparsely vegetated areas.

The area surrounding the disturbed portion of the plot is composed of moist and wet graminoid tundra. The landform is primarily strangmoor and non-patterned ground. Small patches of high-centered polygons and mixed high- and low-centered polygons extend into the undisturbed plot. Some of the ponds had dried up, and their mud bottoms were exposed. The disturbed area covers approximately 50 percent of the plot.

The undisturbed plot is located south of the disturbed plot and is slightly offset from it. It is composed of moist and wet graminoid tundra. The landform is predominately non-patterned ground and strangmoor, with patches of high-centered polygons and mixed high- and low-centered polygons. Several ponds are also present, some of which partially receded during the summer.

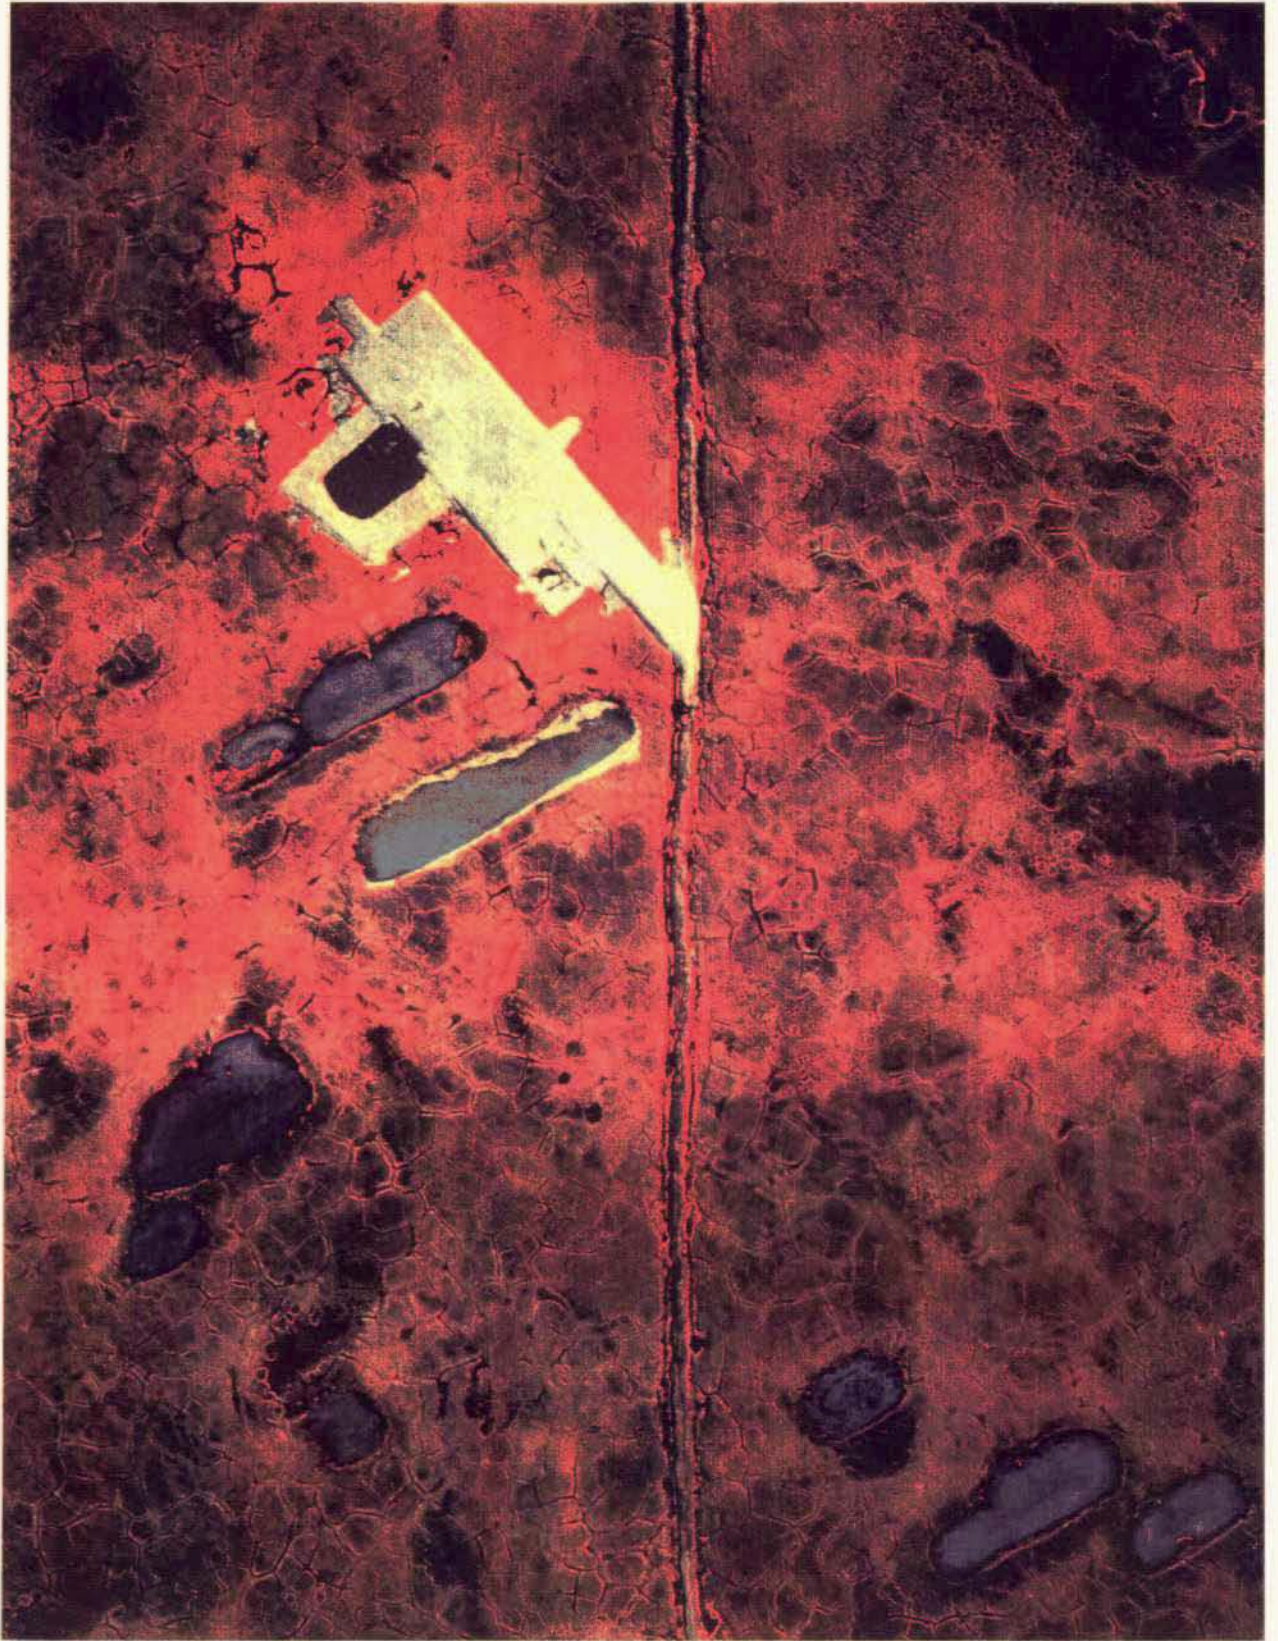
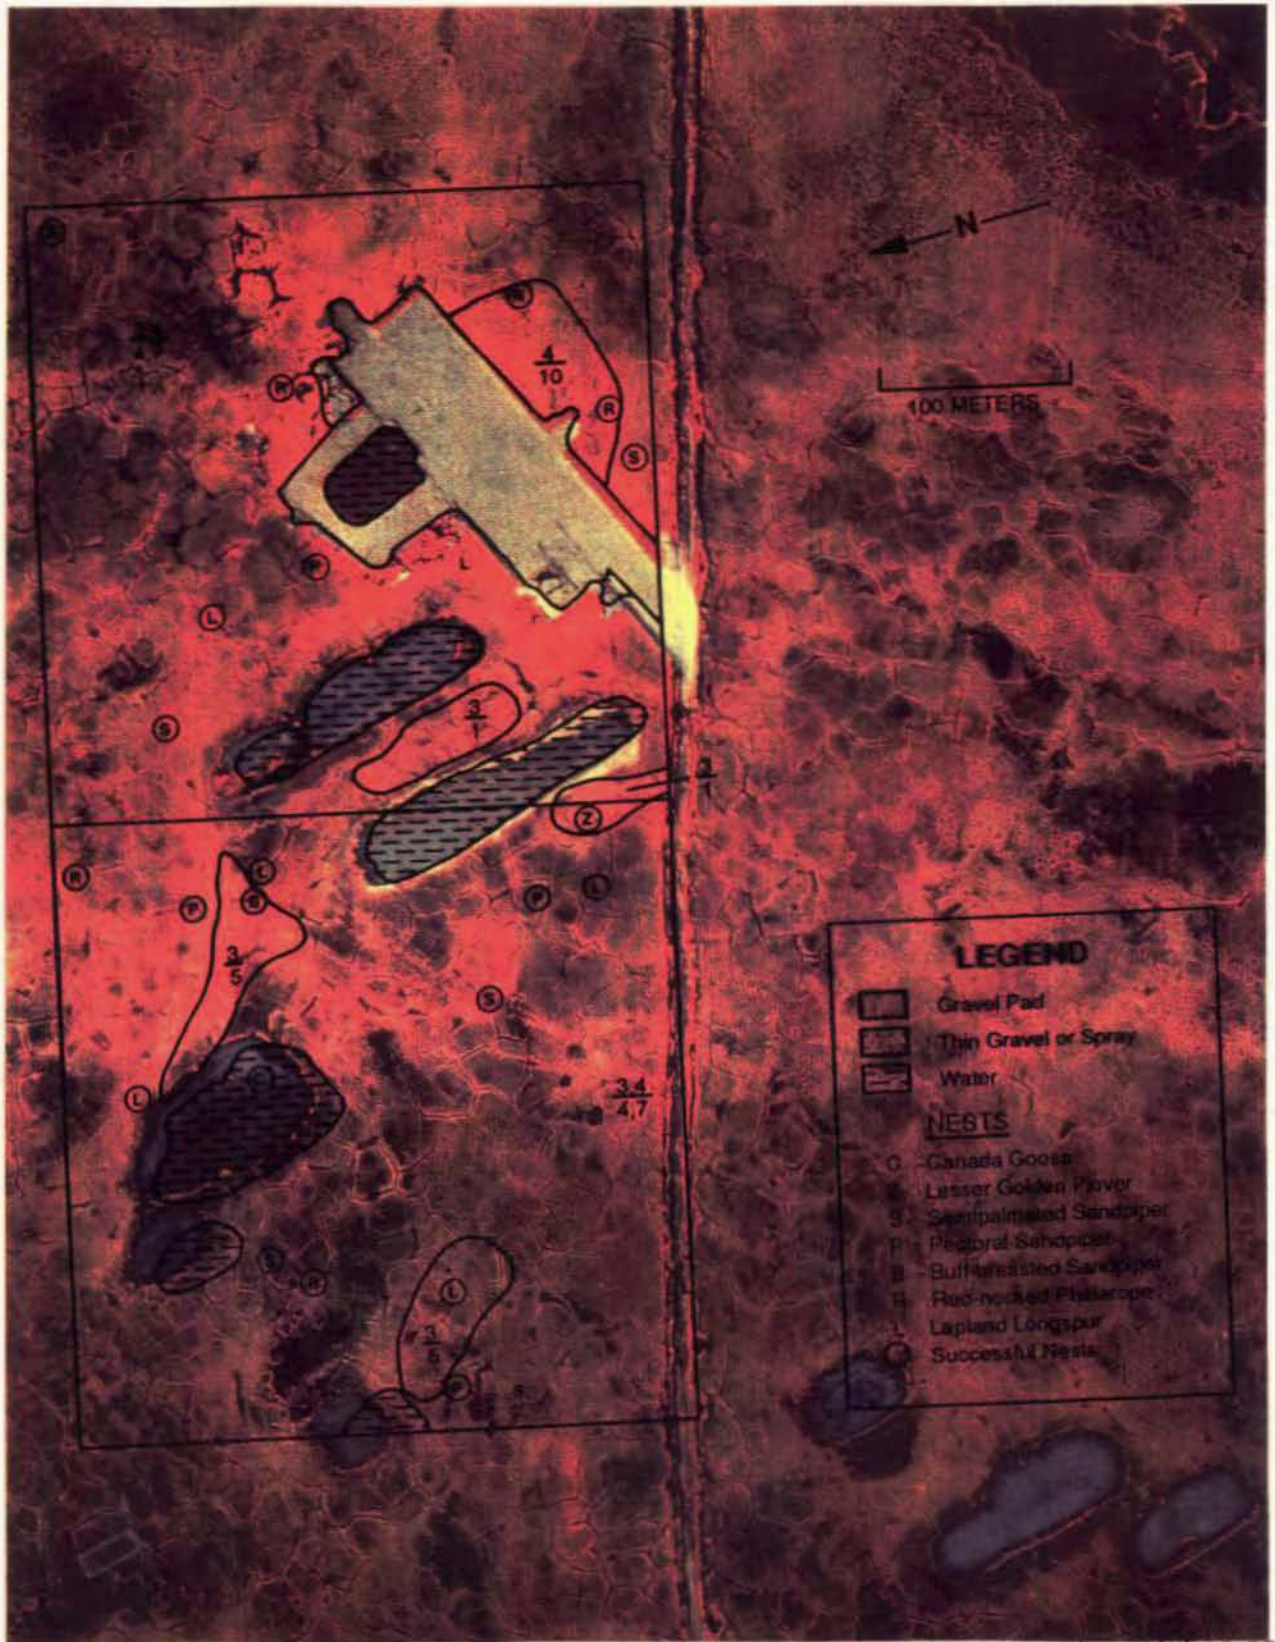
Fig. A-9. Gravel disturbance, nest locations, and geobotanical types of tundra patches on disturbed and undisturbed study plots, Getty State, Prudhoe Bay, Alaska, 1990.

Getty State (Fig. A-9) is located in the Prudhoe Bay Unit in Sec. 2, T10N, R13E approximately 2 km southwest of A Pad. The closest access is from a gravel road south of A Pad from which Getty State can be seen. It lies approximately 1 km south of this road and can be reached in about 15 minutes on foot.

The pad dimensions are approximately 180 m x 65 m. Gravel thickness over most of the pad is approximately 1.5 m. Little thermokarsting is evident other than on a small portion of the pad's western corner where gravel thickness was only about 0.6 m. Several small patches of gravel spray are present around the edges of the pad. A reserve pit attached to the north side of the pad was filled with water and is surrounded by a gravel berm. The gravel disturbance and reserve pit cover approximately 17 percent of the study plot.

The area surrounding the pad is composed of moist and wet graminoid tundra. The landform is primarily low-centered polygons and strangmoor with patches of high-centered polygons and non-patterned ground also present. Extensive thermokarsting has occurred on the tundra north and east of the pad producing deep water-filled troughs. Natural water bodies are present on the western portion of the plot.

The undisturbed plot is adjacent to the west edge of the disturbed plot. The tundra is composed of moist and wet graminoids. The landform is primarily low-centered polygons and strangmoor with patches of mixed high- and low-centered polygons. A small patch of low-relief high-centered polygons overlaps the disturbed plot at the southern boundary of both plots. This southern boundary is paralleled by a peat road which is about 10 m off the plots. Several ponds are also present.

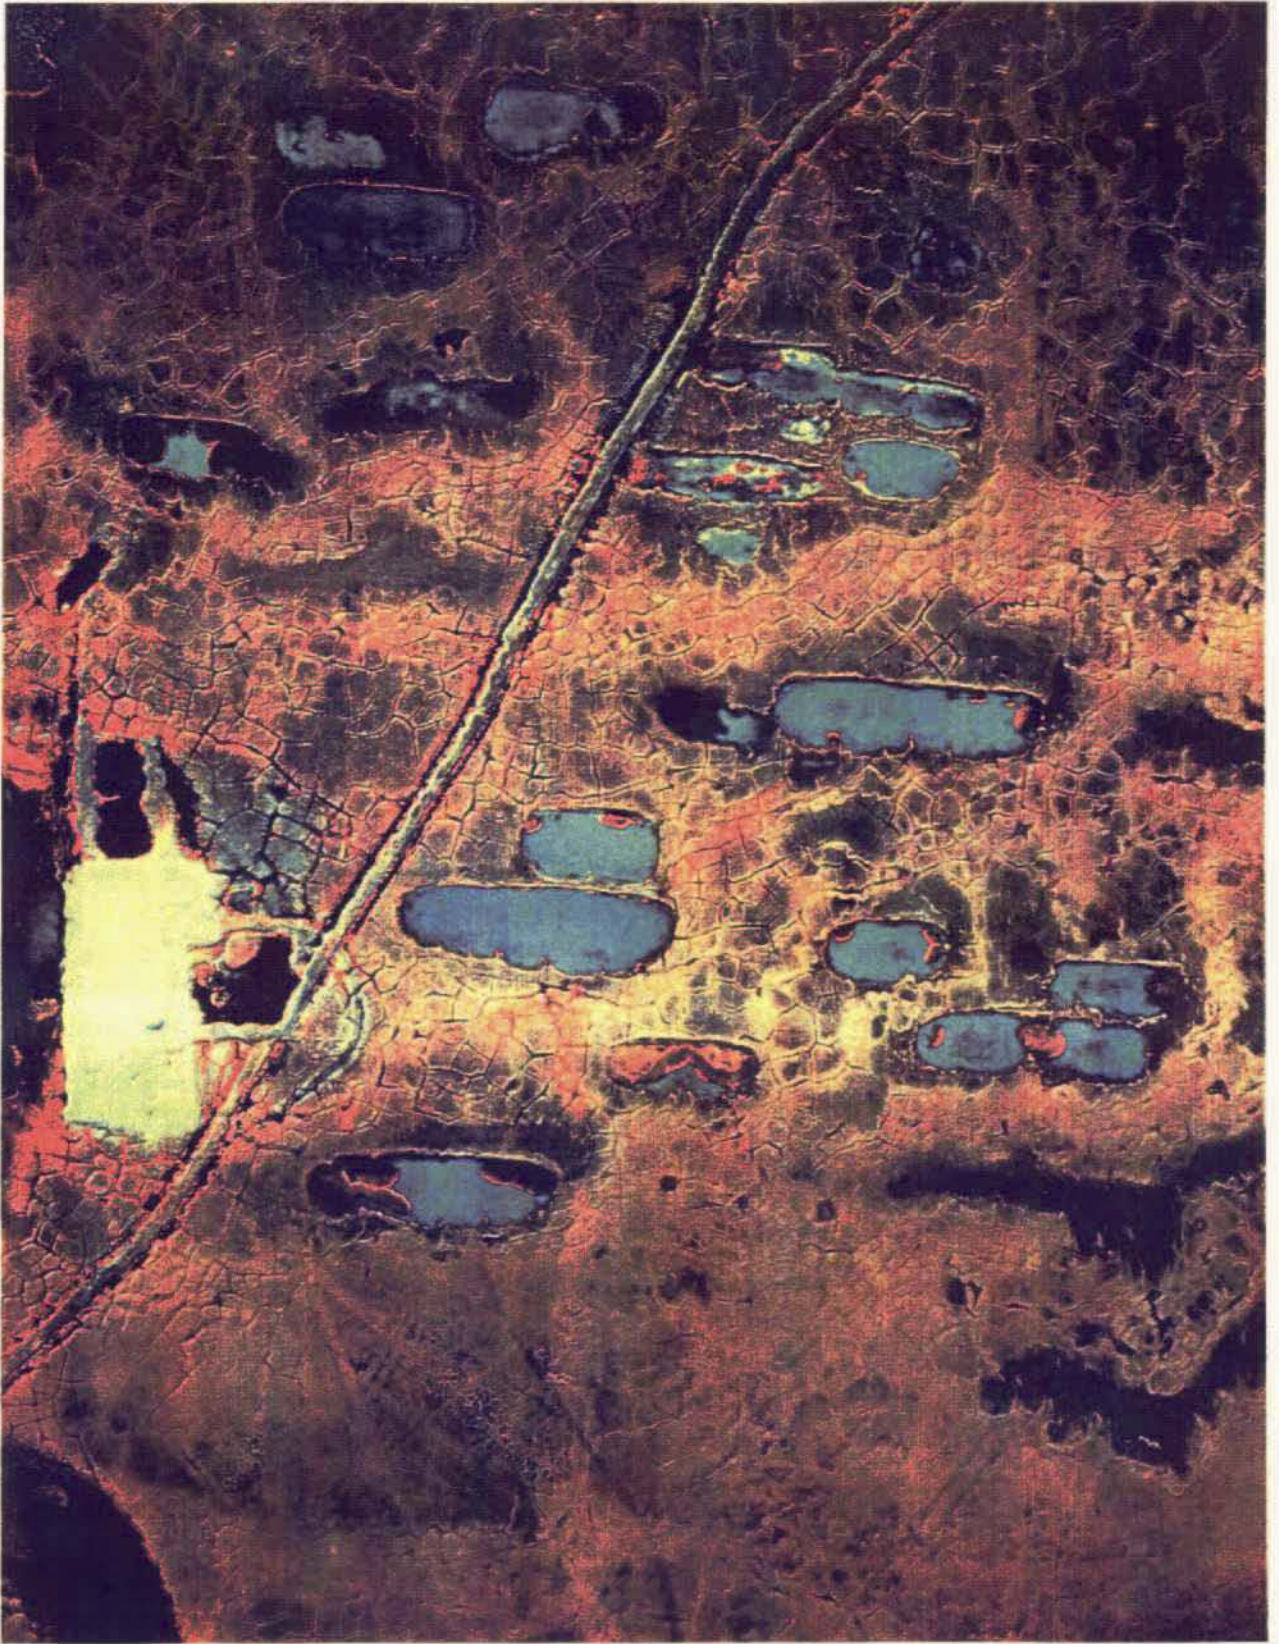
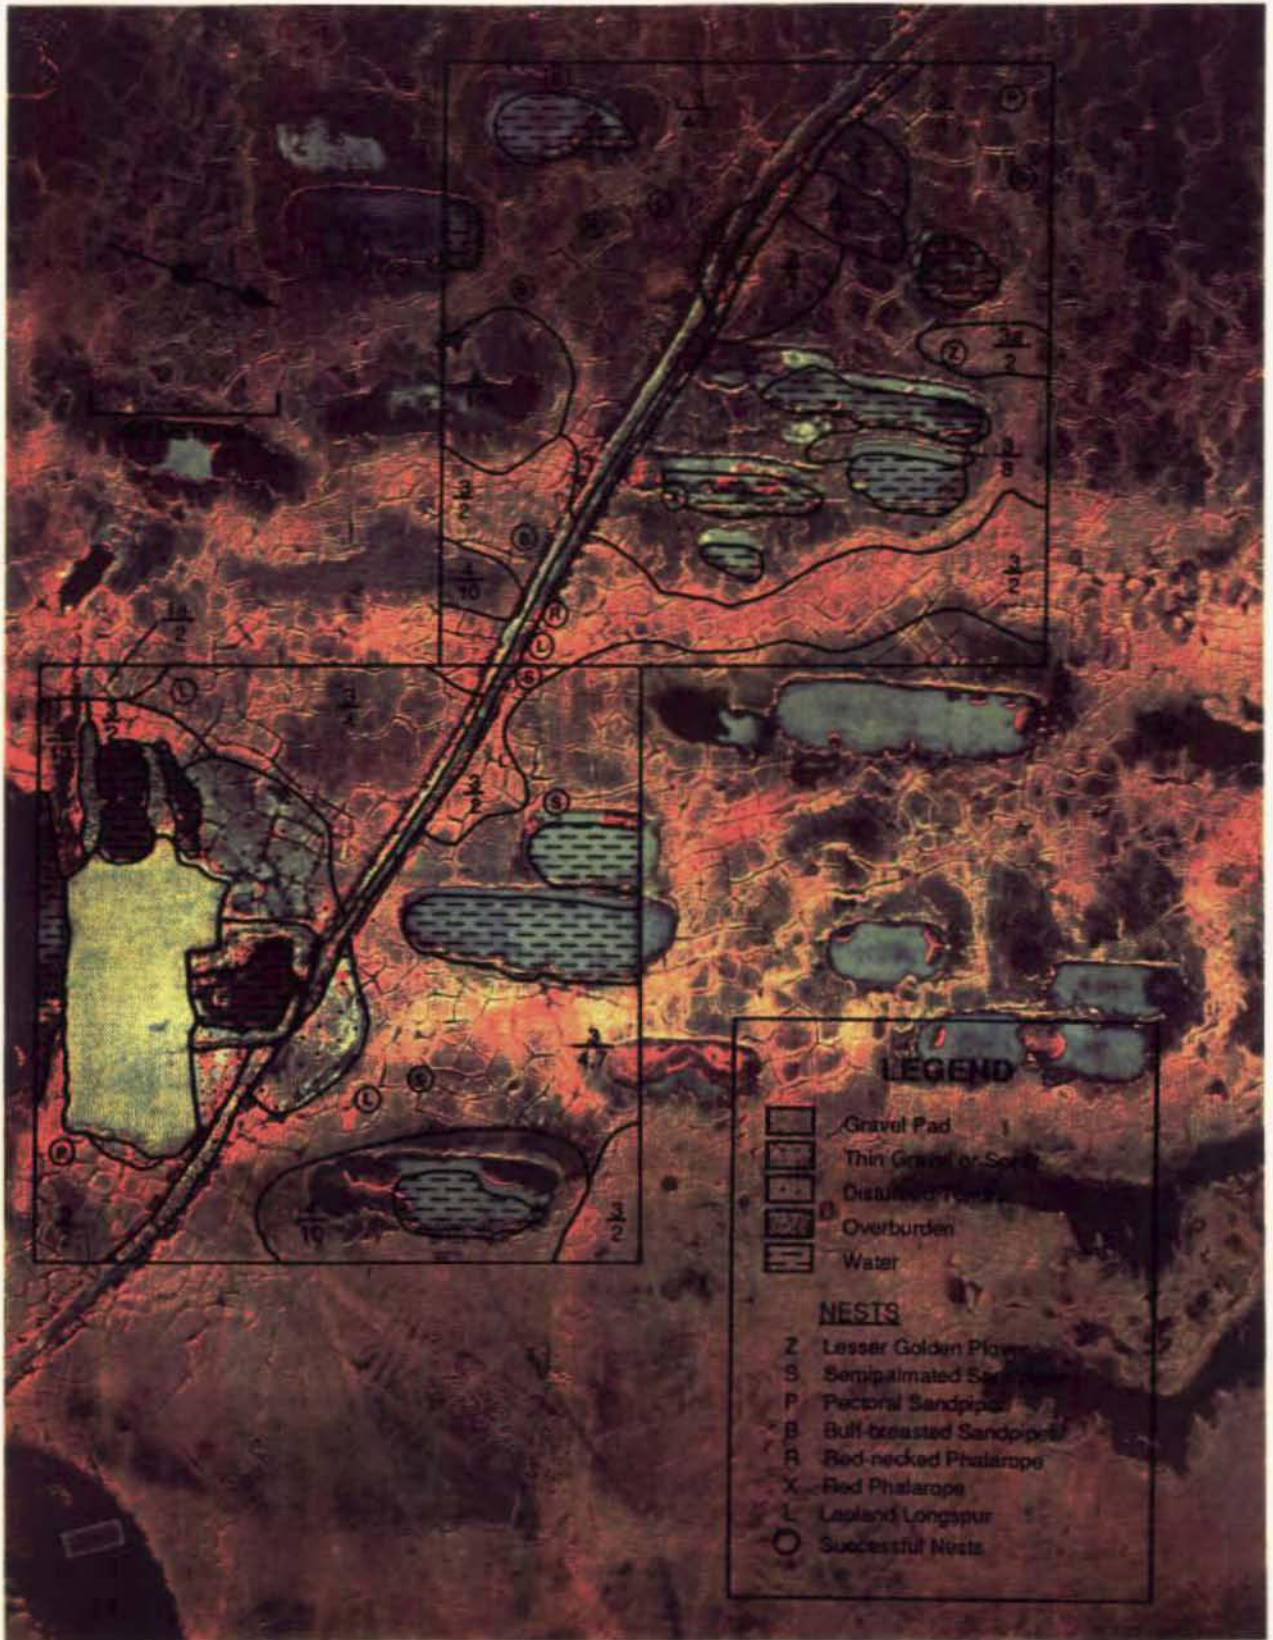
Fig. A-10. Gravel disturbance, nest locations, and geobotanical types of tundra patches on disturbed and undisturbed study plots, Put State 1, Prudhoe Bay, Alaska, 1990.

Put State 1 (Fig. A-10) is in the Prudhoe Bay Unit in Sec. 7, T10N, R14E, about 0.6 km southwest of X pad. There is no road access to the pad, but it can be seen from X pad, and reached in approximately 15 min on foot.

The pad dimensions are approximately 70 m x 160 m. Gravel thickness averages about 1.3 m. Topography is fairly uniform, but some areas exhibit mild thermokarsting. No water was present in thermokarst troughs. The well head is located slightly north of the pad center and consists of a pipe imbedded in a gravel mound. A group of wood pilings is embedded in parts of the western portion of the pad. Some gravel spray is present near the east side of the pad. An old peat road passes through the study plot just north of the pad.

The gravel, gravel spray, reserve pits, and overburden (not including the peat road) cover approximately 18 percent of the disturbed plot. An area of disturbance north of the pad is sparsely vegetated and has scattered vehicle tracks and thermokarsting. Including this area, disturbance covers approximately 26 percent of the disturbed plot. The peat road is not included in this figure because it also passes through the undisturbed plot.

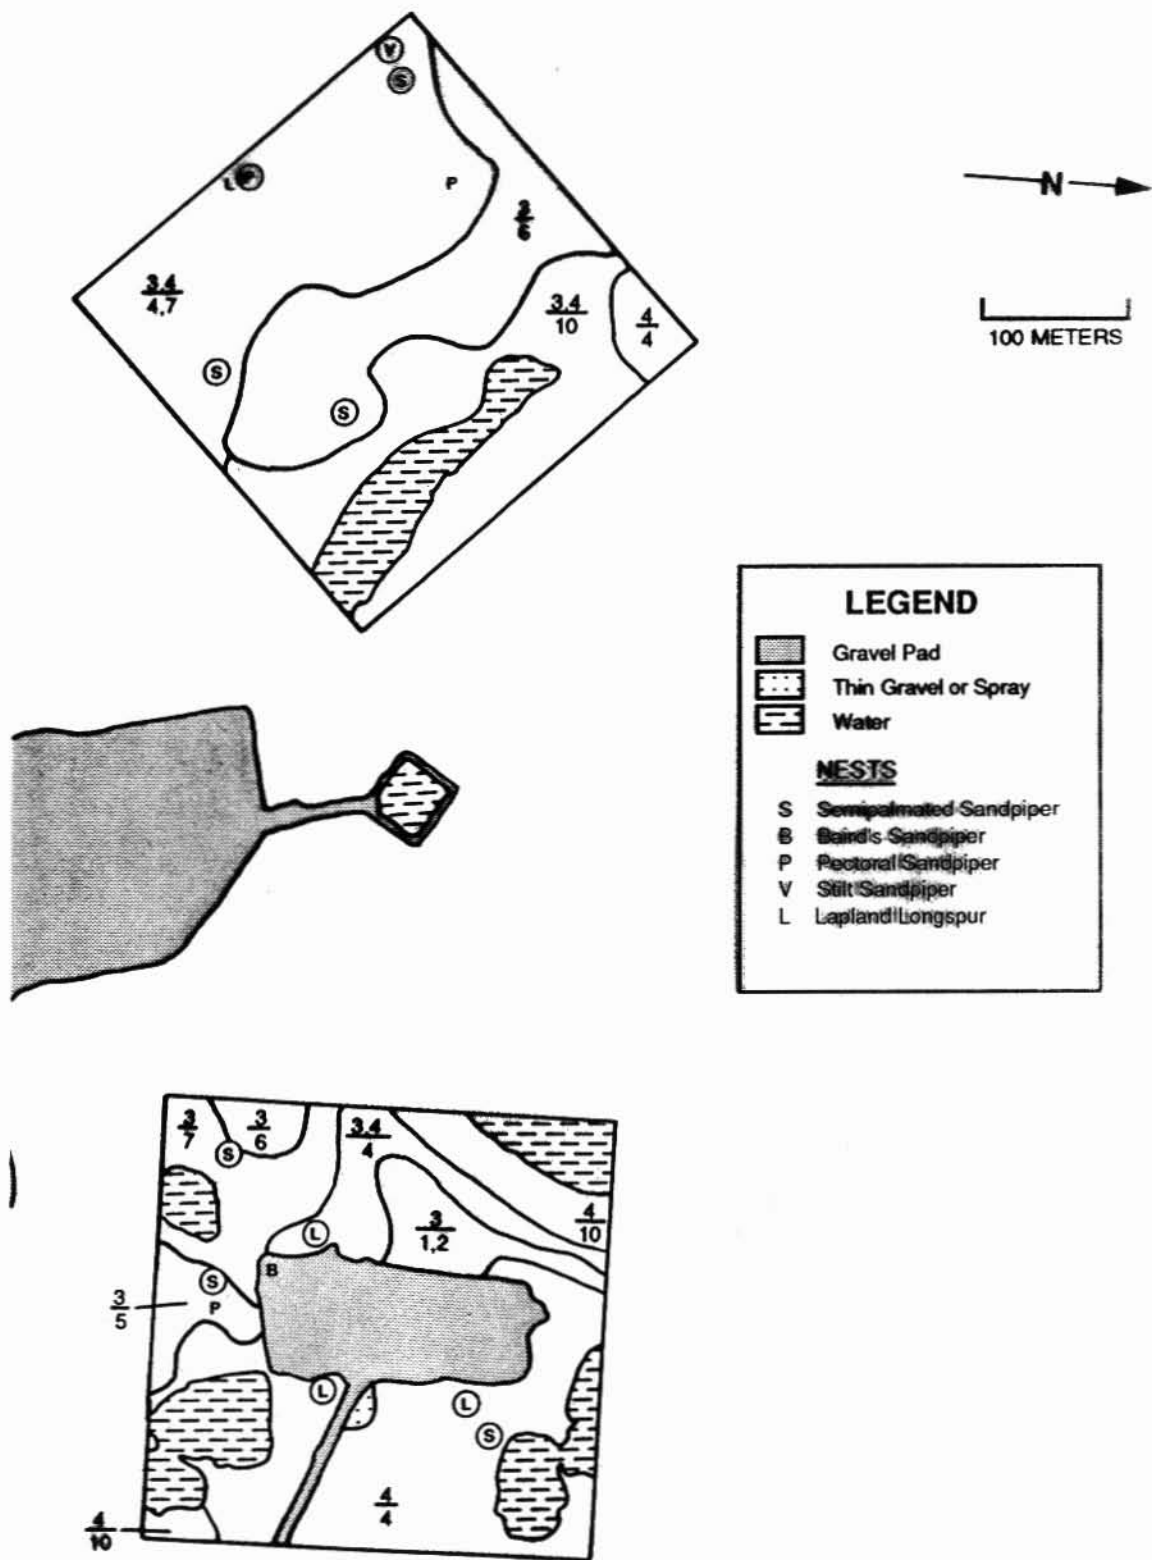
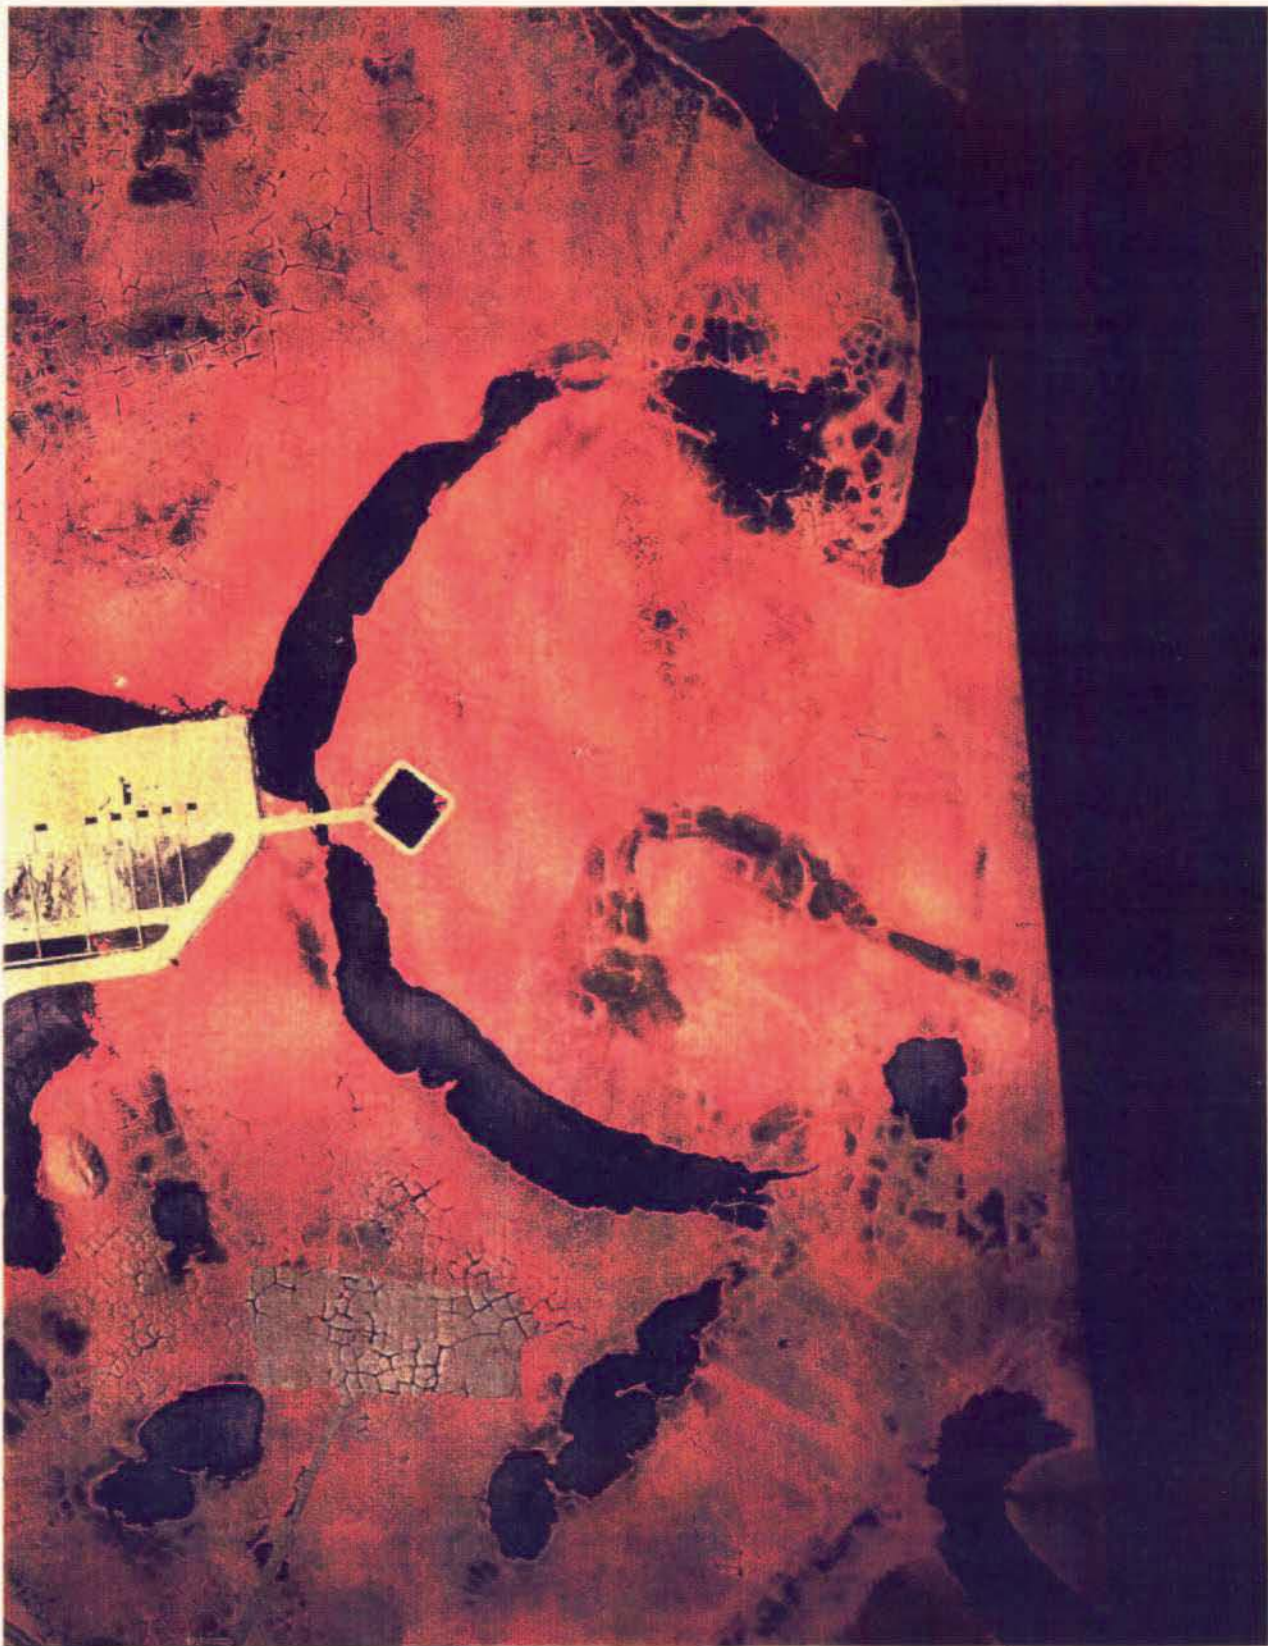
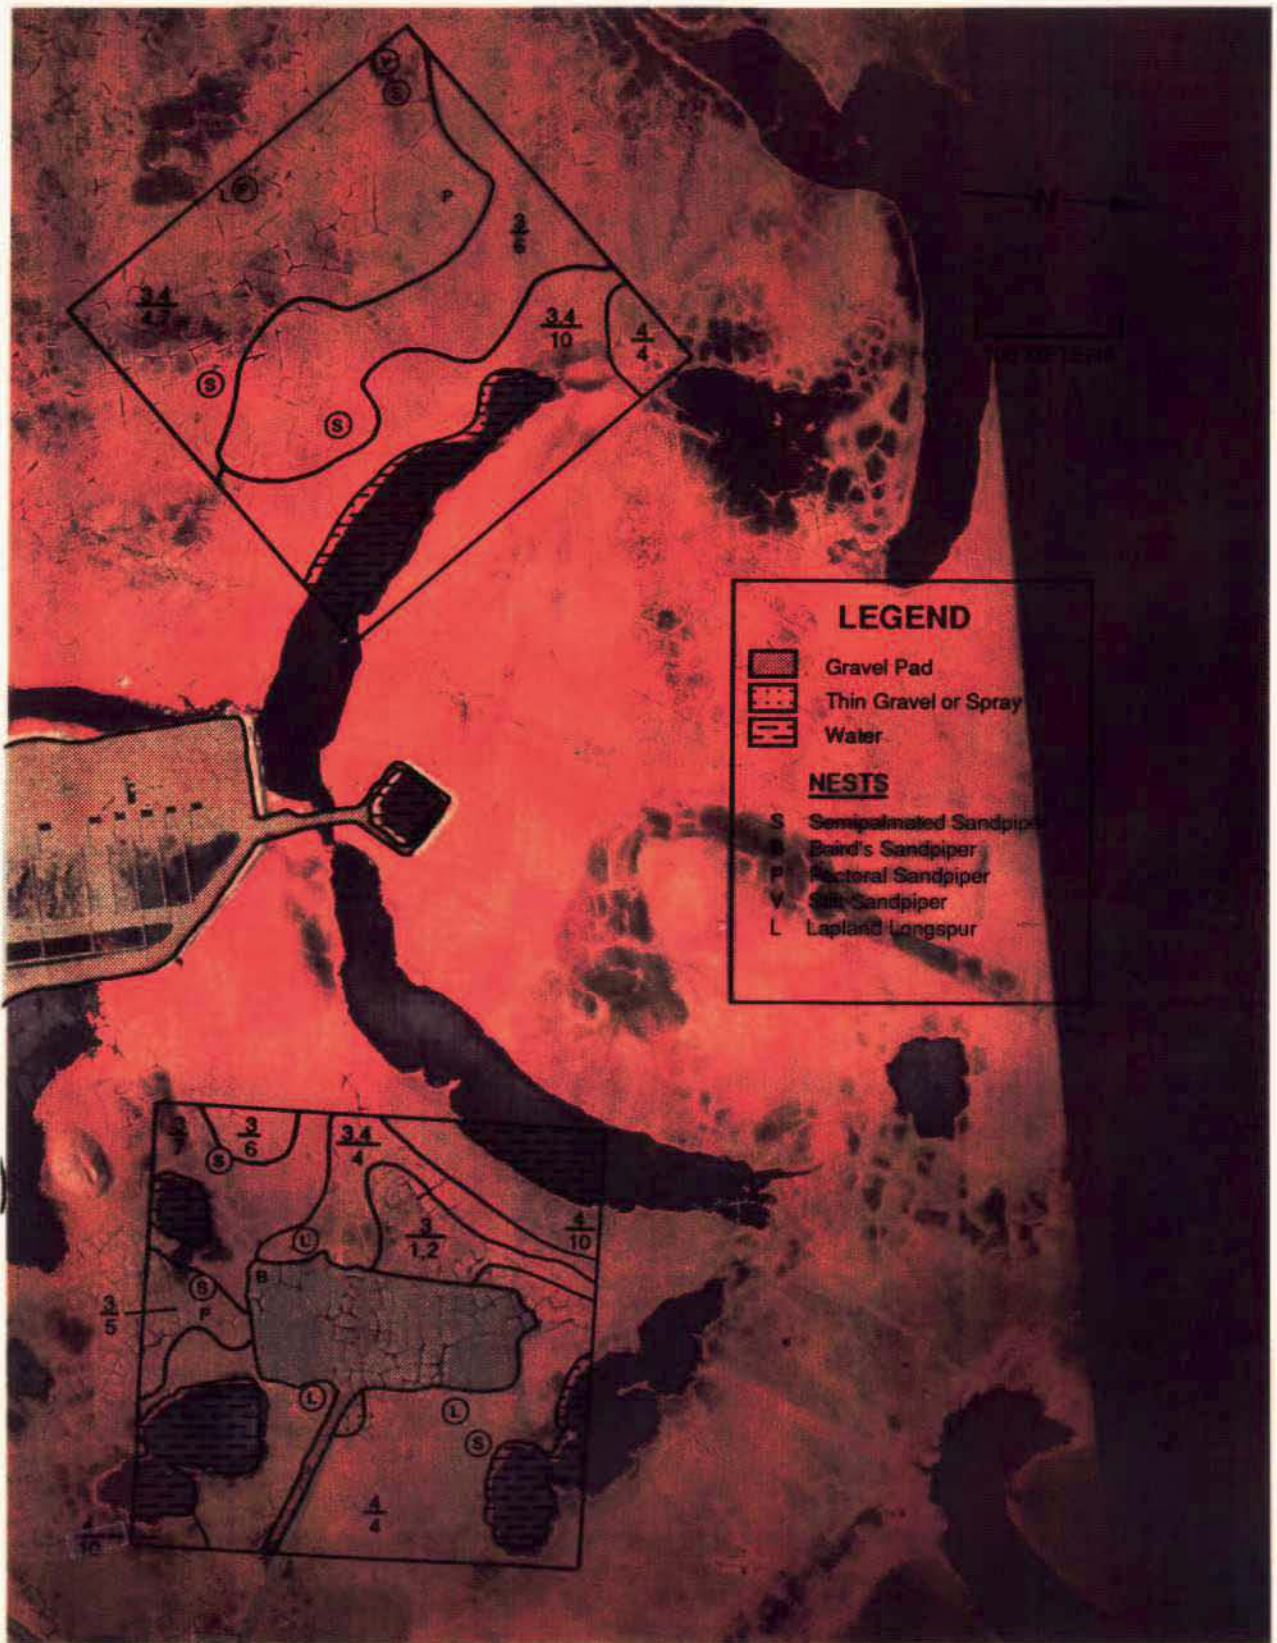
Fig. A-11. Gravel disturbance, nest locations, and geobotanical types of tundra patches on disturbed and undisturbed study plots, Storage Pad, Prudhoe Bay, Alaska, 1990.

Storage Pad (Fig. A-11) is located in the Prudhoe Bay Unit in Sec. 27, T11N, R14E. It is about 0.3 km east of the north end of Drill Site 7. A gravel road from the pad intersects the southern end of the Drill Site 15 access road at an expansion loop in the pipeline next to the road. Storage Pad can be reached in about 2 min on foot from this point. This pad was not an exploratory well site.

The pad dimensions are approximately 185 m x 80 m. Gravel thickness is approximately 0.5 m over most of the pad. Thermokarsting is well developed and many troughs were filled with water, particularly on the southern portion. Plant colonization has occurred over the entire pad and is most pronounced on the southern portion. (For a list of plants identified at this site see Table B-1, Appendix B). Part of the gravel access road and a patch of gravel spray are also included in the disturbed plot. The gravel disturbance covers approximately 17 percent of the plot.
