Source Water Assessment

A Hydrogeologic Susceptibility and Vulnerability Assessment for Tundra Women's Coalition Drinking Water System, Bethel, Alaska

PWSID # 271114.001

DRINKING WATER PROTECTION PROGRAM REPORT 1123
Alaska Department of Environmental Conservation

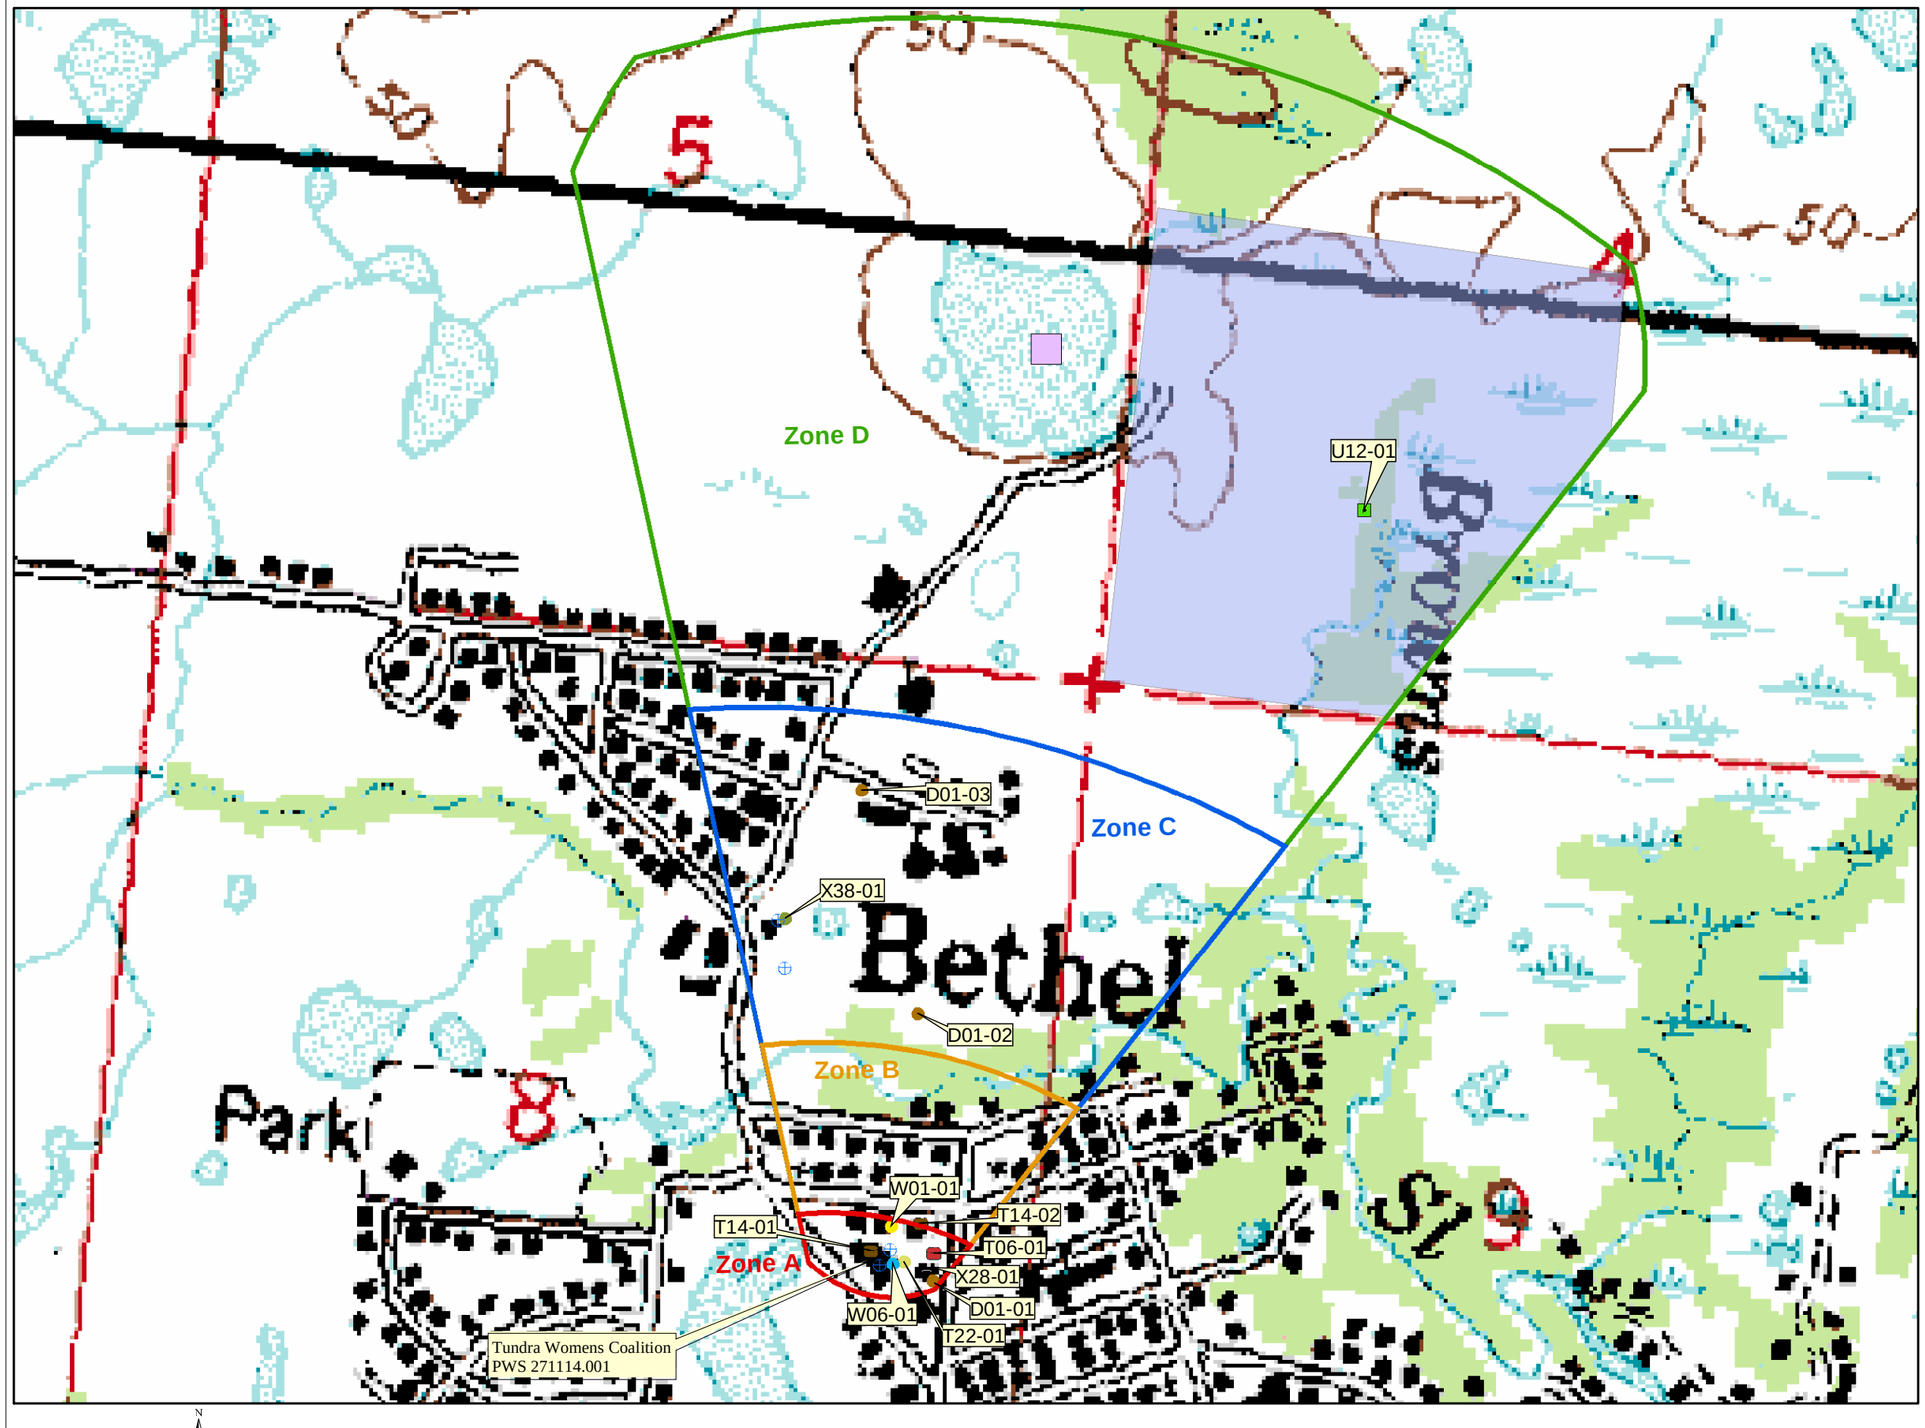
Drinking Water Protection Area
and Potential and Existing Contaminant Sources
(Map C)

Identified potential and current sources of contaminants for the public drinking water source include: domestic wastewater collection systems, aboveground fuel tanks, roads, wastewater holding tanks, an abandoned well, monitoring wells, water supply wells, a pipeline, firehouses, a domestic wastewater treatment plant disposal pond/lagoon, a landfill, and an ADEC recognized leaking underground storage tank (LUST) site. These identified potential and existing sources of contamination are considered as sources of bacteria and viruses, nitrates and/or nitrites, volatile organic chemicals, heavy metals, cyanide and other inorganic chemicals, synthetic organic chemicals, and other organic chemicals contaminant categories.

The sources are displayed on Map C of Appendix C and summarized in Table 1 of Appendix B.

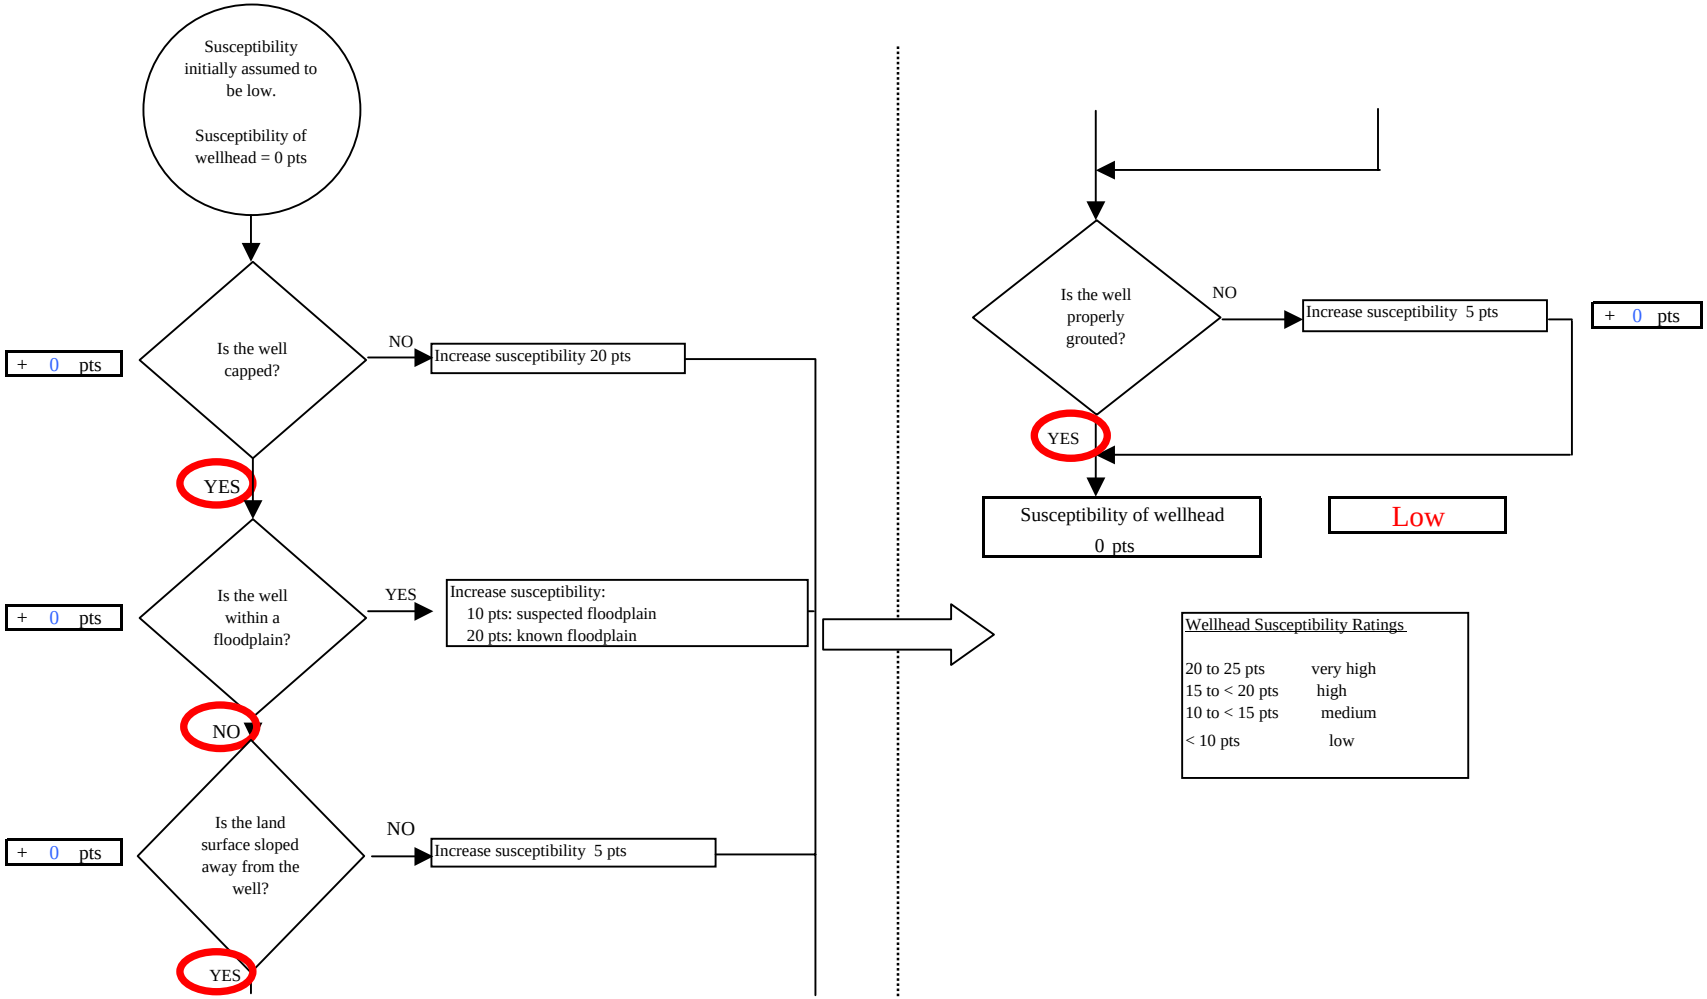
Chart 1. Susceptibility of the wellhead - Tundra Womens Coalition (PWS No. 271114.001)

The Tundra Women's Coalition's water well is in a confined aquifer. Confined aquifers are less susceptible to potential groundwater quality impacts posed by the migration of surface water contaminants downward from the surface. Table 2 shows the susceptibility scores and ratings for this PWS.

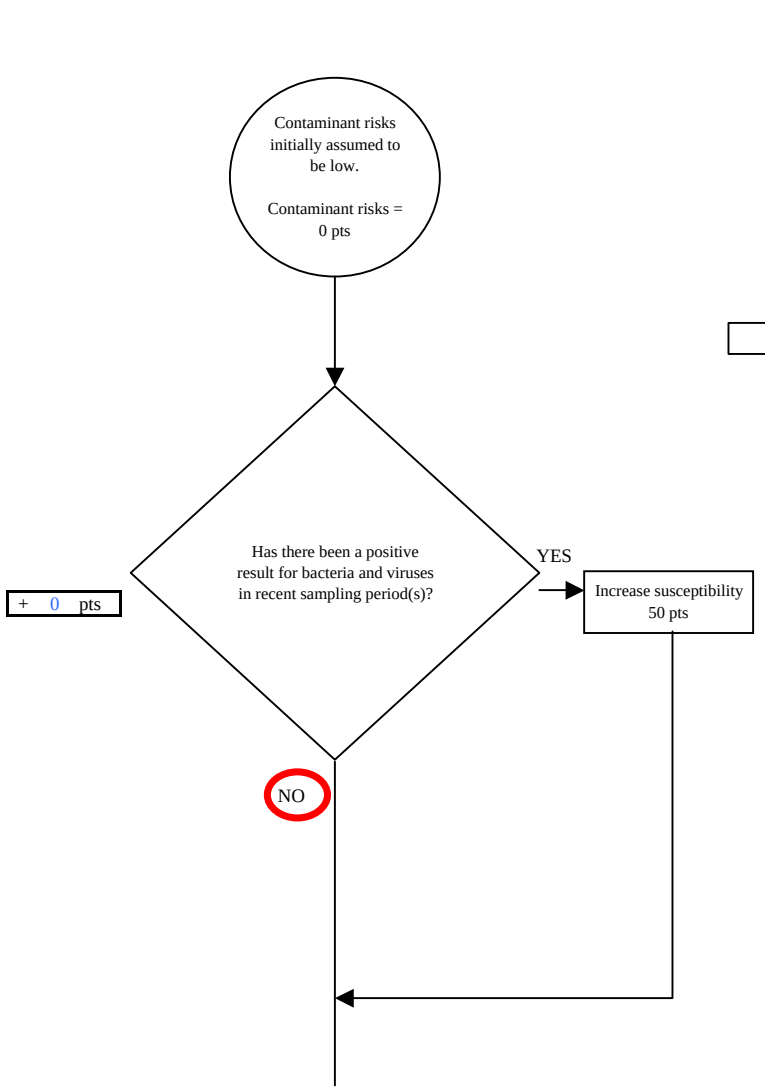
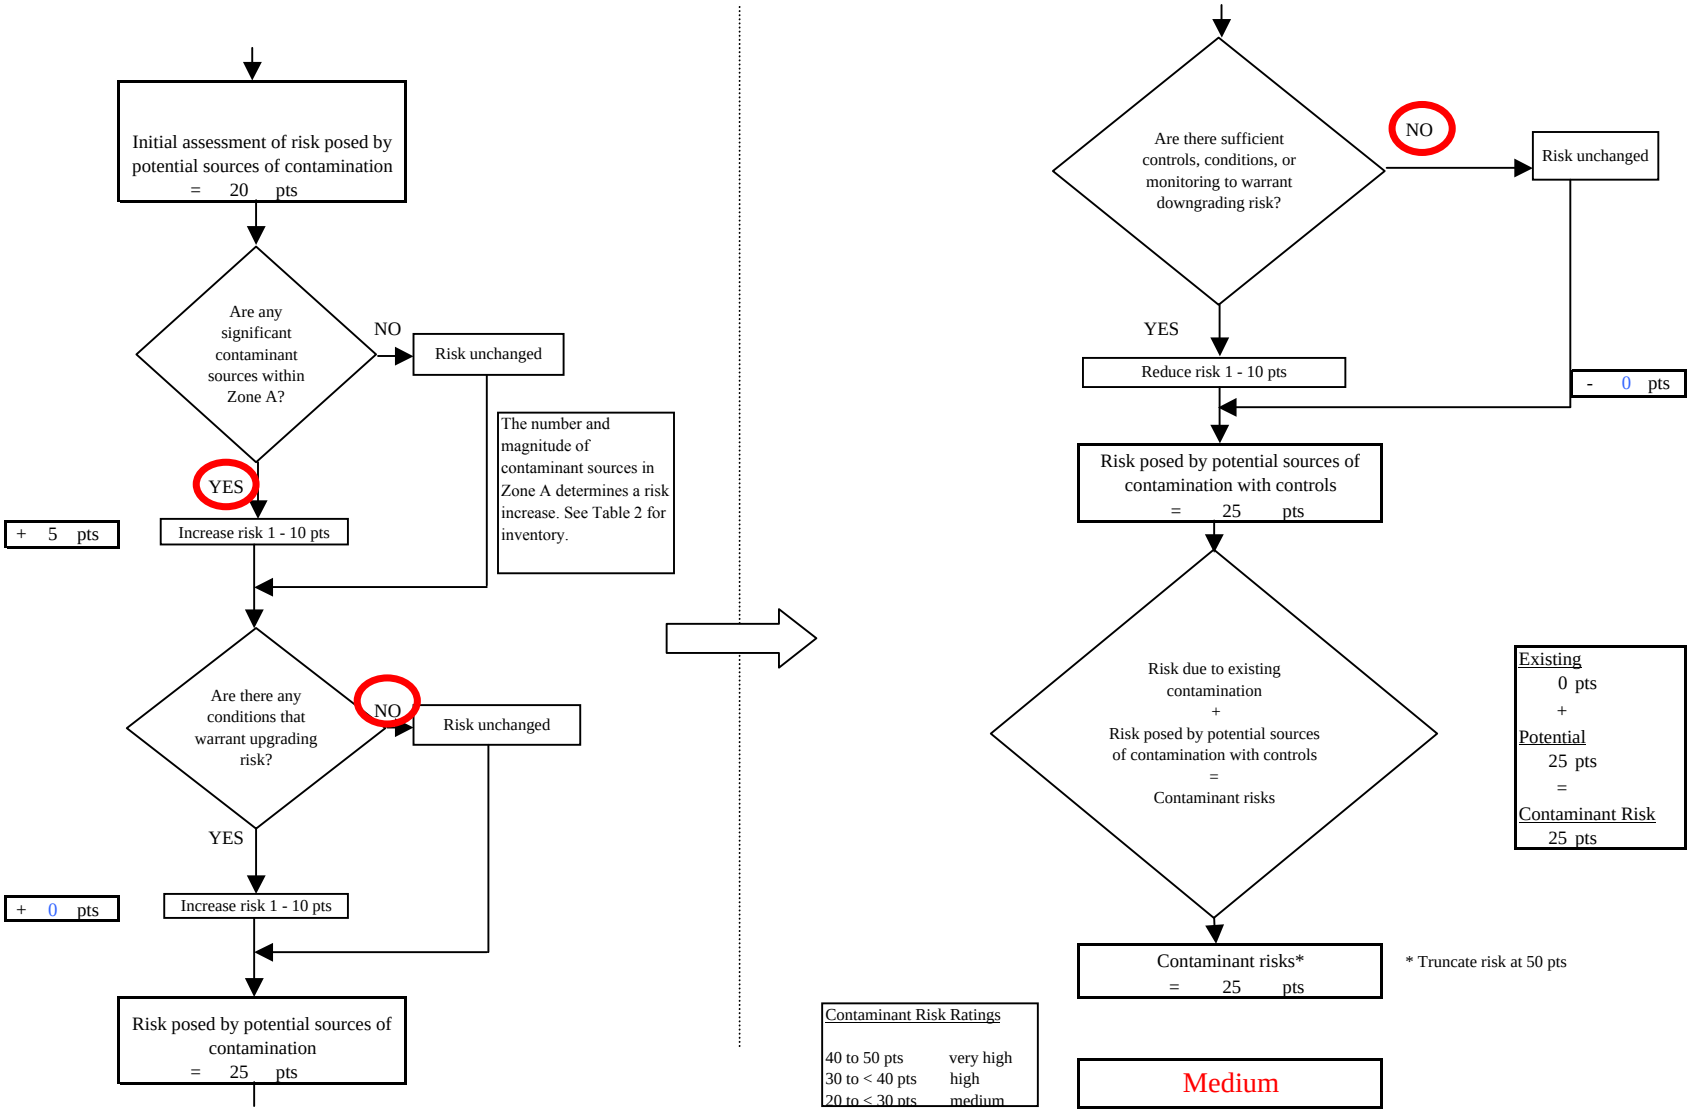
Chart 3. Contaminant risks for Tundra Womens Coalition (PWS No. 271114.001) - Bacteria & Viruses

The contaminant risk for bacteria and viruses is **Medium**. The risk is primarily attributed to the presence of a landfill and a domestic wastewater treatment plant disposal pond/lagoon in Zone D (see Table 2 – Appendix B).

A positive bacteria count has not been reported in recent (within five years) sampling events (See Chart 3 – Contaminant Risks for Bacteria and Viruses in Appendix D). Only a small amount of bacteria and viruses are required to endanger public health.

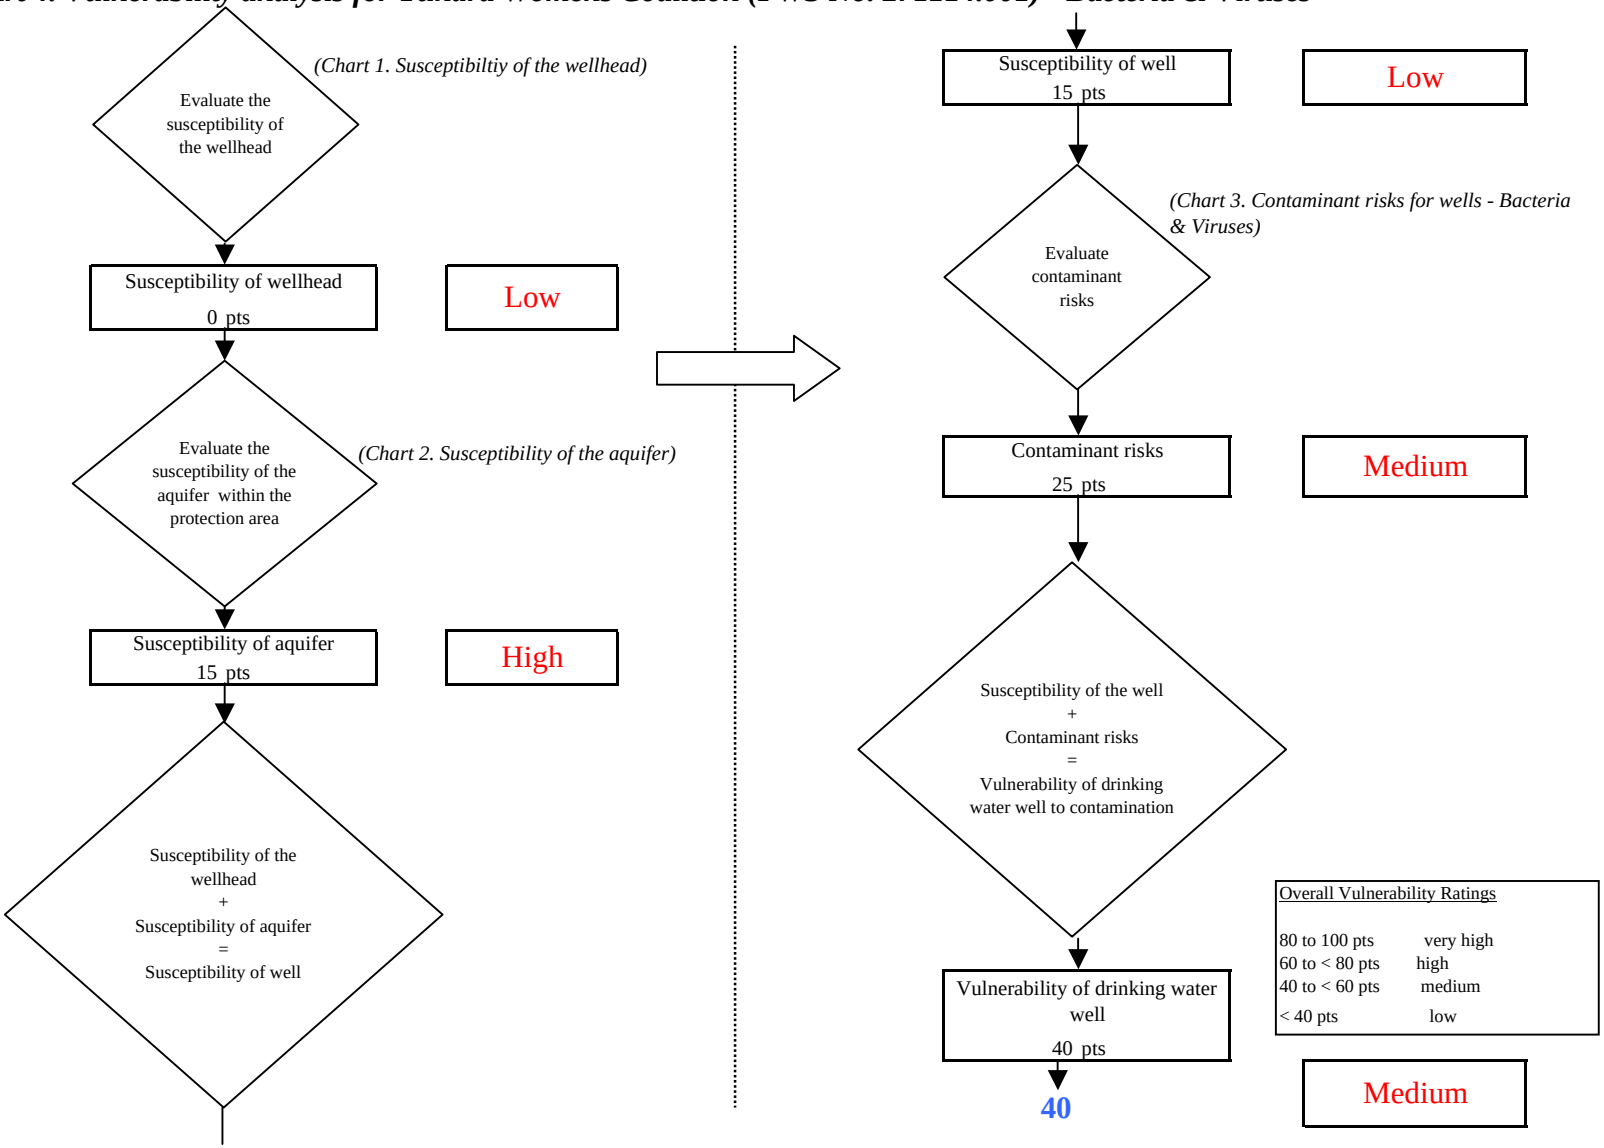
Chart 4. Vulnerability analysis for Tundra Womens Coalition (PWS No. 271114.001) - Bacteria & Viruses

After combining the contaminant risk for bacteria and viruses with the natural susceptibility of the well, the overall vulnerability of the well to contamination is **Medium**.

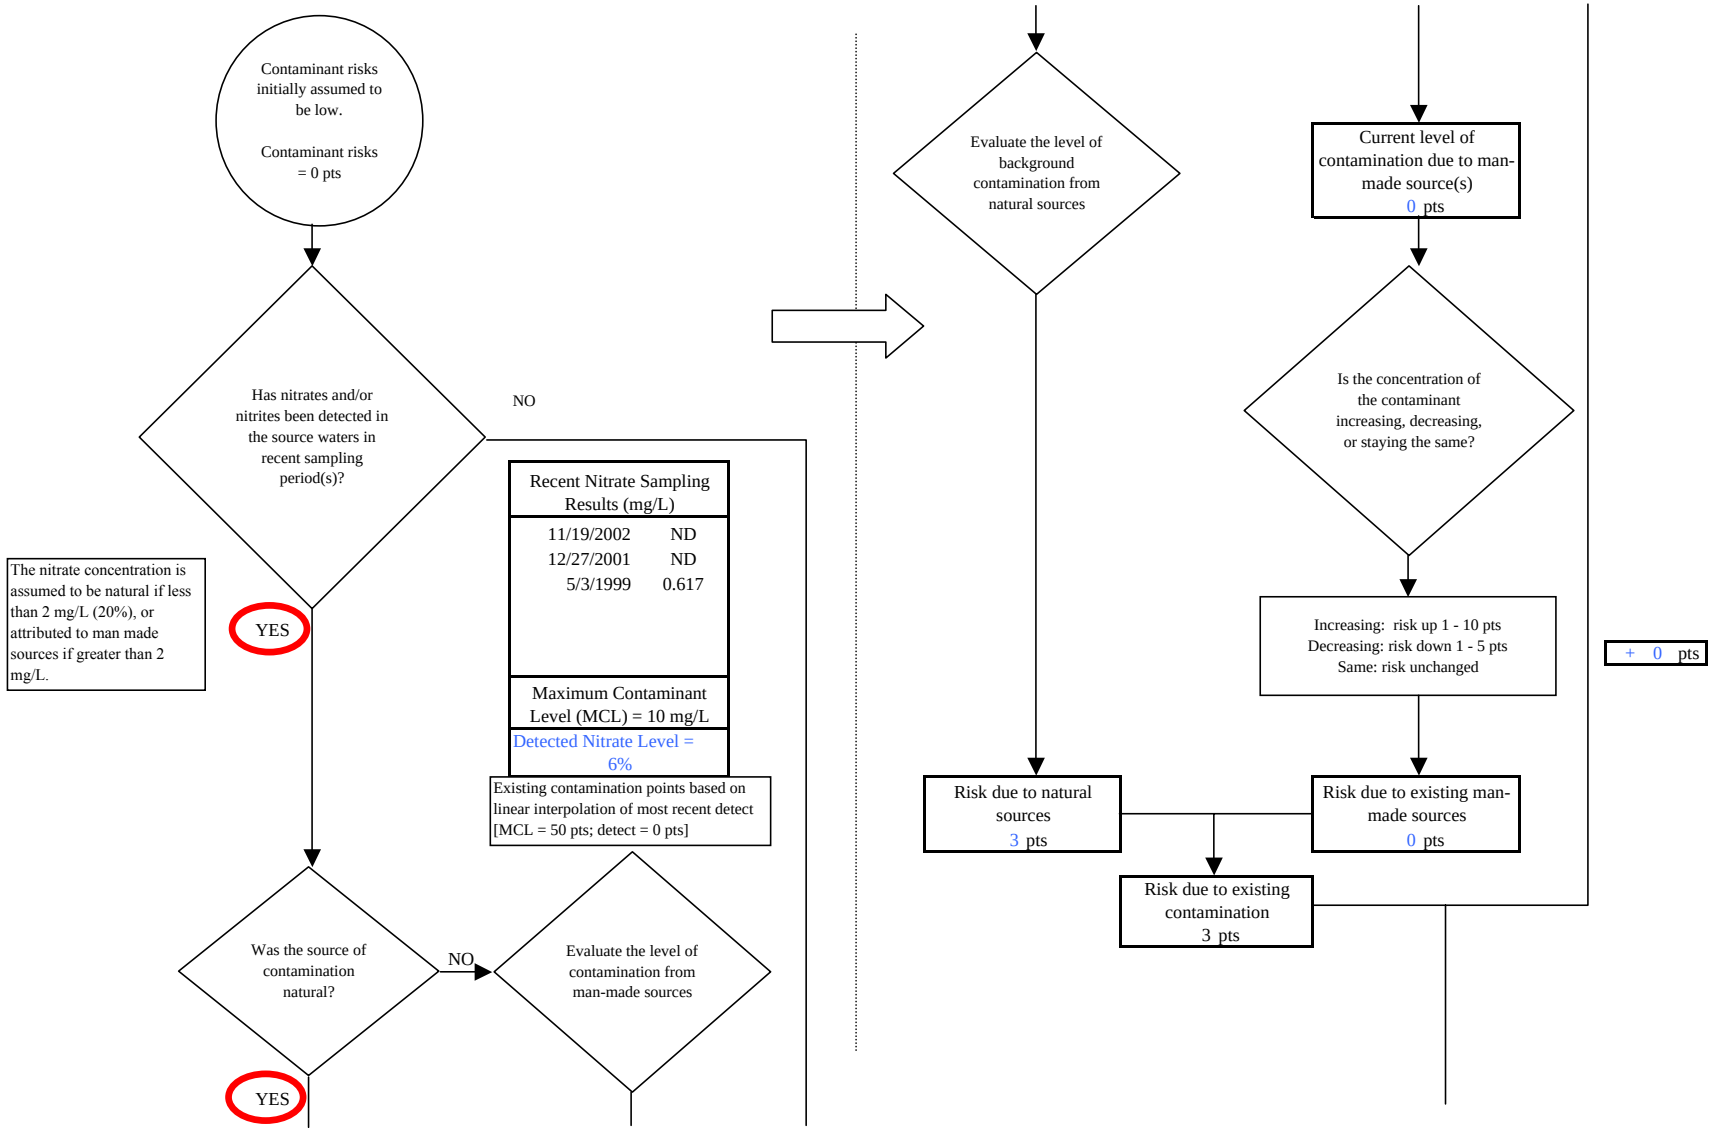
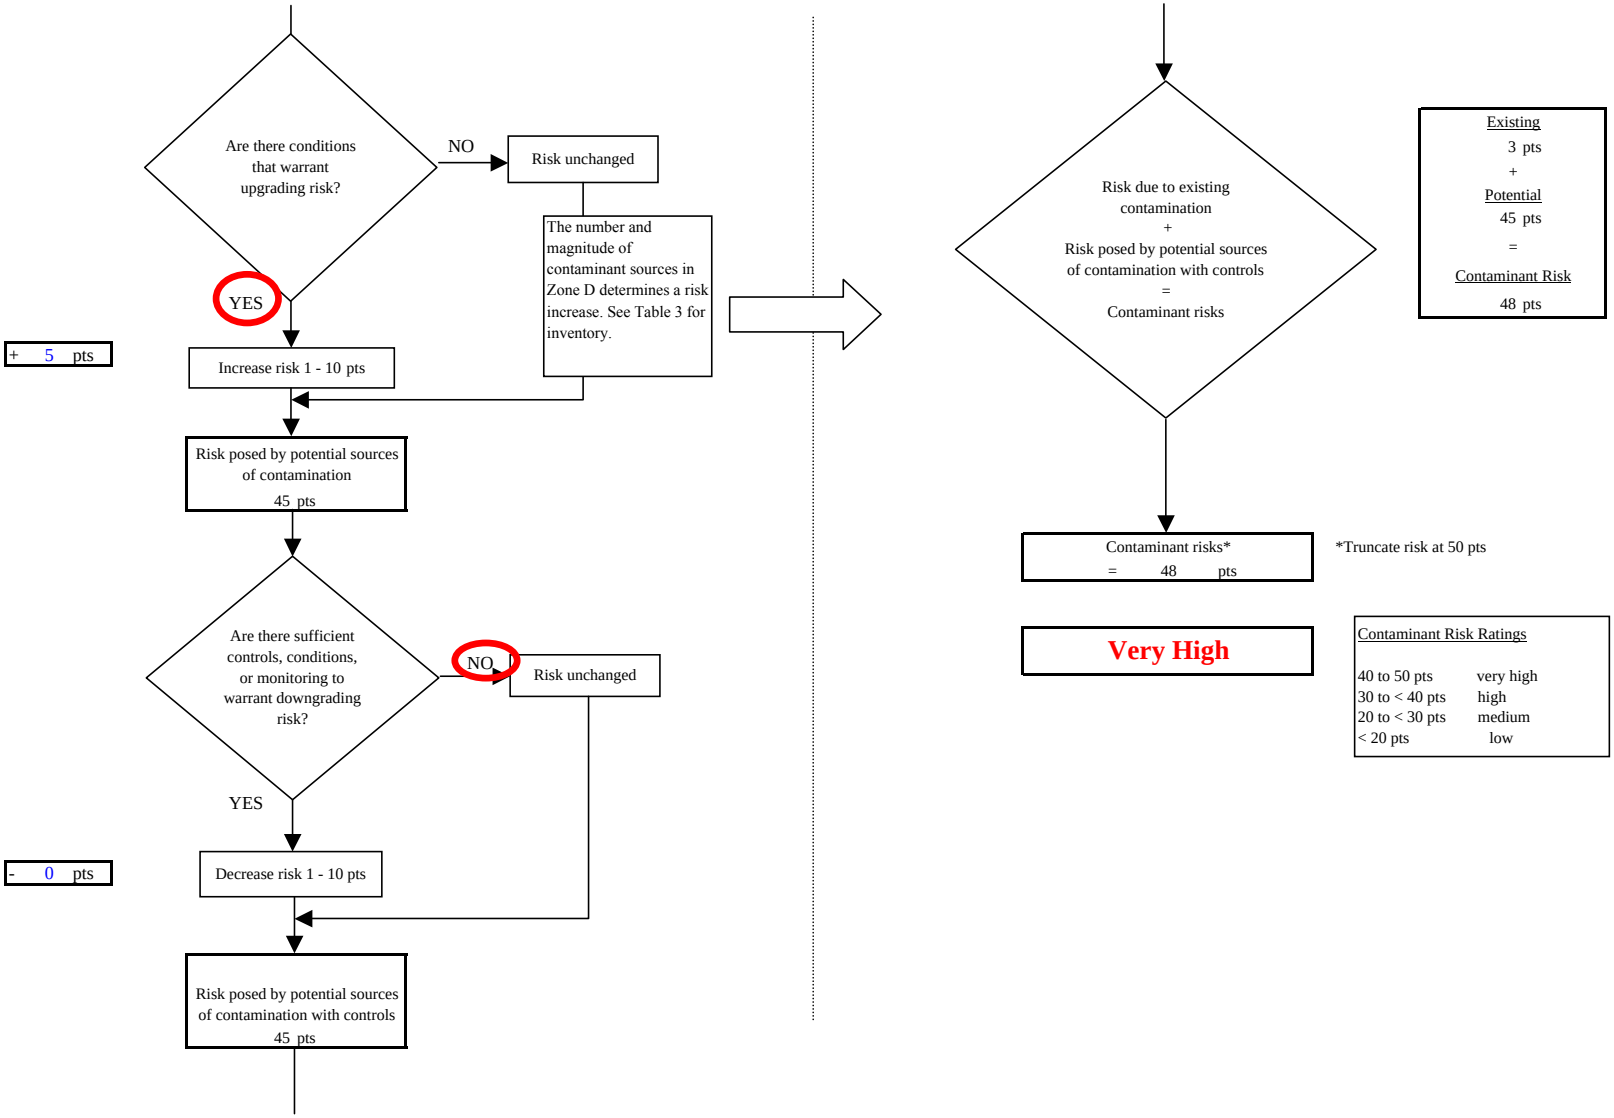
Chart 5. Contaminant risks for Tundra Womens Coalition (PWS No. 271114.001) - Nitrates and Nitrites

The contaminant risk for nitrates and nitrites is **Very High**. The risk to this source of public drinking water is primarily attributed to the presence of an abandoned well, a landfill, and a domestic wastewater treatment plant disposal pond/lagoon in Zones A and D (see Table 3 – Appendix B).

Nitrates are very mobile, moving at approximately the same rate as water. The sampling history for this well indicates that low levels of nitrates have been detected in recent sampling events. However, the reported concentrations of nitrates do not exceed the maximum contaminant level (MCL) of 10 mg/L. Nitrate concentrations in uncontaminated groundwater are typically less than 2 mg/L; therefore, nitrate concentrations above 2 mg/L may be indicative of man-made sources (See Chart 5 - Contaminant Risks for Nitrates and/or Nitrites in Appendix D).

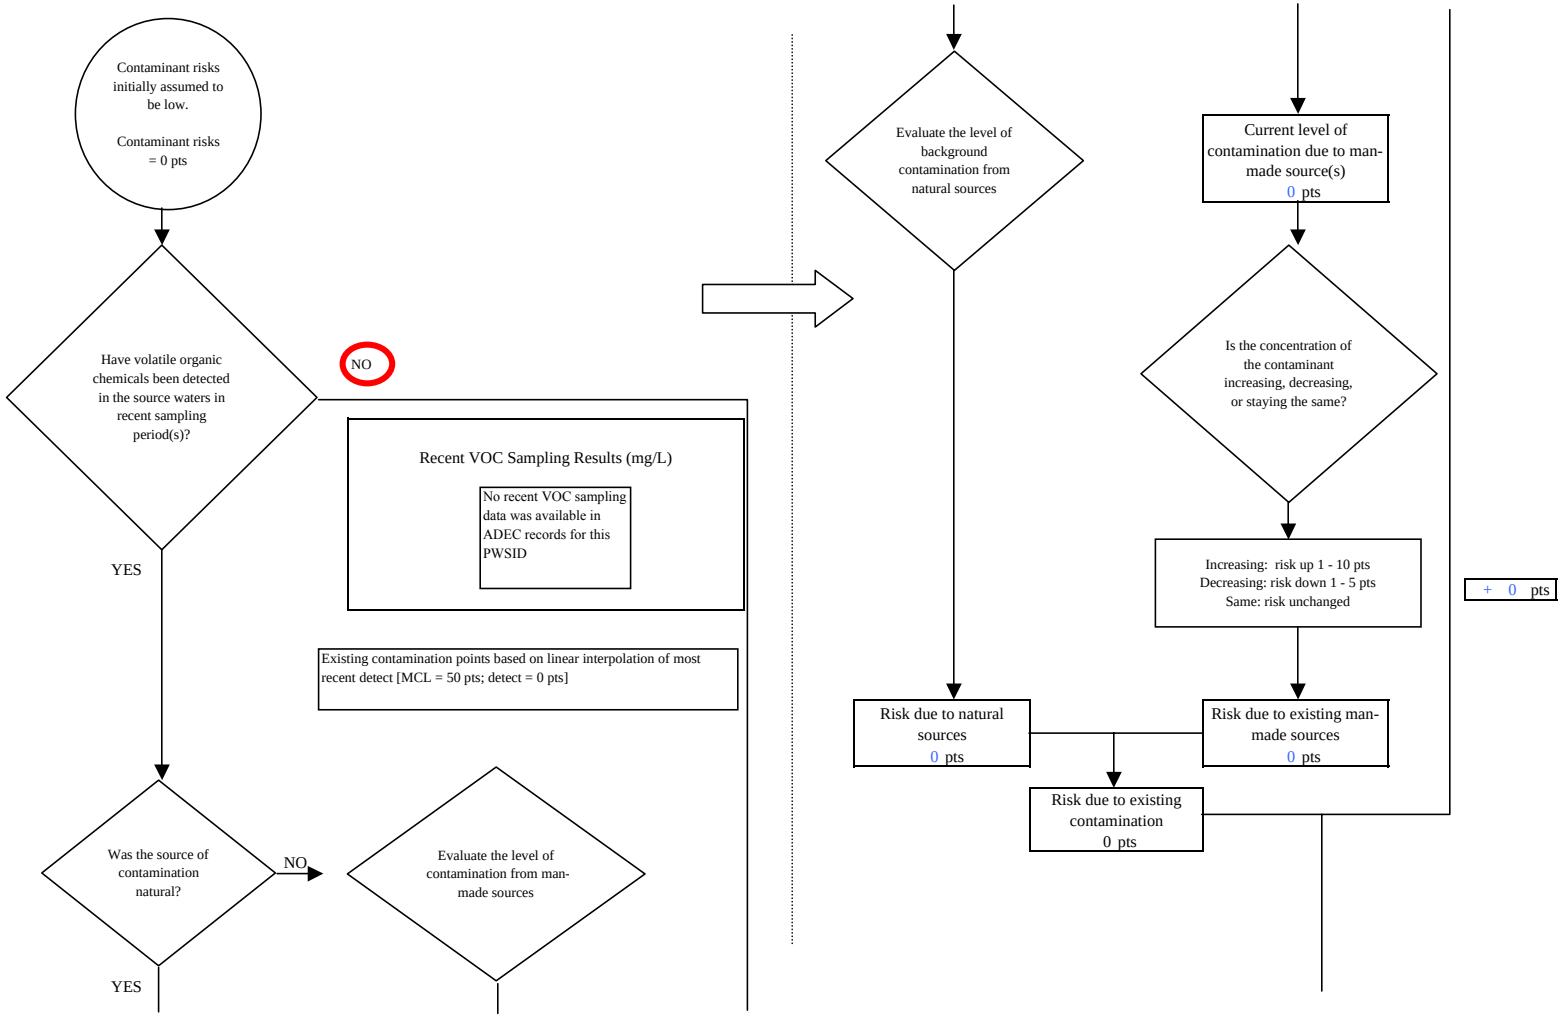
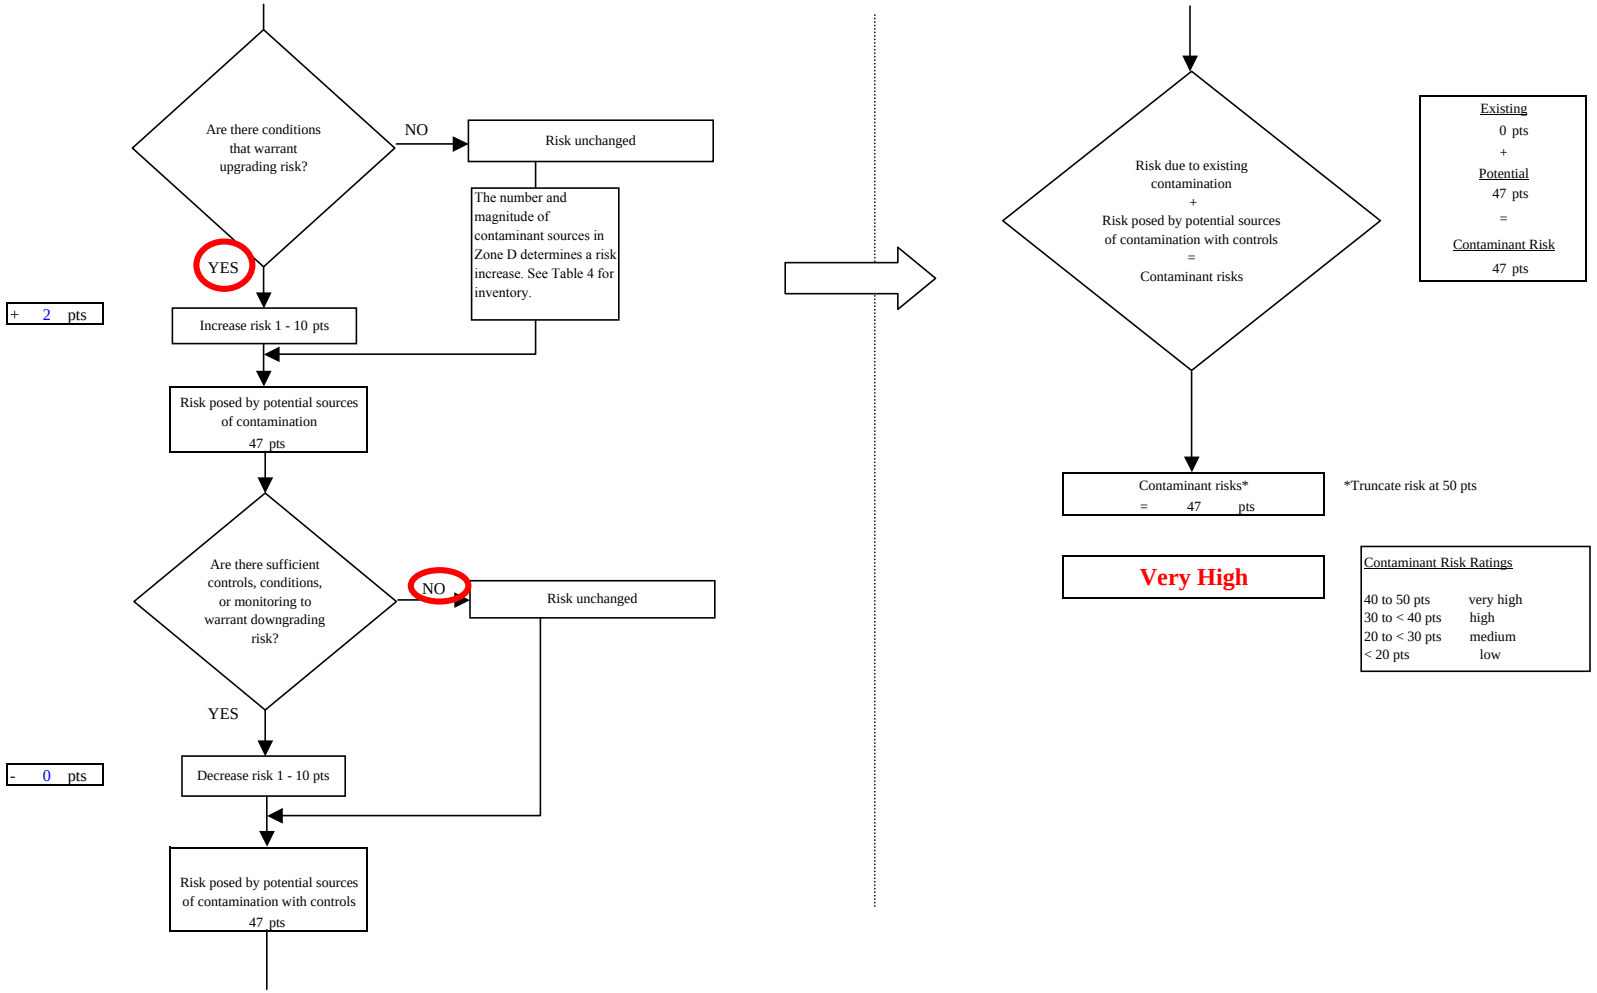
Chart 7. Contaminant risks for Tundra Womens Coalition (PWS No. 271114.001) - Volatile Organic Chemicals

The contaminant risk for volatile organic chemicals is **Very High**. The risk is primarily attributed to the presence of an abandoned well, a landfill, and an ADEC LUST site in Zones A and D. Numerous other potential contaminant sources are also found within the protection area (see Table 4 – Appendix B).

No recent sampling data was available in ADEC records for the Tundra Women's Coalition (See Chart 7 – Contaminant Risks for Volatile Organic Chemicals in Appendix D).

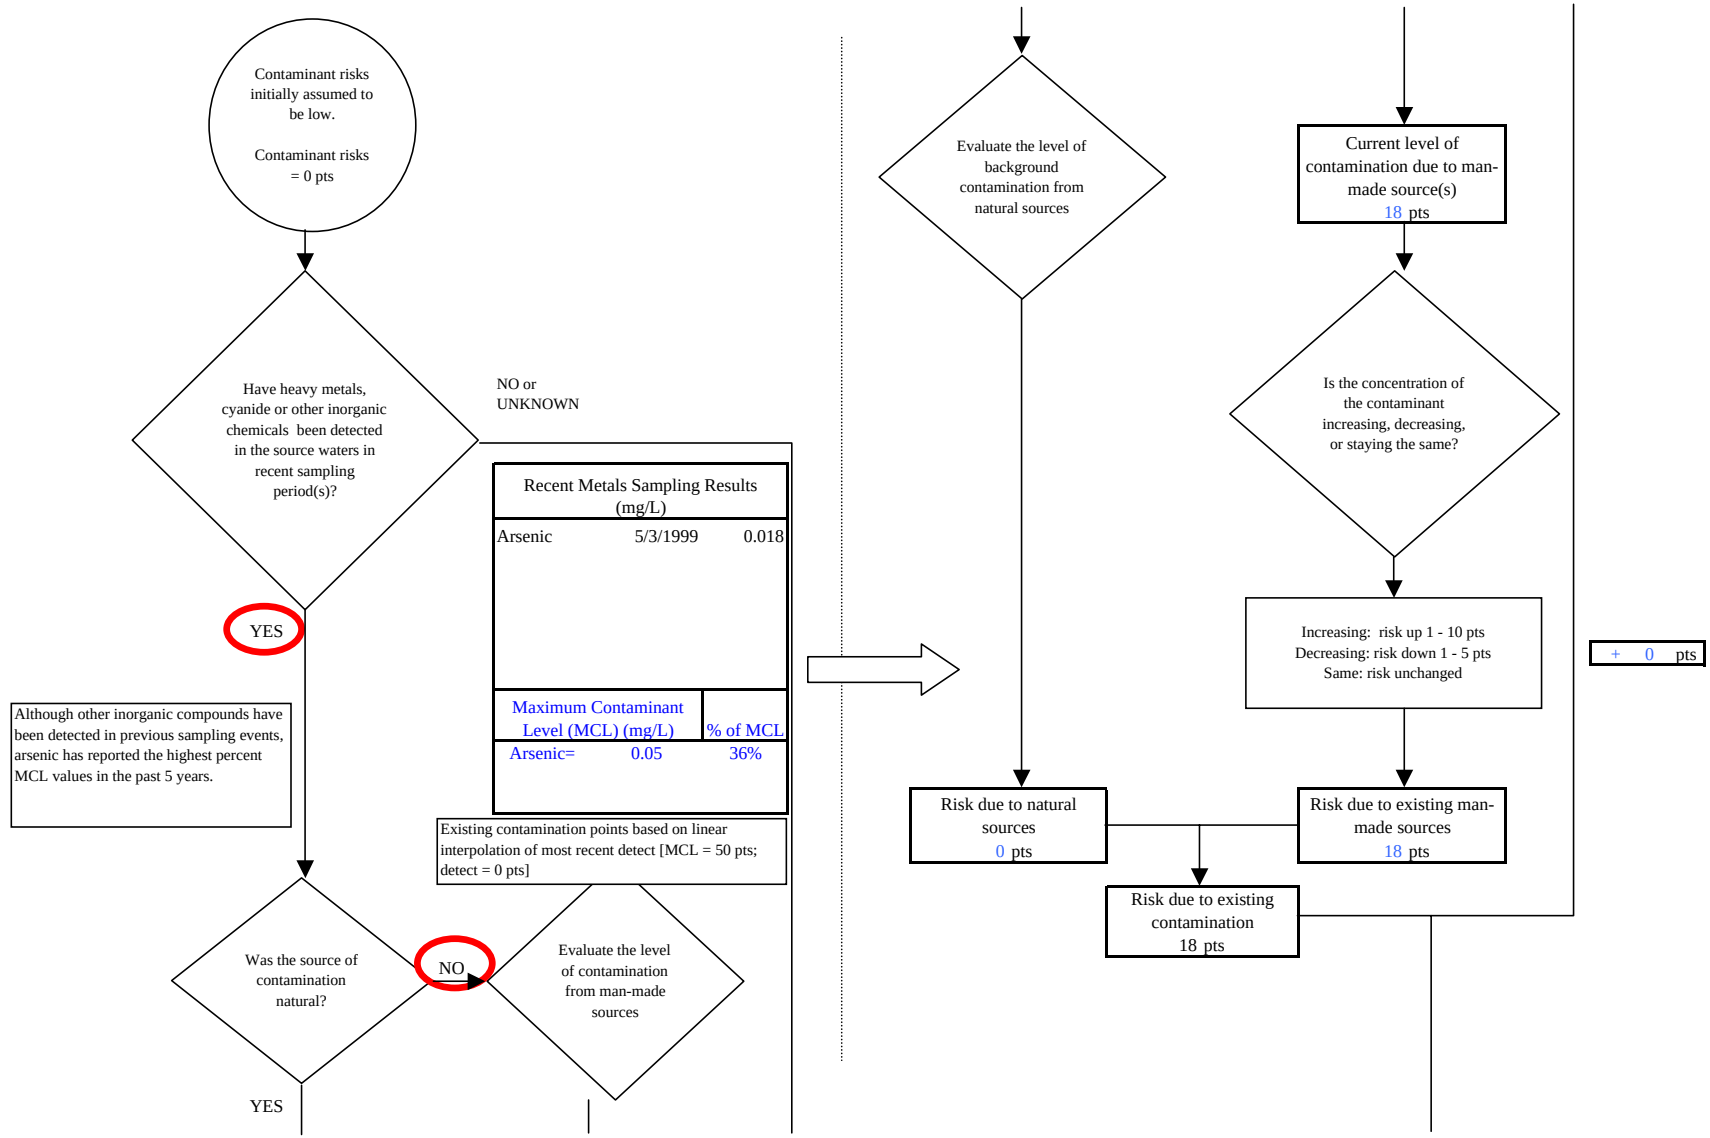
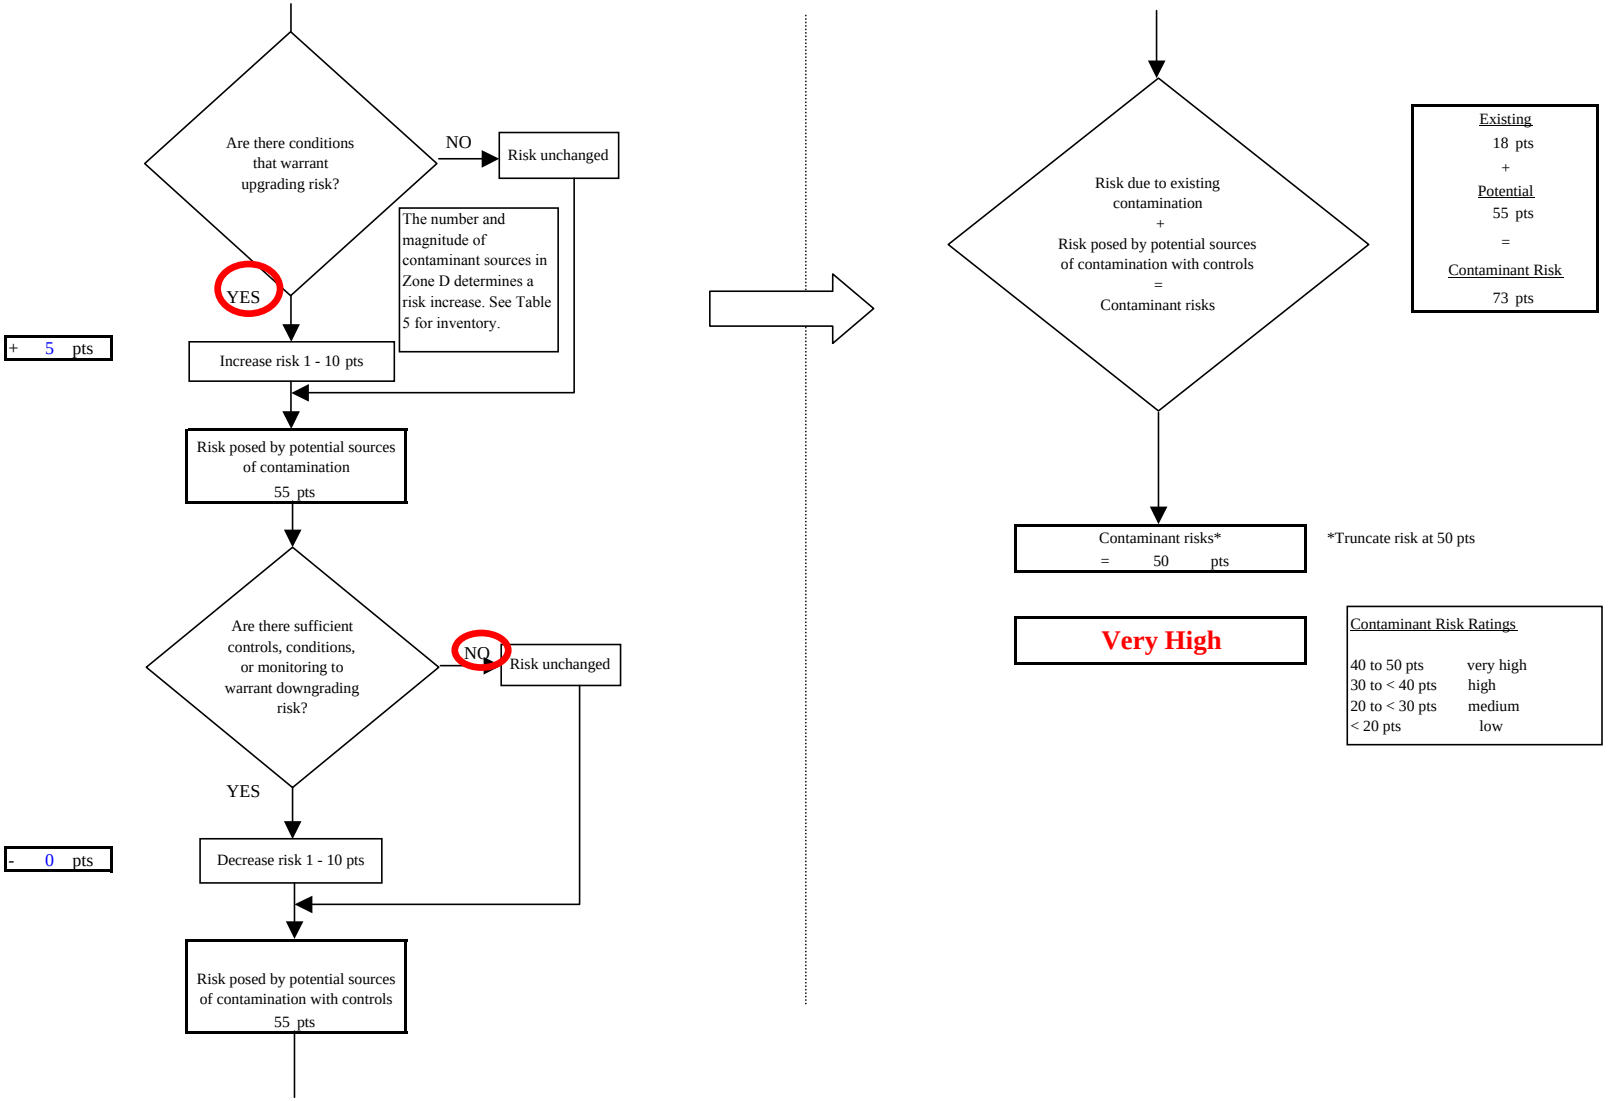
Chart 9. Contaminant risks for Tundra Womens Coalition (PWS No. 271114.001) - Heavy Metals, Cyanide and Other Inorganic Chemicals

The contaminant risk for heavy metals, cyanide and other inorganic chemicals is **Very High**. The risk is primarily attributed to the presence of an abandoned well, a landfill, and an ADEC LUST site in Zones A and D. Numerous other potential contaminant sources are also found within the protection area (see Table 5 – Appendix B).

Based on review of recent sampling records for this public water system, arsenic has been detected in recent sampling history. However, the analyte did not exceed the MCL of 0.05 mg/L (see Chart 9 – Contaminant Risks for Heavy Metals, Cyanide, and Other Inorganic Chemicals in Appendix D).
