Source Water Assessment

A Hydrogeologic Susceptibility and Vulnerability Assessment for Tundra Women's Coalition Drinking Water System, Bethel, Alaska

PWSID # 271114.001

DRINKING WATER PROTECTION PROGRAM REPORT 1123
Alaska Department of Environmental Conservation

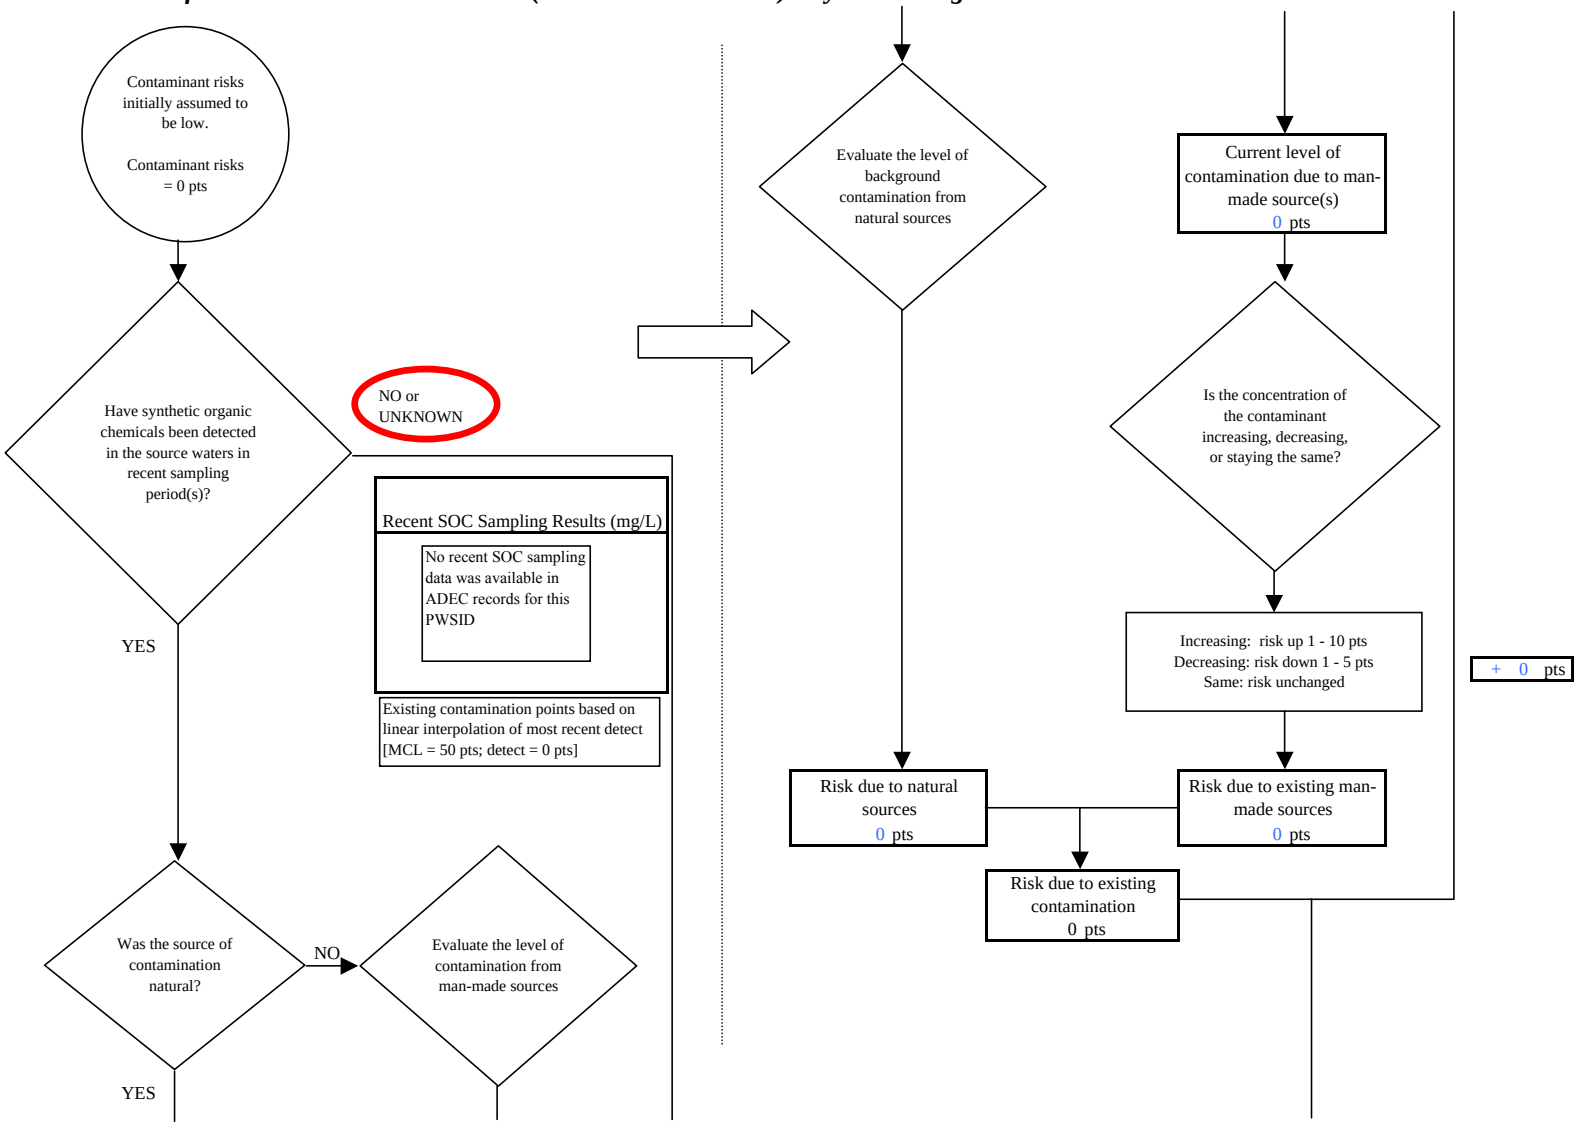
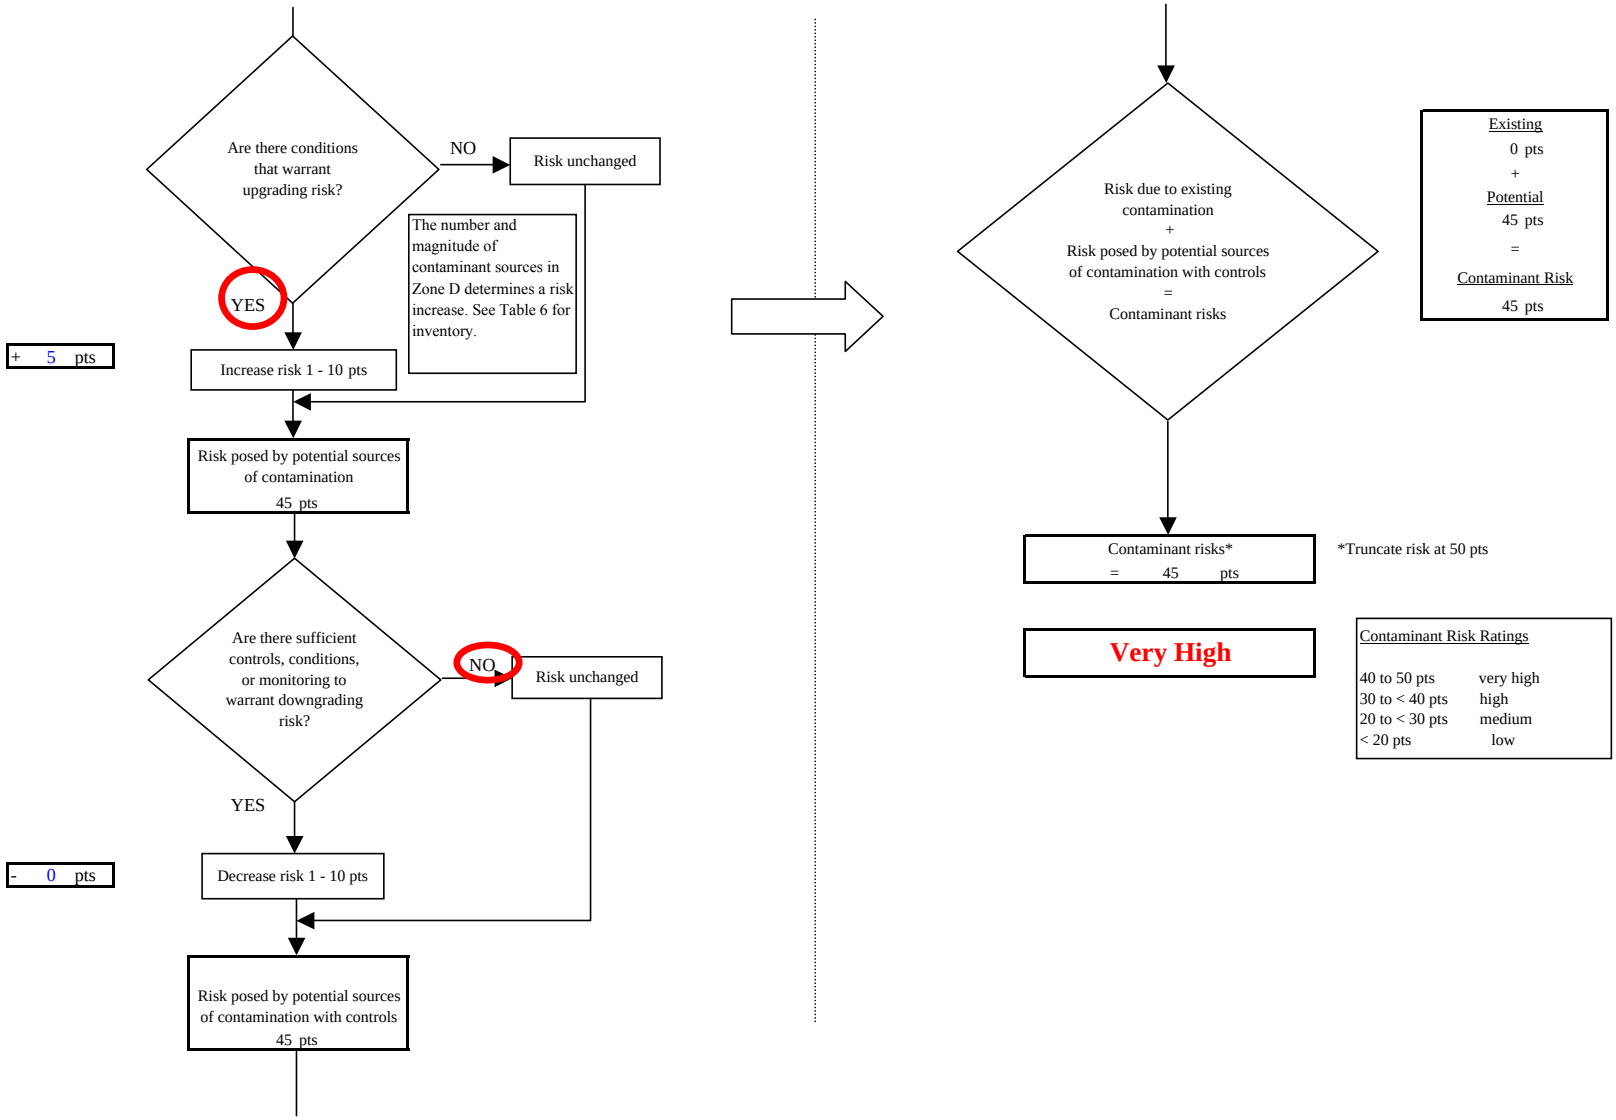
Chart 11. Contaminant risks for Tundra Womens Coalition (PWS No. 271114.001) - Synthetic Organic Chemicals

The contaminant risk for synthetic organic chemicals is **Very High**. The risk is primarily attributed to the presence of an abandoned well and a landfill in Zones A and D (see Table 6 – Appendix B).

No recent sampling data was available in ADEC records for the Tundra Women's Coalition (See Chart 11 – Contaminant Risks for Synthetic Organic Chemicals in Appendix D).

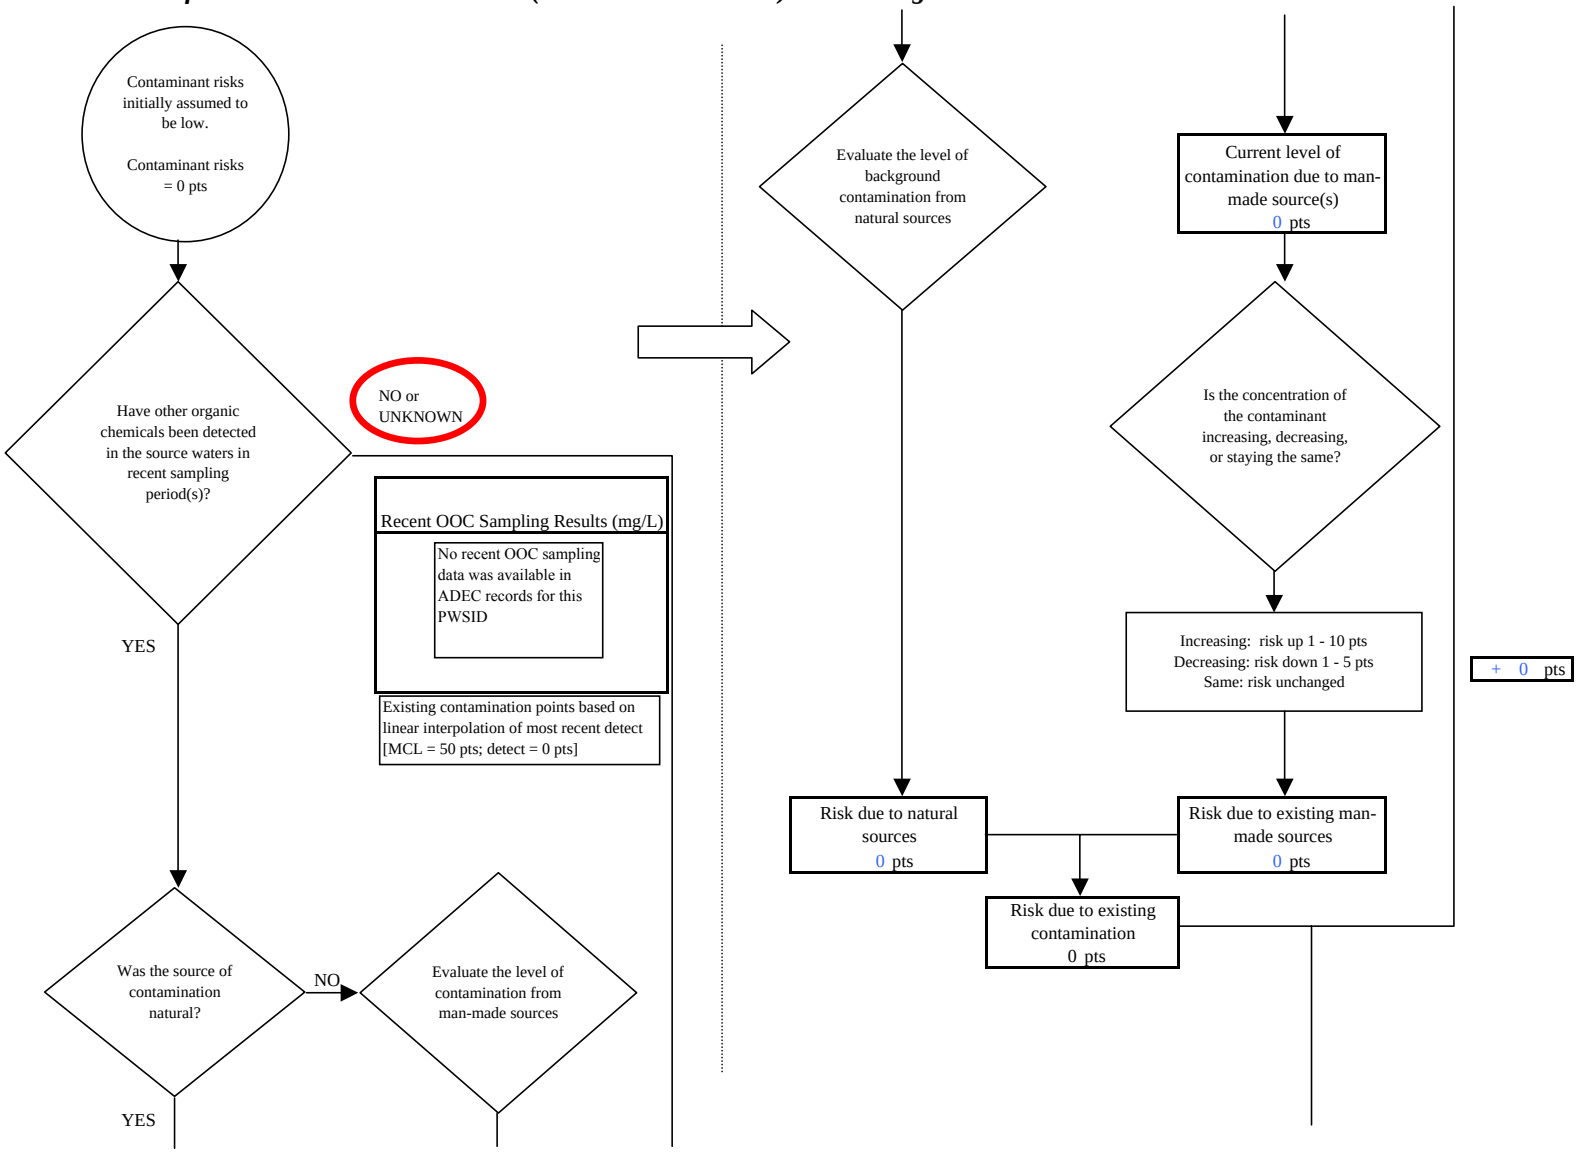
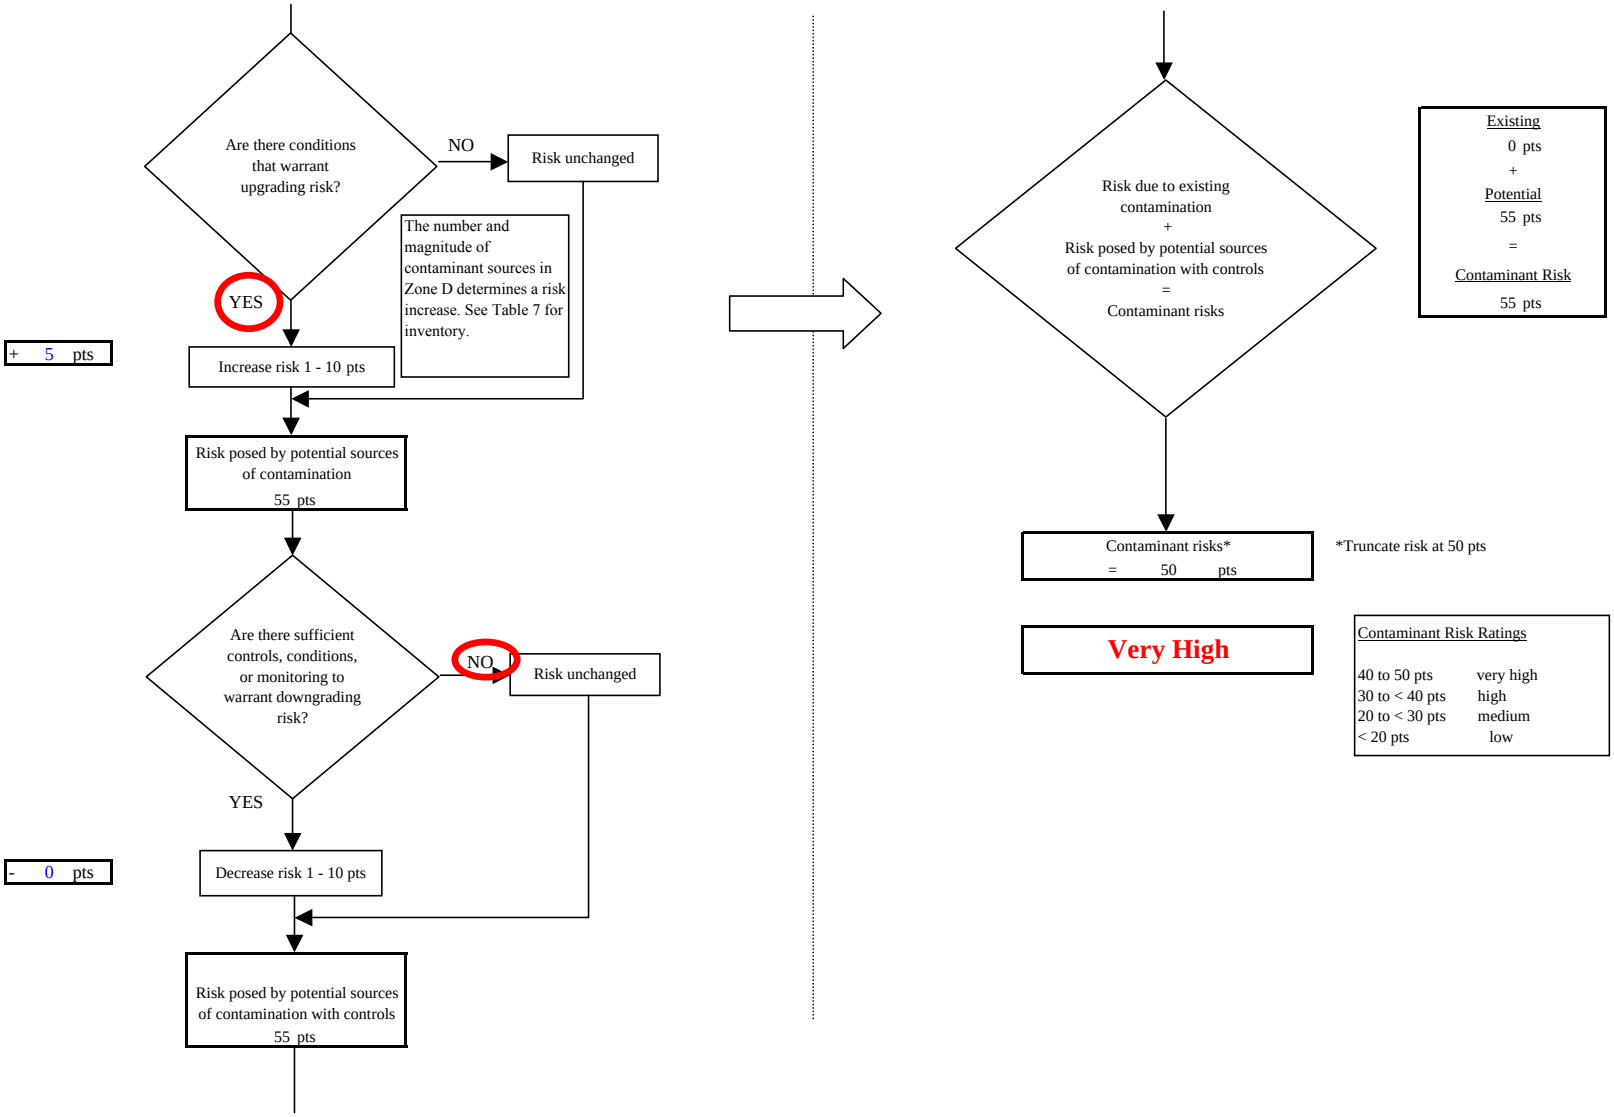
Chart 13. Contaminant risks for Tundra Womens Coalition (PWS No. 271114.001) - Other Organic Chemicals

The contaminant risk for other organic chemicals is **Very High**. The risk is primarily attributed to the presence of an abandoned well, a pipeline, and a landfill in Zones A and D. Numerous other potential contaminant sources are also found within the protection area (see Table 7 – Appendix B).

No recent sampling data was available in ADEC records for the Tundra Women's Coalition (See Chart 13 – Contaminant Risks for Other Organic Chemicals in Appendix D).
