Source Water Assessment

A Hydrogeologic Susceptibility and Vulnerability Assessment for United Pentacostal Church Drinking Water System, Bethel, Alaska

PWSID # 271790.001

February 2004

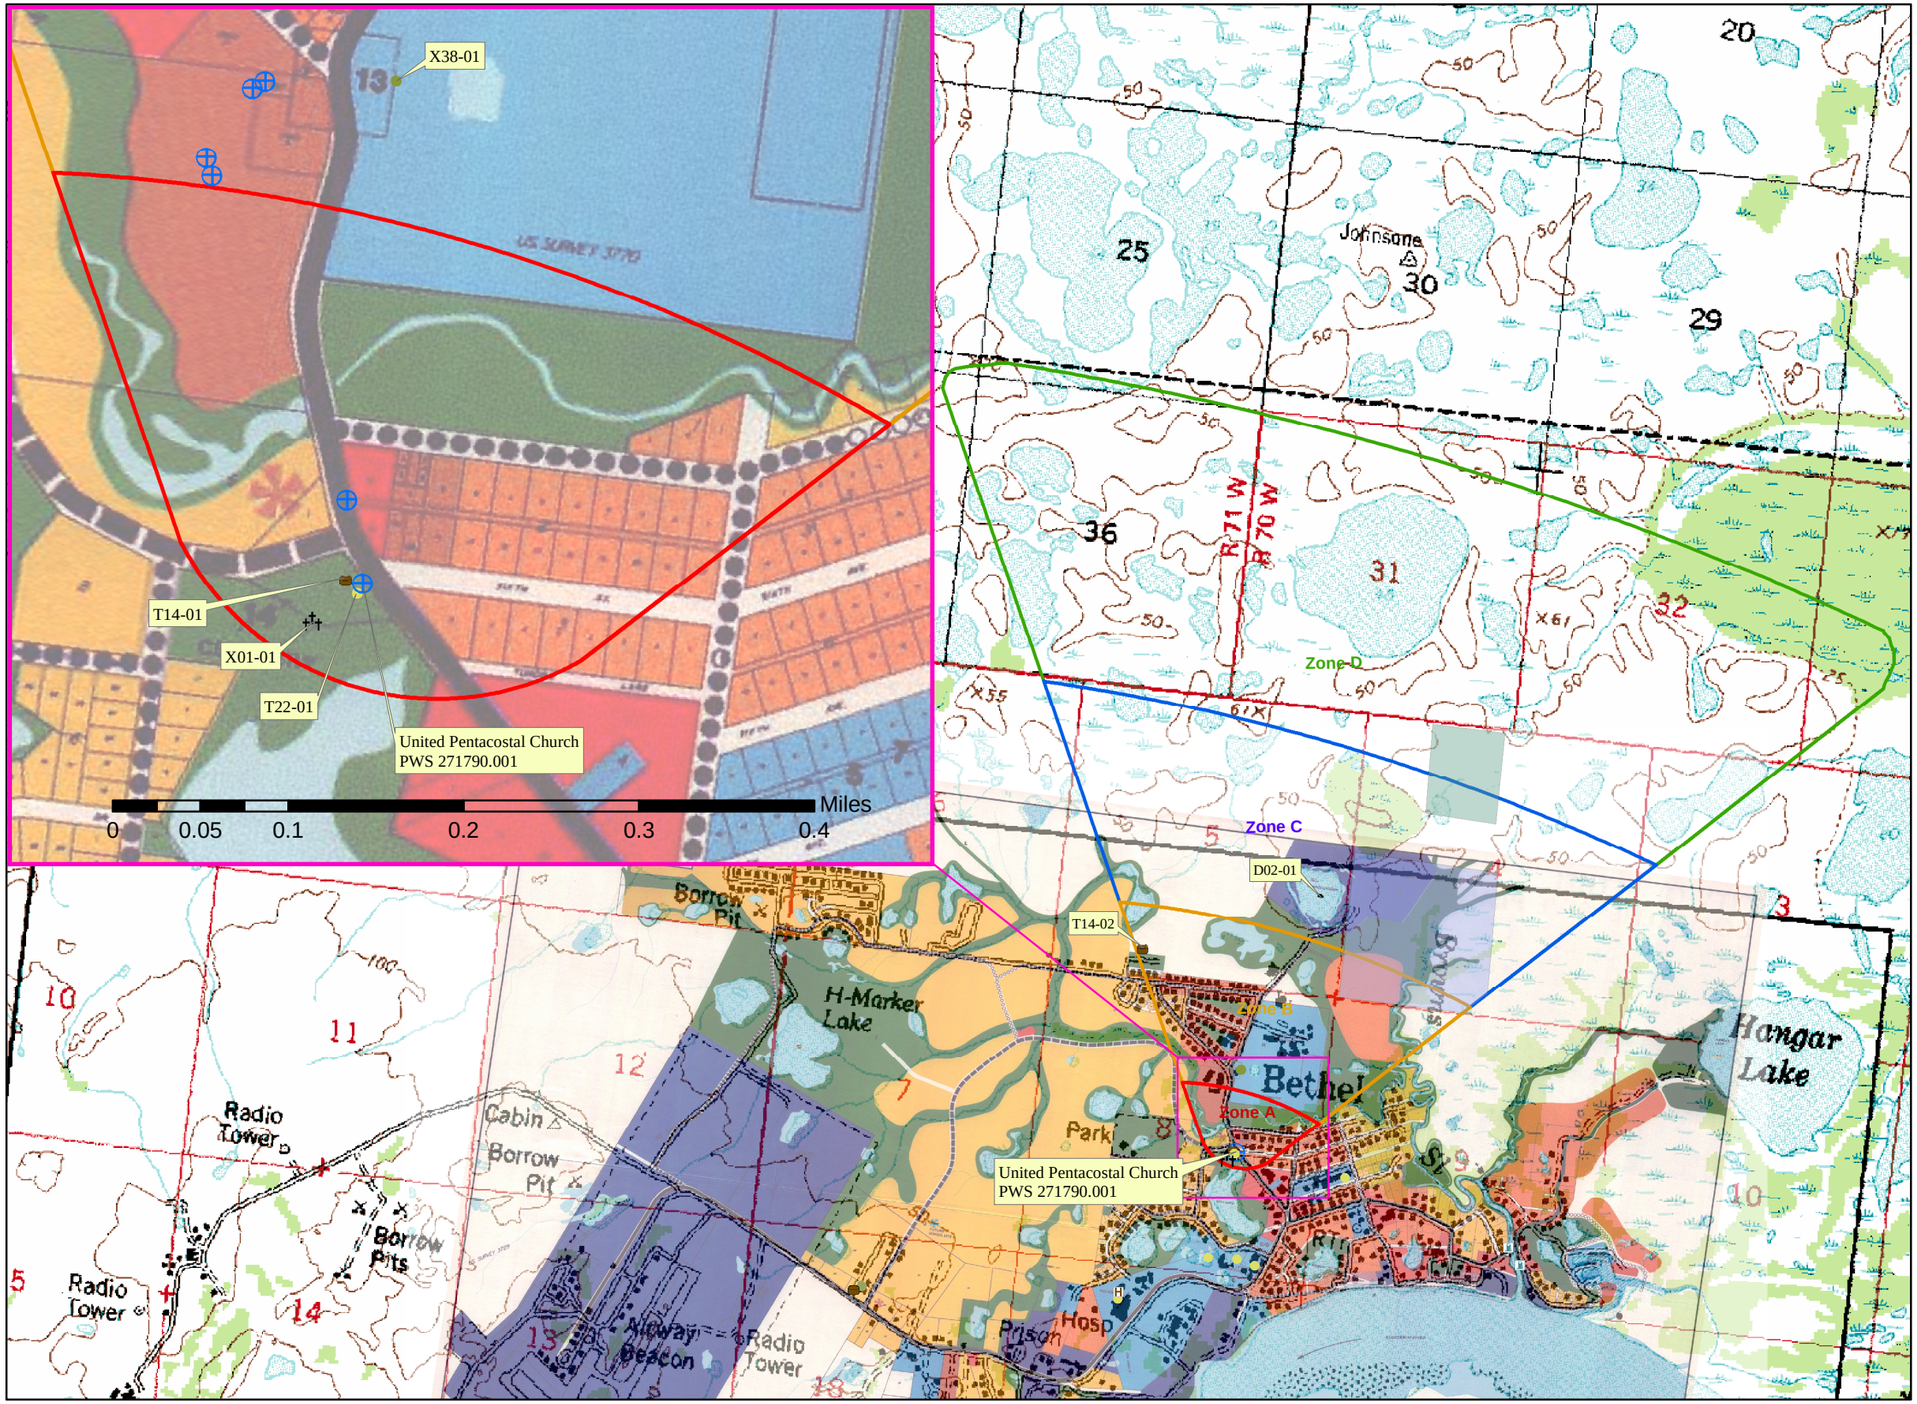
Appendix C Map C

Identified potential and current sources of contaminants for the primary public drinking water source include: aboveground fuel tanks, wastewater holding tanks, water supply wells, a cemetery, landfills, a firehouse, an Alaska Department of Environmental Conservation (ADEC) recognized contaminated site, and a domestic wastewater treatment plant disposal pond/lagoon. These identified potential and existing sources of contamination are considered as sources of bacteria and viruses, nitrates and/or nitrites, and volatile organic chemicals. Overall, the water well received a vulnerability rating of **Very High** for the bacteria and viruses, nitrates and nitrites, and volatile organic chemicals contaminant categories.

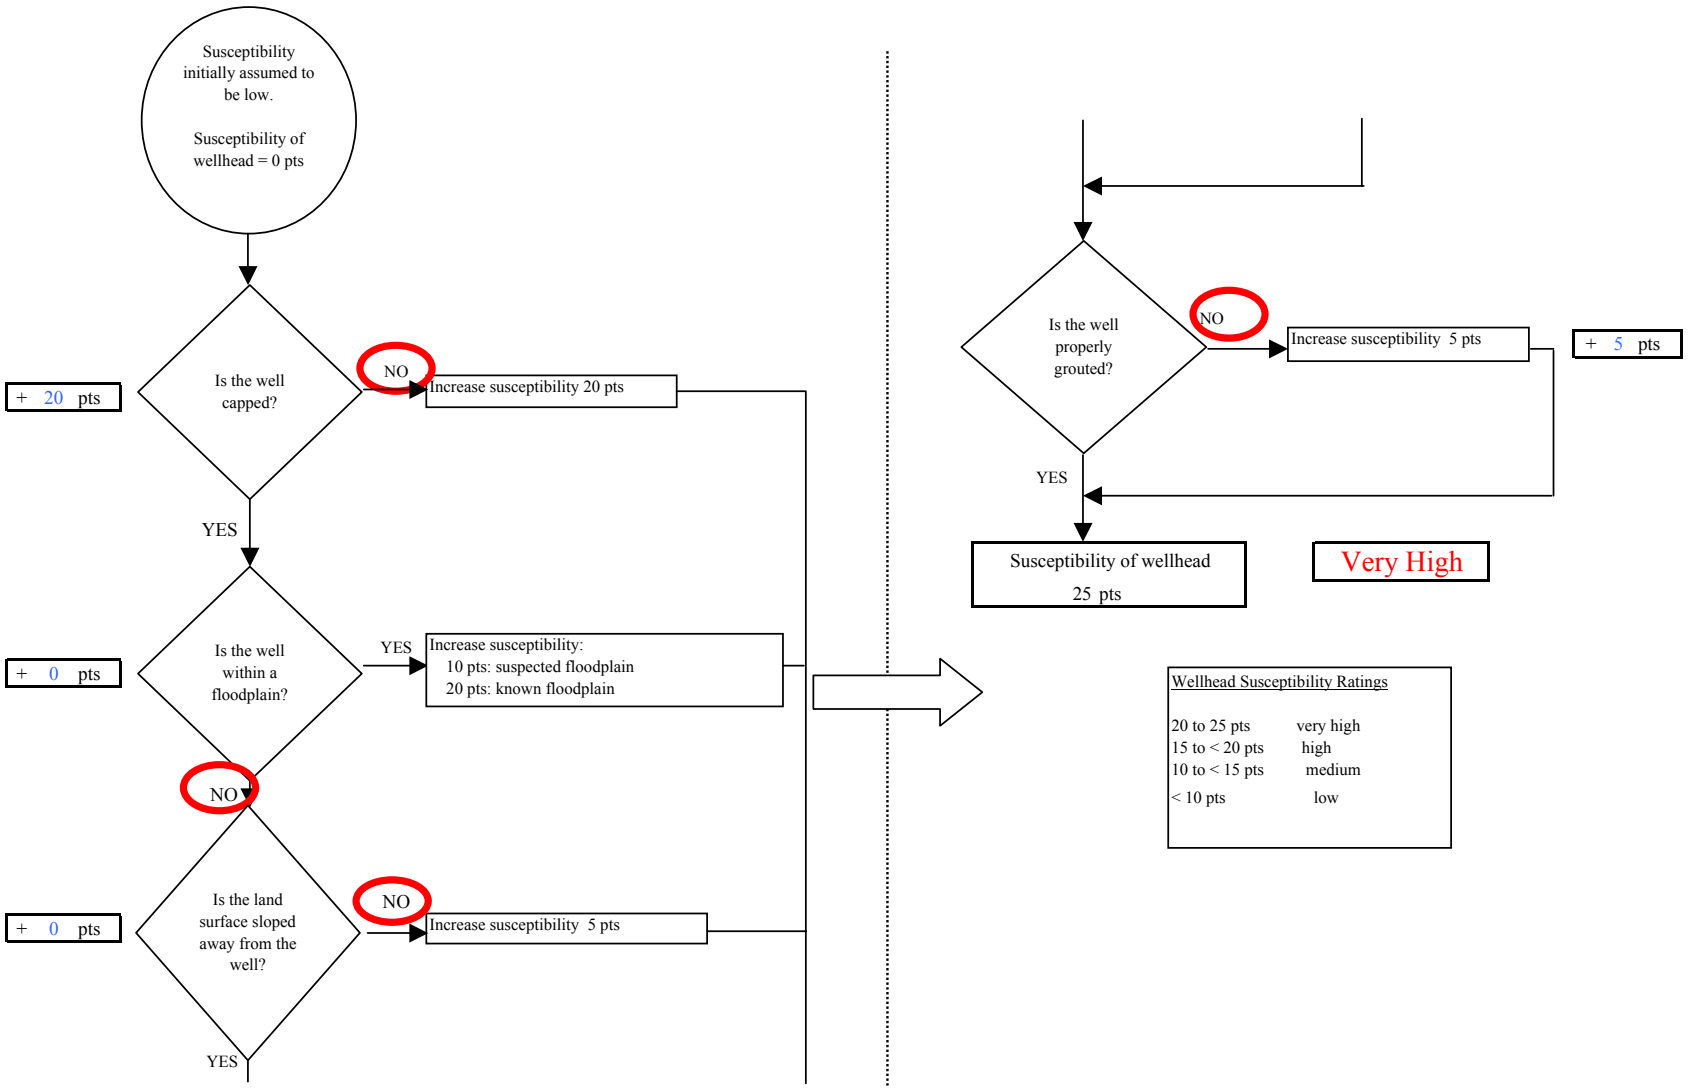
Chart 1. Susceptibility of the wellhead - United Pentacostal Church aka: Brass Buckle (PWS No. 271790.001)

Score	Rating
Susceptibility of the Wellhead	25	Very High
Susceptibility of the Aquifer	15	High
Natural Susceptibility	40	Very High

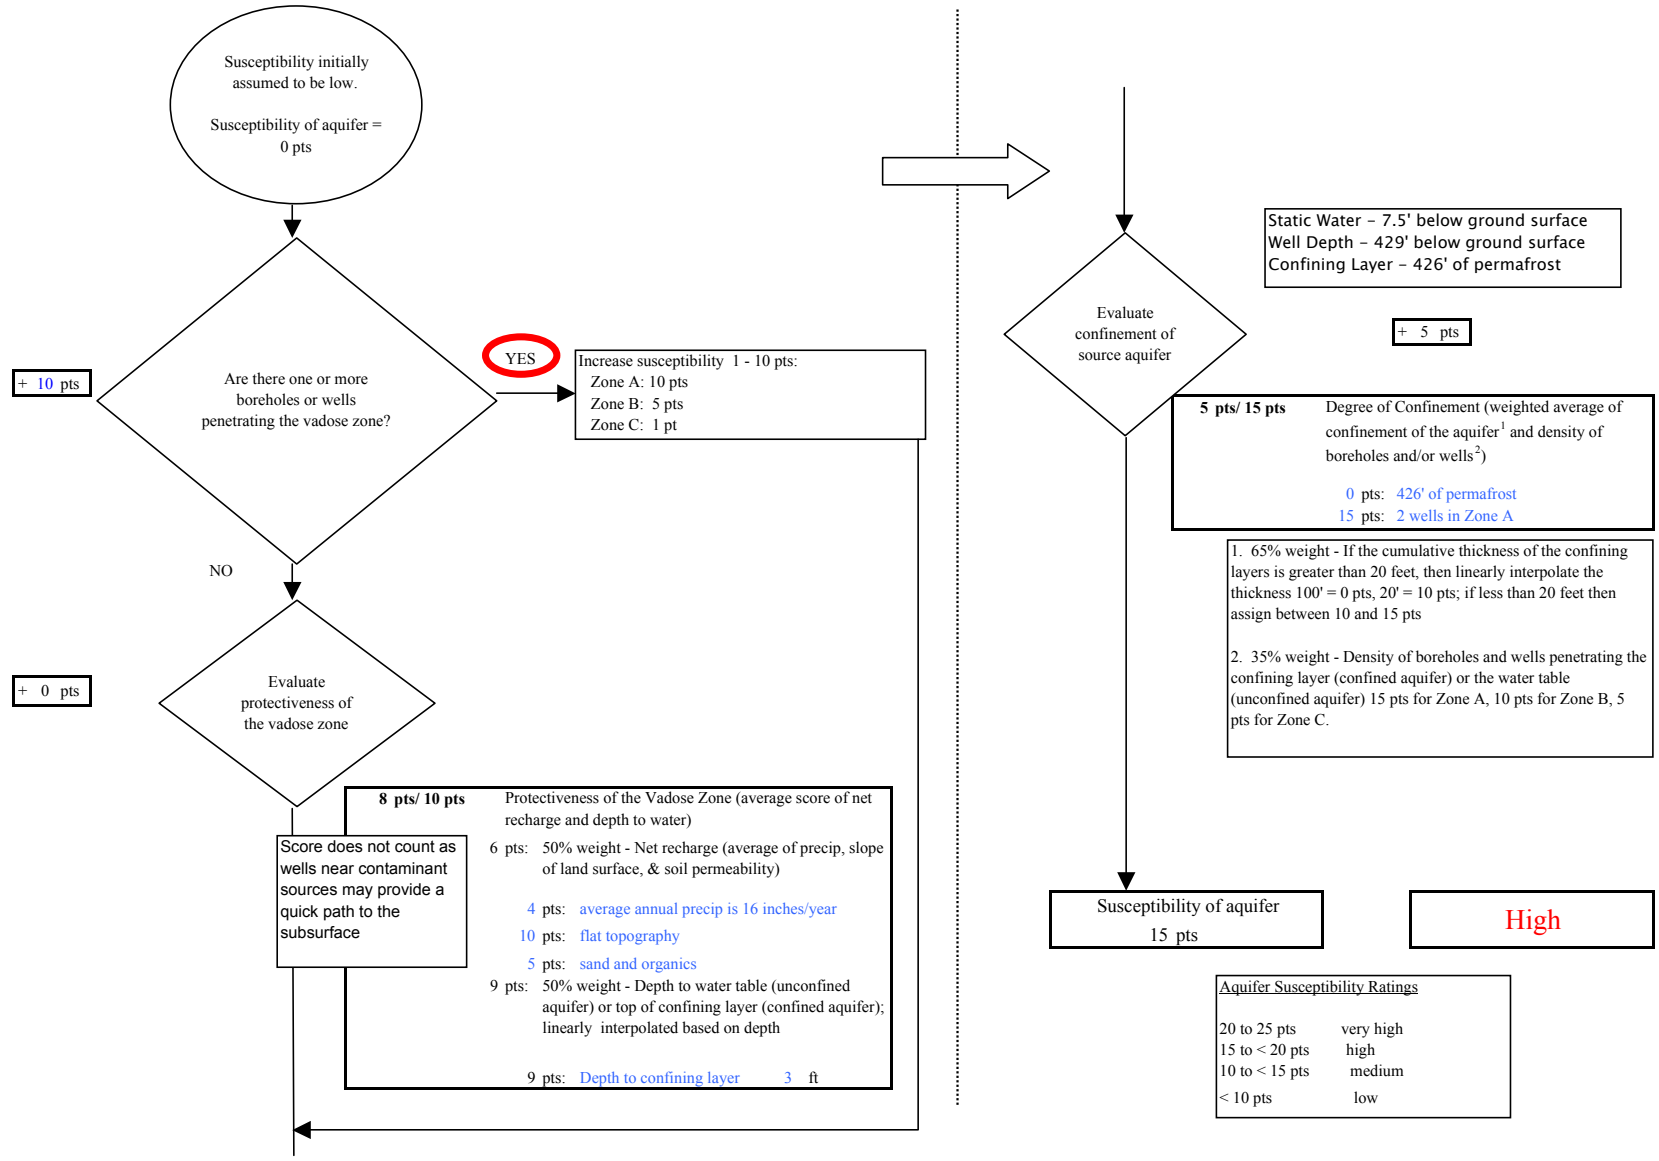
Chart 2. Susceptibility of the aquifer United Pentacostal Church aka: Brass Buckle (PWS No. 271790.001)

The United Pentacostal Church water well is in a confined aquifer. Confined aquifers are less susceptible to potential groundwater quality impacts posed by the migration of surface water contaminants downward from the surface. Table 2 shows the Susceptibility scores and ratings for both wells in this PWS.

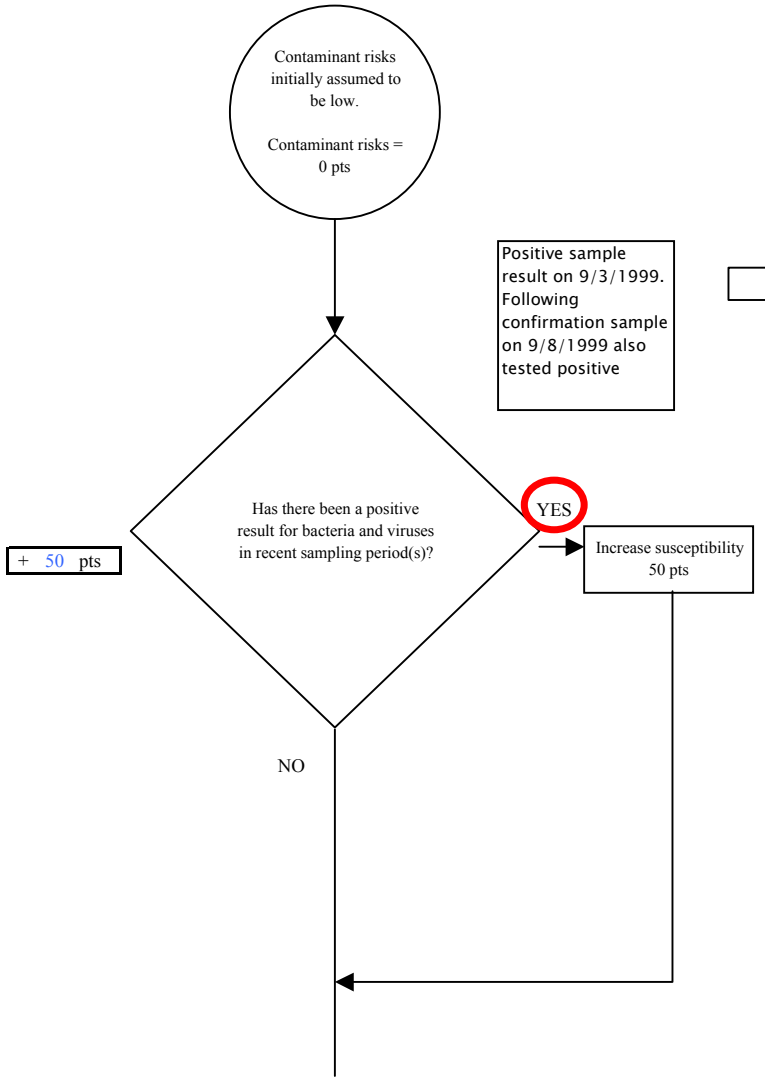
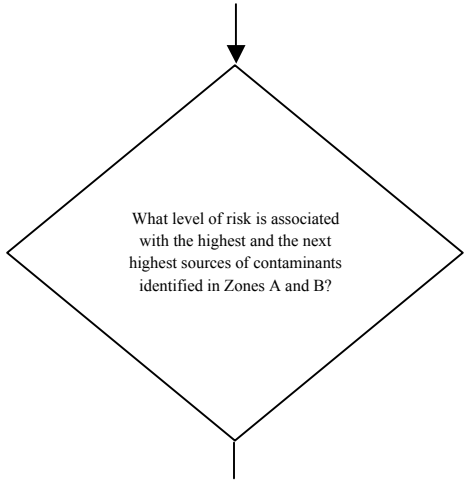
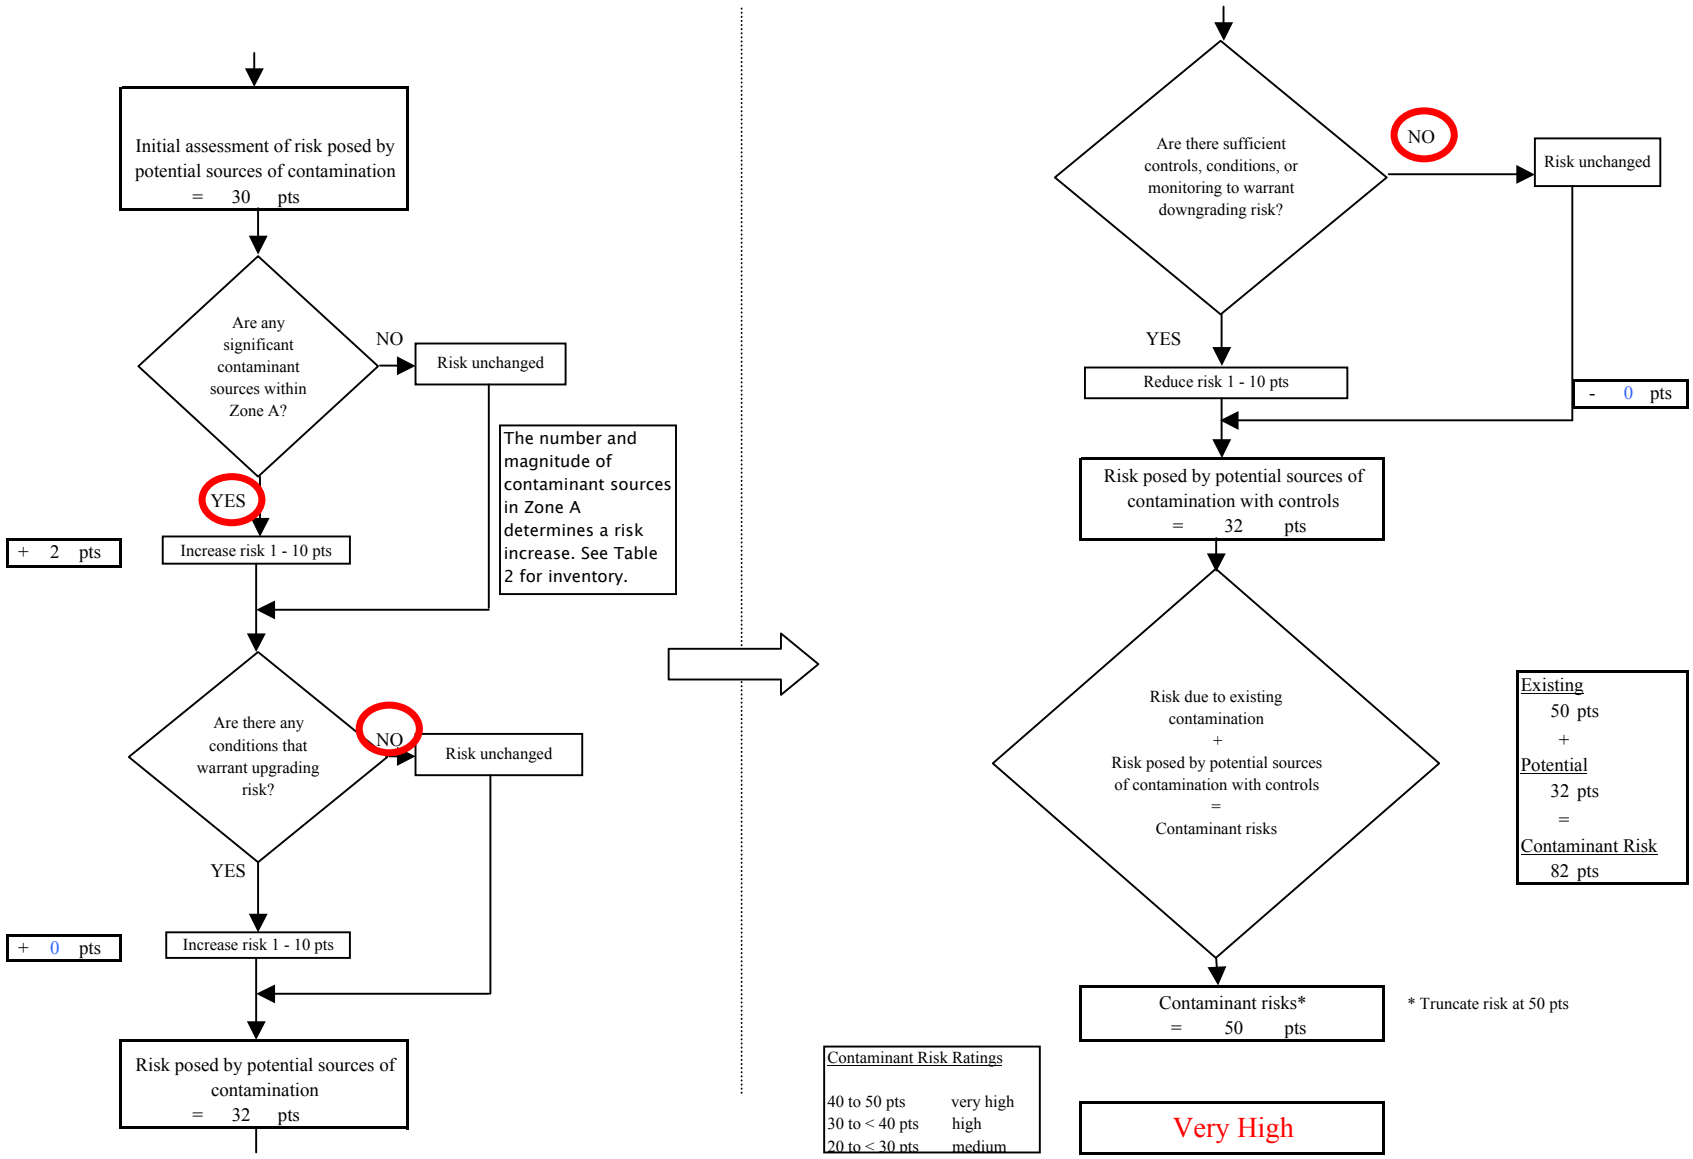
Chart 3. Contaminant risks for United Pentacostal Church aka: Brass Buckle (PWS No. 271790.001) - Bacteria & Viruses

The contaminant risk for bacteria and viruses is **Very High**. The risk is primarily attributed to the presence of bacteria in recent sampling results and the presence of a landfill in Zone B (See Table 2 – Appendix B).

A positive bacteria count has been reported and confirmed in a follow-up sample in recent (within five years) sampling events. Only a small amount of bacteria and viruses are required to endanger public health.

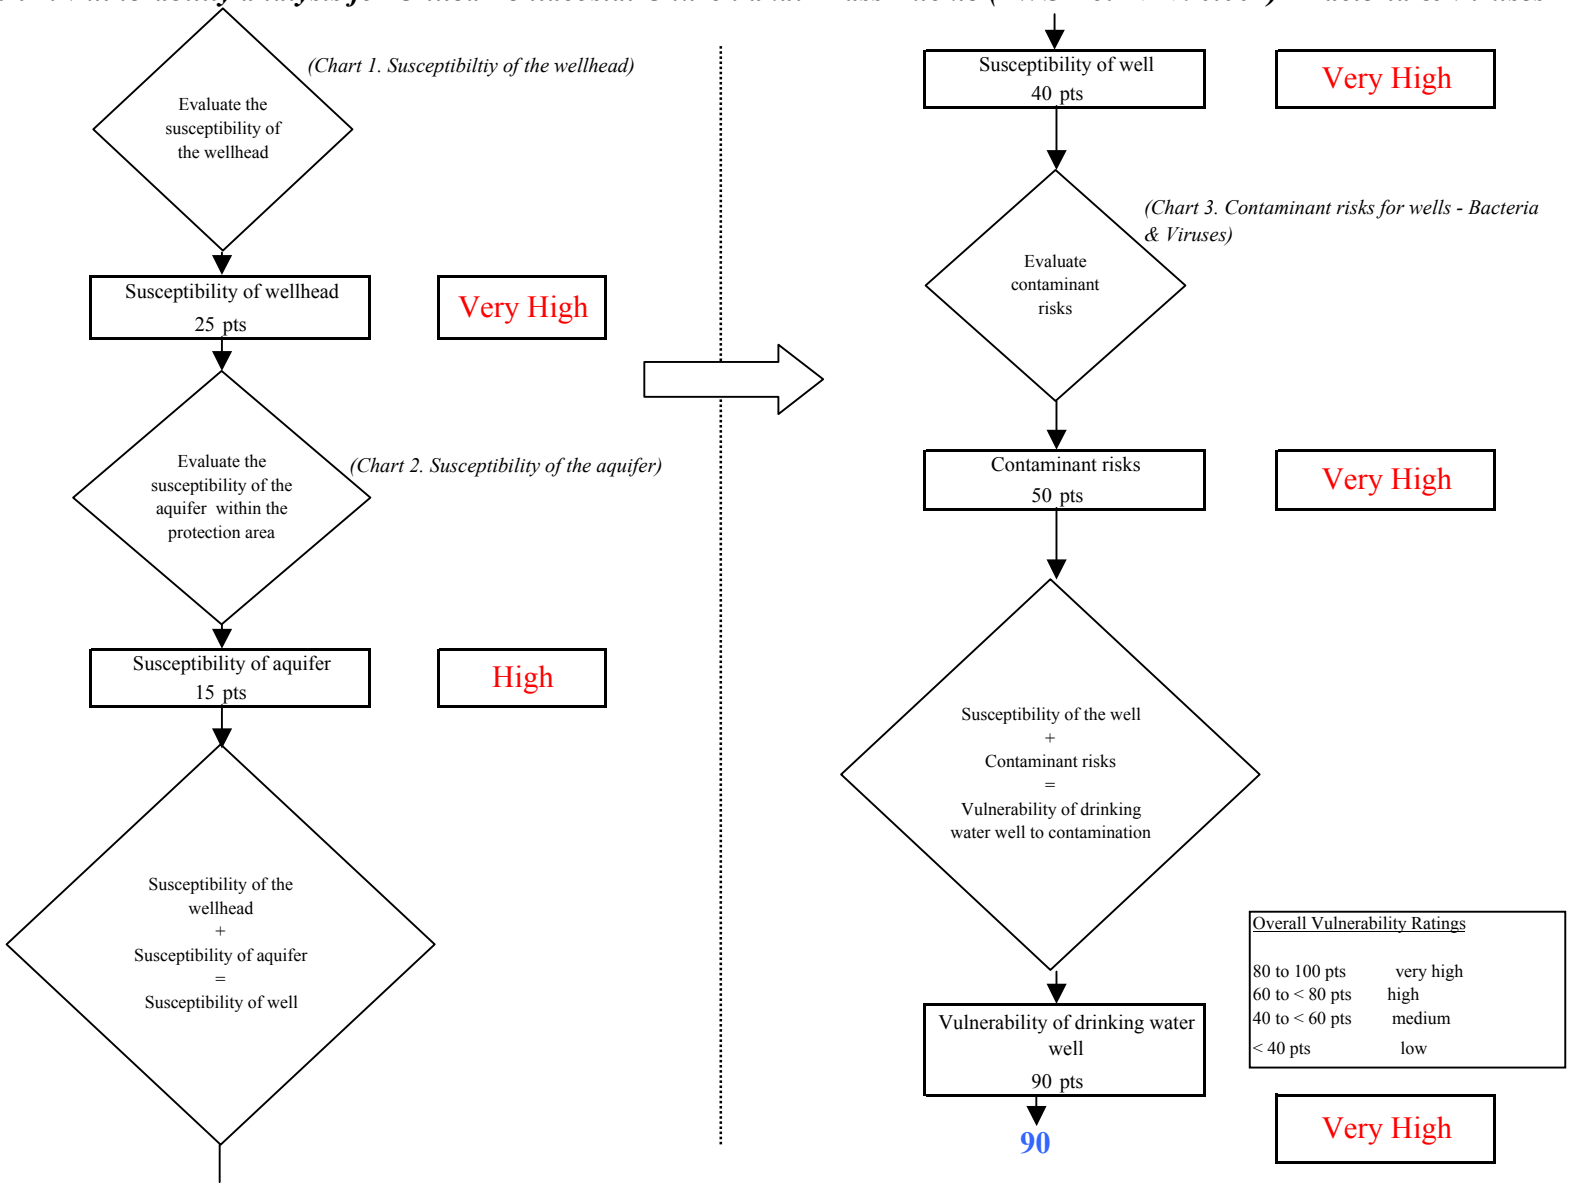
Chart 4. Vulnerability analysis for United Pentacostal Church aka: Brass Buckle (PWS No. 271790.001) - Bacteria & Viruses

After combining the contaminant risk for bacteria and viruses with the natural susceptibility of the well, the overall vulnerability of the well to contamination is **Very High**.

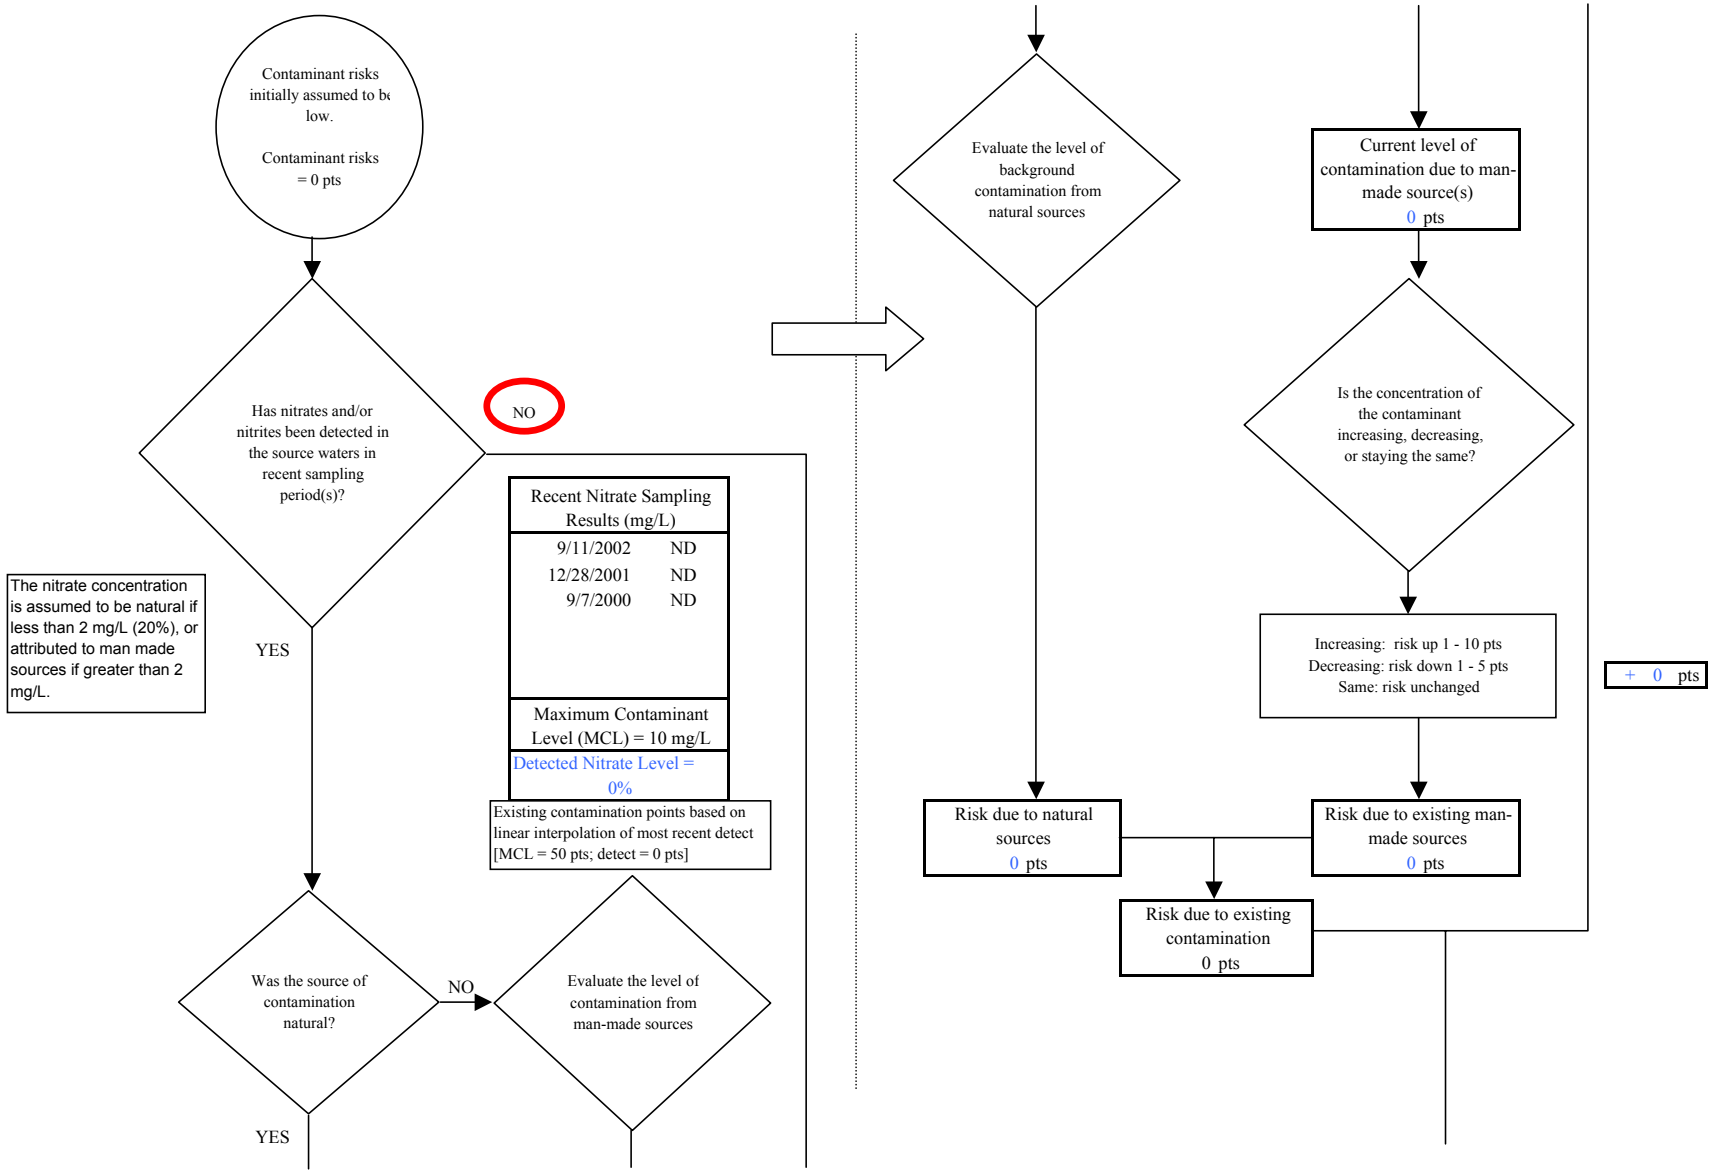
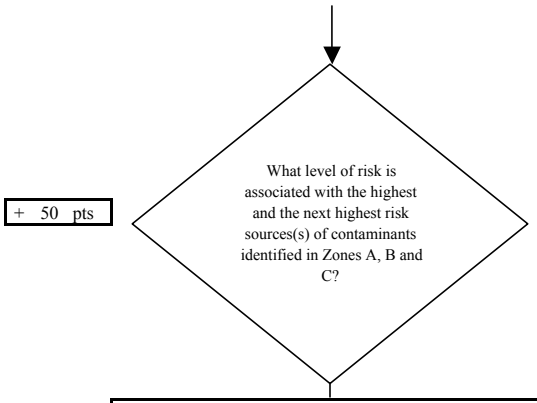
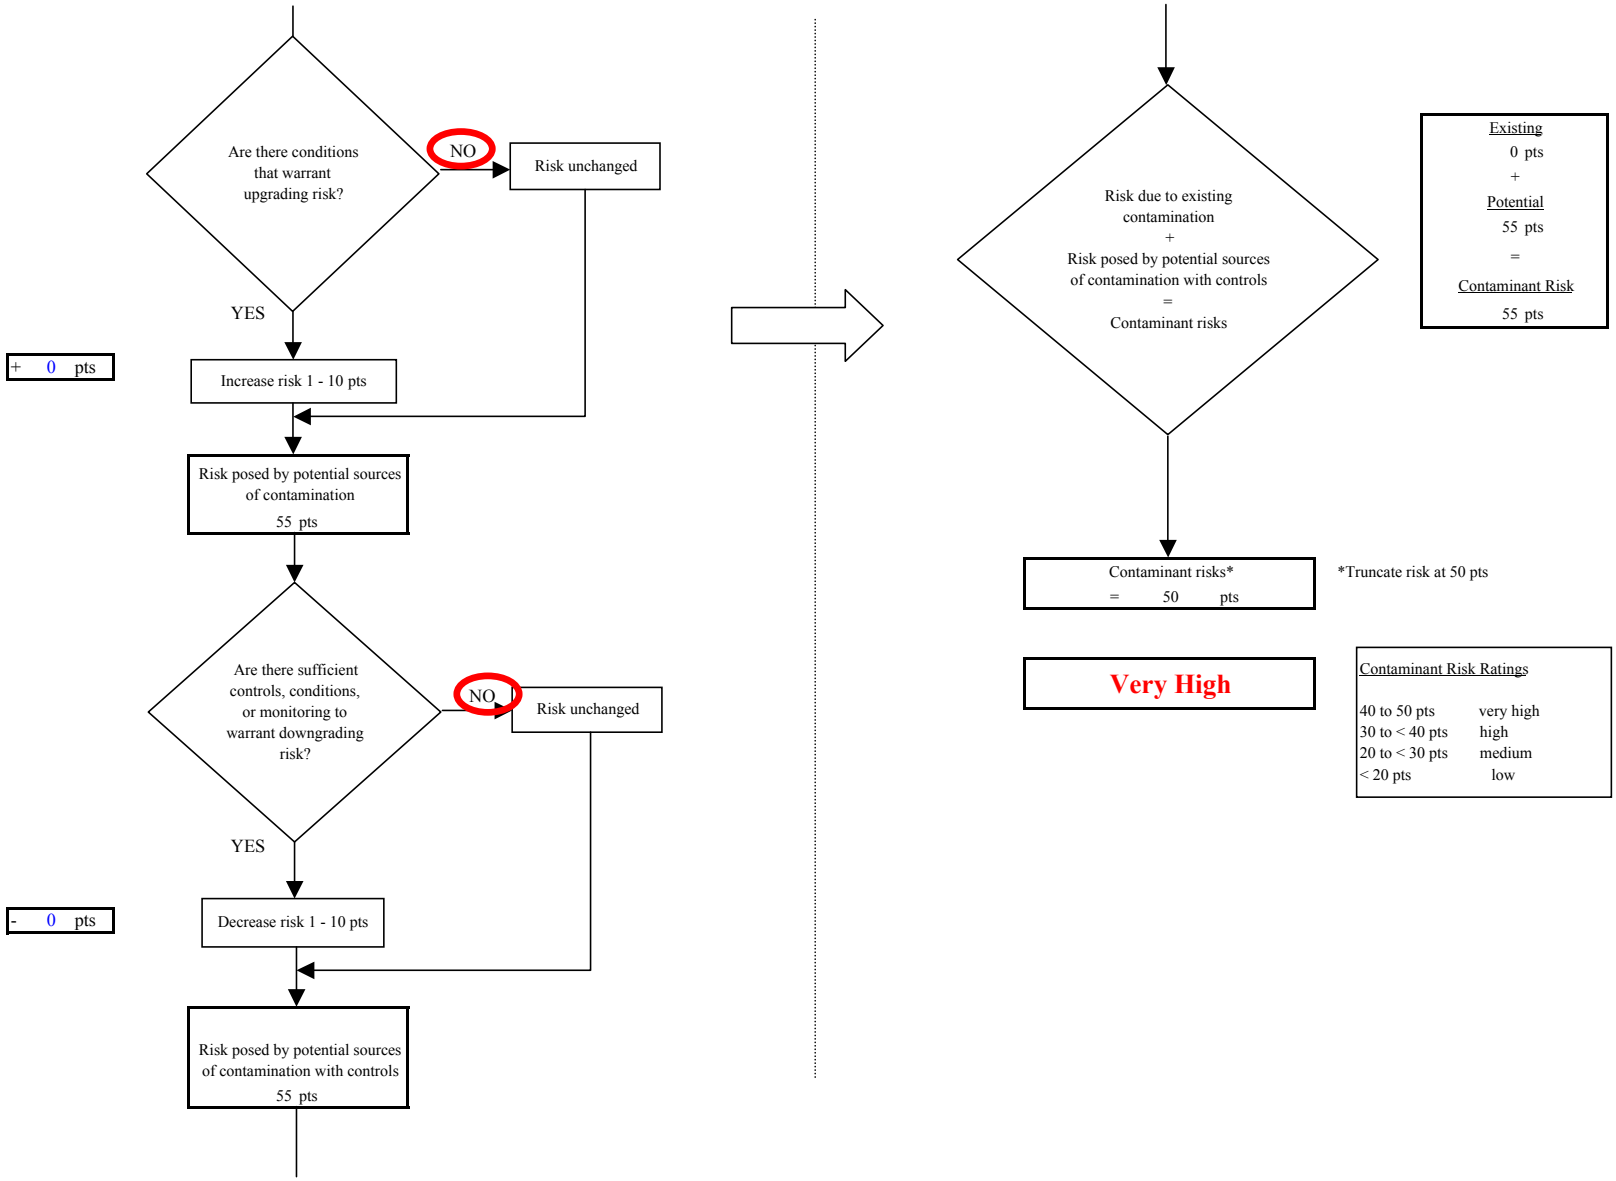
Chart 5. Contaminant risks for United Pentacostal Church aka: Brass Buckle (PWS No. 271790.001) - Nitrates and Nitrites

The contaminant risk for nitrates and nitrites is **Very High**. The risk to this source of public drinking water is attributed to the presence of a domestic wastewater treatment plant disposal pond/lagoon and landfills in Zones B and C (See Table 3 – Appendix B).

Nitrates are very mobile, moving at approximately the same rate as water. The sampling history for this well indicates that nitrates have not been detected in recent sampling events. Nitrate concentrations in uncontaminated groundwater are typically less than 2 mg/L; therefore, nitrate concentrations above 2 mg/L may be indicative of man-made sources (See Chart 5 - Contaminant Risks for Nitrates and/or Nitrites in Appendix D).

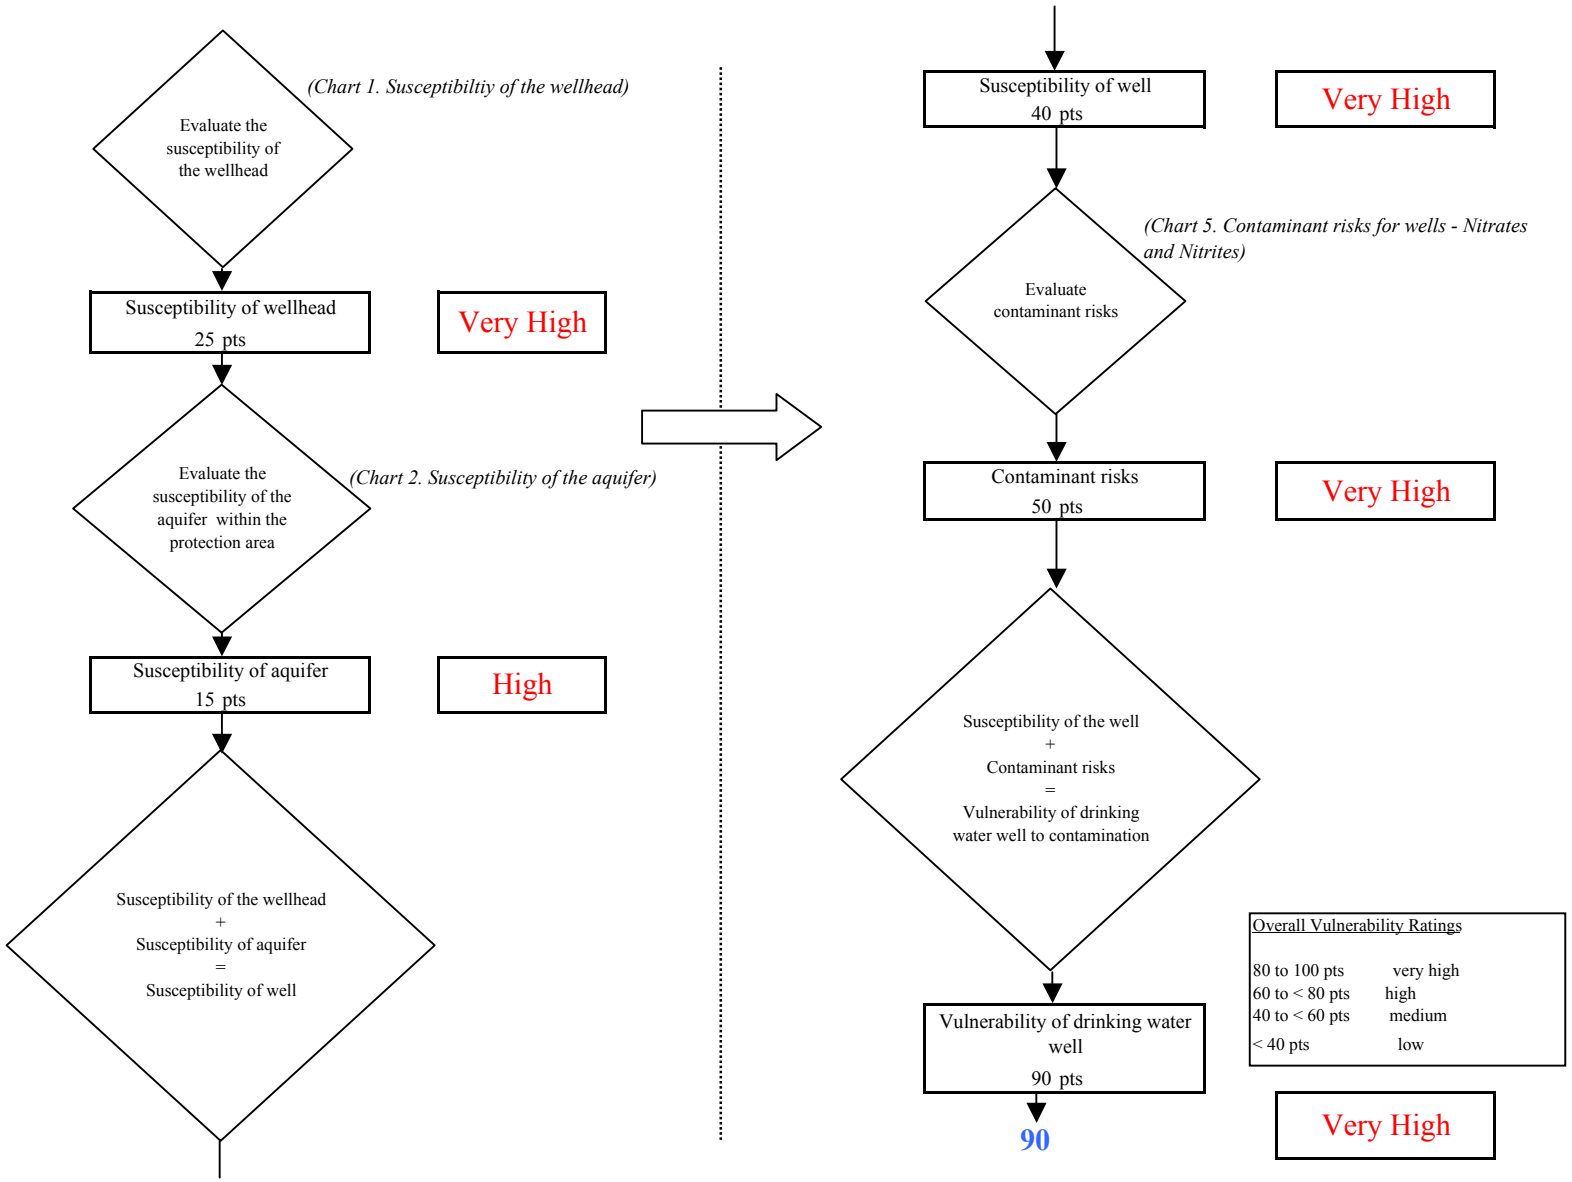
Chart 6. Vulnerability analysis for United Pentacostal Church aka: Brass Buckle (PWS No. 271790.001) - Nitrates and Nitrites

After combining the contaminant risk for nitrates and nitrites with the natural susceptibility of the well, the overall vulnerability of the well to nitrate and nitrite contamination is **Very High**.

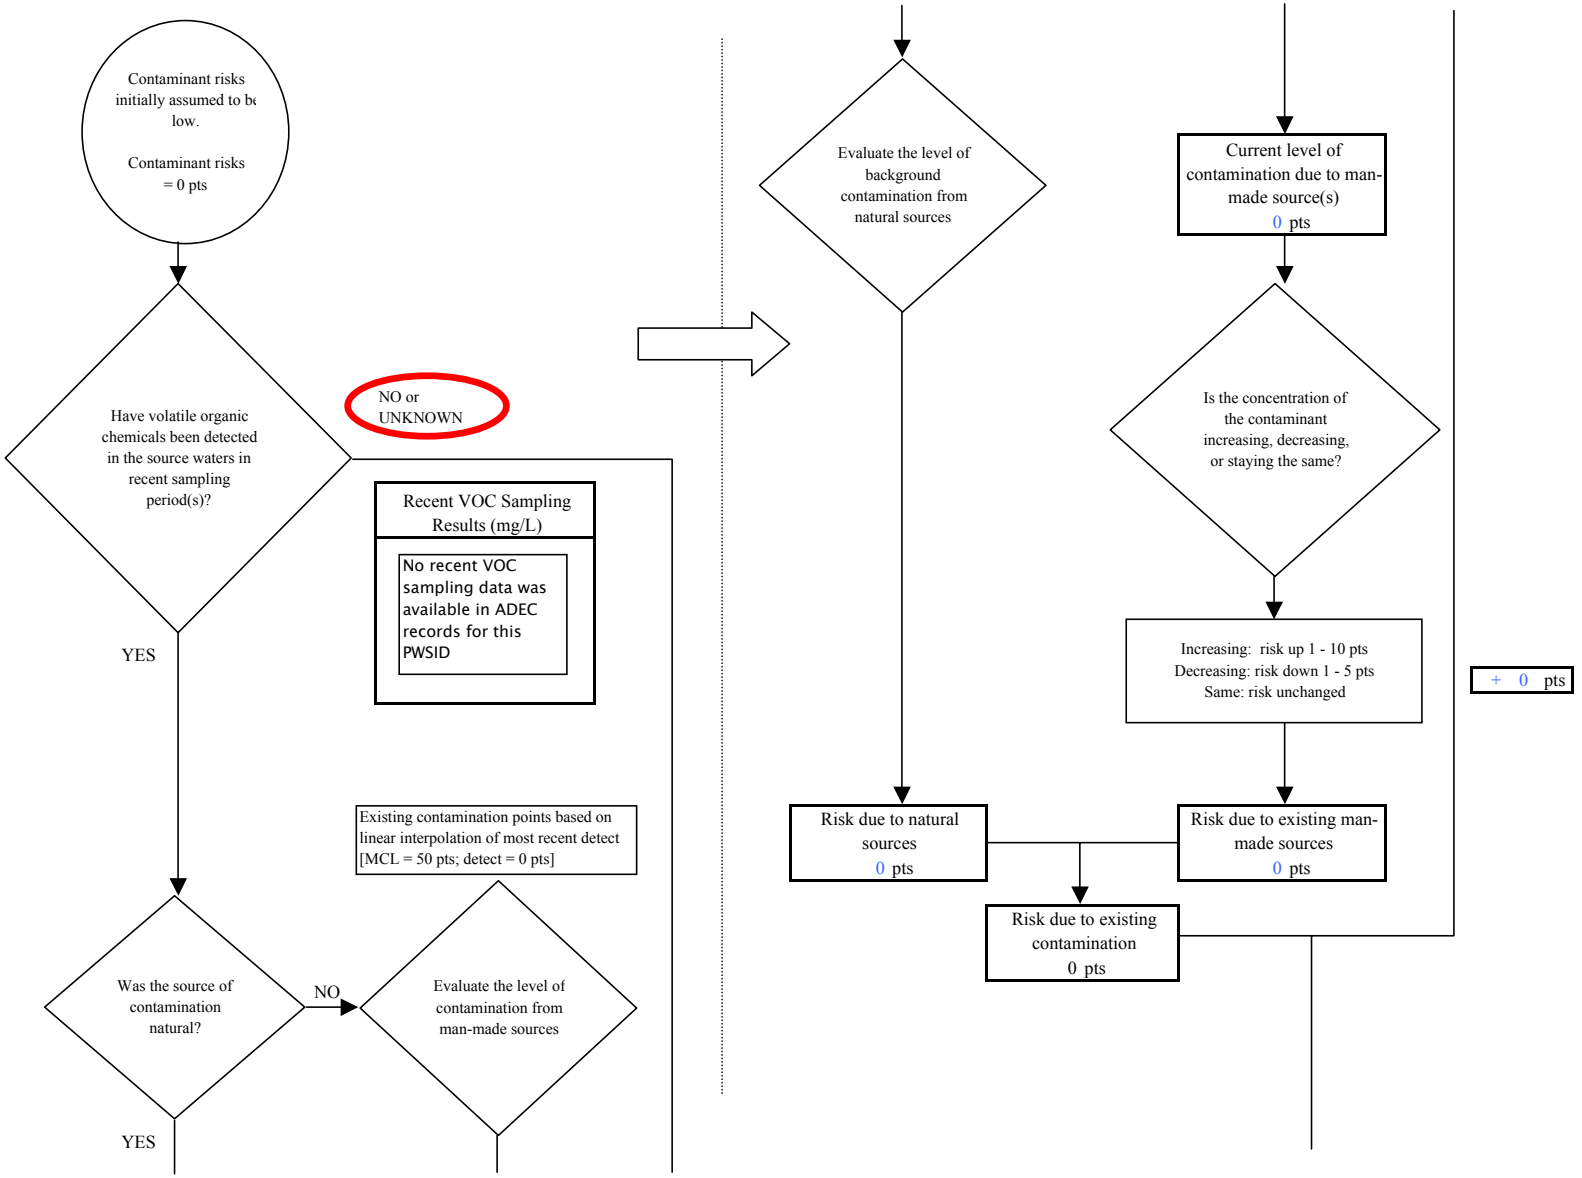
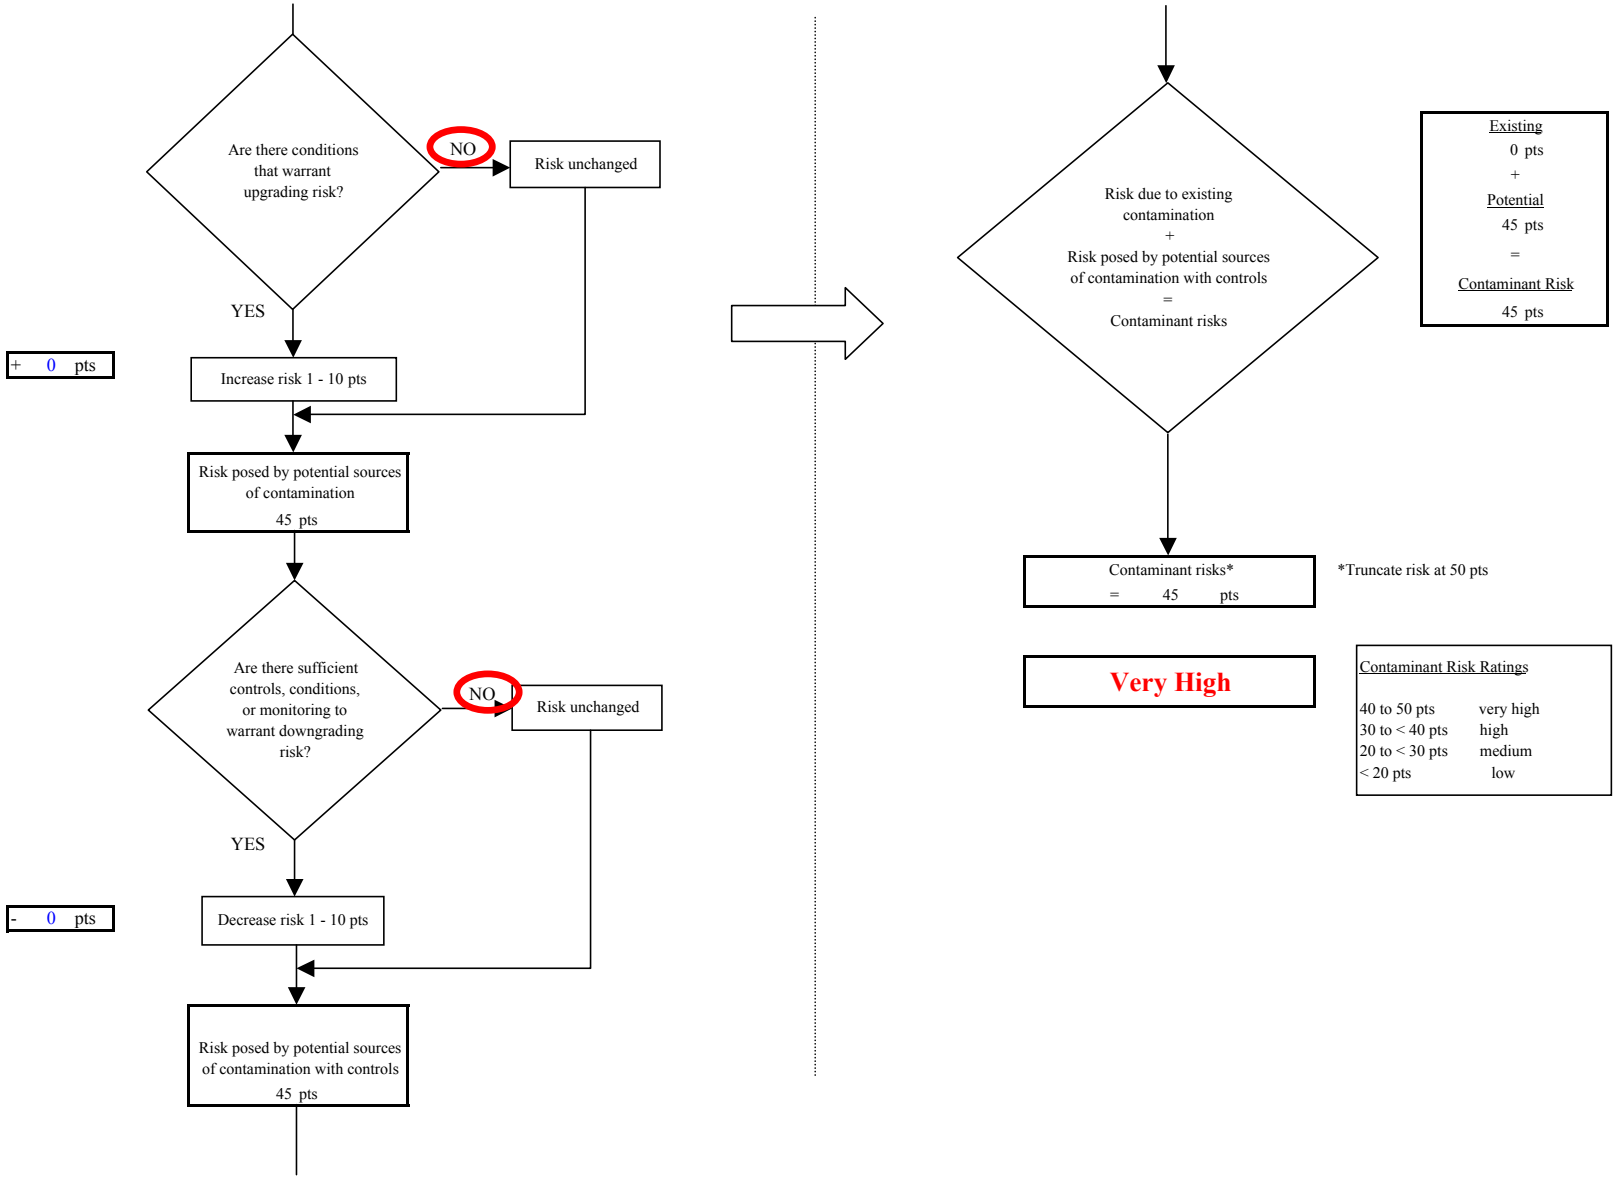
Chart 7. Contaminant risks for United Pentacostal Church aka: Brass Buckle (PWS No. 271790.001) - Volatile Organic Chemicals

The contaminant risk for volatile organic chemicals is **Very High**. The risk is primarily attributed to the presence of an ADEC recognized contaminated site and landfills in Zones B and C (see Table 4 – Appendix B).

No recent sampling data was available in ADEC records for the United Pentacostal Church (See Chart 7 – Contaminant Risks for Volatile Organic Chemicals in Appendix D).
