## A Hydrogeologic Susceptibility and Vulnerability Assessment for Real Alaskan Cabins & R.V. Public Drinking Water System, Sterling, Alaska PWSID # 249662.001

DRINKING WATER PROTECTION REPORT 1732

Alaska Department of Environmental Conservation

January, 2009

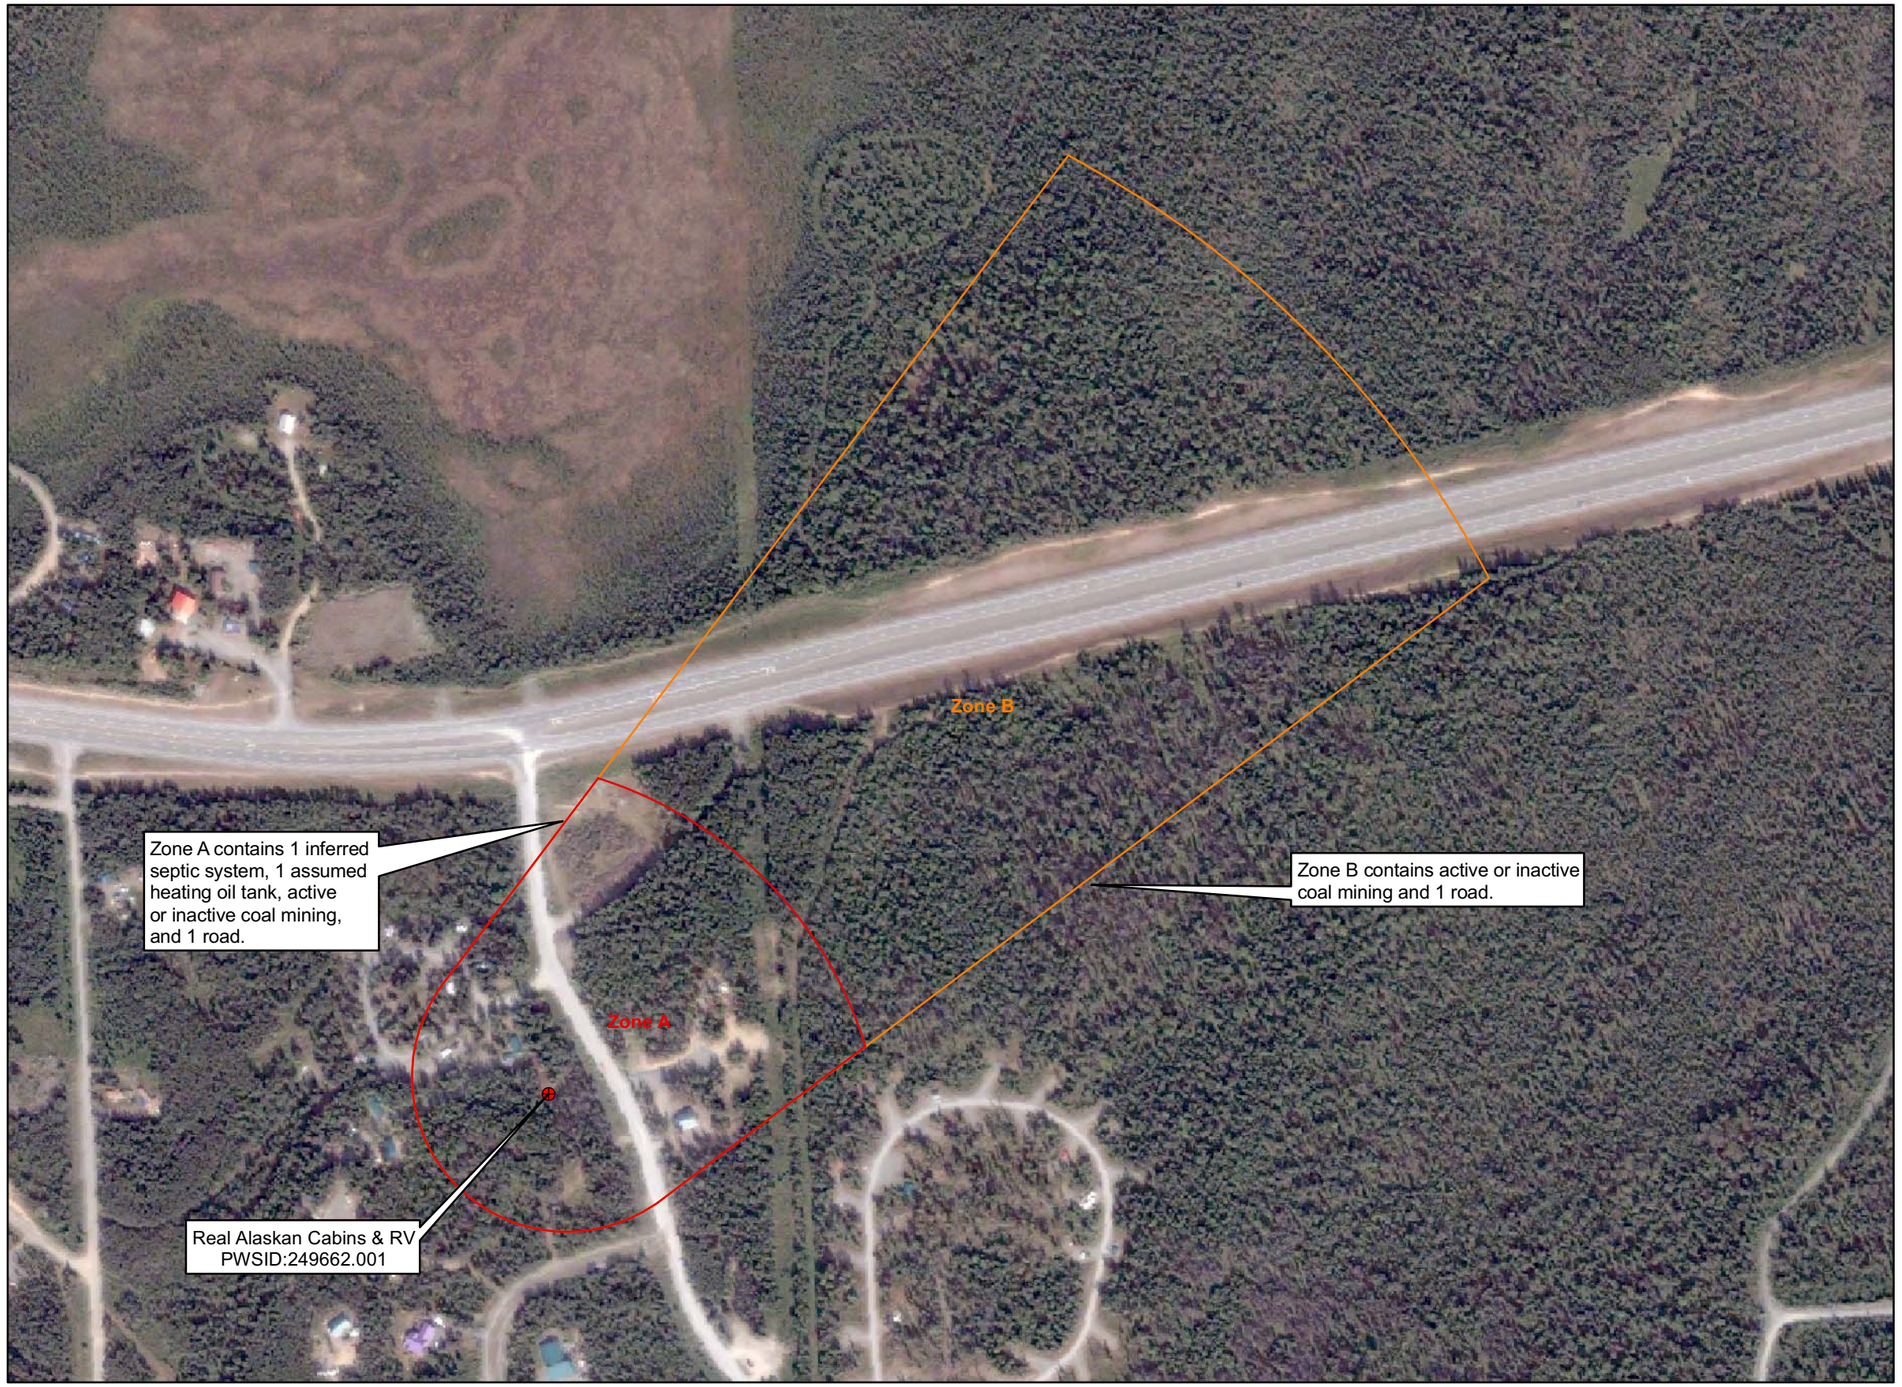
**Appendix C Map C**

The sources are displayed on Map C of Appendix C and summarized in Table 1 of Appendix B.
