SUSITNA HYDROELECTRIC PROJECT

SURVEY OF EXPERIENCE IN OPERATING HYDROELECTRIC PROJECTS IN COLD REGIONS

VOLUME 4 - APPENDIX E

FIELD MEMORANDUM OF VISIT BY H.W. COLEMAN BRITISH COLUMBIA HYDRO (VANCOUVER) AND PEACE RIVER TOWN AND SUPPLEMENTARY MATERIAL

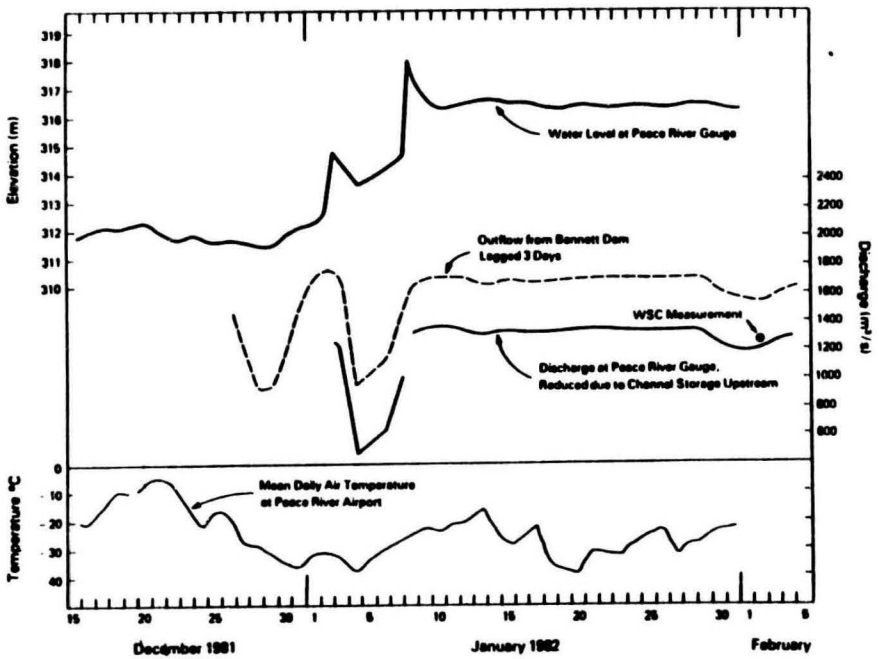
Figure 4: Sequence of Water Levels, Discharges and Temperatures, December 1981 to February 1982

Between Peace River and Dunvegan the average rise in stage associated with the ice cover formation was 3.3 m. With an average channel width of 500 m and a measured celerity of 0.30 m/s, nearly 500 m^3/s of flow was therefore being continuously abstracted into storage, probably reducing the discharge at Peace River to a minimum of about 500 m^3/s on January 4th. This caused the stage to drop about 1.1 m (Figure 4) from the peak associated with ice cover formation.

resumption of normal power output at Bennett Dam a day or two earlier were followed by a massive consolidation and thickening of the new ice cover. A 9-m high jam formed 14 km below Dunvegan, but failed after about 2 hours. A surge of ice and water then moved downstream (Fonstad, 1982), reaching Peace River at 10:30 p.m. (Figure 4). The stage rose abruptly by about 3.5 m to an elevation of 318.15 m, some 3.4 m above the previous stable ice cover and only 1.5 m below the top of the flood protection dikes. Within 2 hours of the peak the stage had dropped by 0.60 m, and after about 36 hours it had dropped a further 1.15 m to an elevation of 316.4 m, where it remained more or less constant for the rest of January. Later aerial inspection indicated that noticeable consolidation of the ice surface extended to about 10 km downstream of Peace River.

On January 8th, 12 hours after the peak at Peace River, the head of the cover was observed to be only 40 km upstream of Peace River, readvancing upstream at a rate of 0.18 m/s[b]. This rate was maintained at least until January 10th. Between then and January 14th the cover advanced very slowly, probably due to warmer temperatures (Figure 4). On January 14th it resumed progression upstream at a rate of 0.18 m/s, and the head passed Dunvegan again in the night of January 15th-16th. With a discharge of about 1700 m^3/s and a mean daily temperature of -25°C, the local stage rise at Dunvegan was 4.7 m.

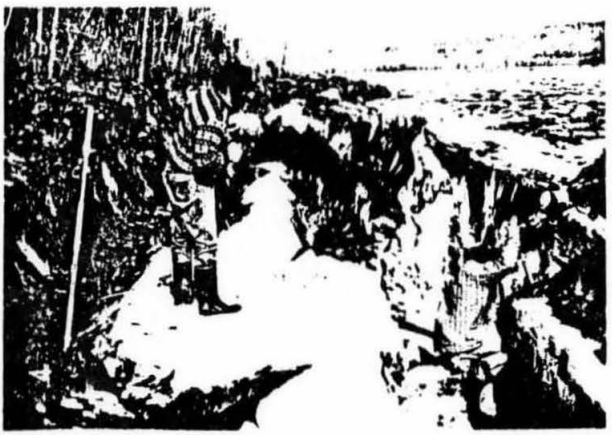
Figure 5: Shear Walls Indicating Ice Thickness, April 1982

The winter measurements indicated a relatively consistent thickness below water level of from 3.8 to 4.2 m, although in some locations the value was as low as 2.3 m. The cover appeared to be formed primarily from frazil slush in which were embedded ice floes originating from broken border ice and frozen crusts of frazil pans. The border ice ranged from 0.5 to 1.0 m in thickness and the frozen crusts were in the order of 0.3 m thick. The maximum ice height along the bank was from 0.9 to 1.5 m above the January 13th water level and more or less corresponded to the maximum water level associated with the ice cover consolidation. The perceived average ice surface on the day of survey was generally from 0.2 to 0.6 m above the water level; where shear lines were evident, ice had pushed up at least 1.6 m above the water level.

Ice thickness measurements were also made at breakup following the passage of the ice front, when many of the exposed shear walls were still intact (Figure 5). Most of the shear walls were about 4 m thick. The reliability of these measurements is not as great as for the winter measurements, but they generally substantiate the latter.

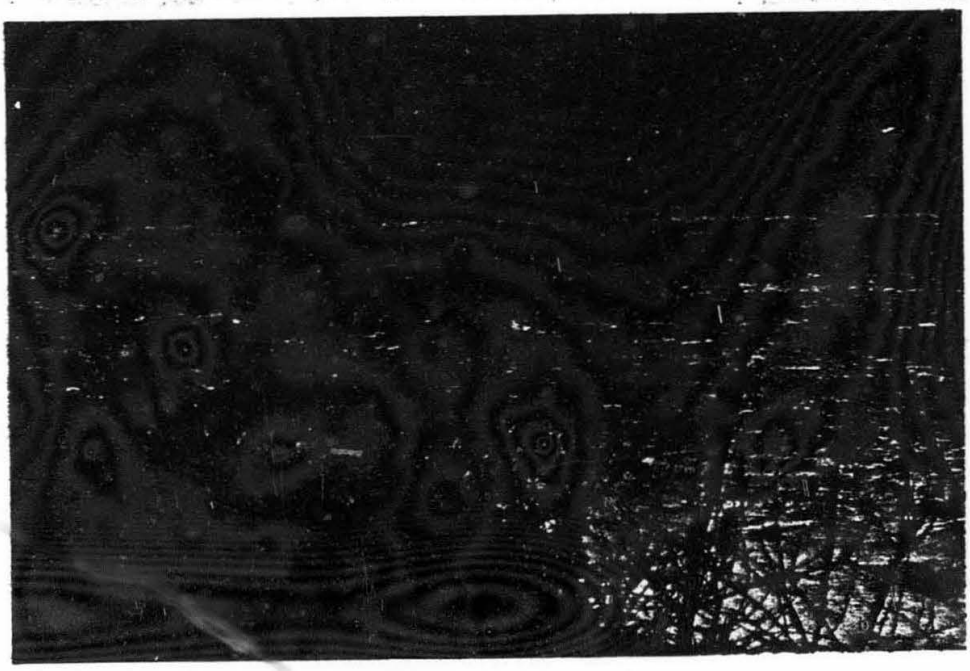
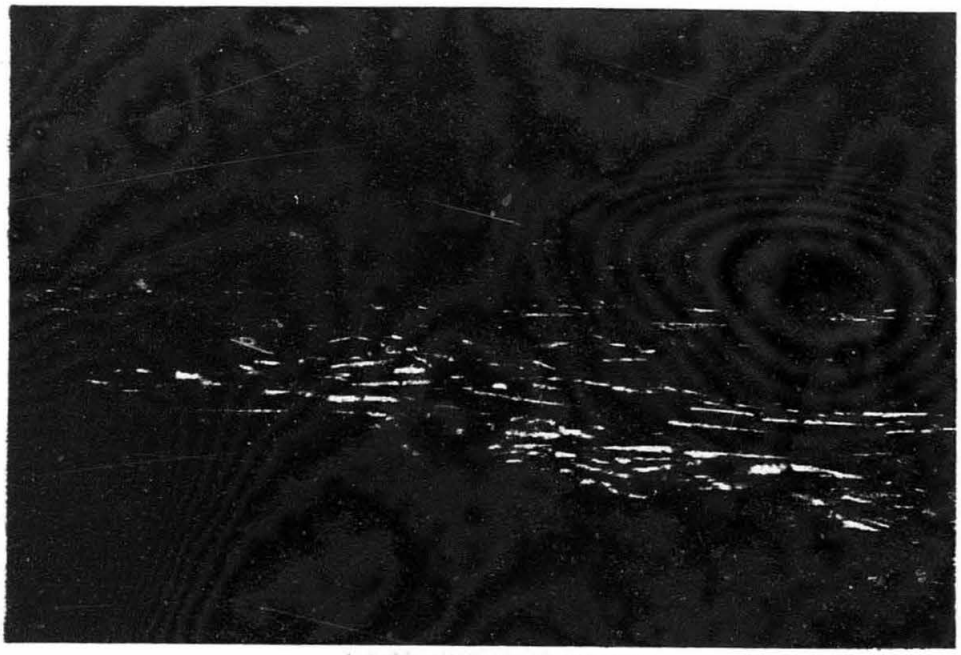
PEACE RIVER TOWN
3 APR 84

After talking with Amirault, I toured the river around town, and drove up river about 25 km to Shaftsbury Ferry. The river was ice coverd generally, with a few areas of weak ice and a few small open leads. The ice level in town appeared to be 5-6 meters below the top of dikes. The ice was generally rough and broken up from consolidation. The river at surface level was generally 500-600 meters wide, excluding islands, and of the order of 5 meters deep. The ice was probably up to 2 meters thick. My general impression from looking at the river ice condition and stage, was that break-up flooding this year will be no problem. However, it has been demonstrated many times that break-up predictions are notoriously unreliable.
