**Fishery Data Series No. 18-28**

# **Fish Passage Assessment and Culvert Inventory on the King Cove and Cold Bay Road Systems**

December 2018

Alaska Department of Fish and Game

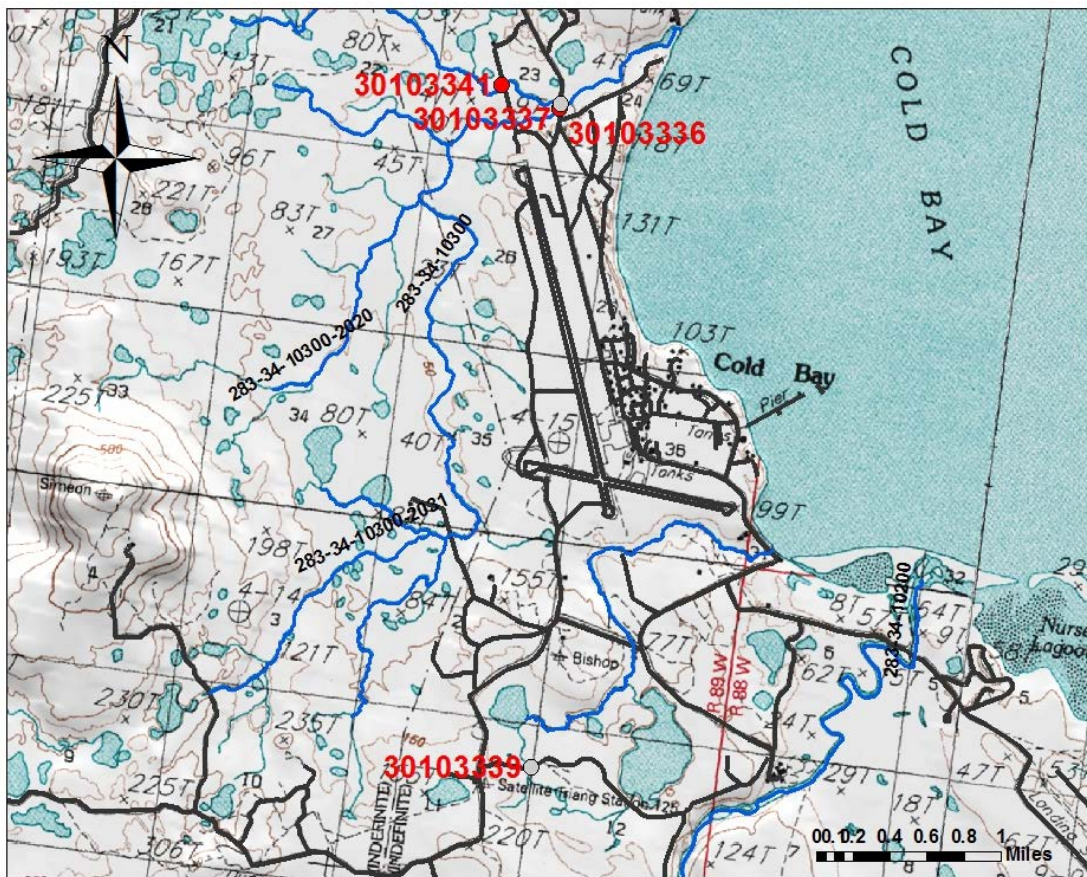
Figure 9.—Map showing culvert of concern on the Cold Bay and Izembek NWR road systems

Of the 6 Red and 3 Gray assessed culverts, the project identified 4 culvert sites of concern and high priority for replacement and restoration (Table 2, Figure 9). These recommendations are based on culvert condition, severity of the barrier, estimated upstream habitat, cataloged anadromous habitat above site, and identified species usage. Except for site 30103338, which was replaced with a stream simulation culvert in 2009 (ADF&G 2009), the remaining sites all show signs of significant deterioration and it is recommended that these culverts be replaced for proper road maintenance and that those replacements consider fish passage for resident species found in those systems.

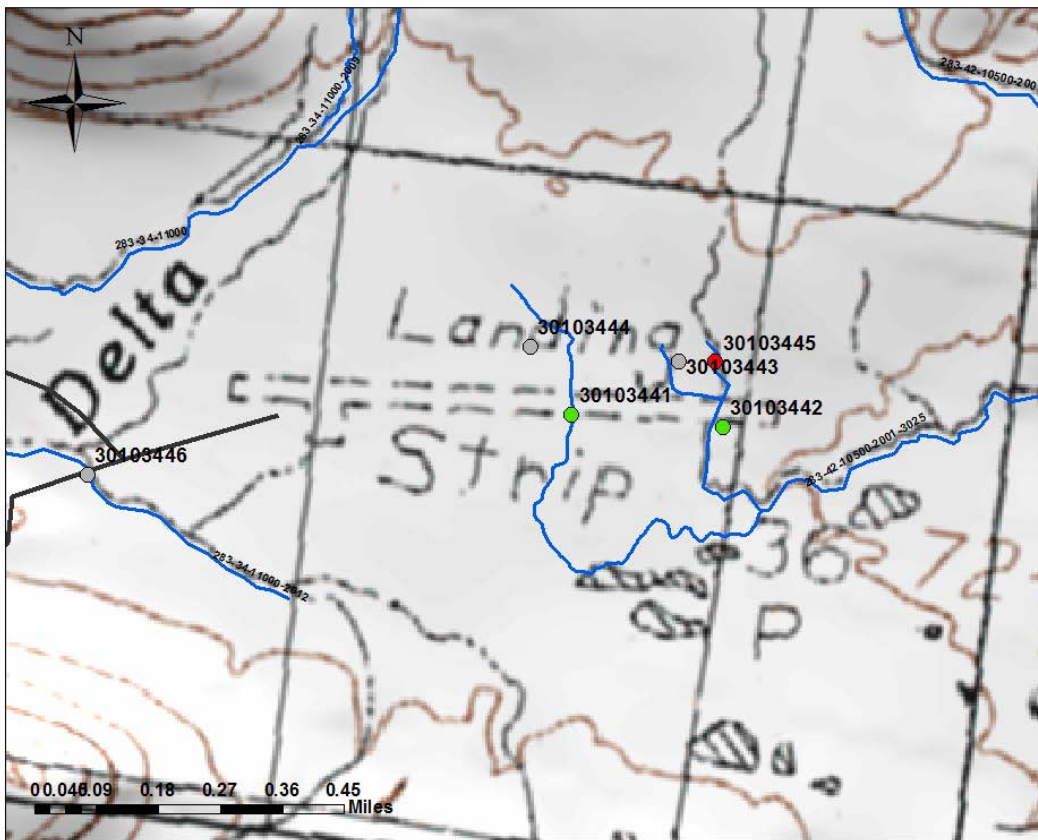
Figure 22.—Map of the culverts around the King Cove airport.

The King Cove airport has 2 anadromous streams that pass under the runway. Both sites 30103441 (AWC # 283-42-10500-2001-3025-4019) and 30103442 (AWC# 283-42-10500-2001-3025-4020) were rated Green by assessment crews, but there are also 3 culverts upstream on an airport access road that are of concern for fish passage (Figure 22). A very large number of spawning pink salmon were observed to be using these streams at the time of survey.

This site is about 500 feet upstream from site 30103441 (Figure 22). This creek has been cataloged for pink, coho, and chum salmon and Dolly Varden char. Cataloged anadromy extends 500 feet upstream beyond the crossing and satellite imagery shows an additional half mile of potential habitat upstream above the end of anadromy. Assessment crews noted that the culvert was undersized for the creek but were unable to access the inlet or upstream habitat because of the airport security fence. Adult pink salmon were observed above and below the culvert. The project recommends replacement with a stream simulation type culvert (Figures 23 and 24).

This site is about 550 feet upstream from site 30103442. The stream is documented for pink salmon and is a tributary to a known coho and chum salmon stream about 1000 feet downstream (Figure 22). The assessment crew was unable to access the culvert inlet or upstream habitat due to a security fence but noted that the culvert appeared to be a potential gradient barrier and that it had inadequate water depth for adult passage. Adult pink salmon were observed downstream of the culvert. The stream is cataloged for pink salmon for a few hundred feet above the crossing, but satellite imagery shows about a half mile of estimated upstream habitat. The project recommends replacement with a stream simulation type culvert (Figures 25 and 26).

Site is located on Airport Road about 4 miles north of the city center and a quarter mile from the airport (Figure 22). A large number of adult spawning pink and chum salmon were observed to move through or attempt to move through this culvert at the time of survey.

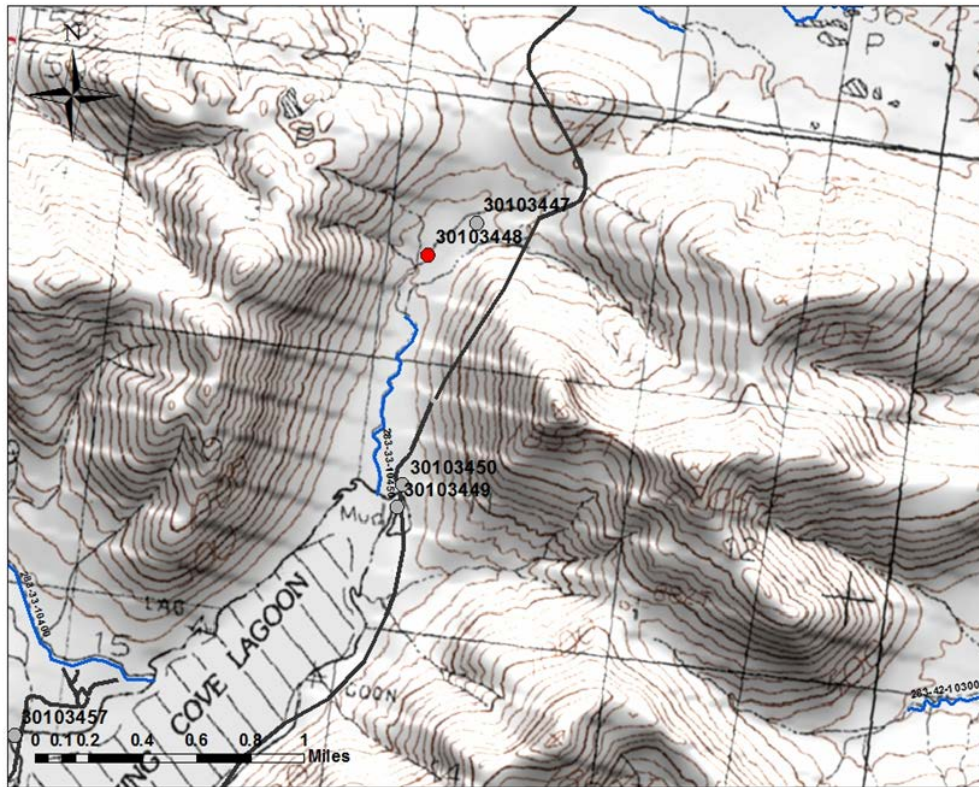
Figure 33.—Map of culverts on the northern end of King Cove Lagoon.

Site is on the shooting range off Airport Road about 3 miles from King Cove (Figure 33). The stream is cataloged in the AWC for chum and pink salmon about 0.3 miles downstream of this culvert. Assessment crews observed fish at the site, most likely Dolly Varden char. Satellite imagery shows about another half mile of potential habitat upstream. Recommend replacement with a stream simulation culvert (Figures 34-36).

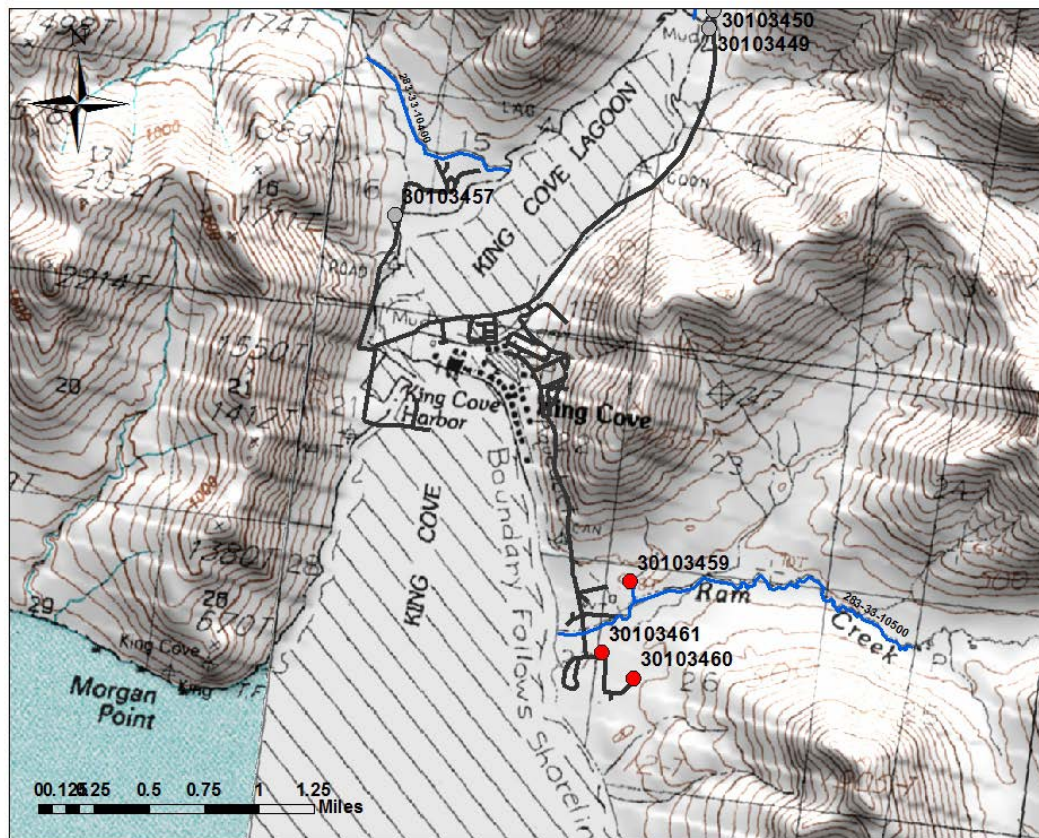
Figure 37.—Map of culverts around the City of King Cove and western King Cove Lagoon

Site is about 1000 feet upstream from the confluence with Ram Creek (AWC # 283-33-10500) and about 950 feet downstream of site 30103460 (Figure 37). The assessment crew observed adult pink salmon and Dolly Varden char up- and downstream from this site. Site consists of 2 culverts, with one capturing all the flow at the time of survey. Culvert has a Red outfall and adult fish were observed leaping to pass through the crossing and stacking up below the culvert. Recommend replacing culverts with a stream simulation culvert (Figures 38–40).
