# **Fish Passage Assessment and Prioritization of Culverts in Gustavus, Haines, Juneau, Skagway, and Sitka, 2011–2012**

May 2020

Alaska Department of Fish and Game

***FISHERY DATA SERIES NO. 20-12***

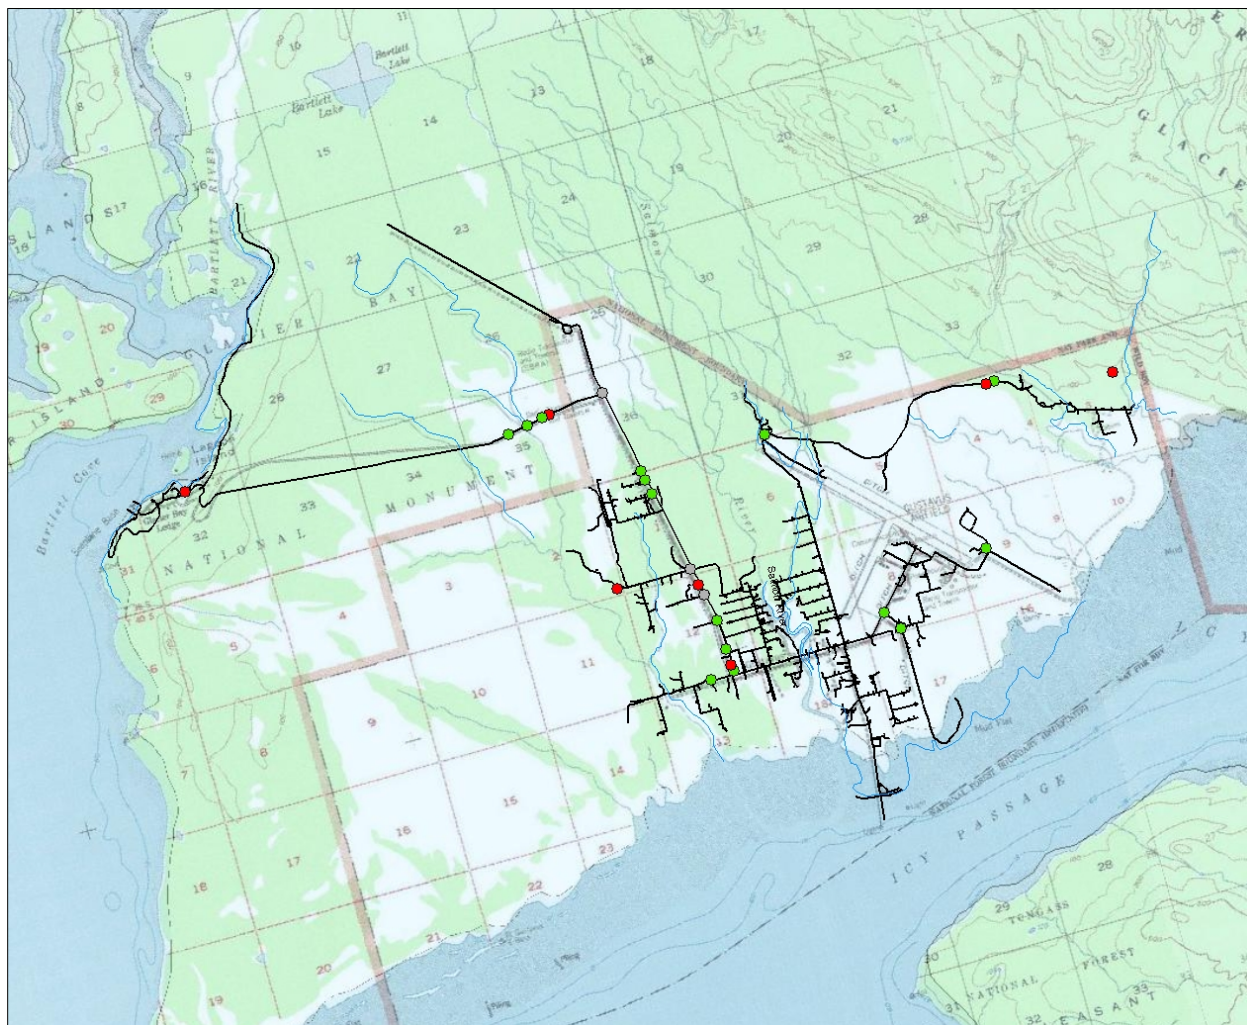
Figure 11.—Map showing surveyed culvert locations in Gustavus and their site ratings.

In Gustavus, 5 sites (25%) on known fish bearing streams were rated Red where the crossing was assumed to be adequate for juvenile fish passage, 3 sites (15%) were rated Gray where the crossing may be inadequate for juvenile fish passage, and 12 sites (60%) were rated Green where the crossing was assumed to be inadequate for juvenile fish passage (Table 3, Figure 11). The project found one culvert site (4%) with an outfall greater than 1 foot (Table 4).

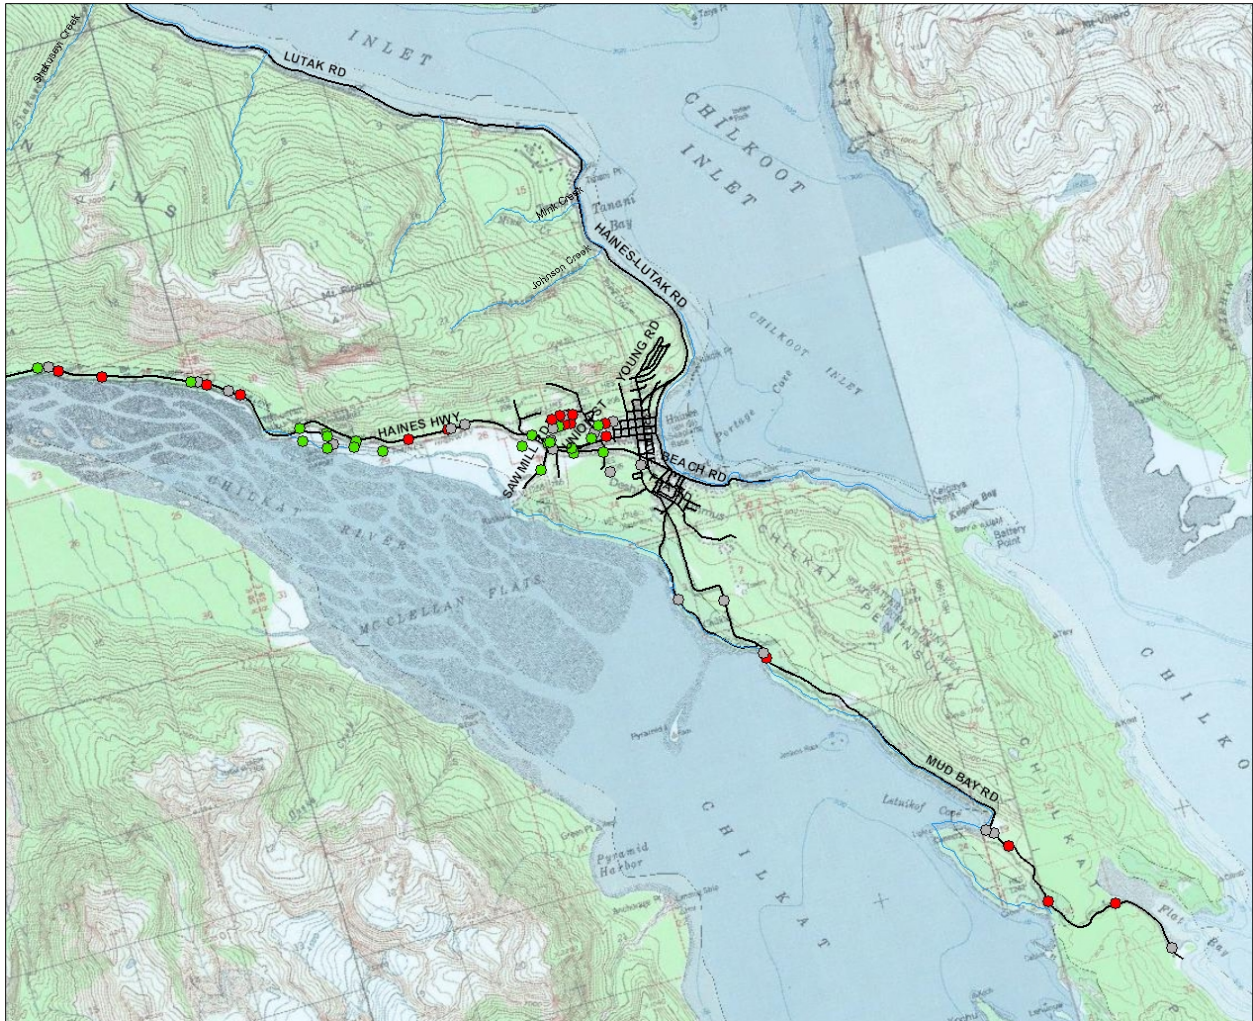
Figure 12.—Map showing assessed site locations and site ratings in Haines and the Chilkat Peninsula.

On streams known to be fish bearing in Haines, the project rated 36 sites (37.1%) Red, 26 sites (26.8%) Gray, 34 sites (35.1%) Green, and 1 site (1%) Black. The project found 14 culvert sites (12.6%) with an outfall over 1 foot, 12 culvert sites (10.8%) with gradients over 4%, with 5 of those sites (4.5%) having both potential adult barriers to fish passage (Tables 3 and 4, Figures 12–14)

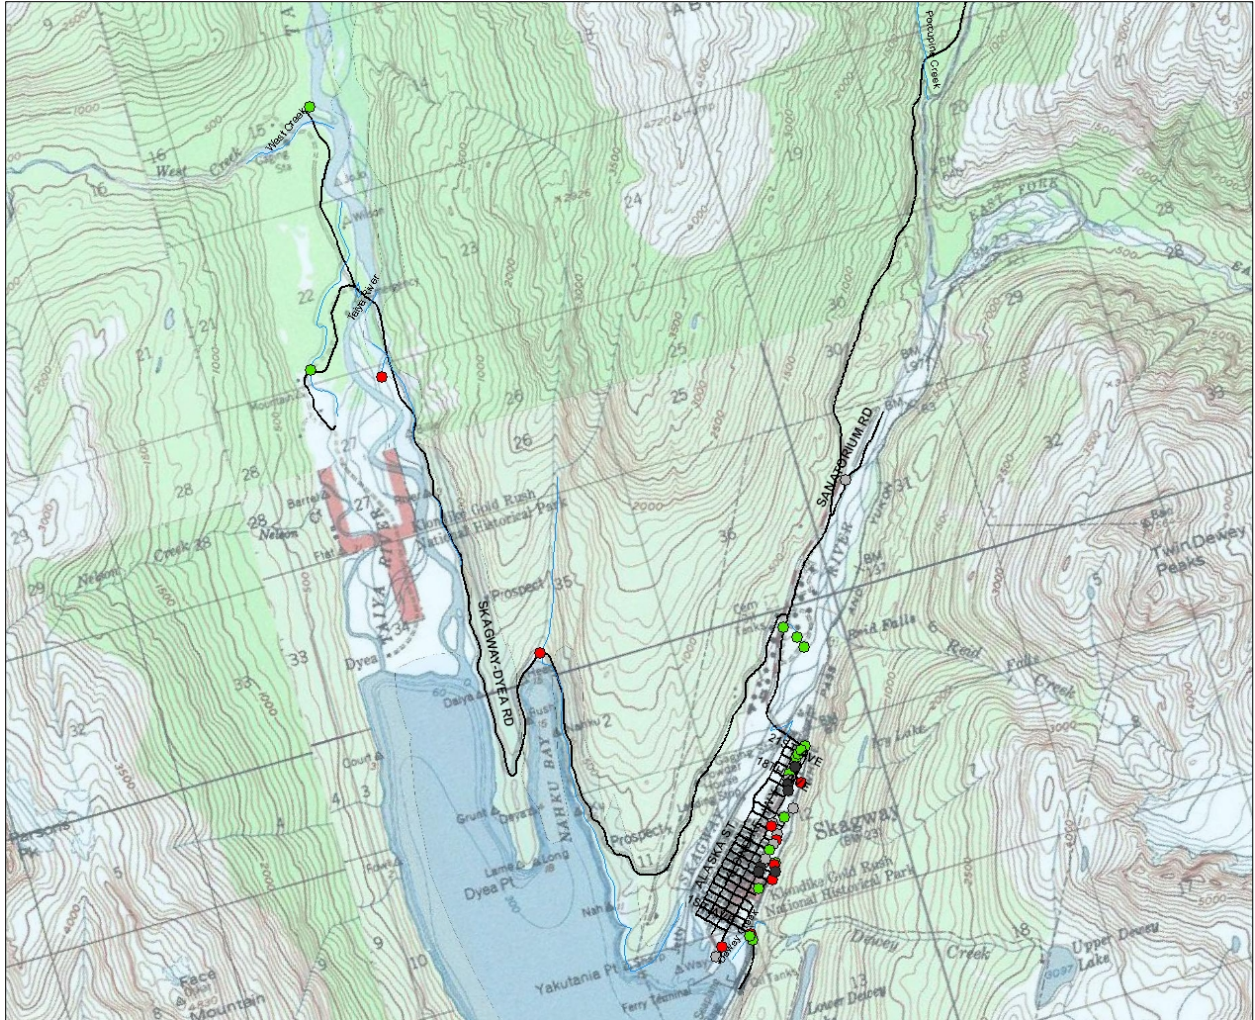
Figure 17.—Assessed site locations and site ratings in the Skagway area.

In the Skagway area on streams known to be fish bearing 8 sites (20%) were rated as Red, 11 sites (27.5%) were rated Gray, 14 sites (35.0%) were rated Green and 7 sites (17.5%) were not able to be rated due to their location on private property and were rated Black (Table 3, Figures 17 and 18). The project documented one site (2.3%) with an outfall over 1 foot and one culvert (2.3%) with a gradient exceeding 4% (Table 4).
