Fishery Data Series No. 21-01

**Fish Passage Assessment, Inventory, and
Prioritization of Culverts on the Ketchikan,
Petersburg, and Wrangell Road Systems, 2013–2016**

June 2021

Alaska Department of Fish and Game

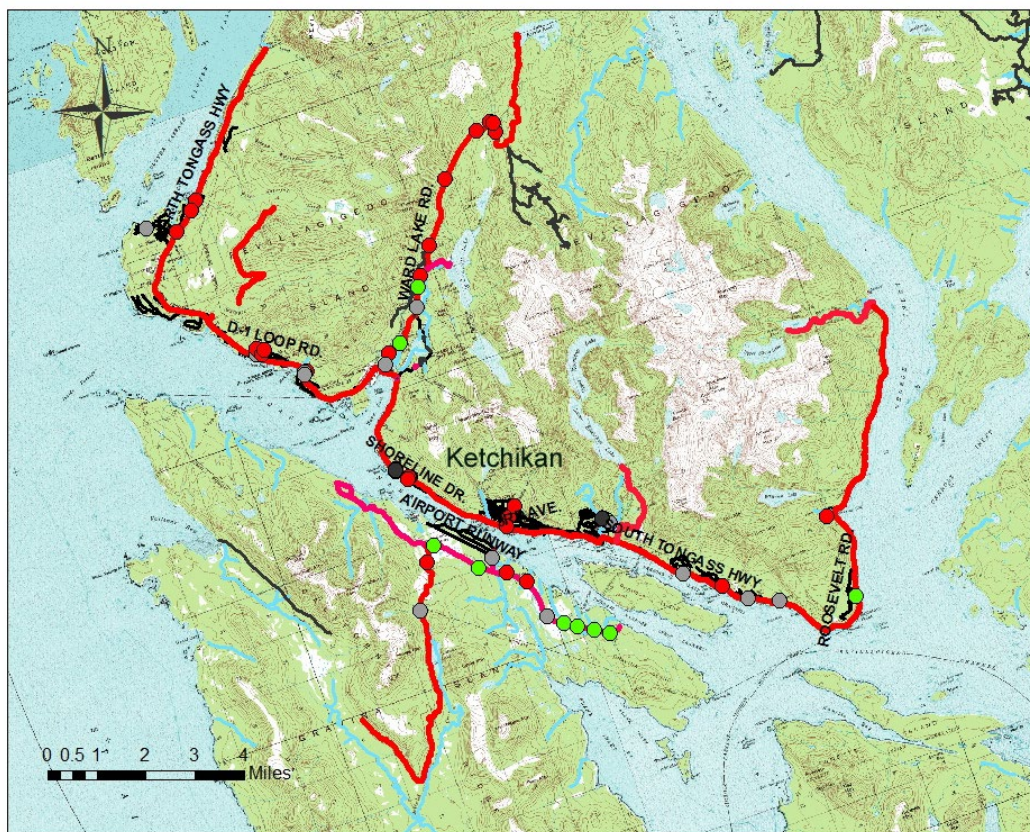
Figure 9.—Map showing assessed culvert sites on the Ketchikan road system, with color-coded ratings.

In 2013, 57 sites were assessed on 87 miles of roads (Figure 9, Table 1). The major factors affecting fish passage at sites assessed in Ketchikan were steep culvert gradients, culvert outfall height, sediment accumulation at the inlet, and constriction (Table 5). Thirty sites were rated Red (52.6%), 14 sites Gray (24.5%), 11 sites Green (19.3%), and 2 sites Black (3.5%) (Table 3). Among these sites, there were 26 Red (55.3%), 11 Gray (23.4%), 9 Green (19.2%), and 1 Black (2%) located on known fish-bearing streams (Table 2); the rest were located on streams the survey crew judged to have habitat potential to bear fish. Twenty-three sites were potential adult barriers of which 18 sites had an outfall height greater than 1 ft, 13 sites had an overall gradient greater than 4%, and 8 sites had both an outfall height greater than 1 ft and a gradient greater than 4% (Table 4).

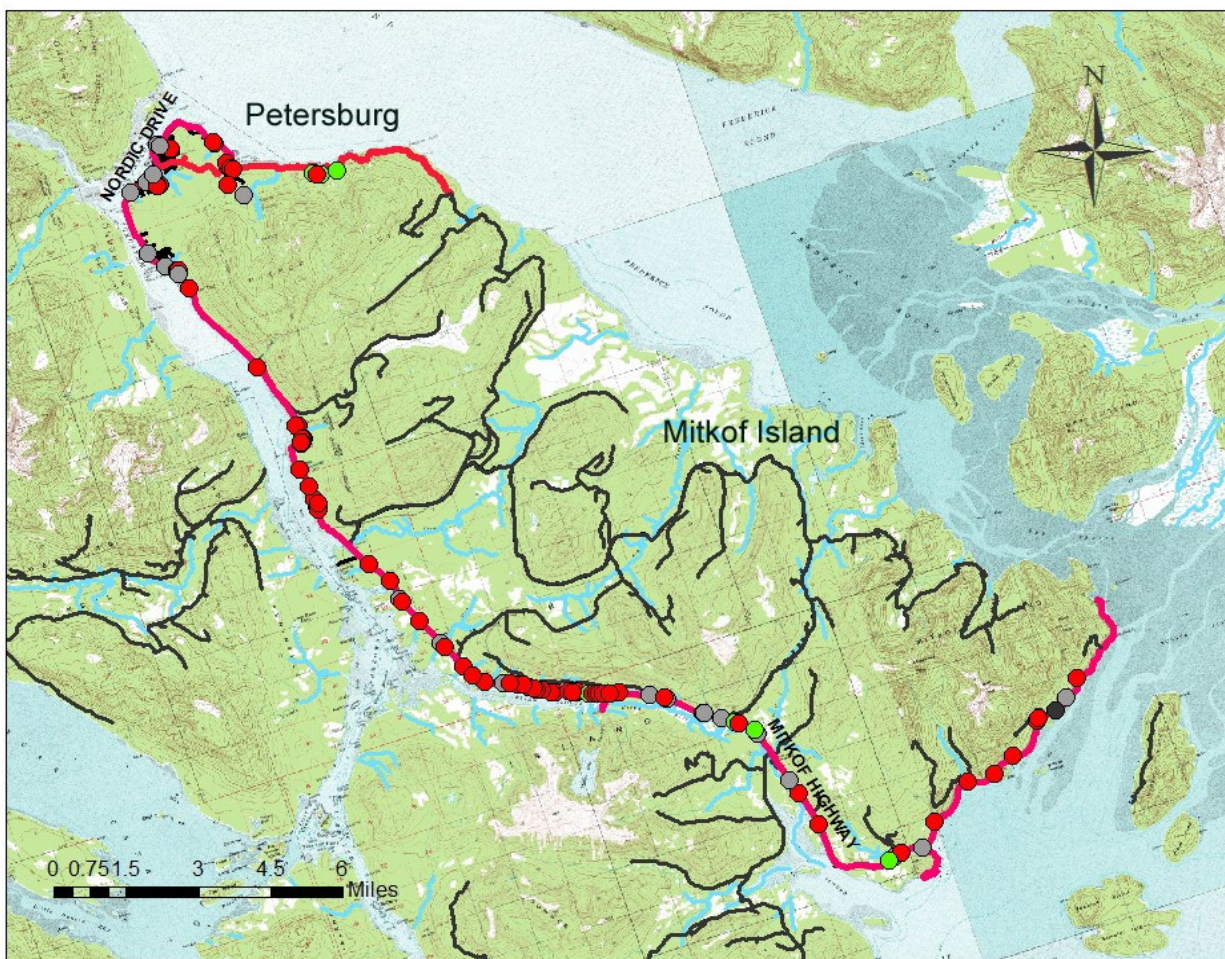
Figure 10.—Map of the sites assessed for fish passage on the Petersburg road system, with color-coded ratings.

In 2013 and 2014, 102 fish passage sites were assessed on over 75 miles of roads in the Petersburg area (Figure 10, Table 1). The major factors affecting fish passage at sites assessed in Petersburg were Red culvert gradients, Red outfall heights, and Gray constriction ratios (Table 5). Sixty-nine sites were rated Red (67.6%), 24 sites Gray (23.5%), 8 sites Green (7.8%), and 1 site Black (1%) (Table 3). Sixty-nine Red sites, 19 Gray sites, and 8 Green sites were on streams known to be fish bearing (Table 2). Thirty-eight sites were potential adult barriers of which 22 sites had outfall

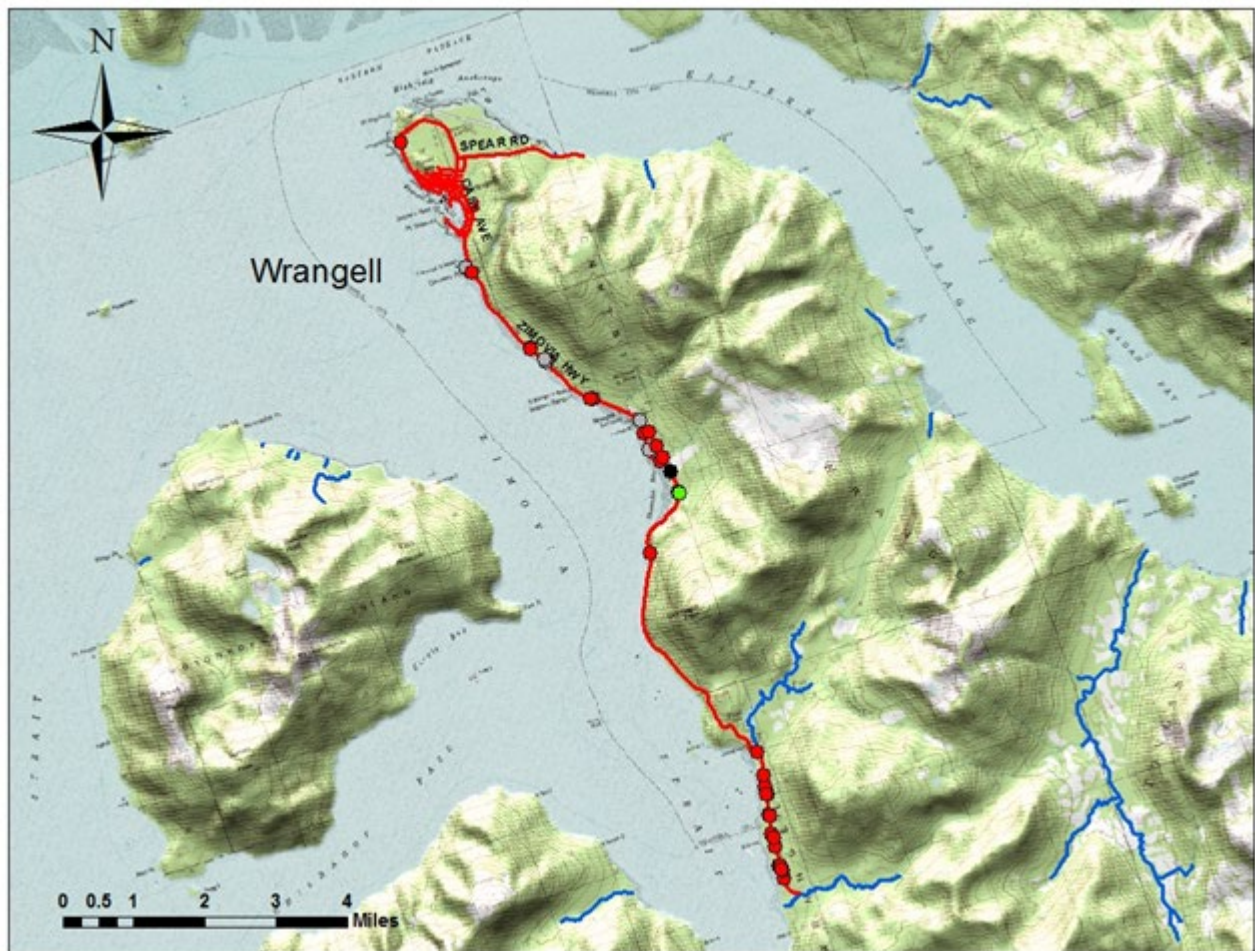
Figure 11.—Map showing sites assessed for fish passage on the Wrangell road system, with color-coded ratings.

In 2014 and 2016, fish passage assessment crews assessed 38 sites in the Wrangell area on over 24 miles of roads (Figure 11, Table 1). The major factors affecting fish passage at sites assessed in the Wrangell area were Red culvert gradient, Red outfall height, and Gray constriction ratio (Table 5). Thirty sites were rated Red (78.9%), 5 sites Gray (13.2%), 1 site Green (2.6%), and 2 sites Black (5.3%) (Table 3). Of those, 15 Red sites (78.9%), 3 Gray sites (15.8%), and 1 Green site (5.3%) were located on streams known to be fish bearing (Table 2). The project found 27 potential adult barriers of which 17 sites had an outfall height greater than 1 ft, 19 sites had a culvert gradient greater than 4%, and 9 of the 27 sites had both an outfall height greater than 1 ft and a gradient greater than 4% (Table 4).

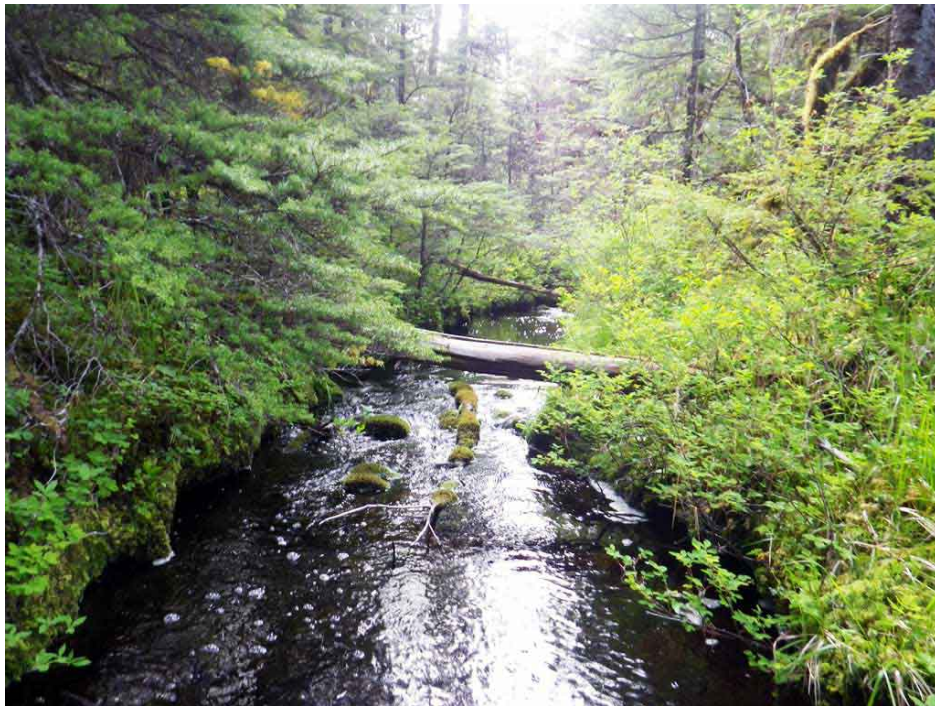
Figure 20.—Site 10203301, Mitkof Highway, Letti Creek (AWC# 106-44-10070), Petersburg, outlet showing outfall onto riprap barrier.
