PRELIMINARY INTERPRETIVE REPORT 2012-2

**ACTIVE AND POTENTIALLY ACTIVE FAULTS ALONG
THE ALASKA HIGHWAY CORRIDOR, TETLIN JUNCTION
TO THE CANADA BORDER**

Rich D. Koehler and Gary A. Carver

May 2012

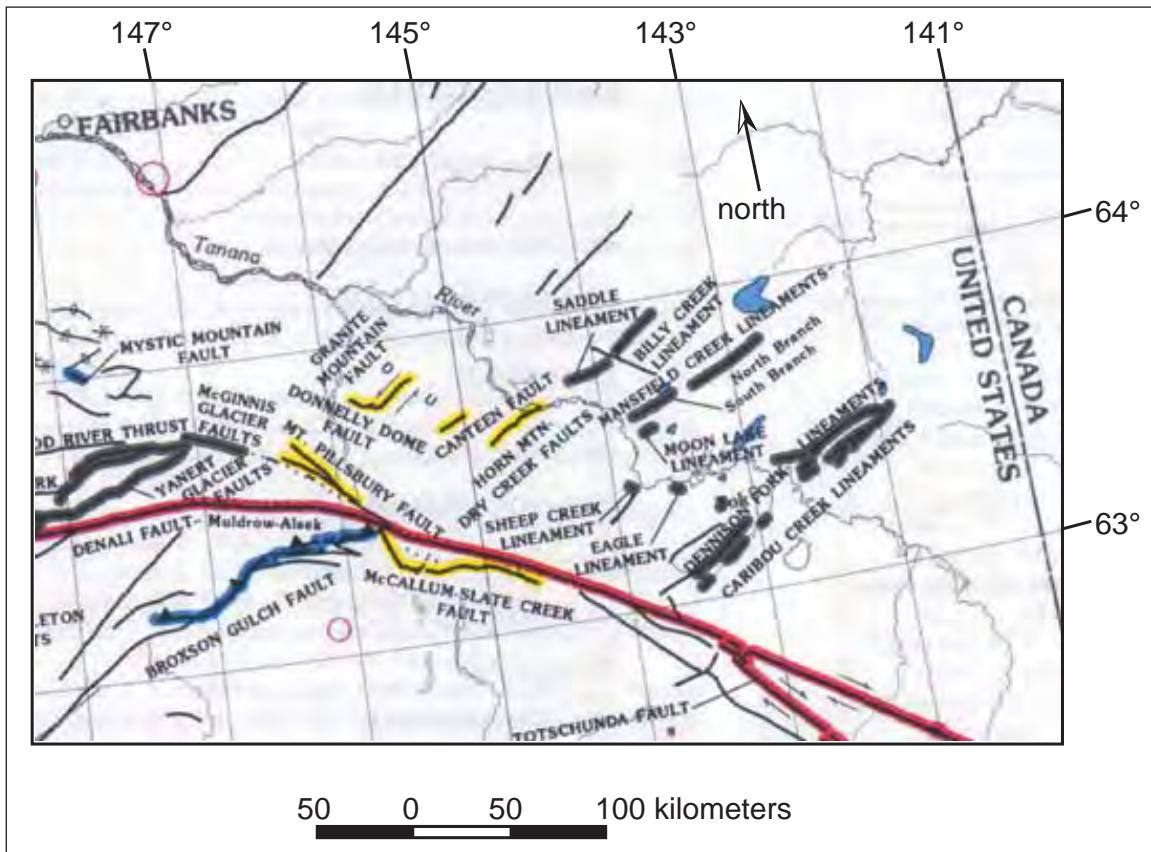
Figure 2. A section of the Neotectonic Map of Alaska (Plafker and others, 1994) showing the Caribou Creek and Dennison Fork lineaments as "suspicious" faults (shaded black).

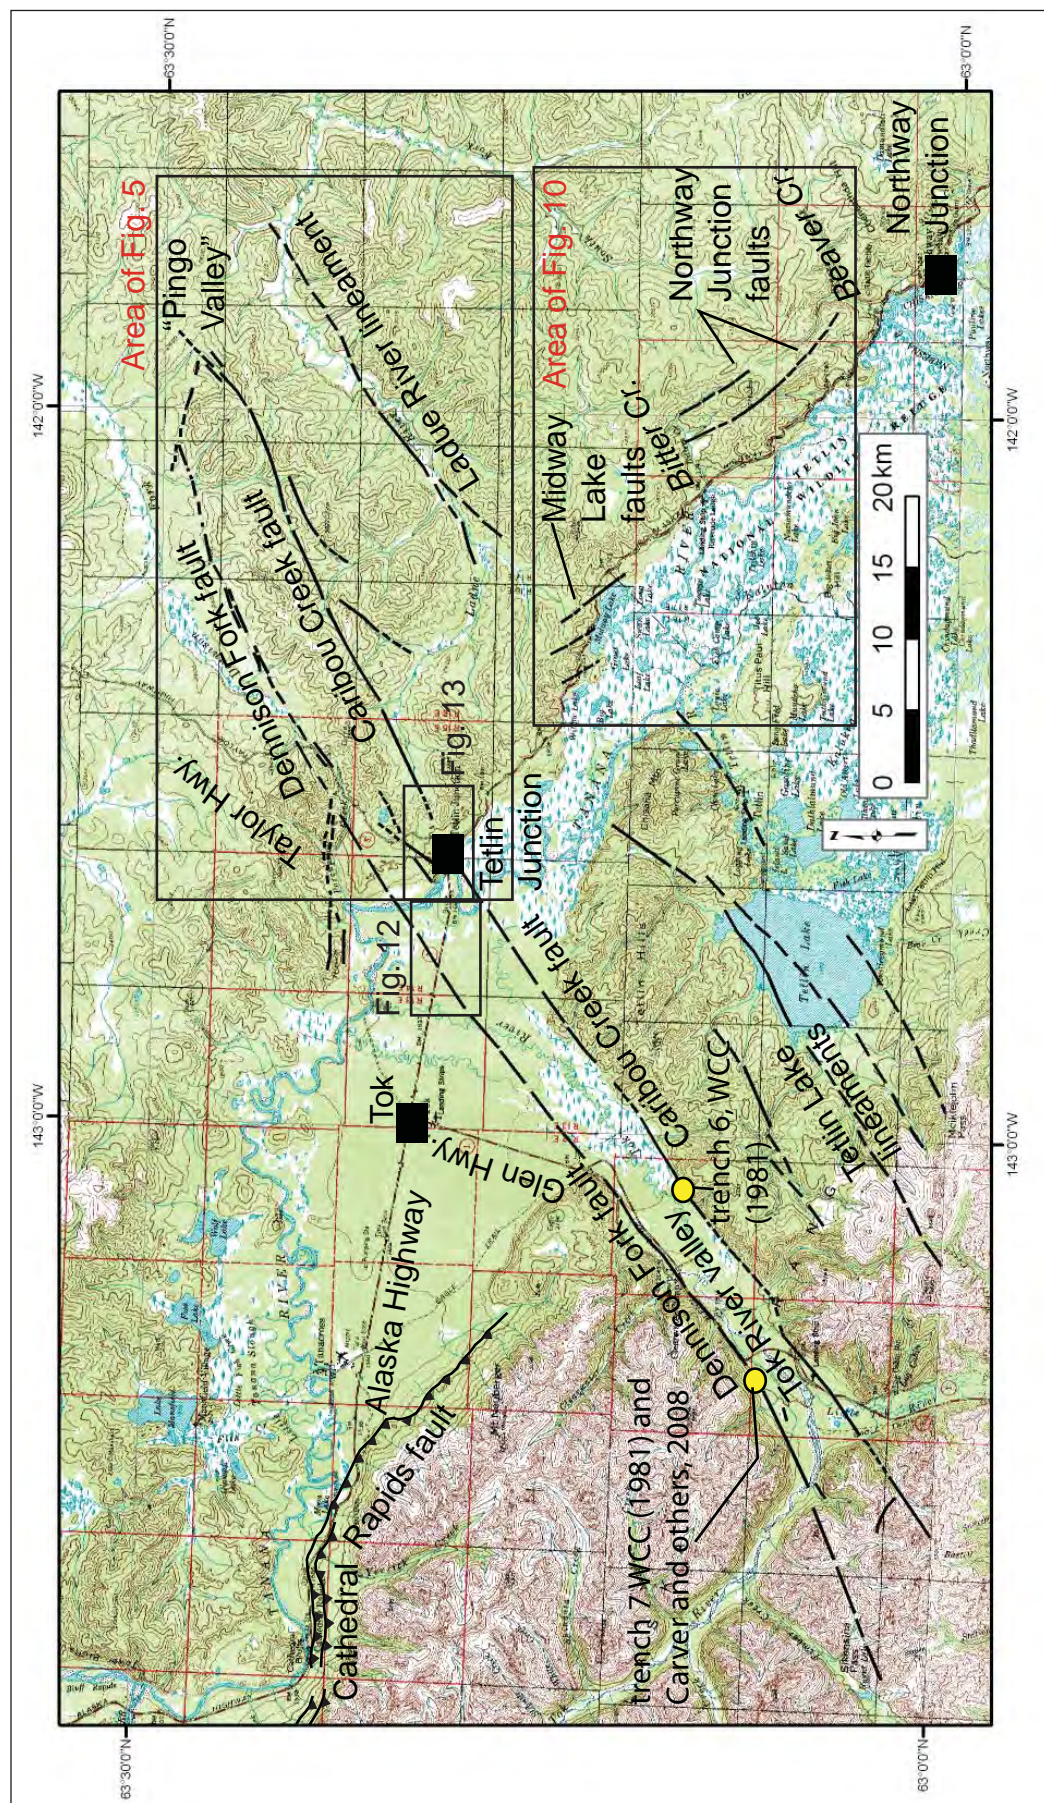
The Tok River lineaments were originally identified by Woodward–Clyde Consultants (1979) as a candidate significant fault zone extending northeast from the Tok River valley and into the Yukon–Tanana Upland (fig. 4). In their report the southwestern part of the zone was named the “Tok River lineament” and the northeastern part of the zone was divided into a northwest trace named the Dennison Fork lineament and a southeastern trace named the East Fork Aeromagnetic Anomaly. The Tok River lineament includes traces along both the northwestern and southeastern margins of the Tok River valley (WCC, 1979). The two traces were interpreted based on the linear valley margins and the presence of 4- to 7-m-high scarps along the bedrock/Quaternary alluvial contact. The possibility of active tectonic displacement along these inferred structures led Woodward–Clyde (1981) to perform more detailed field studies to further characterize the features. In their 1981 report, the system was called the Tok River fault zone and further subdivided into the upland and Tok Valley segments of the Dennison Fork fault and Caribou Creek fault (formerly the East Fork Aeromagnetic Anomaly). In this report, we use the later nomenclature to summarize the air photo and field observations of Woodward–Clyde Consultants (1979; 1981) and the results of this study.

Figure 4. Topographic map of the western part of the segment 3 study area showing faults investigated and the locations of previous trenches of Woodward-Clyde Consultants (1981) and Carver and others (2010).

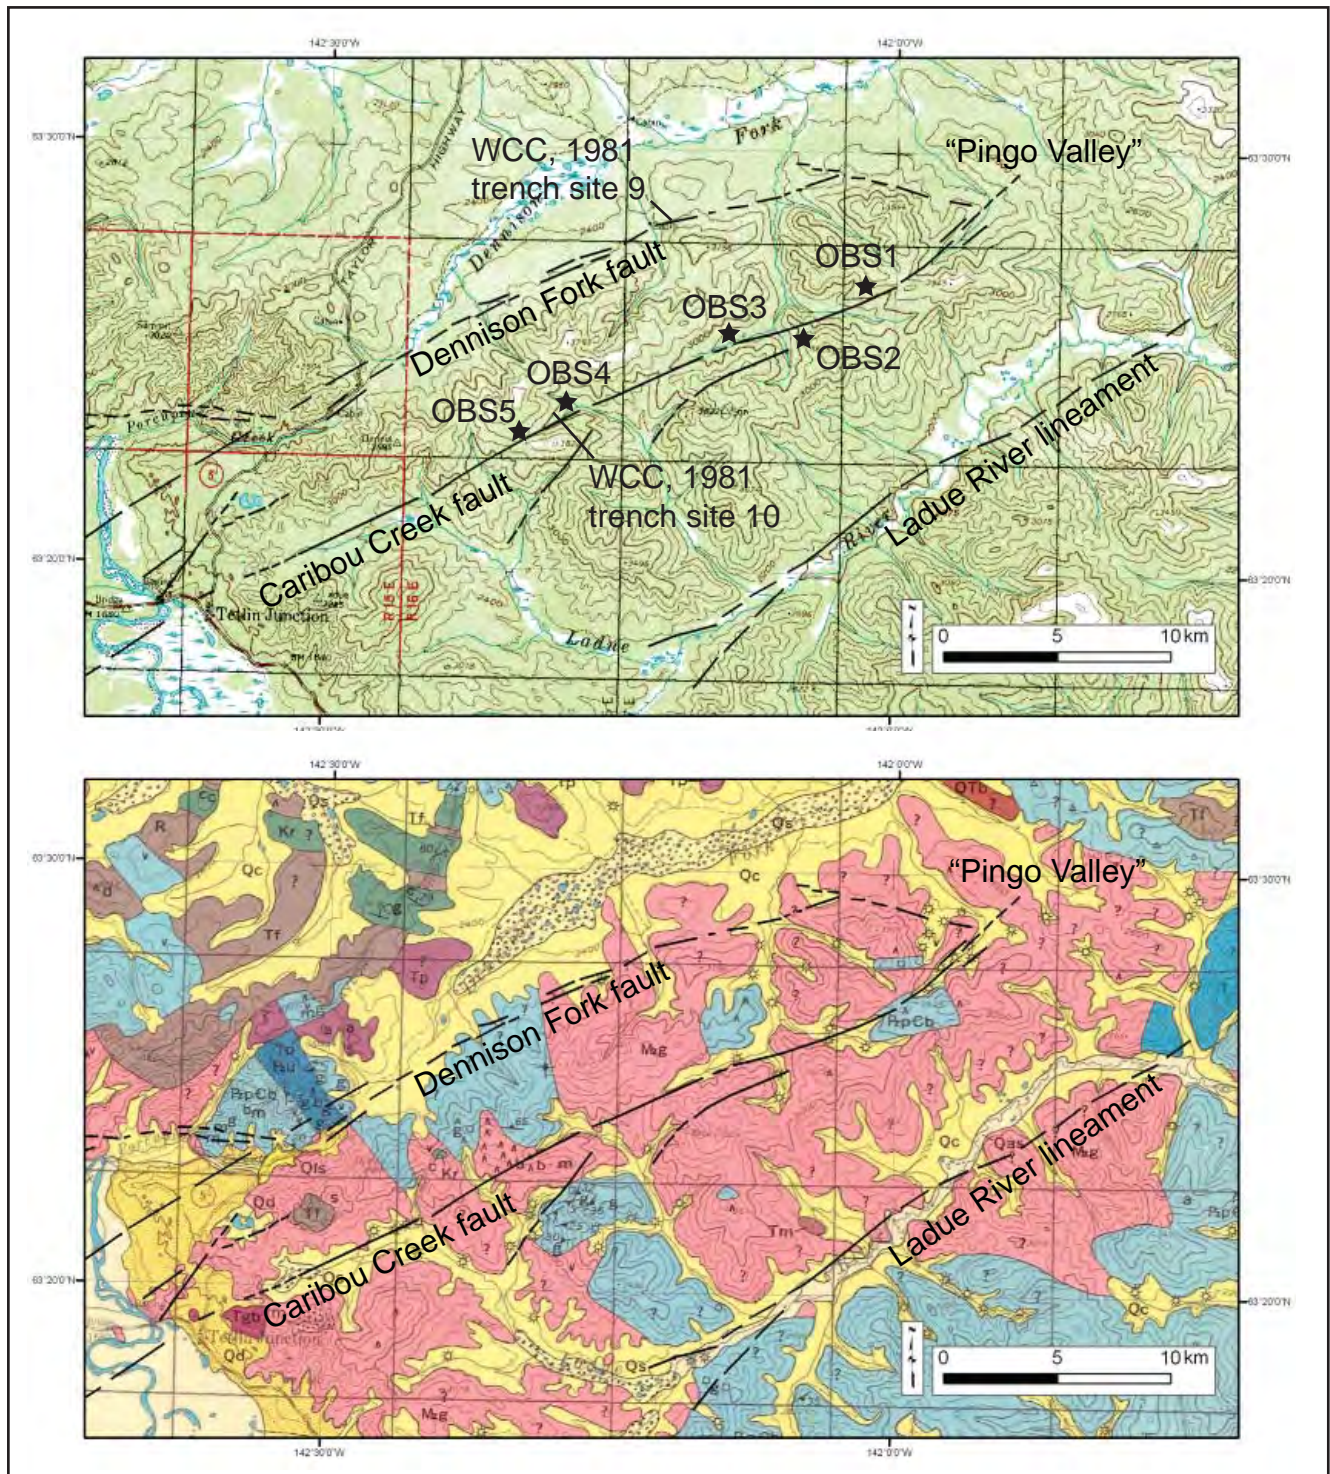
Figure 5. Topographic map (top) and geologic map (bottom) showing locations of the upland segments of the Dennison Fork and Caribou Creek faults and the Ladue River lineament. Also shown are observation points (OBS 1–OBS 5) from this study and locations of previous trenches by Woodward–Clyde Consultants (1981). Geologic map from Foster and others (1970).

range front is characterized by rounded subdued slopes, a well-developed drainage network, and low-gradient alluvial fans that grade into the Dennison Fork valley flats. Recent fires have cleared vegetation, providing for unobstructed views of surface morphology. We were unable to verify the majority of geomorphic features shown on the Woodward–Clyde (1981) map, and infer that these features were either modified and/or removed by surface processes over the last 30 years, were too subtle to definitively attribute their formation to active fault displacement, or were originally misinterpreted. Several vegetation lineaments may have been destroyed by fires.

A single fault trench (trench site 9, WCC, 1981) was excavated across the fault where it coincides with a subtle break in slope and crosses an inset terrace surface (fig. 5). The trench exposed granitic bedrock overlain by grus and alternating layers of silt and organic soils. Woodward–Clyde Consultants (1981) identified several faults in the granitic bedrock; however, they could not trace the faults into the overlying sediments, and none of the stratigraphic units depicted in the log are displaced. The alternating layers of silt and soils were interpreted by Woodward–Clyde (1981) to represent individual left-lateral offset events with surface faulting occurring as recently as $7,950 \pm 250$ yr BP (sample 9-C-5, plate C-4, WCC, 1981). Alternatively, the buried soils could be produced by airfall tephras or variable eolian loess deposition over time, or both. Further, the plan view map of site 9 (WCC, 1981) does not show a lateral offset of the terrace riser, which is inconsistent with repeated Holocene earthquakes. We infer that the stratigraphic relations are depositional and that the trench does not record Holocene surface-rupturing earthquakes. This inference is consistent with the weak tectonic geomorphology and absence of youthful surficial scarps at the trench site. We did observe a short bedrock scarp preserved on a bedrock knob outboard of the range front directly north of trench site 9. This scarp is oriented slightly more westerly than the mapped trace of the fault and does not continue into the alluvium to the west.

Based on the lack of youthful, continuous tectonic indicators, the presence of a sinuous, well-degraded range front, and a reinterpretation of the trench log of site 9, we infer that the upland trace of the Dennison Fork fault has not been active during the Holocene, and likely the Quaternary. We further infer that the location of the fault on previous maps is poorly constrained and may be buried somewhere in the Dennison Fork valley consistent with bedrock differences across the valley. Some of the lineaments discussed in the Woodward–Clyde Consultants report (1981) could be related to bedrock bedding contrasts or old faults.

Approximately 9 km southwest of Pingo Valley, an alignment of pingos and a well-expressed south-facing scarp extends along the northern side of an east- to west-trending valley (OBS 1, fig. 5). This scarp is slightly misaligned with the mapped trace of the fault and appears to be confined to bedrock. Southwest of this feature, the fault projects across a spur ridge that is not deformed (OBS 2) and continues southwest along another linear valley (OBS 3) characterized by intermittent subtle to moderately expressed northwest-facing scarps along the base of the slope on the south side of the valley. Piles of boulders have accumulated at the base of the scarps and bedrock is exposed in the scarp faces.

At OBS 3, a north-facing alluvial fan emanates from a broad colluvial hollow that occurs along the alignment of scarps (figs. 5 and 6). From the air, we noted the possibility of the fault extending part way across the eastern side of the fan. Subsequently, we conducted ground traverses along the fault and surveyed several topographic profiles to evaluate the recency of faulting in more detail. A semi-continuous bedrock scarp ranging from 2 to 10 m high extends along the base of the slope on either side of the fan (figs. 6 and 7). Scattered tabular boulders averaging 1–2 m in diameter are present at the base of the scarp. Profiles 1 and 2 were surveyed across the scarp west and east of the fan, respectively. These profiles show the scarp is gently sloping, but contains several subtle breaks in slope (bevels?). Profile 2 has an oversteepened base; however this feature is localized. Profile 3 was surveyed across the projection of the scarp in the older part of the alluvial fan (surface Hf2, fig. 6), where we observed two

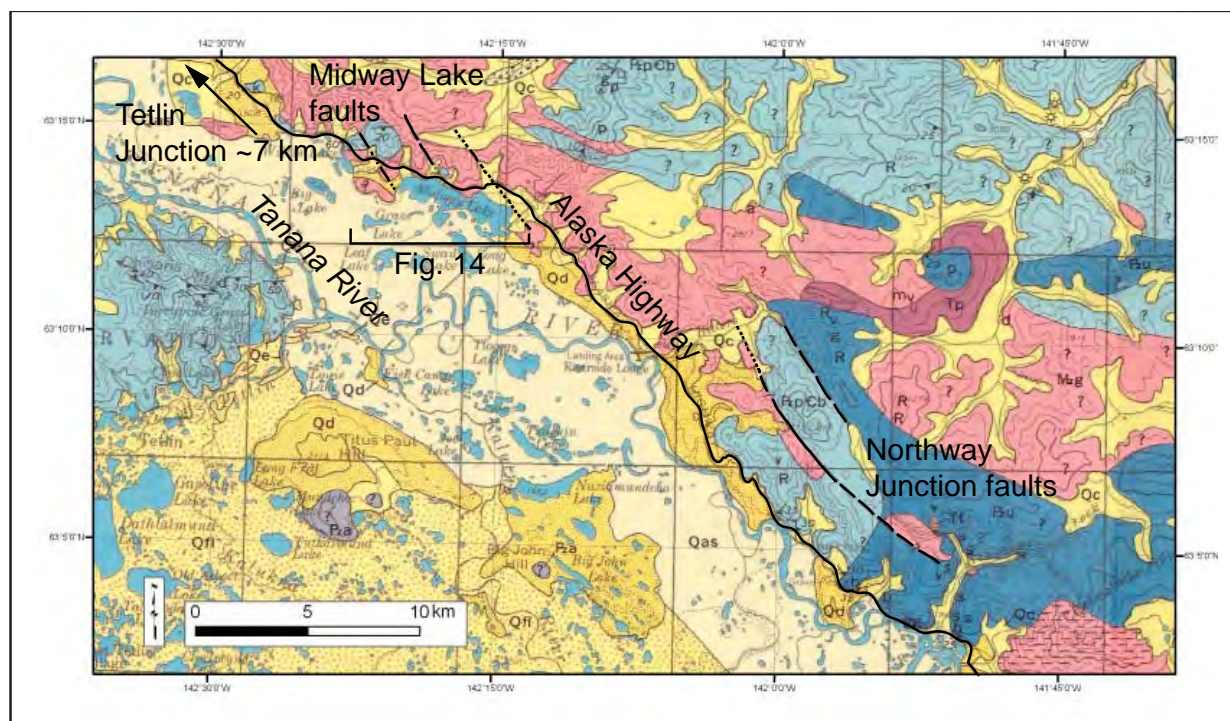
The Midway Lake faults consist of three roughly parallel N30°W- to N35°W-trending faults that occur north of Midway Lake, approximately 15 km southeast of Tetlin Junction (figs. 4 and 10). In this report we refer to the traces of the Midway Lake faults as Midway Lake East, Midway Lake Central, and Midway Lake West faults. The faults were mapped by Foster (1970) as approximately located and concealed, extending short distances (~3 to 5 km) across granitic and metamorphic rocks. We performed independent ground and aerial reconnaissance along the Midway Lake faults. Topographically, the faults are not well defined, although several poorly developed saddles and sidehill drainages are noted (WCC, 1979). Woodward–Clyde (1979) did not observe geomorphic, hydrologic, geologic, or vegetational features suggestive of active faulting along the Midway Lake faults or along their projection into Quaternary and Holocene surficial deposits.

In the hills along the southern side of the Yukon–Tanana Upland, the Midway Lake faults are only expressed by broad, subdued saddles in the crests of bedrock knolls. The Midway Lake West fault projects southeast from a broad saddle in a rounded ridge, down a south–southeast-trending gully and into the Tanana River floodplain between Swan Lake and Long Lake. A roadcut (milepost 1291) approximately 100 m west of the fault reveals granitic bedrock overlain by 1–2 m of loess. A well-developed cambic soil has developed into the loess, which is unbroken across the length of the roadcut. Ground traverses were conducted across the mapped trace of the Midway Lake West fault northwest of the highway. Several old roads were encountered, however, no scarps or other geomorphic indicators of the presence of a youthful fault were observed. A volcanic outcrop on the east side of the gully, which contrasts with the granitic rock observed to the west, indicates the presence of a bedrock fault contact beneath the gully.

Figure 10. Location of the Midway Lake and Northway Junction faults shown in the geologic map of Foster and others (1970).

The Midway Lake Central fault trends along a gently sloping, southeast-trending valley north of the highway and projects into Midway Lake. In the Tanana River floodplain the fault projects along the southeast side of Long Lake. We performed several ground traverses across the fault approximately 100–200 m north of the highway. Although we discovered several old, overgrown roads, the floor of the valley was observed to be flat to gently rolling, with no indication of scarps or other tectonic features trending south–southeast down the valley. Both the Midway Lake West and Central faults project across Quaternary deposits of the Tanana River floodplain, including abandoned and inactive floodplain alluvium, stream terrace alluvium, swamp, and eolian deposits (Reger and others, 2011). Aerial observations indicate that these sediments are not displaced along either fault, and continuous lineaments oriented south–southeast are absent.

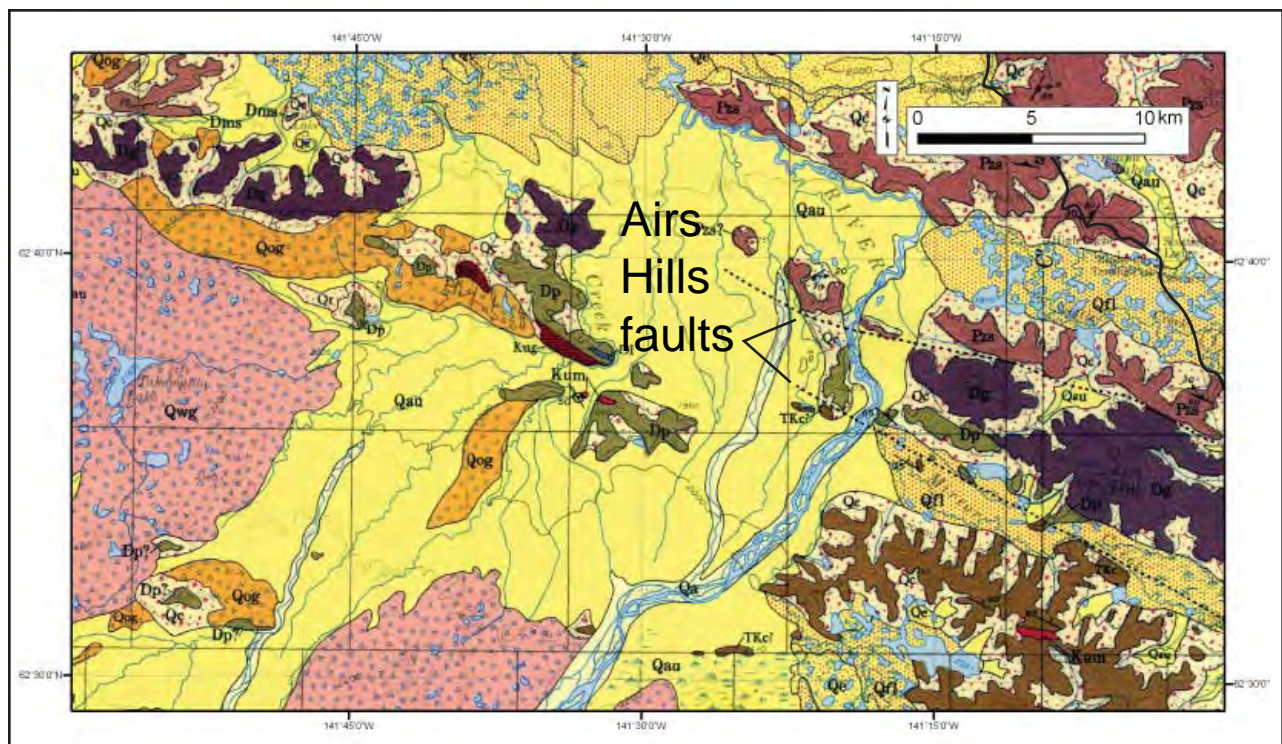
The Airs Hills faults generally bound Airs Hill and consist of two subparallel N70°W-trending faults originally mapped by Richter (1976) in Alaska and by Tempelman-Kluit (1974) across the border in the Yukon Territory (fig. 11). In Alaska, the faults are primarily concealed beneath alluvium and their locations are inferred from bedrock relations exposed in the hills on either side of the fault traces. The northern fault trace juxtaposes lower Paleozoic quartz–mica schist on the north against Devonian massive greenstone on the south. The southern fault separates Devonian phyllite and metaconglomerate on the north from Tertiary or Cretaceous conglomerate and sandstone on the south. The Chisana River crosses each fault trace at a high angle and is not laterally displaced. Woodward–Clyde Consultants (1979) suggested that tonal and vegetation anomalies may align with drainages, but determined that geomorphic features indicative of active faulting were absent along the faults.

Helicopter reconnaissance was conducted along the entire length in Alaska of both traces of the Airs Hills faults. Near the vicinity of the Canada border along the northeastern side of Airs Hill, the northern fault trace is mapped along a sideslope of a broad, gently sloping valley. A second linear vegetation lineament occurs south of the mapped trace. No scarps or other tectonic geomorphic features were observed along the mapped trace and the

Figure 11. Location map of the Airs Hills faults shown in the geologic map of Richter (1976).

vegetation lineament was determined to be an embankment related to stream-channel incision. Farther west, the northern trace extends across a broad tributary valley to Scottie Creek. There, the topography along the fault trace is characterized by a slight topographic high that appears to deflect headwater-draining streams to the east about 30 m. However, based on smooth, gentle-gradient slopes along the fault directly east and west of the topographic high and the absence of clear scarps, we infer that the topographic high may be related to variable differences in erosion of the bedrock and not related to youthful faulting. The southern fault trace extends along the alluvial valley of Mirror Creek and is mapped as concealed along its entire length (Richter, 1976). We observed several linear stream segments along Mirror Creek; however, the valley floor is flat, devoid of scarps, and does not appear to be deformed along the fault trace. The southern range front of Airs Hill along the southern trace is deeply eroded by a well-developed drainage network and is not straight. Several isolated, partially buried bedrock knobs along the fault trace may be evidence of older deformation along the fault. Geomorphic indicators of youthful tectonic deformation are not present along either trace of the Airs Hills faults, indicating that these faults have not been active in the Holocene.
