PB90-916405  
NTSB/MAR-90/04

# NATIONAL TRANSPORTATION SAFETY BOARD

## MARINE ACCIDENT REPORT

GROUNDING OF  
THE U.S. TANKSHIP EXXON VALDEZ  
ON BLIGH REEF, PRINCE WILLIAM SOUND  
NEAR VALDEZ, ALASKA  
MARCH 24, 1989

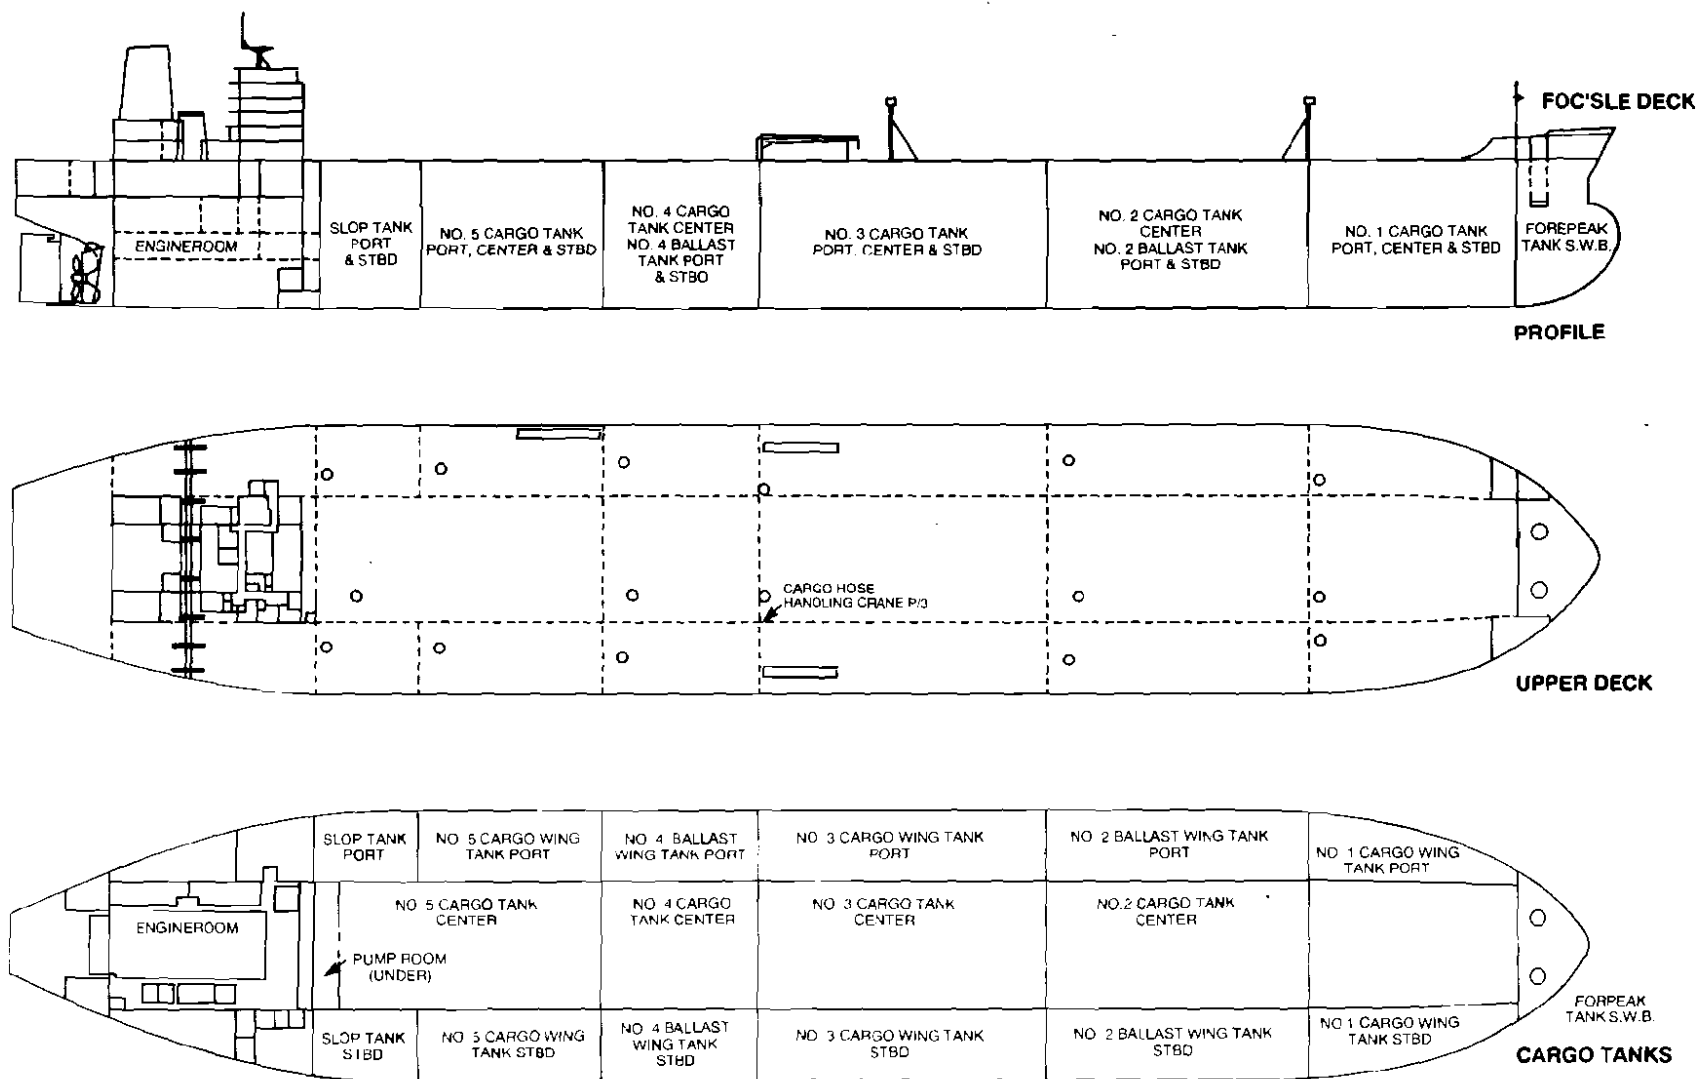
Figure 4.--Profile and plan views of EXXON VALDEZ.

The EXXON VALDEZ was a typical modern tankship of all welded steel construction with a continuous main deck, raised foc'sle, straight raked stem, bulbous bow and transom-type stern. (See figure 4.) A split deckhouse was located aft on the main deck of the vessel above the engineroom. The forward section of the split deckhouse contained the navigation bridge (wheelhouse), radio room, recreation rooms, officer and crew dining facilities and accommodations, steward's stores, hospital, gymnasium, swimming pool, and the cargo control room. An overhead gantry-type crane for handling ship's stores was installed athwartship in the space between the forward and after sections of the split deckhouse. The after section of the deckhouse contained the emergency diesel generator room, inert gas system, halon cylinder storage room, and the emergency battery room. The machinery spaces below the split deckhouse contained the main propulsion engine, machinery control room, steering gear room, ships service electrical generators, and auxiliary machinery.

The EXXON VALDEZ measured 987 feet long overall, 166 feet wide, and 88 feet deep from the main deck (at the side) to the flat keel. The tankship had a maximum draft (loaded) of 64.5 feet with a corresponding deadweight tonnage of 214,861 and a displacement of 240,291 long tons. At maximum draft, the tankship could transport about 1.48 million barrels of crude oil per voyage.

Eighteen cargo, ballast, and slop tanks were located forward of the pumproom and were divided into five transverse tank sections. The sections were numbered from 1 to 5, beginning at the bow, with a port wing tank, a center tank, and a starboard wing tank in each section. The ballast tanks consisted of the forepeak, Nos. 2 and 4 port, and starboard wing tanks. The cargo oil tanks included Nos. 1 across (port wing, center, and starboard wing), center No. 2, Nos. 3 across, center No. 4, and Nos. 5 across. A permanently installed crude oil wash system was fitted in all the cargo tanks. Slop tanks were located aft of port and starboard wing cargo oil tanks Nos. 5. Void tanks (double bottoms) were located below the port and starboard slop tanks.

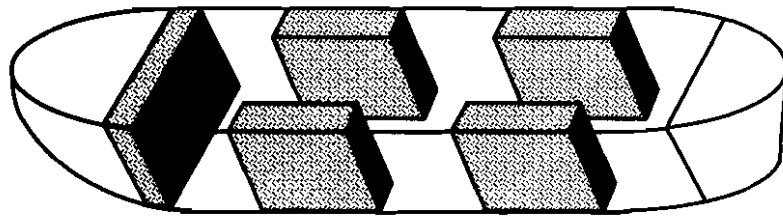
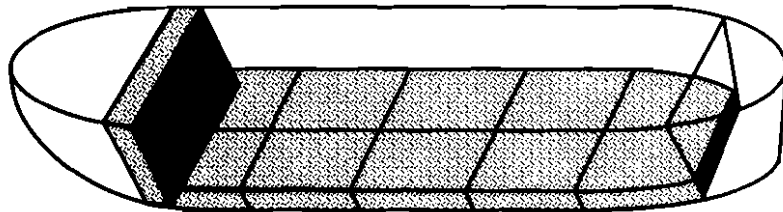
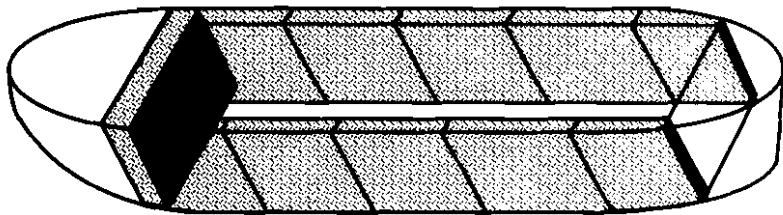
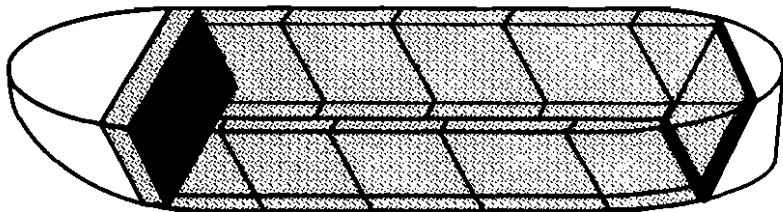
Figure 12.--Tankship design alternatives.

- (a) Double Bottoms.--Tank vessels can be designed and constructed with various tank arrangements that can reduce the oil outflow if there is an accident. For instance, a tank vessel can be fitted with a double bottom extending along the length of the cargo tank area as shown in figure 12b. (See page 87.)

collision protection, a tank vessel can be designed with double sides, with the longitudinal bulkheads fitted closer to the side shell and all the wing tanks dedicated to carrying water ballast, as shown in figure 12c (see page 87). This design provides maximum protection against collision damage but no protection against grounding damage.

- (c) Double Hulls.--A tank vessel can be designed with a double hull in which water ballast would be placed in both double bottom and wing tanks, as shown in figure 12d (see page 87). Although this option probably entails the highest construction cost, at about 15 to 19 percent of total construction costs, it provides maximum protection against oil outflow owing to collisions and groundings. A tank vessel fitted with a double hull would have adequate ballast capacity to navigate in heavy weather without having to use any cargo tanks, thereby minimizing operational pollution. For example, in addition to the ballast in the wing ballast tanks, the EXXON VALDEZ needed to load about 25,000 long tons of water ballast into the No. 3 center cargo tank to navigate safely under heavy weather conditions.

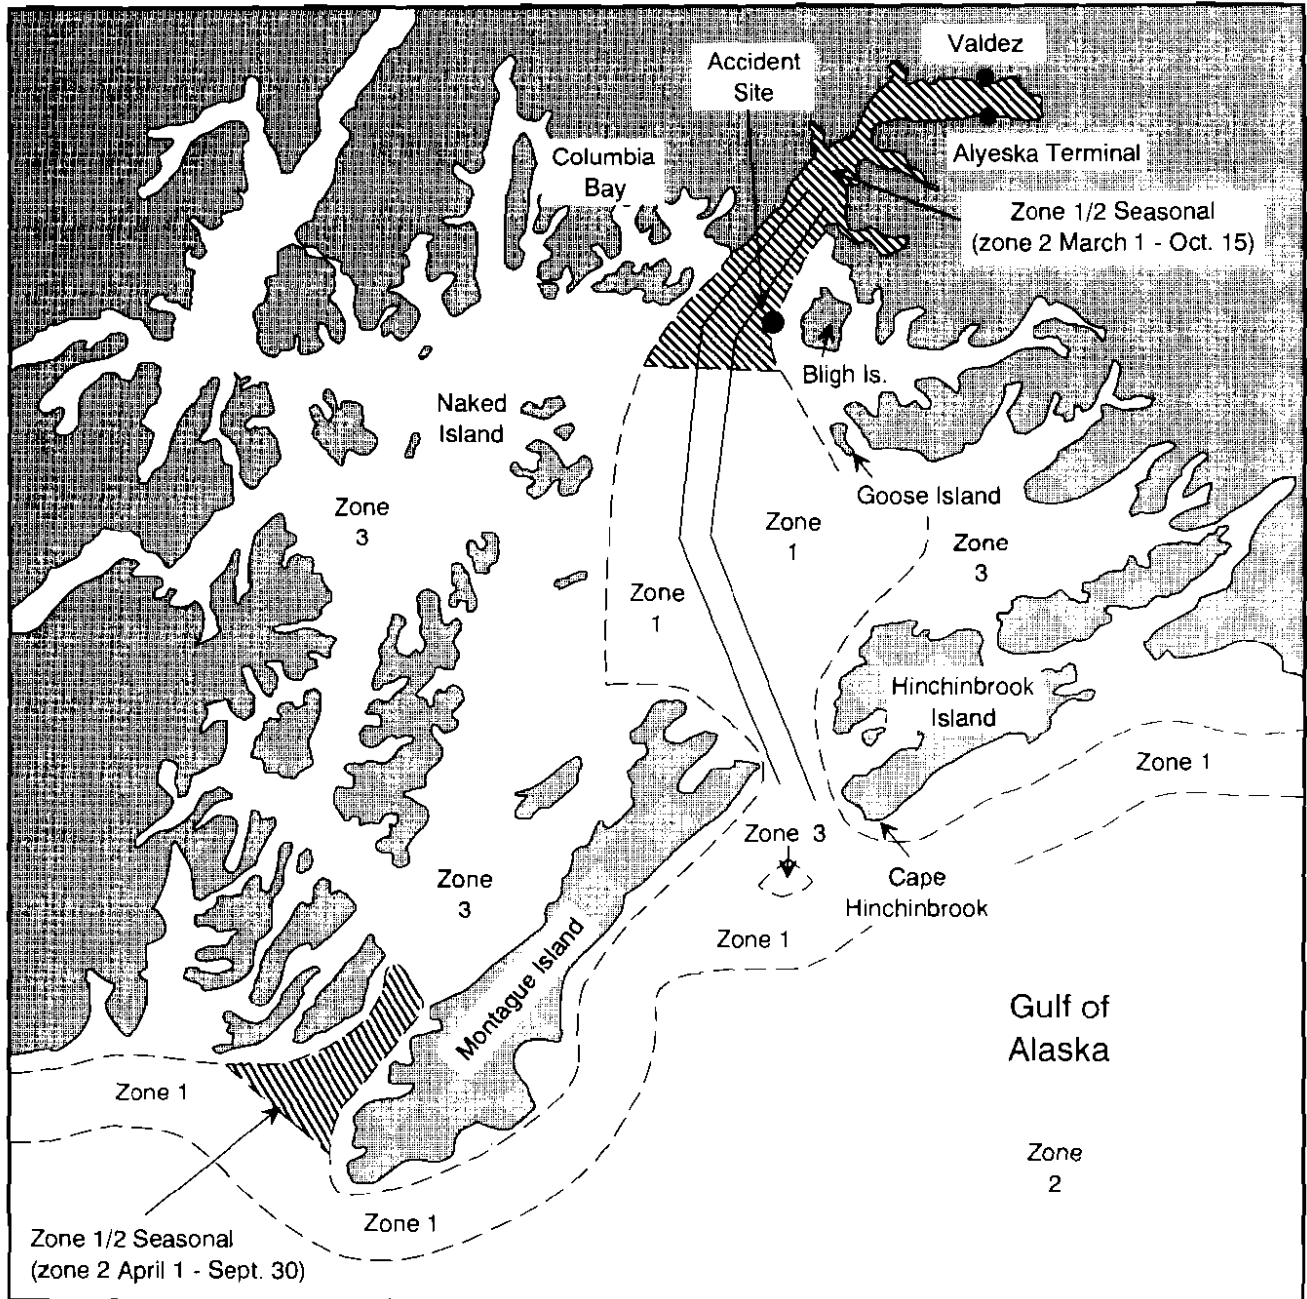
Figure 13.--Oil dispersant use zones.

The cochairmen of the RRT on March 10, 1989, and ADEC's Chief, Oil and Hazardous Spill Response Section on March 20, 1989, approved an amendment to the Memorandum of Agreement between the Coast Guard, EPA, and ADEC regarding Oil Dispersant Use Guidelines for Alaska that specifically addressed the use of dispersants in Prince William Sound and incorporated this amendment into the RCP for Alaska. The Sound was divided into three zones (see figure 13):

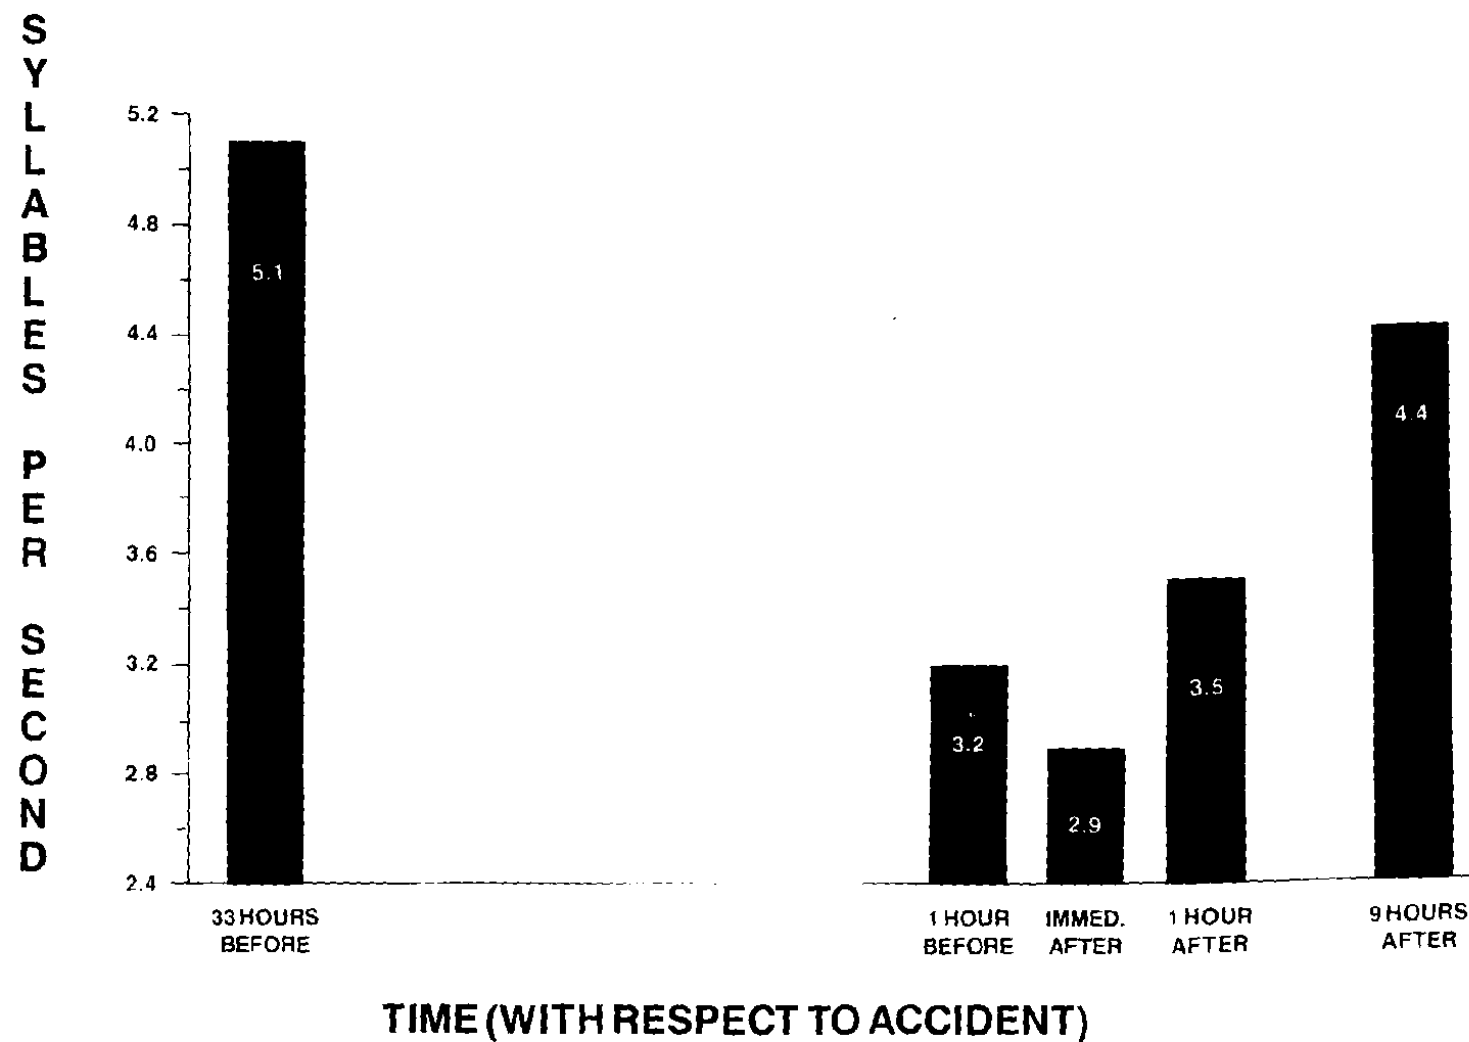
Figure 15.--Graph summarizing speaking rate.

speech 9 hours after the accident and that it was significantly slower than his speech 33 hours before the accident.

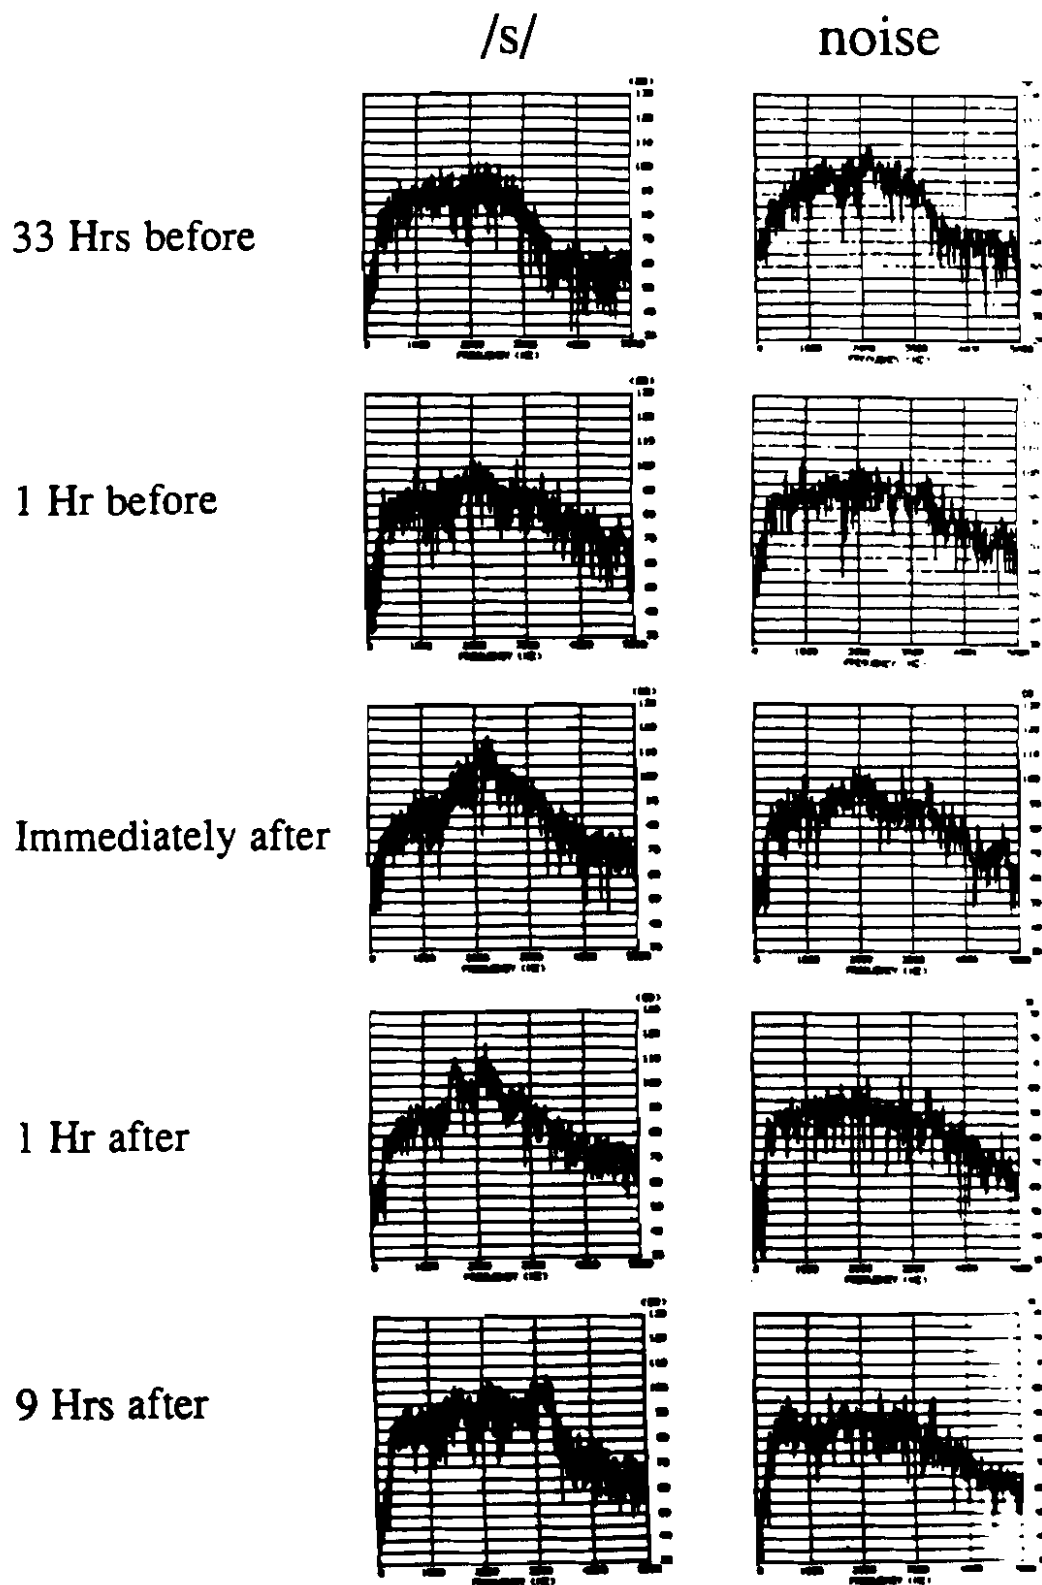
Figure 3. Power spectra of /s/ paired with spectra of nearby open-mike pauses from each of the NTSB recordings.

duction. In listening to the recordings, we observed a number of gross misarticulations and segmental misarticulations around the time of the accident. We also found acoustic evidence in two of the recordings made near the time of the accident (0, +1) for a misarticulation of /s/. Finally, we found that Captain Hazelwood was speaking more slowly, and used a lower fundamental frequency with more fundamental frequency jitter around the time of the accident as compared with his speech 33 hours before the accident and his speech in the televised interview.

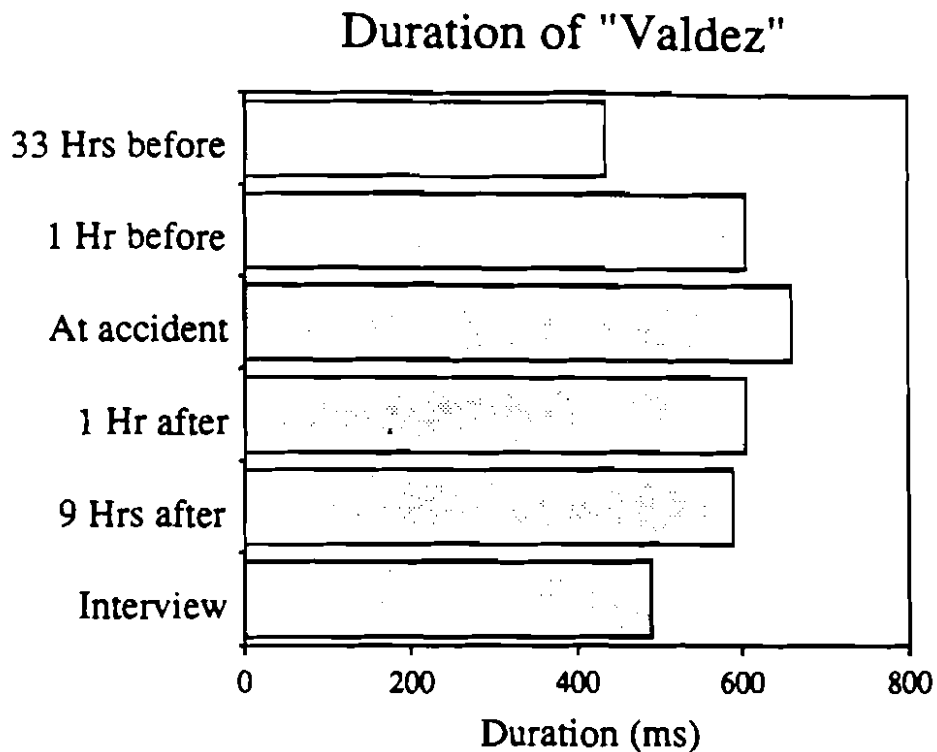
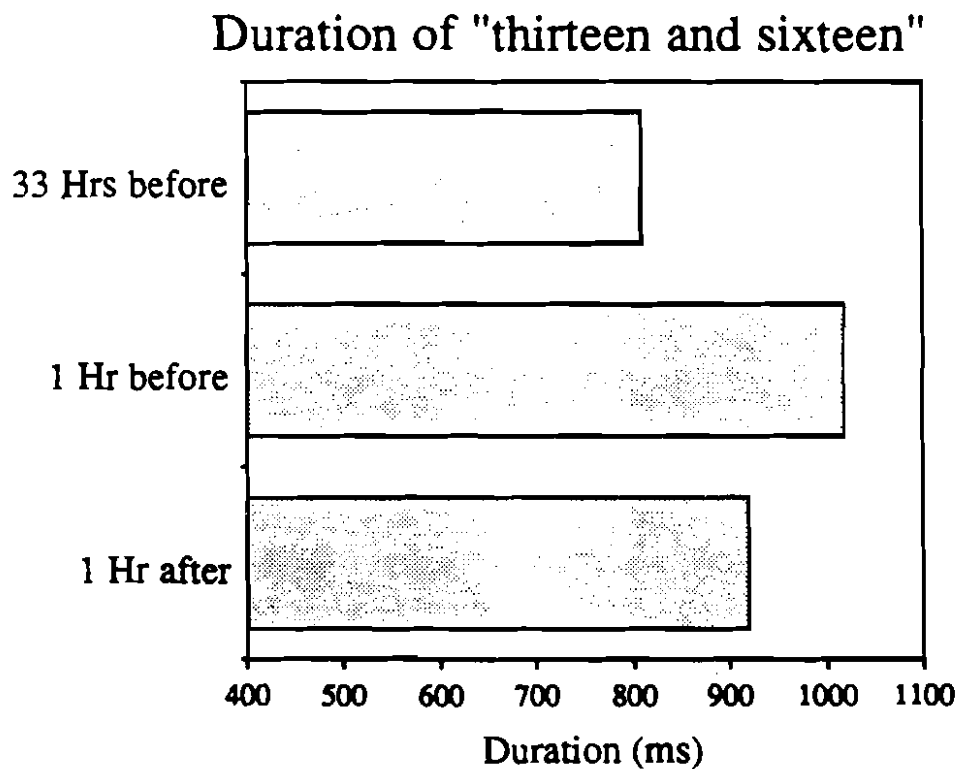
We also measured the duration of the phrase *thirteen and sixteen* which occurred in discourse final position in three of the recordings (33 hours before the accident, one hour before the accident and one hour after the accident). These measurements are shown in the bottom panel of Figure 5. As with the durations of the phrase *Exxon Valdez*, this analysis indicates that Captain Hazelwood was speaking more slowly in the recordings made around the time of the accident than in the recording made 33 hours before the accident.

**Figure 5.** Top panel: Duration of the word *Valdez* from the NTSB tapes (data is the same as that in Figure 4) compared with the same word produced in a similar discourse position in the televised interview. Bottom panel: Duration of the phrase *thirteen and sixteen* from recordings made at three times around the time of the accident.

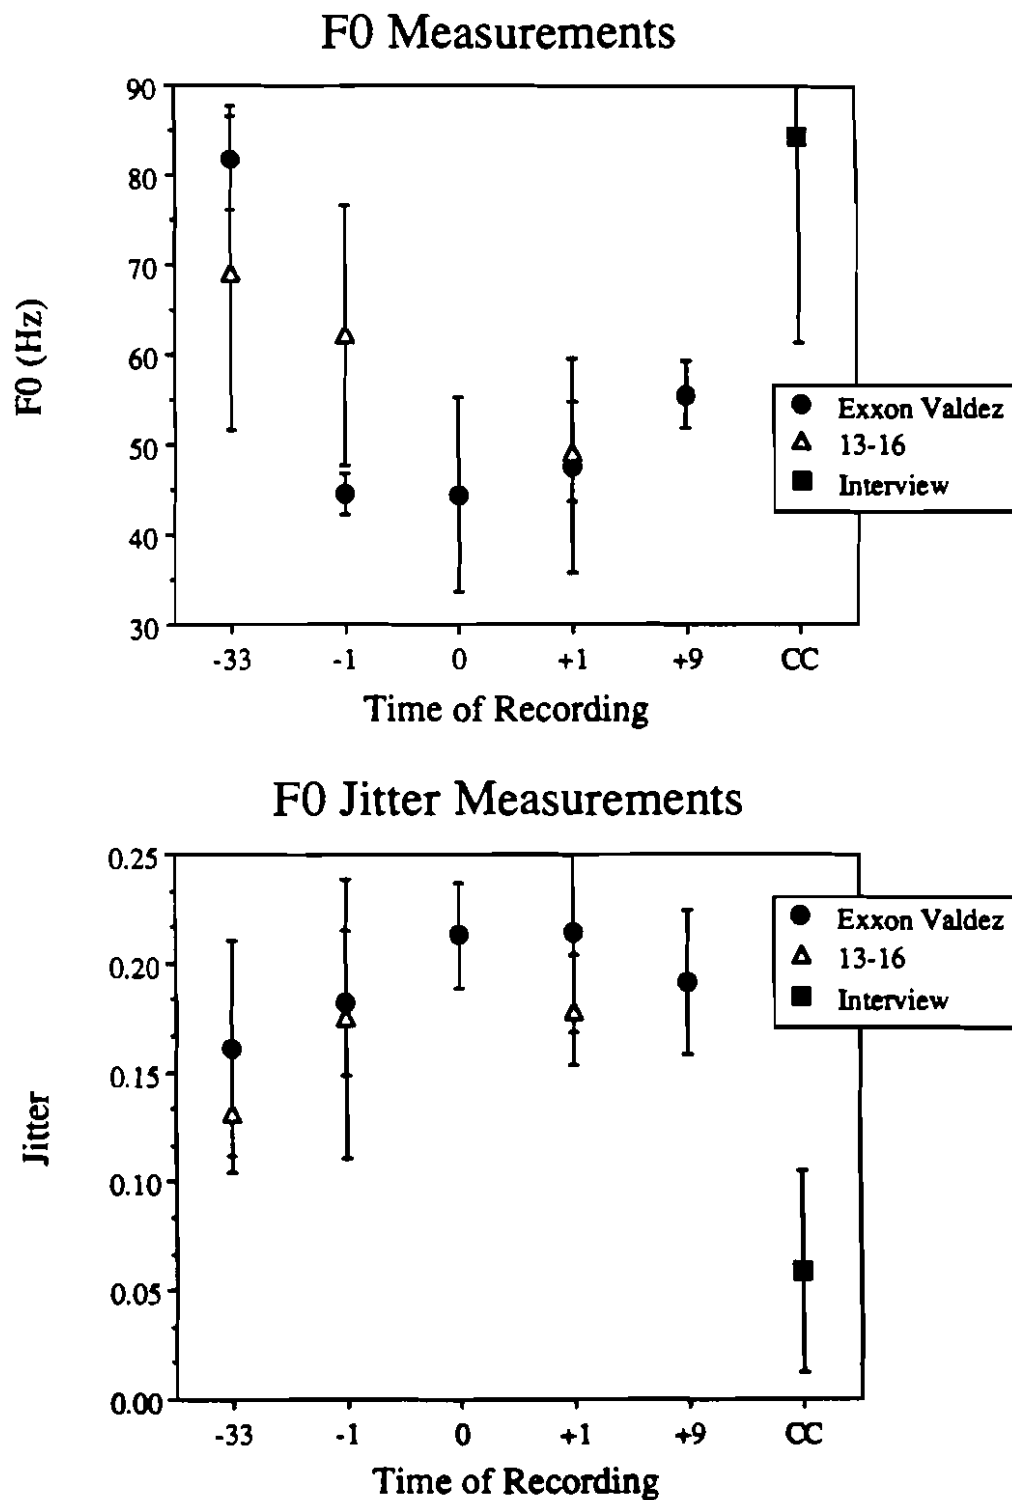
The top panel of Figure 6 shows voice fundamental frequency (F0) averaged across the phrase *Exxon Valdez* in each of the speech samples, the phrase *thirteen and sixteen* from three of the NTSB recordings, and one sentence from the televised interview. We took F0 measurements from each of the four vowels in *Exxon Valdez* (which occurred at least twice in each of the NTSB recordings). We were not able to measure F0 in all of the vowels in *thirteen and sixteen* because this phrase occurred in utterance final position in the recordings and was produced with quite low amplitude. Each point in Figure 6 for *thirteen and sixteen* is based on measurements from at least two vowels. The last point in each panel shows data averaged across a sentence in the televised interview<sup>9</sup>.

As the top panel shows, voice fundamental frequency was dramatically lower in the samples recorded around the time of the accident.<sup>10</sup> Also, this panel shows the average F0 range in each speech sample. The different samples cannot be distinguished by their F0 range (except perhaps the items from the recording made nine hours after the accident), but there was a trend for items near the time of the accident to have more F0 jitter (bottom panel of Figure 6). This finding is consistent with Pisoni & Martin's (1989) observation that speakers had higher standard deviation of F0 after alcohol consumption. (Note the discussion above concerning the ways in which SD F0 may be affected.) The lower jitter in the sentence taken from the televised interview (CC) is consistent with Brenner et al.'s (1985) observation that talkers have less F0 jitter when in stressful situations.

Figure 6. Top panel: Average fundamental frequency (pitch of voice) in *Exxon Valdez*: thirteen and sixteen and from one sentence in the televised interview as a function of time of recording. Bottom panel: F0 jitter measurements from the same speech samples.
