Klawock Watershed Road Condition Survey

Jeff Nichols, Brian Frenette, and Moira Ingle

December 2002

Alaska Department of Fish and Game

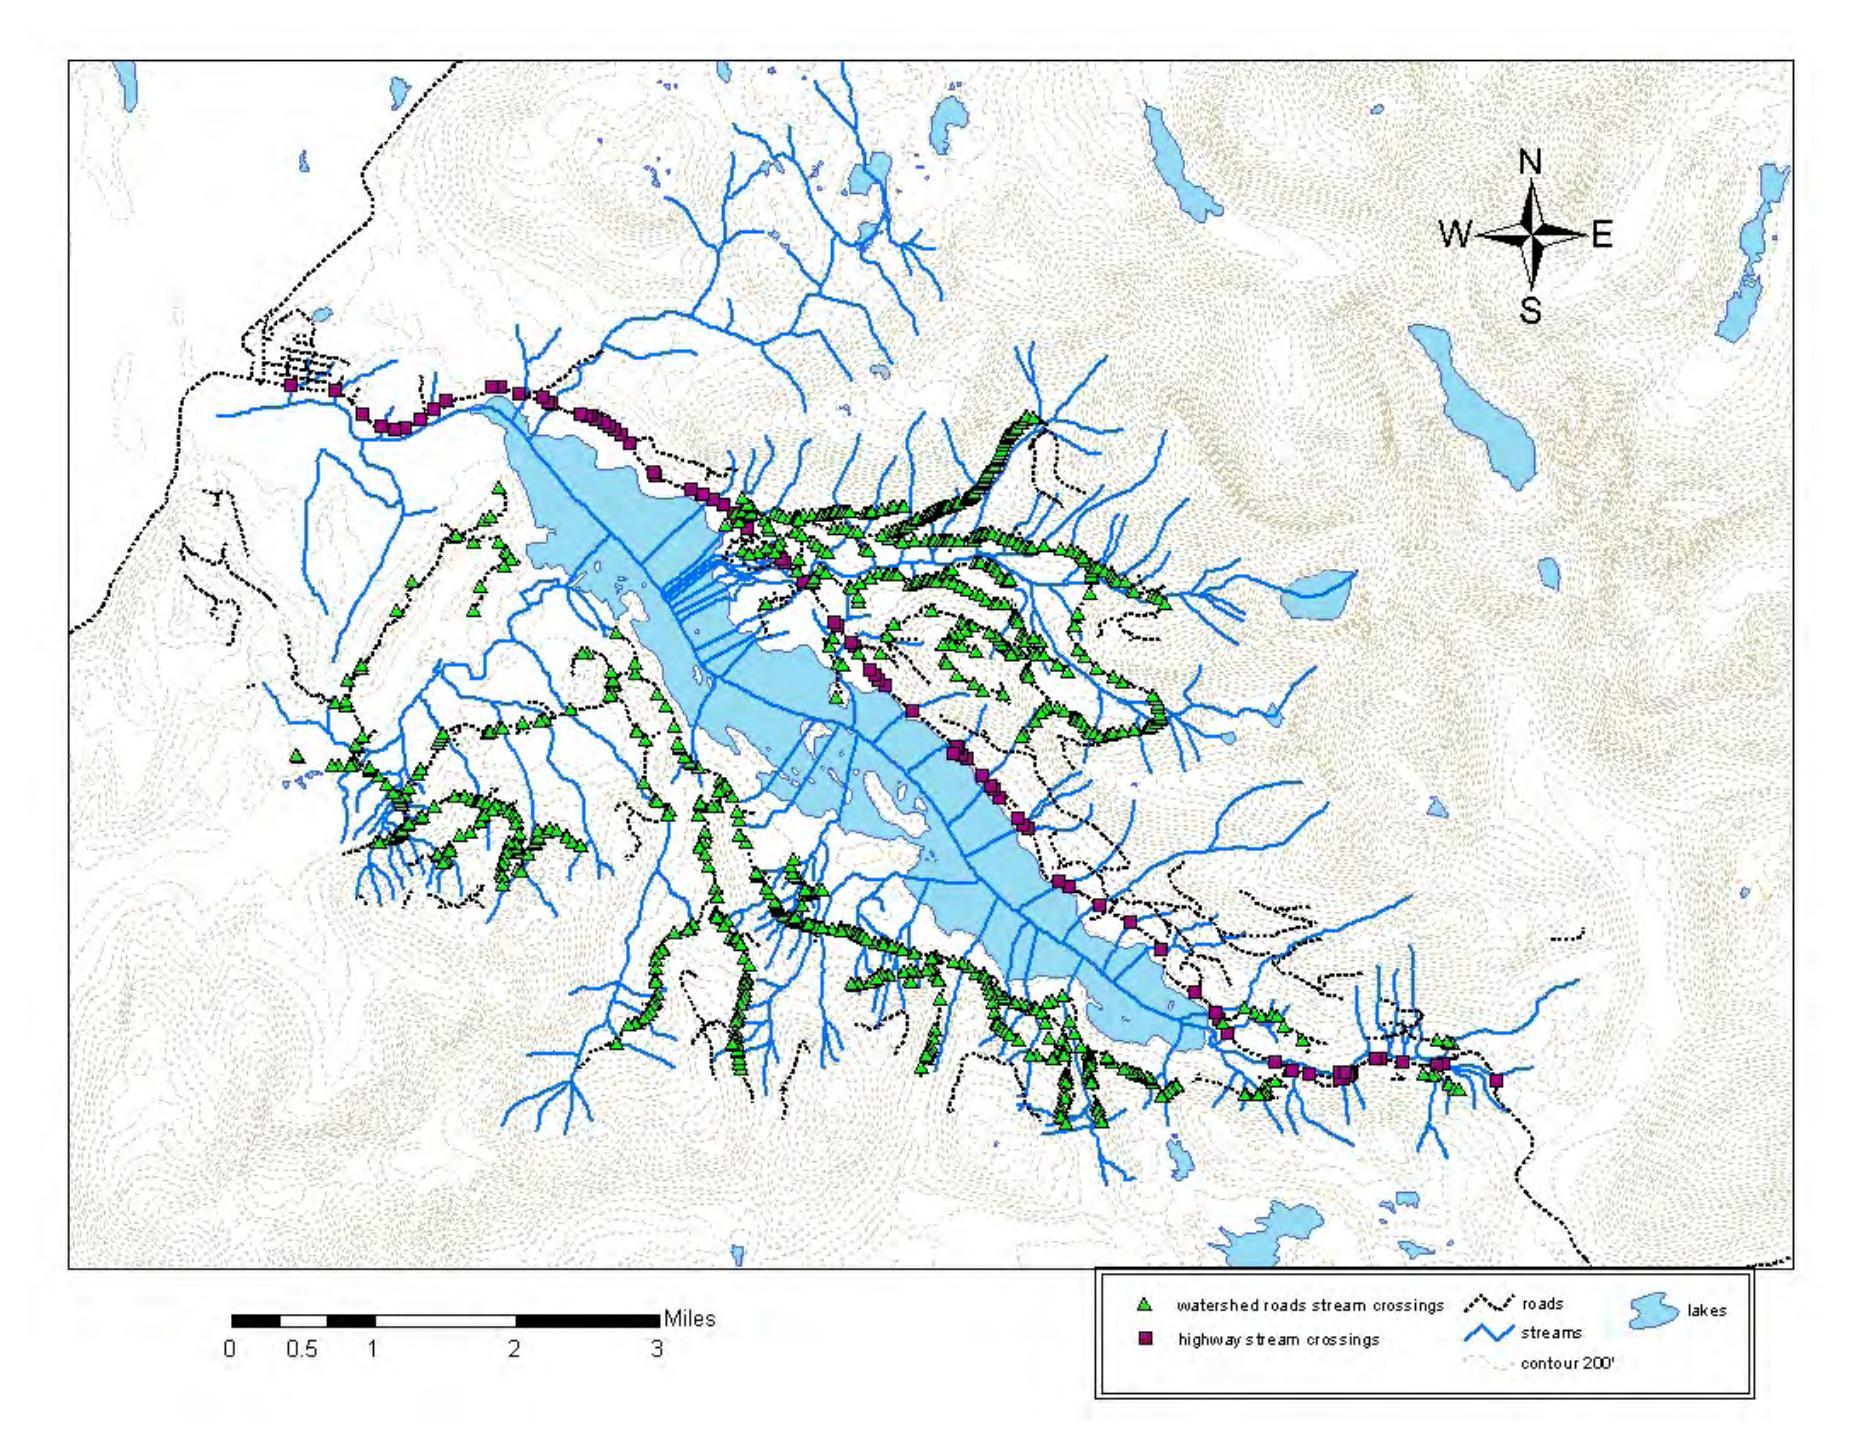
Over 400 stream crossings were documented on the watershed (Figure 3). These included streams associated with a variety of structures, specifically addressed in the following sections.

Figure 3. Location of all stream crossings associated with permanent and temporary roads in the Klawock Watershed, Southeast Alaska.

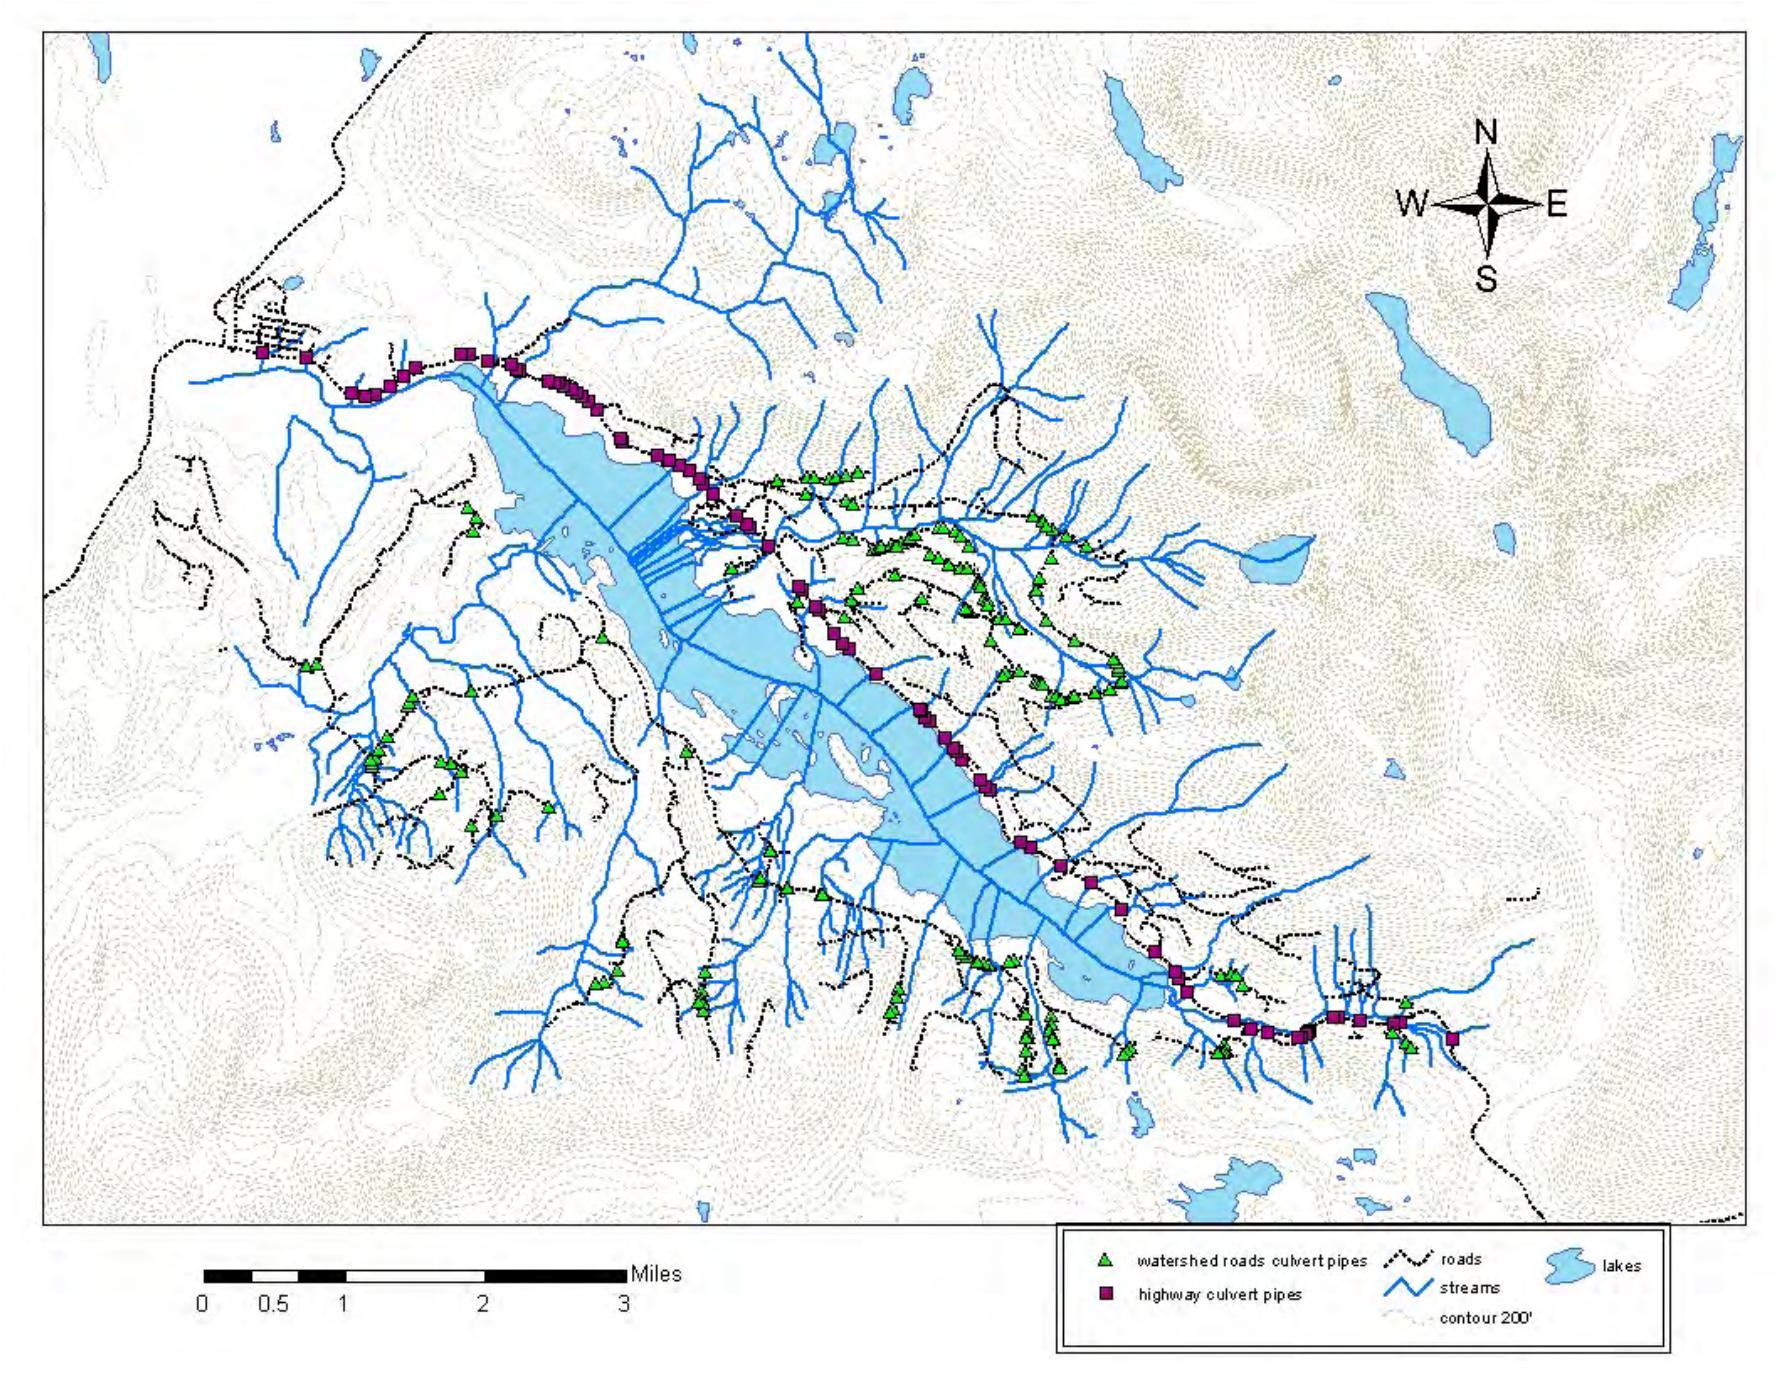
Two types of culvert pipes were used to allow stream passage on the watershed roads: Corrugated Plastic Pipes (CPPs) and Corrugated Metal Pipes (CMPs). The latter represented the majority of stream crossing structures, accounting for over 59% of all structures on the watershed (Figure 4).

Figure 4. Location of all culvert pipes associated with permanent (Klawock-Hollis Highway) and temporary (watershed) roads in the Klawock Watershed, Southeast Alaska.

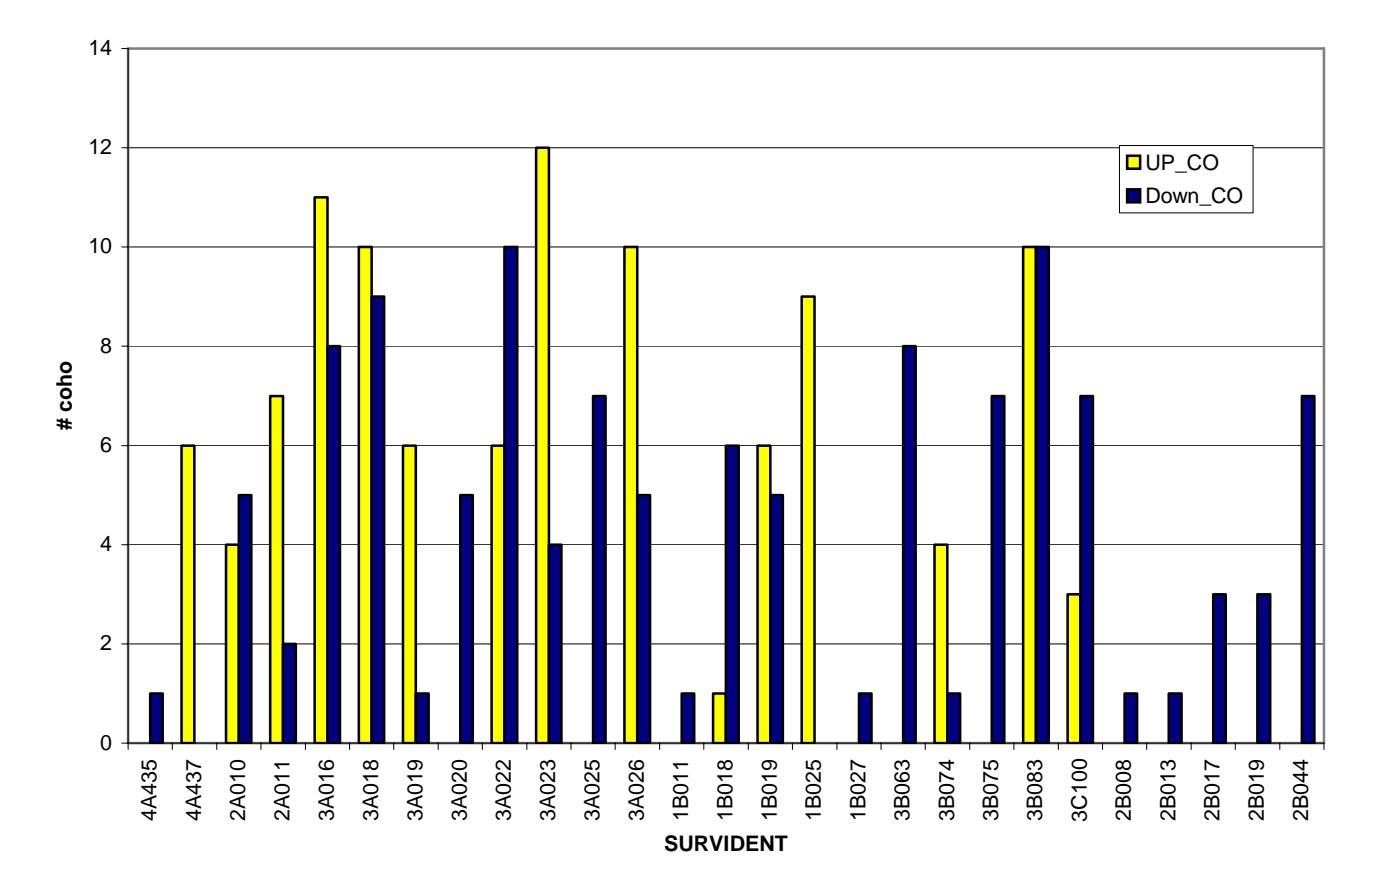
H&R staff baited and set 206 minnow traps to determine fish presence and distribution patterns at 73 locations across the watershed. Full results are summarized in Appendix 6. Coho salmon, *Oncorhynchus kisutch*, were the only anadromous species captured in H&R trapping efforts on the watershed and were captured at 27 locations; at 12 of these locations, coho were captured downstream of the stream crossing feature only (Figure 8).

Figure 8. Coho trapping results upstream (UP_CO) and downstream (Down_CO) of stream crossing structures on Klawock Watershed.

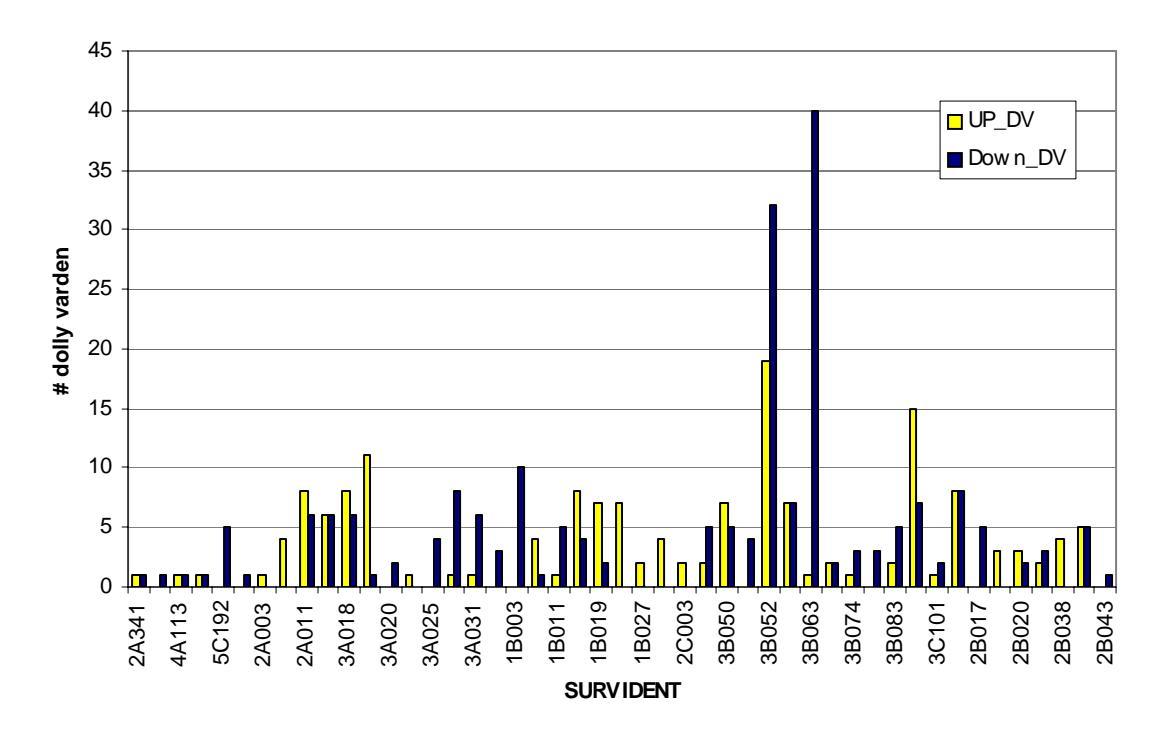
Dolly Varden, *Salvelinus malma*, were captured at 47 locations throughout the watershed; at 11 of these locations, dolly varden were captured only downstream of the crossing feature (Figure 9). Cutthroat trout, *Oncorhynchus clarki* were captured at a total of 39 locations throughout the watershed, 12 of which included locations where cutthroat were only captured downstream of the crossing structures (Figure 10).

Figure 9. Dolly Varden trapping results upstream (UP_DV) and downstream (Down_DV) of stream crossing structures on the Klawock Watershed.

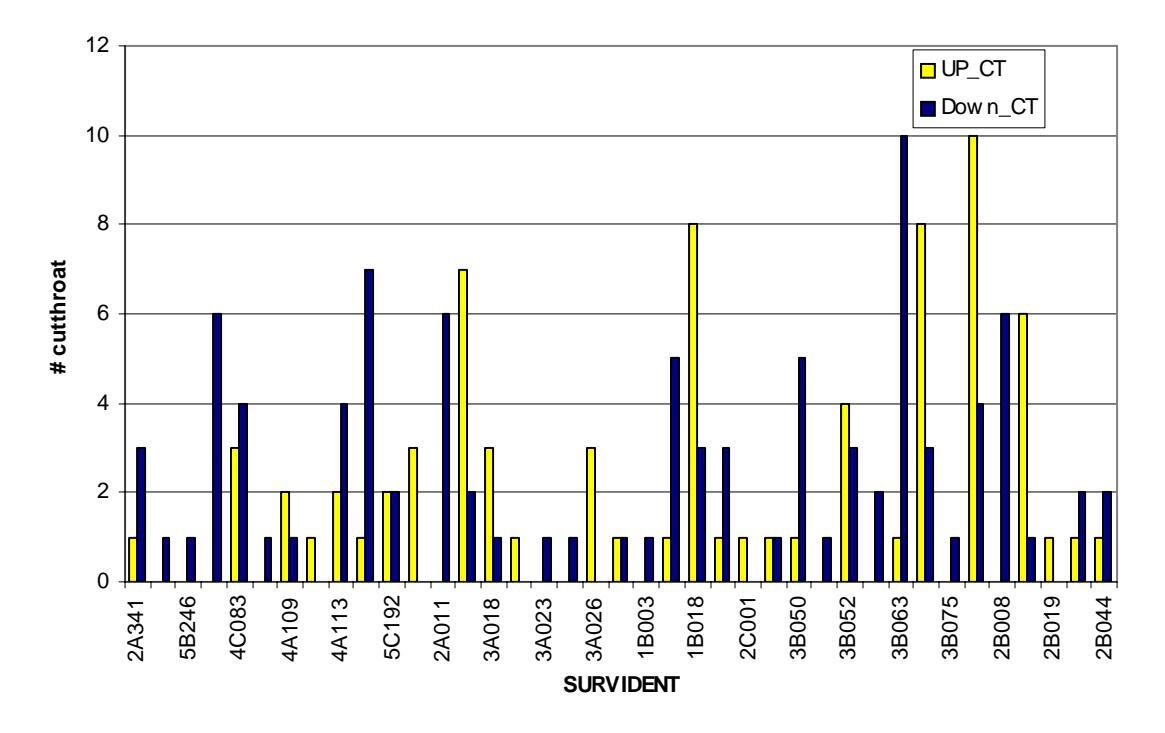
Figure 10. Cutthroat trapping results upstream (UP_CT) and downstream (Down_CT) of stream crossing structures on the Klawock Watershed.

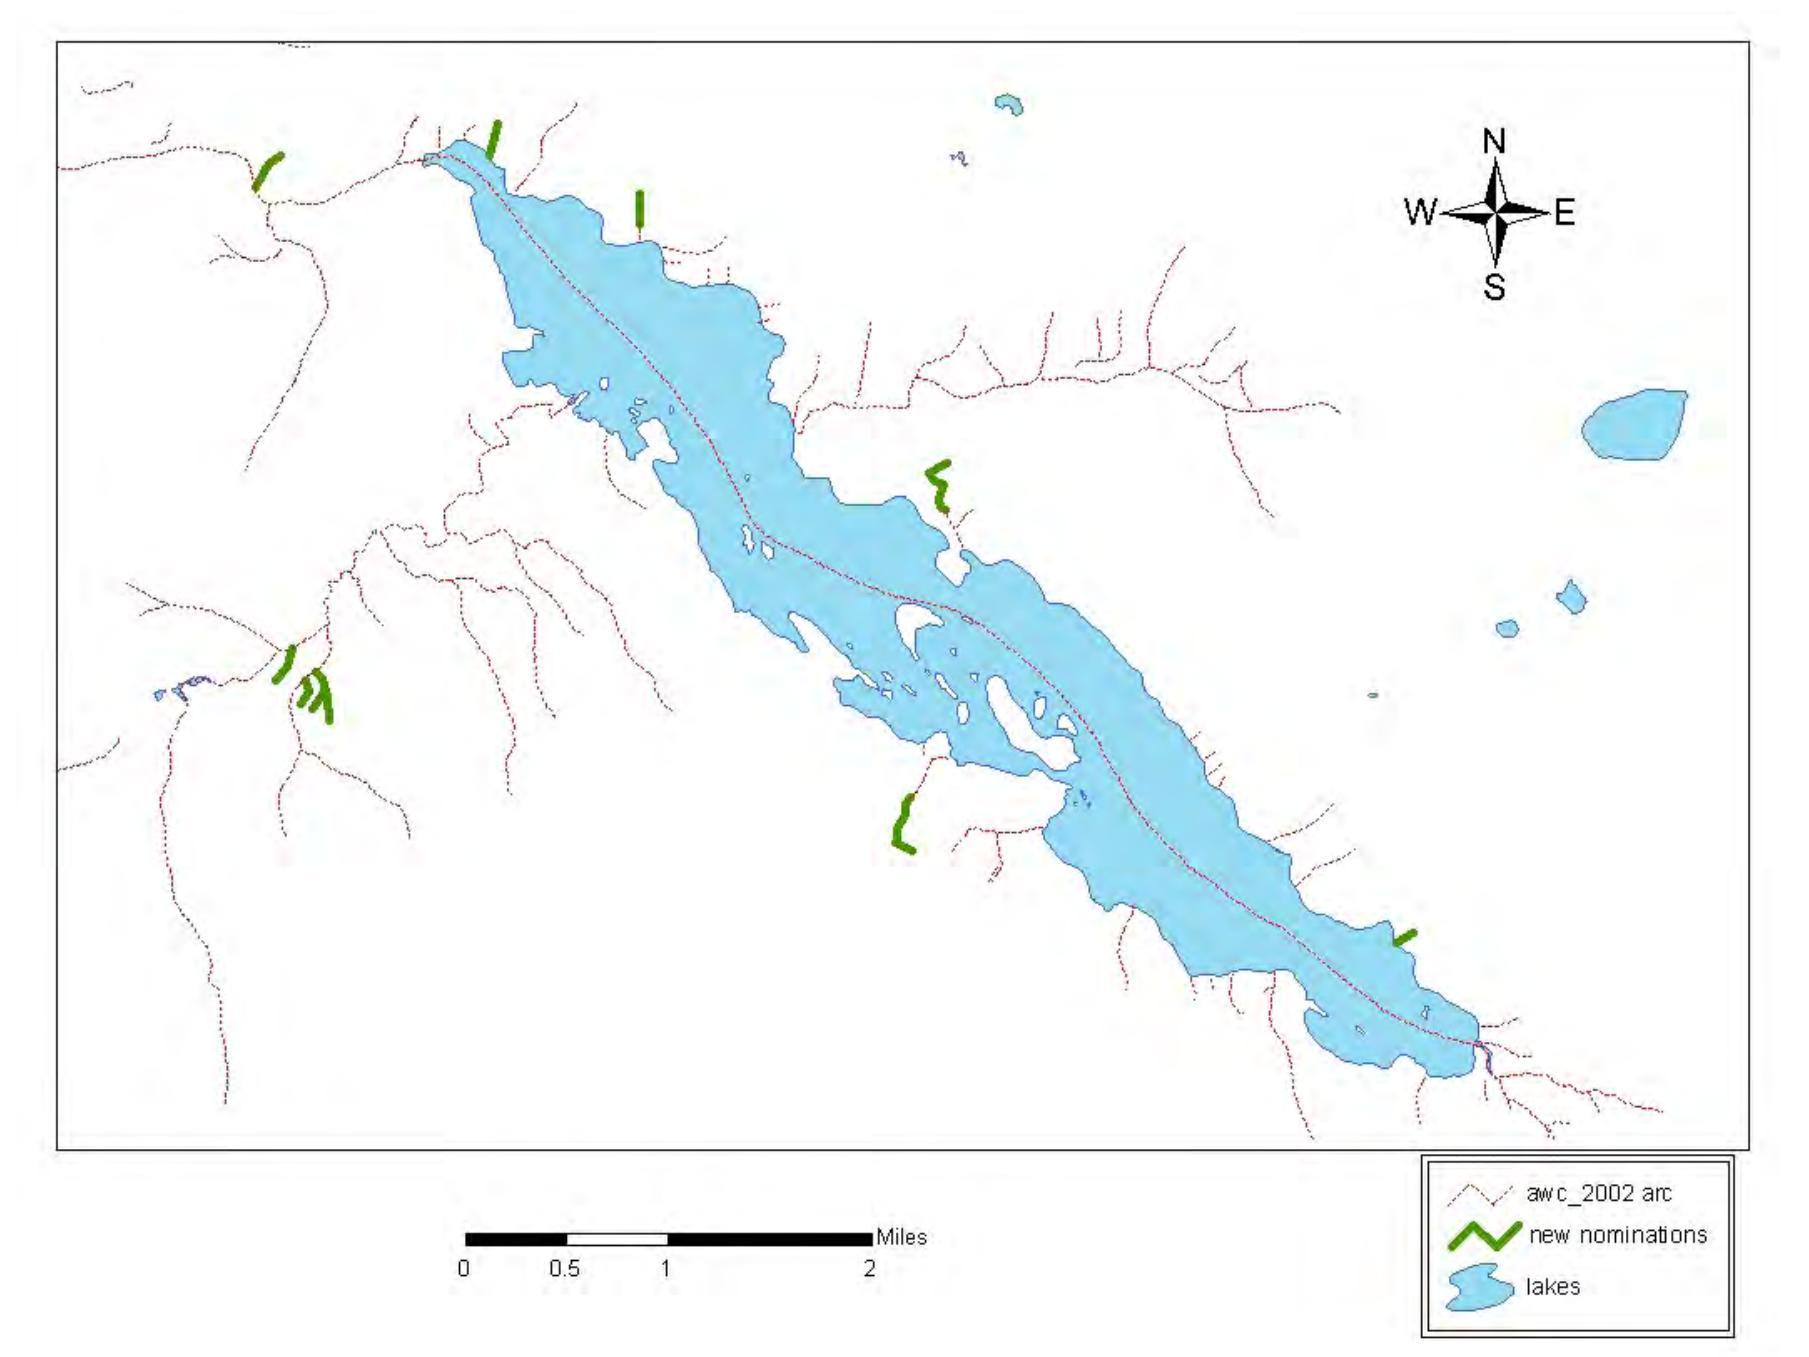
H&R trapping efforts during the course of the RCS work have led to the addition (or extension) of at least eight stream arcs in the Anadromous Waters Catalog. These will be nominated for update in the next cycle of nominations in 2004. The current distribution of known anadromous streams is depicted in Figure 11 and includes the draft updates mentioned.

Figure 11. Current known hydrography of anadromous waters within the Klawock Watershed, Prince of Wales Island, based on digital AWC (draft 2002) and fish trapping efforts during Road Condition Surveys, 2002.
