ROAD CONDITION SURVEY FOR THE FOREST ROAD SYSTEM IN THE KENAI PENINSULA BOROUGH

PREPARED FOR: The Alaska Sustainable Salmon Fund (AKSSF)

DATE OF REPORT: March 1, 2015

PREPARED BY: Joel Nudelman, Forest Practices/Resource Forester, Alaska Department of Natural Resources Division of Forestry, Juneau, AK (907) 465-5406

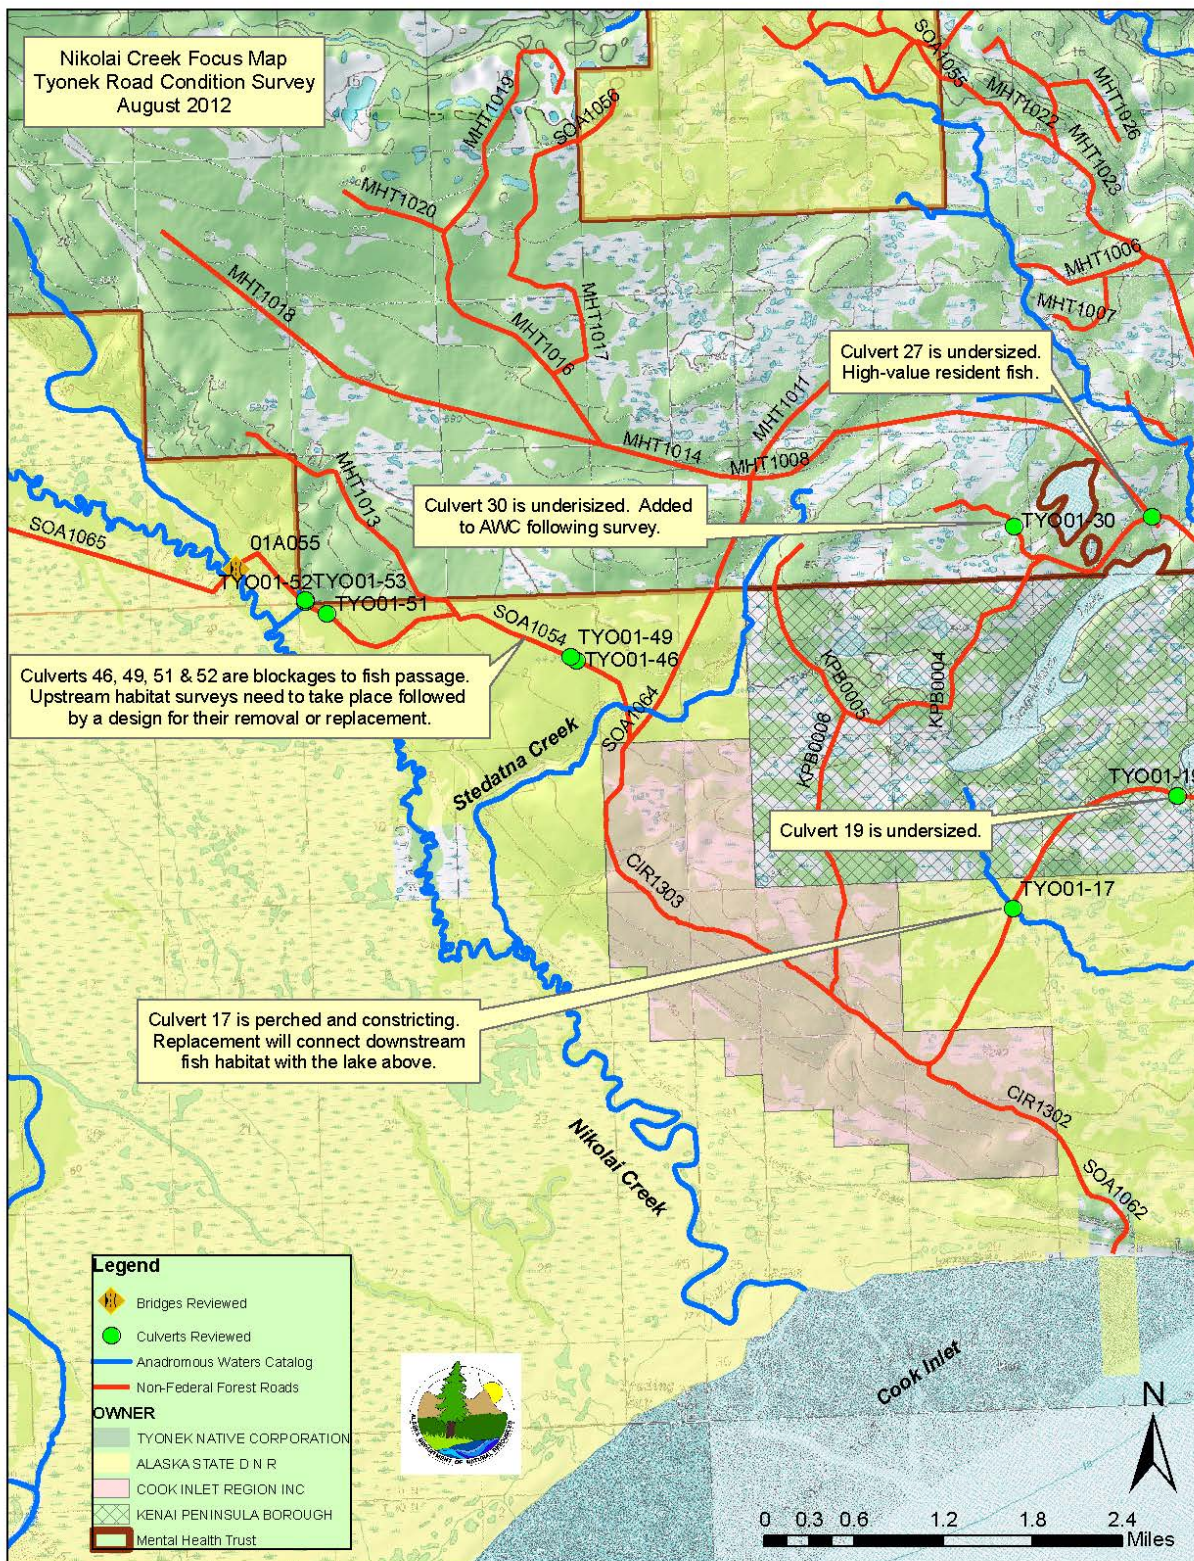
Figure 6. Map showing fish culverts in need of attention.

To date, two culverts have come off the Category B list and are now in Category A, meeting full FRPA and Title 16 compliance. One more in Category B is the process of being replaced by a bridge and a funding source is being sought after for a fourth culvert on Category B. All four culverts are on land owned by Tyonek Native Association. The Tyonek Conservation District and Tyonek Native Association have taken a proactive approach in evaluating the need to remove and replace these four culverts as well as secure funding.

On the State road segments, DOF has applied for funding through the Sustainable Salmon Fund to replace one culvert (road SOA 1061) and evaluate the upstream habitat and possible removal of three others (roads SOA1063 & SOA1054). These culverts are highlighted in yellow on Table 3. In December 2014, DOF received notice that the grant application was not funded, partly due to a concern of northern pike migrating into this waterway system. DOF will be working with ADFG to determine the extent of the risk posed by Pike and how to mitigate that. DOF will continue to seek funding to repair the low-rated fish culverts and will work closely with ADFG and the Tyonek Conservation District to ensure that replacement will be beneficial.

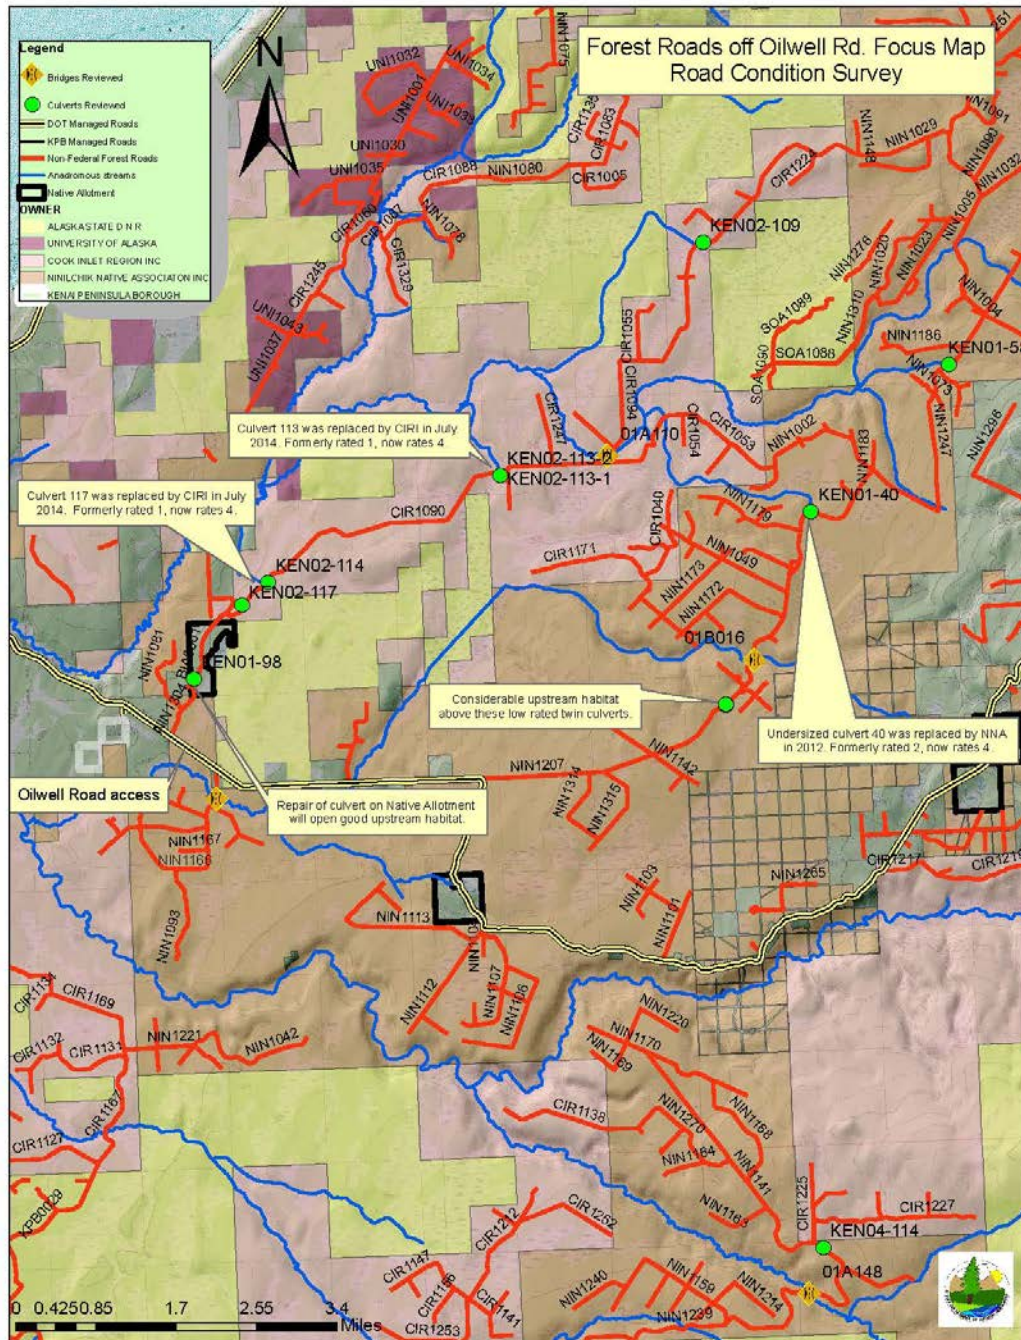
Figure 8. Map showing low-rated fish culverts and replaced culverts by CIRI and NNA.

Since this survey began in 2011, four low rated culverts have been replaced by their landowners. They were originally in the Category C list (previously rated 1 and 2) and are now in the Category A, all with an updated rating of 4. The four culverts are highlighted in yellow on Table 3. CIRI replaced two of those culverts (road CIR1090) and added an additional relief culvert to one of them. NNA replaced the remaining two (roads NNA1245 and NNA1247).

Two additional low-rated culverts remain on both the CIRI and NNA road systems. There's an additional low-rated culvert on a Native allotment, which is an inholding of NNI. DOF will work with the landowners to seek funding sources for their replacement.

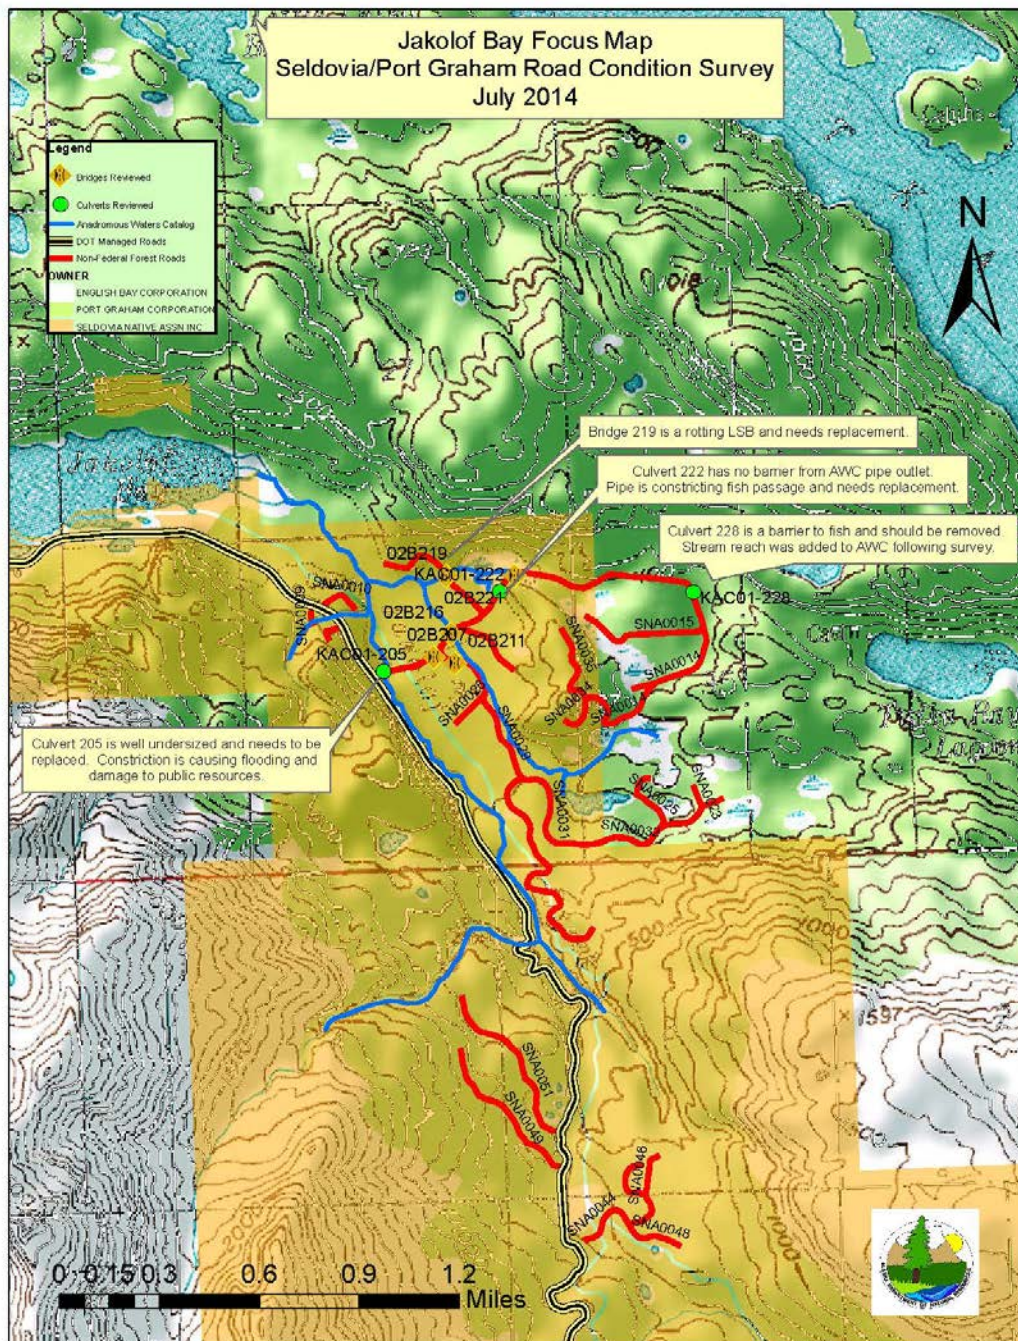
Figure 10. Map showing low-rated fish culverts and a bridge needing replacement.

There are three low-rated culverts in close proximity of each other in the Seldovia area. They're all in the Jakolof watershed and need to be replaced. The most problematic culvert was a 7-foot diameter pipe located in Jakolof Creek (see culvert KAC01-205 on Table 3). George Oliveira, Alaska Department of Transportation, Seldovia, explained that stream bed-load has aggraded above the culvert causing flooding and damage of the adjacent State highway. All three culverts are out of compliance with FRPA and Title 16, but the one on Jakolof Creek is causing the most visible damage and affects other public resources besides fish. DOF will work with Habitat and the landowners to rectify the problem. The landowners are aware of the problem.
