# SVALBARD AIRPORT GEOTECHNICAL STUDY: ENGINEERING METHODOLOGY AND RESULTS

Truls Mølmann<sup>1</sup>, Bjarne Bergheim<sup>2</sup>, Mark Valeriote<sup>3</sup>

## Abstract

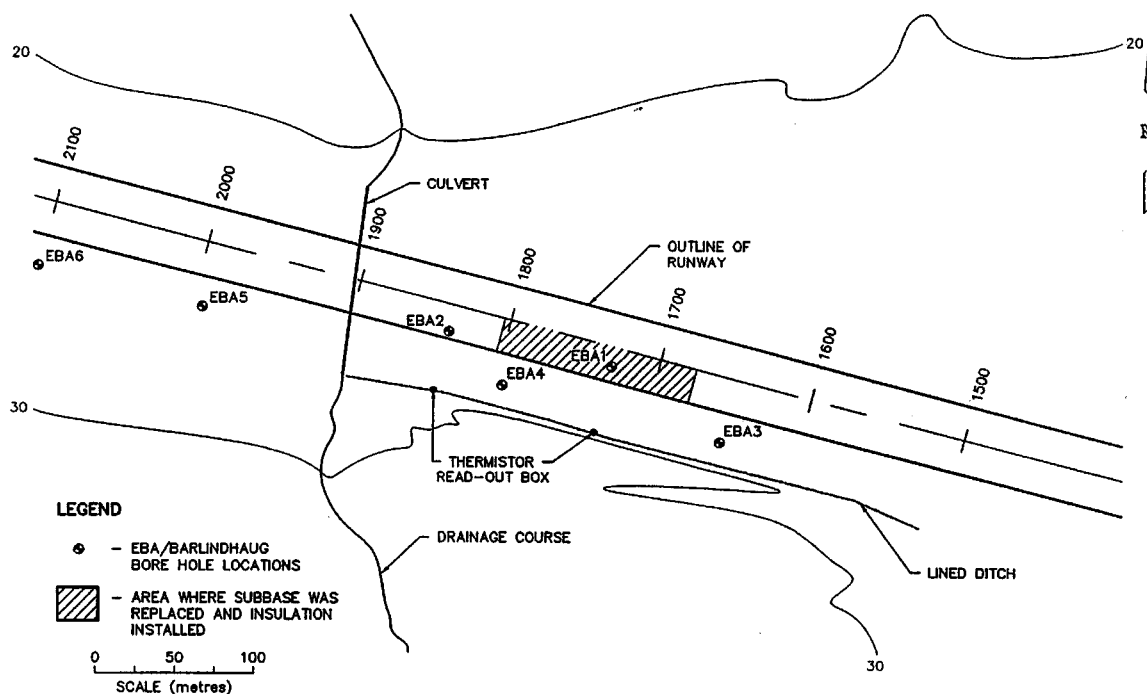
Figure 3. Borehole Location Plan.

Six boreholes were drilled at the Svalbard Airport using an Atlas Copco ROC 701 air-track drill rig contracted from Store Norske Spitsbergen Kulkompani AS (SNSK). The borehole locations, as numbered EBA1 through EBA6, are presented in Figure 3. (Instanes A/S drilled one borehole (MP3) at the western section of the runway).

Boreholes EBA1 and EBA2 were drilled to depths of 10.3 m and 15.3 m respectively. EBA1 was selectively located in the insulated section of the runway, while EBA2 was located in the non-insulated section. EBA3 through EBA6 ranged in depths from 5.5 m to 7.4 m. Undisturbed samples were obtained for the first time where soil conditions were suitable using a 75 mm diameter permafrost core barrel. The undisturbed samples obtained allowed the determination of ice content, particle size distribution, Atterberg limits, bulk density and salinity. Disturbed samples were also obtained from the air-circulated cuttings where coarse-grained soil was encountered.
