SUSITNA HYDROELECTRIC PROJECT

1980-81 GEOTECHNICAL REPORT

**VOLUME 1
TEXT
FINAL DRAFT**

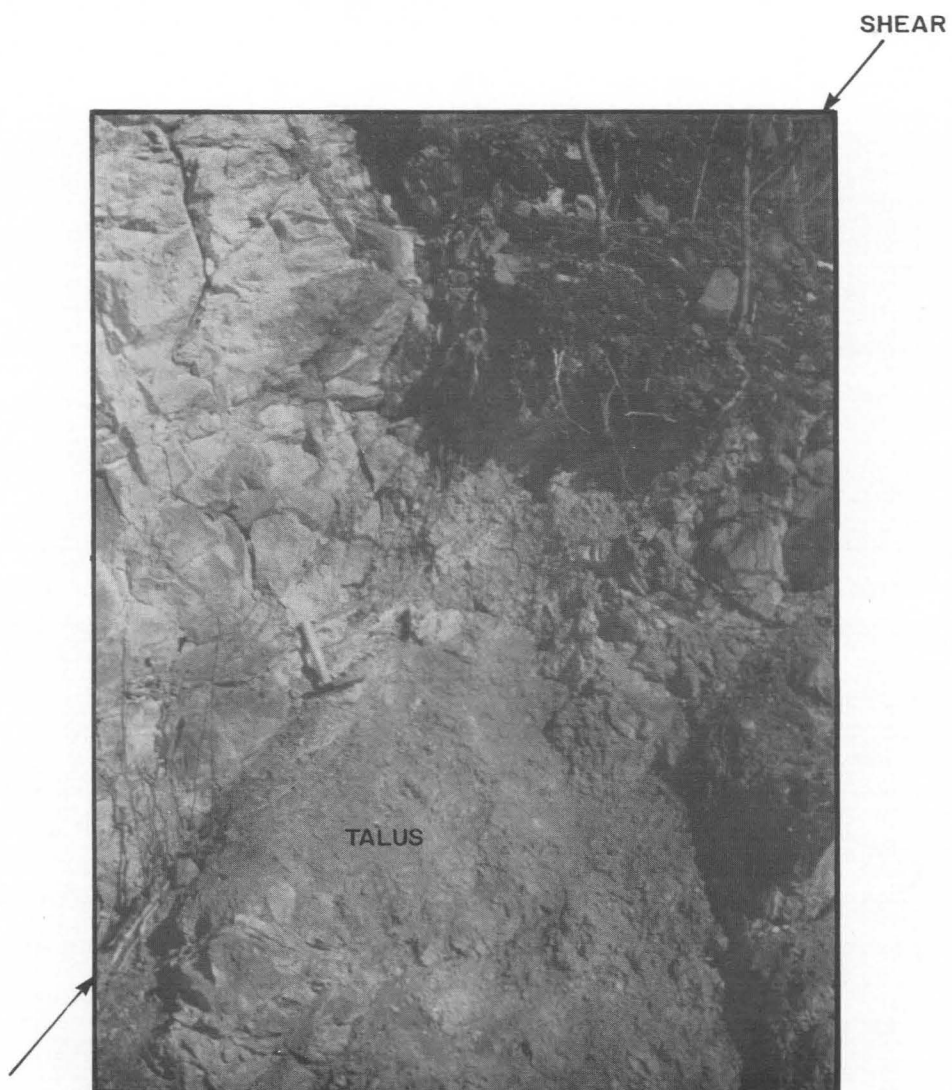
VIEW LOOKING NORTH ALONG STRIKE
OF SHEAR; DIP 57° WEST
RIVER LEVEL - NORTH BANK
"THE FINS" AREA

WATANA
TYPICAL SHEAR

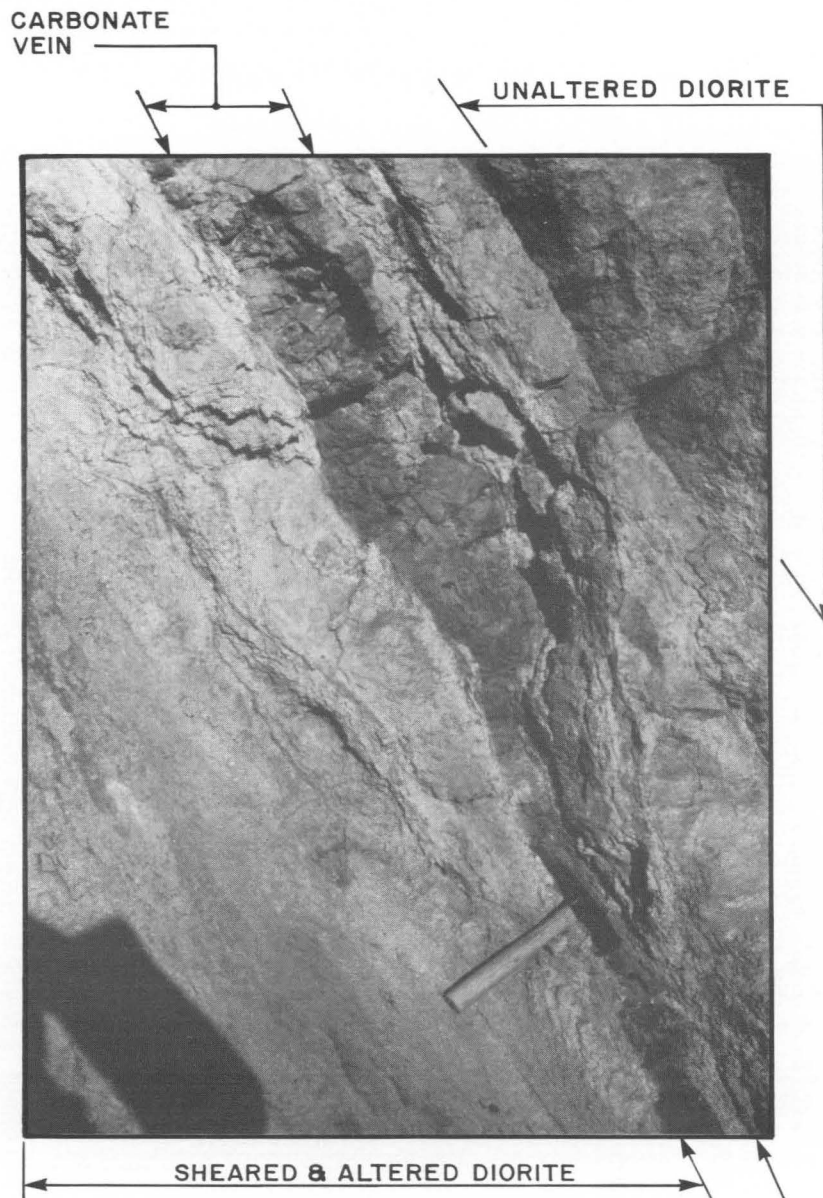
Widths of these alteration zones most often range up to 20 feet but are generally under 5 feet. An exception is in BH-12 on the south bank which drilled over 300 feet into an alteration zone (Figure 6.5, see Subsection [iv]). Several shear/alteration zones are exposed in "The Fins" and range from 10 to 55 feet wide.

EAST SIDE OF 55 FT. WIDE SHEAR/ALTERATION ZONE
RIVER LEVEL- NORTH BANK "THE FINS" AREA

WATANA
SHEAR/ALTERATION ZONE

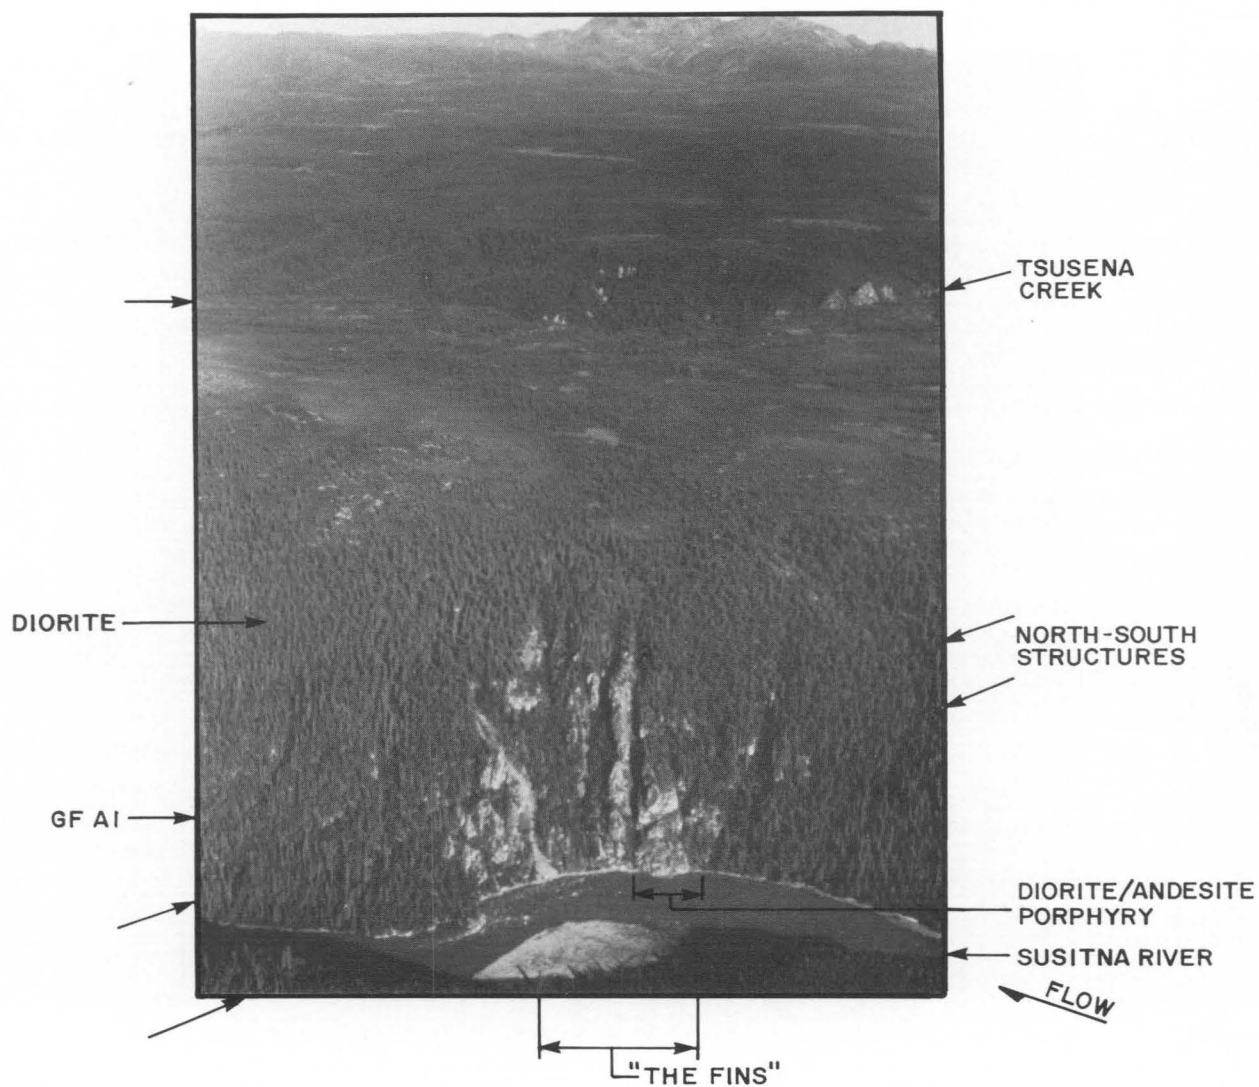
- No geologic or geotechnical conditions were found to affect the feasibility of an embankment dam at the site.
- The significant geologic features "The Fins" and "Fingerbuster" are considered unsuitable rock for construction of surface and underground facilities and should be avoided if at all possible.

The overall trend of "The Fins" is 300 to 310°. Dips are steep to vertical. The extension of this feature to the northwest is inferred from seismic refraction lines SL 81-15, SL 81-15x, and SW-3 which show low seismic velocities (10,000-12,700 feet per second) in bedrock, as well as low bedrock elevation along the projection of "The Fins" (Figure 6.5). In contrast, the bedrock seismic velocity northeast and southwest of this feature is about 18,000 feet per second (Appendices H and I).

AERIAL VIEW OF "THE FINS"
LOOKING NORTHWEST ALONG STRIKE

WATANA
"THE FINS"

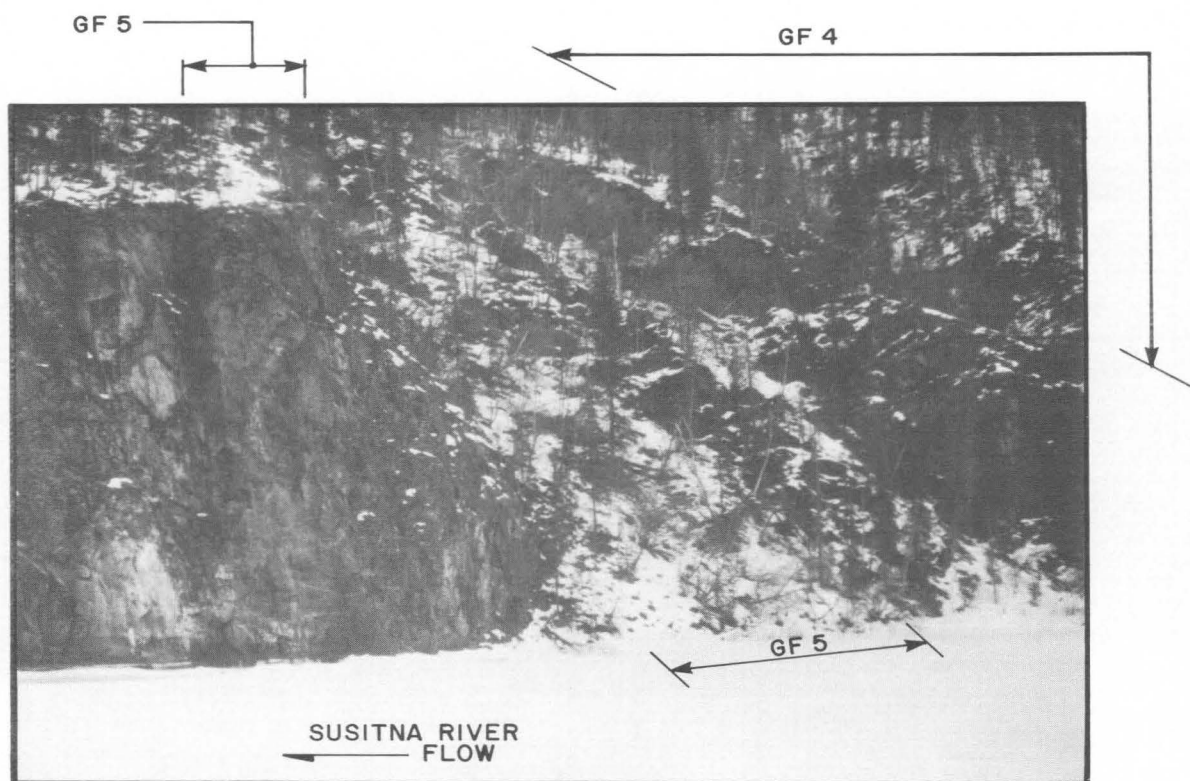
GF 4B has been correlated with a shear/fracture zone and alteration zone in DH-11 (Figure 6.4) at borehole depth 189.0-197.7 feet. The fracture zone is iron oxide stained. The upper three feet of the zone is hydrothermally altered and contains 0.2 foot of clay gouge and breccia. Permeabilities in this zone are high, typically ranging between 10^{-2} cm/sec to 10^{-3} cm/sec. Most joints are coated with sandy silt/clay and minor carbonate. The projection of the GF 4A and GF 4B structures would intersect the proposed diversion tunnels (Figure 6.3) at a high angle.

On the south bank, the GF 5 structure is correlated to a 10-foot-wide fracture zone at river level and a series of minor northwest-trending shears between Elevation 1650 and 1850. Farther up slope, it is correlated with a moderately low (15,000 feet per second) velocity zone along SL 80-3 and a bedrock depression found in borehole DH-25 (Figure 6.8). In this area, overburden thickens from 10 or 15 feet to nearly 80 feet. On the north bank, GF 5 will likely intersect the proposed diversion tunnels (Figure 6.3).

VIEW LOOKING NORTHEAST
NORTH BANK

WATANA
GEOLOGIC FEATURES GF 4 AND GF 5

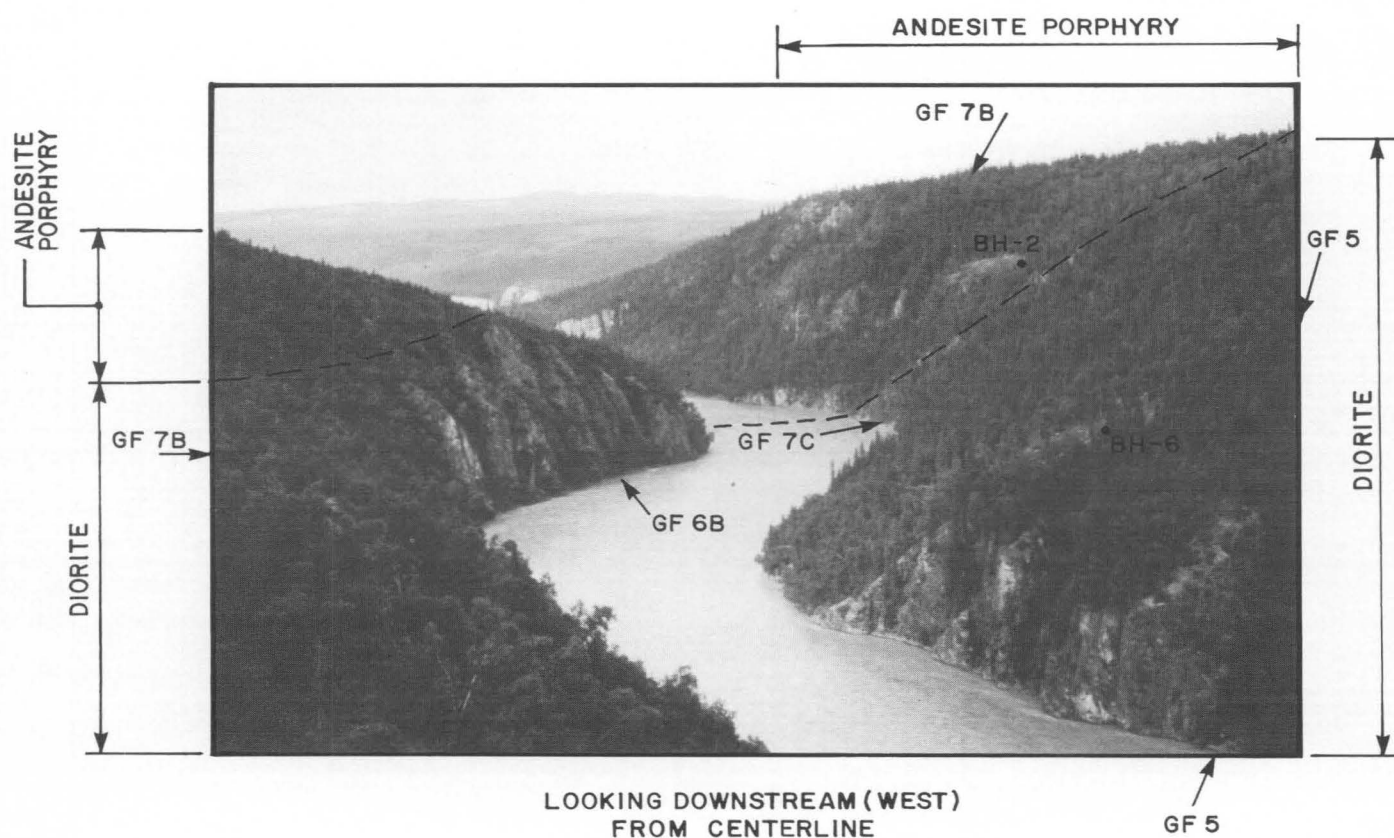
1. GEOLOGIC FEATURES GF 5, GF 6B, GF 7B, AND GF 7C DESCRIBED IN SECTION 6.1.
2. DASHED LINE IS ANDESITE PORPHYRY & DIORITE CONTACT.

WATANA
GEOLOGIC FEATURES DOWNSTREAM OF CENTERLINE

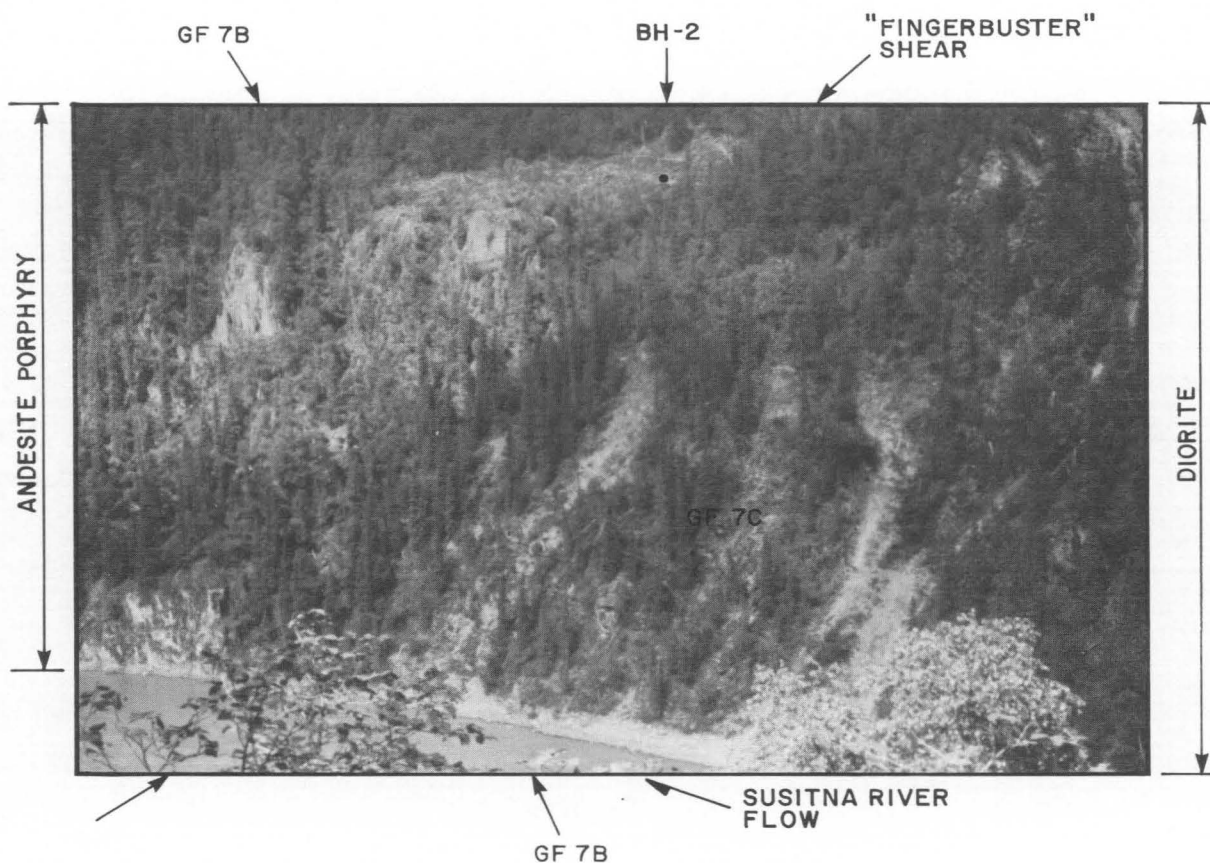
FIGURE 6.19

On the north bank in the andesite porphyry, subarea GF 7B lies in a deep, vegetated gully trending at 290° (Figures 6.3 and 6.19). Exposures in the gully show very closely spaced vertical fractures trending approximately 290° with thin zones of breccia and gouge. The andesite porphyry on the gully walls is slightly to moderately weathered. Figure 6.20 shows where GF 7B intersects the "Fingerbuster" at river level on the north bank (see next subsection). Subarea GF 7B has been projected across the river to correlate with features exposed along the base of the cliffs in area GF 6B (Figure 6.3). GF 7B appears to dip at 75° to the north. This is based on the slope of the cliff face and dips of shears behind and at the base of the cliff. GF 7B was also correlated with a shear zone intersected from 97.8 to 104.0 feet in DH-1 (Figure 6.6). This zone is slightly to moderately altered, with shears less than 6 inches wide. The rock is moderately hard, but soft in shear zones. RQDs are generally less than 40 percent in DH-1 with permeabilities about 10^{-3} cm/sec. Shearing may also exist in DH-3 where core loss of 6.7 feet occurred near the top of rock between 94.0 and 104.7 feet. Subarea GF 7B projects to the southeast from the river bank and is exposed in a steep-walled, 10-to-15-foot wide gully at the andesite porphyry/diorite contact at Elevation 1750. GF 7B crosscuts both of these rock types. The rock in the zone itself has a granular nearly schistose character typical of cataclastic rocks. The rock has been healed and resheared. No exposures of GF 7B were found beyond this point; however, it has been tentatively correlated to a 10,000-feet-per-second zone on seismic line SW-1

1. GEOLOGIC FEATURES "FINGERBUSTER", GF 7B, AND GF 7C DESCRIBED IN SECTION 6.1.
2. ANDESITE PORPHYRY & DIORITE CONTACT ALONG "FINGERBUSTER" SHEAR.

WATANA
"FINGERBUSTER" AREA
NORTH BANK

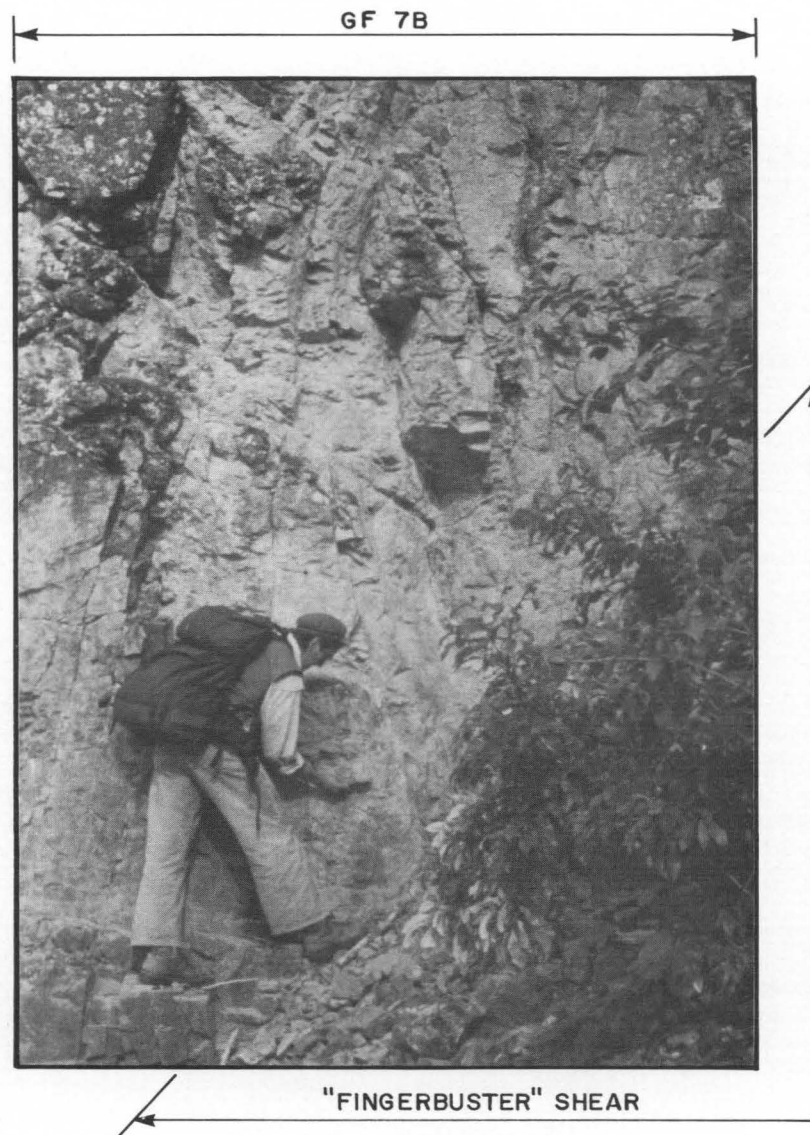
VIEW LOOKING NORTHWEST
ANDESITE PORPHYRY OUTCROP
RIVER LEVEL - NORTH BANK

NOTE:
GEOLOGIC FEATURES "FINGERBUSTER" AND GF 7B
DESCRIBED IN SECTION 6.1.
