A RECONNAISSANCE OF TRACTOR TRAILS AND RELATED PHENOMENA ON THE NORTH SLOPE OF ALASKA

JEROME R. HOK

1969

U.S. DEPARTMENT OF THE INTERIOR
BUREAU OF LAND MANAGEMENT

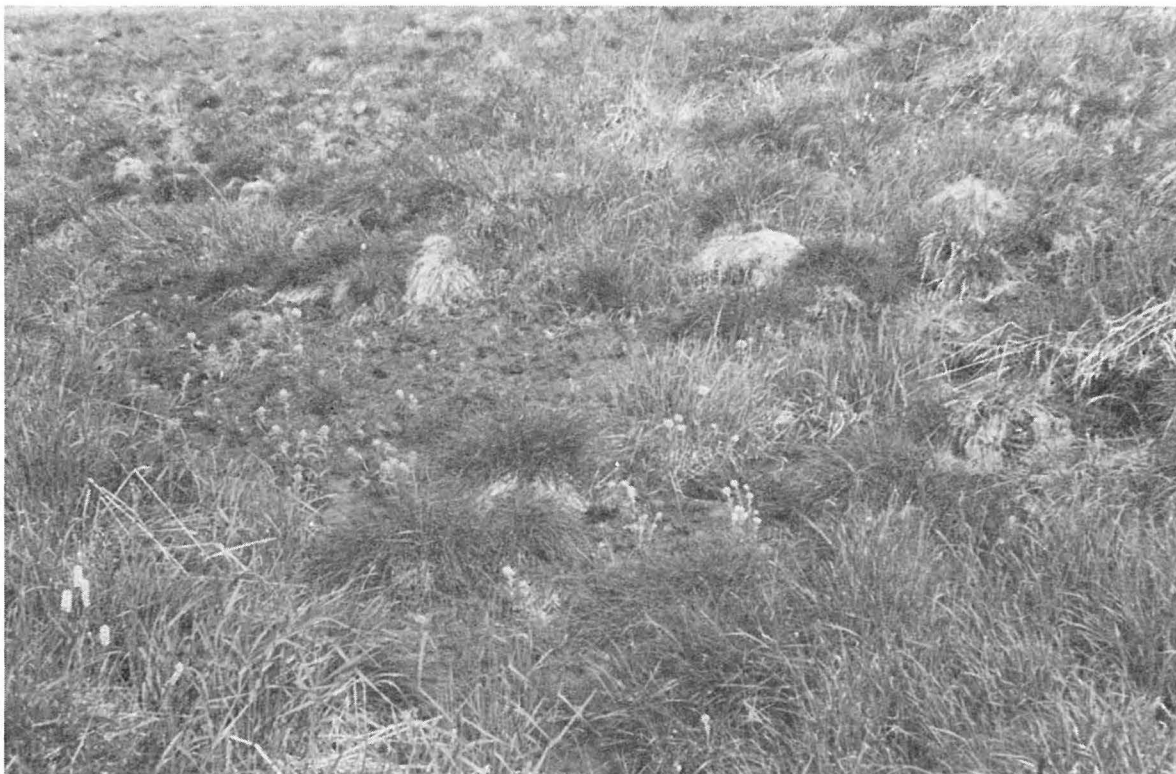
Photo 49: A close-up of unstable spot in bed of trail shown above.
