# Susitna-Watana Hydroelectric Project (FERC No. 14241)

# 2012 Susitna River Water Temperature and Meteorological Field Study

# Appendix A

# **APPENDIX A: PHOTOGRAPHS AND SITE INFORMATION**

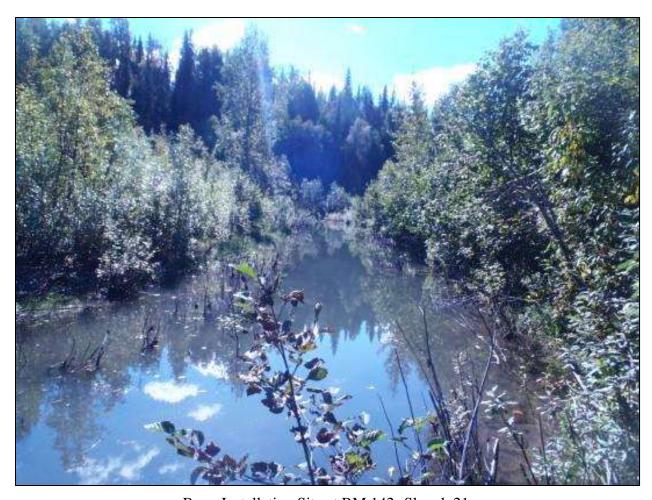
October 22, 2012 – System present and in approx. 2 feet of water. Downloaded and redeployed at 12:30 ADT.

Buoy Installation Site at RM 142- Slough 21

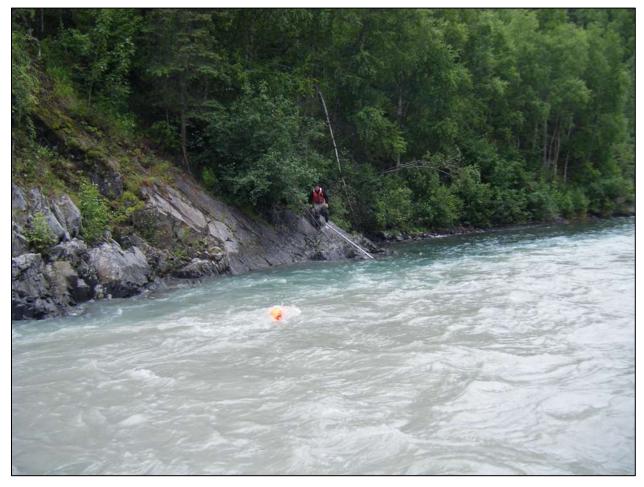
**September 27, 2012** – Buoy has migrated to shore. Redeploy. Anchor 1 tidbit downloaded. Pipe silted in bottom 4 feet of pipe.

October 22, 2012 – Buoy System present and in approx. 2 feet of water. Downloaded and removed system at 11:48 ADT. No winter system deployed due to shallow river conditions.

Buoy and Pipe Systems at RM 148.0 – Susitna below Portage Creek

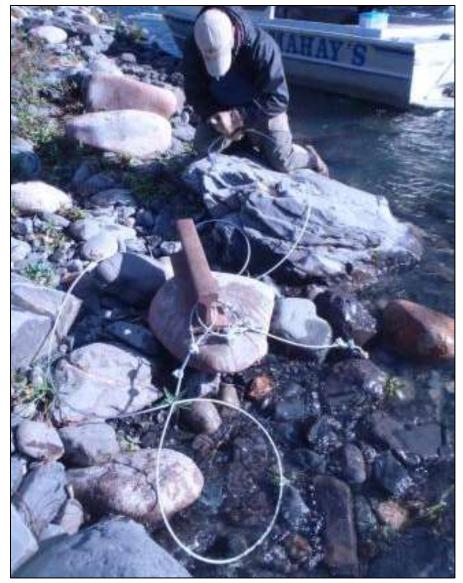
**September 27, 2012** – Downloaded system at 12:34 ADT. Thermistor migrated to mid-stream.

**October 22, 2012** – Shallow water observed. Downloaded system and re-deployed system at 11:55 ADT.

Buoy Installation at RM 148.8- Portage Creek

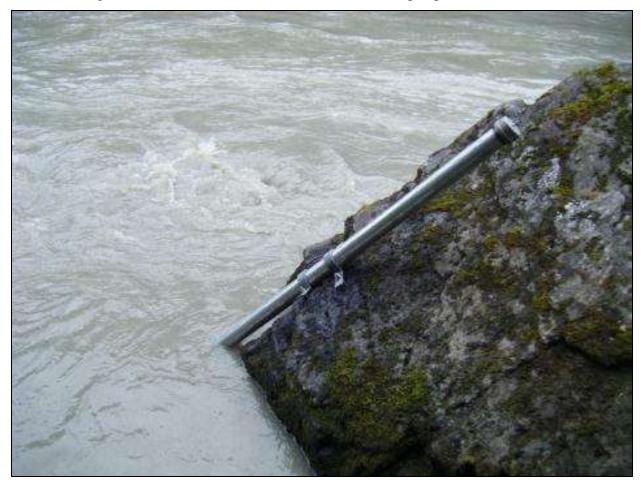
The housing pipe was fastened to a rock with two pipe brackets and lag bolts slightly upstream of the buoy. The pipe houses 13 feet of cable with the thermistors attached with steel wire at intervals along the cable with one at the end mounted to the top cap.

Pipe Installation at RM 148.8- Above Portage Creek

Station Note: 10174171 may have exposure to air. Use 10174169 for water temperature.

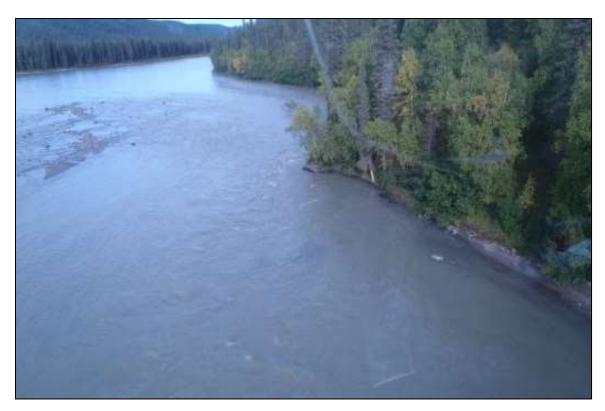
**Station Notes:** Three thermistors were attached to an 8 feet buoy cable with wire and cable clamps and deployed at this location. The system was deployed in a deep back eddy which should have water all year long.

**September 25, 2012** – System intact. Downloaded at 16:45 ADT and removed summer buoy string with multiple data loggers. Replaced with winter, single data logger system (data logger # 10174284).

Buoy at RM 180.3 – Susitna below Tsusena Creek

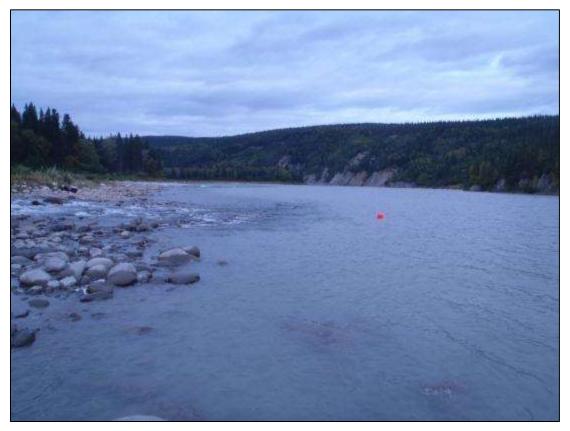
**Station Notes:** Two thermistors were installed at this site, attached to a 6 feet cable and then to a buoy. The system was deployed at the mouth of the smaller of the two channels shown on the map. The best location for this system would be in the main stem of the creek, due to the shallowness of the current location.

Buoy Installed at RM 206.8 - Kosina Creek

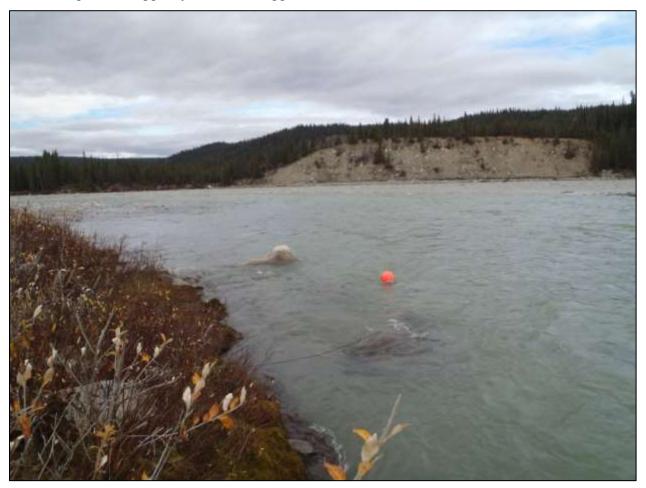
**Station Notes:** Two thermistors attached to a buoy by a 6 feet cable, wire, and cable clamps were deployed at this site. The system was deployed at the proposed location in the deepest area that could be found.

**September 25, 2012** – System intact but had moved down stream slightly but in at least 2 feet of water. Downloaded sensors at 14:00 ADT and removed summer buoy string. Replaced with winter, single data logger system (data logger # 10174278).

Buoy System Installed at RM 233.4 -Oshetna River
