SUSITNA-WATANA HYDROELECTRIC PROJECT
 LINEAMENT GROUP 20
 MAP DATA

FIGURE
 A20.1

79_218900_Alaska_Railbelt/2189_Lineament Report October 2013, modified 10.18.13

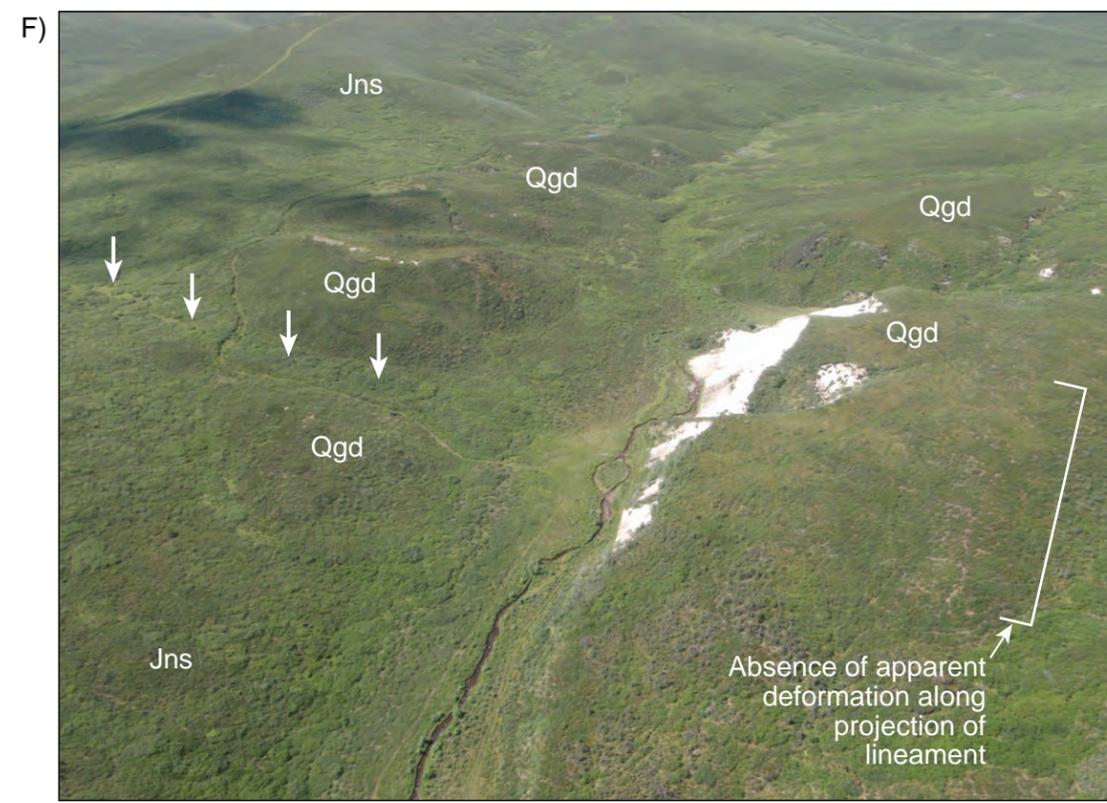
Photograph looking northwest from location F.

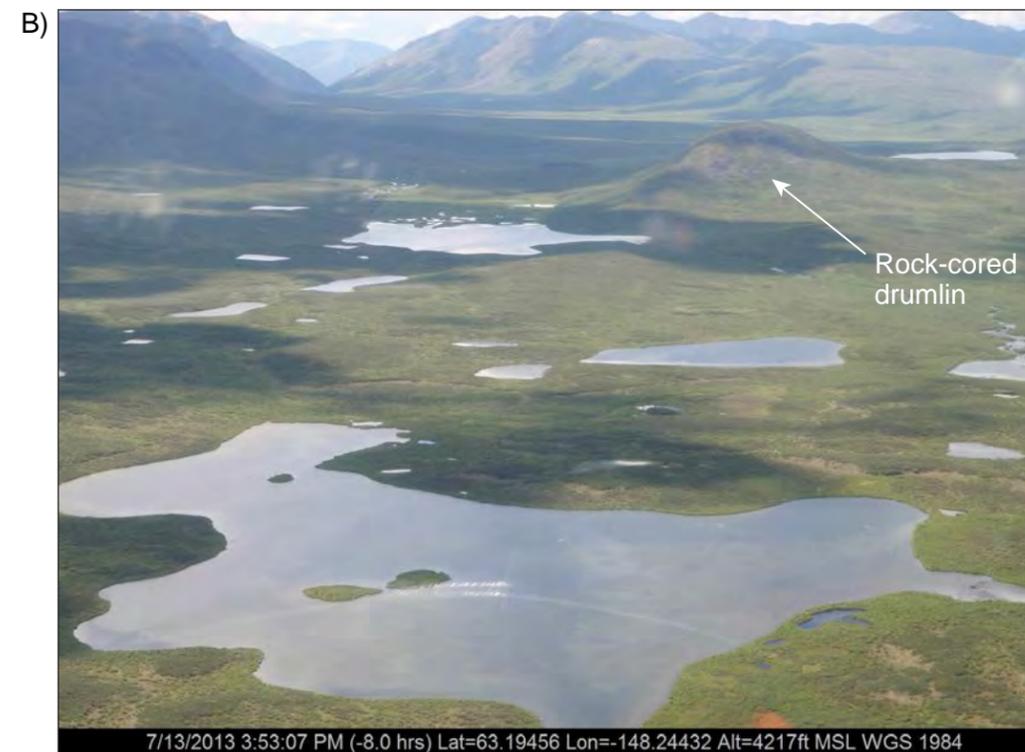
View looking northwest across western portion of lineament group 21a towards approximately 120-meter-tall rock-cored drumlin. View is looking up the Brushkana Creek valley. Note lack of obvious expression of mapped lineaments in the foreground.

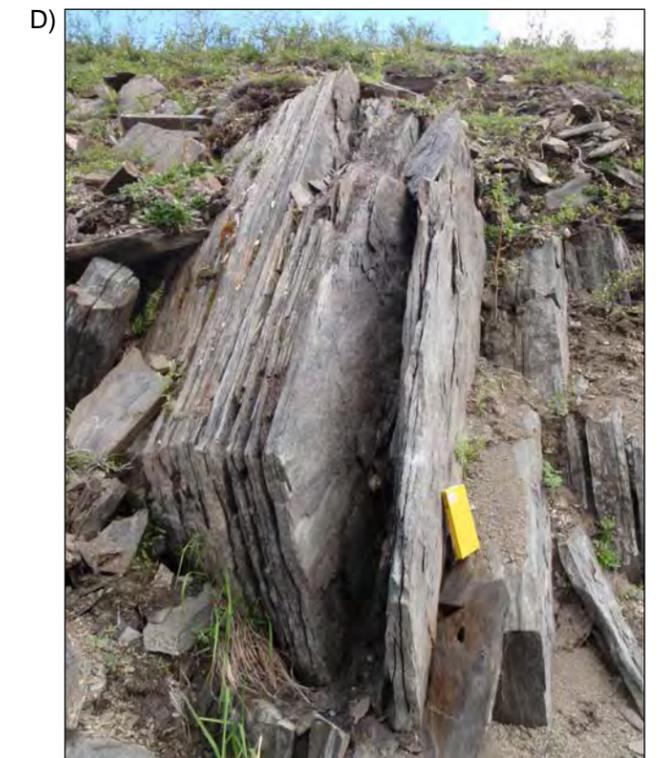
Detail of vertically-dipping phyllite.

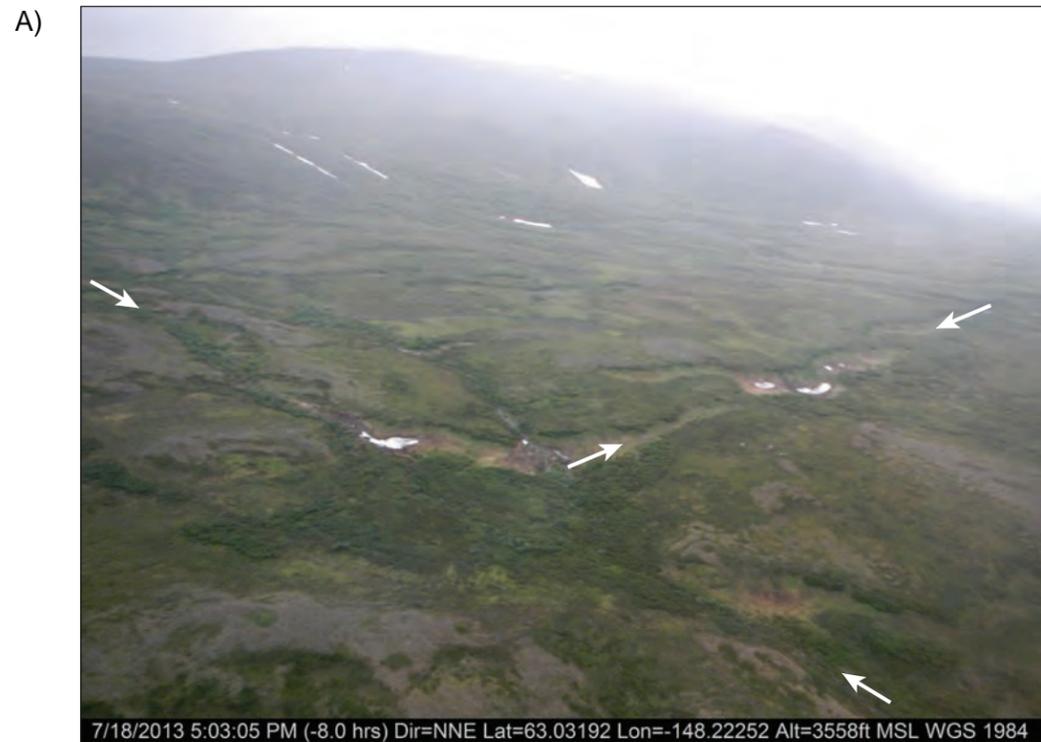
View looking north-northeast up the Deadman Creek valley. Note the numerous downhill-facing solifluction scarps. Large arrows point along mapped lineaments.

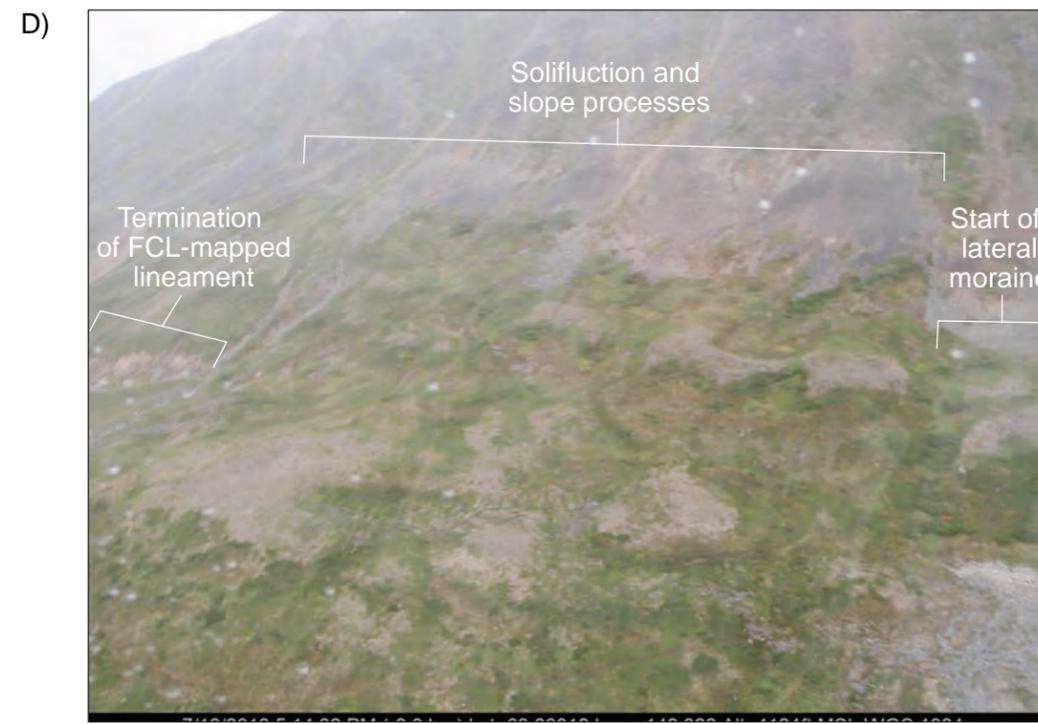
View looking northeast at area of solifluction and termination of mapped lineament.

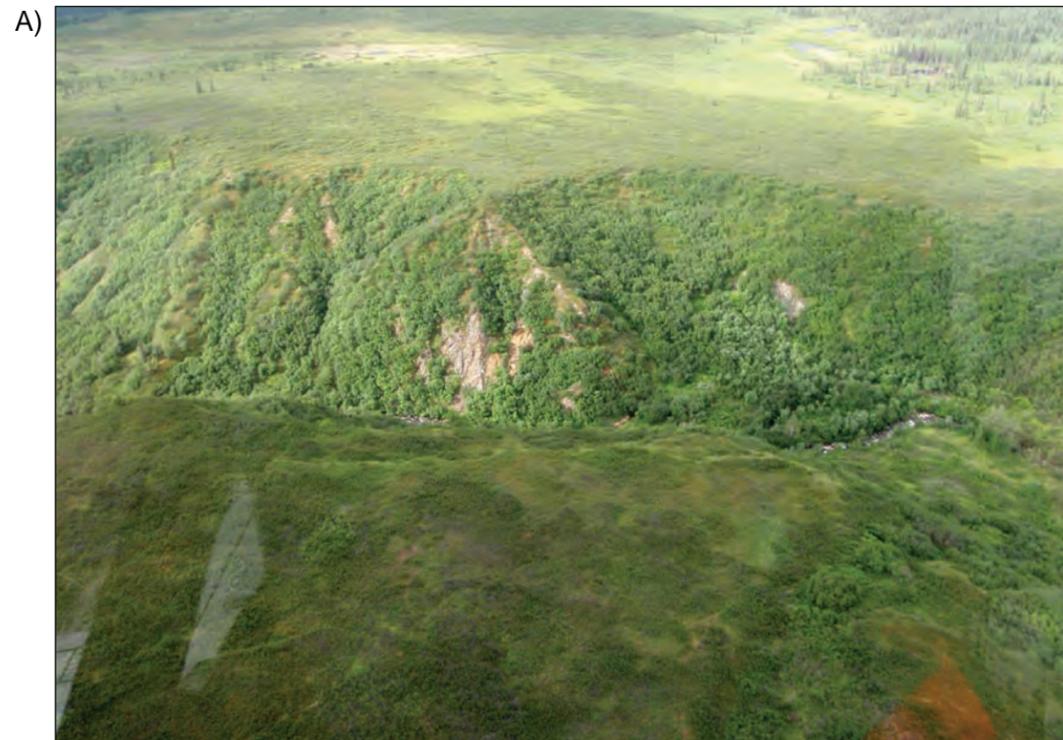
View looking west at unnamed canyon and smooth Quaternary surface in the background.

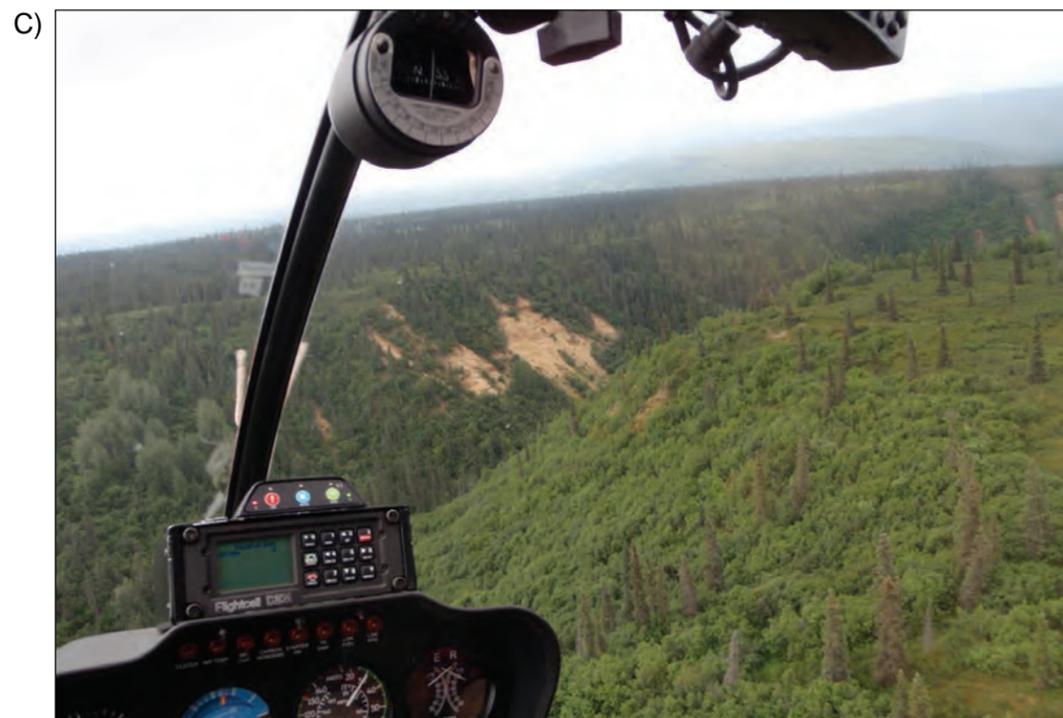
View looking southeast at exposure in left bank of unnamed drainage creek where till apparently overlies lake sediments and fluvial washout gravel. The lenticular beds in the fluvial gravel appear horizontal but are not laterally extensive.

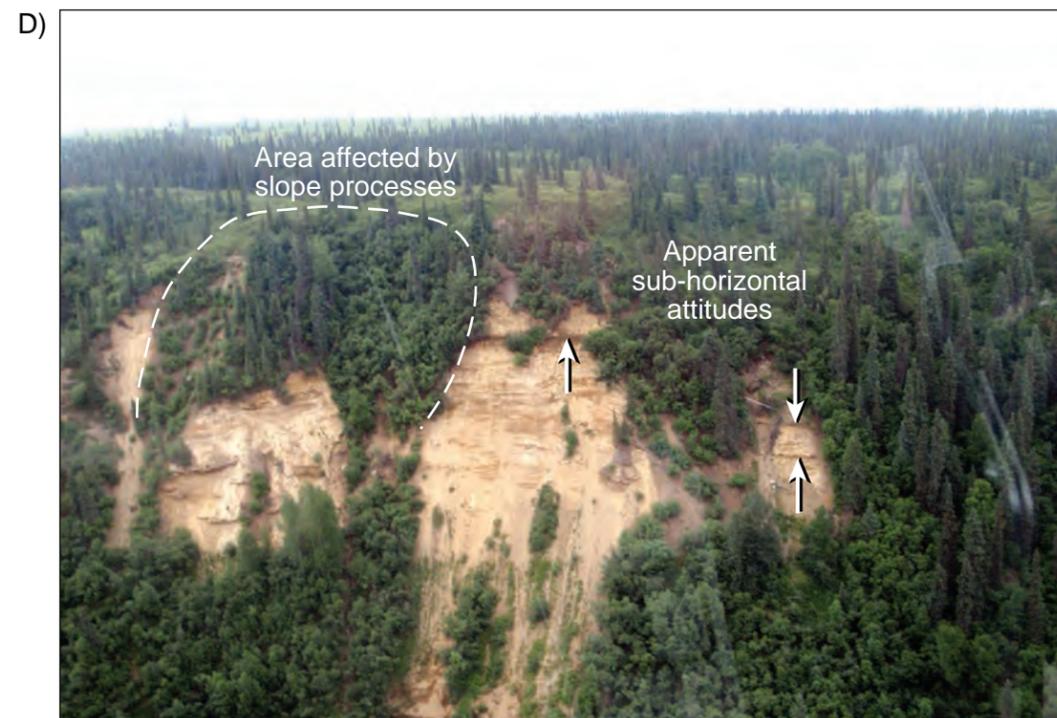
Close up view of exposure shown in Photograph (B). Note the apparently sub-horizontal basal contact between overlying till and underlying lacustrine deposits. Note sediments on the left of the image are influenced by landslide processes and not in-place locally.

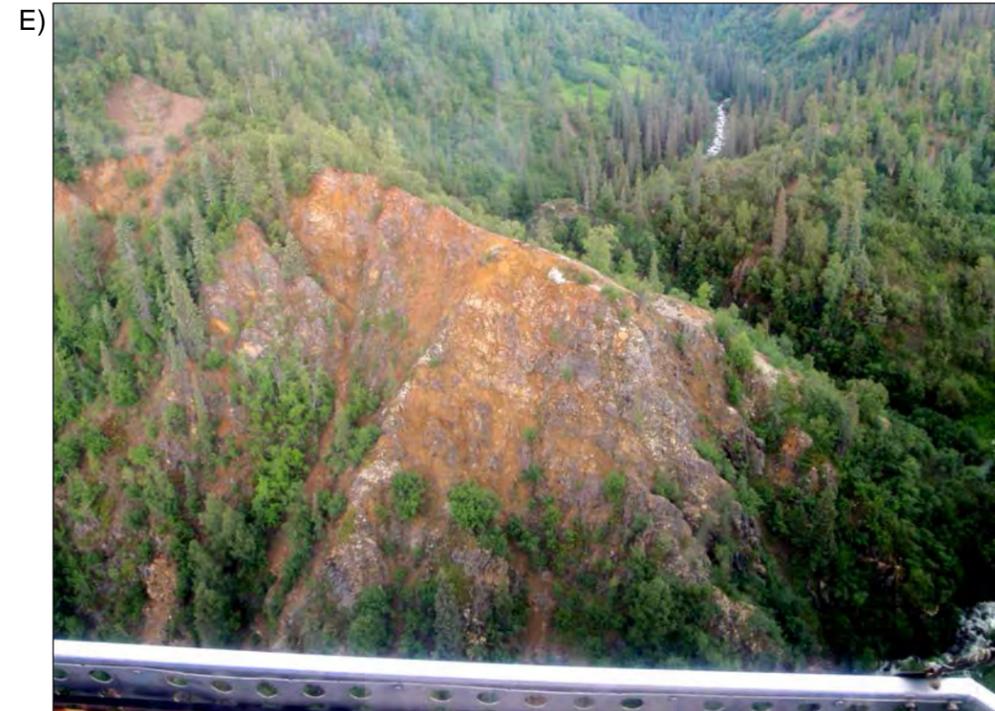
View looking north at ridge along projection of mapped lineaments. Orange color is attributed to chemical weathering of rock. Lithologies appear consistent across ridge and discontinuities or shear zones absent.

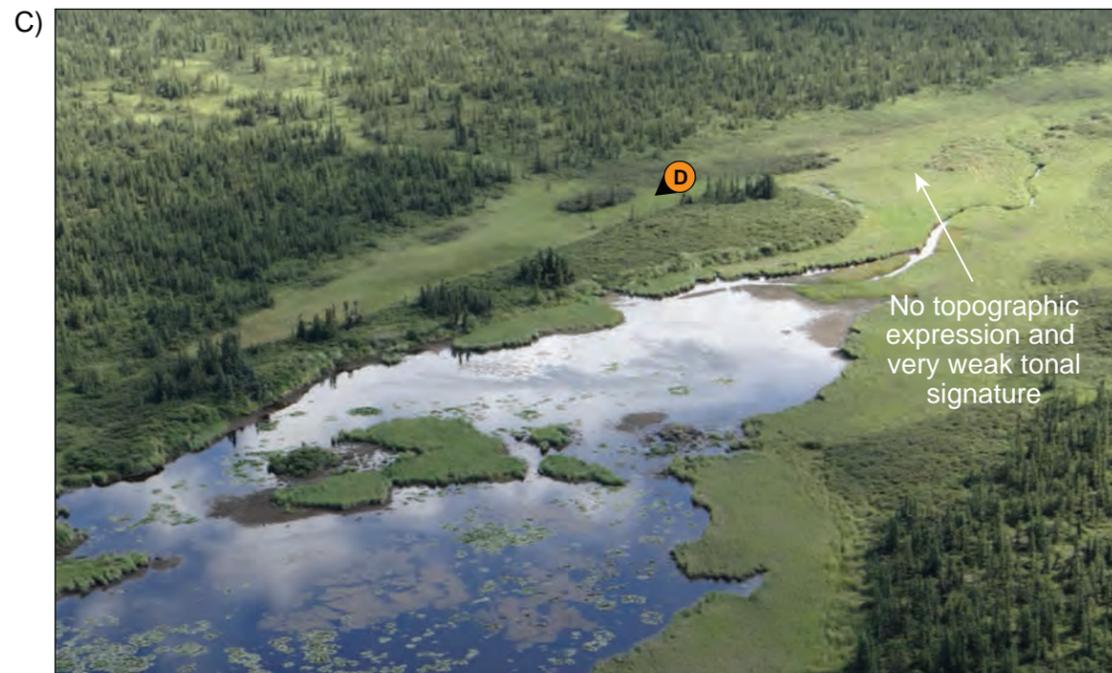
View looking south across strong vegetation lineament associated with a ~2-meter-high linear ridge. Note that topographic expression of ridge abruptly dies out and does not continue to the west.

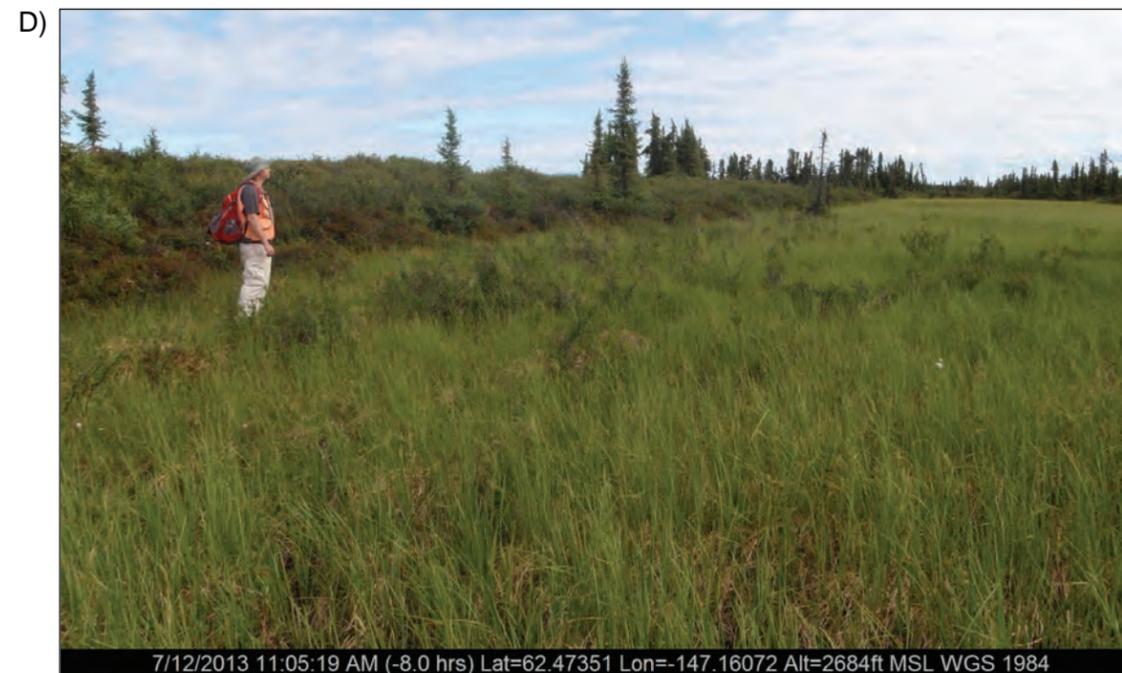
View looking northeast along south side of vegetation lineament and ~2-meter-high linear ridge shown in Photograph C. Positive feedback of vegetation growth and organic matter accumulation on the linear ridge may accentuate the apparent relief of the ridge.

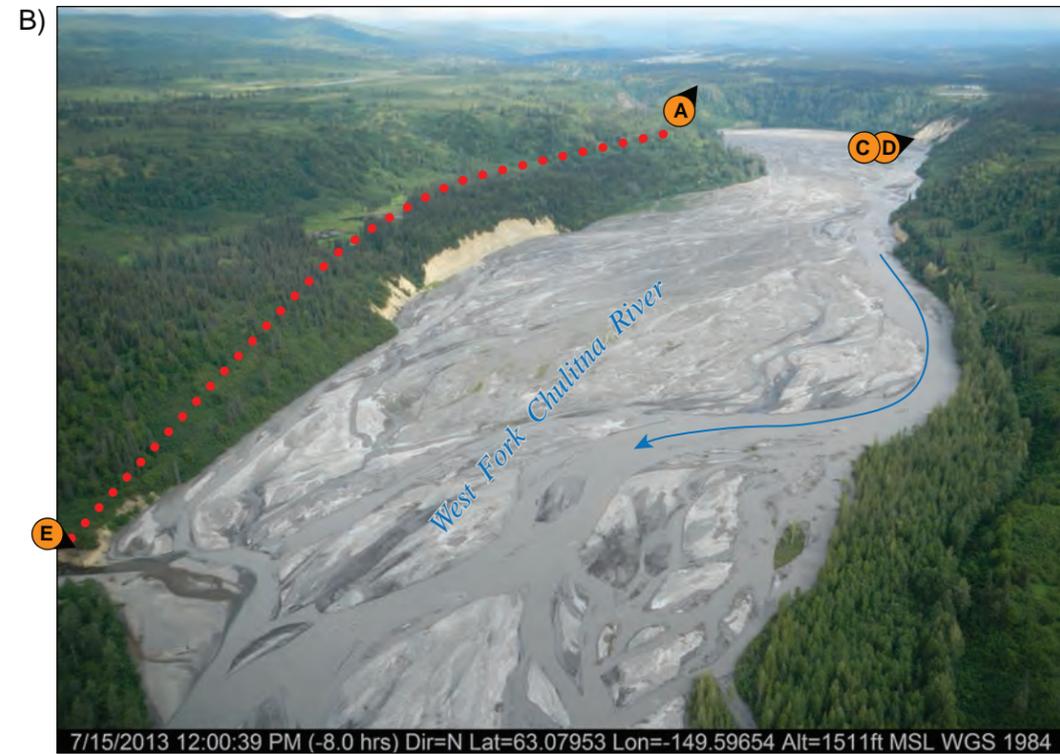
View looking north (upstream) along the West Fork Chulitna River valley at exposures described in text and photographs below.

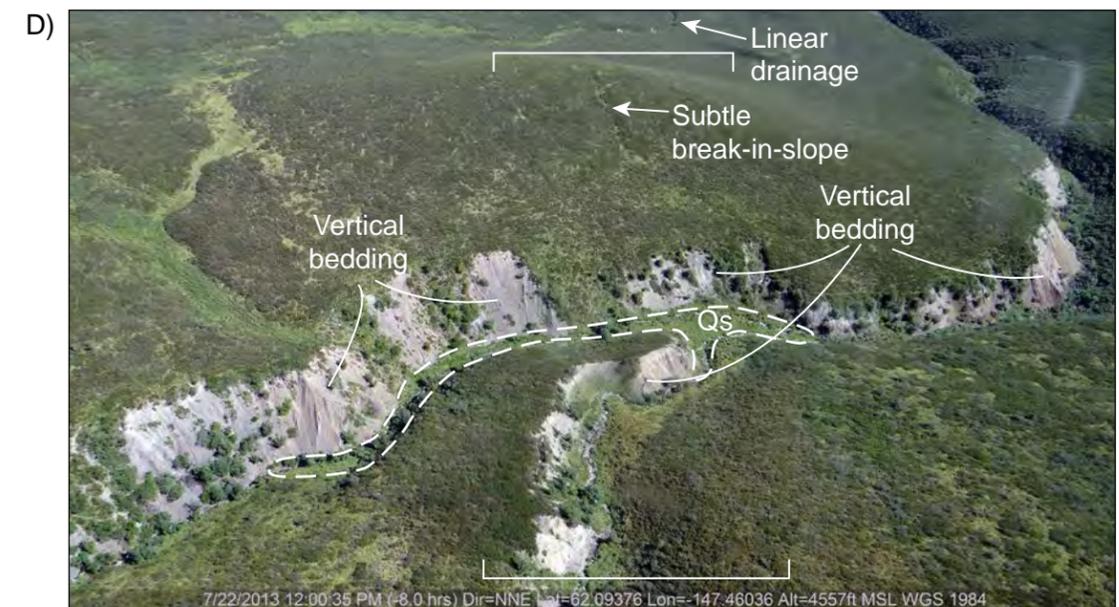
View looking northeast from location D along-strike with a Csejtey et al. (1978) mapped fault. A wide zone of deformation is expressed as vertical bedding exposed in outcrops. Note alignment of the break-in-slope on ridge crest, linear drainage, and the deformation zone.

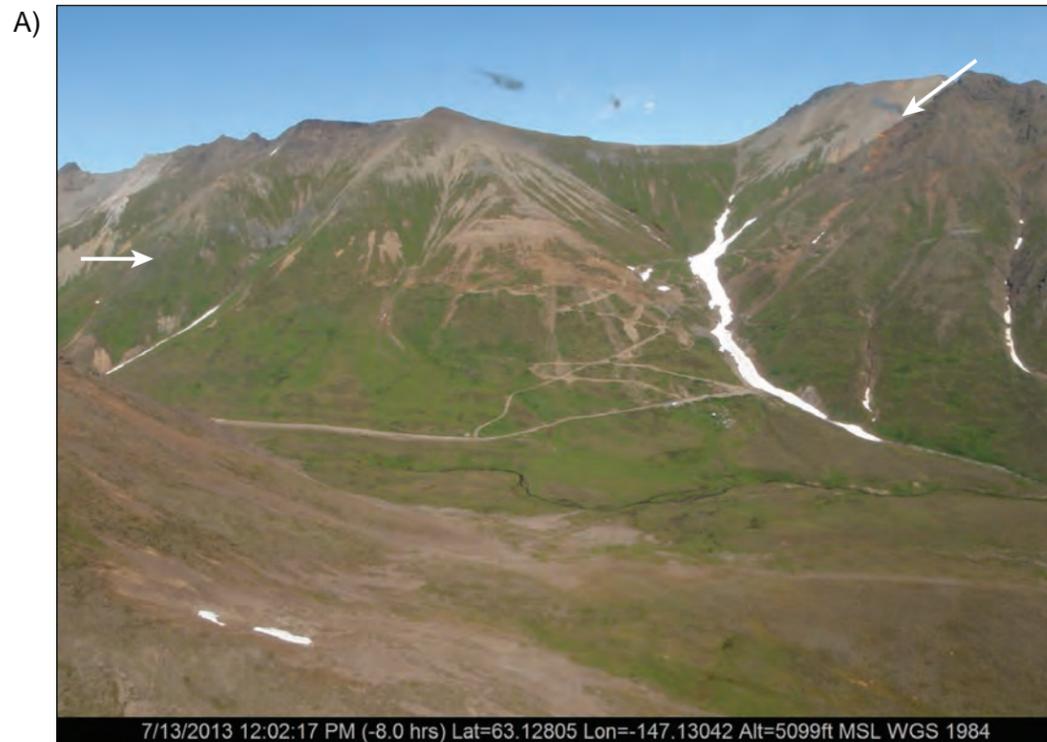
View looking northwest at mine site located along apparent rock type contrast and mapped fault. Arrows point along mapped fault.

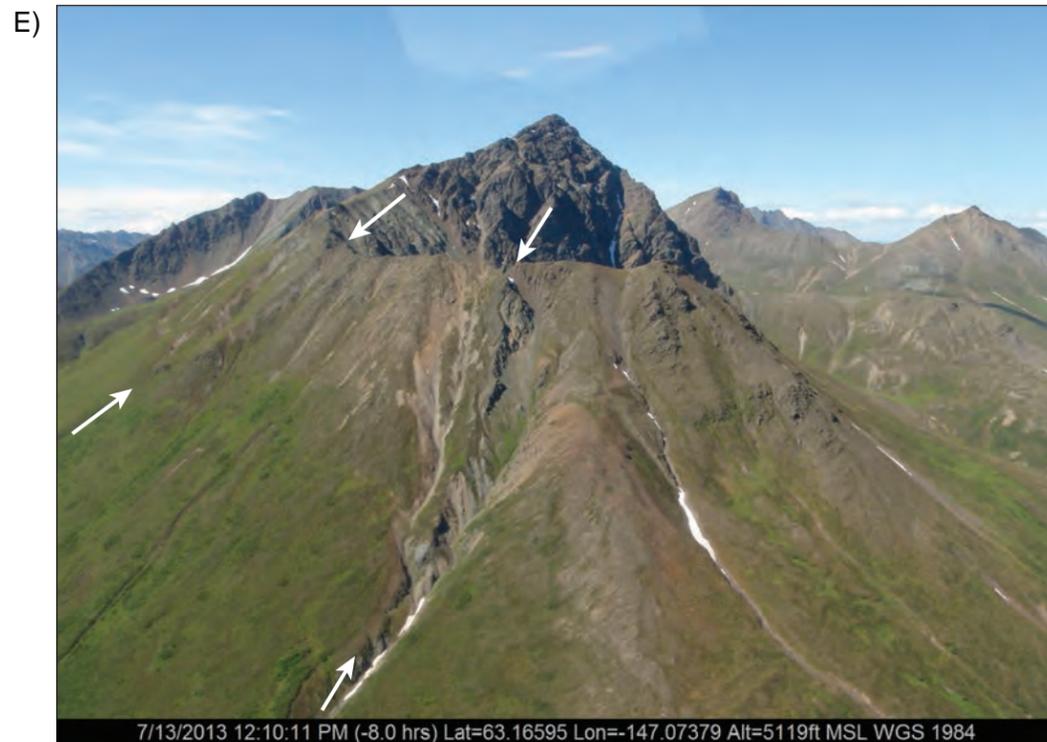
View looking southwest at several rock type contrasts (shown by arrows) that coincide with previously mapped faults.

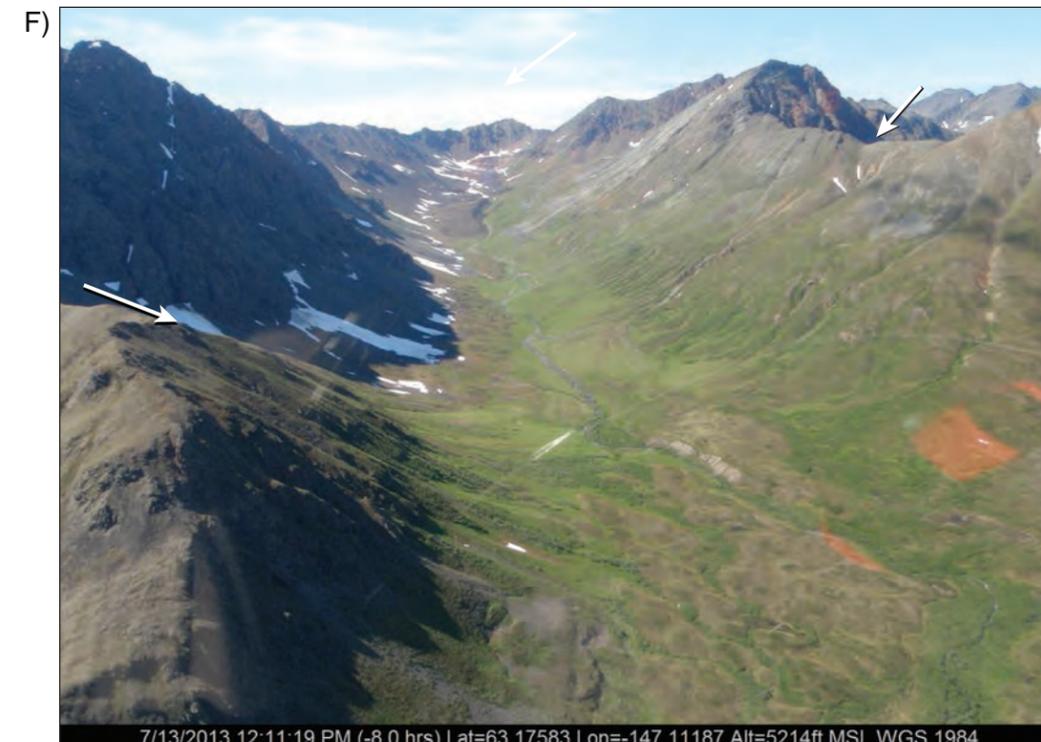
View looking south-southwest up glaciated valley that shows no expression of the mapped Black Creek fault that is present in adjacent bedrock ridges.

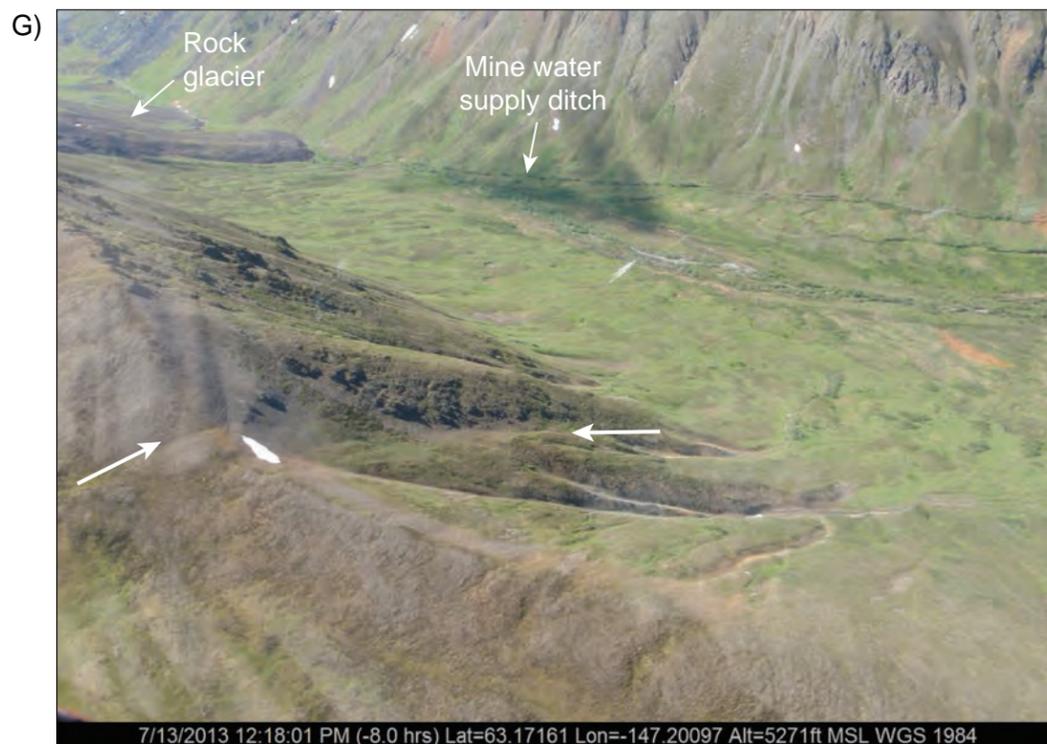
View looking southwest across an FCL-mapped lineament that corresponds to the trace of mapped Black Creek fault marked by a rock contrast. Note that no expression of faulting exists along trend in the glacial sediments of the valley floor.

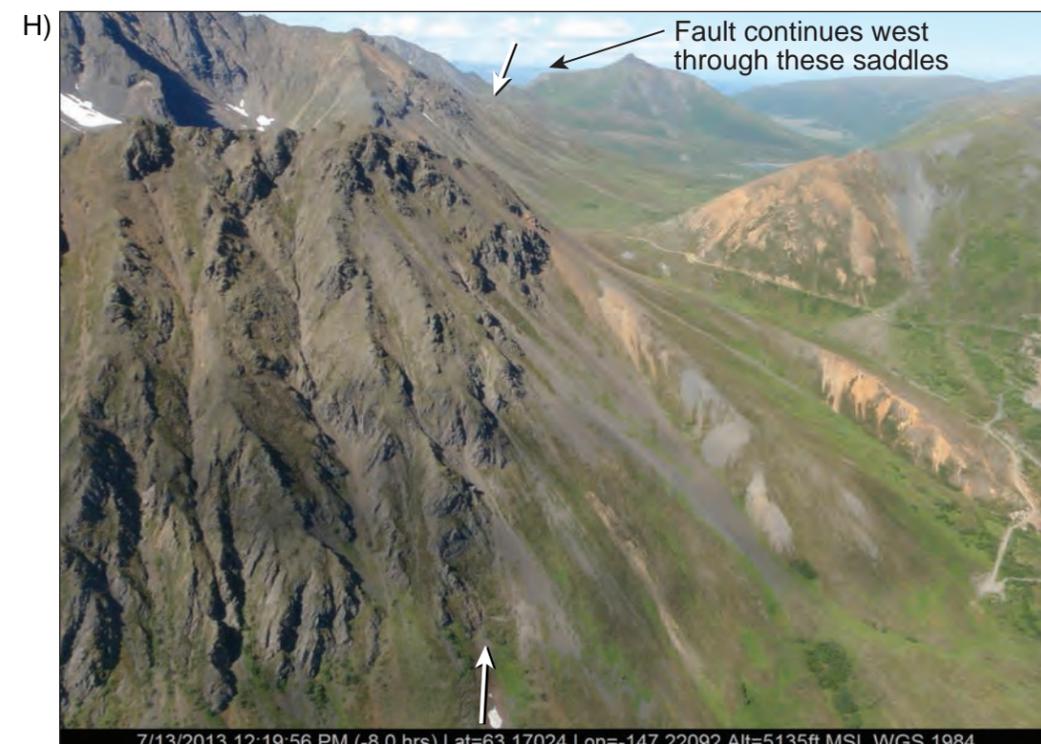
View looking west along the Black Creek fault. Note the obvious rock type contrast across the fault. Aerial reconnaissance confirmed the presence of the fault in bedrock ridges to the west and the lack of expression in glacial sediments in adjacent valley bottoms.
