Figures

SUSITNA-WATANA HYDROELECTRIC PROJECT

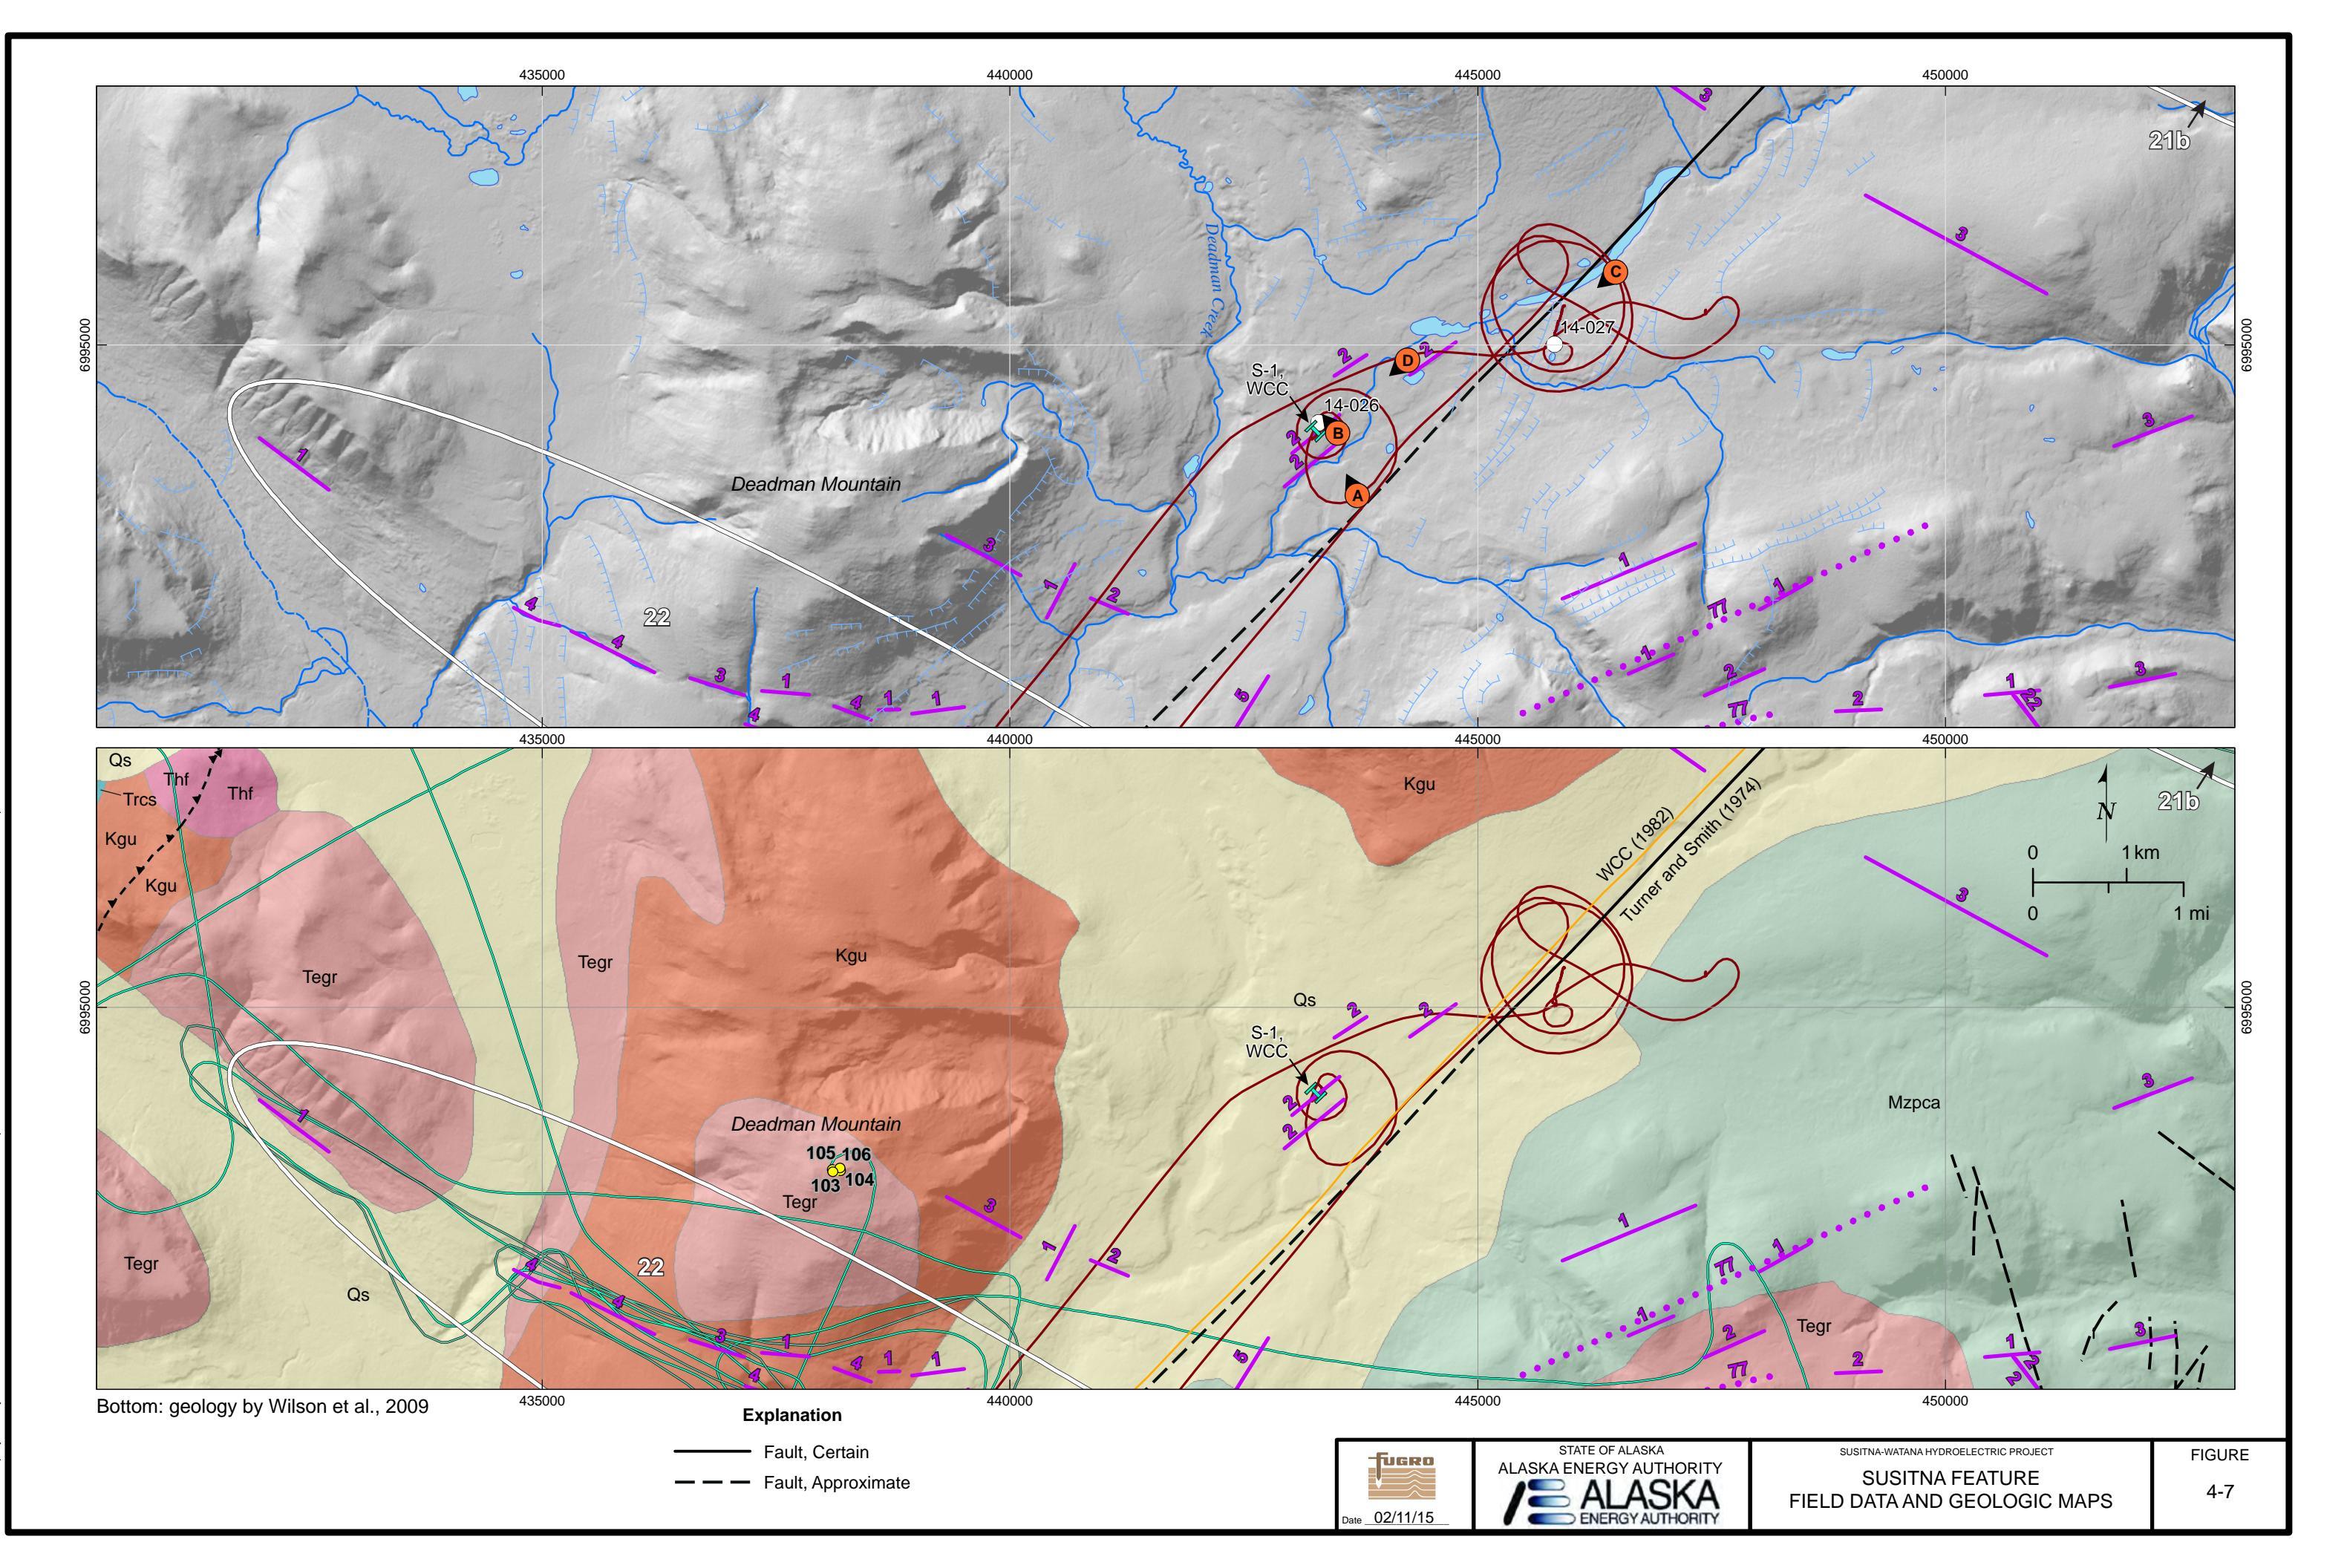
View looking northwest at slope breaks along postulated Susitna feature. 1982 trench site is also shown on Figure 4-5. Numerous slope breaks of similar size are present along Deadman Creek and in background.
