SUSITNA-WATANA HYDROELECTRIC PROJECT
 LINEAMENT GROUP 12b
 MAP DATA

FIGURE
 A12b.1

79_218900_Alaska_Railbelt/2189_Lineament Report October 2013, modified 10.18.13

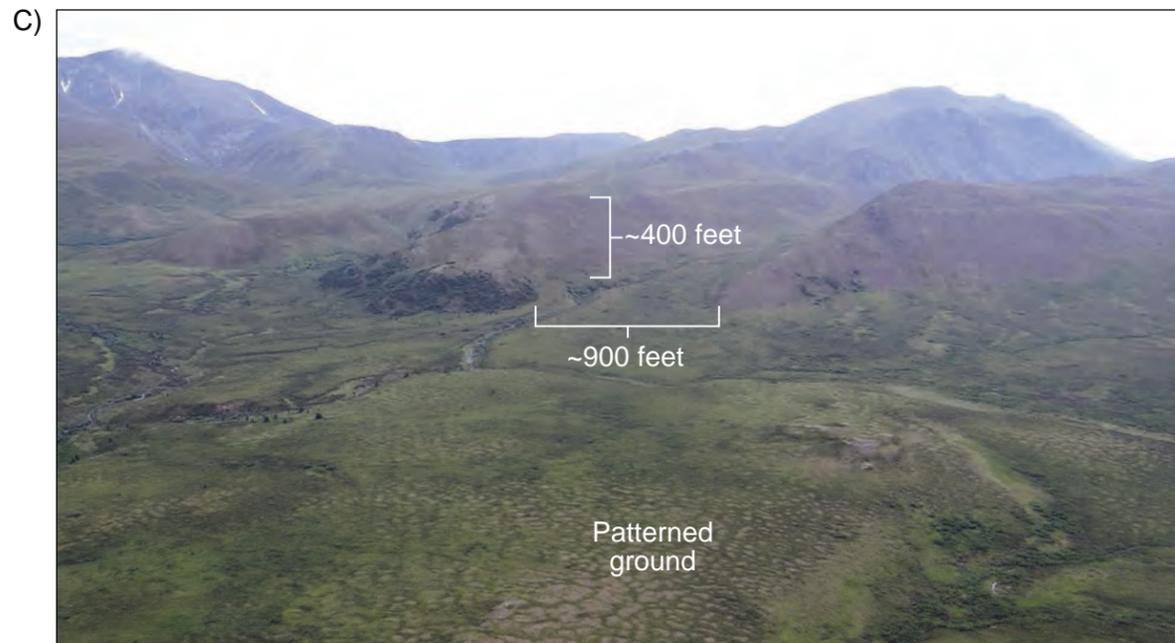
View southerly up-valley into glacial valley along lineaments geomorphically expressed as linear valley and drainage. Underfit creek in deep linear valley suggests landform created by sub-ice channel meltwater.

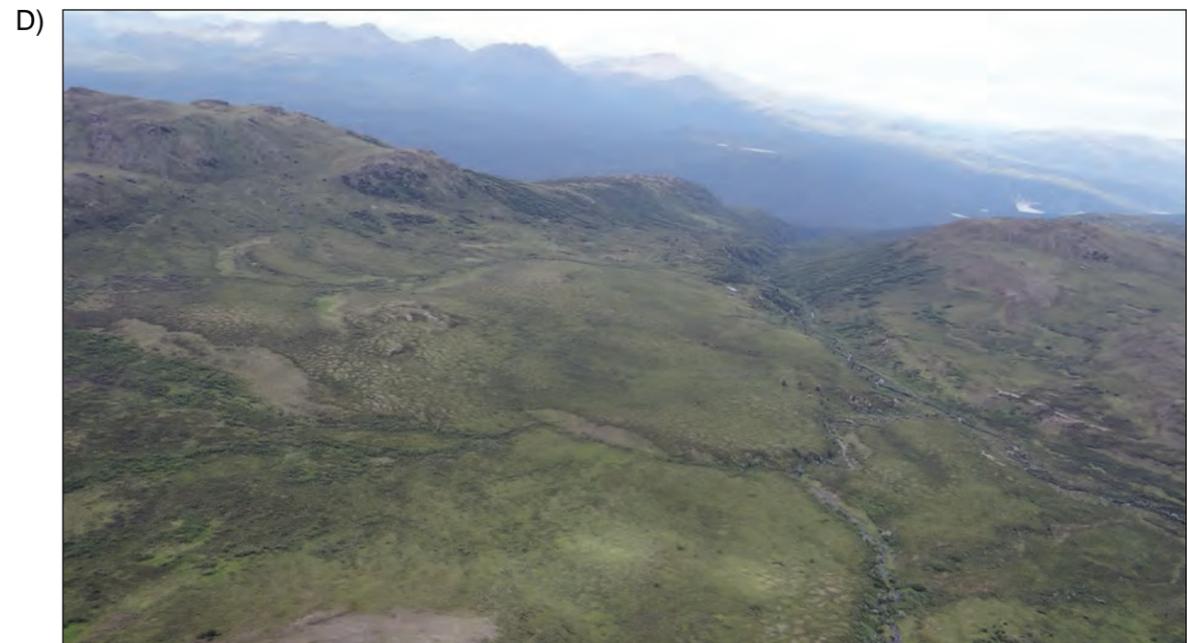
View northerly down-valley along lineaments geomorphically expressed as linear drainage. Thin cover of unconsolidated surficial sediment mantles the Paleozoic rocks.

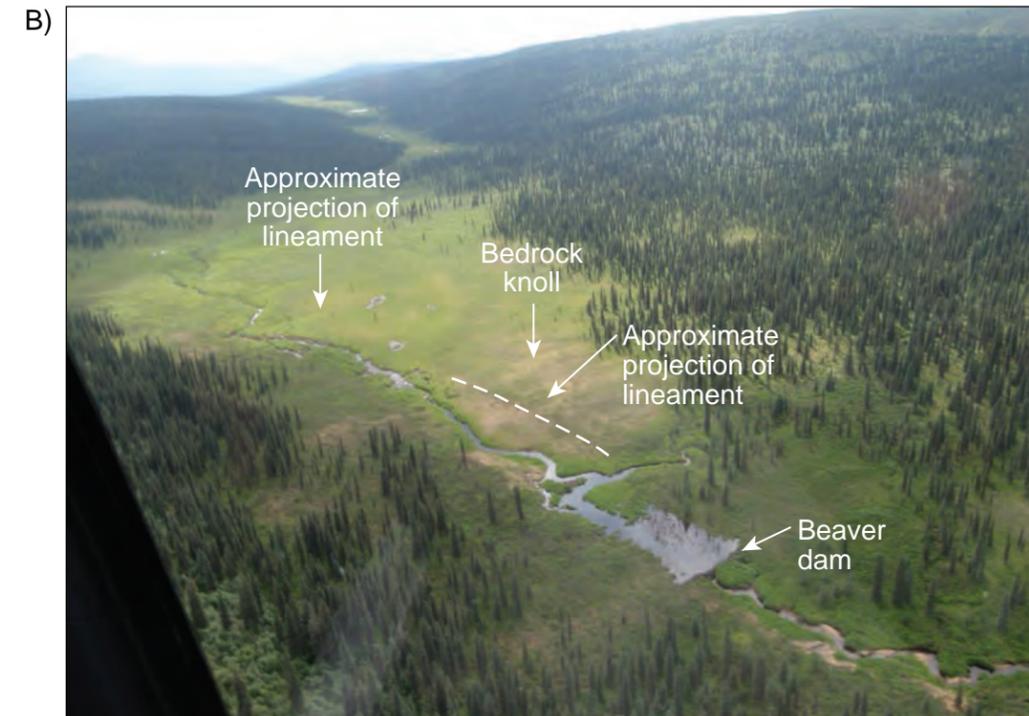
View looking north-northeast at creek in boggy (Holocene) drainage. Lineament is expressed as a depositional contact along the shallow bedrock knoll.

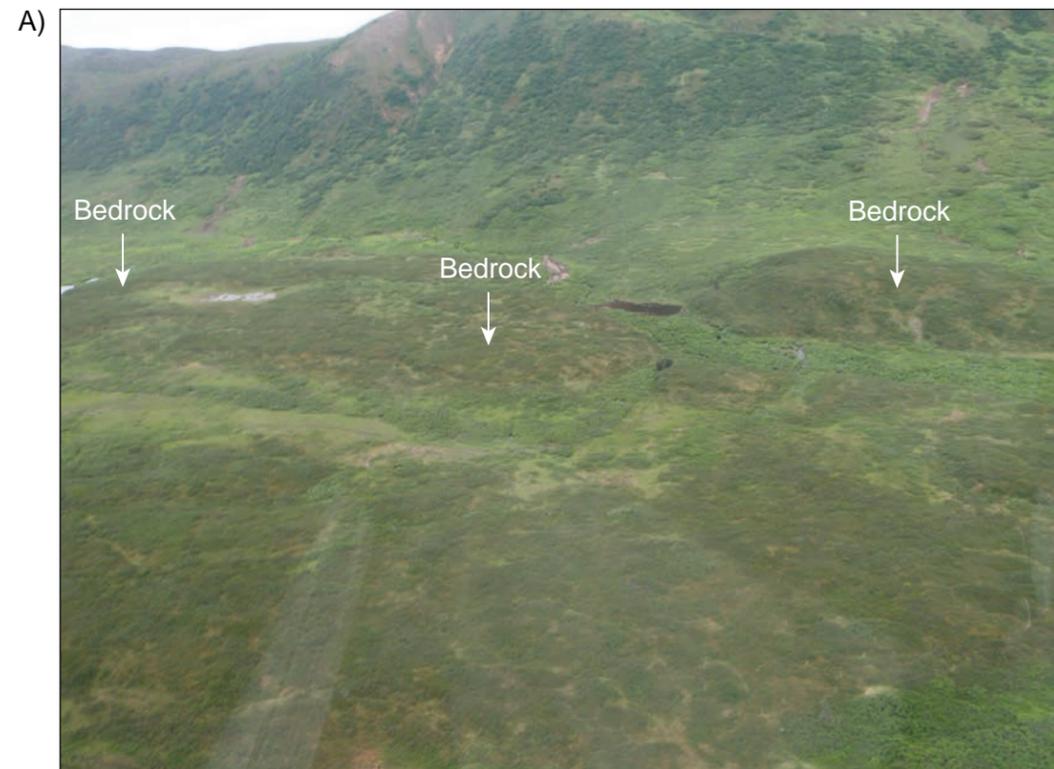
View looking westerly at break-in-slope at base of hillside and undulating glacially-eroded bedrock knobs in foreground.

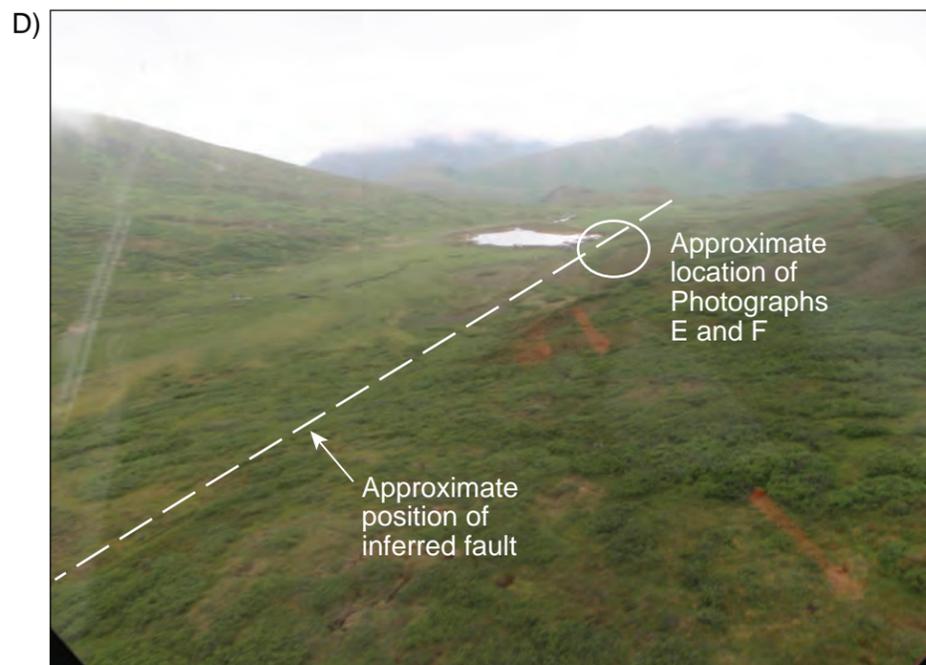
View looking south along southern extent of group 17b, along which an inferred bedrock fault is mapped by Wilson (2009). Photographs B and C are adjacent to lake.

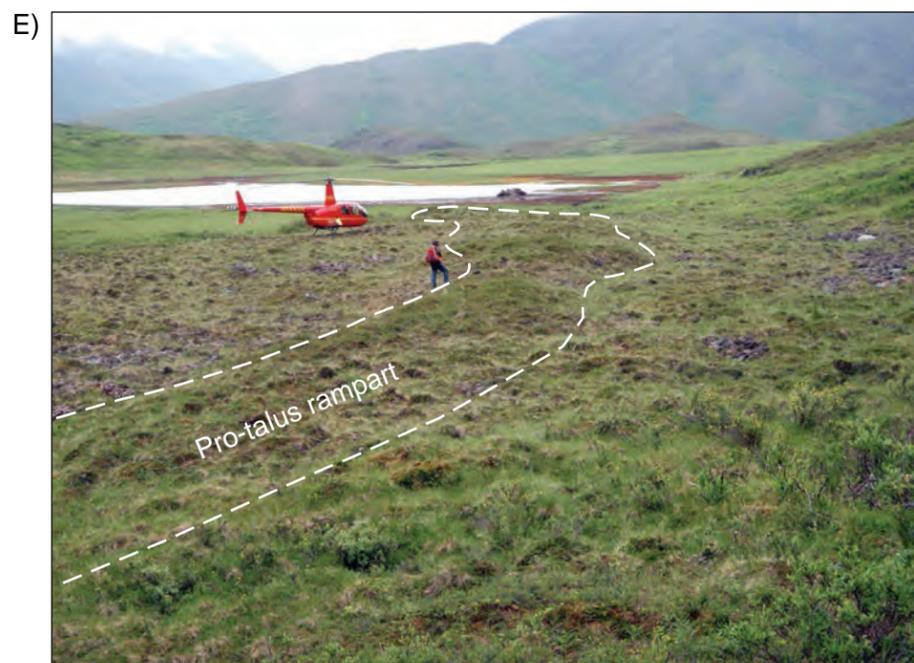
View looking south at pro-talus rampart and GPS waypoint 15. Note lateral distance between base of slope to crest of rampart. Geologist for scale is about 180 cm tall.

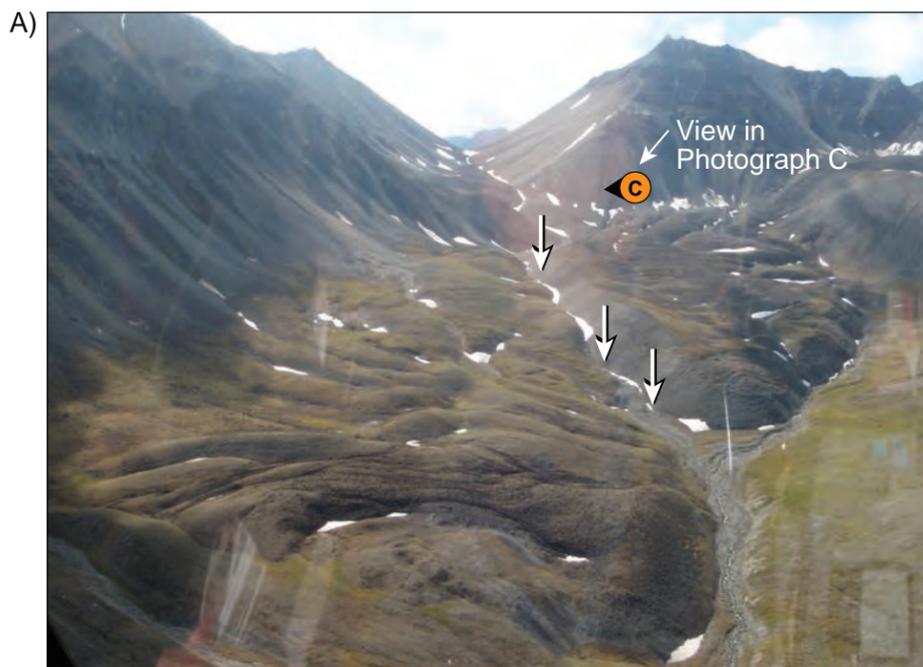
View looking southeasterly at lineament expressed at erosional drainage cutting through the likely Holocene rock glacier deposit.

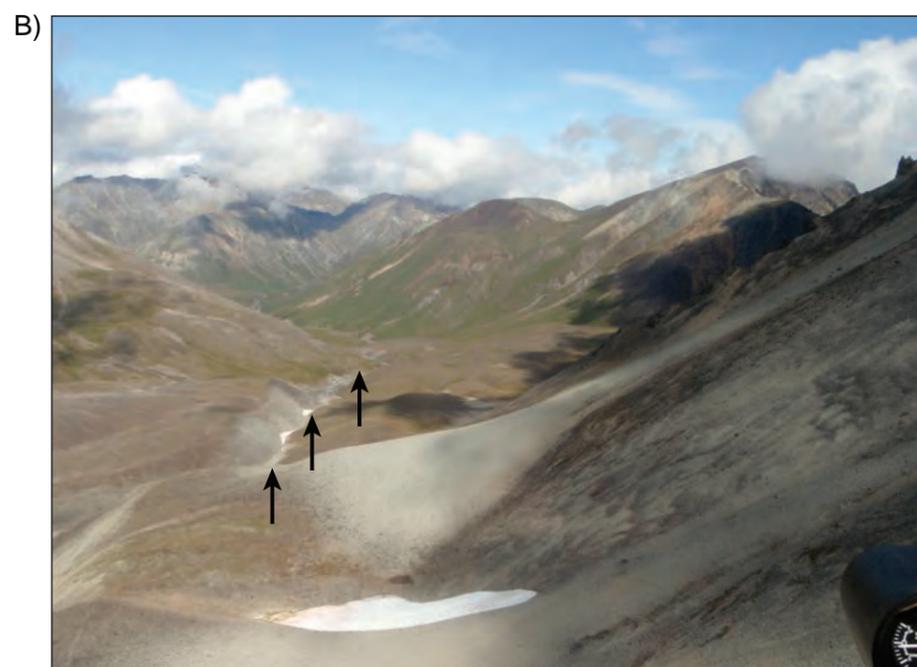
View looking northwesterly (opposite that in Photograph A) at lineament expressed as erosional drainage cutting through the likely Holocene rock glacier deposit.

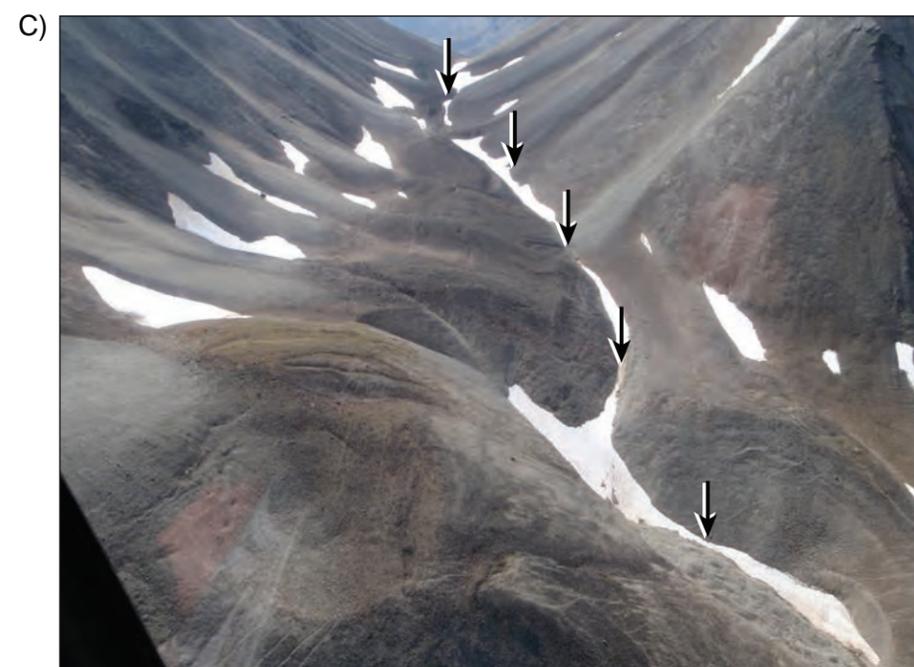
View looking southeasterly at lineament expressed as likely Holocene rock glacier deposit contacting the valley floor.

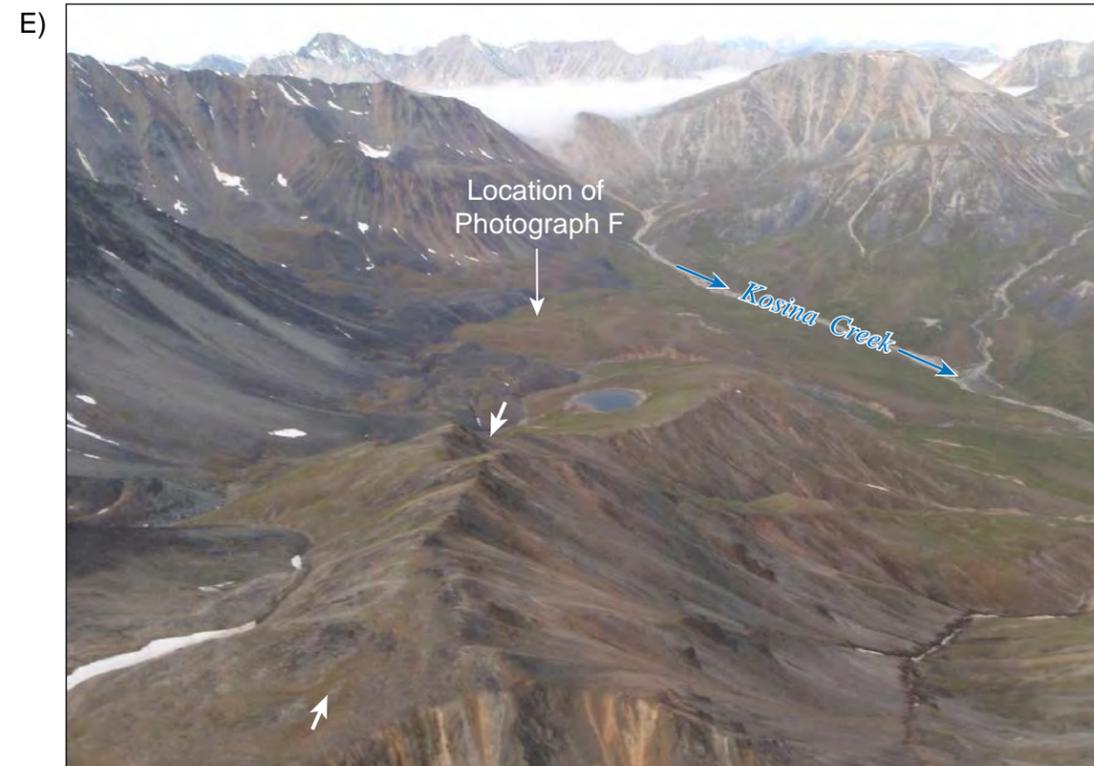
Photograph from location E looking southwest down the ridgeline shown in Photograph D. View is 180 degrees from that in Photograph D. Note presence of rock glacier and glacial deposits in valley bottom. Arrows point along apparent contact.

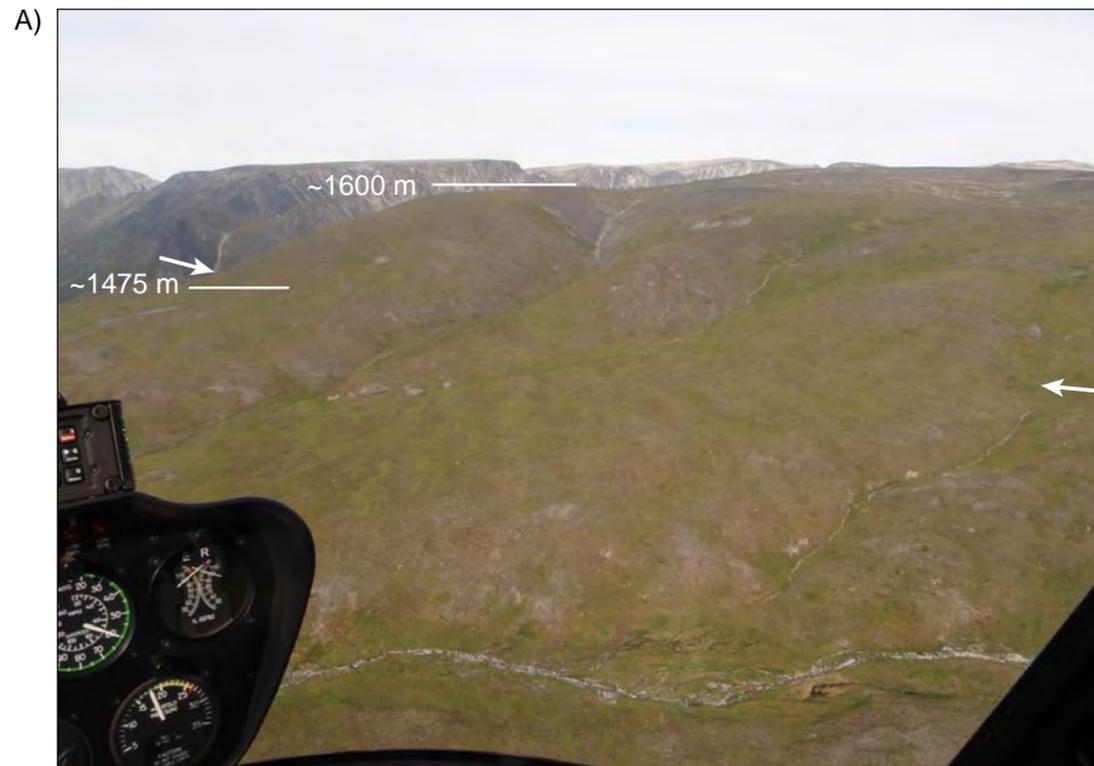
Photograph taken from location A looking west. Arrows point along trend of mapped lineaments along southwest-facing aligned break-in-slope. Note the rounded and subdued nature of break-in-slope. Relief across break-in-slope is ~125 m.

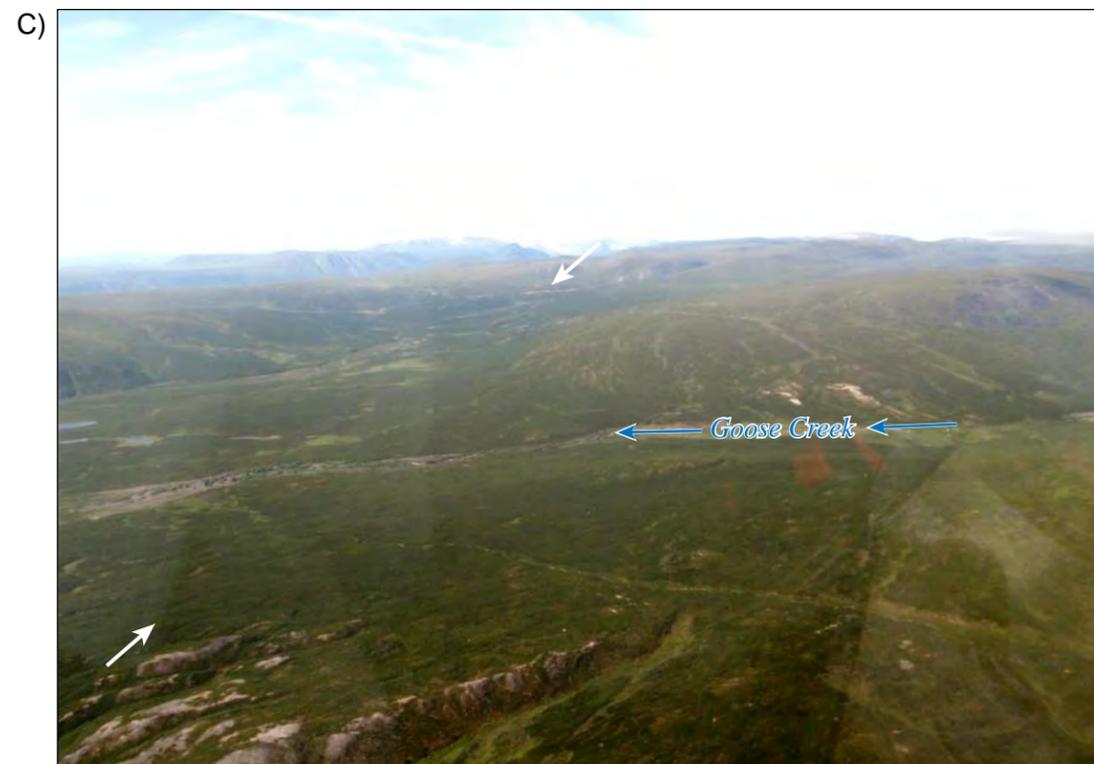
Overview photograph looking southwest from location C along alignment of mapped lineaments. Arrows point along trend of lineament group 19. Note absence of expression of lineaments within the landscape across the Goose Creek portion of the lineament group.

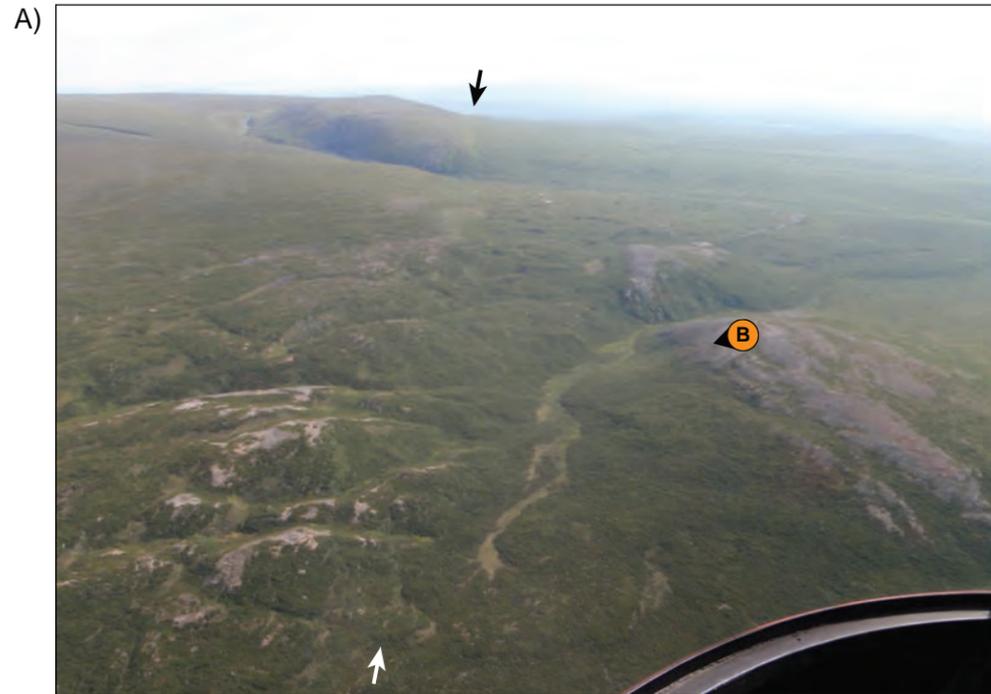
Photograph looking north-northeast from location A along the east-facing break-in-slope that defines the northeast portion of LG 19. Arrows point along alignment of mapped lineaments.

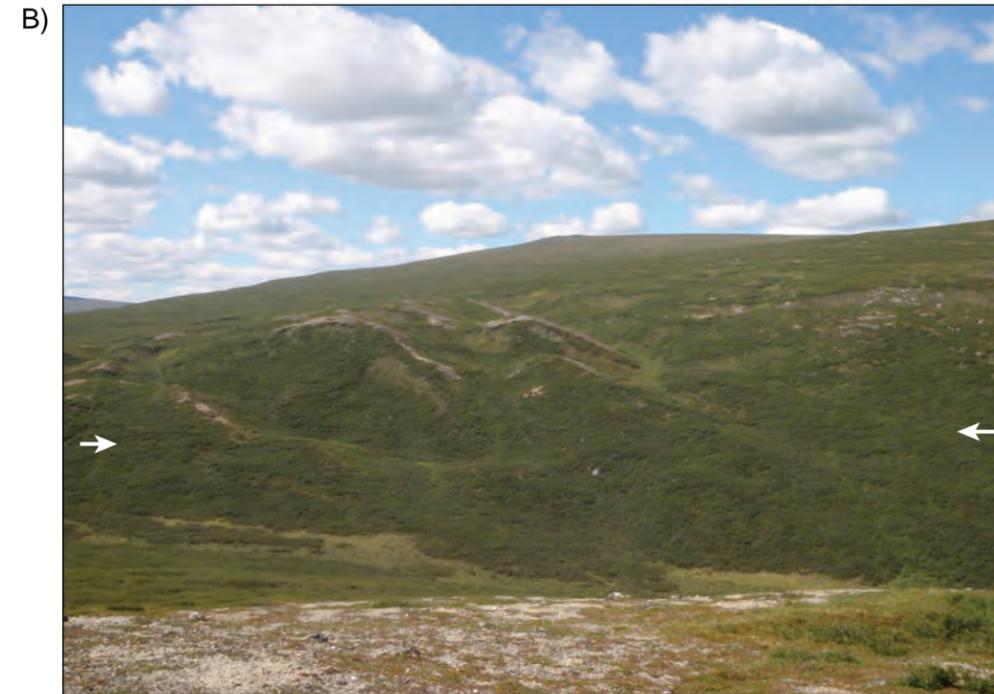
Photograph looking northwest from location B at sub-ice fluvially-eroded channels. Arrows point along the trend of mapped lineaments that make up group 19.

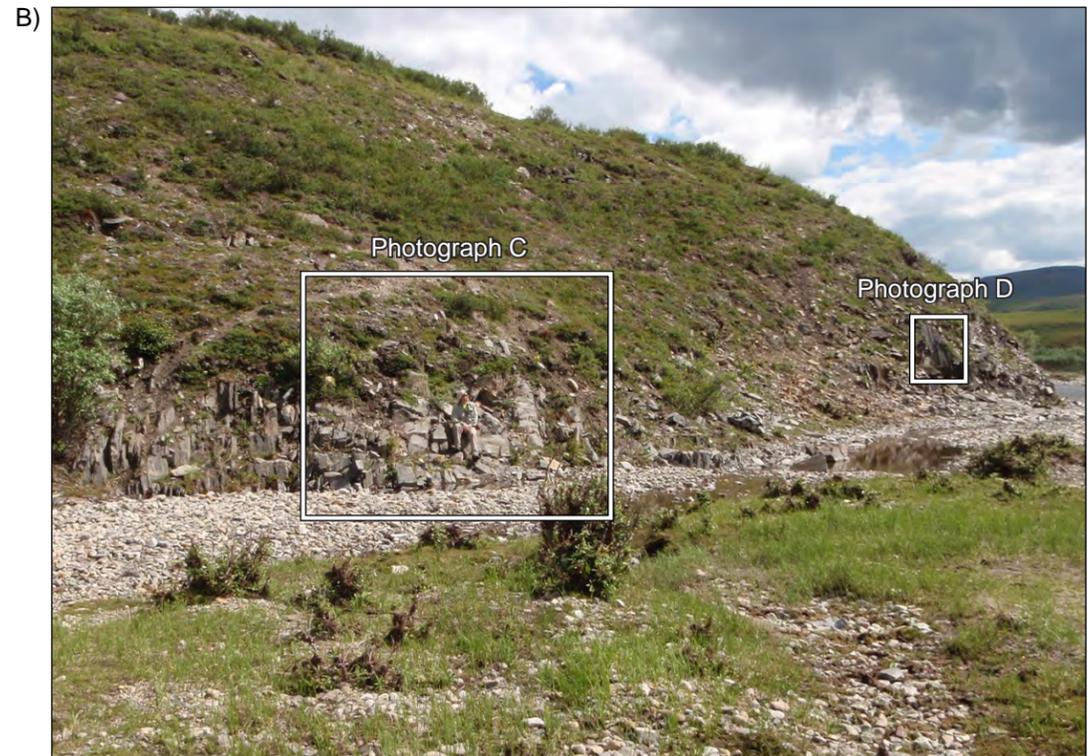
Overview of east-southeast striking, vertically-dipping phyllite exposures located at GPS waypoint 009.
