SUSTINA-WATANA HYDROELECTRIC PROJECT  
Broad Pass Area

**Appendix B:  
Strip Maps and Photographic Documentation  
of Lineament Data for Lineaments Mapped by Reger et al. (1990)**

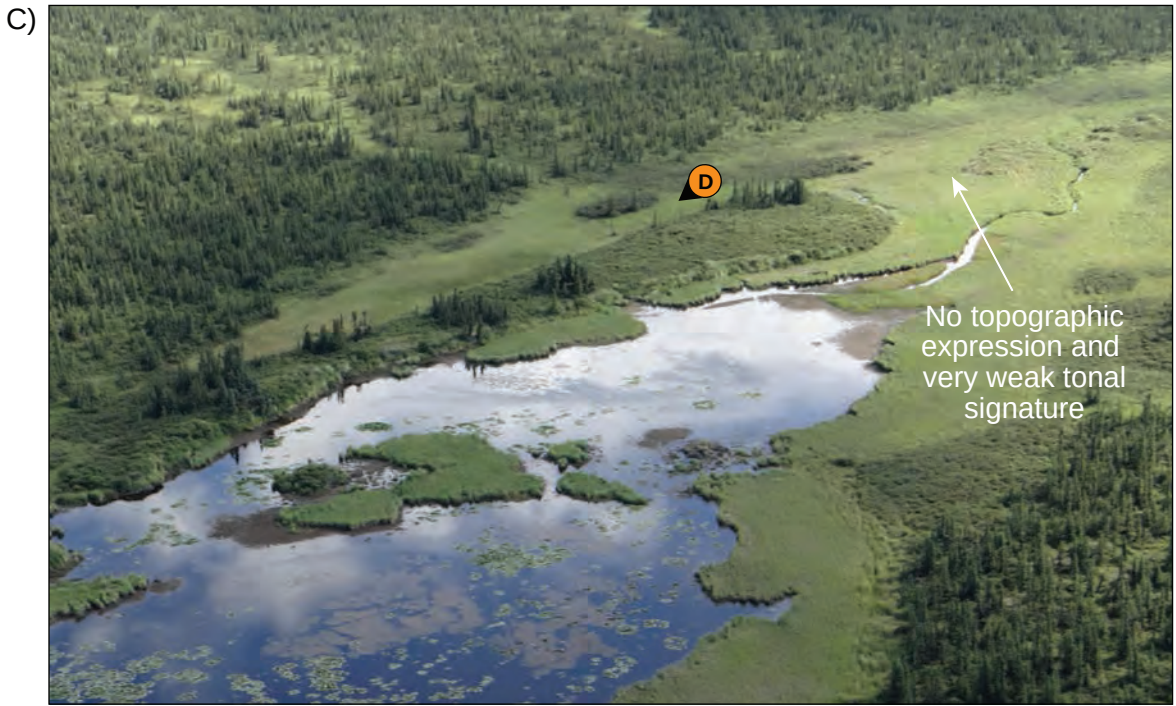
View looking south across strong vegetation lineament associated with a ~2-meter-high linear ridge. Note that topographic expression of ridge abruptly dies out and does not continue to the west.

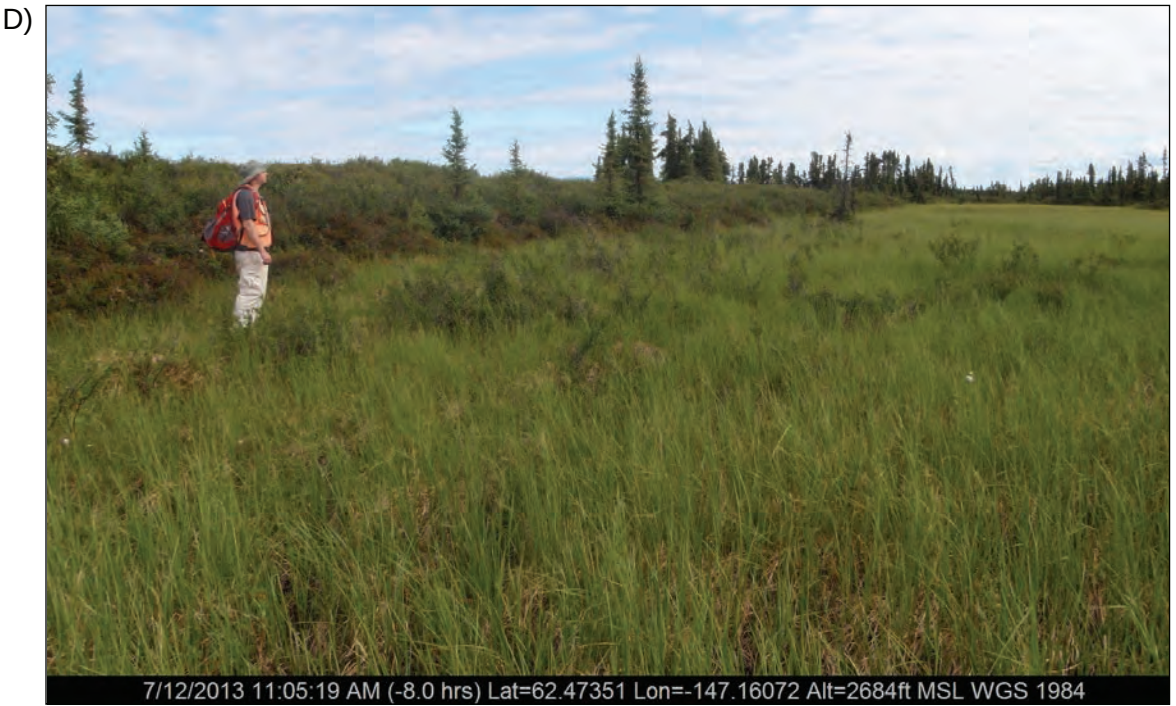
View looking northeast along south side of vegetation lineament and ~2-meter-high linear ridge shown in Photograph C. Positive feedback of vegetation growth and organic matter accumulation on the linear ridge may accentuate the apparent relief of the ridge.

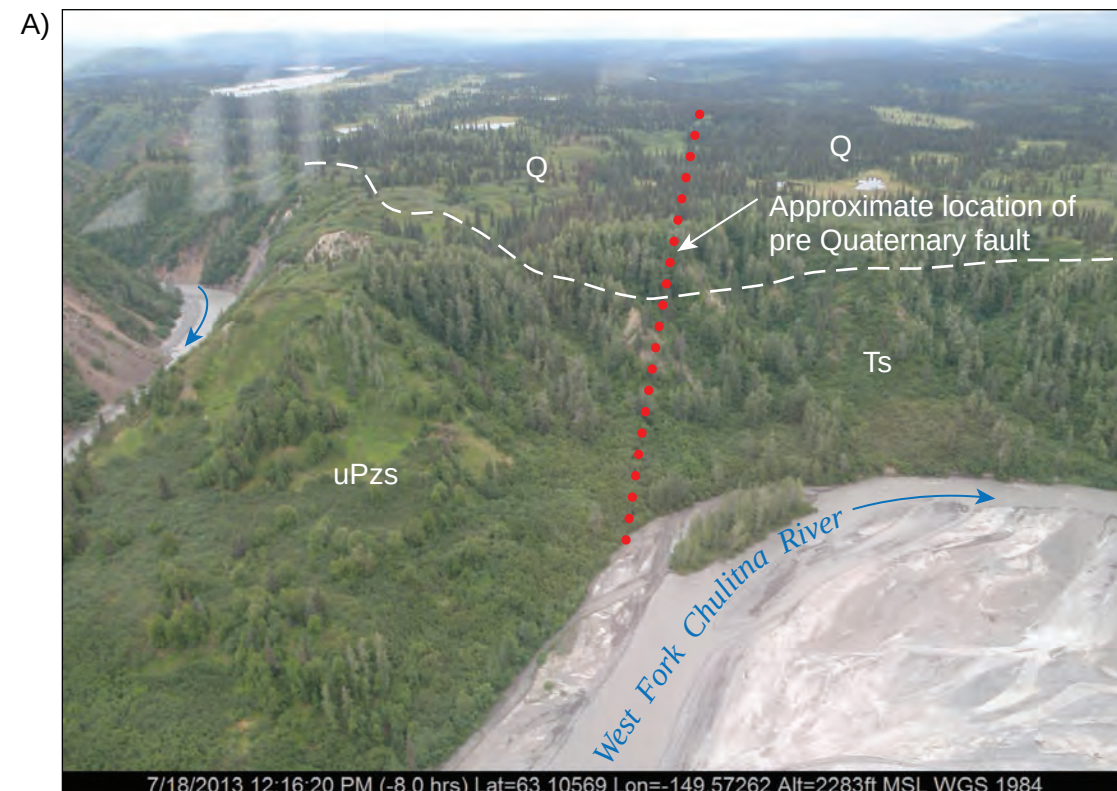
View looking north at location where mapped fault would traverse across Quaternary sediments.

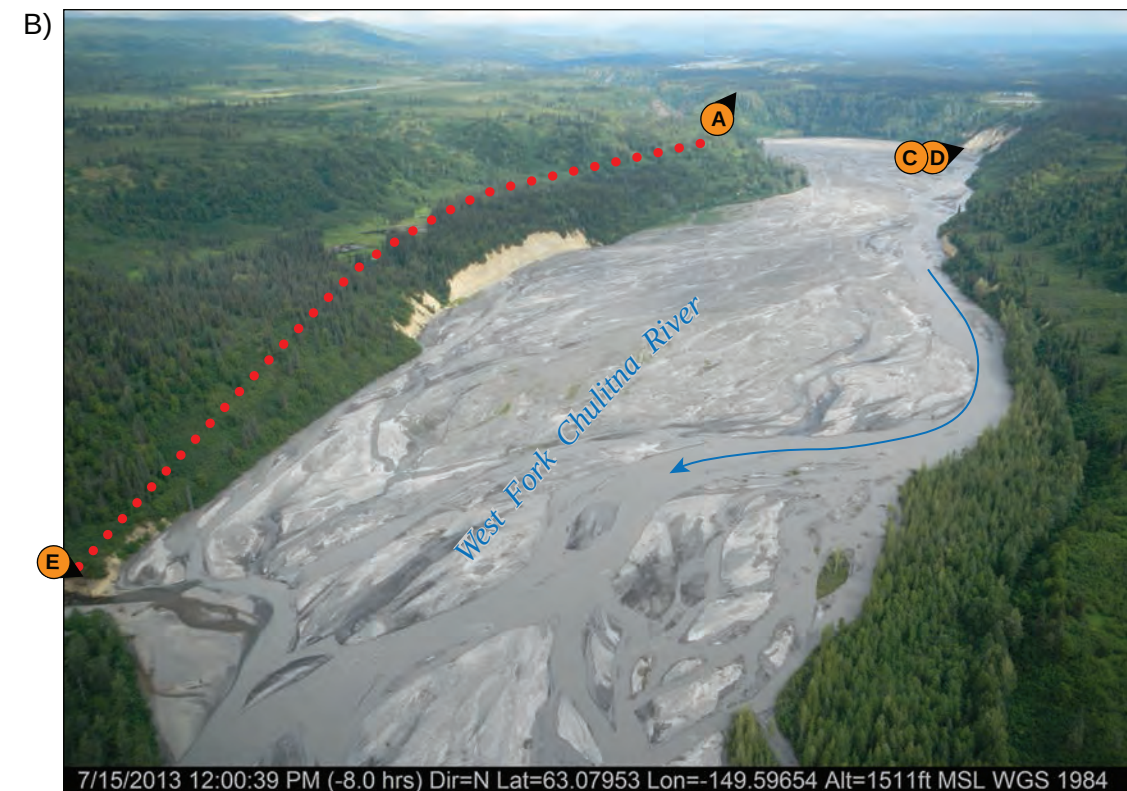
View looking north (upstream) along the West Fork Chulitna River valley at exposures described in text and photographs below.

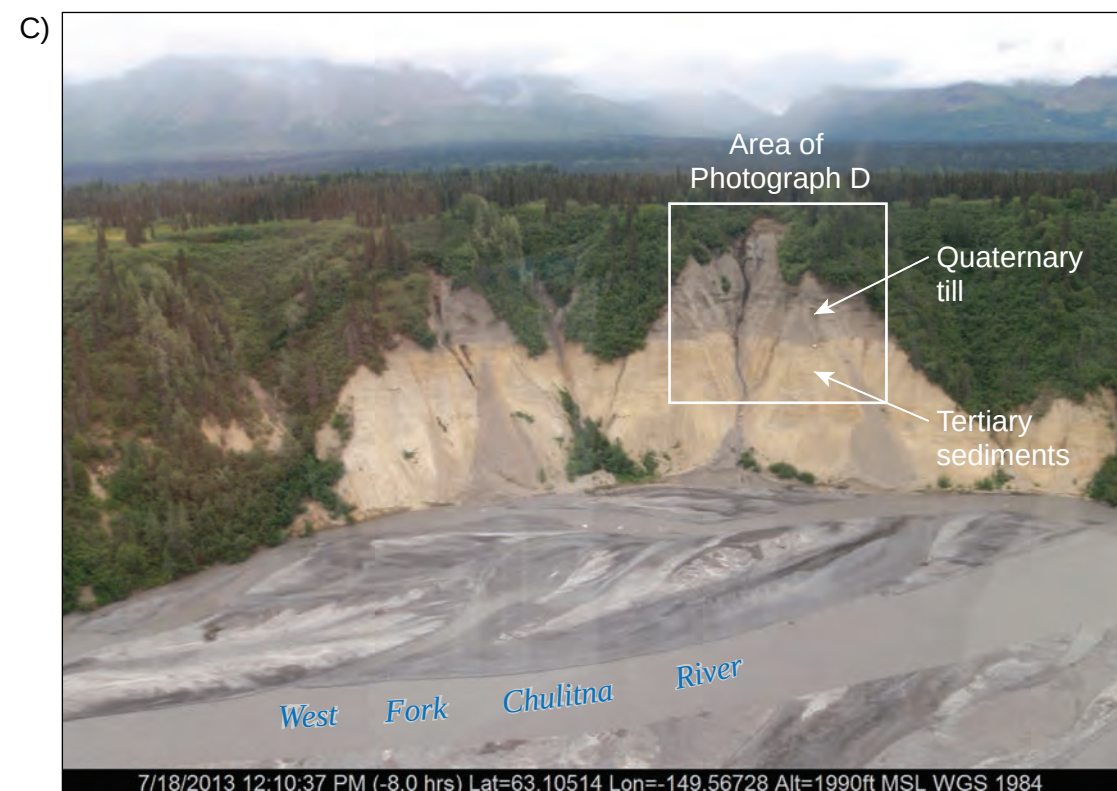
View looking west at exposure along east bank of the West Fork Chulitna River demonstrating Quaternary till overlying Tertiary fluvial sediments.

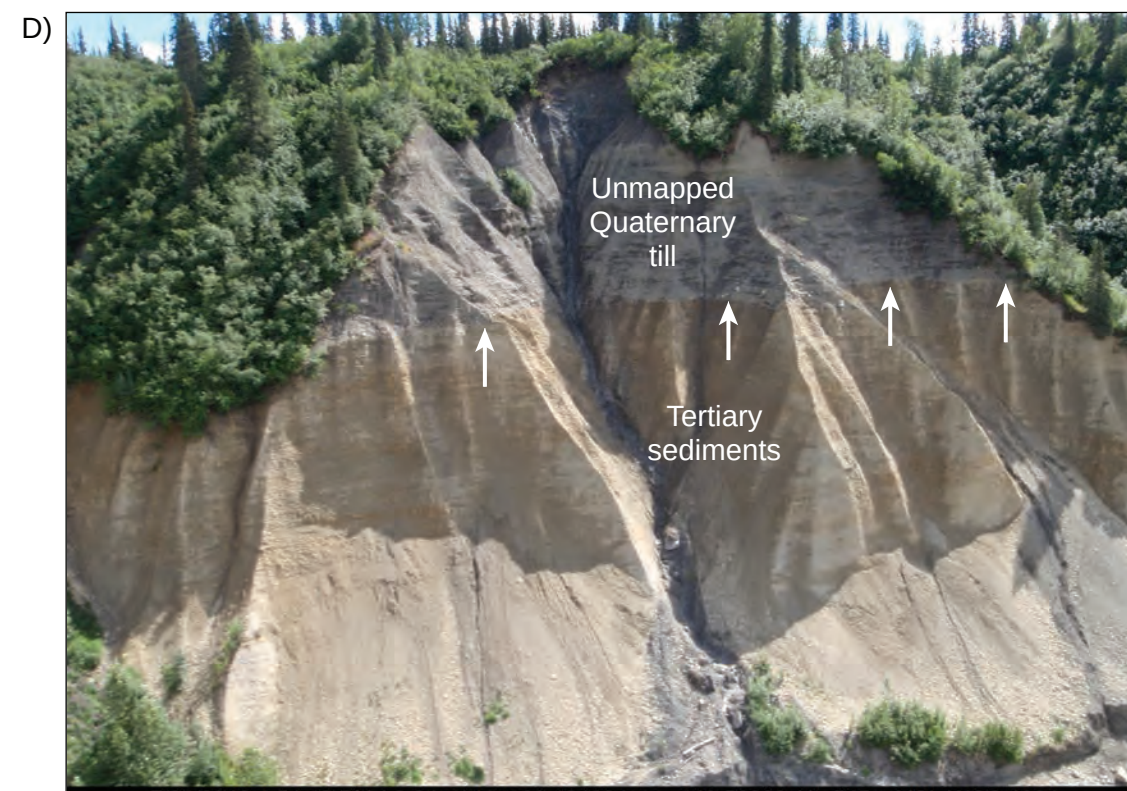
Close up view of exposure shown in Photograph C. Basal contact between overlying till and underlying fluvial deposits appears to be sub-horizontal.

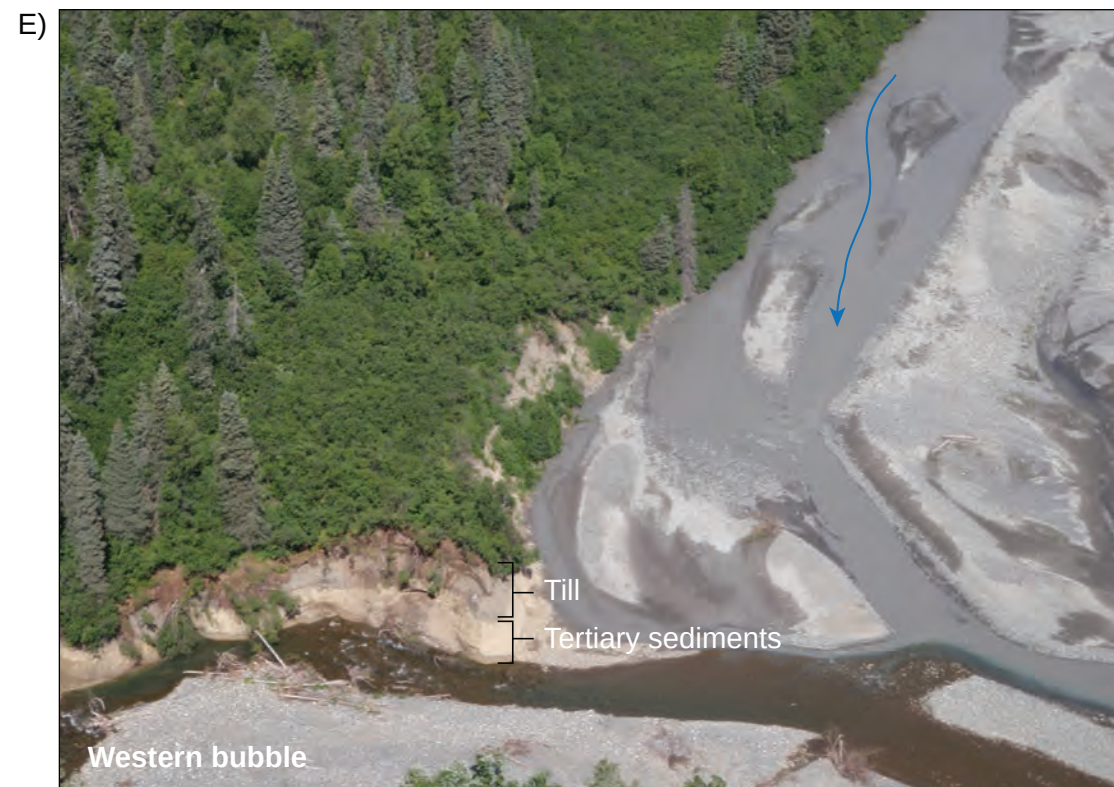
View looking northeast at subhorizontal contact between till and Tertiary sediments.

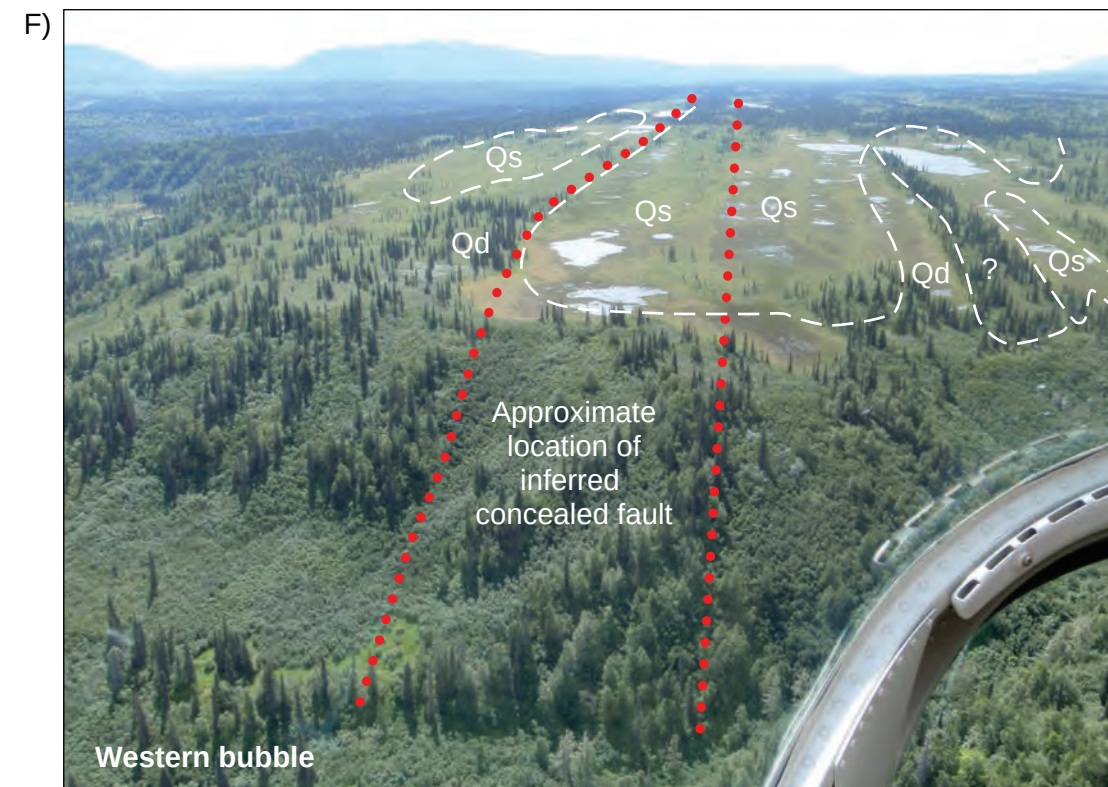
View looking south along Quaternary surface directly south of river valley. Marshy Quaternary sediments show no evidence of deformation or offset.

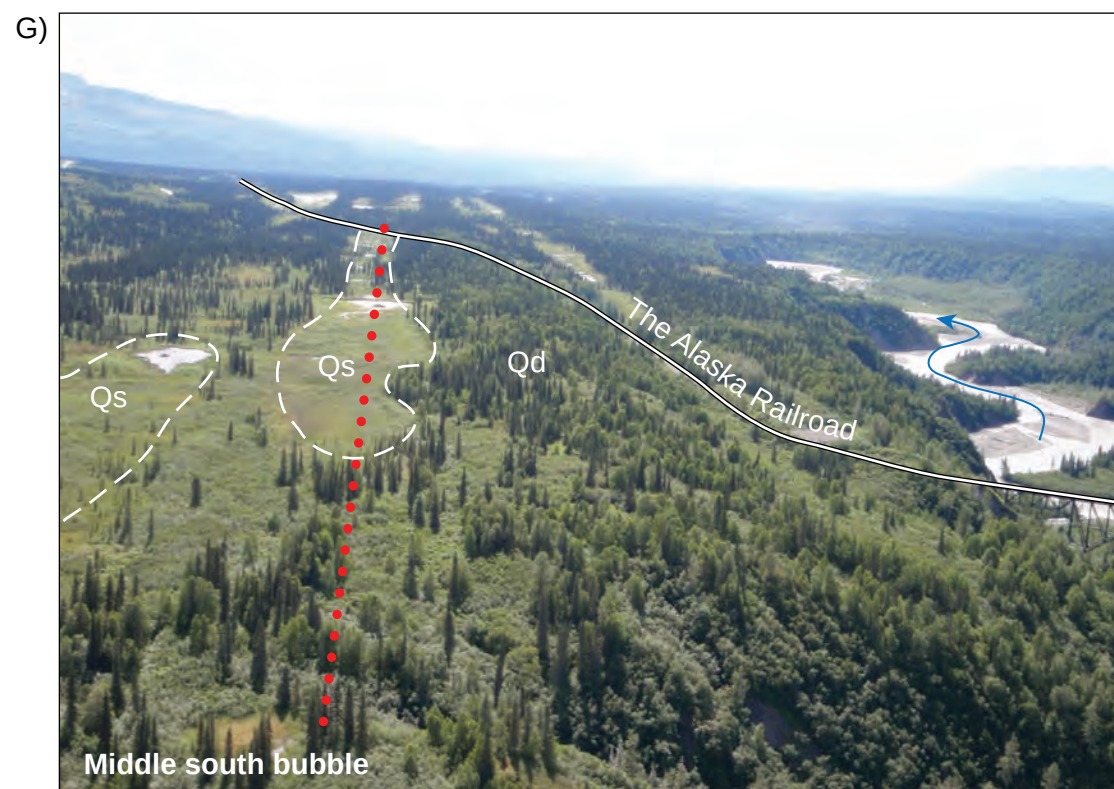
View looking south at location where inferred fault would traverse east of railroad tracks. Fault is mapped as juxtaposing Triassic and Cretaceous rocks outcropping in creek behind photograph. No evidence of faulting in Quaternary deposits.

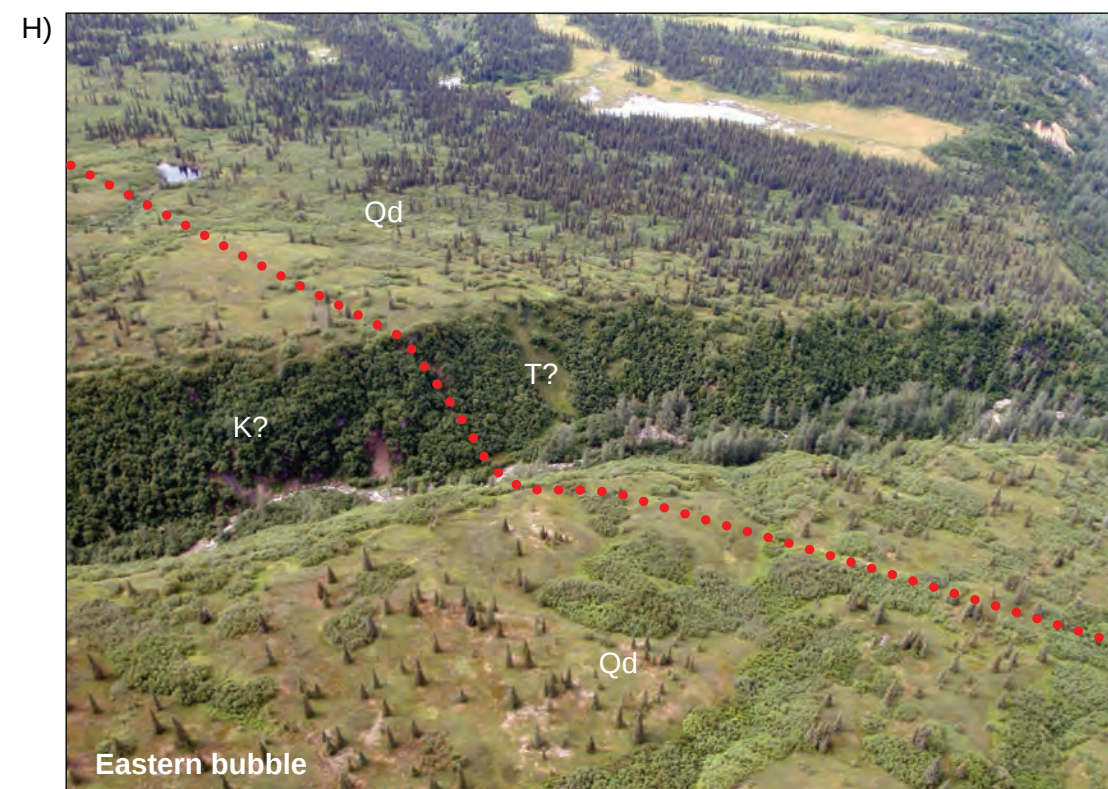
View looking west at creek exposure along projection of mapped fault that depicts Cretaceous/Tertiary juxtaposition. Undisturbed surfaces support absence of Quaternary faulting.

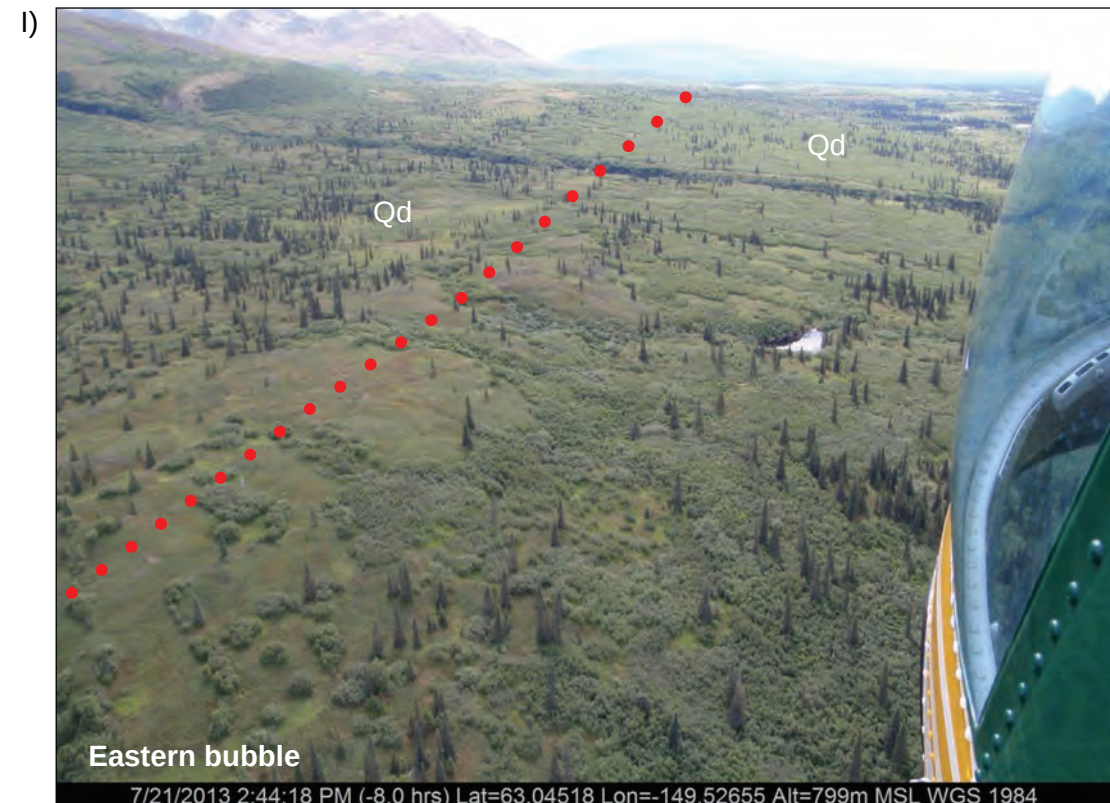
View looking west at creek exposure shown in Photograph H, Figure A-BP.2, showing morphology of Quaternary deposits along strike.

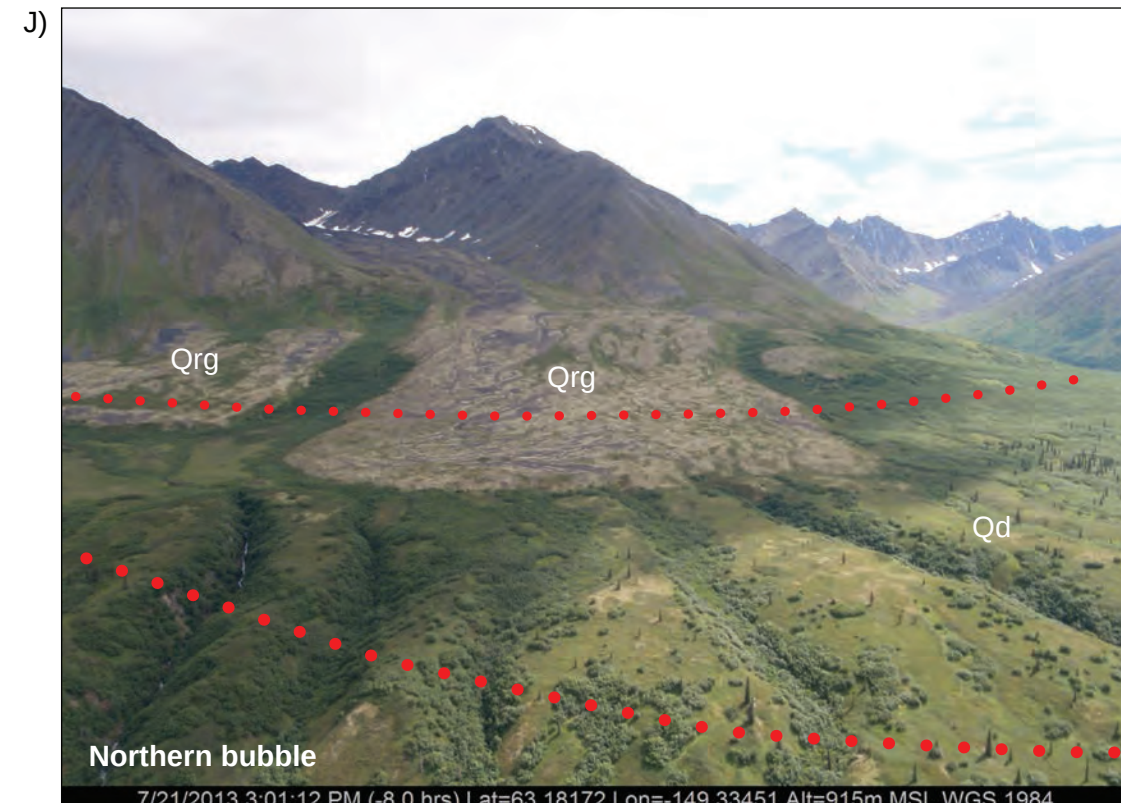
View looking east at uninterrupted interfluvies in dissected Quaternary glacial drift along with the mapped fault projects. Undisturbed surfaces support absence of Quaternary faulting.

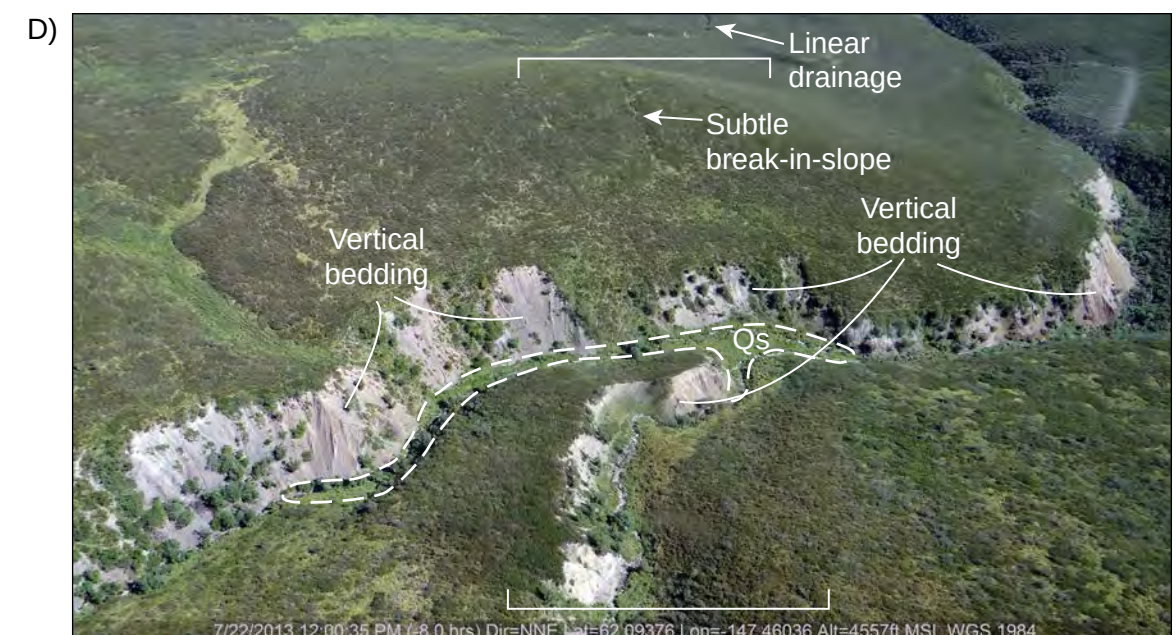
View looking northeast from location D along-strike with a Csejtey et al. (1978) mapped fault. A wide zone of deformation is expressed as vertical bedding exposed in outcrops. Note alignment of the break-in-slope on ridge crest, linear drainage, and the deformation zone.

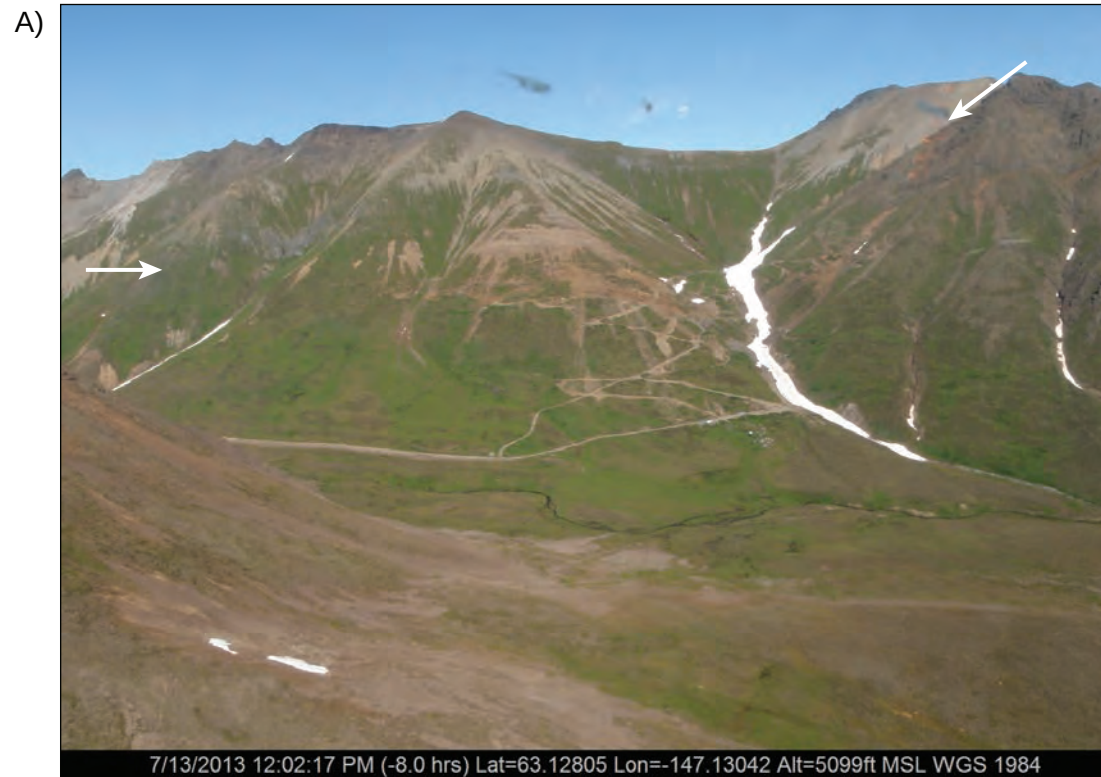
View looking northwest at mine site located along apparent rock type contrast and mapped fault. Arrows point along mapped fault.

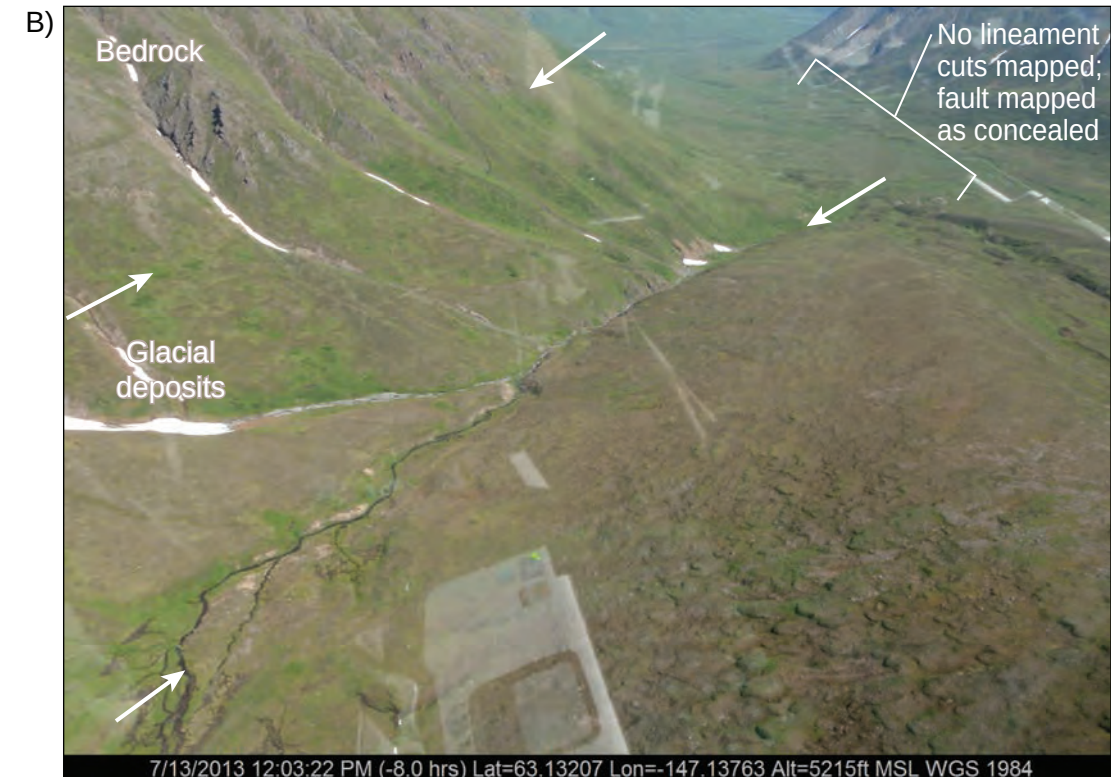
View looking northeast along linear drainage mapped as a lineament by FCL that coincides with a mapped fault. Another FCL-mapped lineament lies at the subtle break-in-slope and may correspond to the ice limit elevation.

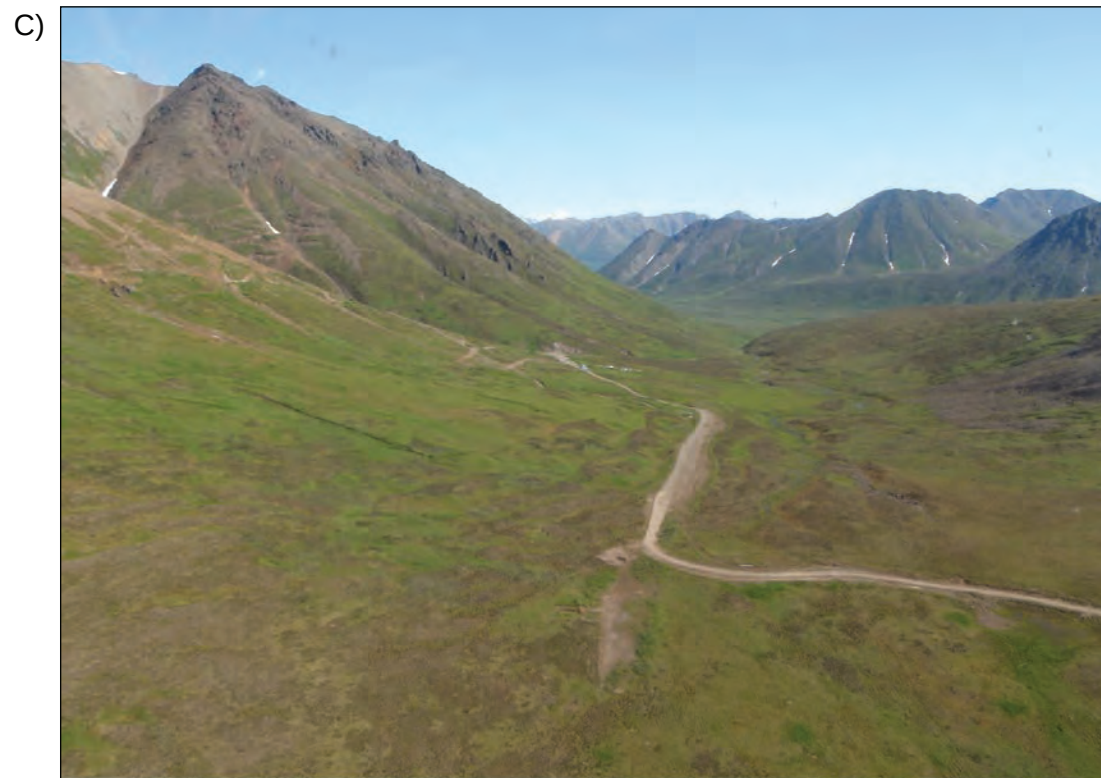
View looking northeast through the broad saddle at the head of the linear drainage shown in Photograph B. Note the absence of any tectonic geomorphic features.

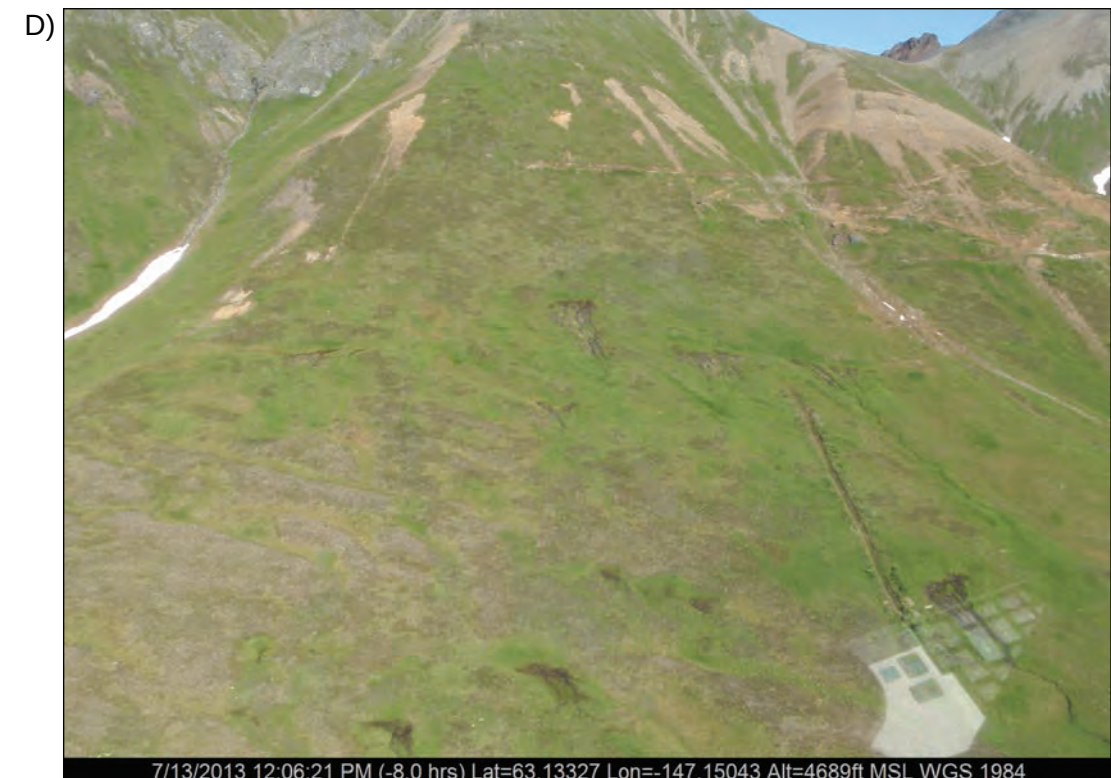
View looking northwest at location of FCL-mapped lineaments and mining roads partly shown in Photograph C. Note that FCL-mapped lineaments on the sidehill are not readily apparent and correspond to subtle break-in-slope like that shown in Photograph B.

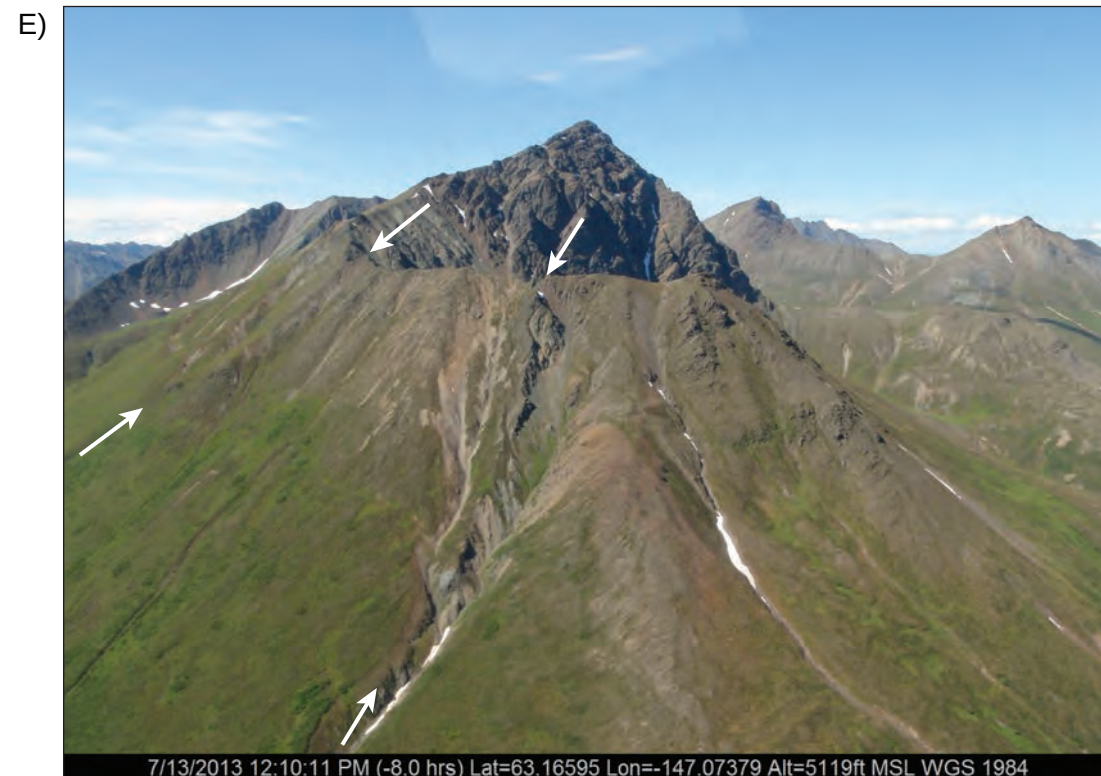
View looking southwest at several rock type contrasts (shown by arrows) that coincide with previously mapped faults.

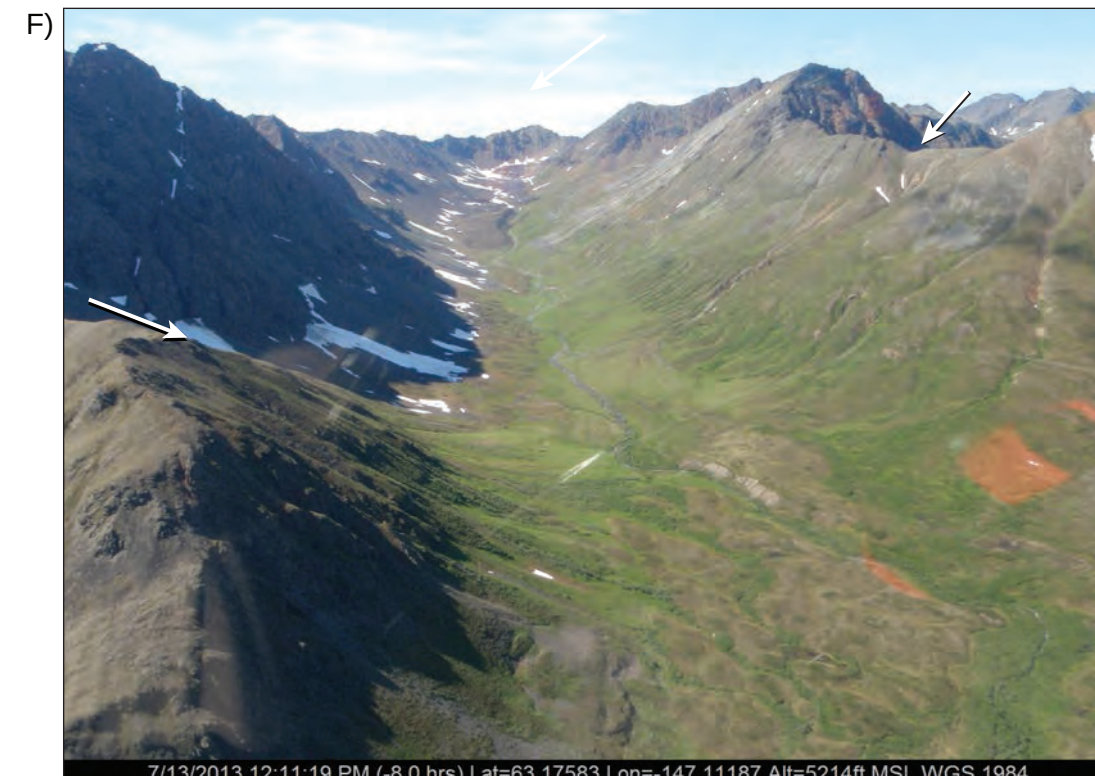
View looking south-southwest up glaciated valley that shows no expression of the mapped Black Creek fault that is present in adjacent bedrock ridges.

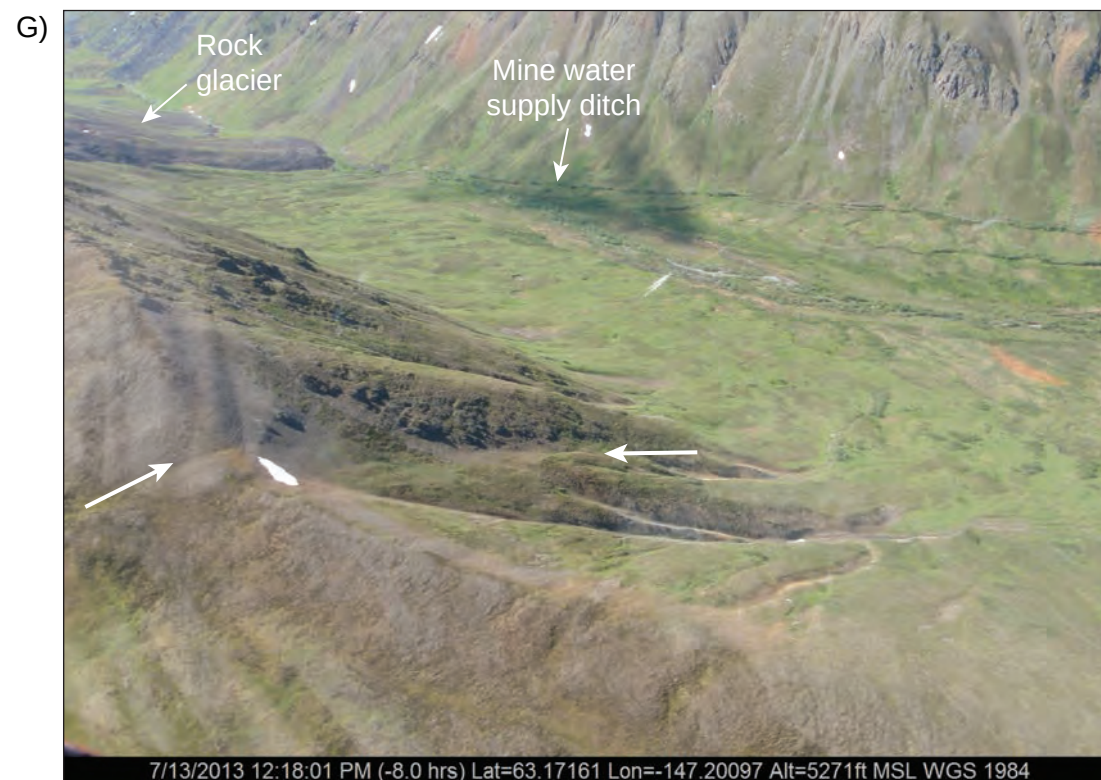
View looking southwest across an FCL-mapped lineament that corresponds to the trace of mapped Black Creek fault marked by a rock contrast. Note that no expression of faulting exists along trend in the glacial sediments of the valley floor.

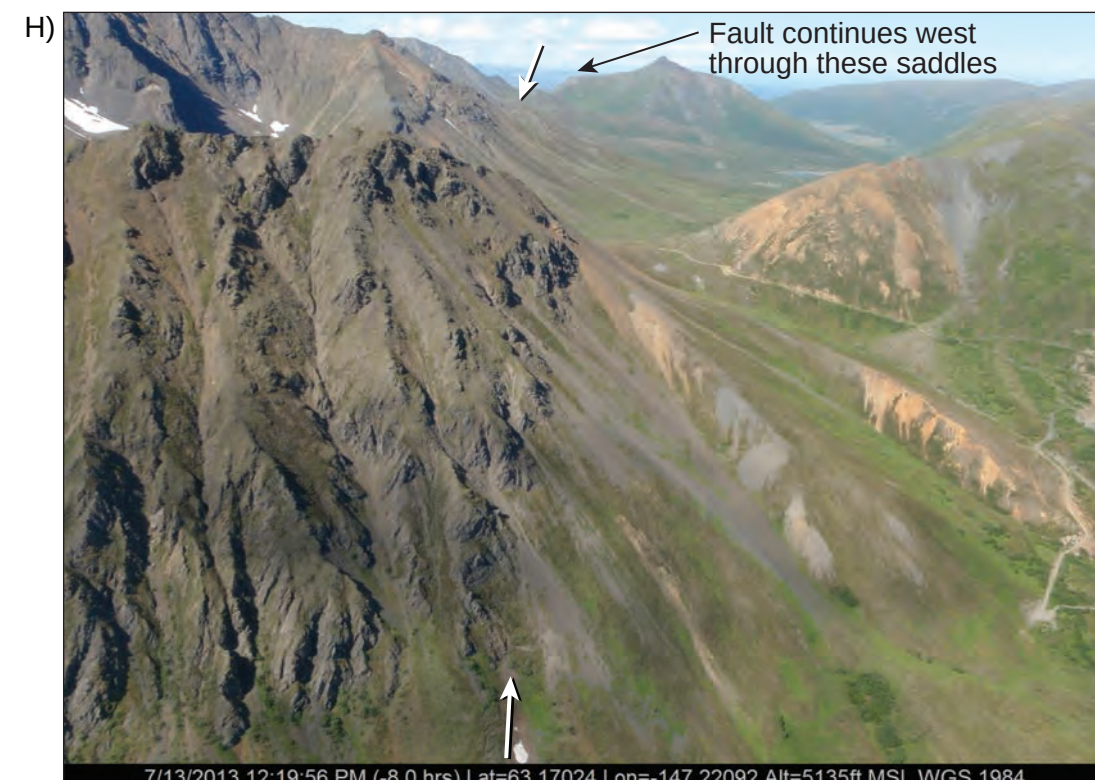
View looking west along the Black Creek fault. Note the obvious rock type contrast across the fault. Aerial reconnaissance confirmed the presence of the fault in bedrock ridges to the west and the lack of expression in glacial sediments in adjacent valley bottoms.

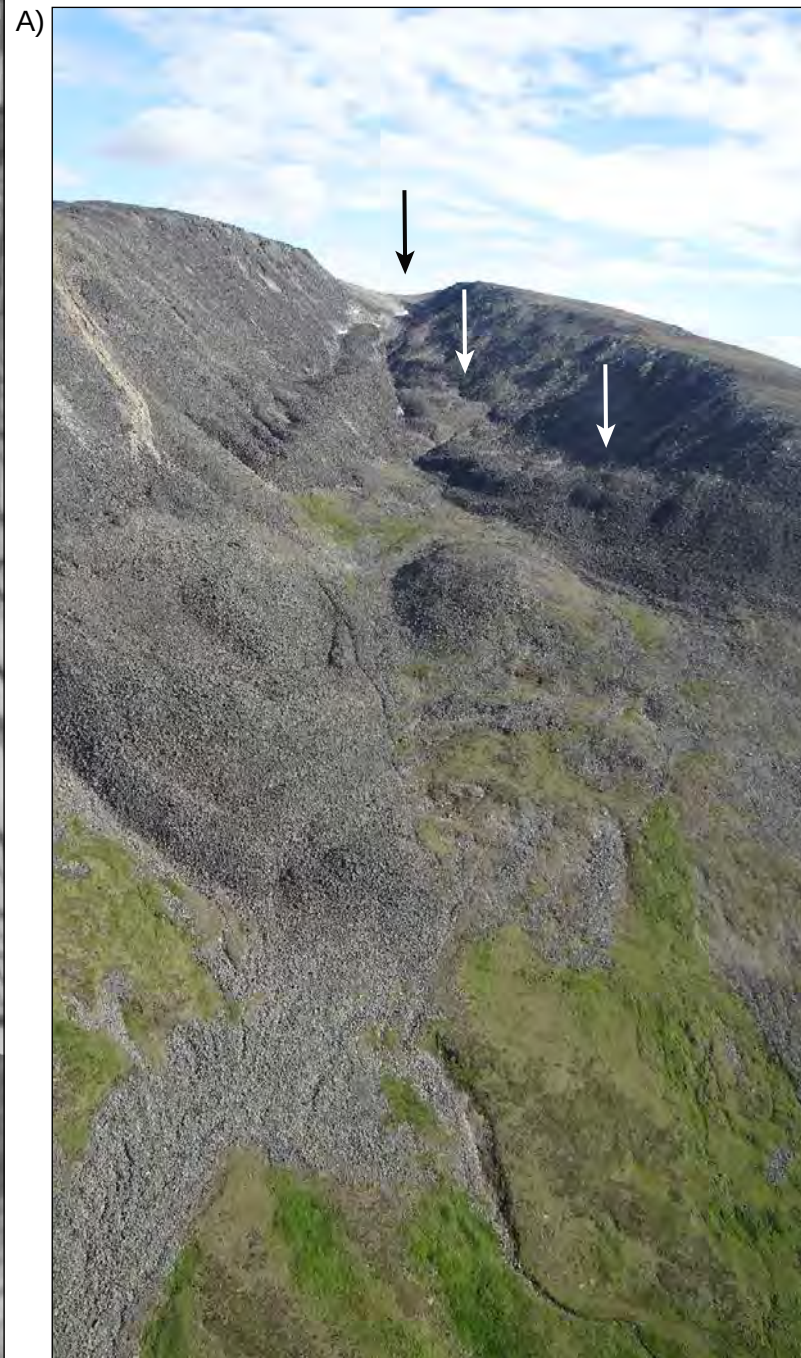
View looking northeast from location A. Arrows show location of mapped trace of lineament.

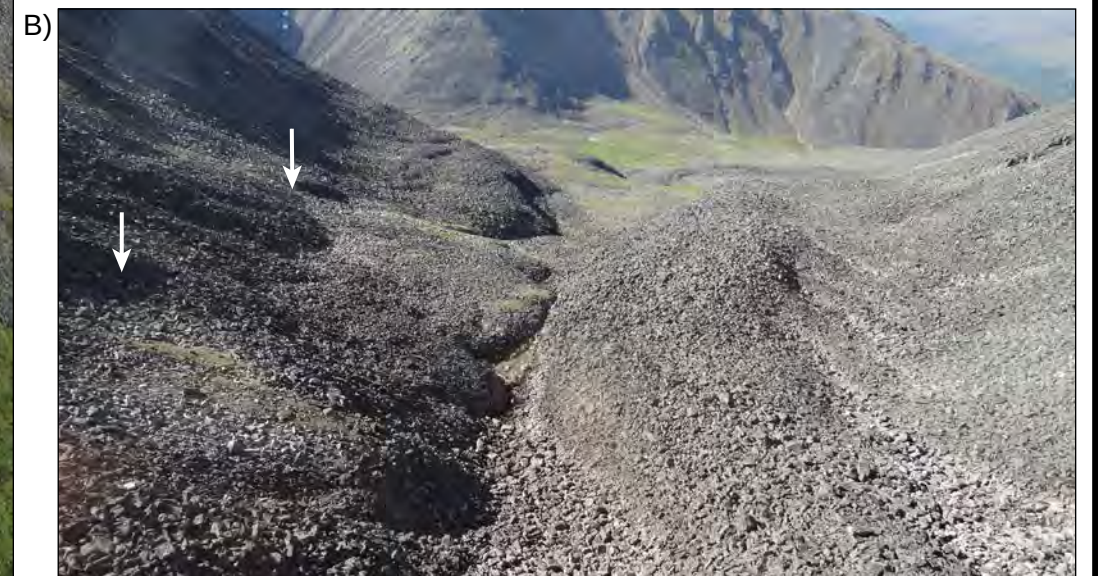
View looking southwest from location B. Arrows show the location of lineament. Note the semi-linear and lobate toe of talus deposit.

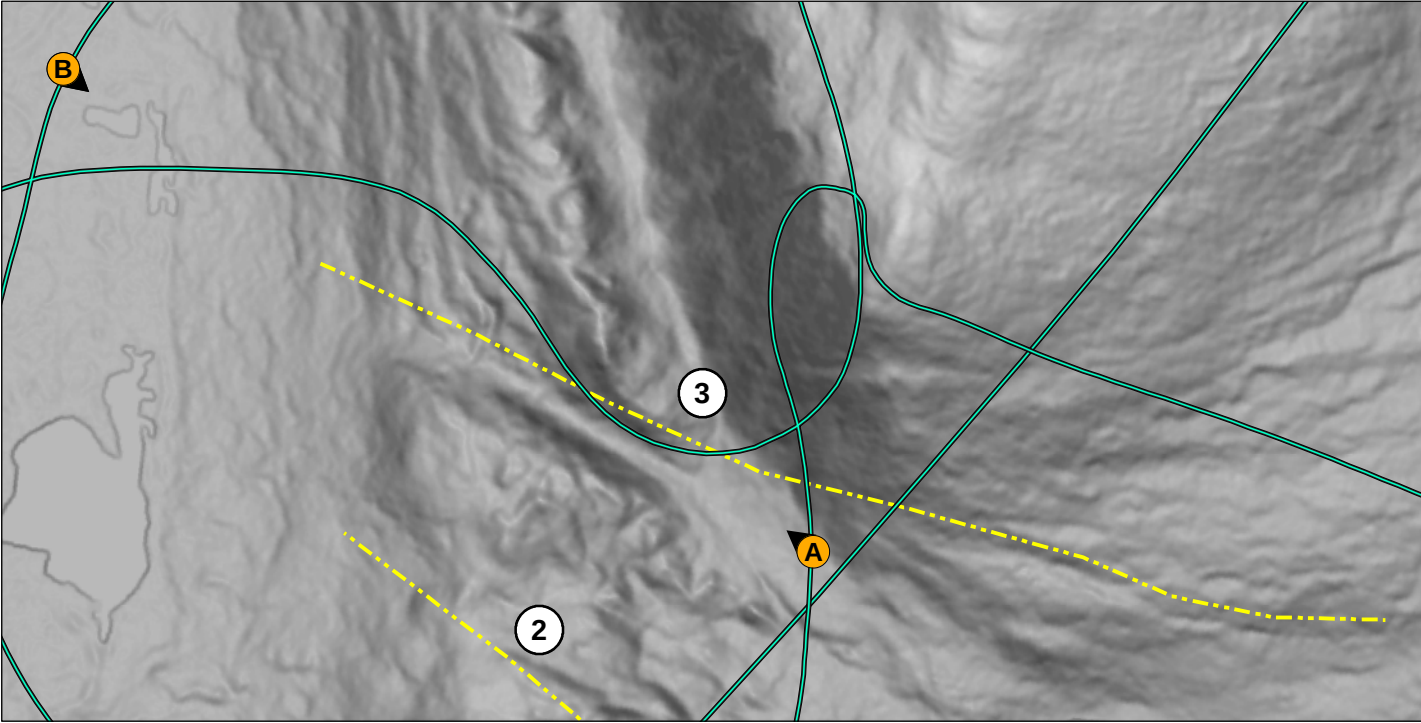
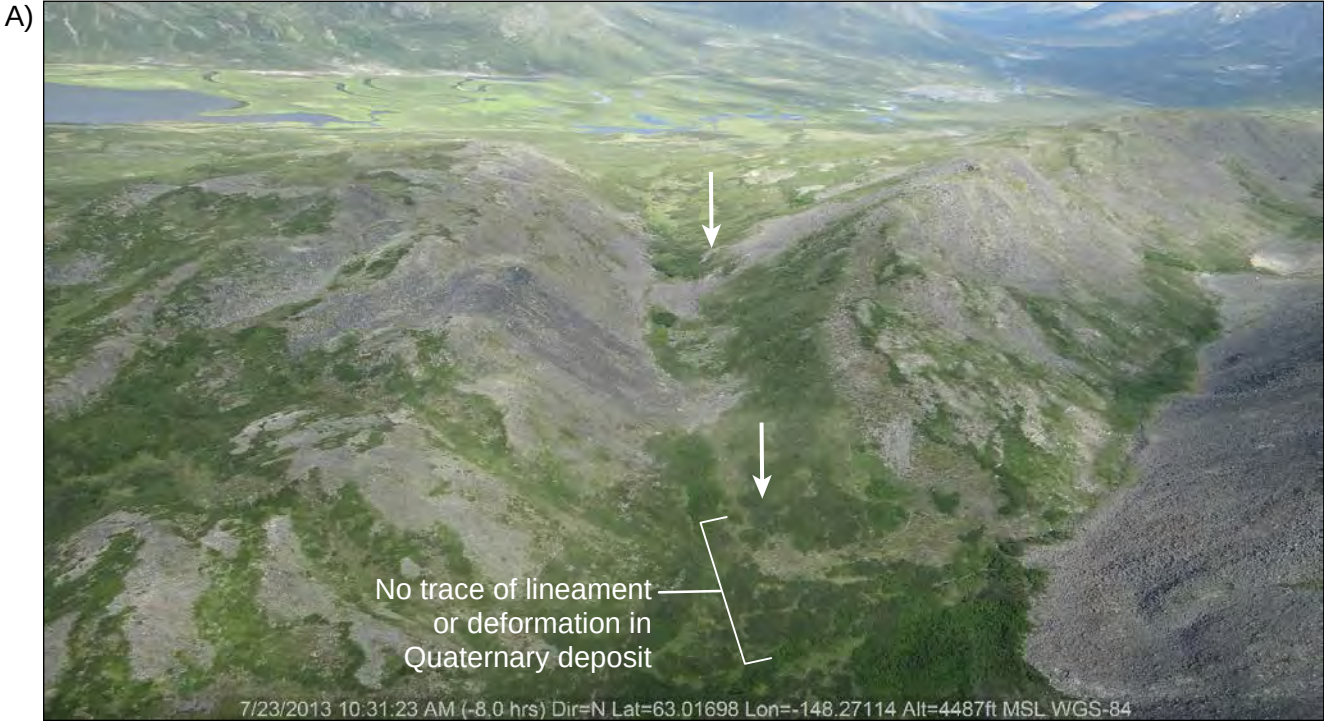
View looking northwest from location A. Arrows show the projected trace of lineament. Note absence of lineament or deformation in Quaternary deposits.
