SUSTINA-WATANA HYDROELECTRIC PROJECT  
Broad Pass Area

**Appendix B:  
Strip Maps and Photographic Documentation  
of Lineament Data for Lineaments Mapped by Reger et al. (1990)**

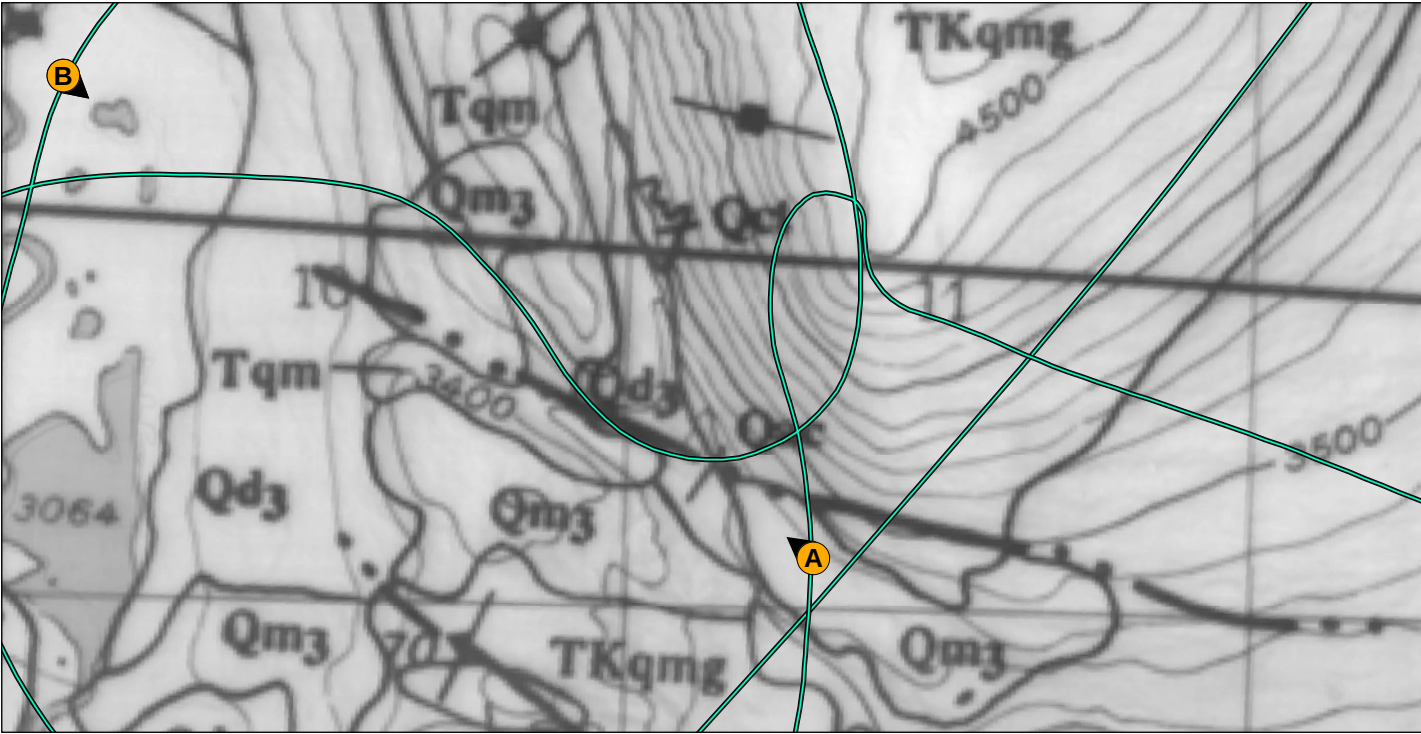
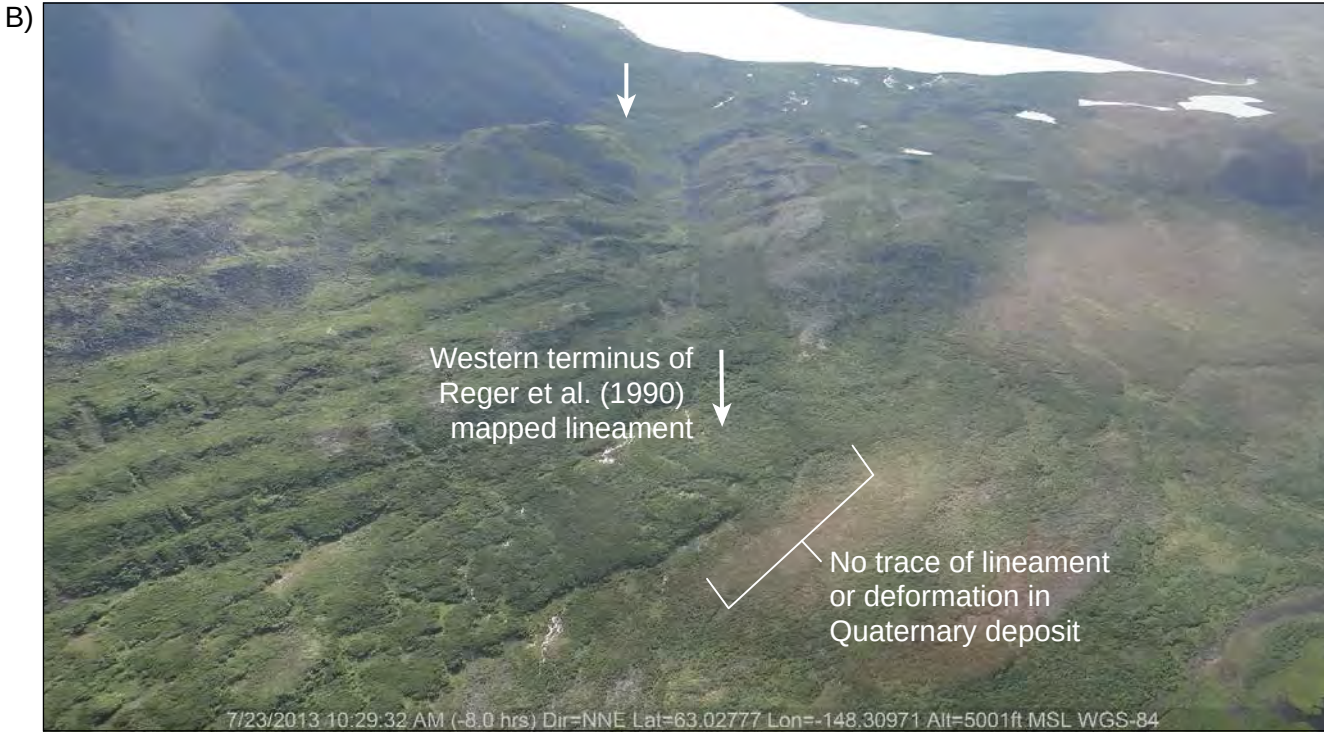
View looking southeast from location B. Arrows show the projected trace of lineament. Note absence of lineament or deformation in Quaternary deposits.

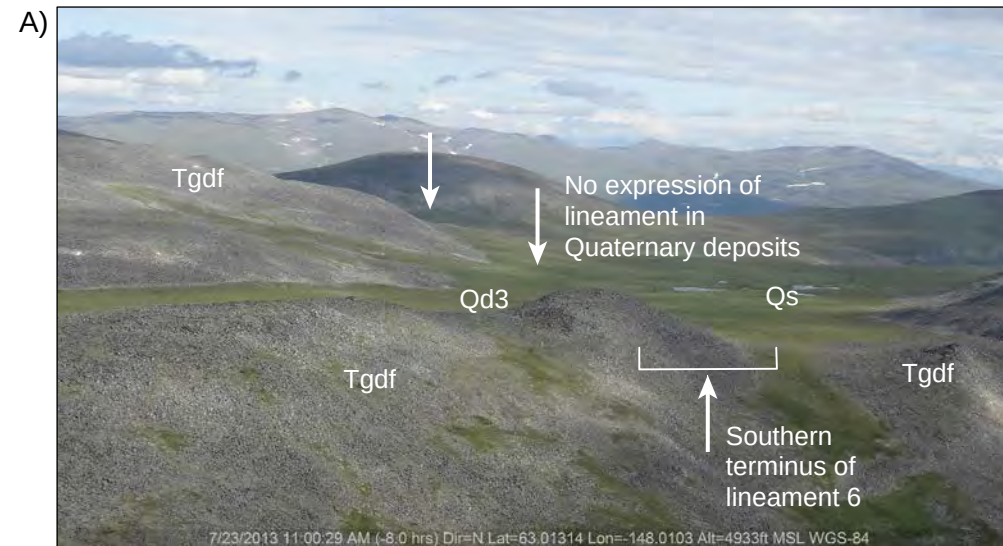
View looking northwest from location A. Arrows and brackets show the projected trace of mapped lineament. Note absence of lineament or deformation in Quaternary deposits.

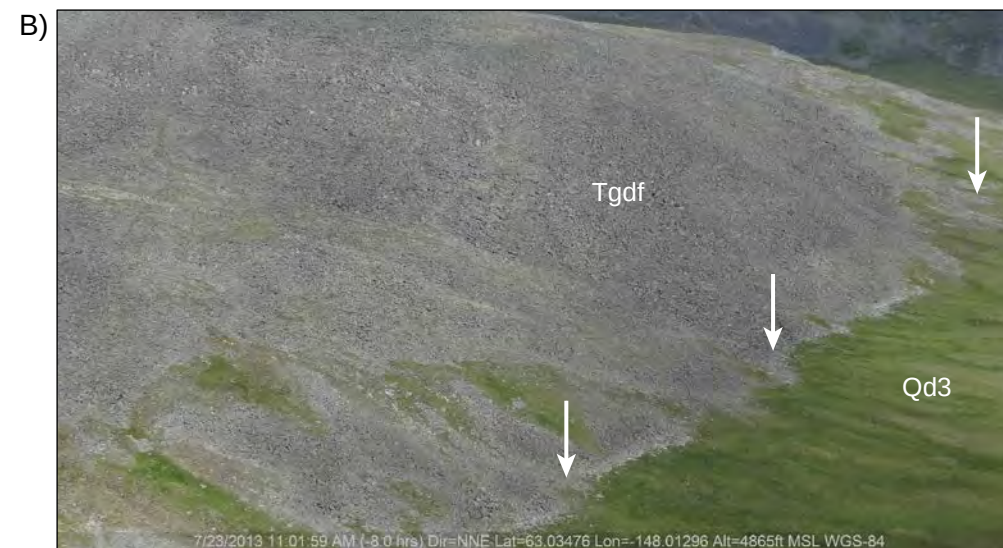
View looking northwest from location B. Arrows show the projected trace of lineament.

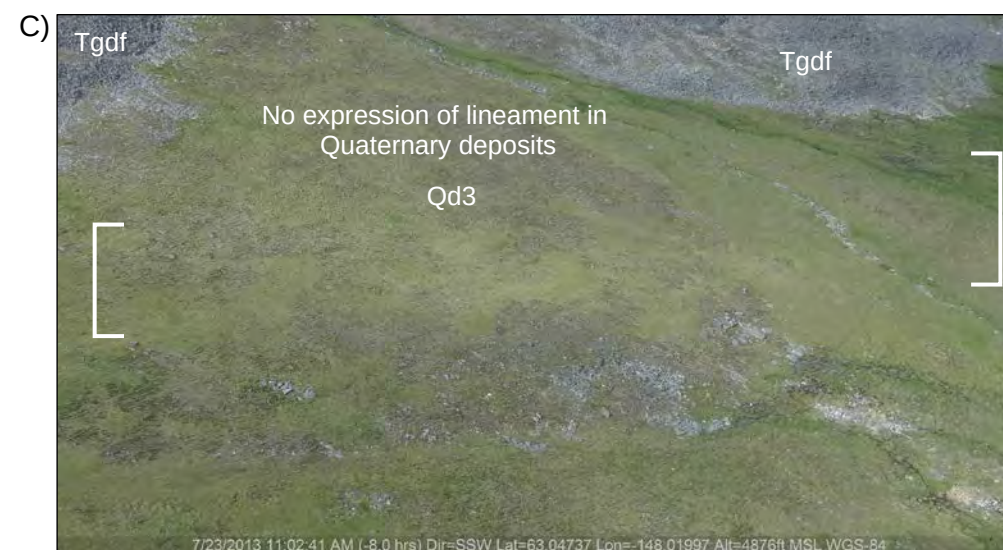
View looking west from location C. Brackets indicate the projected trace of lineament. Note absence of lineament or deformation in Quaternary deposits.

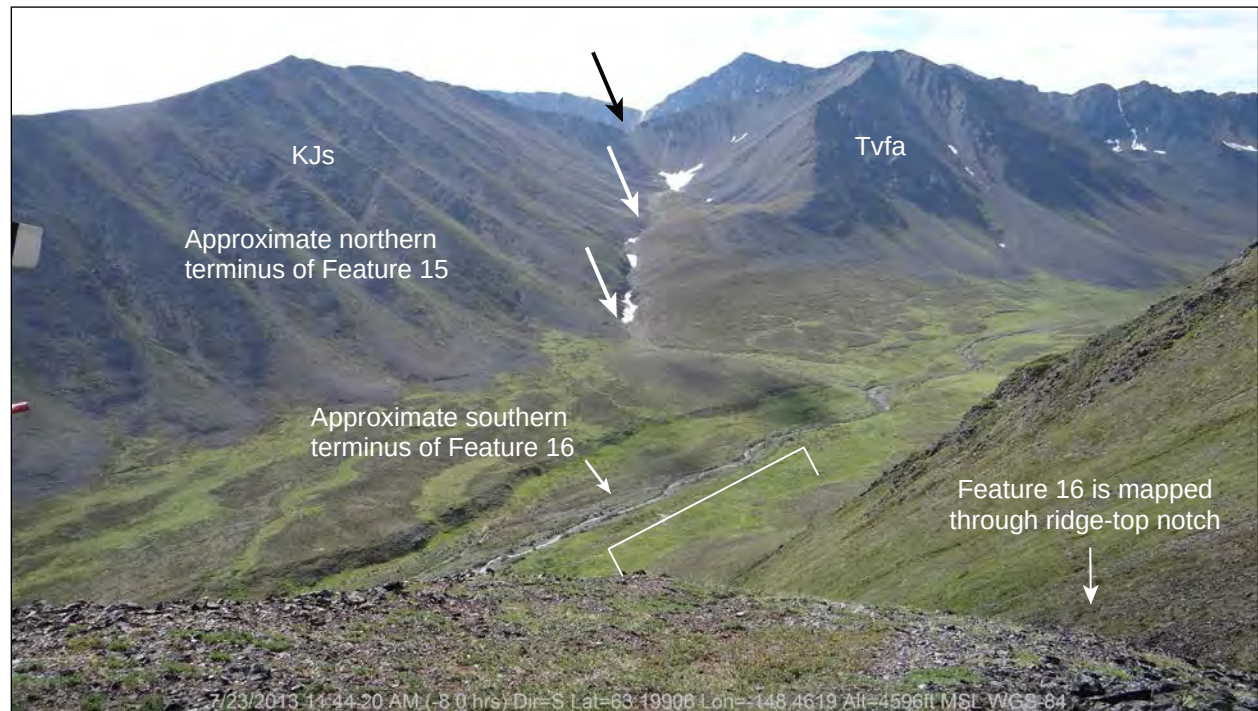
C)

View looking south from location C. The arrows and bracket indicates the projected path of Feature 15 and 16 faults. Note absence of linear expression in valley floor within Quaternary deposits.

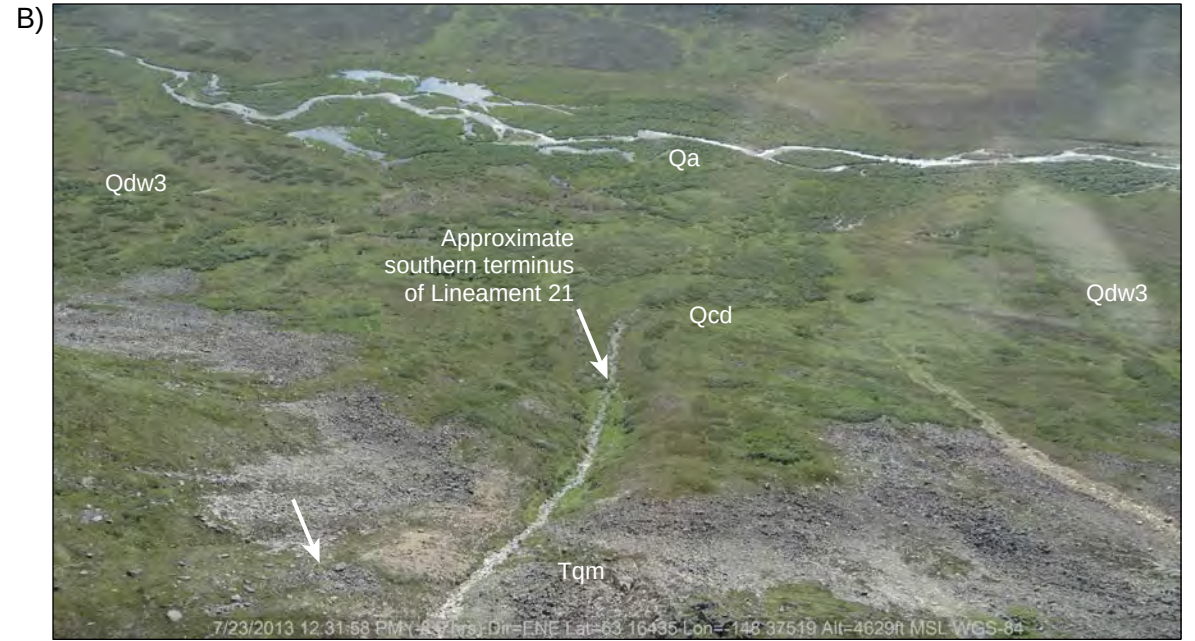
View looking southeast from photograph location B. Arrows show the projected trace of Feature 21 lineament.

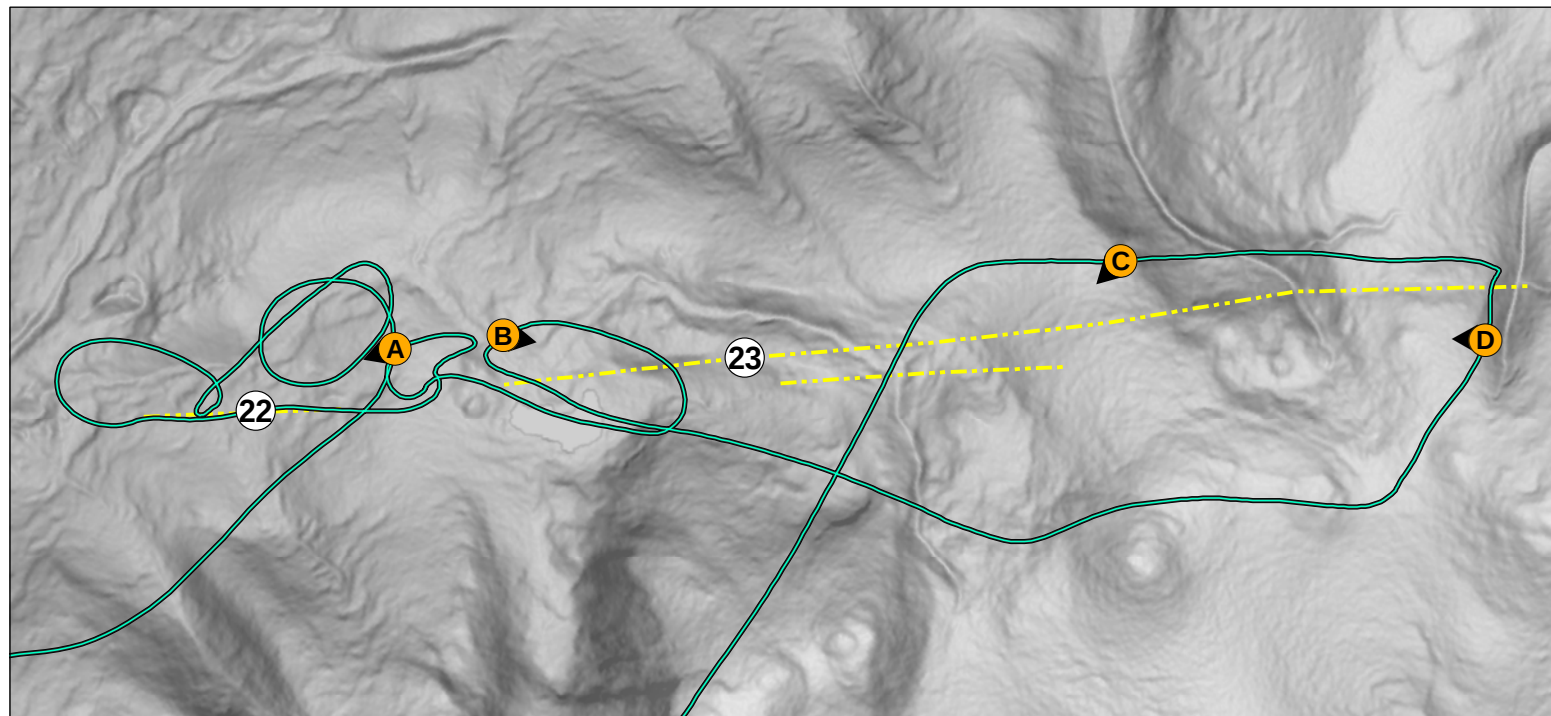
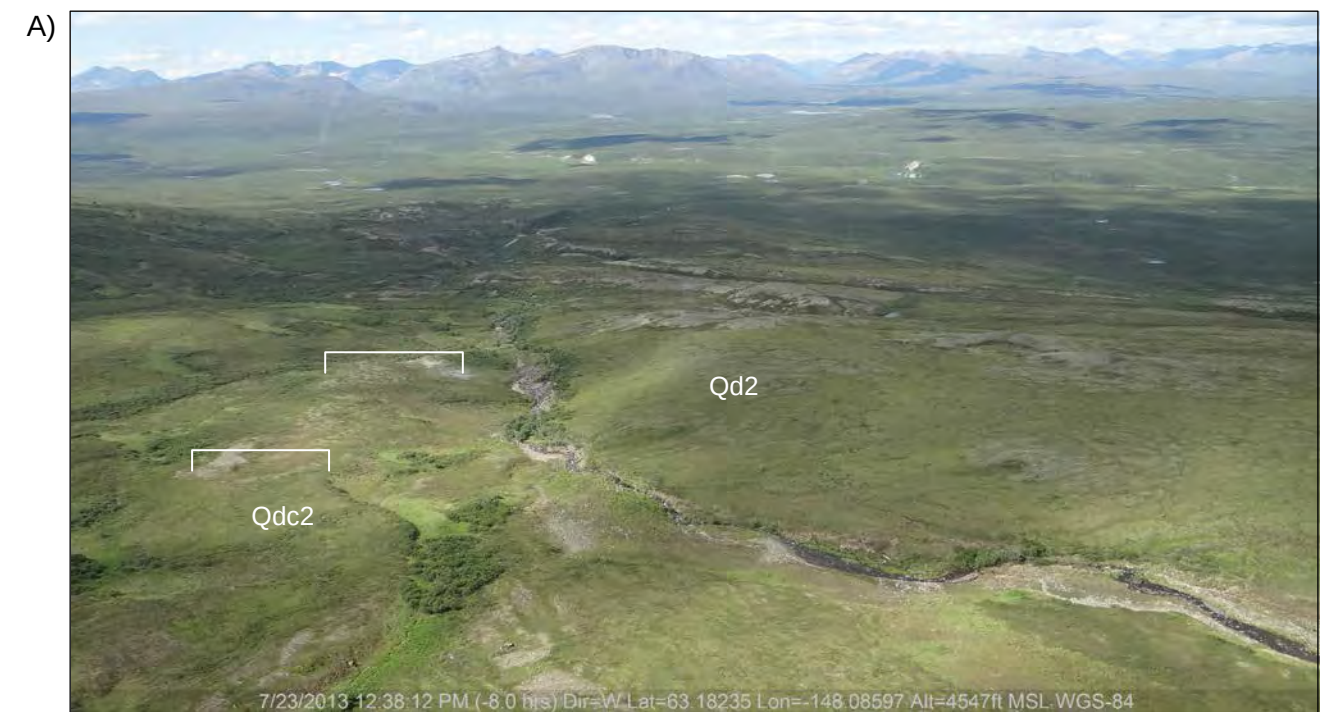
View looking west from photograph location A. Brackets show the projected trace of Feature 22. Note the absence of a continuous lineament along the projected trace and exposed till on low relief ridge crest between drainages.

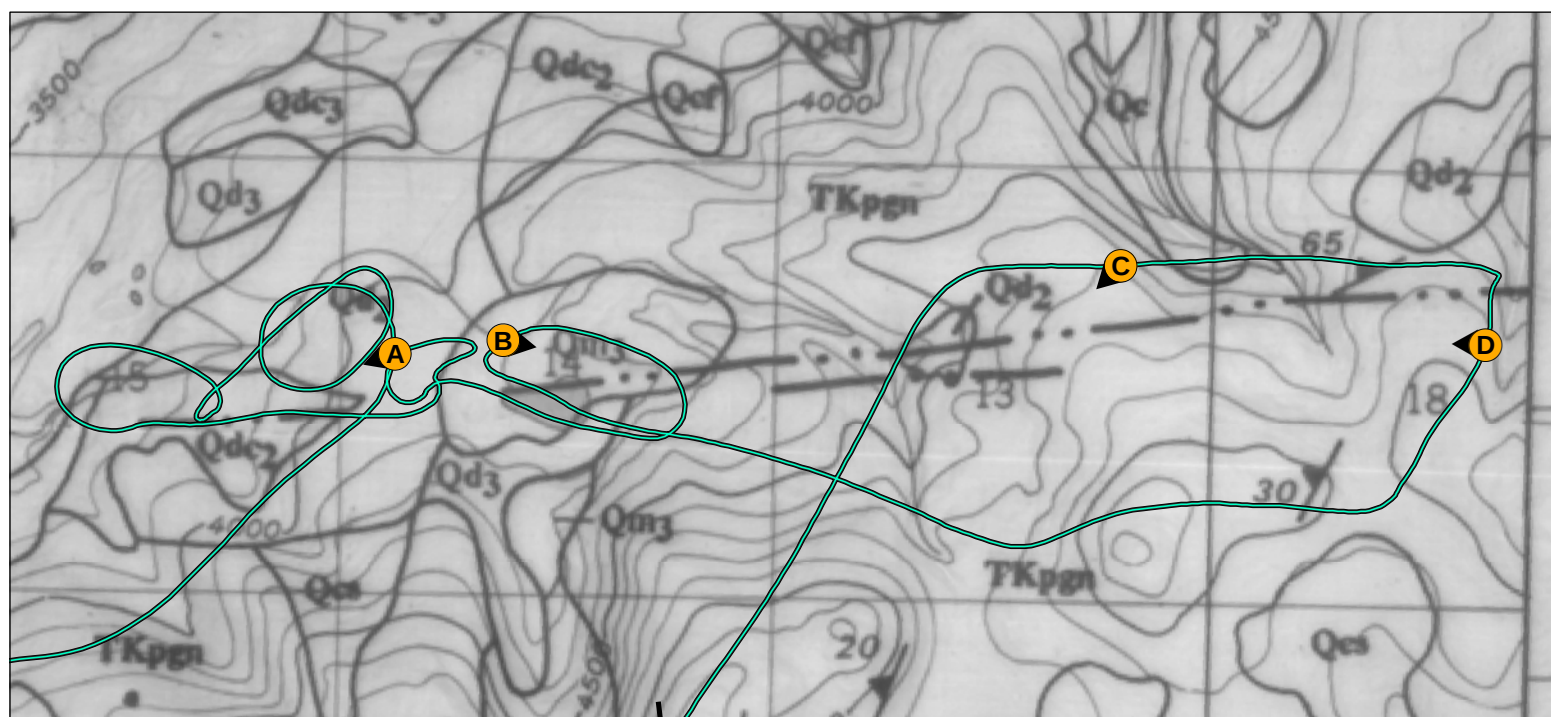
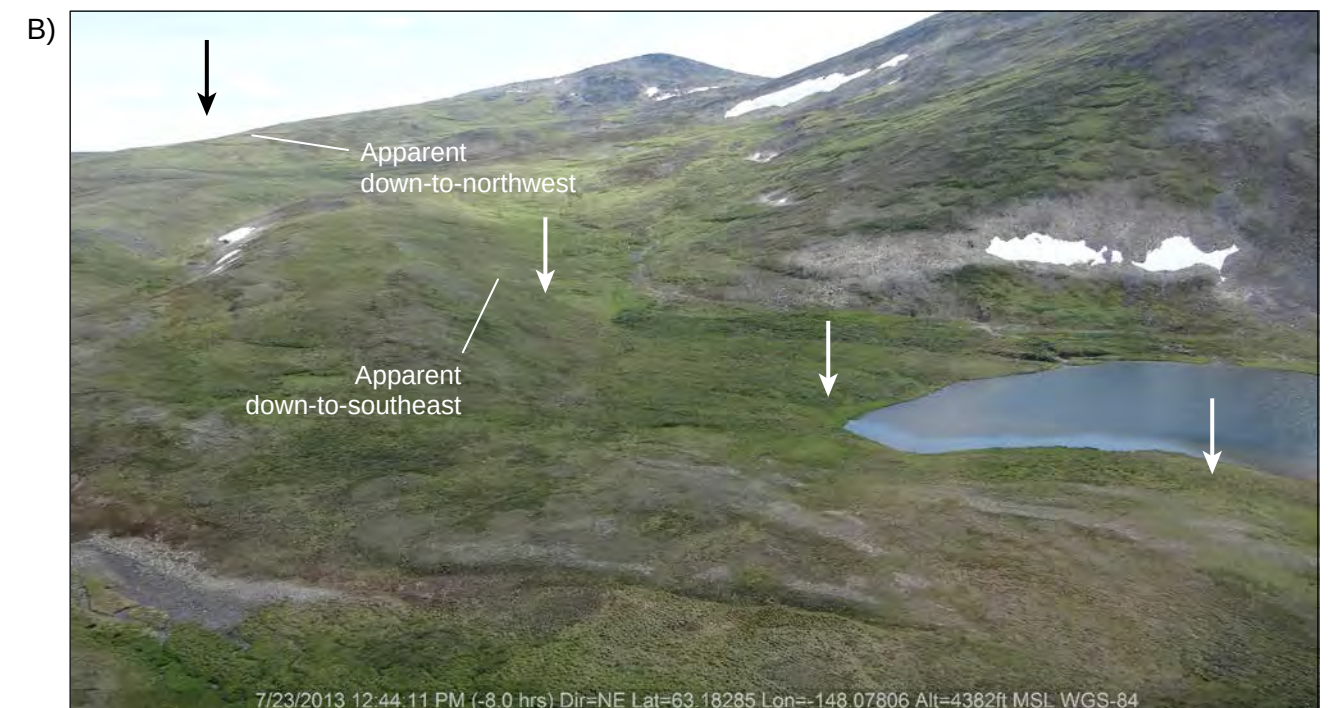
View looking east from photograph location B. Arrows and brackets indicate the projected path of Feature 22 lineament. Note change in apparent vertical displacement.
