## Susitna-Watana Hydroelectric Project Document ARLIS Uniform Cover Page

| <b>Title:</b><br><br>Geomorphology study, Study plan Section 6.5, 2014-2015 Study Implementation Report. Appendix A. Susitna River upper river reconnaissance photographs | | <b>SuWa 289</b> |

## APPENDIX A: SUSITNA RIVER UPPER RIVER RECONNAISSANCE PHOTOGRAPHS

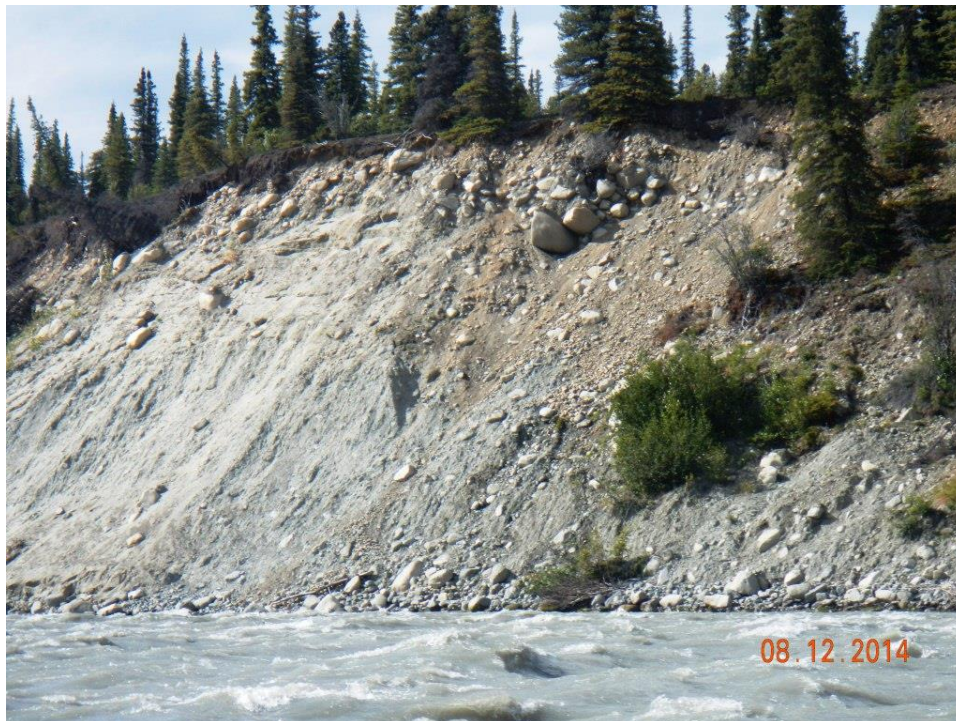
**Figure A.2-38– High eroding lateral moraine with large cobbles and boulders at PRM 235 (P714).**
