**Susitna-Watana Hydroelectric Project  
(FERC No. 14241)**

**Study of Fish Passage Barriers in the Middle and  
Upper Susitna River and Susitna Tributaries (9.12)**

**Part A - Appendix A  
Tributary Geologic Barriers**

**Part A - Appendix B  
Middle River Tributary Delta Surveys Outside of  
Focus Areas**

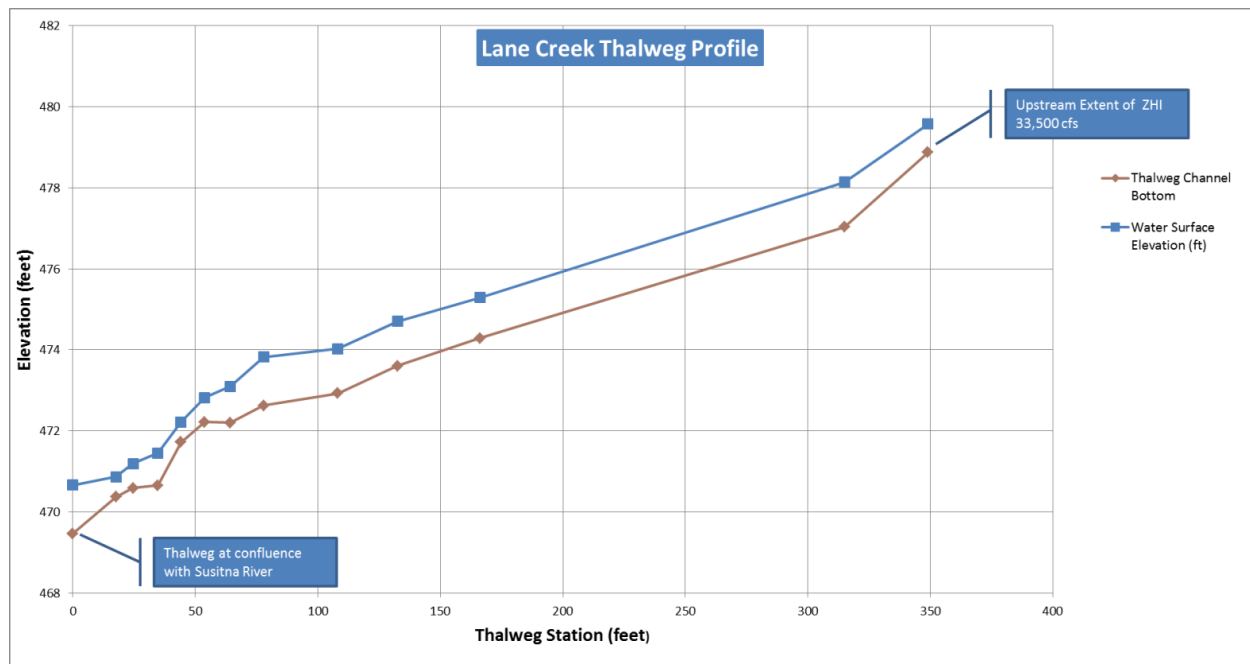
Figure B4. Lane Creek thalweg profile.

Lane Creek left a very confined and established channel only a short distance upstream of the creek mouth (Figure B3). During high Susitna flow conditions, it was likely that the creek met the river at the end of the confined channel reach (Figure B4). The creek mouth was characterized by large cobbles and small boulders with a debris apron (Table B2). Flows began to spread out across this small boulder apron as it passed the downstream extent of the confining creek bank before reaching the Susitna. No noticeable incision had occurred across the apron, and there was no distinct thalweg.

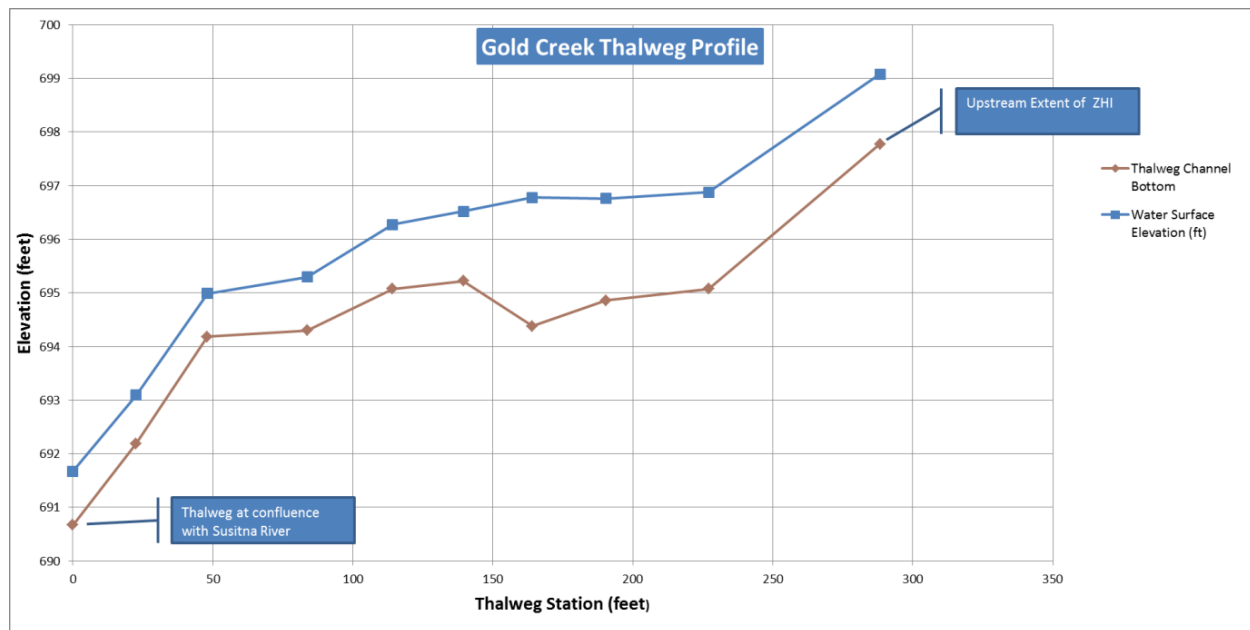
Figure B14. Gold Creek thalweg profile.

The mouth of Gold Creek consisted of a large debris fan and two stream channels (Figure B13). A steeper channel grade across the deposited apron was consistent with a perched condition, but channel incision on both the main and the secondary channel reduced the gradient of the final drop to the Susitna (Figure B14, Table B6). Flow between the two flow paths consisted of an approximate 60:40 split. Banks of the secondary channel were eroding during the time of survey.
