Susitna-Watana Hydroelectric Project Document ARLIS Uniform Cover Page

**Susitna-Watana Hydroelectric Project
(FERC No. 14241)**

**Baseline Water Quality Study
Study Plan Section 5.5**

**Appendix A
Continuous Temperature Monitoring**

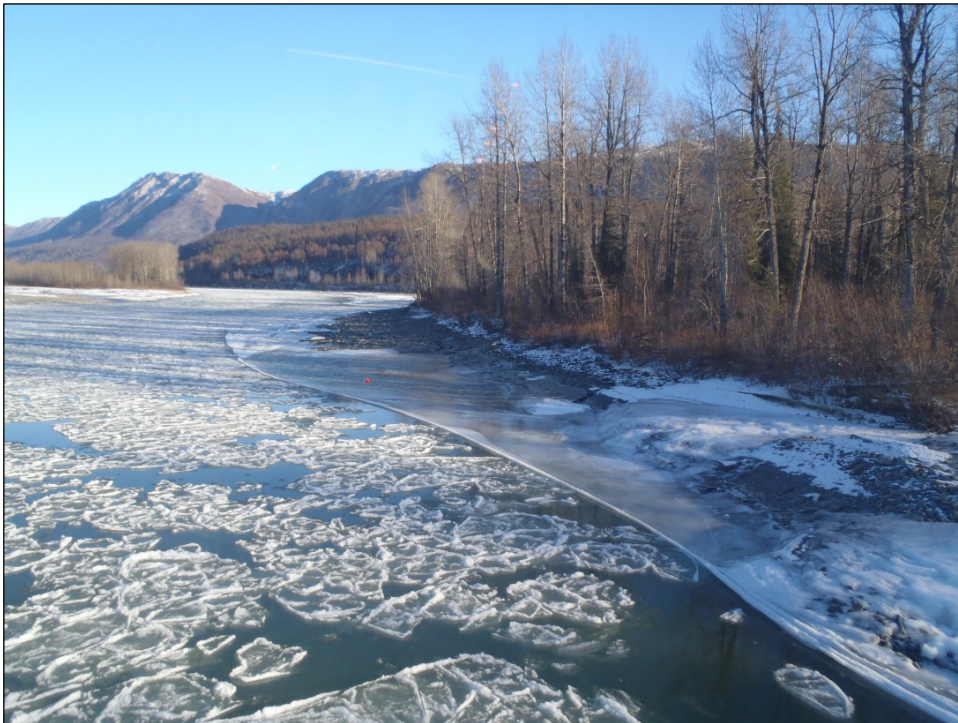
10174321	8 ft	
	10174322	12 ft	
	10174323	16 ft	
Bank-Mounted Pipe Installation			
Not Installed	--	--	No installed due to lack of pipe mounting infrastructure.
Overwinter Installation			
Oct. 23, 2012	10174222	--	10/23/12 – Entire anchor-buoy system and safety cable frozen in shore ice and cannot be completely removed. Download top 2 thermistors, remove buoy, and redeployed as overwinter system.
	10174262		
	10174221		
	10174223		
Sept. 18, 2013	10174323	--	9/18/13 – Found overwinter system deployed in 2012. Downloaded system and removed from site. 9/18/13 – Installed new overwinter system.

Photo A-18c. PRM 134.1 Buoy system prior to retrieval and download on 10/23/12

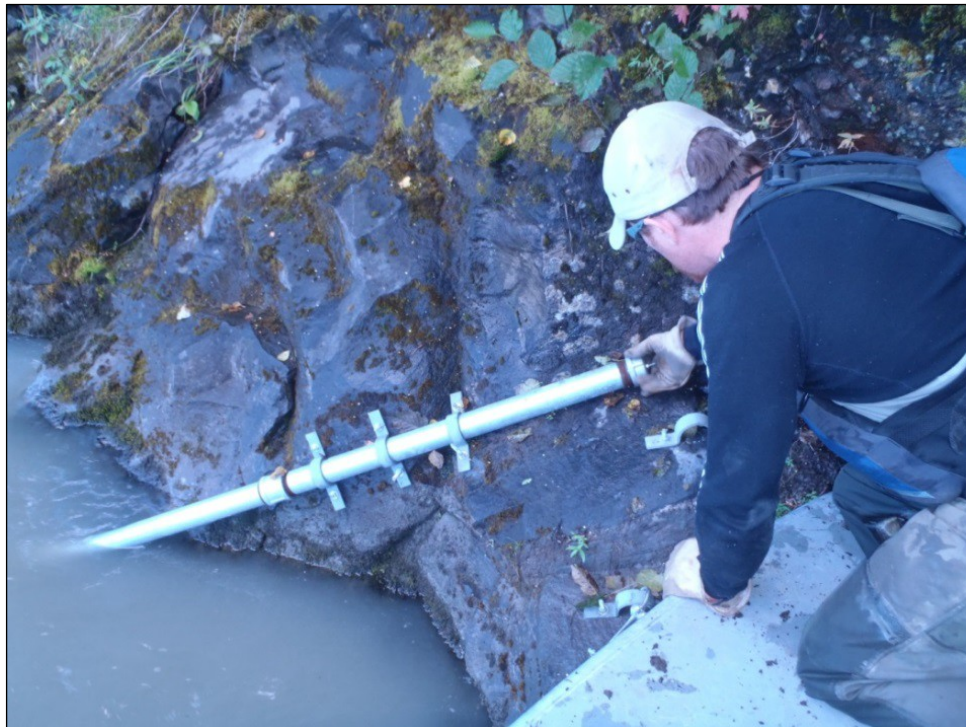
Date Deployed	Thermistor Number	Depth (distance from buoy)	Maintenance and Download Notes
Anchor and Buoy			
July 23, 2012	10174225	2 ft	7/23/12 – The buoy is deployed at the proposed location, 30 ft from the LB, along eddy fence in approximately 6 ft of water. 8/28/12 – Downloaded both buoy and pipe systems 9/27/12 – Buoy missing but replaced. One thermistor (227) was missing and not replaced – no data after 8/28/12. Both systems downloaded. 10/22/12 – Downloaded and removed initial buoy string with multiple data loggers.
	10174224	7 ft	
	10174227	12 ft	
June 30, 2013	10174231	2 ft	6/11/13 – Could not pull overwinter system deployed in 2012. No new system deployed. 6/30/13 – Removed overwinter system and replaced with new anchor – buoy system. 9/18/13 – Removed anchor-buoy system and replaced with overwinter set up.
	10174313	6 ft	
	10174225	10 ft	
Bank-Mounted Pipe Installation			
July 23, 2012	10174226	9.5 ft	The 14 ft housing pipe with 10 ft of cable and single thermistor. 10/23/12 – Pipe was high and dry and tidbit cable was frozen in pipe and could not be removed, no download. 6/20/13 – Pipe thermistor downloaded. 6/24/13 – Pipe system located but could not be opened for download. Additional downloads occurred on 7/10, 7/31, 8/27, and 9/18/13. 9/18/13 – Pulled and down loaded thermistor. Pipe silted in – could not redeploy thermistor for winter.

Photo A-23c. PRM 142.3 – Pipe mounted system at Susitna above Indian Creek

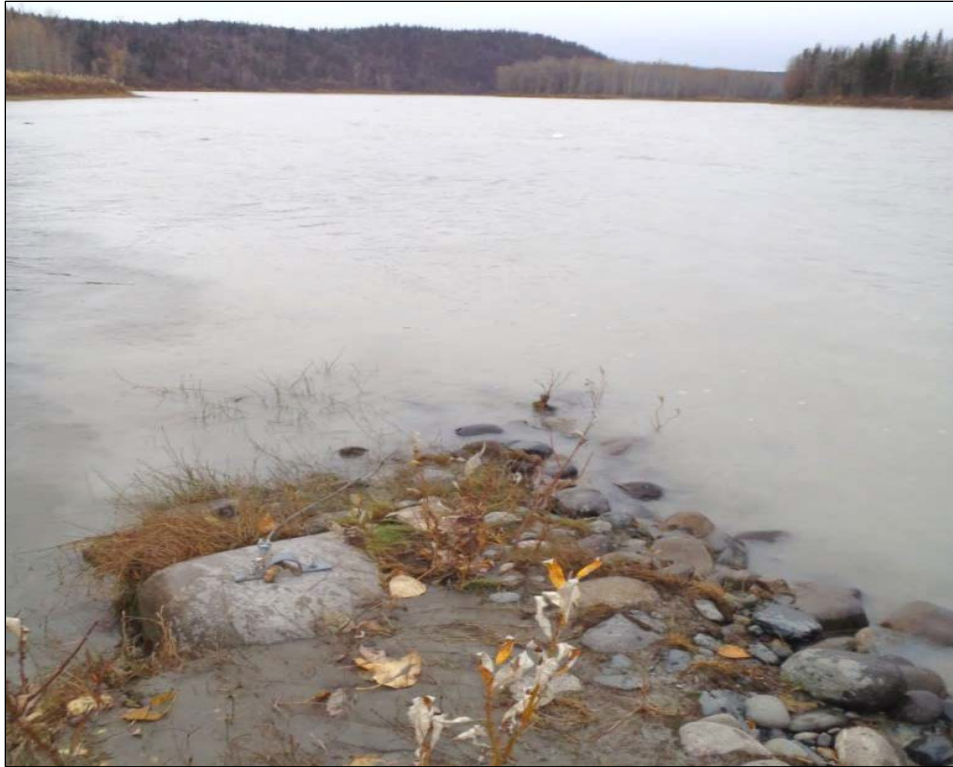
Photo A-24a. Anchor point for 2012 buoy system at PRM 143.6 – Slough 19
