**Susitna-Watana Hydroelectric Project
(FERC No. 14241)**

**Study of Fish Passage Barriers in the Middle and
Upper Susitna River and Susitna Tributaries (9.12)**

**Appendix A
Tributary Geologic Barriers**

Initial Study Report

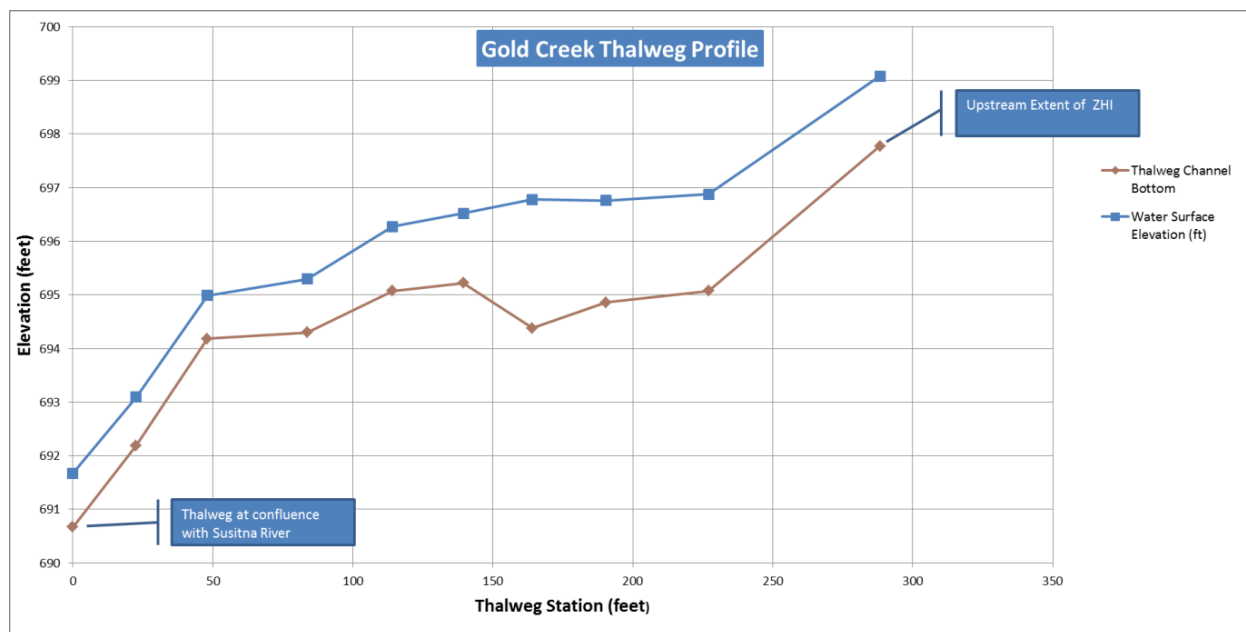
Figure B14. Gold Creek thalweg profile.

The mouth of Gold Creek consisted of a large debris fan and two stream channels (Figure B13). A steeper channel grade across the deposited apron was consistent with a perched condition, but channel incision on both the main and the secondary channel reduced the gradient of the final drop to the Susitna (Figure B14, Table B6). Flow between the two flow paths consisted of an approximate 60:40 split. Banks of the secondary channel were eroding during the time of survey.
