SUSITNA HYDROELECTRIC PROJECT

1980-81 GEOTECHNICAL REPORT

**VOLUME 1
TEXT
FINAL DRAFT**

ALASKA POWER AUTHORITY

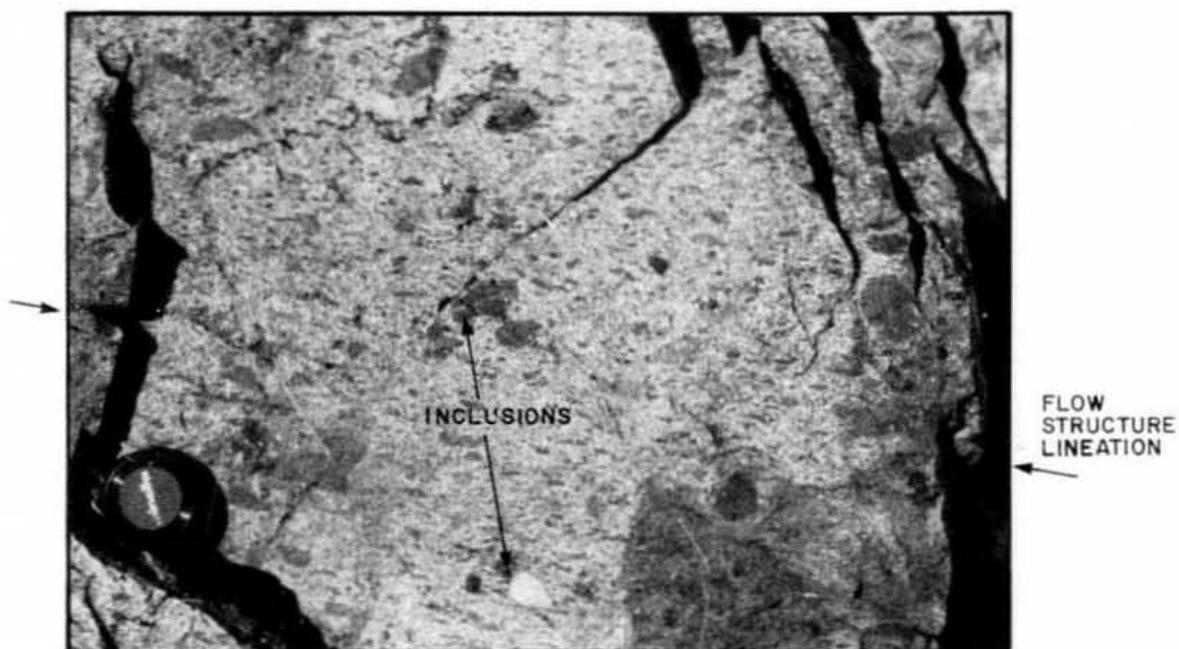
WATANA
ANDESITE PORPHYRY FLOW STRUCTURE & INCLUSIONS

ANDESITE PORPHYRY OUTCROP
RIVER LEVEL - NORTH BANK
"FINGERBUSTER" AREA

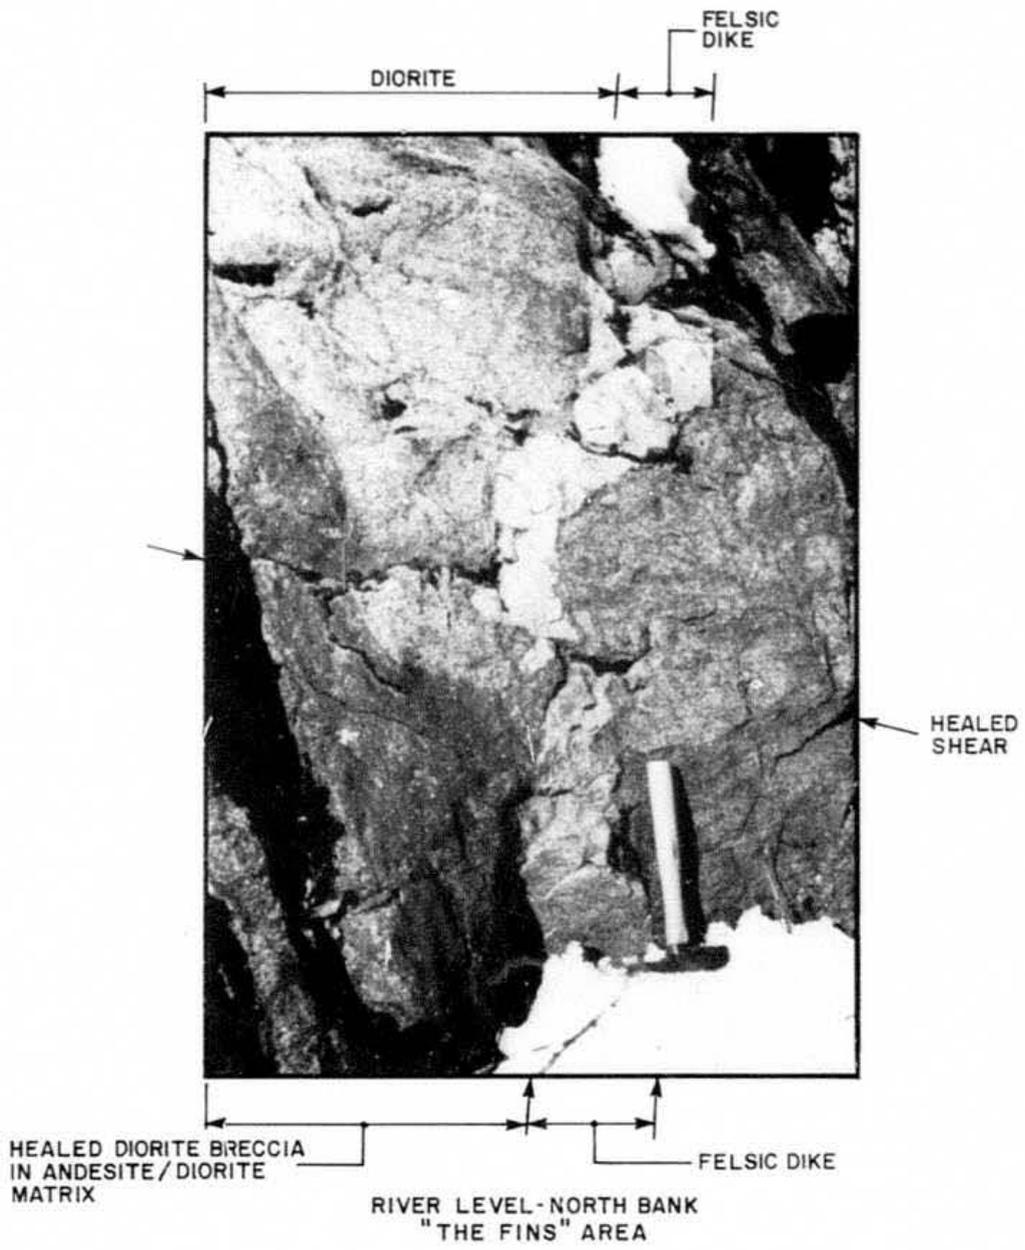
FIGURE 6.11

Felsic dikes are found in outcrops and in all boreholes. Felsic dikes are light gray and aphanitic to medium grained, but generally fine grained. The felsic dikes are composed primarily of feldspar (plagioclase and orthoclase) with up to 30 percent quartz and less than 10 percent mafics. Contacts with the diorite are tight and "welded". The felsic dikes are hard, fresh, and unfractured. Dike widths are up to 6 feet but generally less than 0.5 feet. Felsic dikes have been found offset up to several inches by shears and healed shears in outcrop and in boreholes (BH-3 at 702.7 and 801.3 feet). Figure 6.11 shows a 7-inch wide felsic dike offset along a healed shear. The healed shear is tight and hard.

WATANA
FELSIC DIKE IN DIORITE

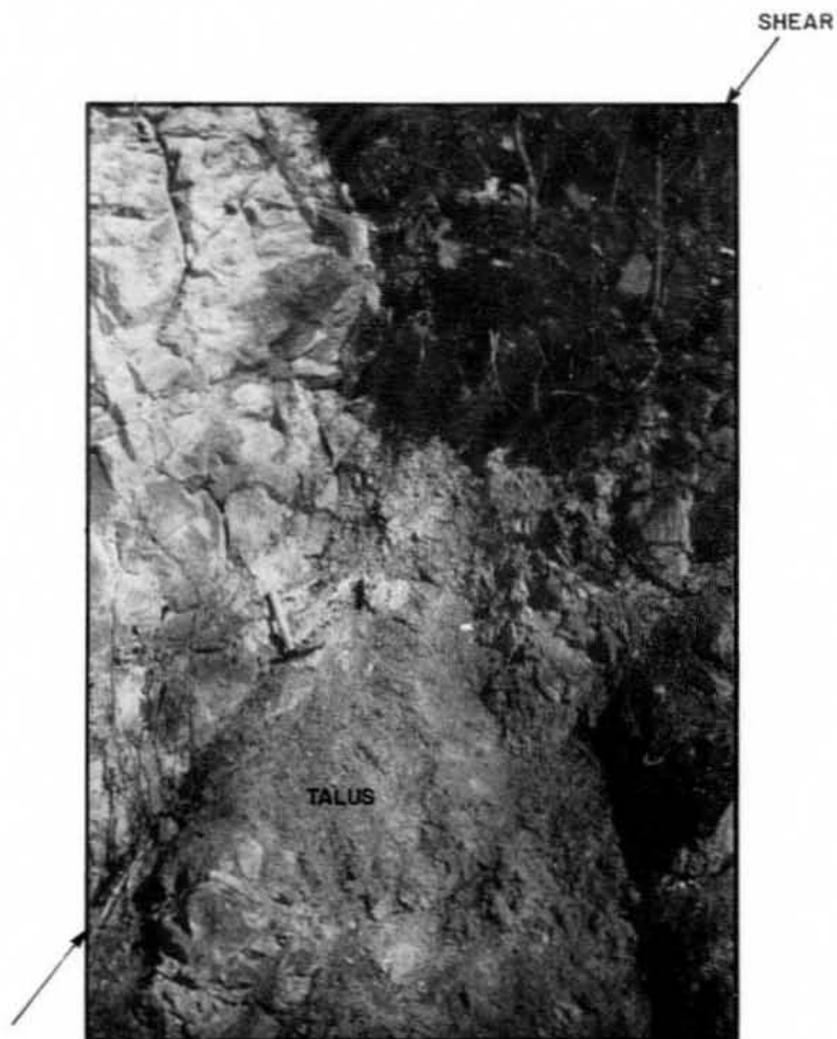
WATANA
TYPICAL SHEAR

VIEW LOOKING NORTH ALONG STRIKE
OF SHEAR; DIP 57° WEST
RIVER LEVEL - NORTH BANK
"THE FINS" AREA

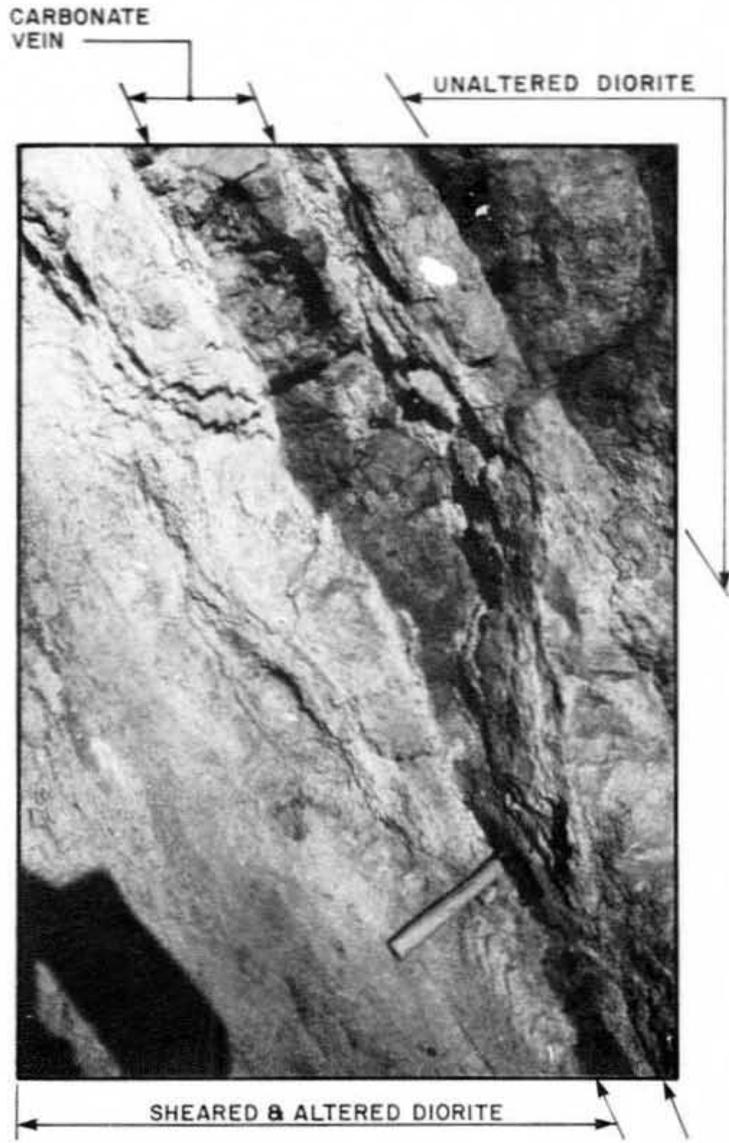
FIGURE 6.15

EAST SIDE OF 55 FT. WIDE SHEAR/ALTERATION ZONE
RIVER LEVEL - NORTH BANK "THE FINS" AREA

WATANA
SHEAR/ALTERATION ZONE

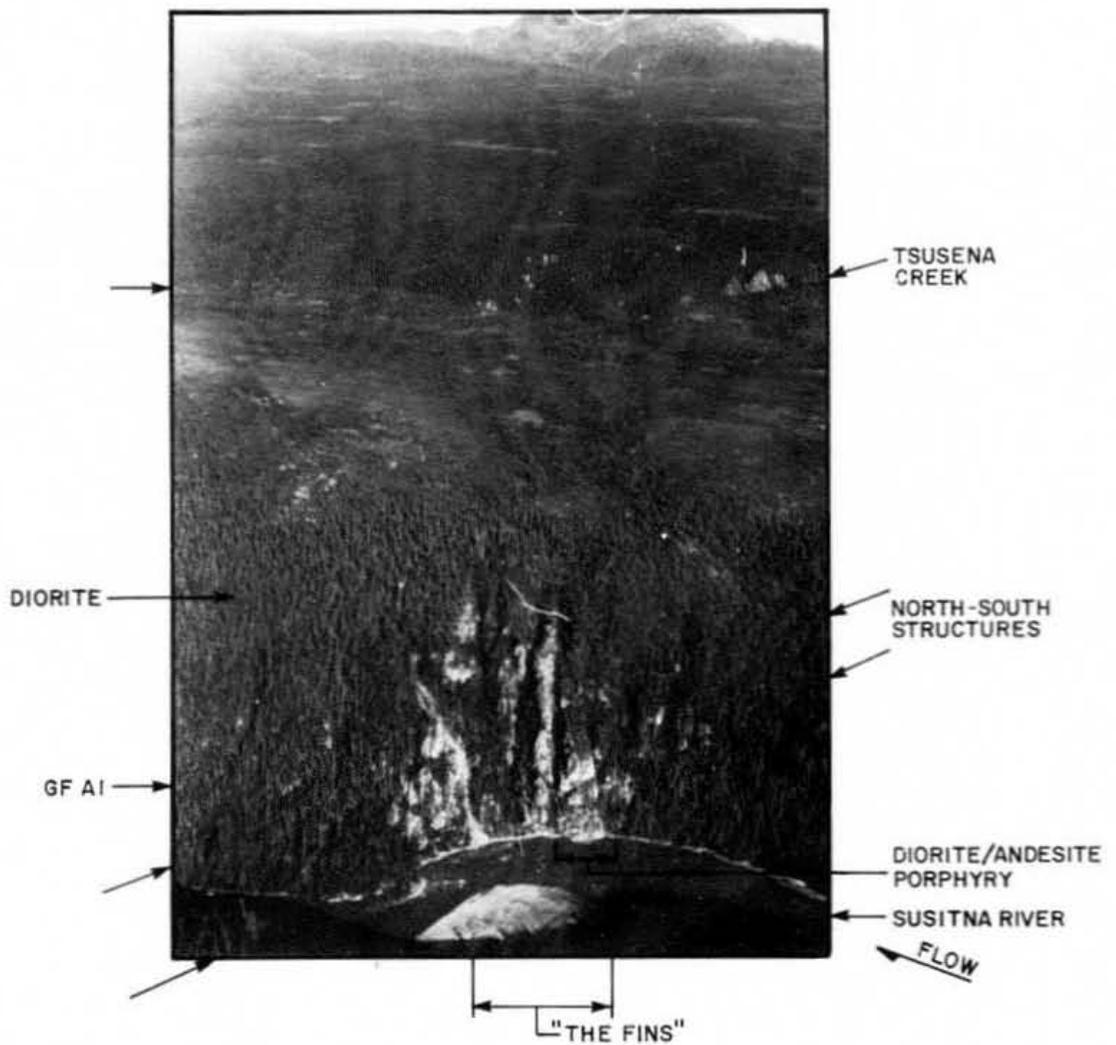
WATANA
"THE FINS"

- Two pronounced sheared and highly fractured zones named "The Fins" and "Fingerbuster" have been mapped immediately upstream and downstream from the damsite.

AERIAL VIEW OF "THE FINS"
LOOKING NORTHWEST ALONG STRIKE

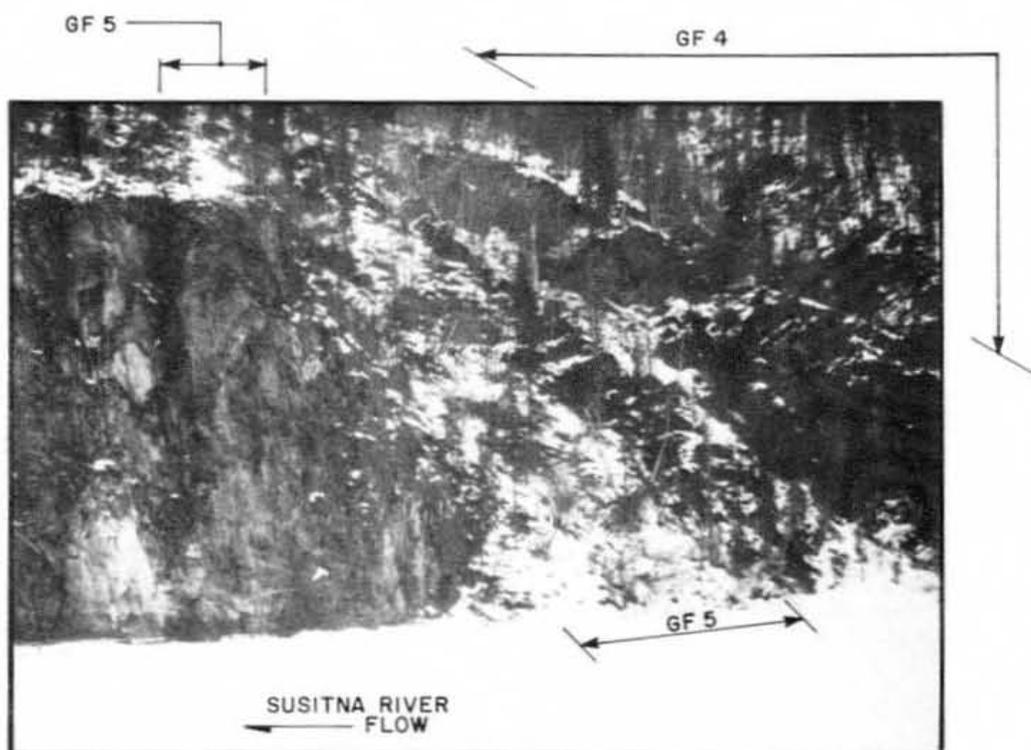
WATANA
GEOLOGIC FEATURES GF 4 AND GF 5

VIEW LOOKING NORTHEAST
NORTH BANK

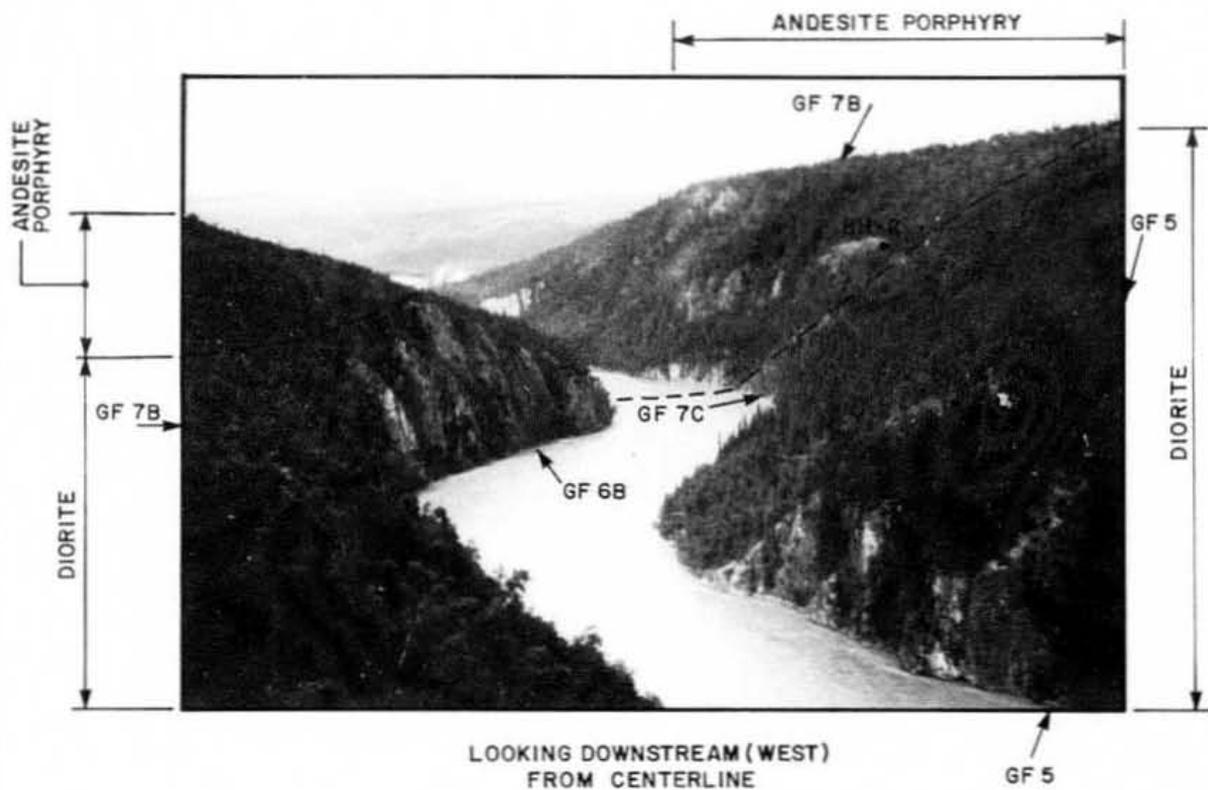
WATANA
GEOLOGIC FEATURES DOWNSTREAM OF CENTERLINE

1. GEOLOGIC FEATURES GF 5, GF 6B, GF 7B, AND GF 7C DESCRIBED IN SECTION 6.1.
2. DASHED LINE IS ANDESITE PORPHYRY & DIORITE CONTACT.

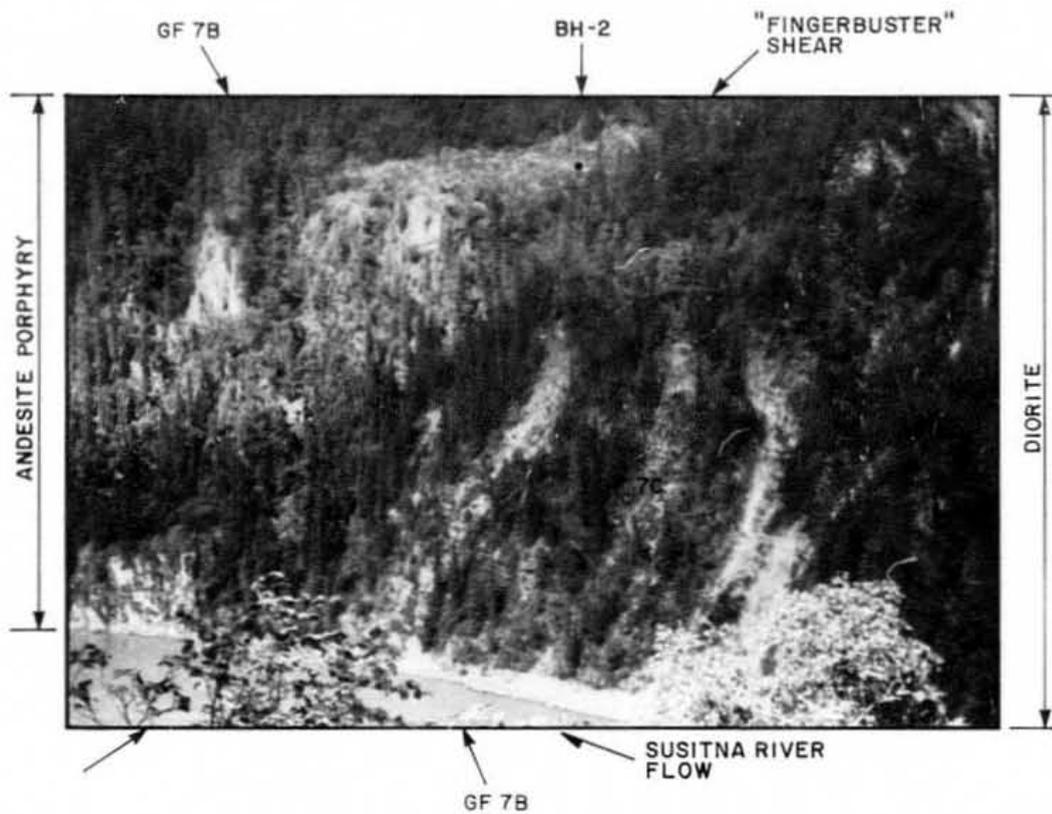
WATANA
 "FINGERBUSTER" AREA
 NORTH BANK

1. GEOLOGIC FEATURES "FINGERBUSTER", GF 7B, AND GF 7C DESCRIBED IN SECTION 6.1.
2. ANDESITE PORPHYRY & DIORITE CONTACT ALONG "FINGERBUSTER" SHEAR.

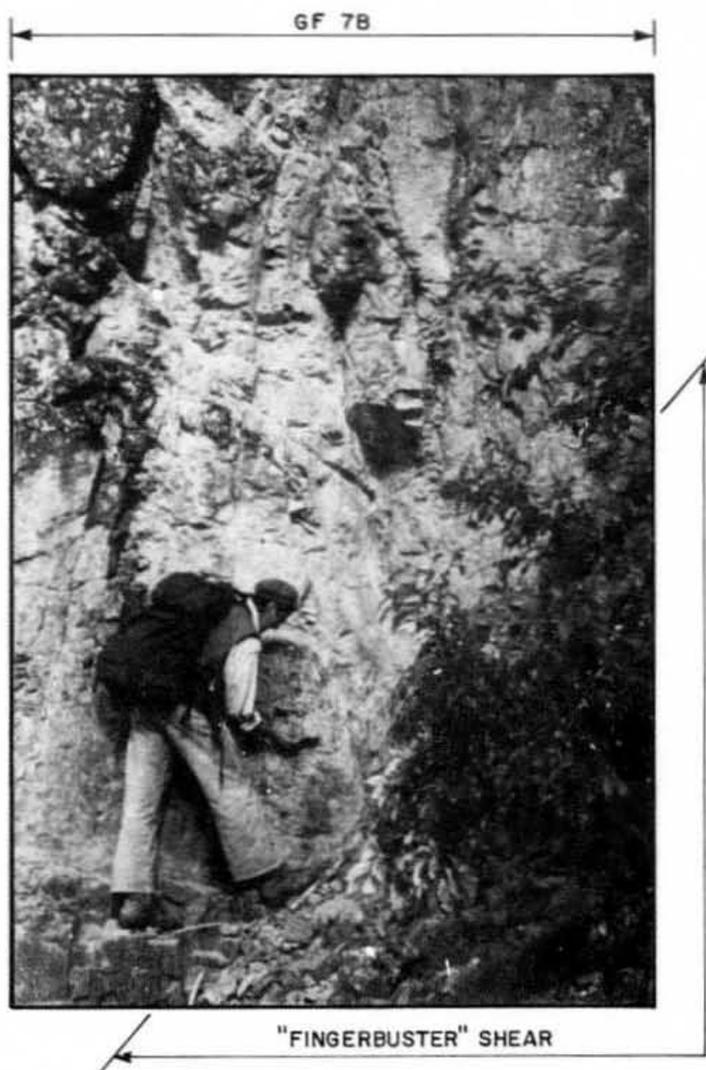
VIEW LOOKING NORTHWEST
ANDESITE PORPHYRY OUTCROP
RIVER LEVEL - NORTH BANK

NOTE:
GEOLOGIC FEATURES "FINGERBUSTER" AND GF 7B
DESCRIBED IN SECTION 6.1.
