### **Denali Avoidance Alternative – Visual Impact Assessment**

### **Affected Visual Environment, Impacts, and Mitigation Measures at Key Observation Points**

## **APPENDIX E-1c: Denali Avoidance Alternative – Existing Conditions and Visual Simulation Imagery for Key Observation Points**

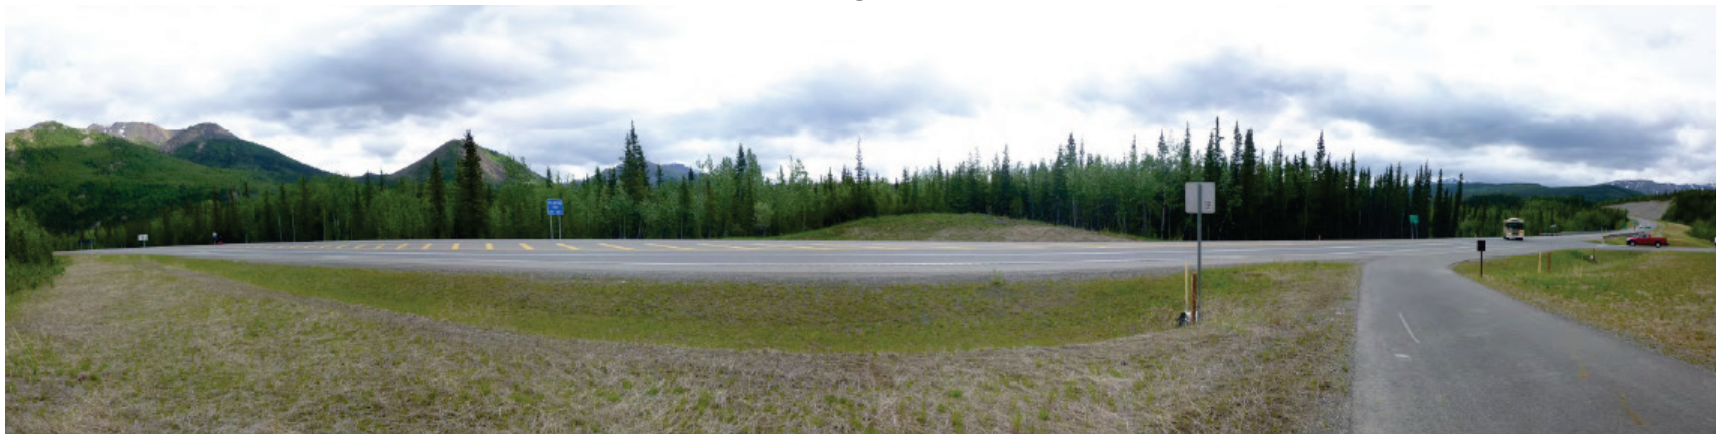
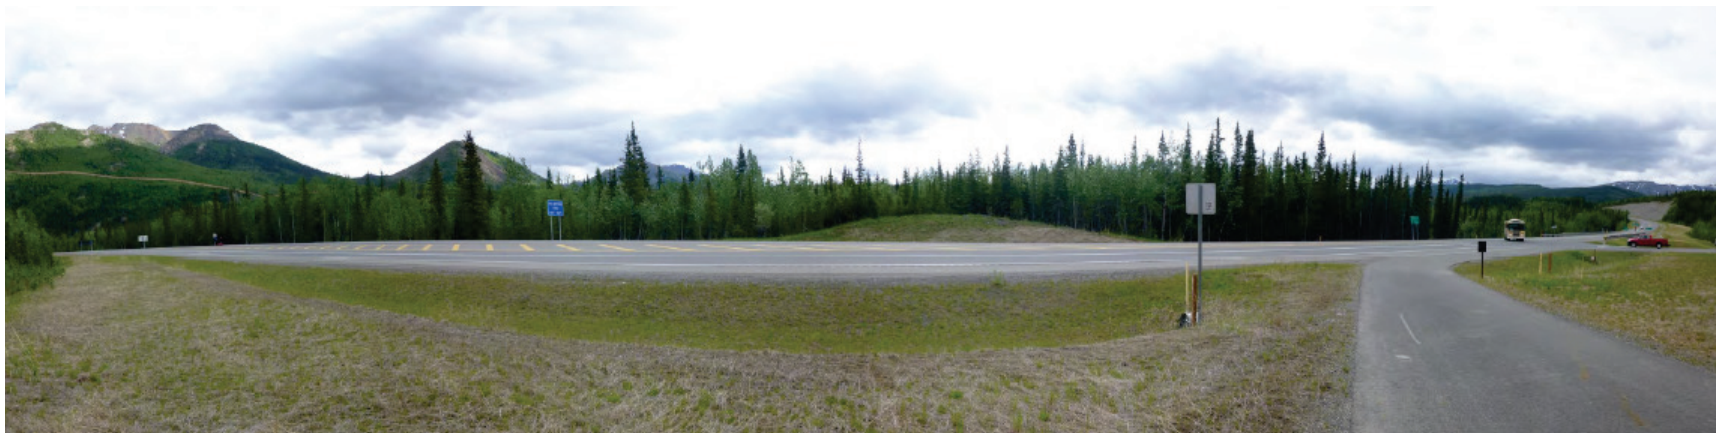
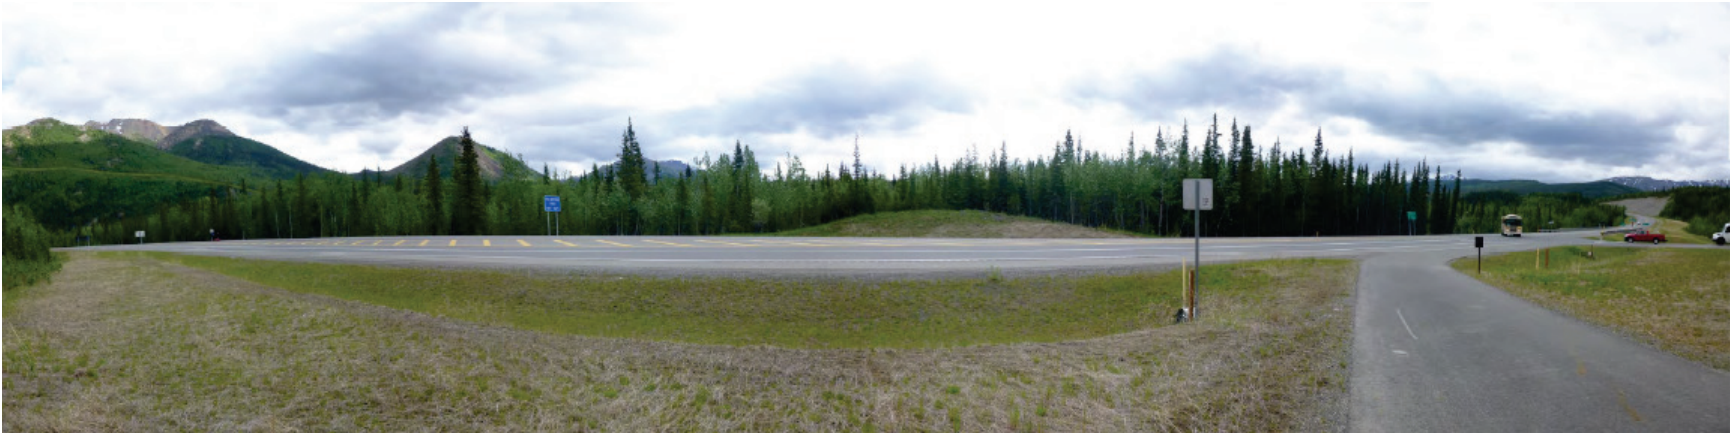
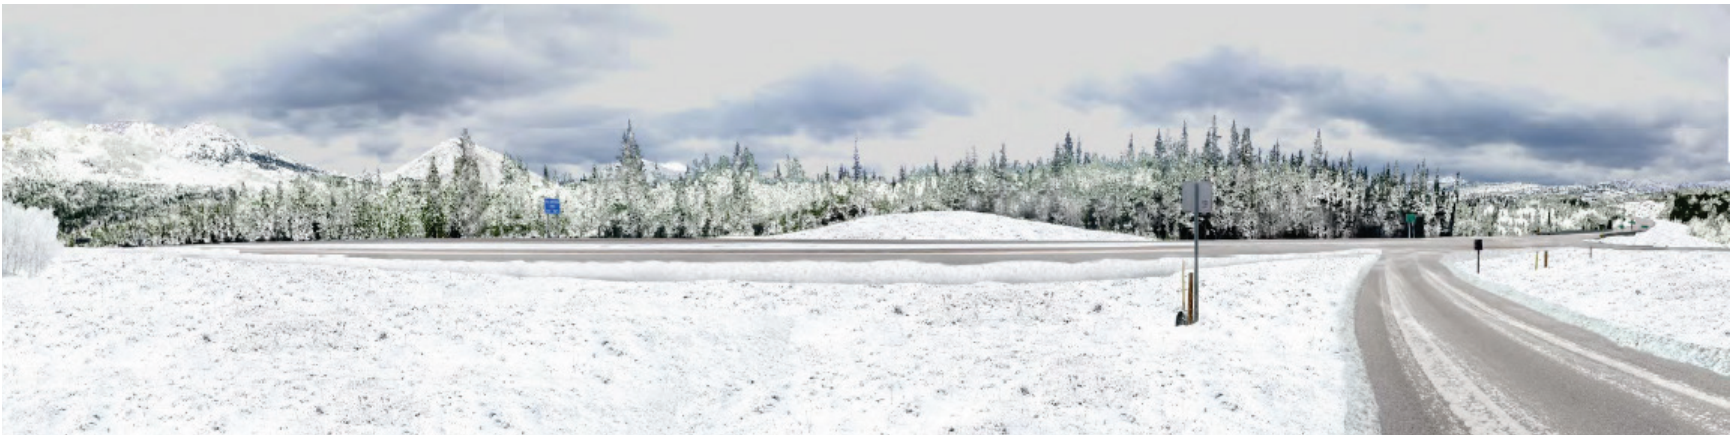
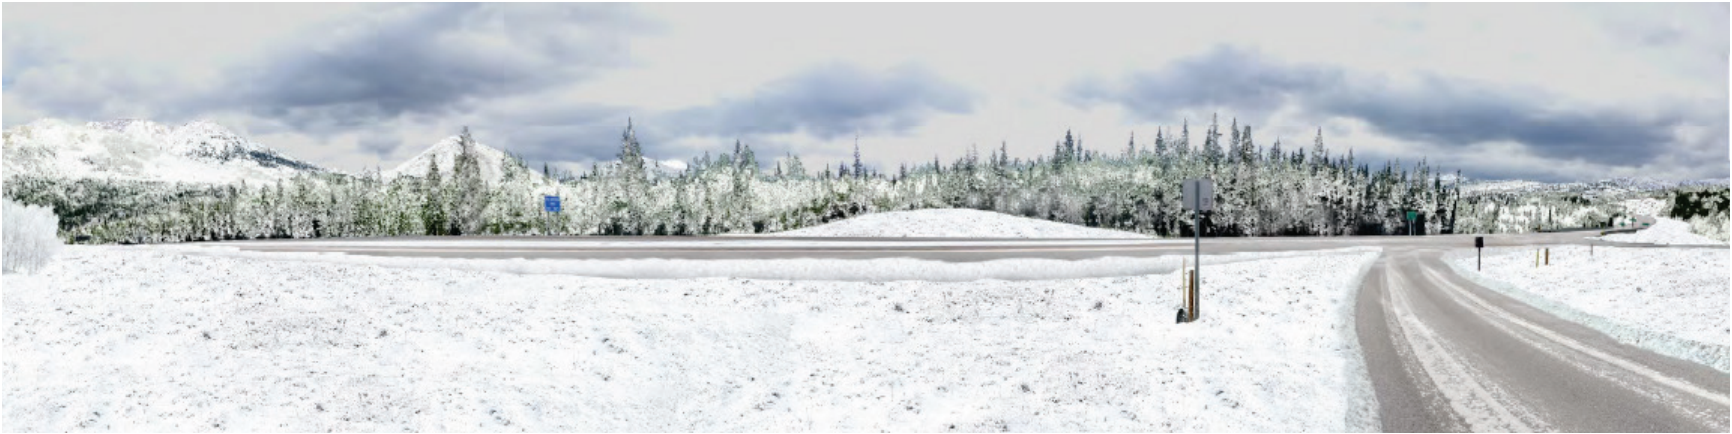
**Figure E.1.2-1: KOP 2018-8: Intersection of George Parks Highway and the DNPP Park Road; View of the Denali Avoidance Alternative to the East**

**a. Existing Conditions**

**b. After Construction**

**c. After Reclamation**

**d. Existing Winter Conditions**

**e. Winter Conditions After Construction**

| Figure E.1.2-1 | KOP 2018-8: Intersection of George Parks Highway and the DNPP Park Road ..... | E-13 |

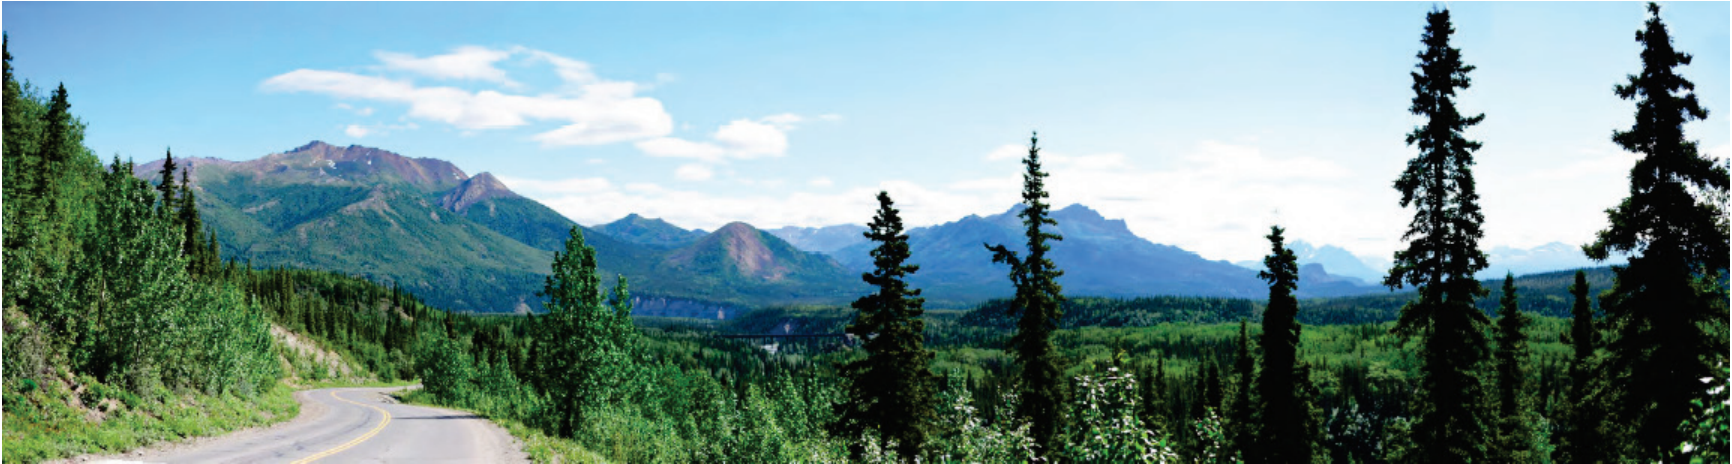
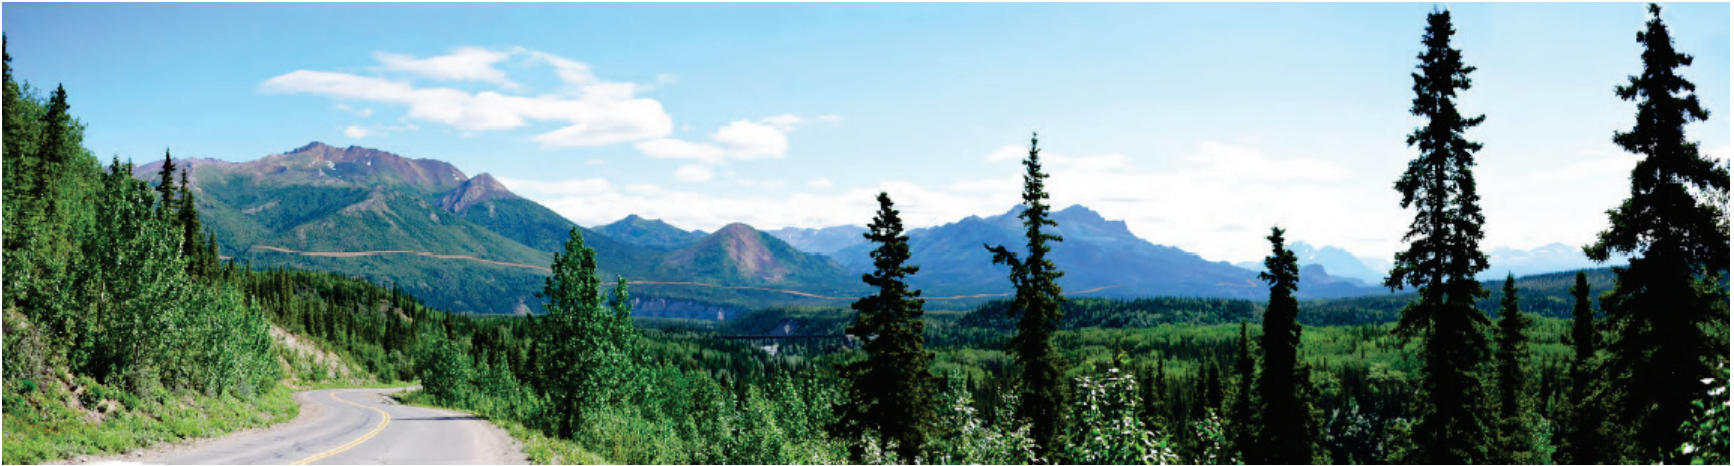
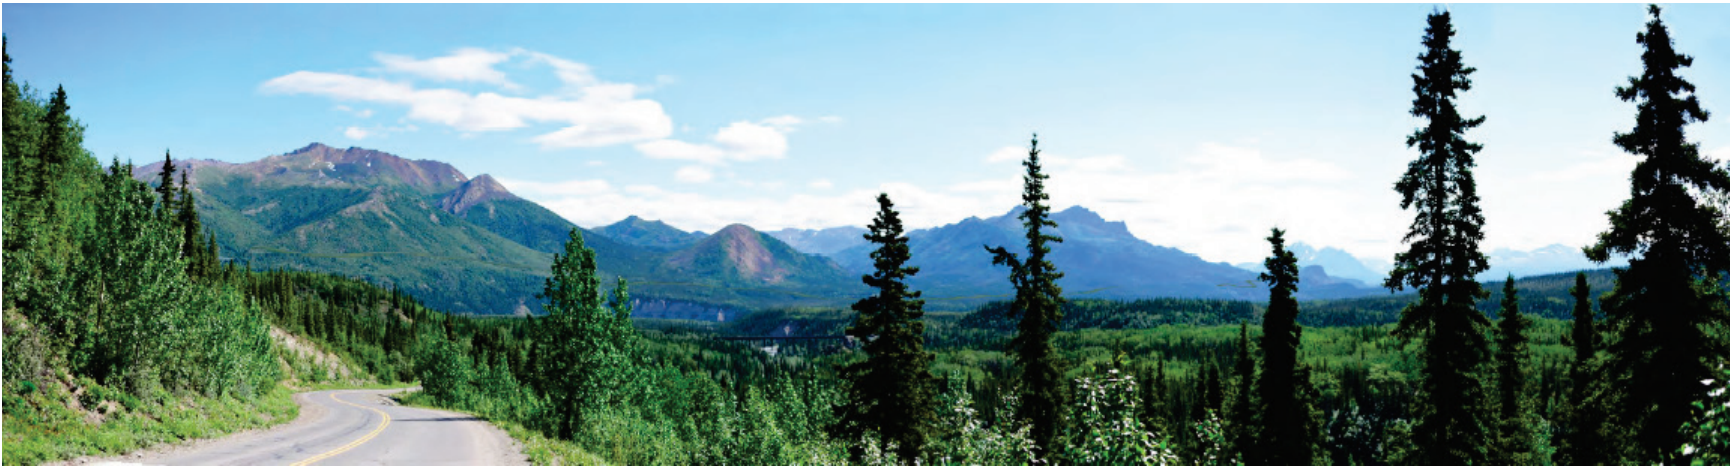
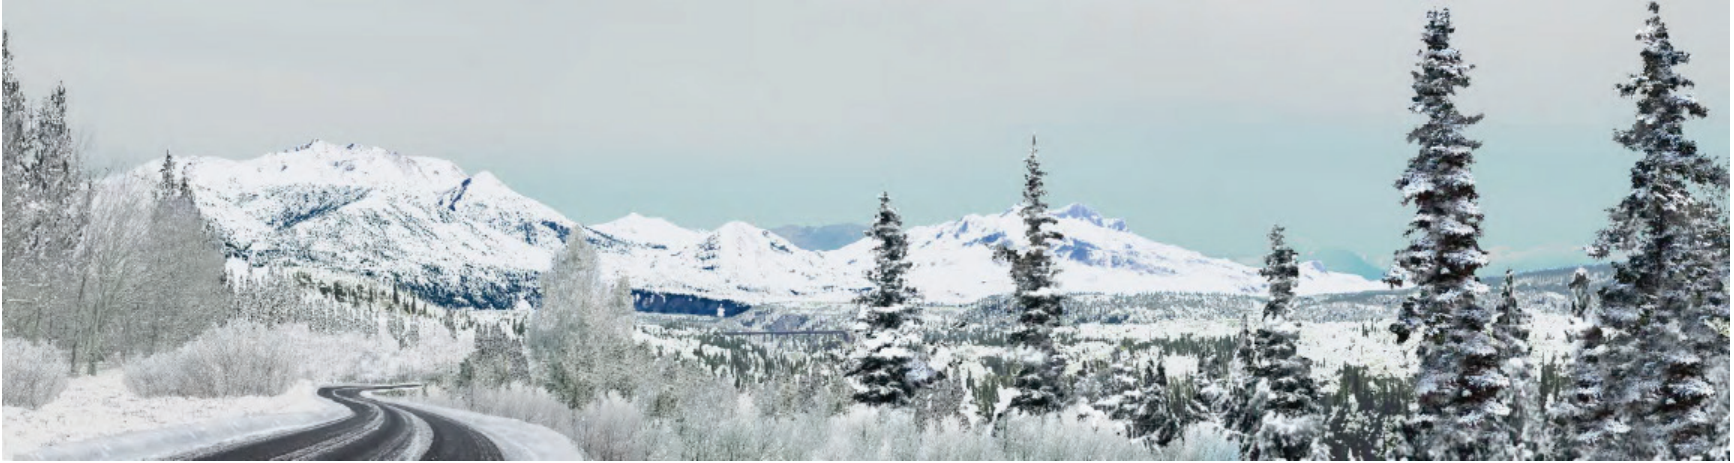
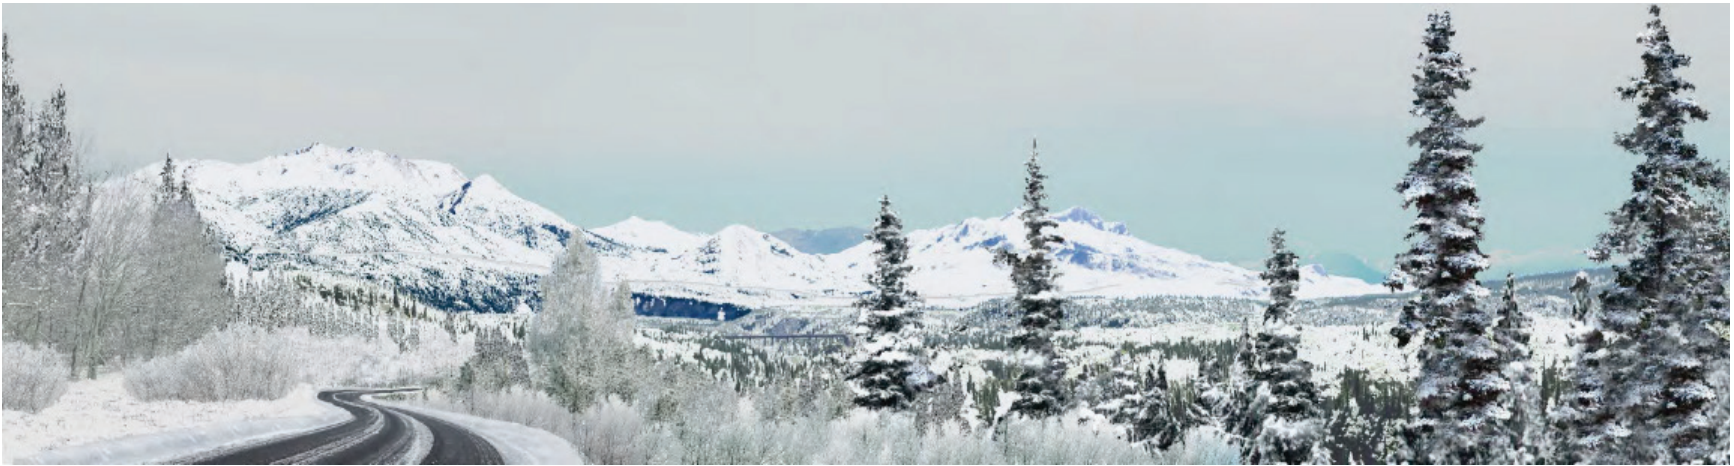
**Figure E.1.3-1: KOP 2018-9: Government Hill; View of the Denali Avoidance Alternative to the East and Southeast**

**a. Existing Conditions**

**b. After Construction**

**c. After Reclamation**

**d. Existing Winter Conditions**

**e. Winter Conditions After Construction**

| Figure E.1.3-1 | KOP 2018-9: Government Hill ..... | E-15 |

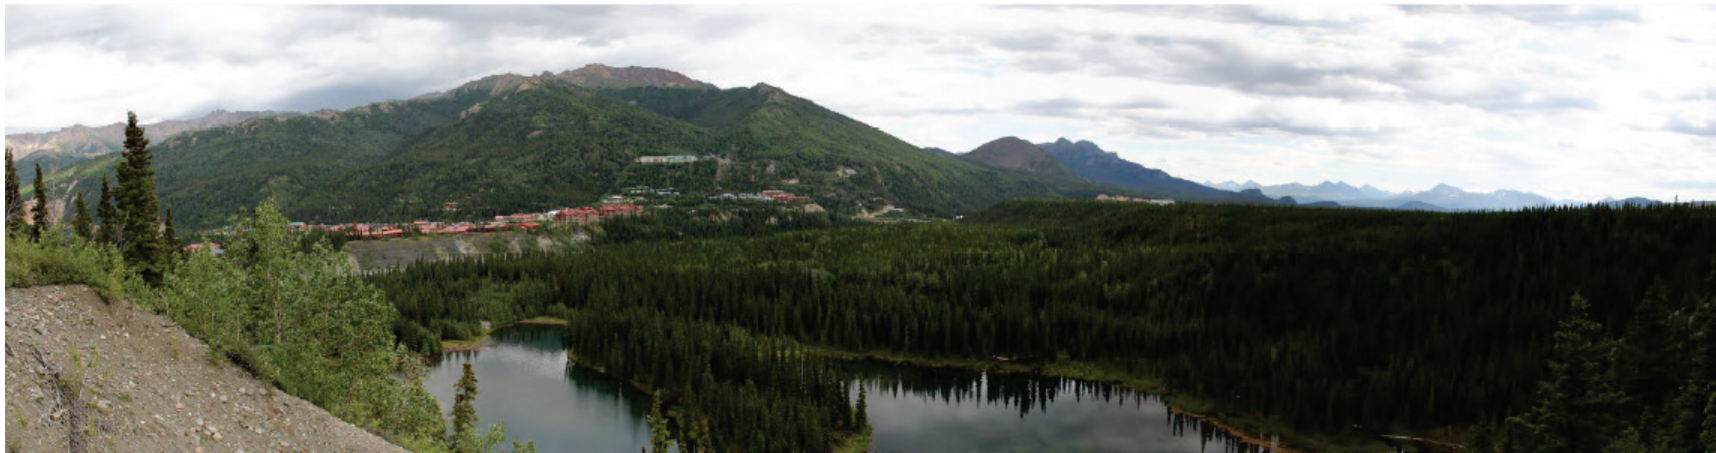
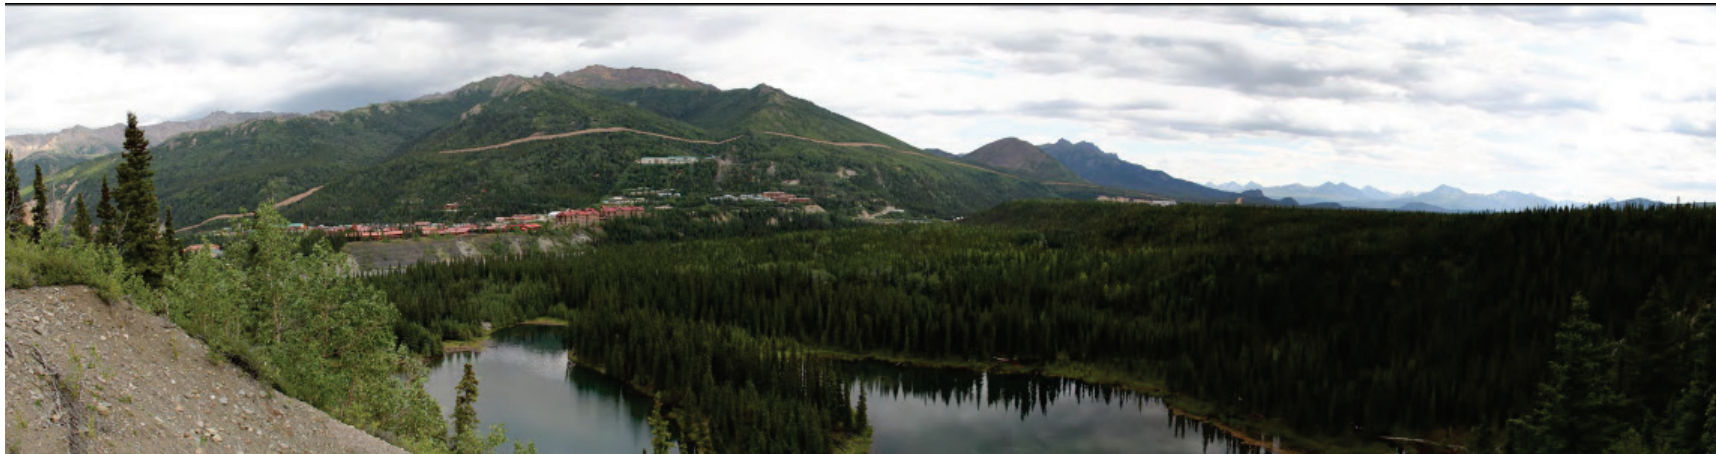
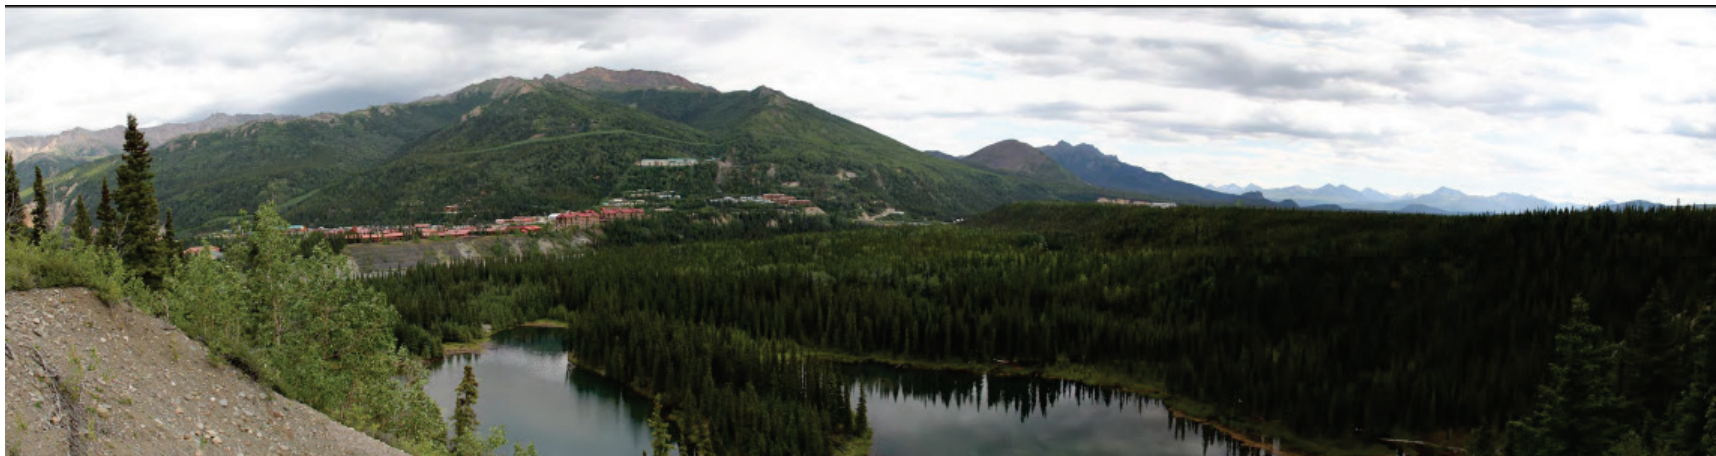
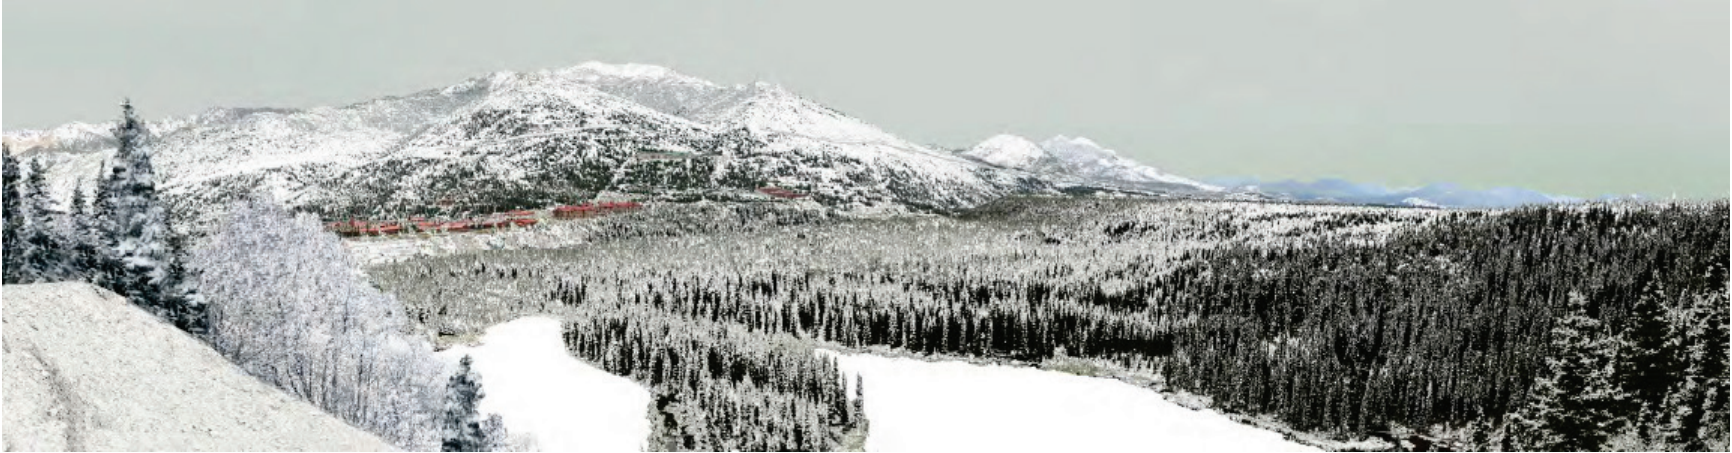
**Figure E.1.4-1: KOP 2018-10: Railroad Above Horseshoe Lake; View of the Denali Avoidance Alternative to the East**

**a. Existing Conditions**

**b. After Construction**

**c. After Reclamation**

**d. Existing Winter Conditions**

**e. Winter Conditions After Construction**

| Figure E.1.4-1 | KOP 2018-10: Railroad Above Horseshoe Lake ..... | E-18 |

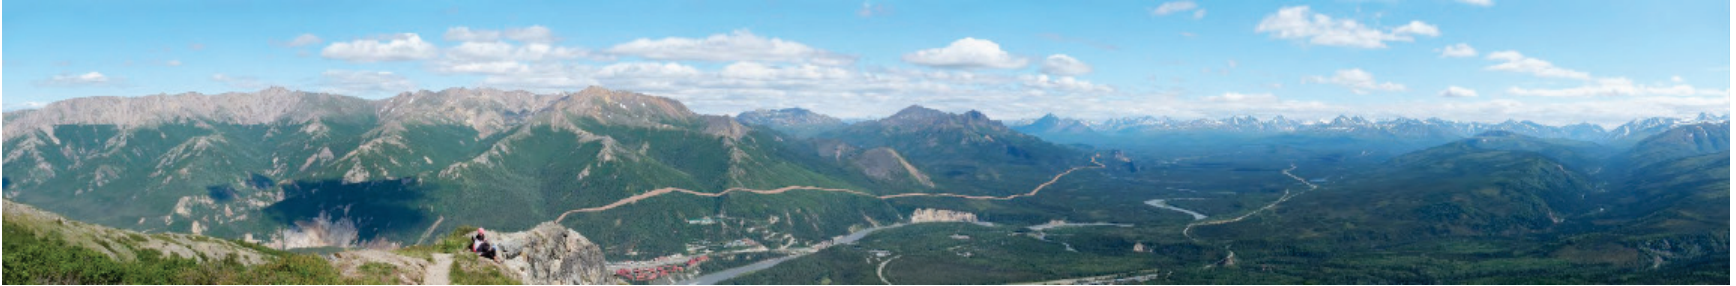
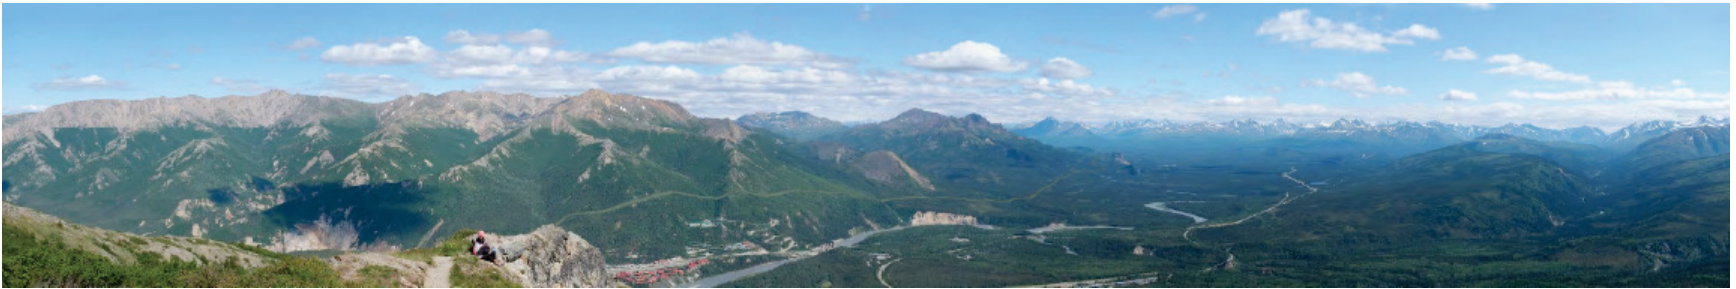
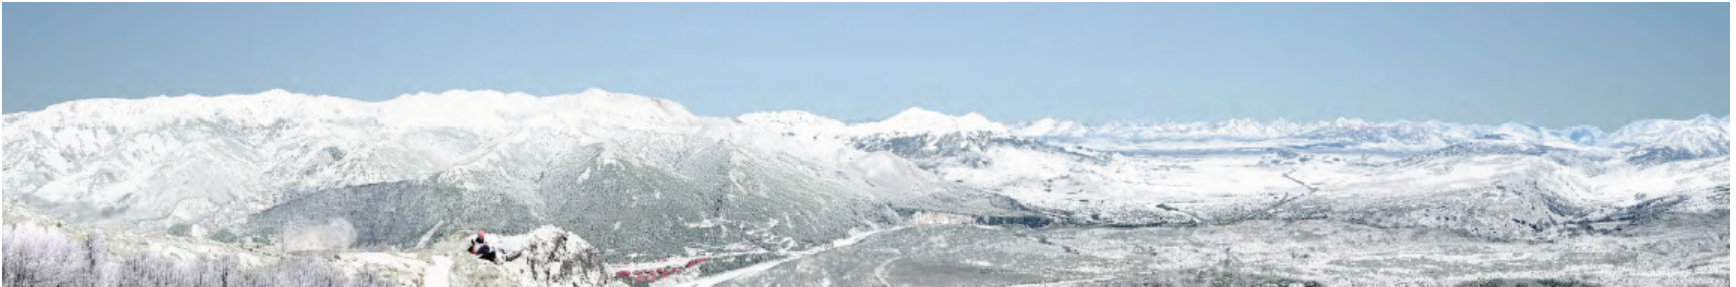
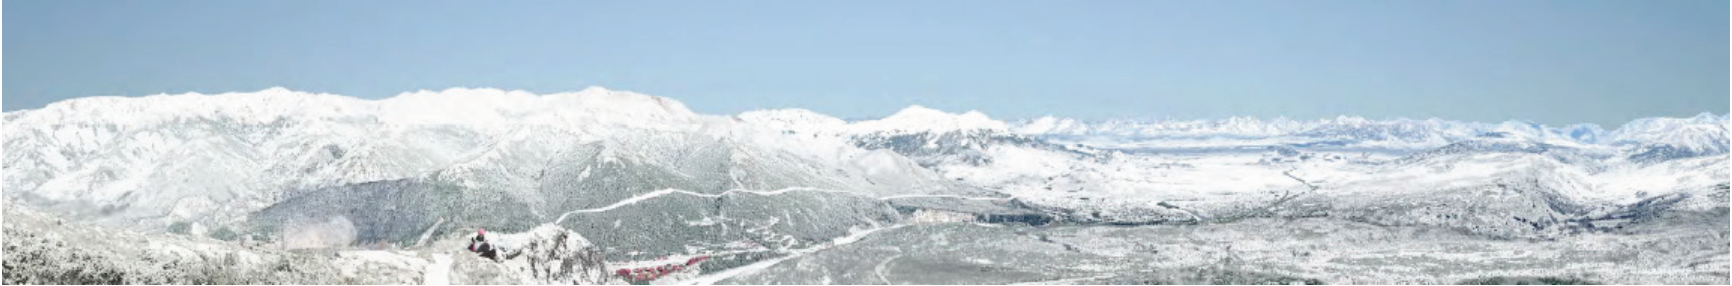
**Figure E.1.5-1: KOP 2018-11: Mt. Healy Overlook Trail Summit; View of the Denali Avoidance Alternative to the East, Southeast, and South**

**a. Existing Conditions**

**b. After Construction**

**c. After Reclamation**

**d. Existing Winter Conditions**

**e. Winter Conditions After Construction**

| Figure E.1.5-1 | KOP 2018-11: Mt. Healy Overlook Trail Summit..... | E-20 |

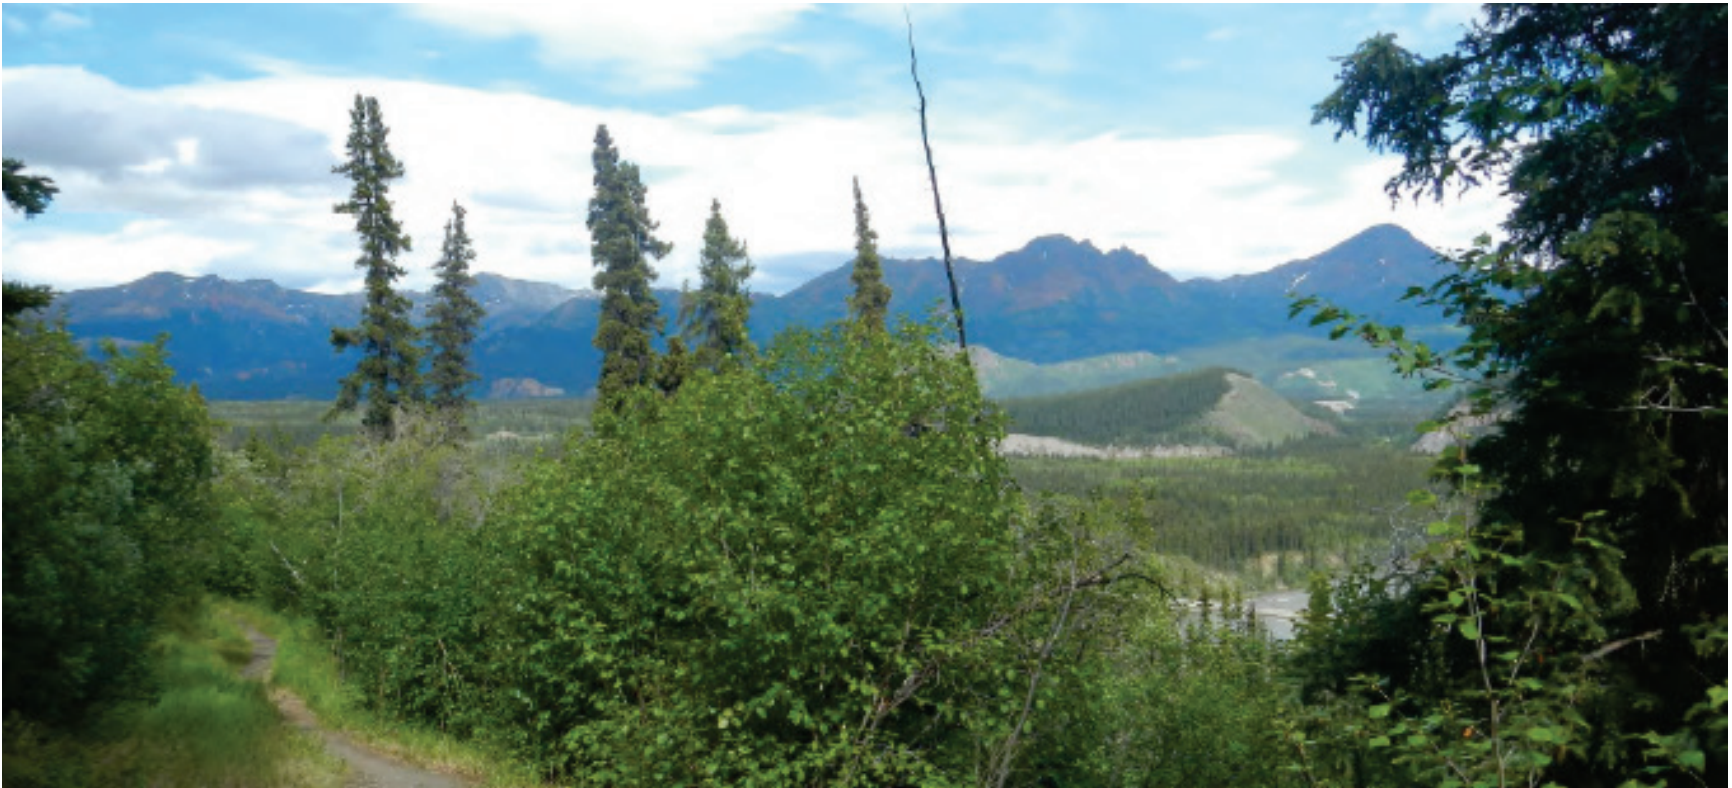
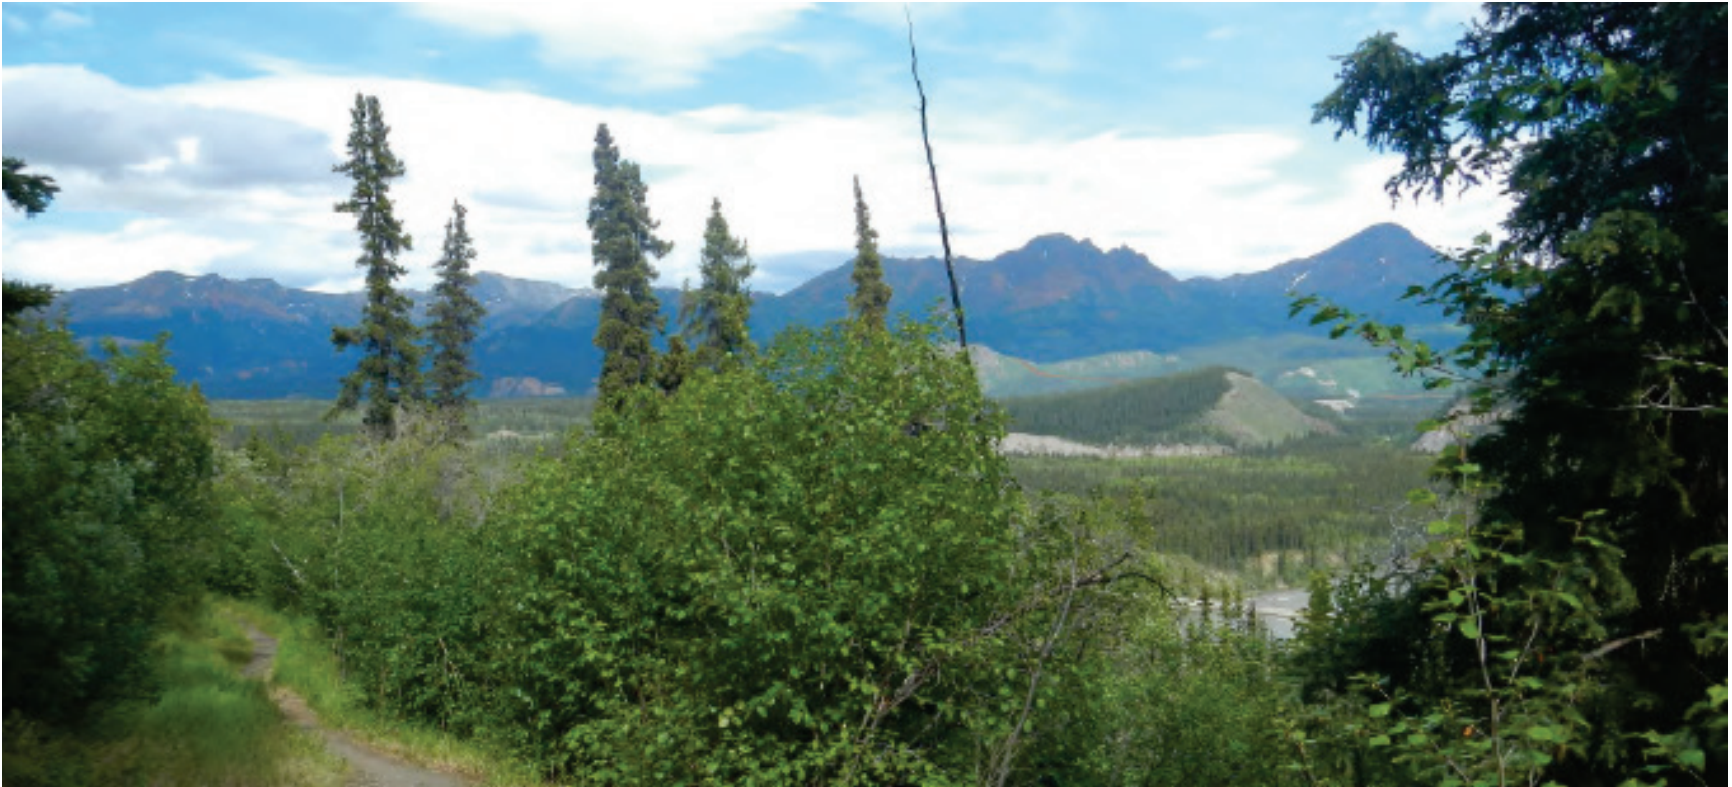
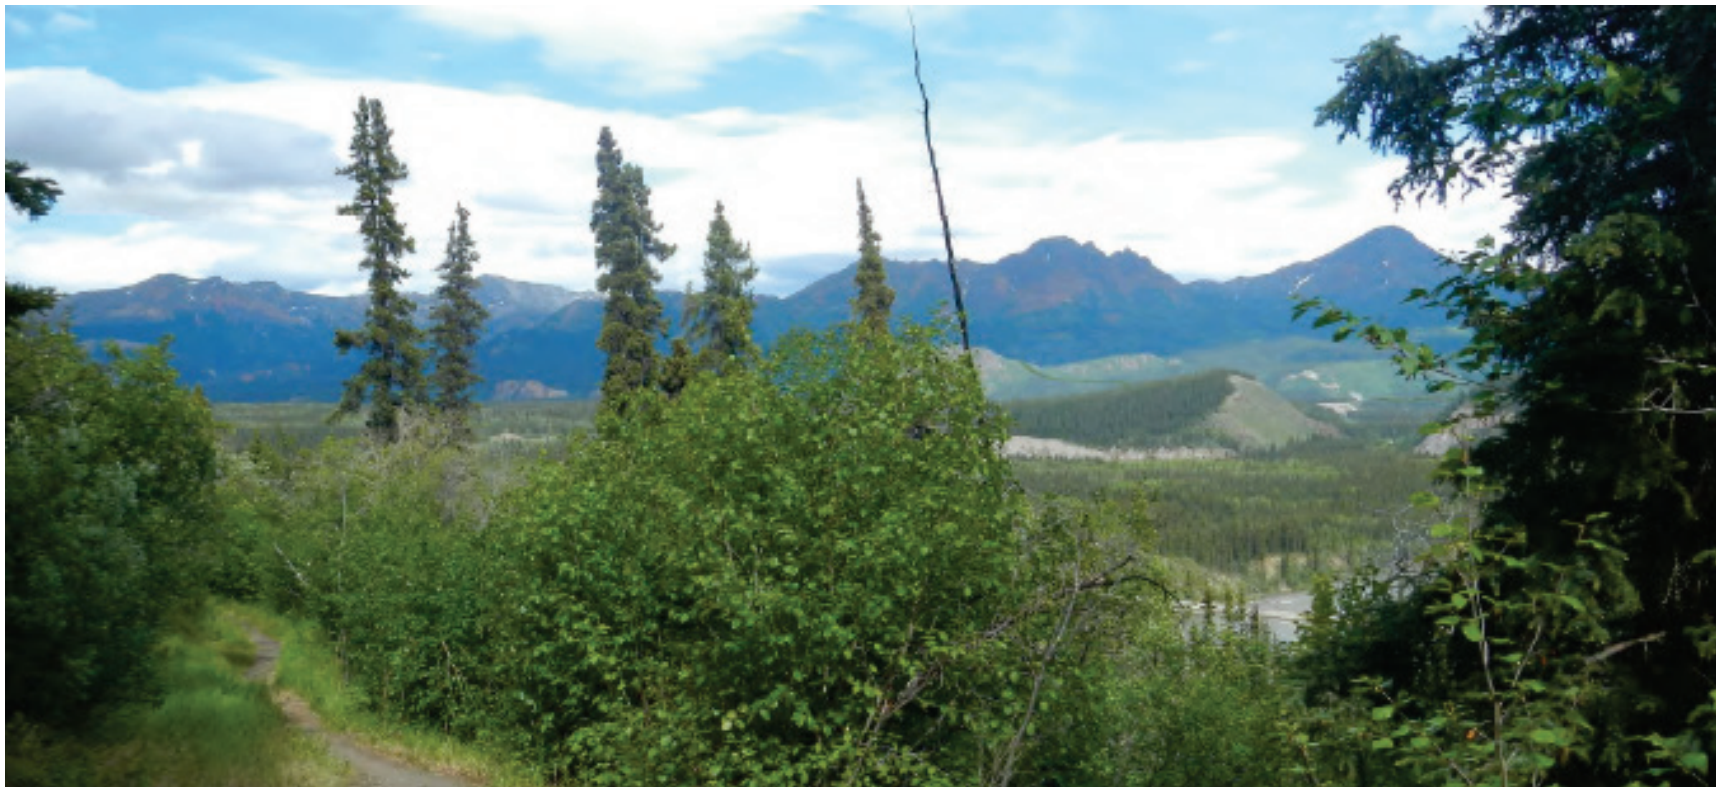
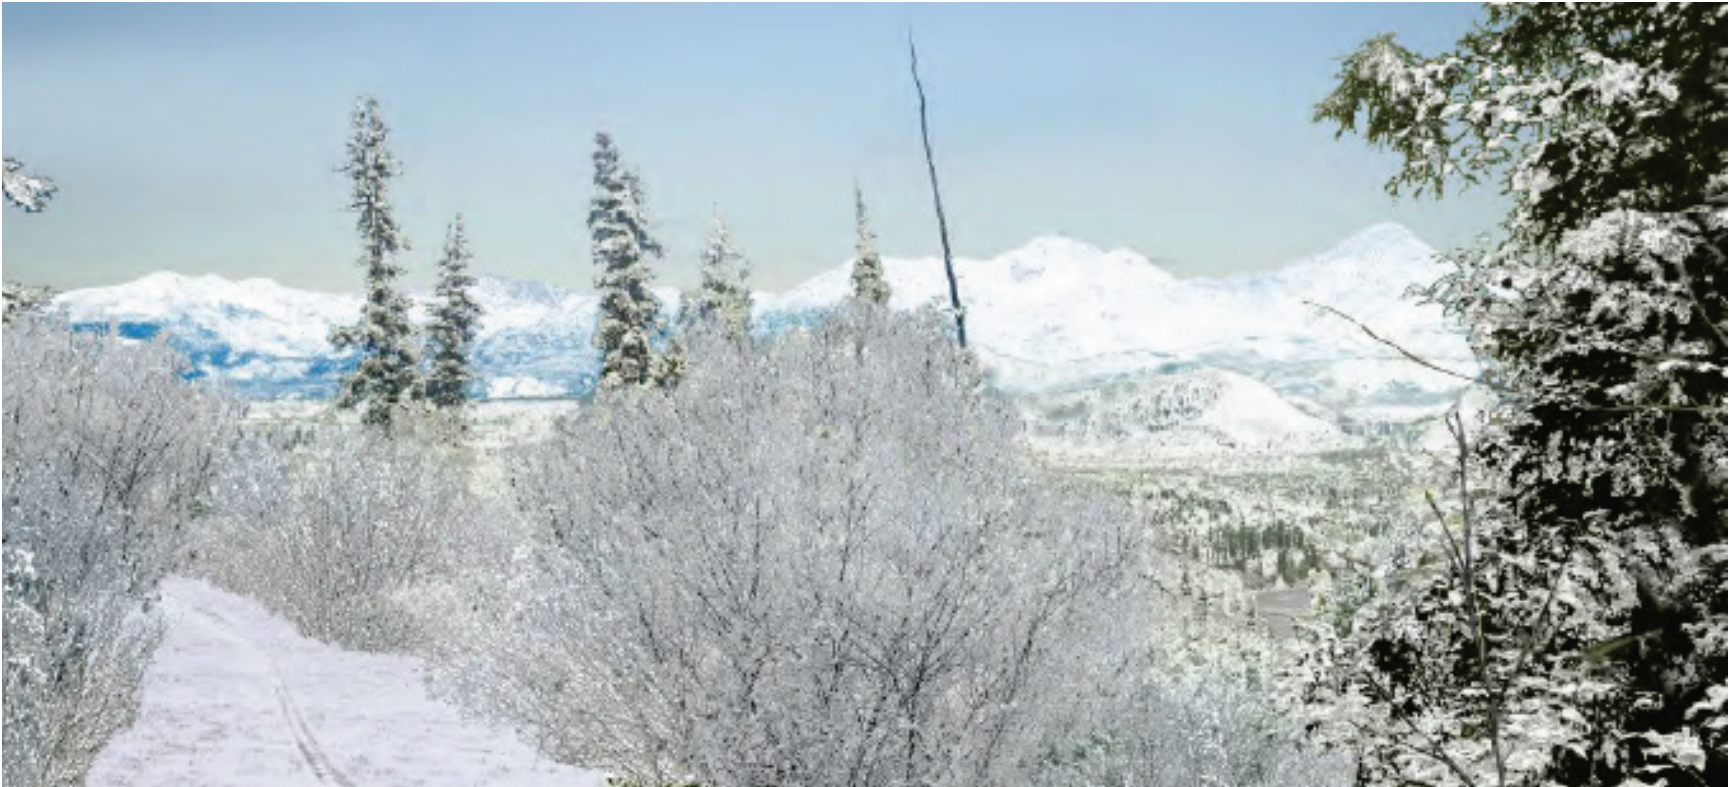
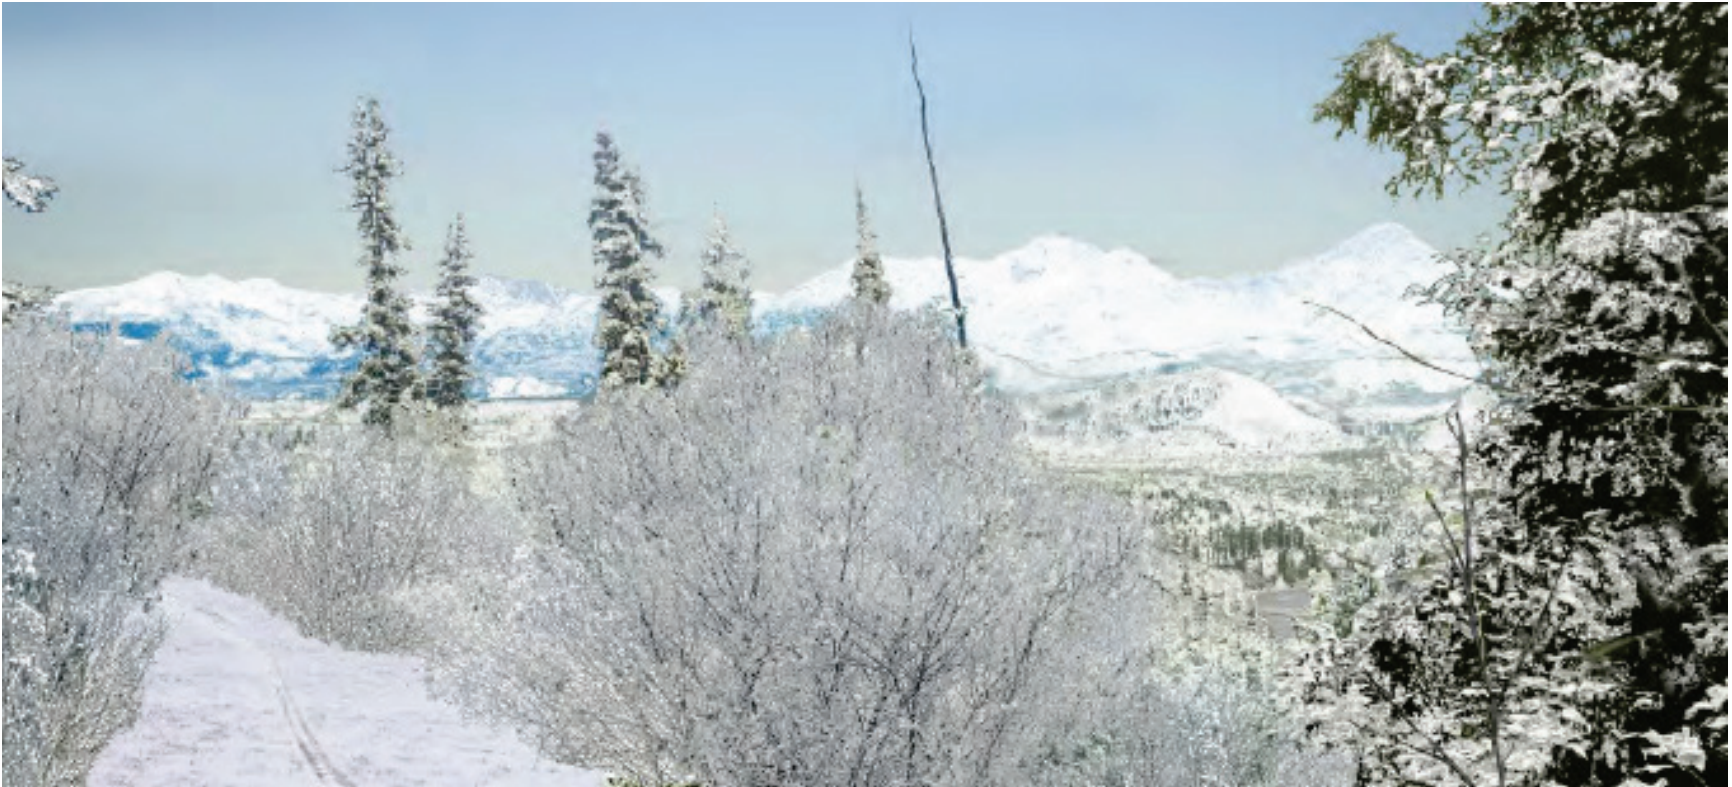
**Figure E.1.6-1: KOP 2018-12: Triple Lakes Trail; View of the Denali Avoidance Alternative to the Northeast**

**a. Existing Conditions**

**b. After Construction**

**c. After Reclamation**

**d. Existing Winter Conditions**

**e. Winter Conditions After Construction**

| Figure E.1.6-1 | KOP 2018-12: Triple Lakes Trail ..... | E-22 |

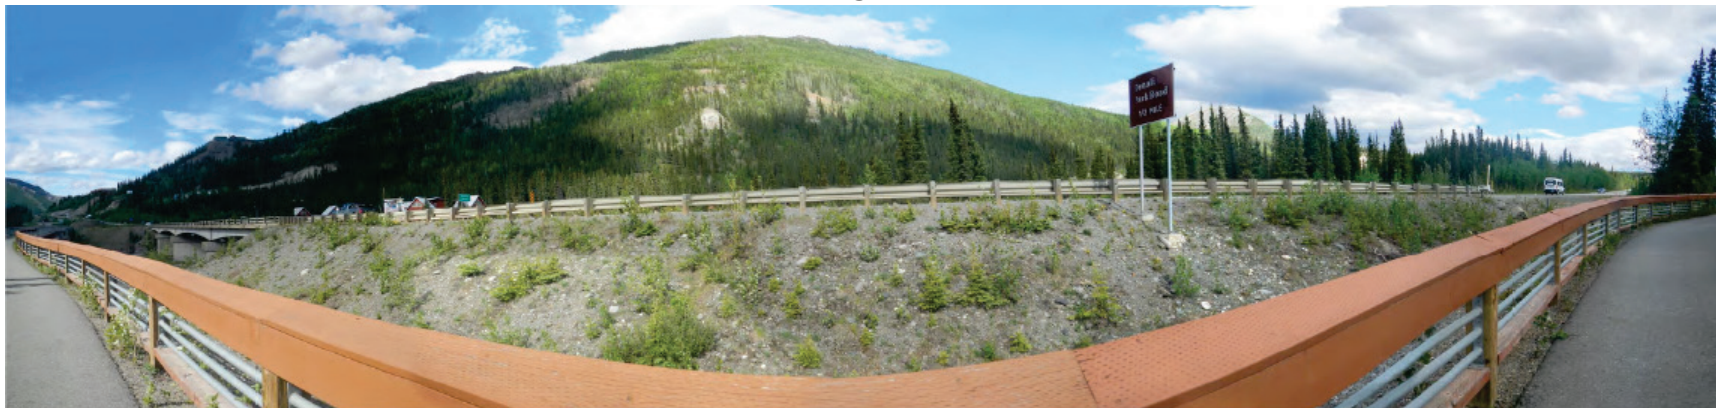
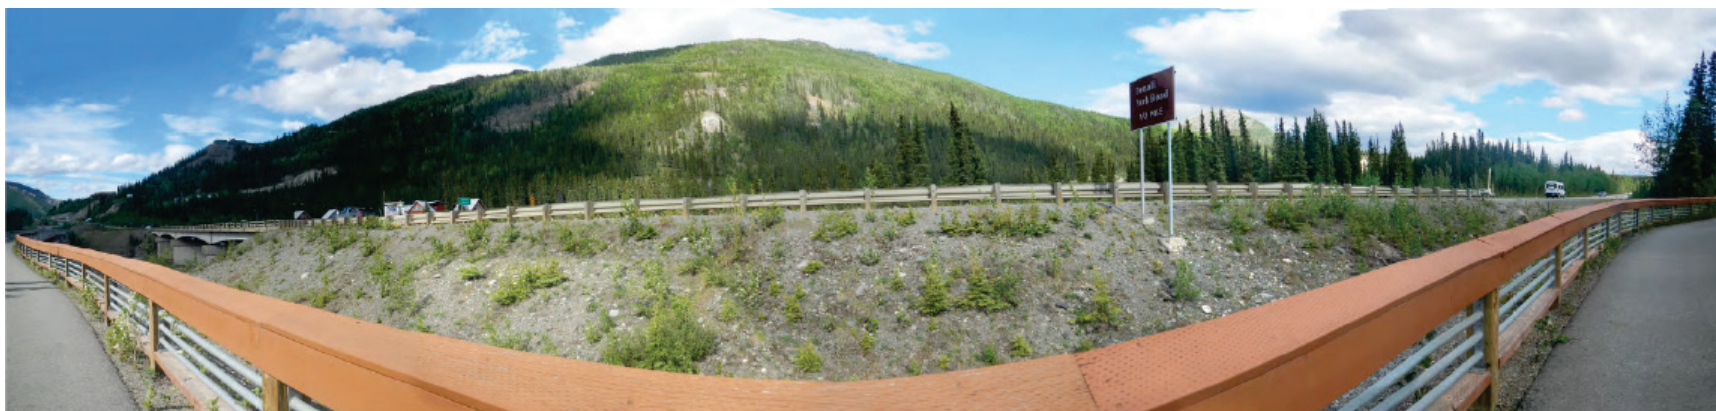
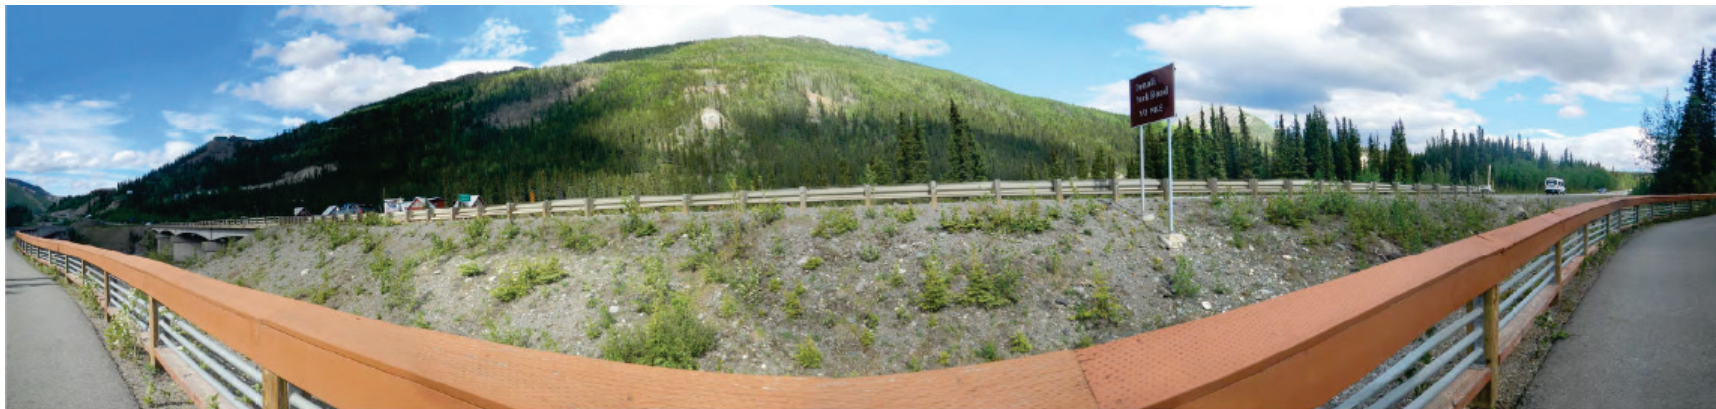
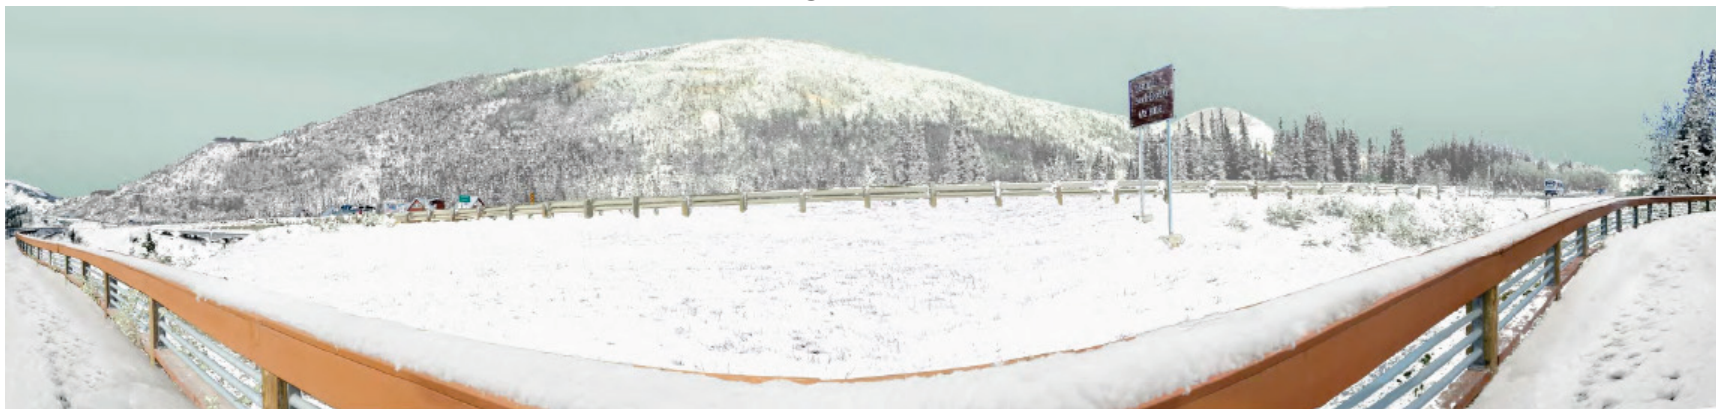
**Figure E.1.7-1: KOP 2018-13: Nenana River Pedestrian Bridge; View of the Denali Avoidance Alternative to the South**

**a. Existing Conditions**

**b. After Construction**

**c. After Reclamation**

**d. Existing Winter Conditions**

**e. Winter Conditions After Construction**

| Figure E.1.7-1 | KOP 2018-13: Nenana River Pedestrian Bridge..... | E-27 |
