### **Denali Avoidance Alternative – Visual Impact Assessment**

### **Affected Visual Environment, Impacts, and Mitigation Measures at Key Observation Points**

## **APPENDIX E-1c: Denali Avoidance Alternative – Existing Conditions and Visual Simulation Imagery for Key Observation Points**

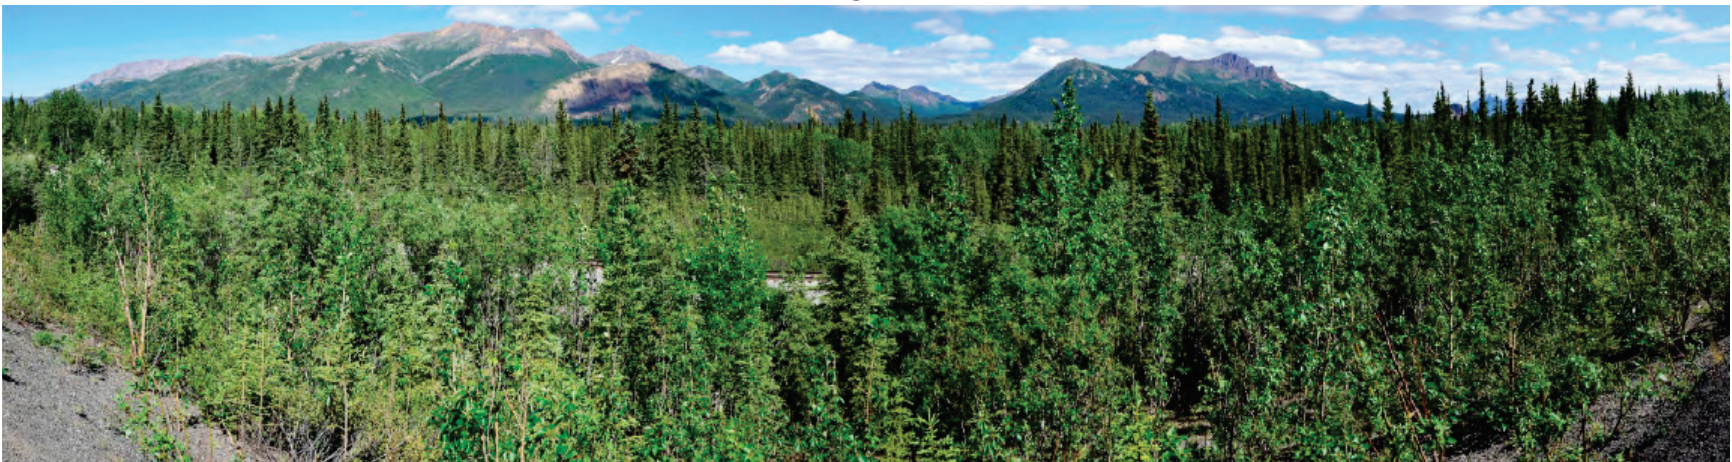
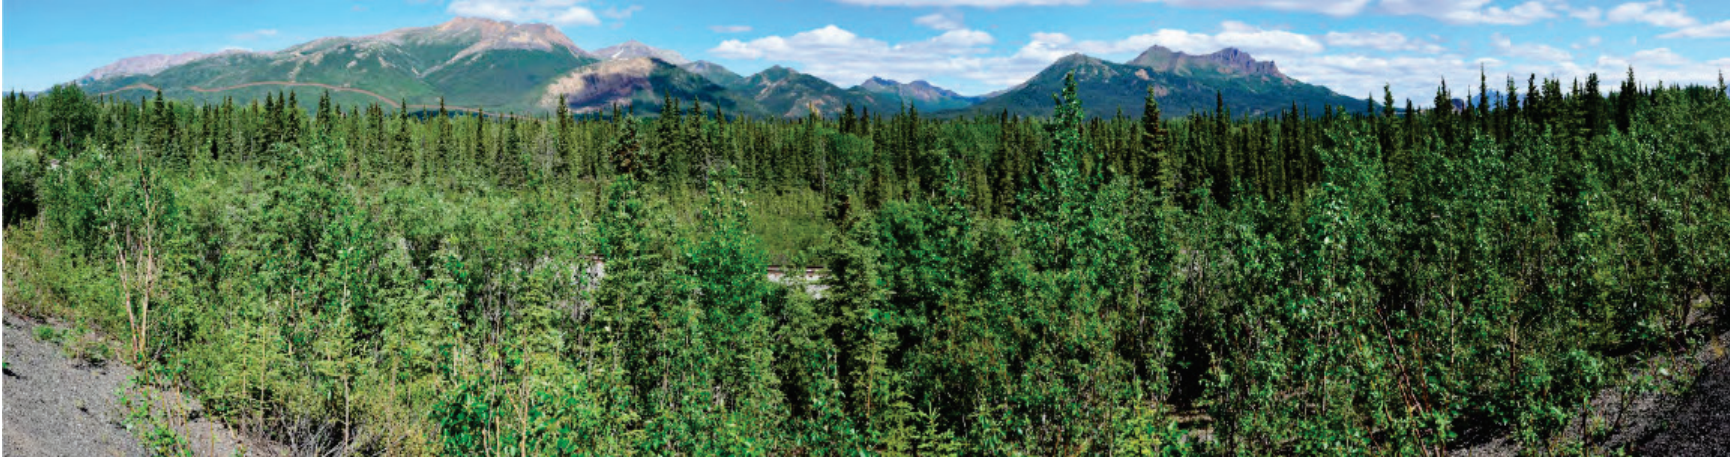
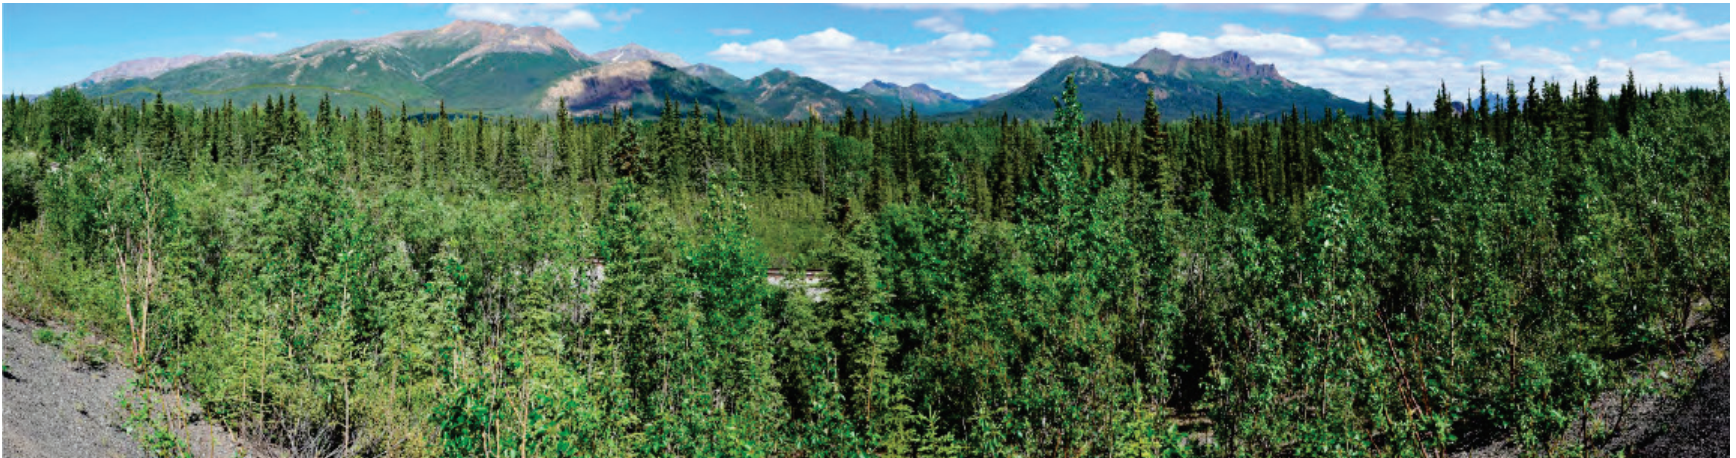
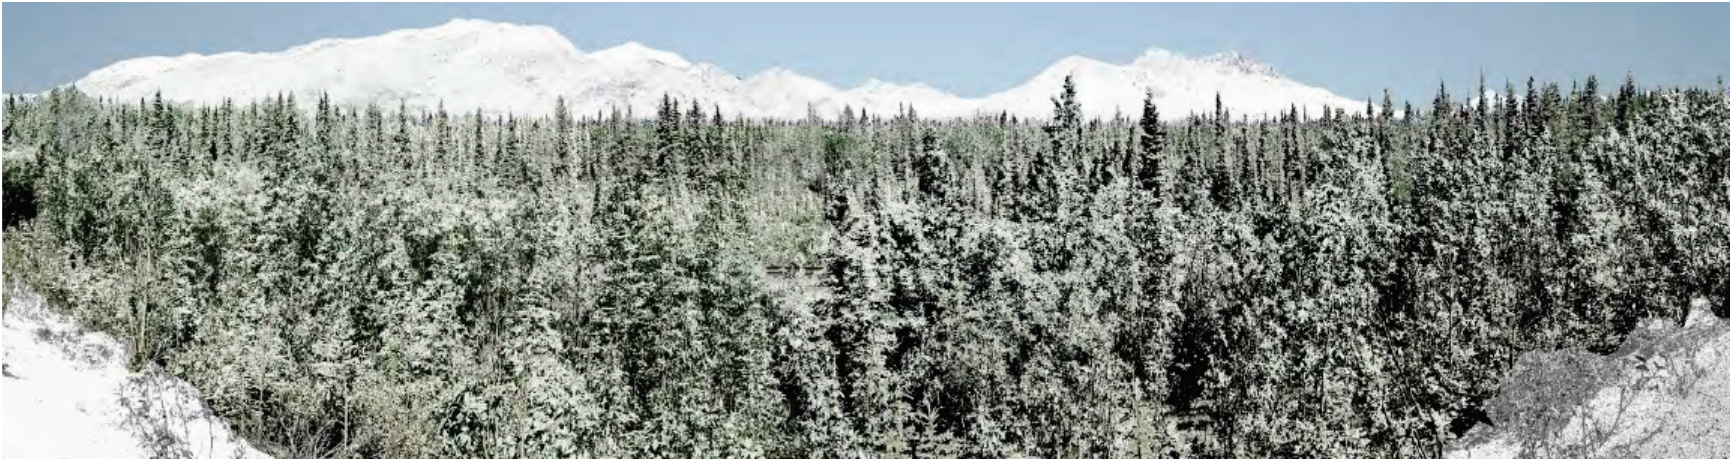
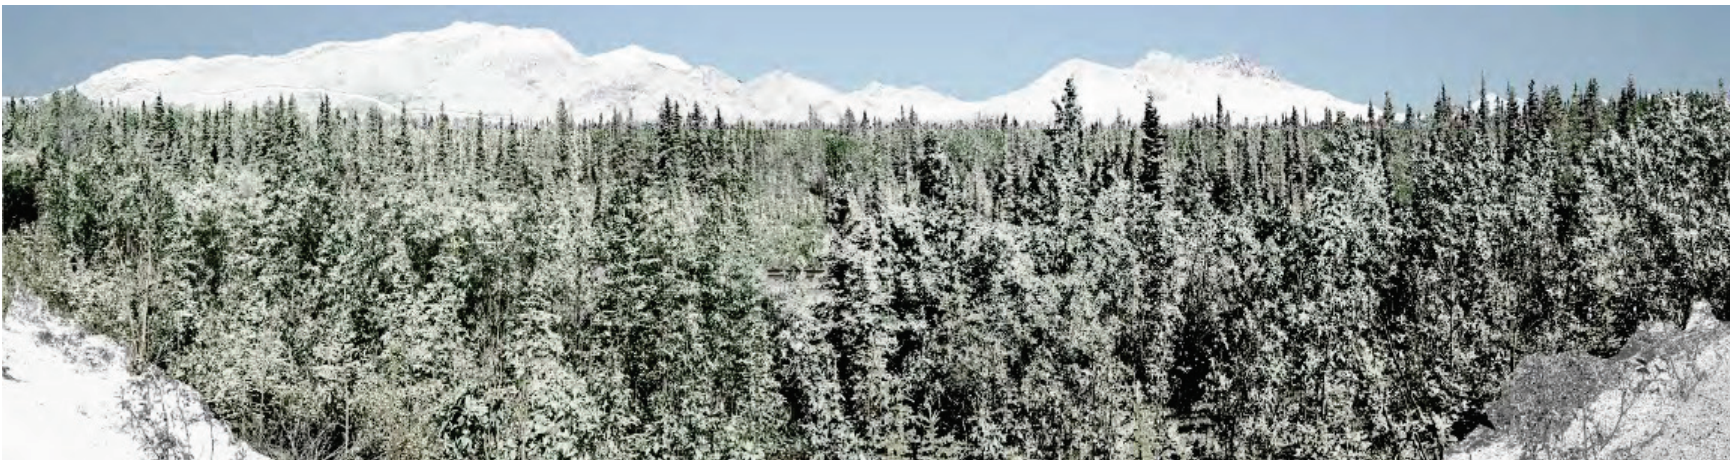
**Figure E.1.8-1: KOP 2018-14: George Parks Highway MP 236; View of the Denali Avoidance Alternative to the East**

**a. Existing Conditions**

**b. After Construction**

**c. After Reclamation**

**d. Existing Winter Conditions**

**e. Winter Conditions After Construction**

| Figure E.1.8-1 | KOP 2018-14: George Parks Highway MP 236 ..... | E-29 |

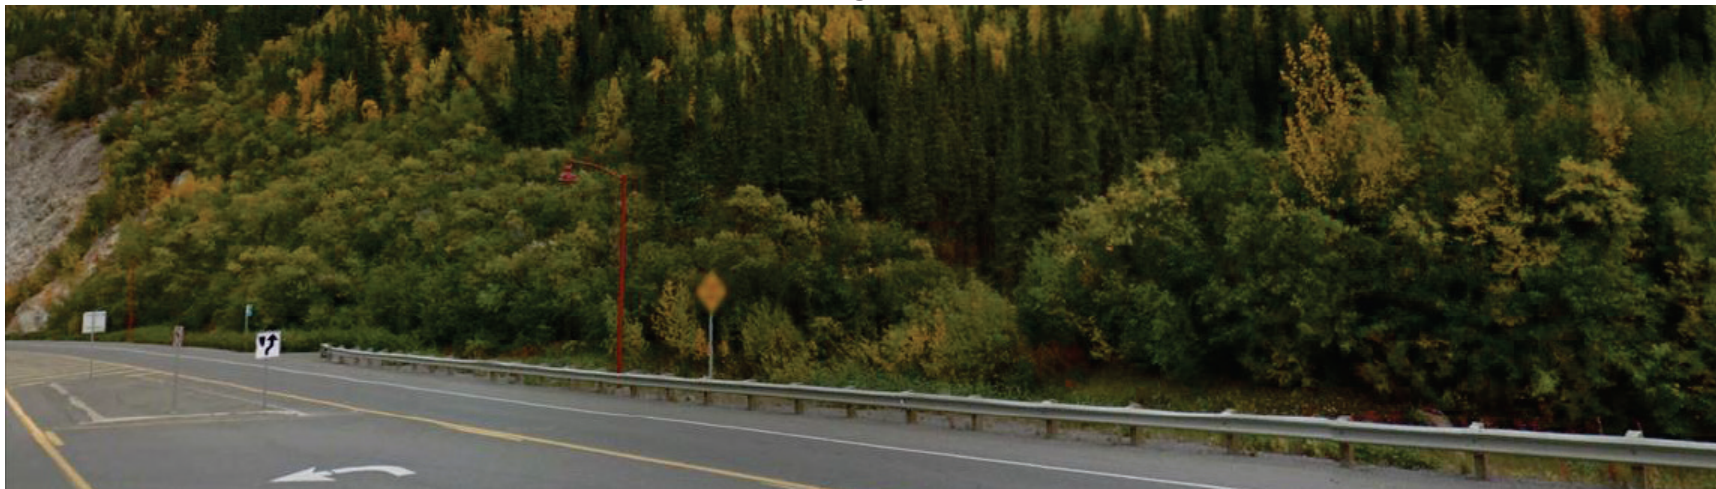
**Figure E.1.9-1: KOP K: McKinley Chalet Resort; View of the Denali Avoidance Alternative to the East**

**a. Existing Conditions**

| Figure E.1.9-1 | KOP K: McKinley Chalet Resort..... | E-32 |
