## Design, construction and performance of dams in continuous permafrost

**ABSTRACT:** Three dams were constructed from a small selection of materials over a short period of time in an area of continuous permafrost in the Canadian Arctic. The design selected for the dams was a rockfill embankment with an HDPE liner. Key features are the geometry of the liner and the planning of the construction schedule that was critical to keep the pervious foundations permanently frozen. This paper summarizes the design, construction and performance of these dams. It highlights the importance of continuous construction control by qualified technical staff. Occurrences of massive ground ice, that required foundation design changes, were encountered and detailed inspection of liner placement/welding during very cold temperatures was required. The dams were completed and are retaining water with a maximum depth of 10 m. Foundation temperature monitoring has shown that the design and the planned construction schedule had resulted in frozen foundations, as required by the design.

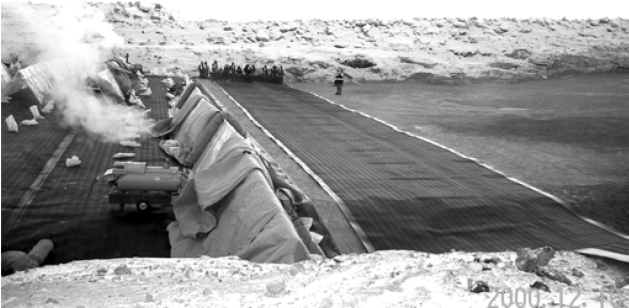
Figure 5. Liner installation during the winter.

During extreme cold conditions, shelters were built for welding the liner (Fig. 5). These shelters were heated and seams were welded in a protected environment. All liner wedge weld seams were pressure tested and all extrusion weld seams were tested by vacuum. All damaged areas, including holes, blisters, cracks and machinery damage were patched with the same HDPE material and extrusion welded. The destructive tests were carried out in accordance with the requirements of the QA/QC Plan.

The testing results and subsequent dam performance suggested that perfect liner jointing was obtained

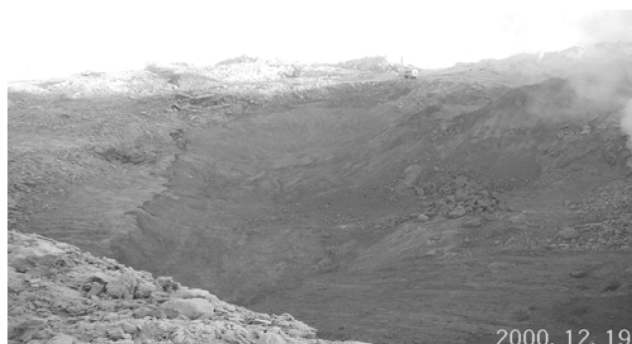
Figure 6. Till blanket placed in the talik.

The entire talik area was excavated to a maximum depth of about 10 m. All broken rock was removed from the base of the excavation and the trench reached competent rock. Water seepage through fractured rock was encountered during the excavation. This water was pumped out and a till blanket was placed on the upstream slope of the excavation to seal off the seepage. Seepage was controlled successfully by the low permeability materials and by subsequent freezing (Fig. 6). This till blanket also smoothed the surface of the excavation for the liner placement.

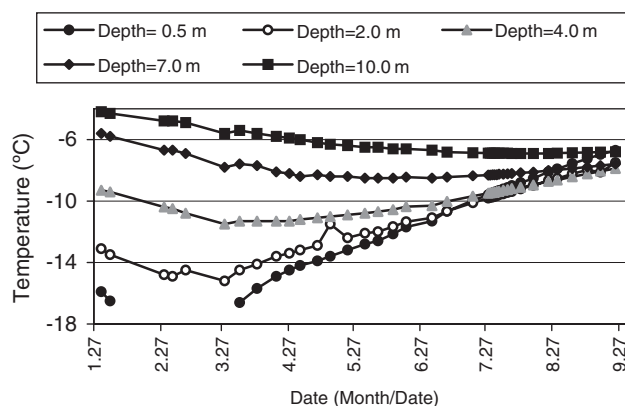
Figure 9. Ground temperatures for the downstream string at North Dam (0+440).

The monitoring of ground temperatures has shown that frozen foundations have been achieved. The temperatures met or exceeded the design requirements.

Figures 7, 8 and 9 show the ground temperature variations for the North Dam, at station 0+440.
