# **Source Water Assessment**

A Hydrogeologic Susceptibility and
Vulnerability Assessment for
Fairhill Community Church Drinking
Water System,
Fairbanks area, Alaska
PWSID # 312693

DRINKING WATER PROTECTION PROGRAM REPORT Report 815
Alaska Department of Environmental Conservation

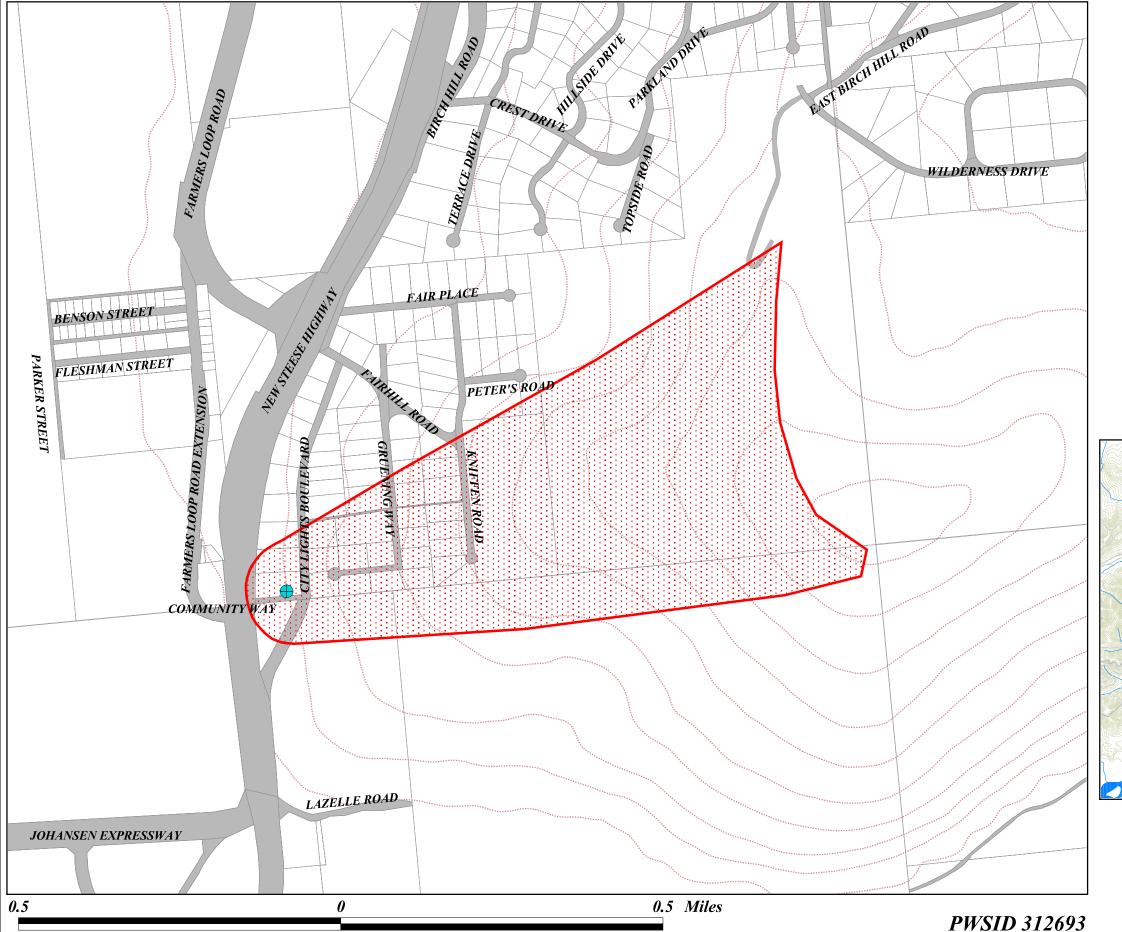
Fairhill Community Church
Drinking Water Protection Area Location Map
(Map 1)

# Fairhill Community Church Drinking Water Protection Area

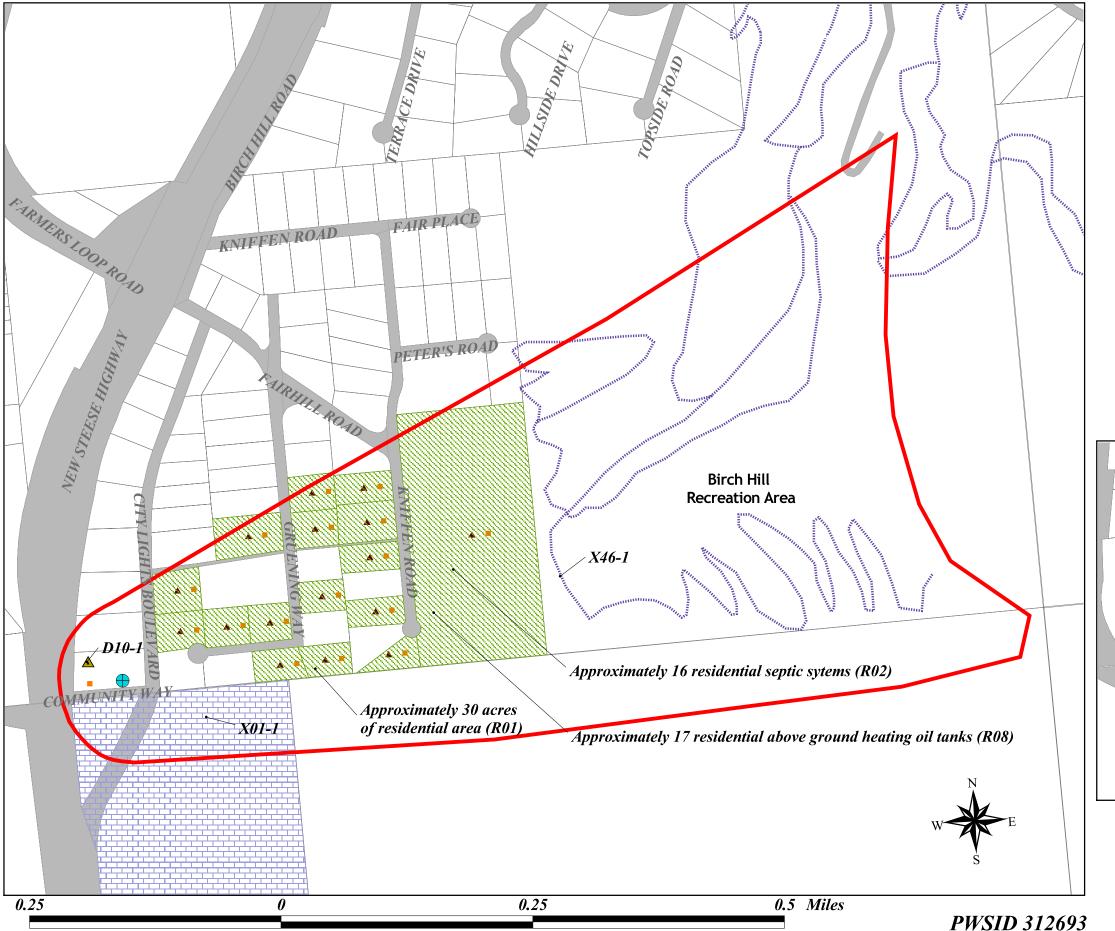
Fairhill Community Church
Drinking Water Protection Area
and Potential and Existing Contaminant Sources
(Map 2)

# Fairhill Community Church Drinking Water Protection Area with Potential and Existing Contaminant Sources

Contaminant Source Type	Contaminant Source ID	CS ID tag	Zone	Map Number	Comments
Injection wells (Class V) Large-Capacity Septic System (Drainfield Disposal Method)	D10	D10-1	A	2	Fairhill Community Church
Residential Areas	R01		A	2	Approximately 30 acres of residential area
Septic systems (serves one single-family home)	R02		A	2	Approximately 16 septic systems (based on number of parcels listed as residential)
Tanks, heating oil, residential (above ground)	R08		A	2	Approximately 17 heating oil tanks (based on number of parcels listed as residential)
Cemeteries	X01	X01-1	A	2	
Highways and roads, dirt/gravel	X24		A	2	4 roads located within Zone A
Dog walking areas/foot trails	X46	X46-1	A	2	Birch Hill Recreation Area
