Willow Master Development Plan

Appendix D.3C Ice Bridge Plan

**2022 Summary Report – Ocean Point Discharge and Water
Quality**

Ocean Point Discharge and Water Quality

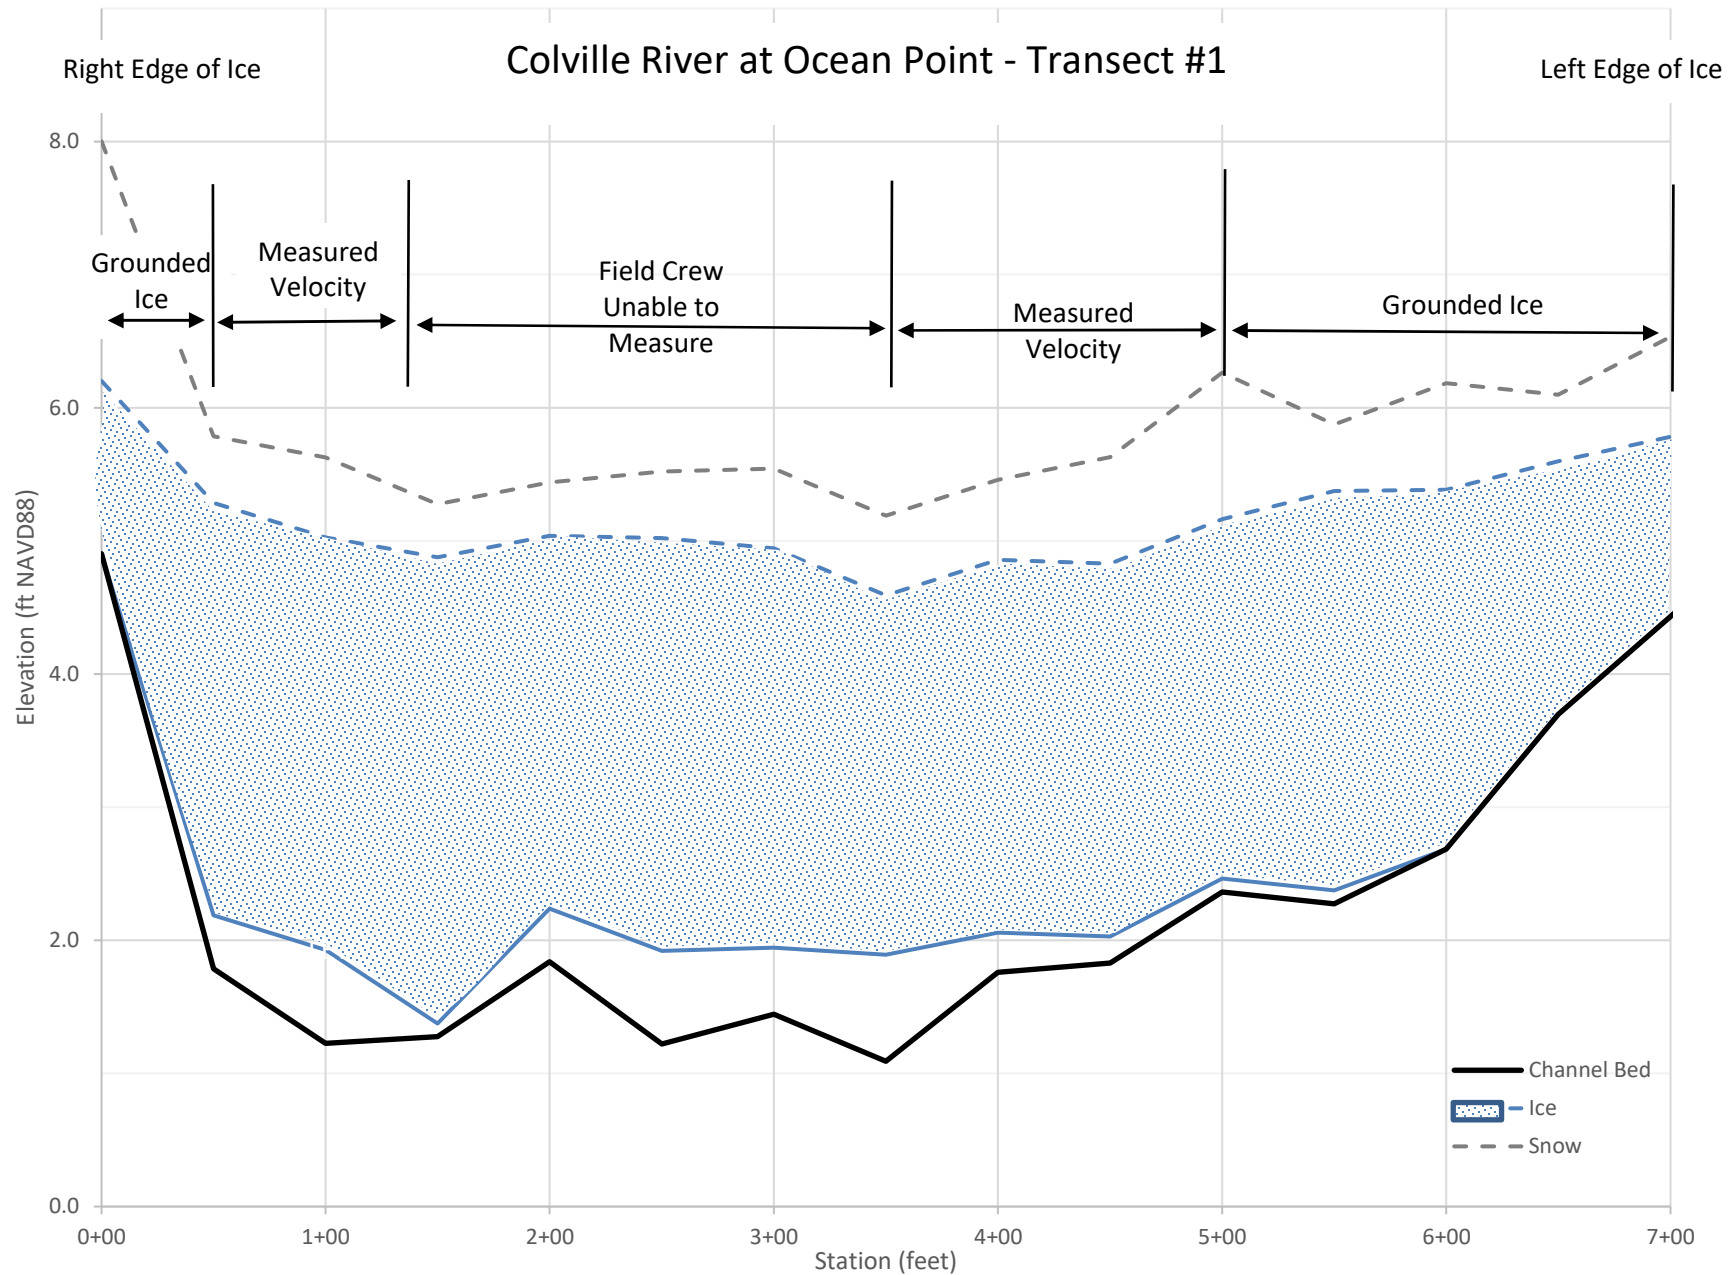
Colville River at Ocean Point - Transect #1

5+00	2.8	2.7	Too shallow for the velocity meter.														
5+50	3.1	3.0	Too shallow for the velocity meter.														
6+00	2.7	2.7	grounded														
6+50	1.9	1.9	grounded														
7+00	0.8	0.8	grounded														
7+50	0.9	0.9	grounded														
Total Discharge:												9.8

The first field event occurred on February 16. ICE profiled the crossing and Michael Baker measured velocity through 4 holes before the velocity meter battery malfunctioned due to the cold temperatures. Two main flow paths were identified at the crossing: the main channel and the western path. Freeboard in the western path (Sta. 0+50 to 1+00) and the main channel were 1.0 foot and 0.0 feet, respectively. The western path was likely grounded out upstream and water in this channel is backwater from downstream where it connects to the main flow path. To estimate the discharge, the main flow path velocities were applied to the missing velocity measurements with the same general depth range. The estimated discharge was 9.8 cubic-feet-per-second (cfs). The crew collected in-situ water quality measurements at the deepest location.

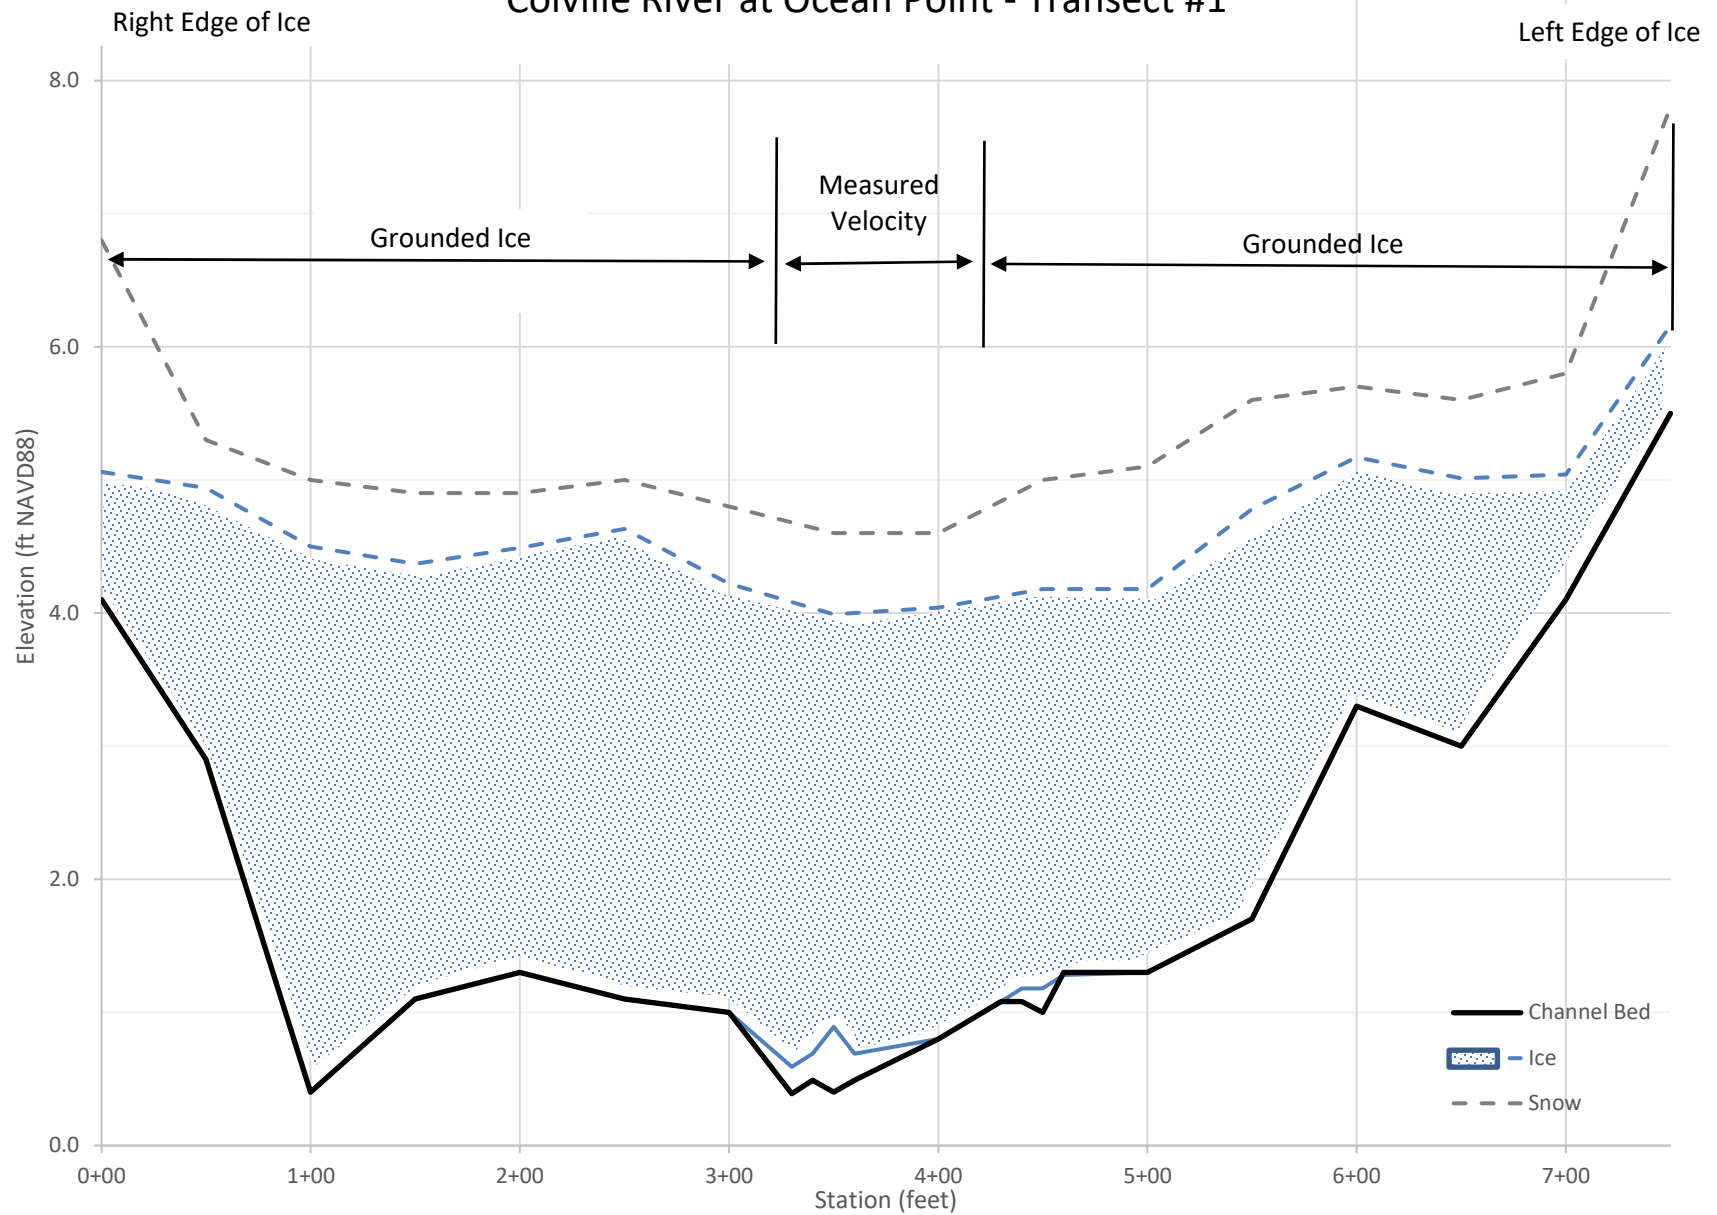
Colville River at Ocean Point - Transect #1

6+50	2.0	2.0											grounded
7+00	0.9	0.9											grounded
7+50	0.7	0.7											grounded
											Total Discharge:		0.04

The second trip occurred on March 3. The field crew collected discharge and water quality measurements at the crossing. This included under-ice cross-sectional bathymetric profiles, velocity, water depth, ice thickness, water surface elevation, site conditions related to overflow, and in-situ water quality. The channel ice was grounded in the middle of the channel creating 2 flow paths. The western flow path (3+30 to 3+60) was deep enough to collect flow measurements, but the eastern path (4+40 to 4+50) was too shallow for the velocity meter to fit under the ice. Discharge was measured at 0.04 cfs.

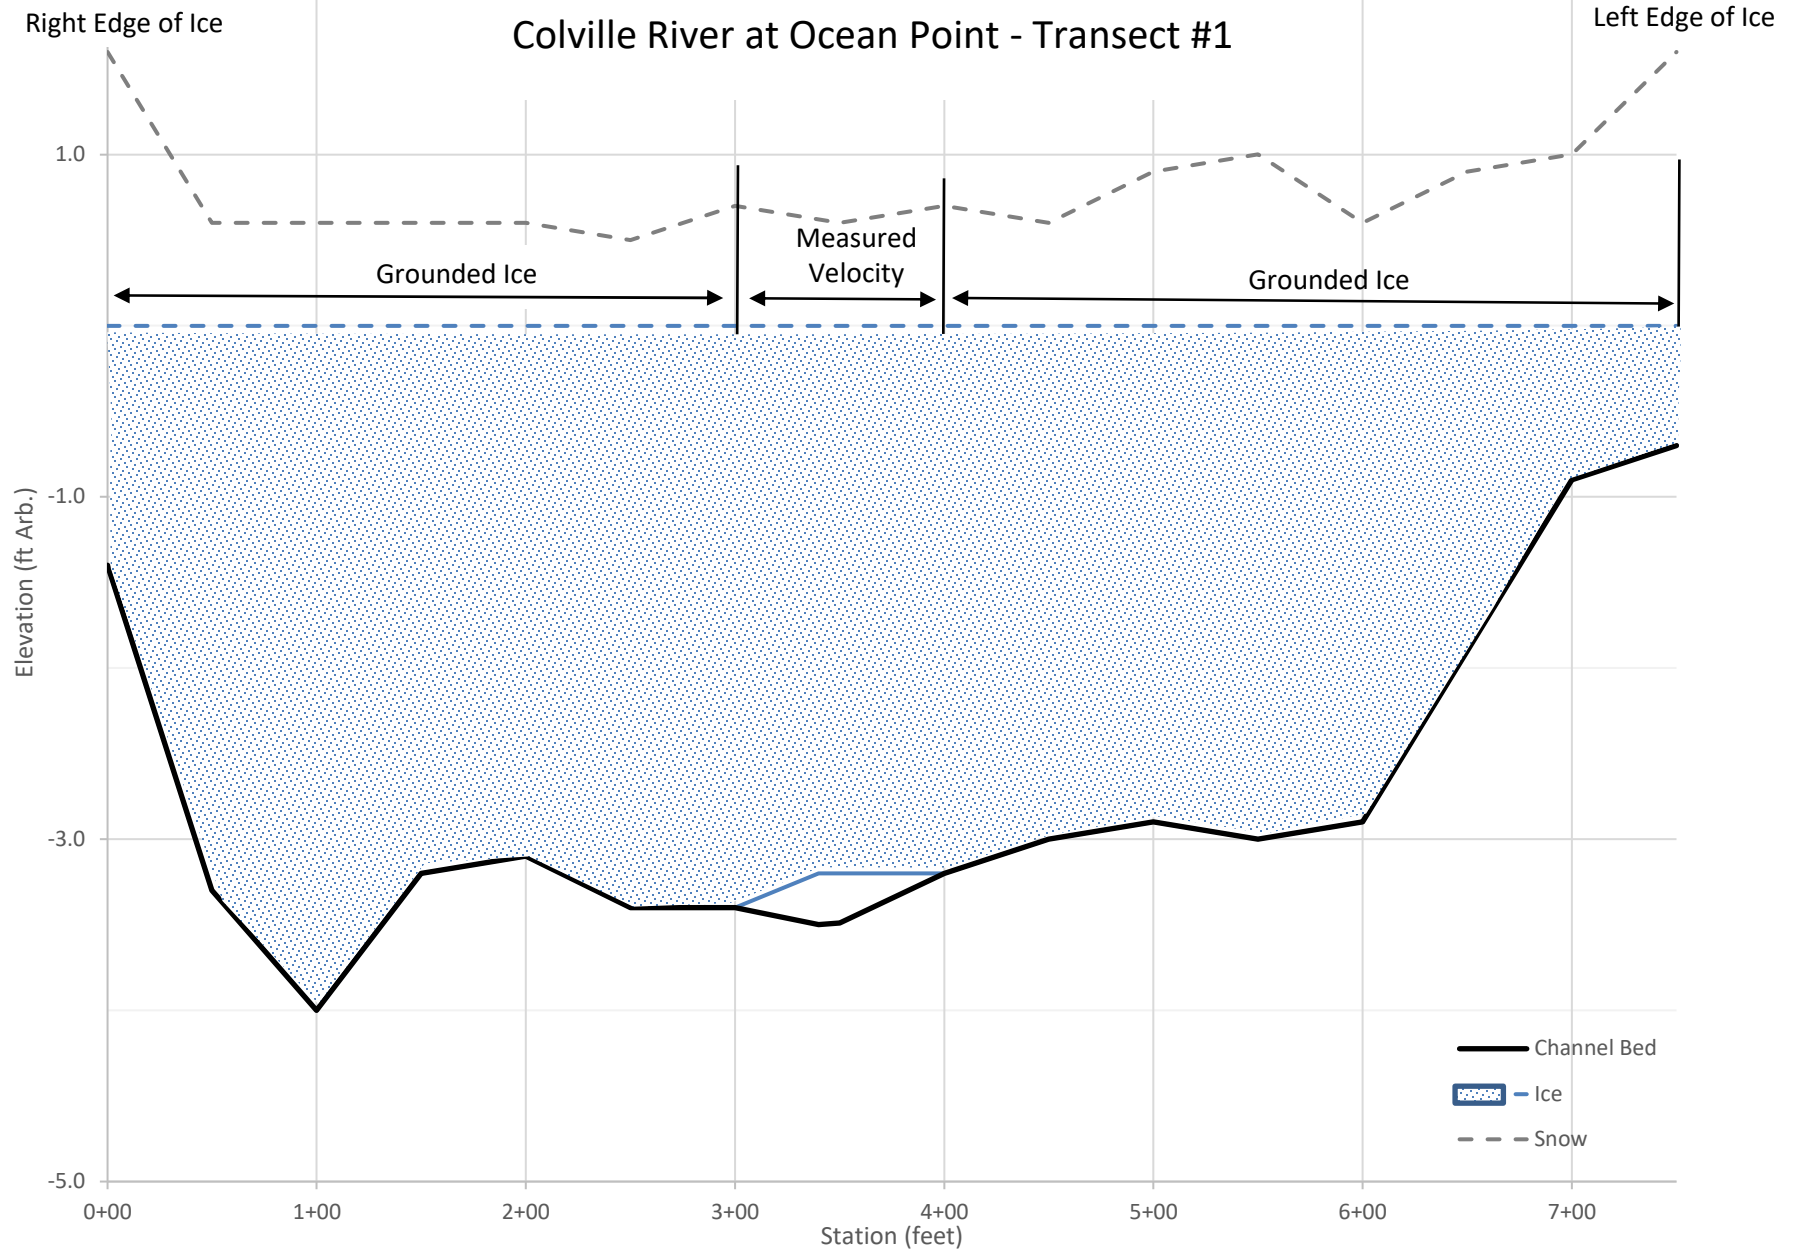
Colville River at Ocean Point - Transect #1

6+00	2.9	2.9						grounded					
6+50	1.9	1.9						grounded					
7+00	0.9	0.9						grounded					
7+50	0.7	0.7						grounded					
											Total Discharge:		0.20

The third trip occurred on March 15. The field crew collected discharge and water quality measurements at the crossing. This included under-ice cross-sectional bathymetric profiles, velocity, water depth, ice thickness, water surface elevation, site conditions related to overflow, and in-situ water quality. The eastern flow path had frozen in and the western flow path was flowing water. Velocities had increased slightly from the previous trip. Discharge was measured at 0.20 cfs.

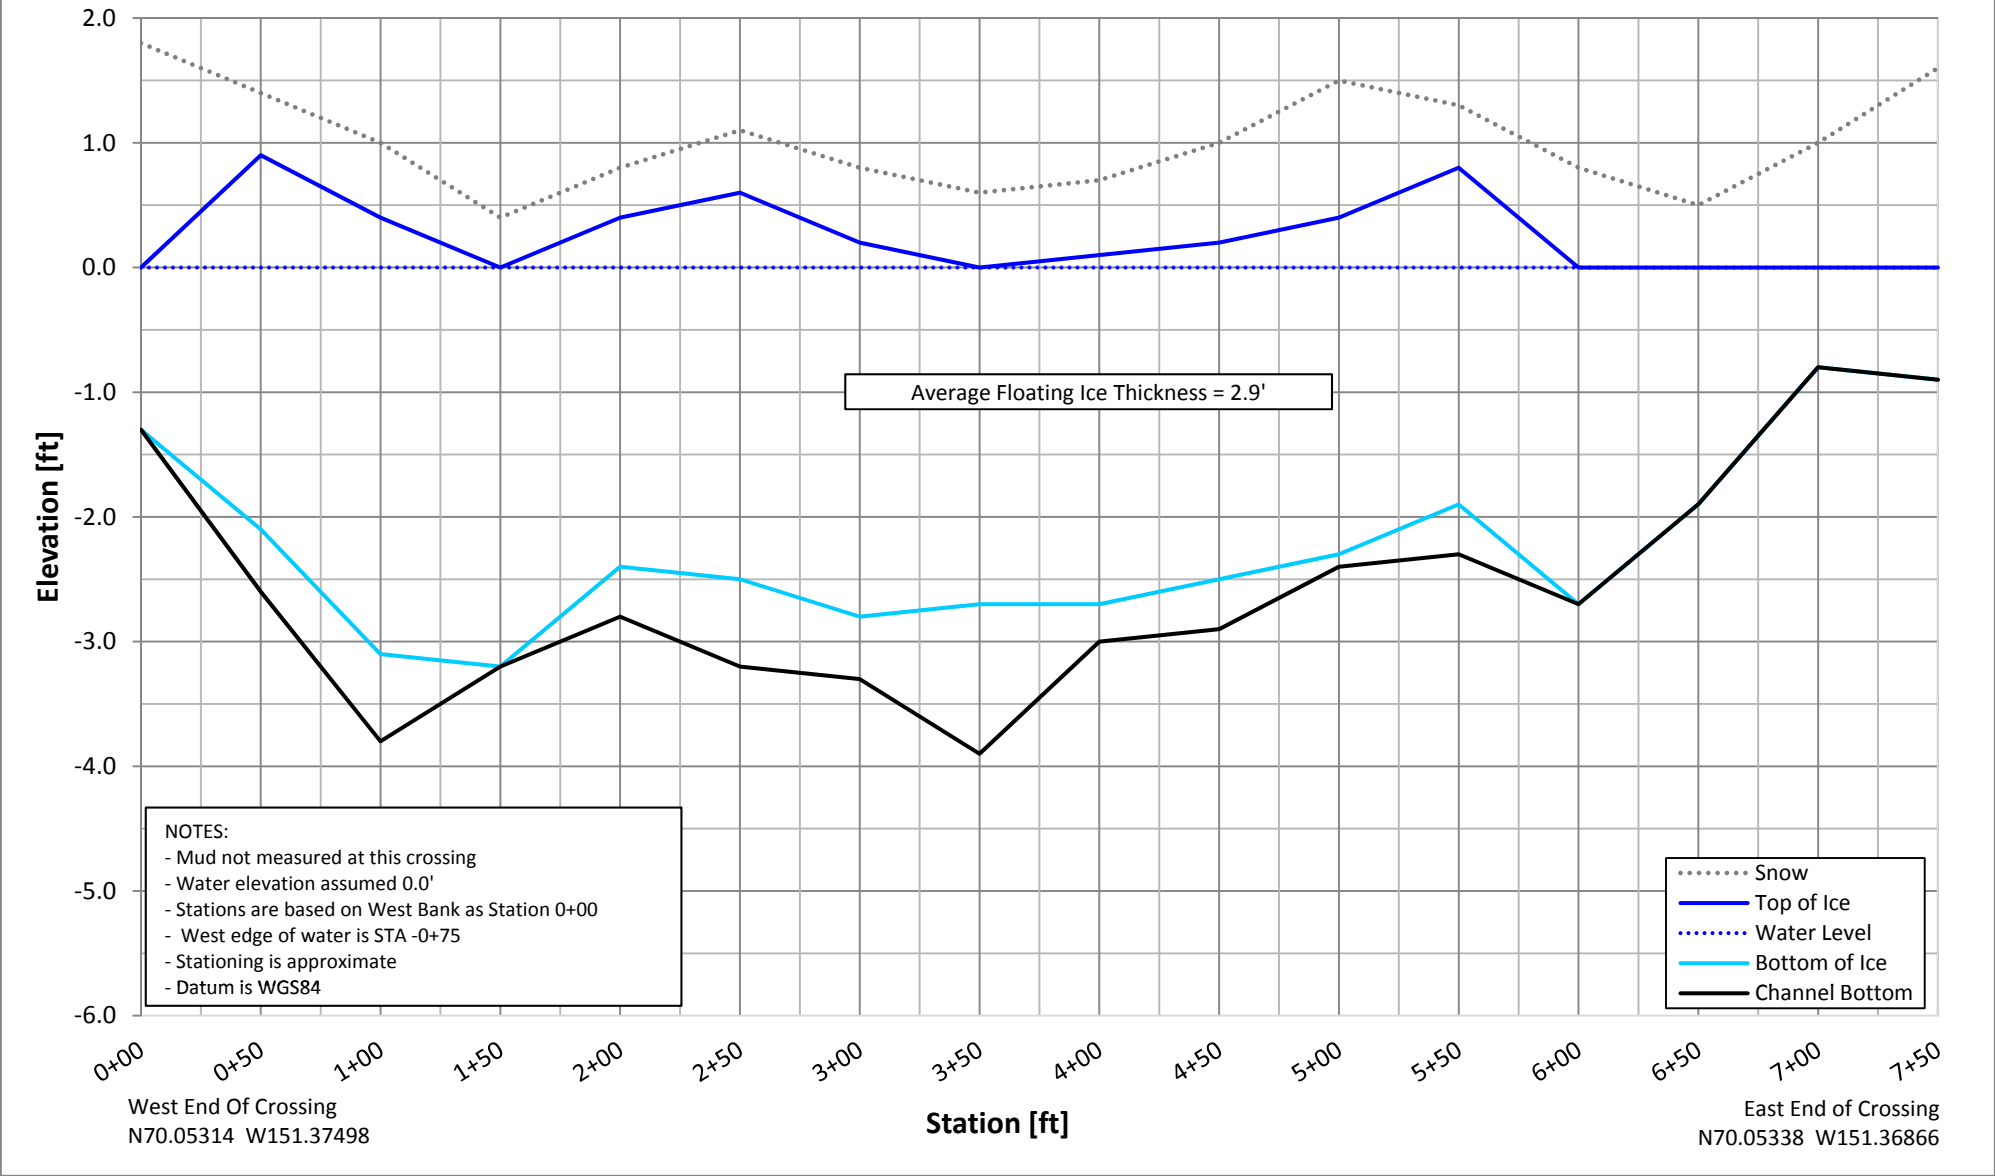
Ocean Point Crossing Profile

February 16, 2022

Previously submitted ice cover season field data is provided in Attachment A including ICE profiles of the crossing for all six trips.

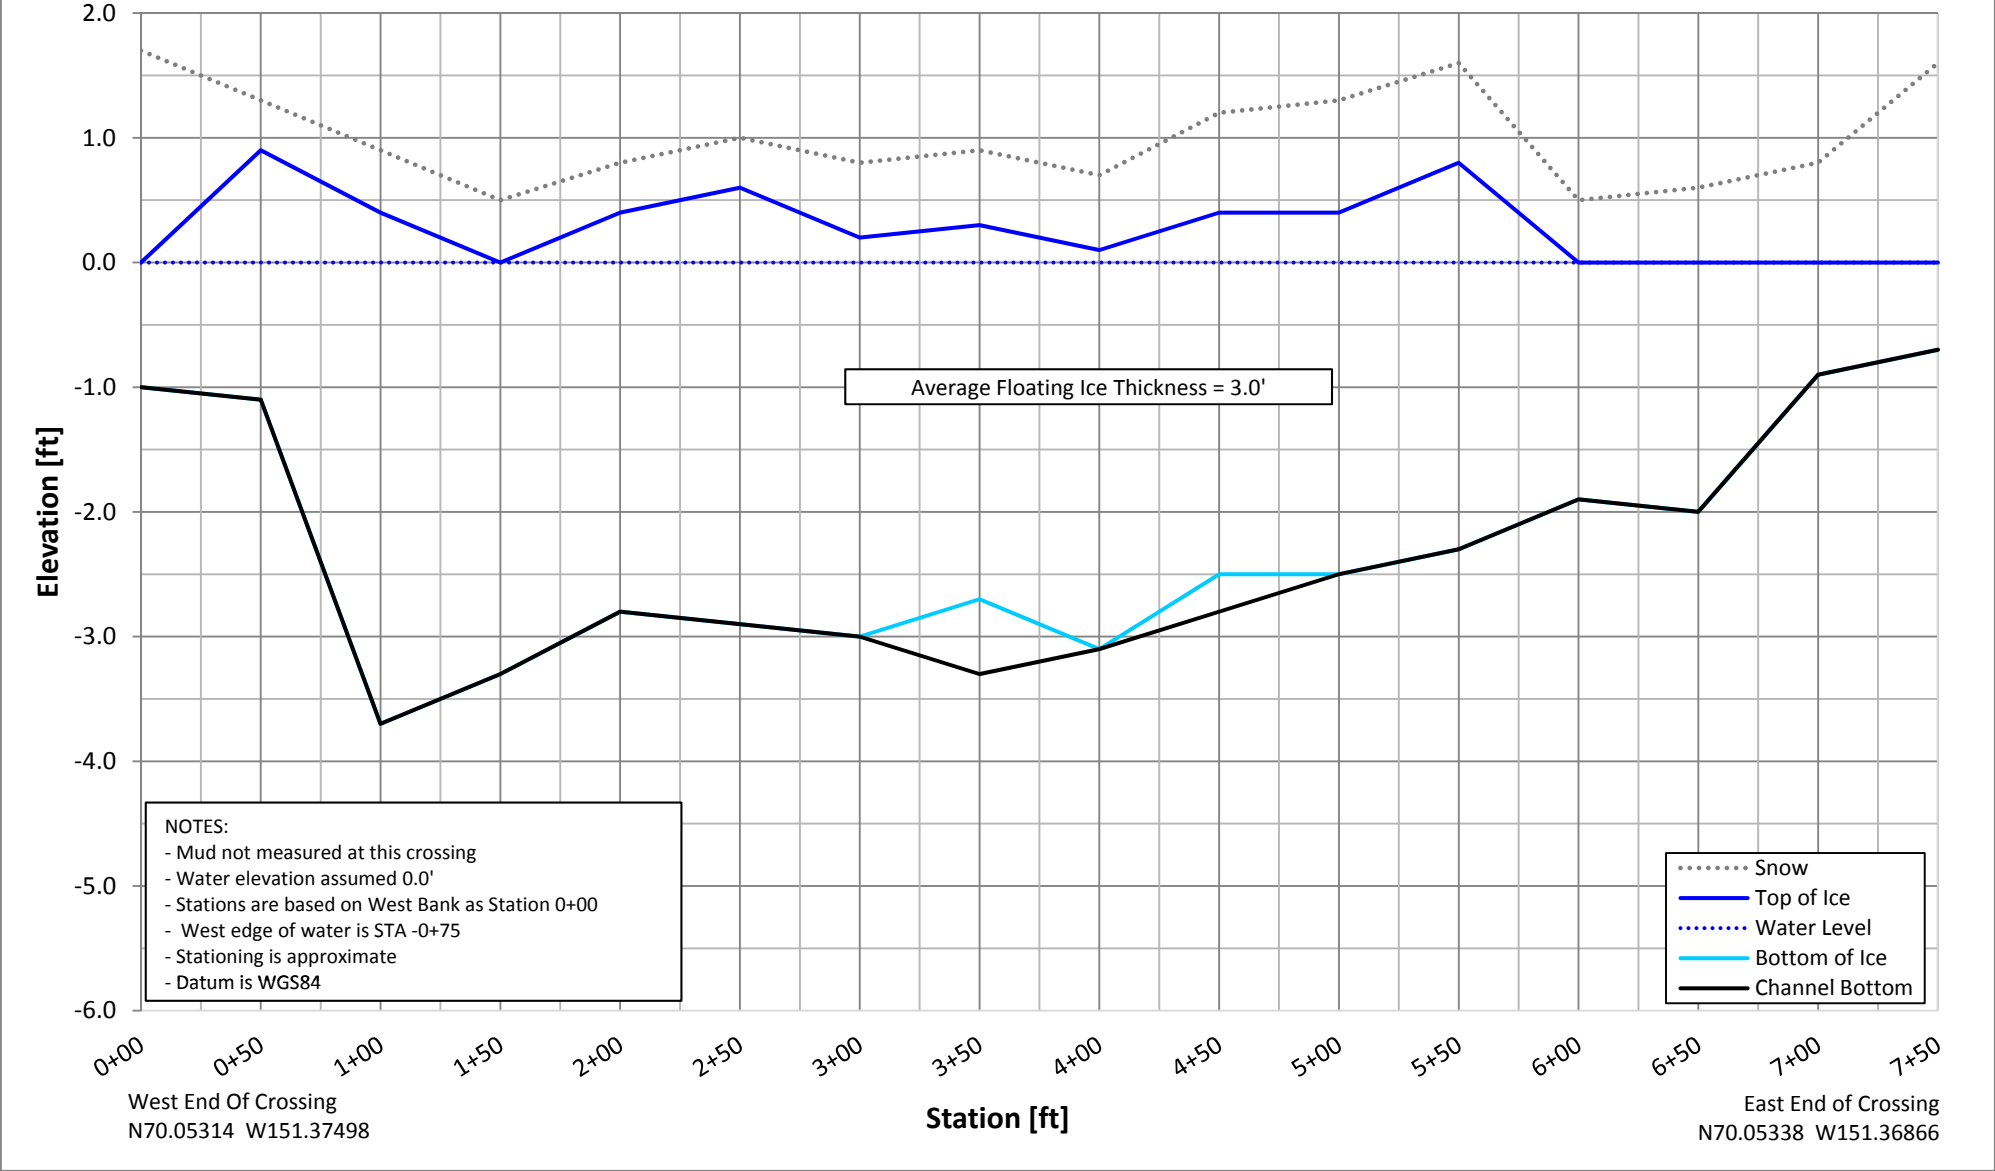
Ocean Point Crossing Profile

March 3, 2022

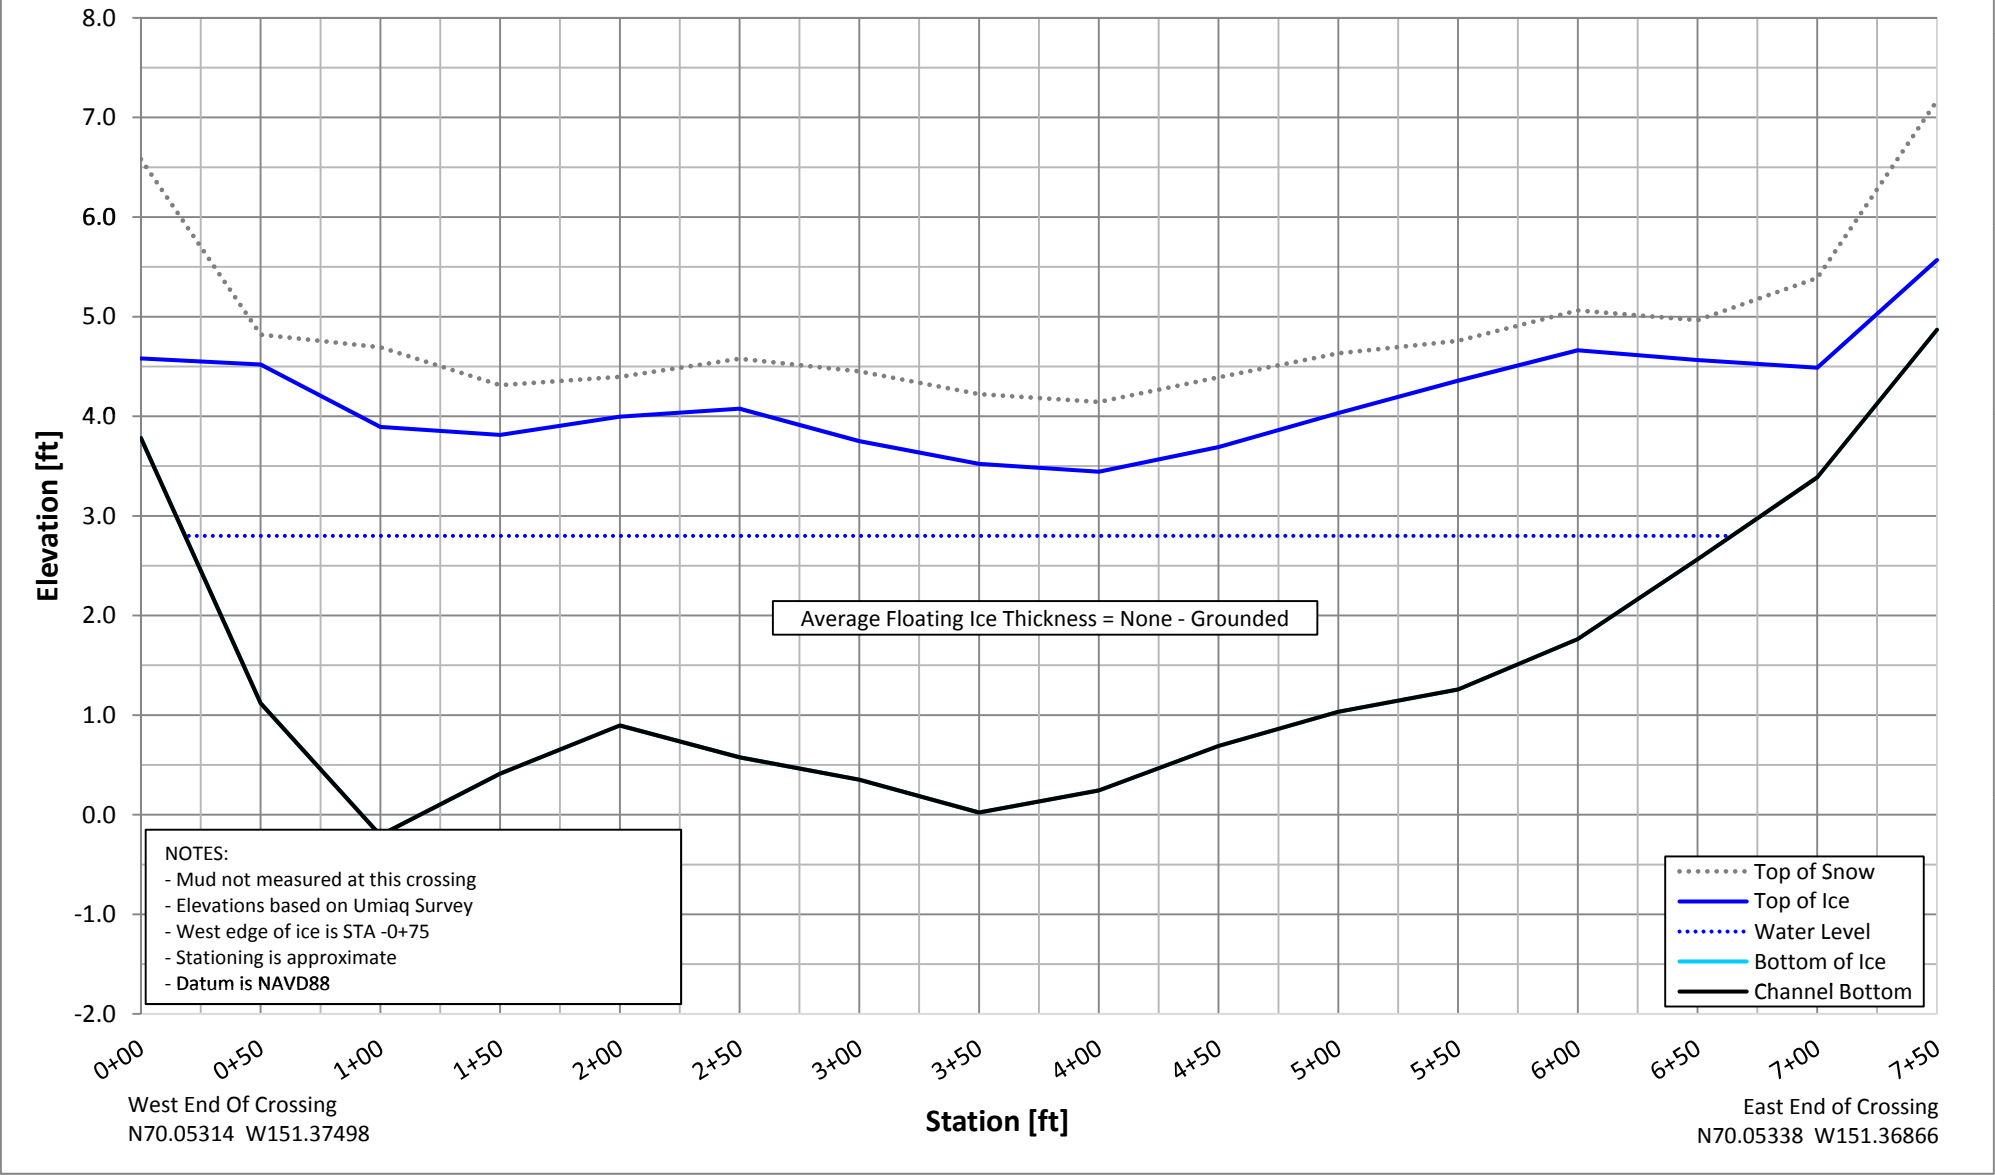
Ocean Point Crossing Profile

March 30, 2022

The last three trips occurred on March 30, April 12 and April 27. The channel ice was completely grounded, leaving no liquid water. A summary of Colville River discharges measured at Ocean Point are provided in Table 3.

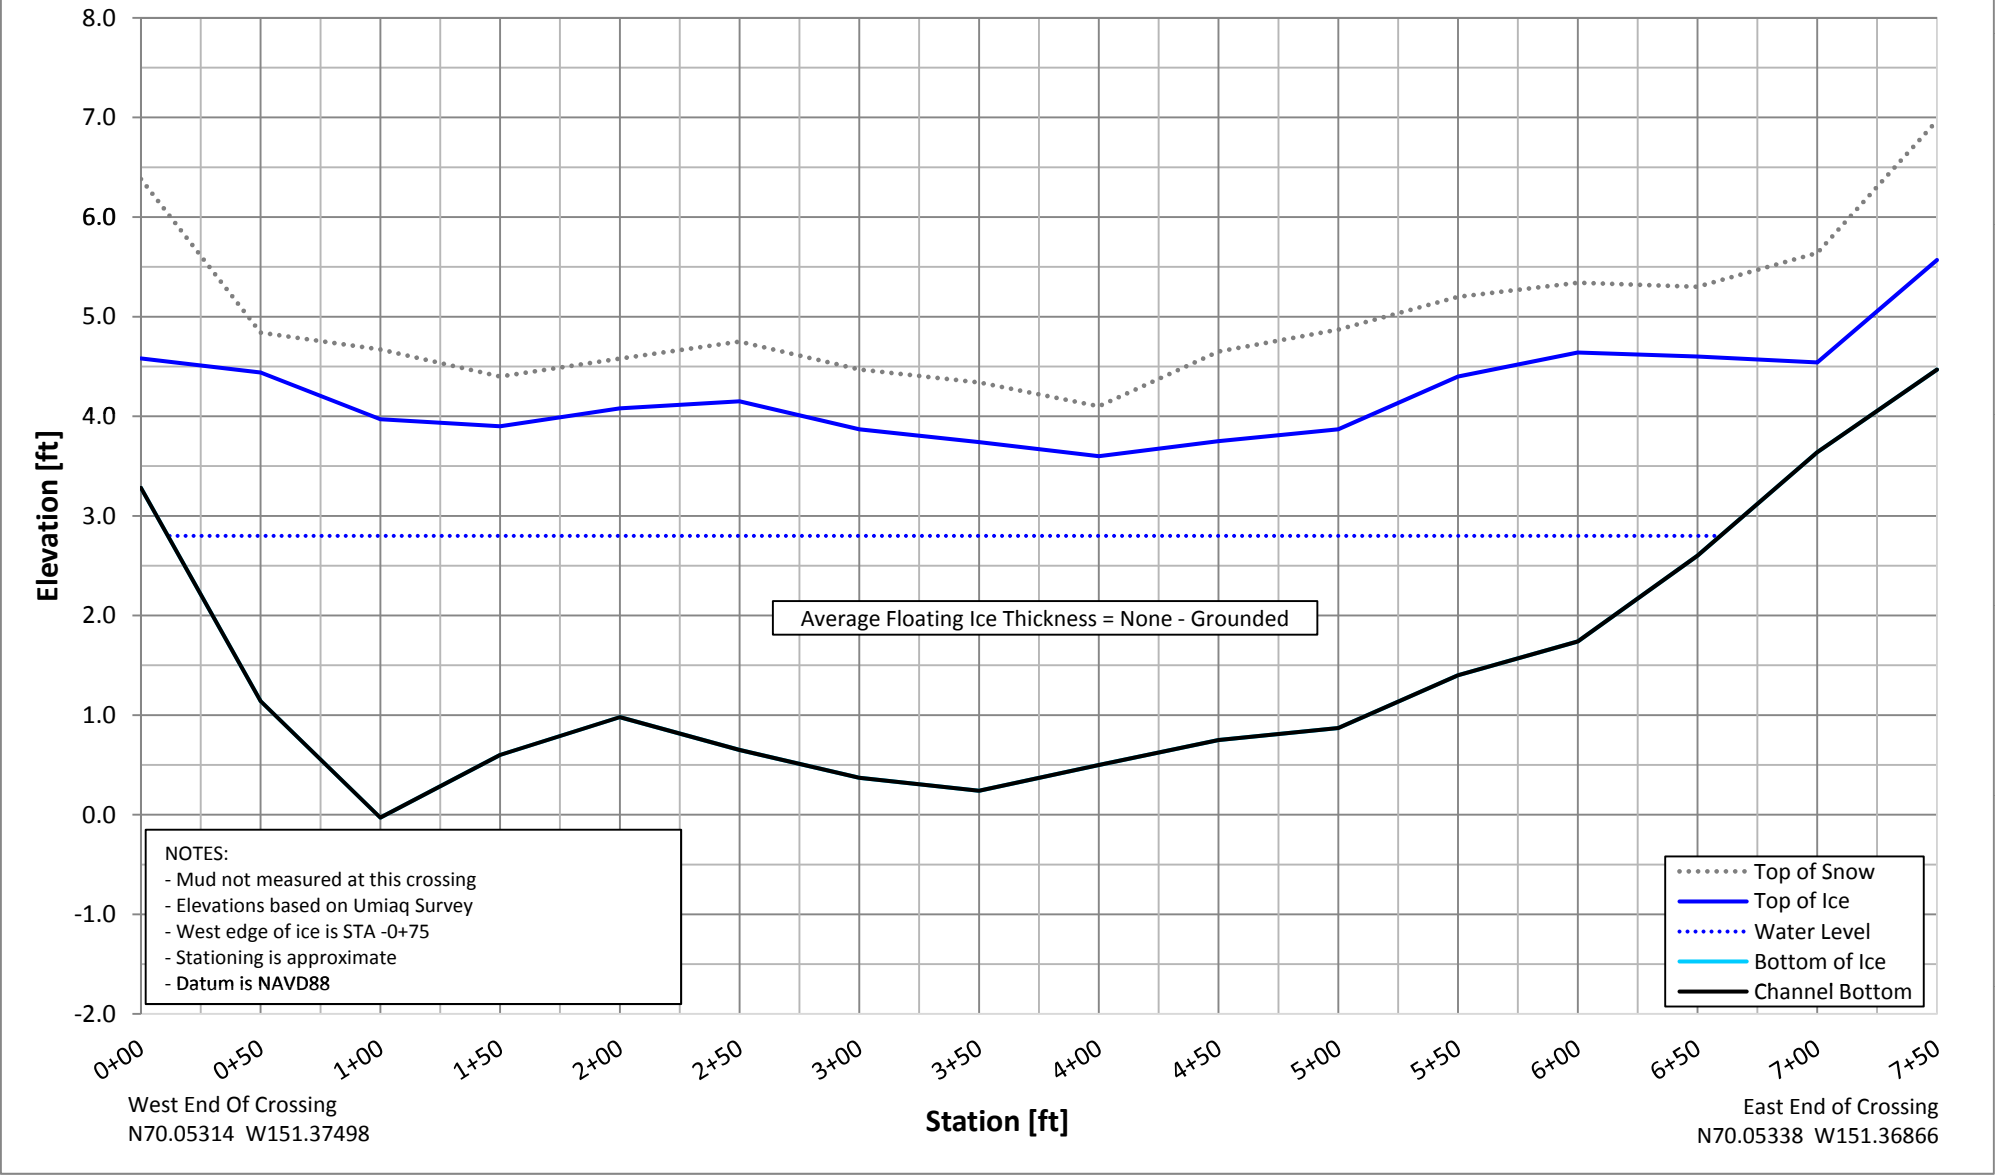
Ocean Point Crossing Profile

April 12, 2022

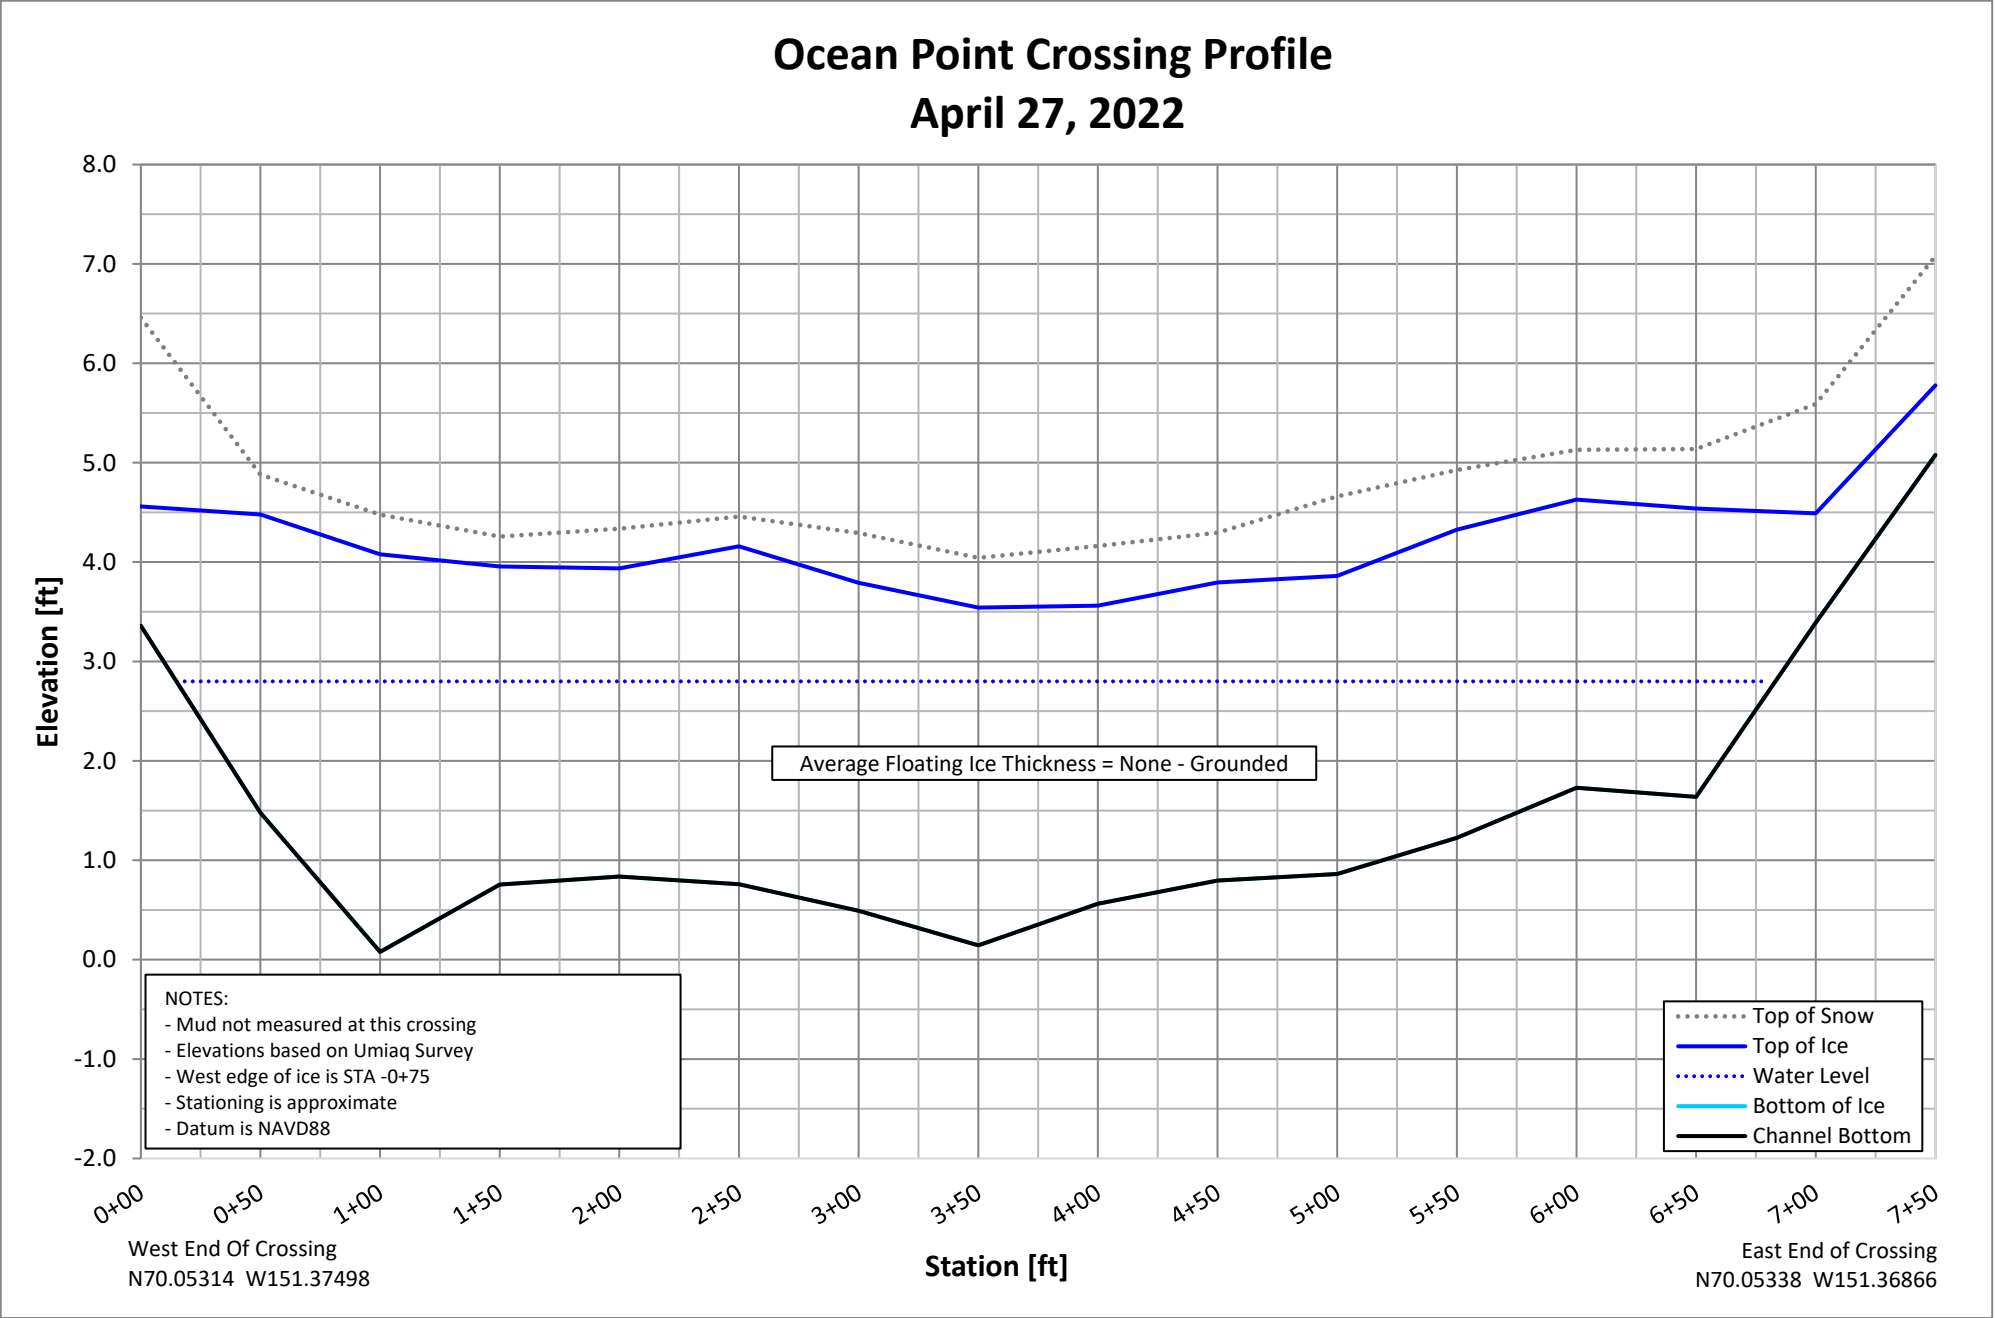
Ocean Point Crossing Profile

April 27, 2022
