CHUGACH REGIONAL ARCHEOLOGICAL REPOSITORY & HERITAGE CENTER

**Condition Assessment Report,
Seward Railroad Depot, Seward Alaska**

JUNE 27, 1997

**SEWARD RAILROAD
DEPOT RENOVATION**

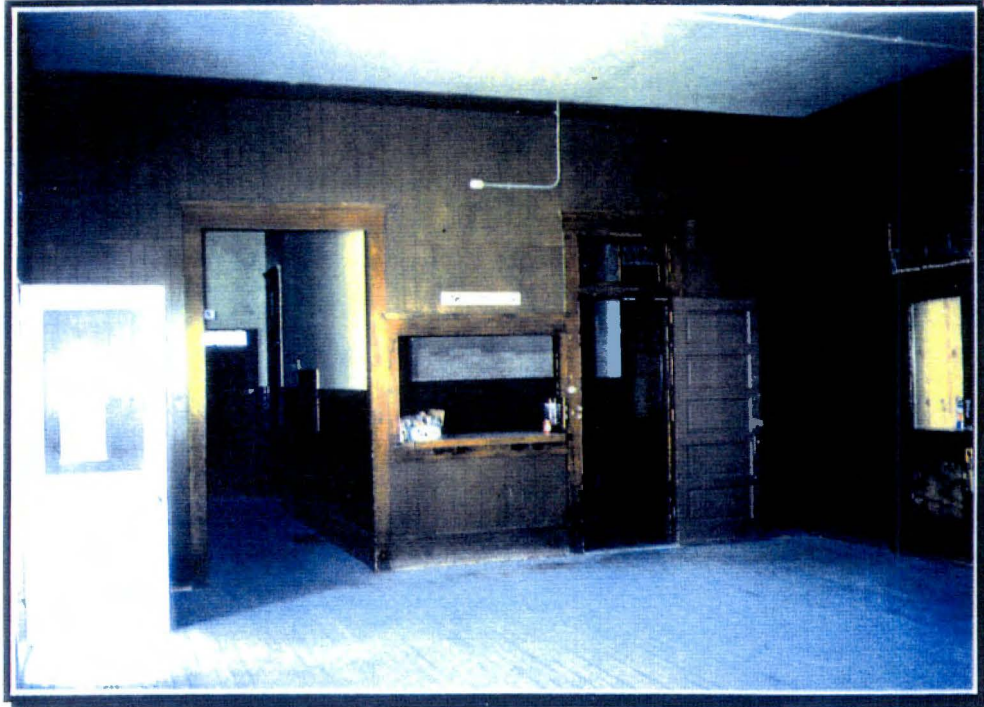
Interior view of waiting room and office area
