# **SUSITNA HYDROELECTRIC PROJECT**

**1982 SUPPLEMENT**

**THE 1980-81 GEOTECHNICAL REPORT**

**DECEMBER 1982**

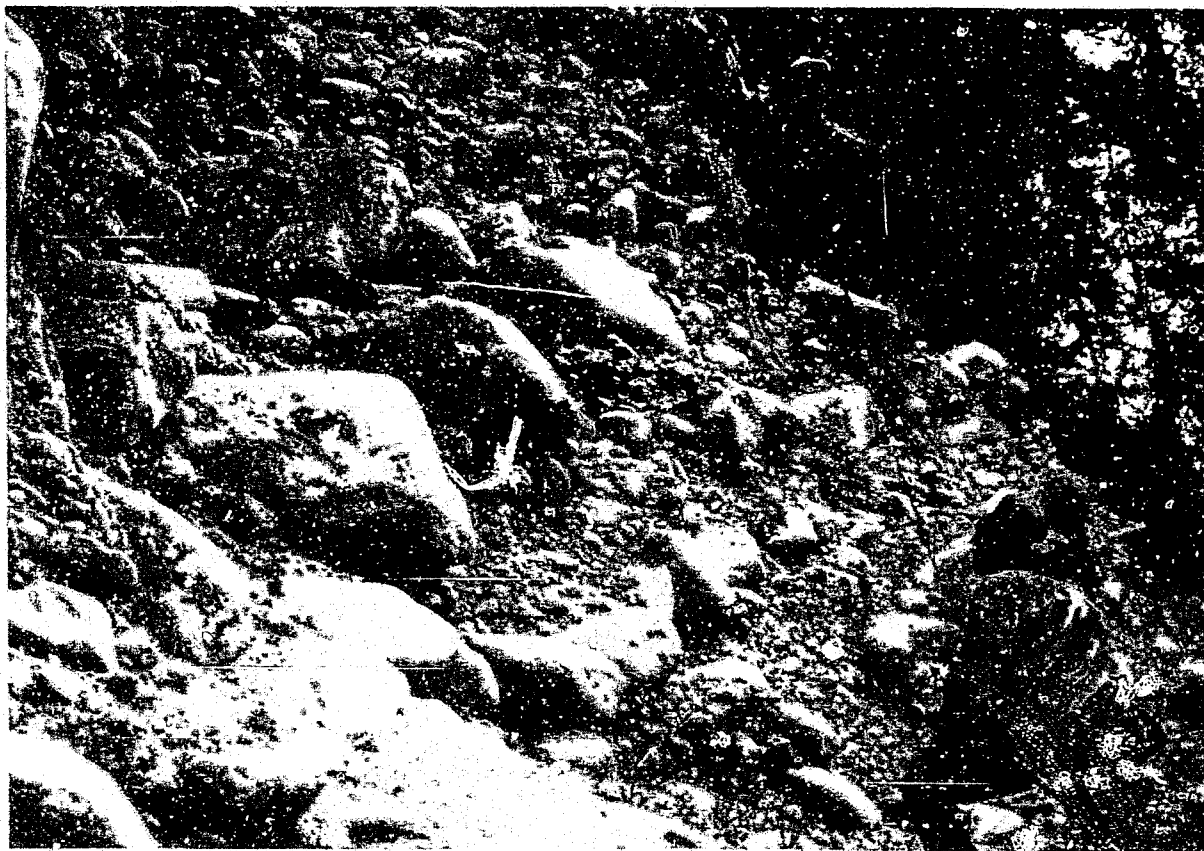
FIGURE 6.5

UNIT F

UNIT G'

WATANA RELICT CHANNEL/BORROW SITE D  
TYPICAL MATERIAL PHOTOS  
SHEET 5 OF 7
