SUSITNA HYDROELECTRIC PROJECT

1980 - 81 GEOTECHNICAL REPORT

VOLUME 2
APPENDIX A-F
FINAL DRAFT

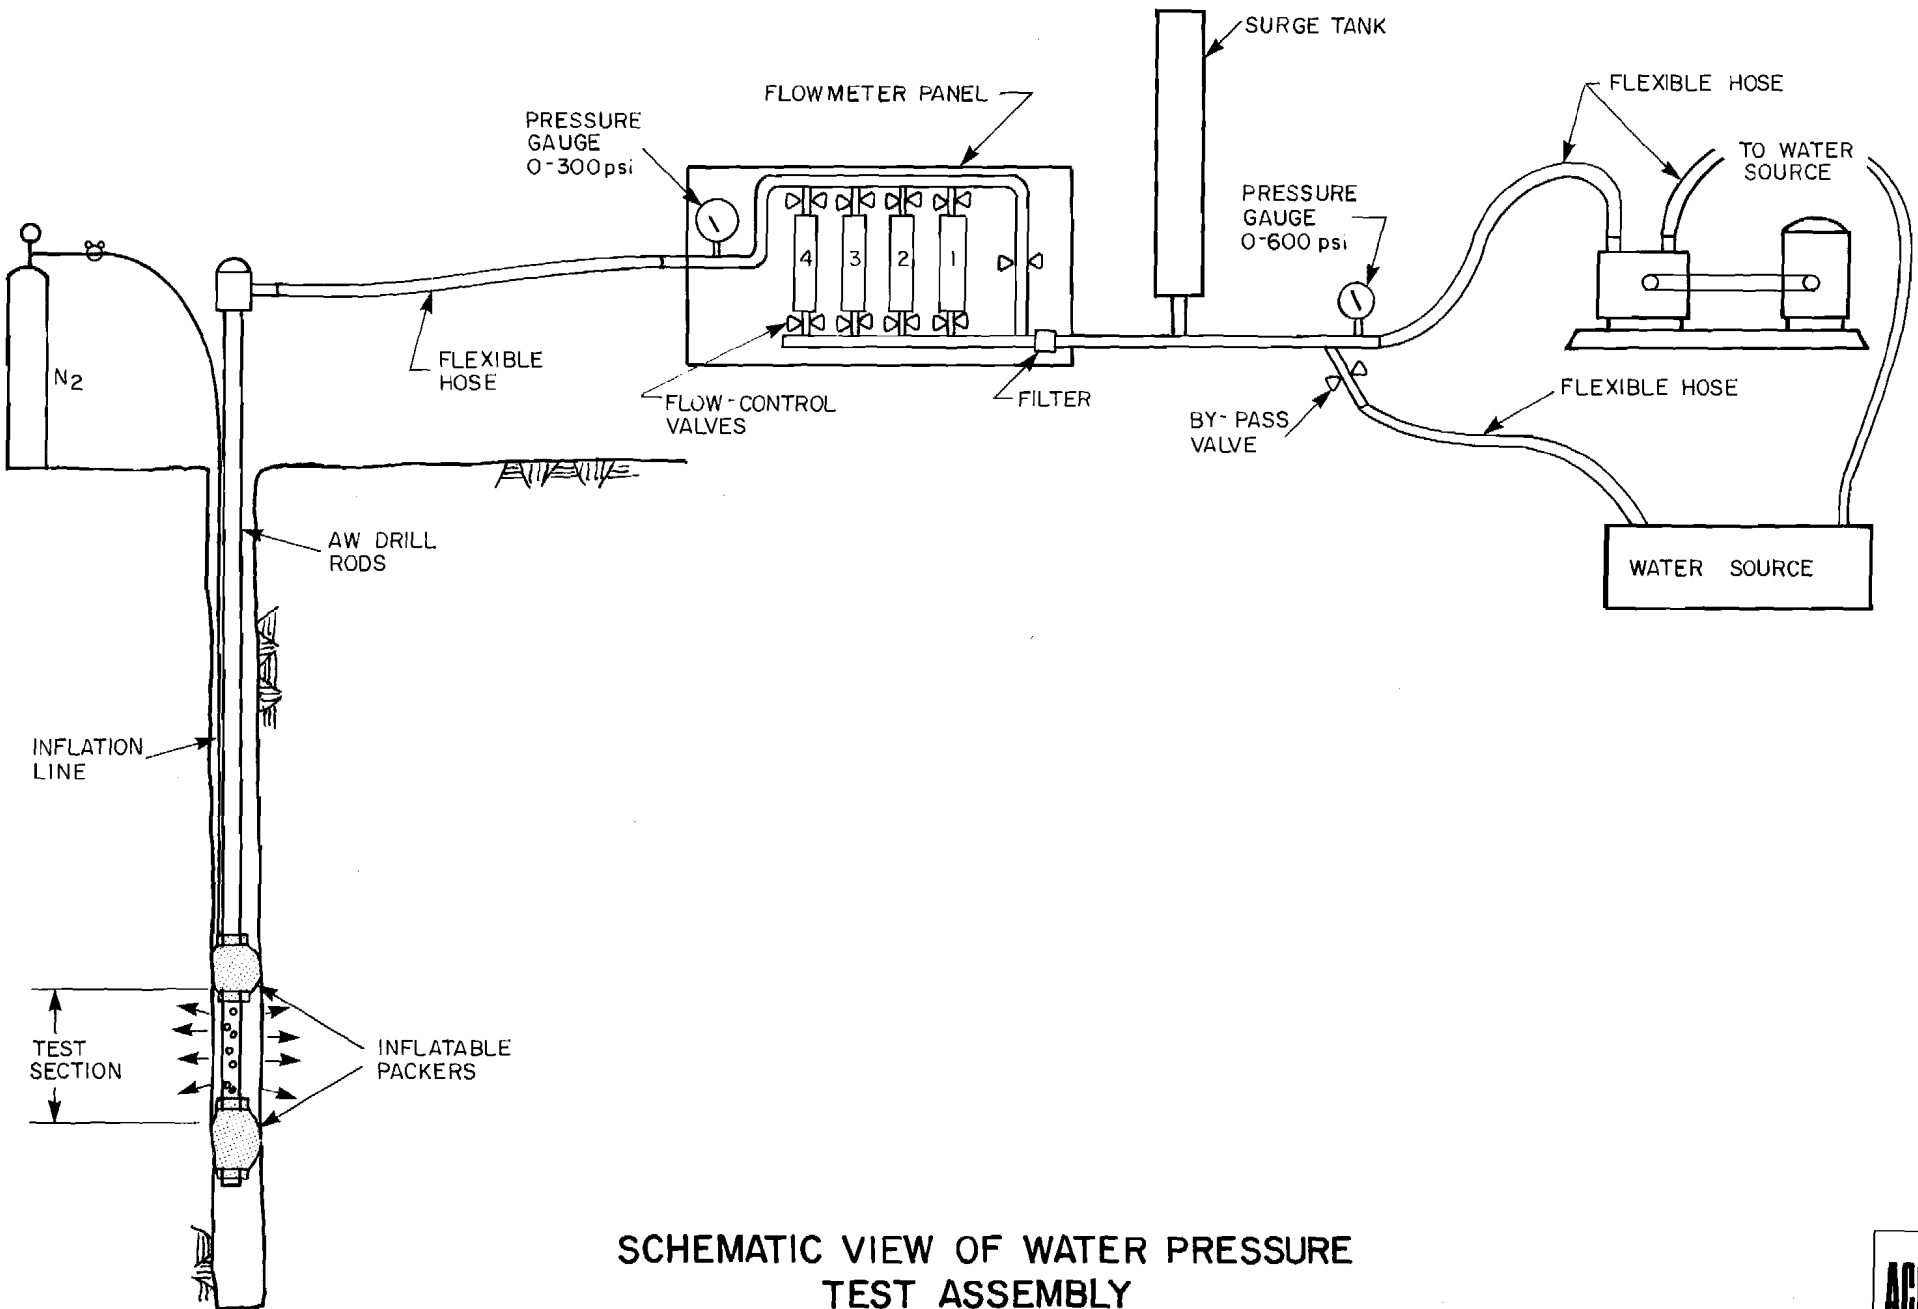
**SCHEMATIC VIEW OF WATER PRESSURE
TEST ASSEMBLY**

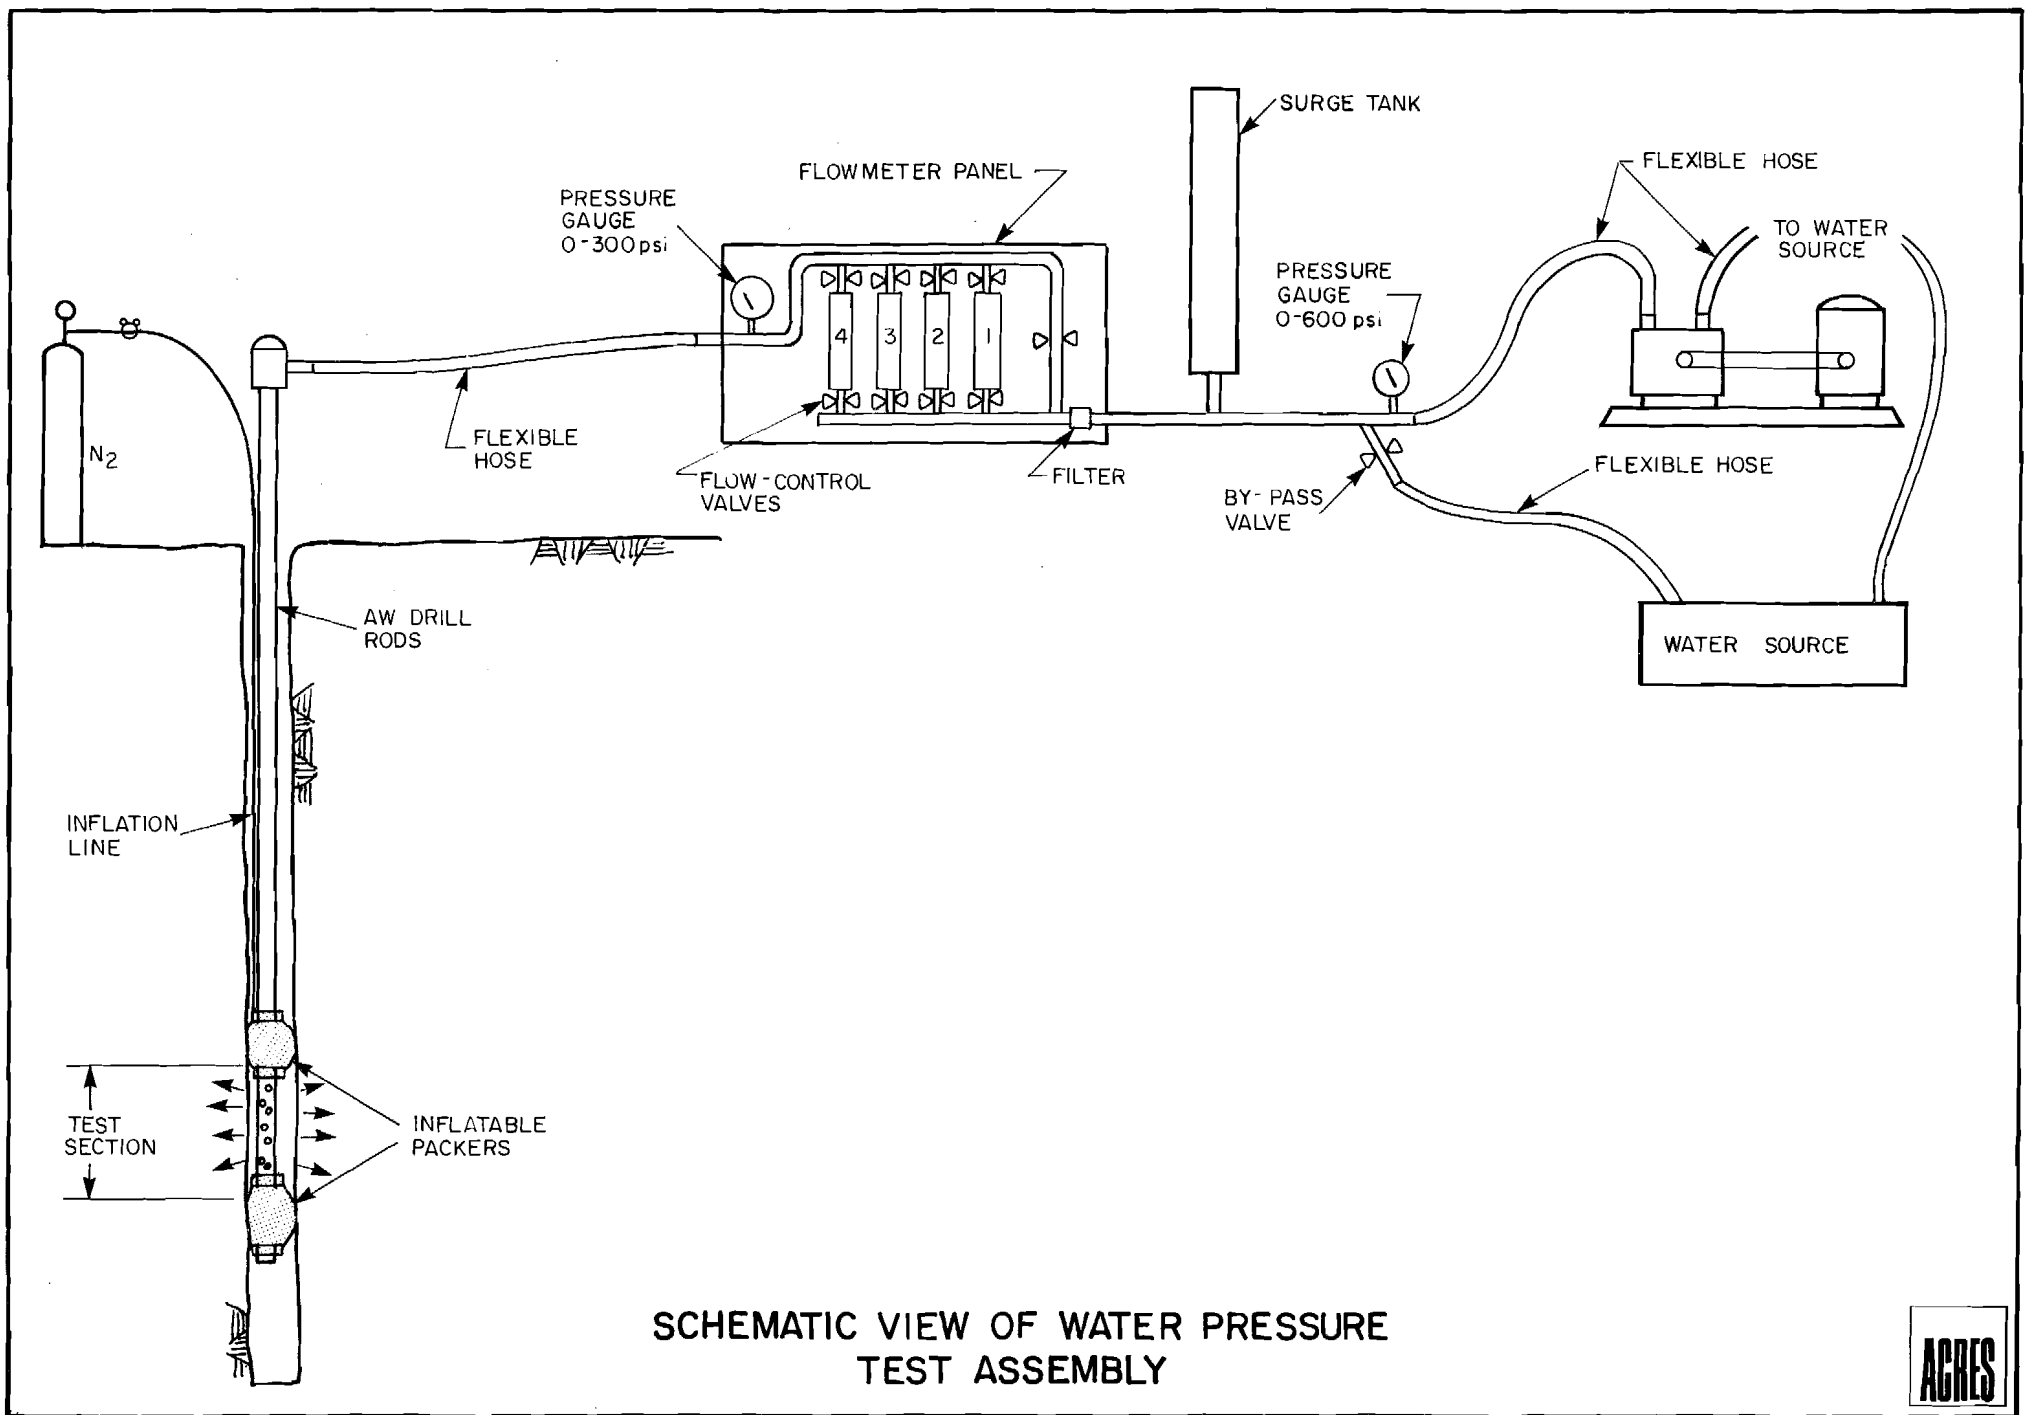
SCHEMATIC VIEW OF WATER PRESSURE TEST ASSEMBLY

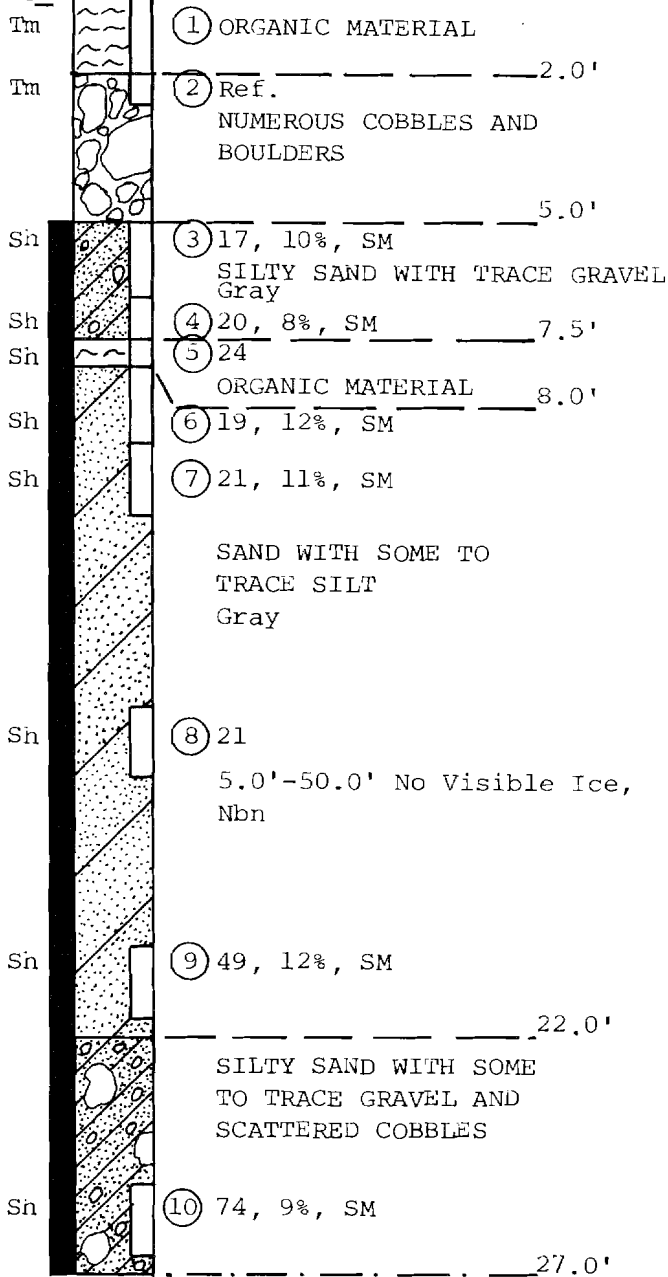
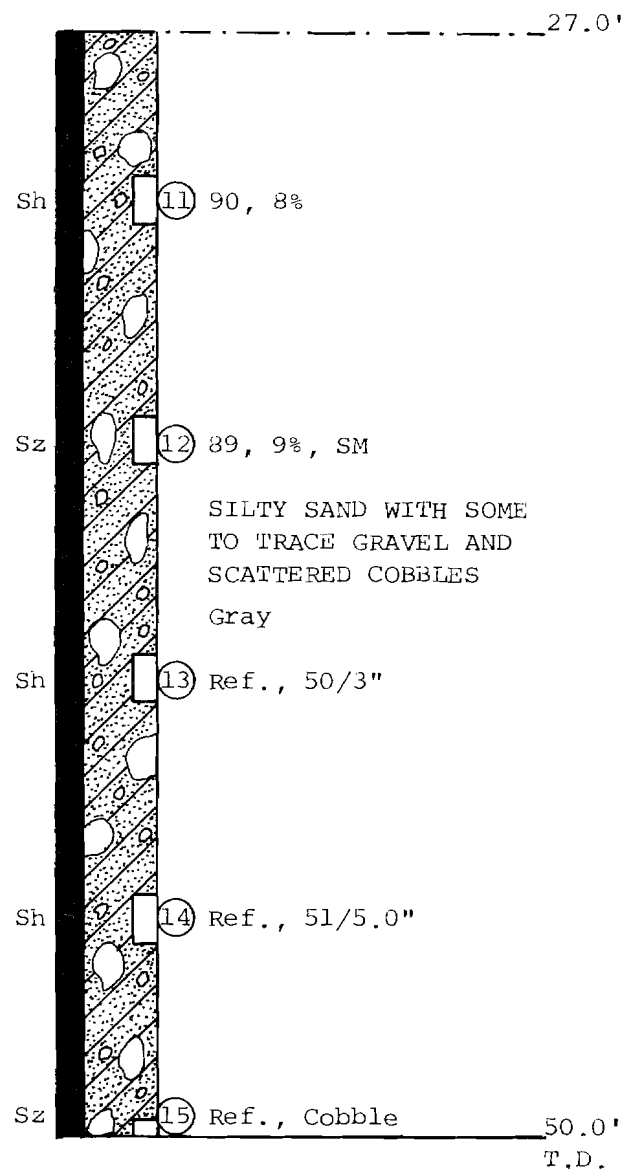
AH-D6
8-22-81 0.0' 0.0'

Thermal Probe Installed to 50.0'
Stand Pipe Piezometer Installed to 50.0'

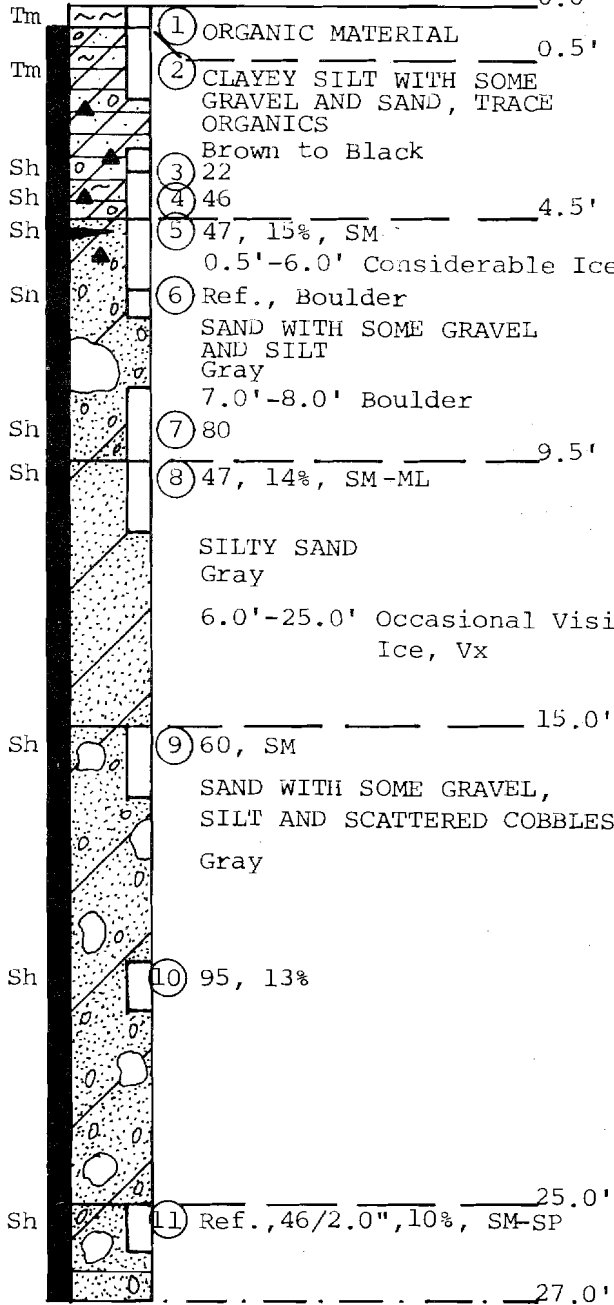
AH-D8 Elevation 2276.1'

Water Table Not Encountered. T.D. Thermal Probe Installed to 50.3'

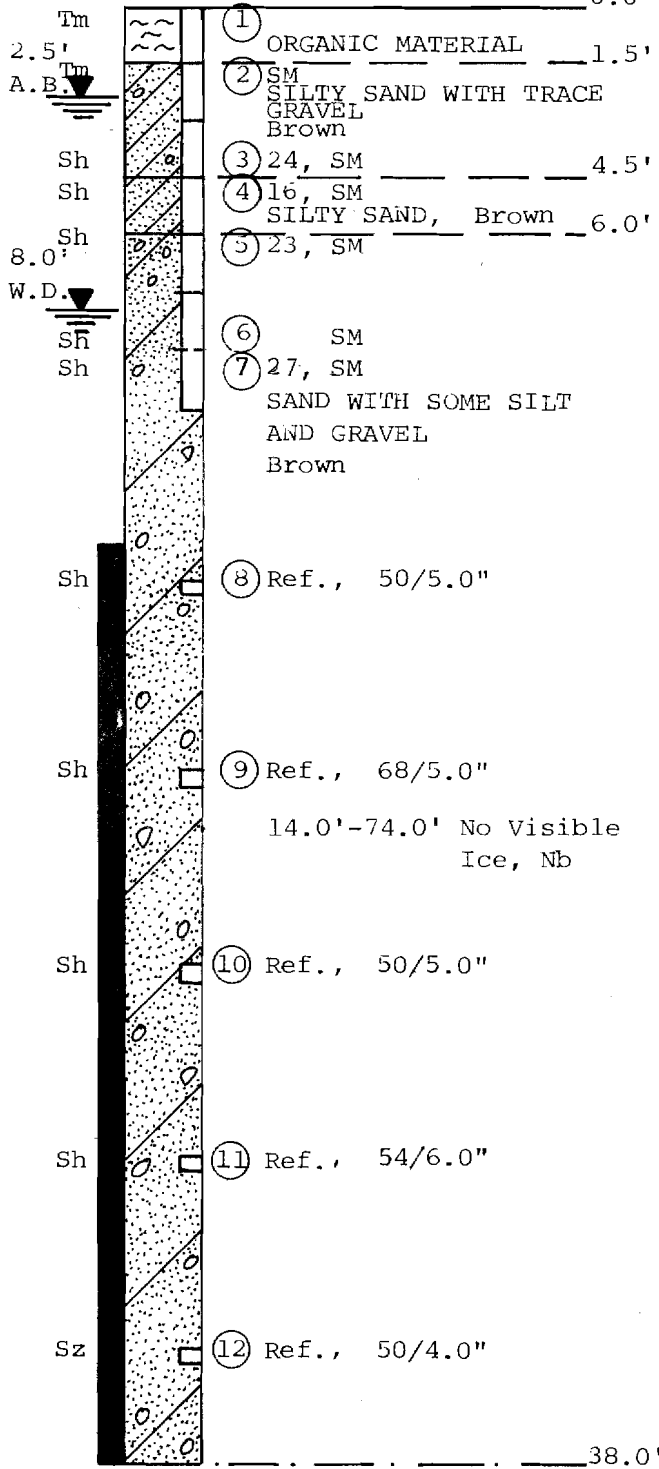
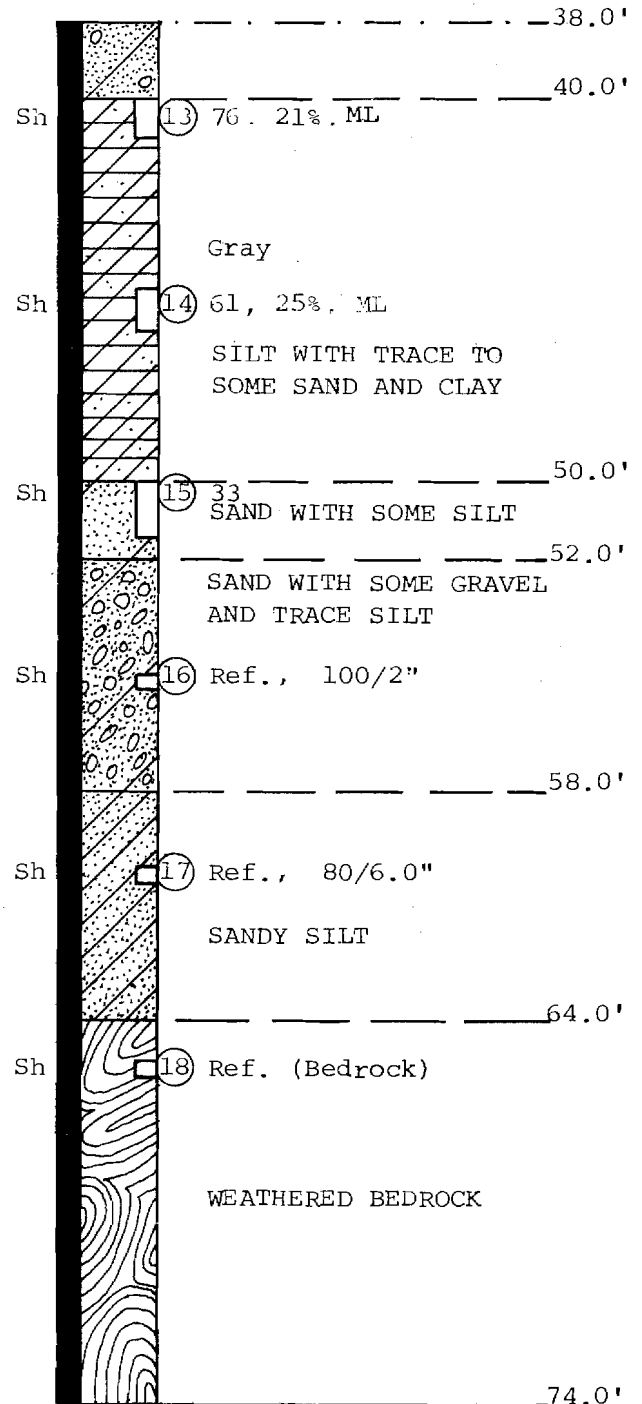
AH-D9
7-25-81

T.D.
 Thermal Probe Installed to 72.0'
 Stand Pipe Piezometer Installed to 66.0'

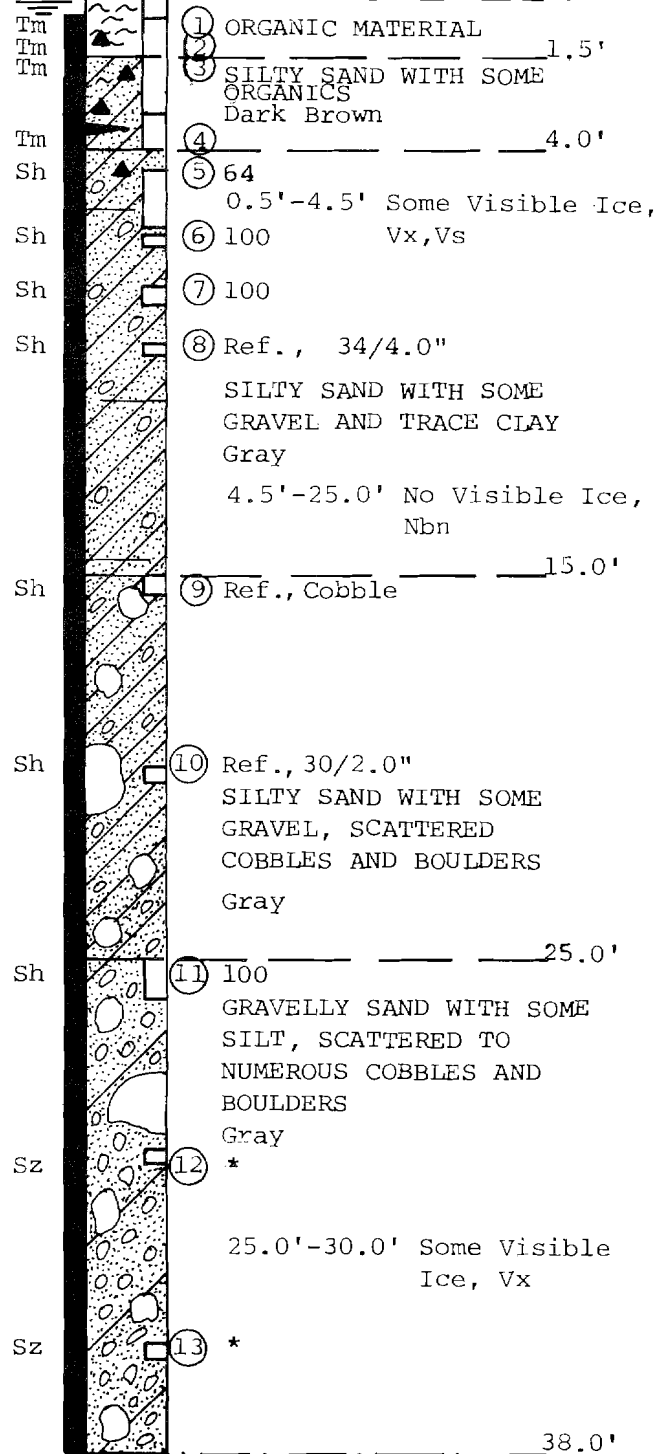
AH-D12

GRAVELLY SAND WITH SOME SILT, SCATTERED TO NUMEROUS COBBLES AND BOULDERS

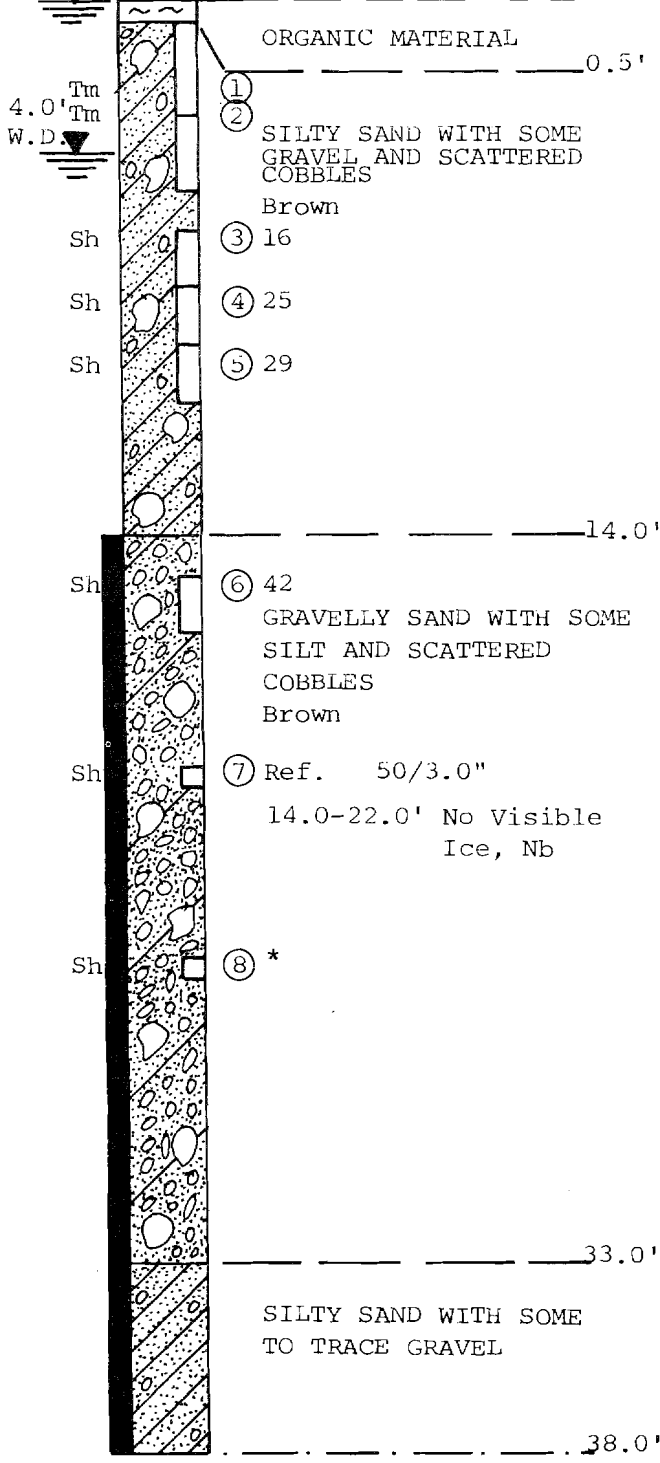
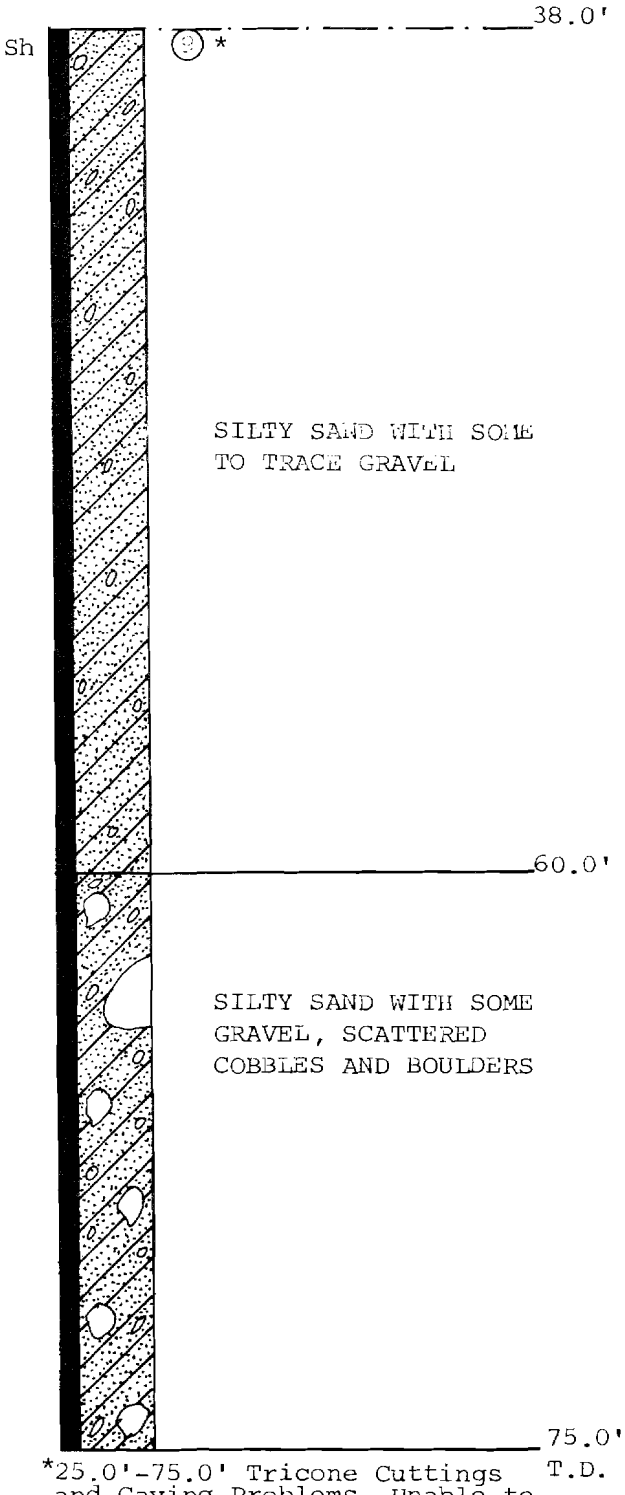
0.0' AH-D14 Elevation 2272.7'
 A.B. 8-27-81 0.0'

*25.0'-75.0' Tricone Cuttings T.D. and Caving Problems, Unable to Sample Undisturbed Material.
 Thermal Probe Installed to 31.0'
 Stand Pipe Piezometer Installed to 31.0'.

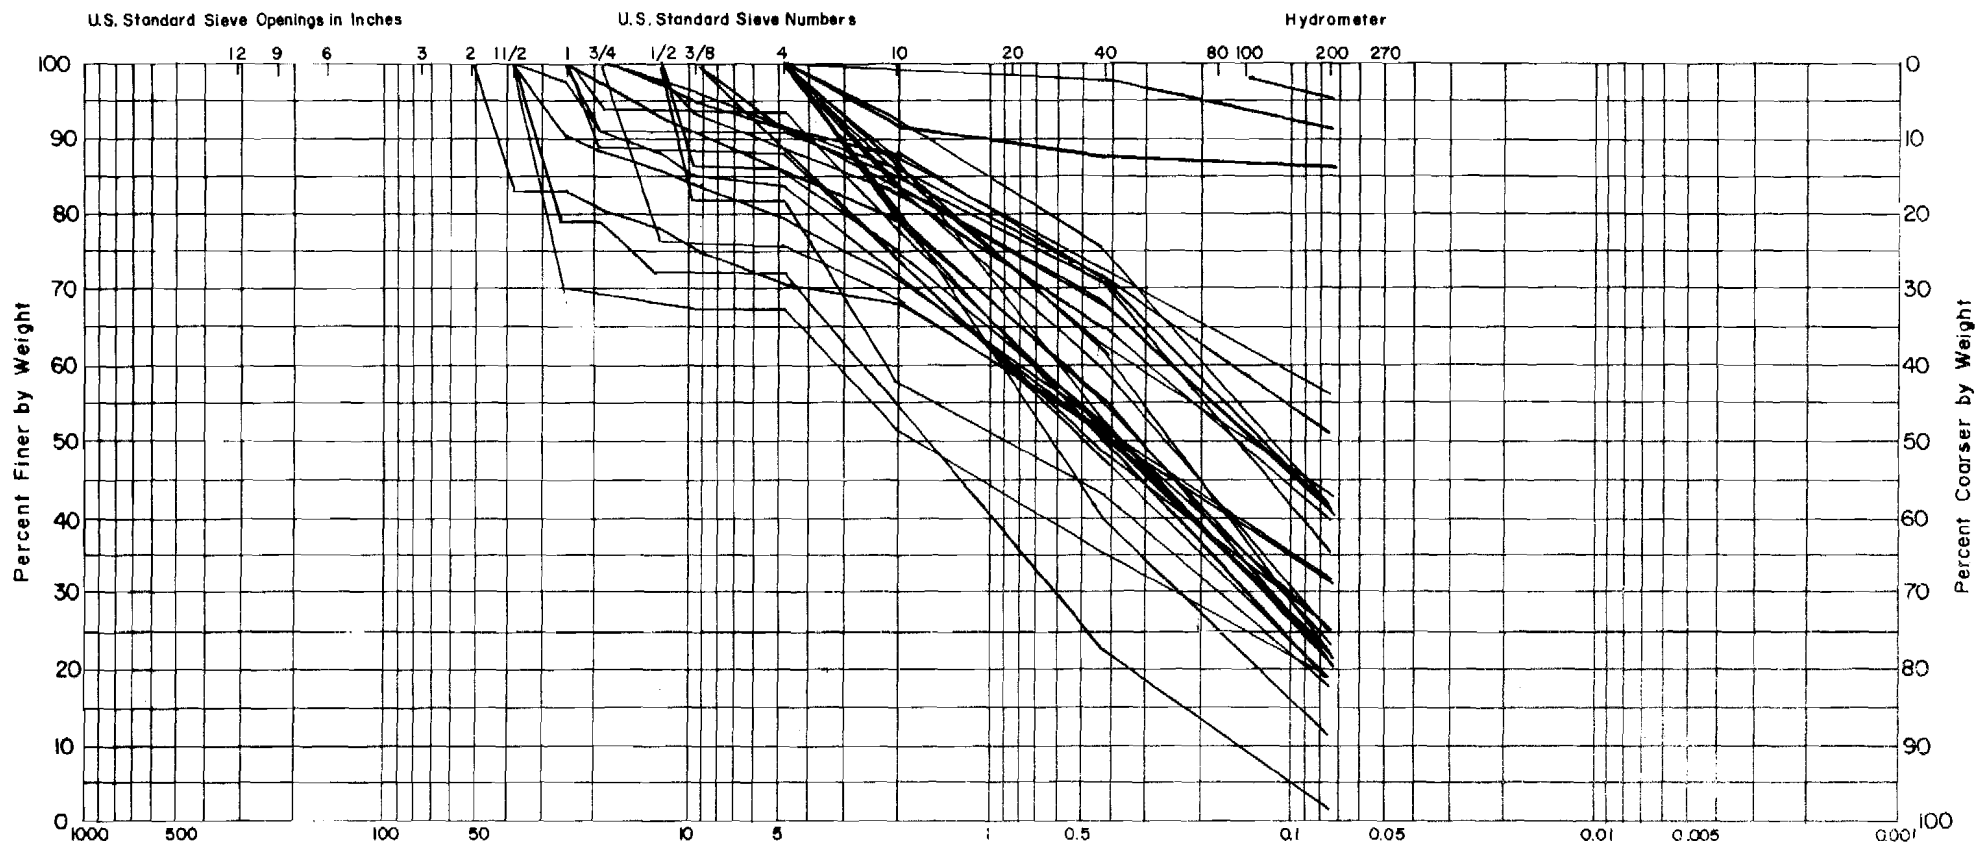
BOULDERS	COBBLES	GRAVEL		SAND			FINES	
		Coarse	Fine	Coarse	Medium	Fine	Silt Sizes	Clay Sizes

BORROW AREA D
COMPOSITE GRADATION CURVE

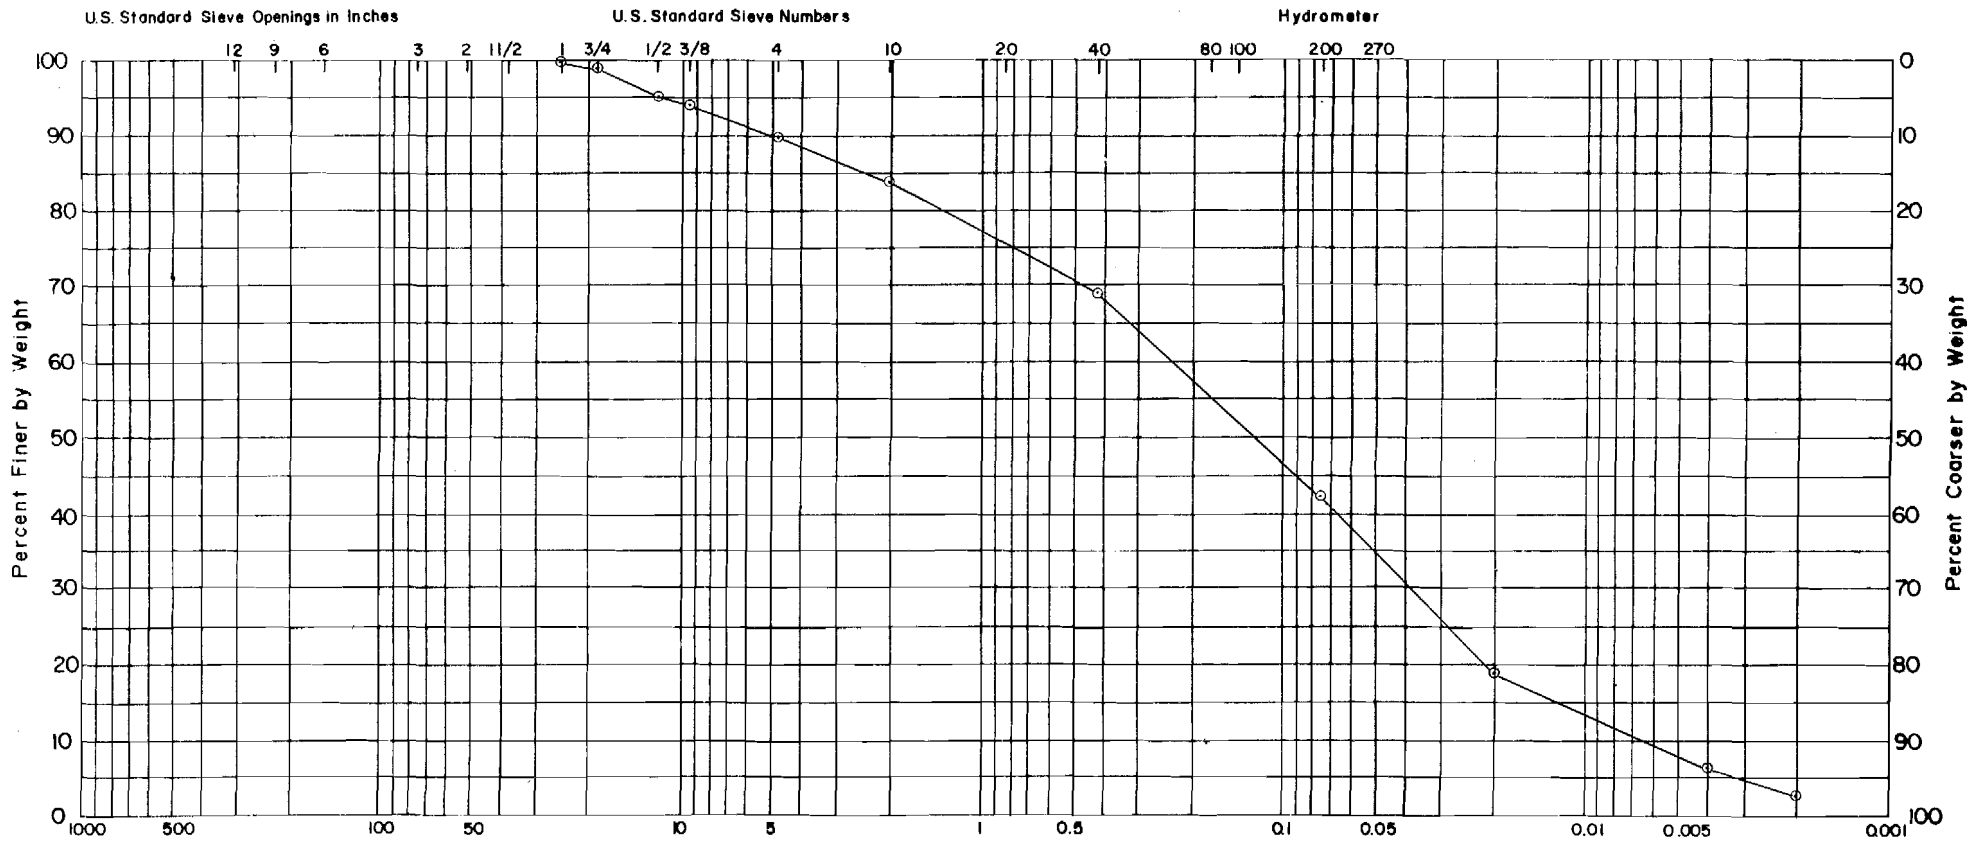
BORROW AREA D

SAMPLE NO.	MOISTURE CONTENT	DRY DENSITY	LL	PI	CLASSIFICATION & DESCRIPTION
AH-D1-5 (6.0-7.5')	11.1%		NV	NP	SM SILT AND SAND WITH TRACE GRAVEL AND TRACE CLAY Non Viscous, Non Plastic

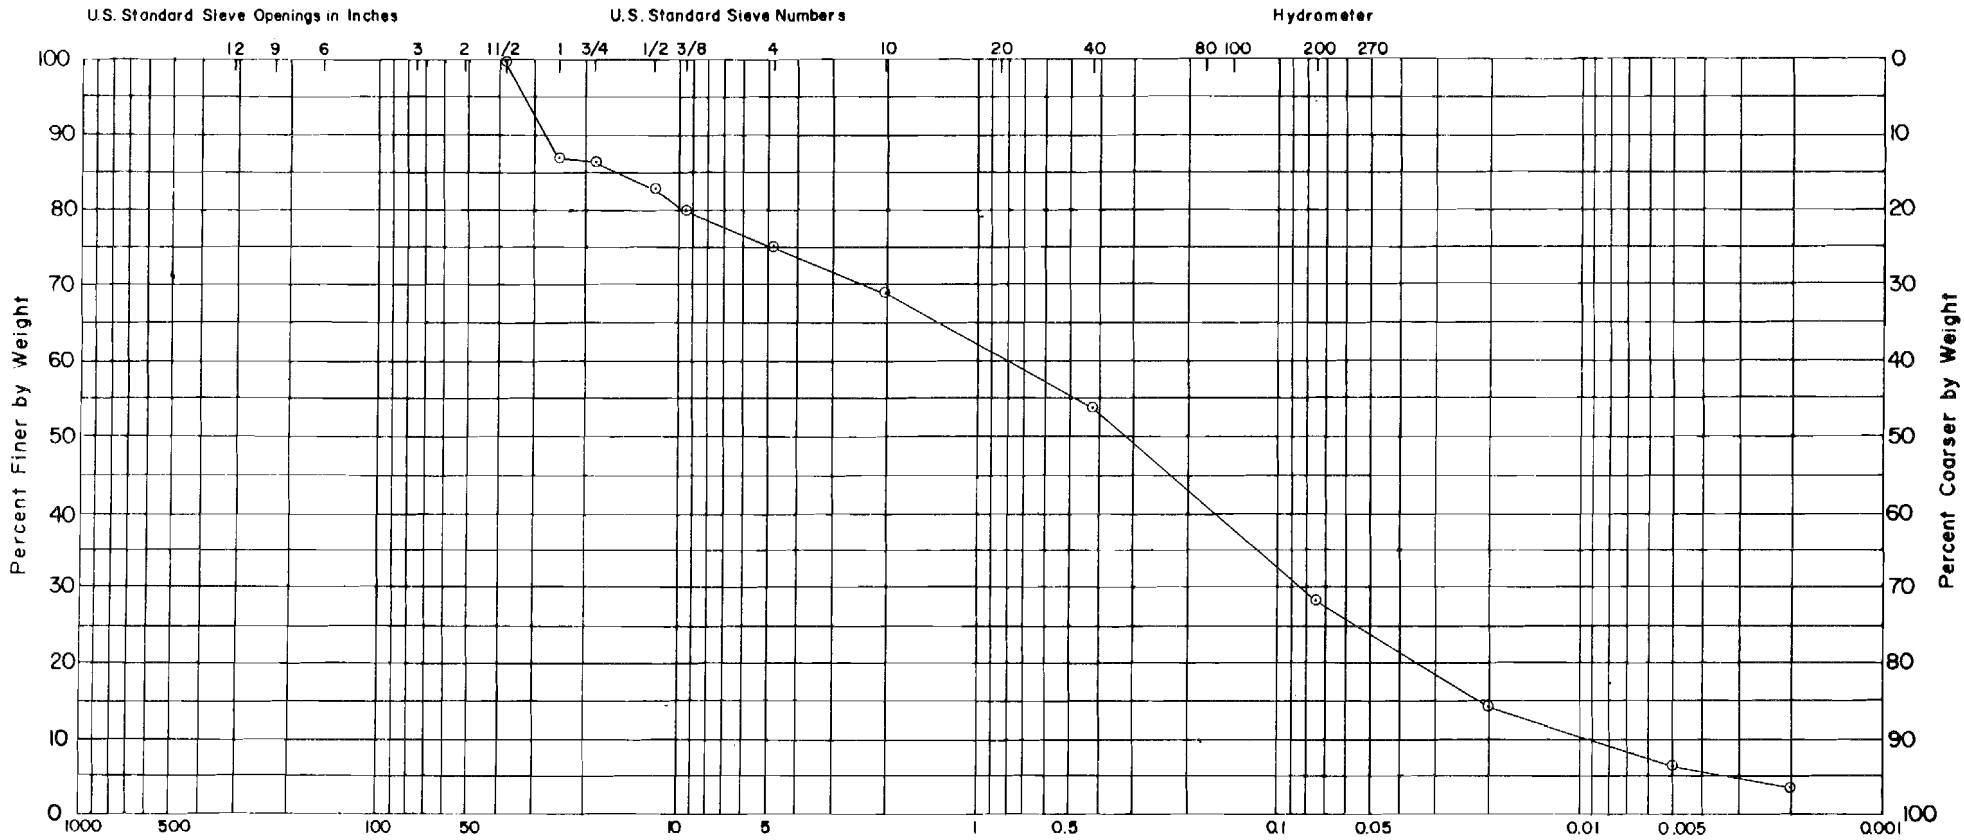
BORROW AREA D

SAMPLE NO.	MOISTURE CONTENT	DRY DENSITY	LL	PI	CLASSIFICATION & DESCRIPTION	
AH-D1-6 (8.0-8.5')	6.7%				SM	GRAVELLY SILTY SAND WITH TRACE CLAY

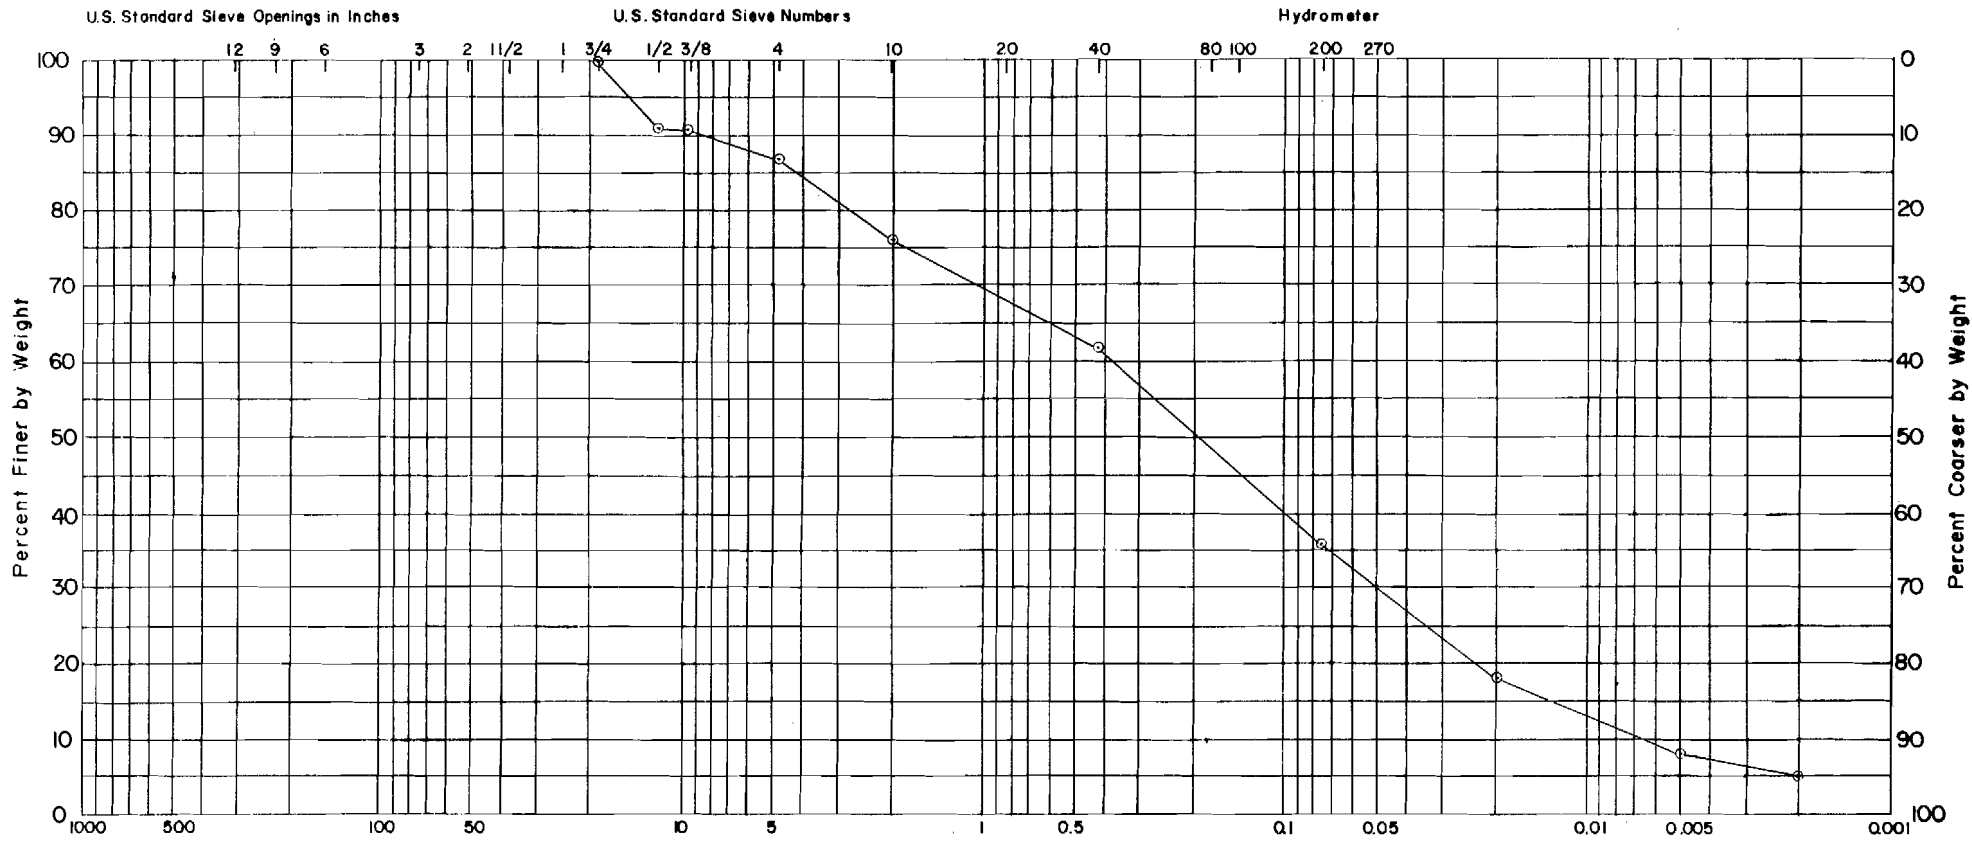
BORROW AREA D

SAMPLE NO.	MOISTURE CONTENT	DRY DENSITY	LL	PI	CLASSIFICATION & DESCRIPTION
AH-D1-7 (10.0-10.3')	6.6%				SM SILTY SAND WITH SOME GRAVEL, TRACE CLAY

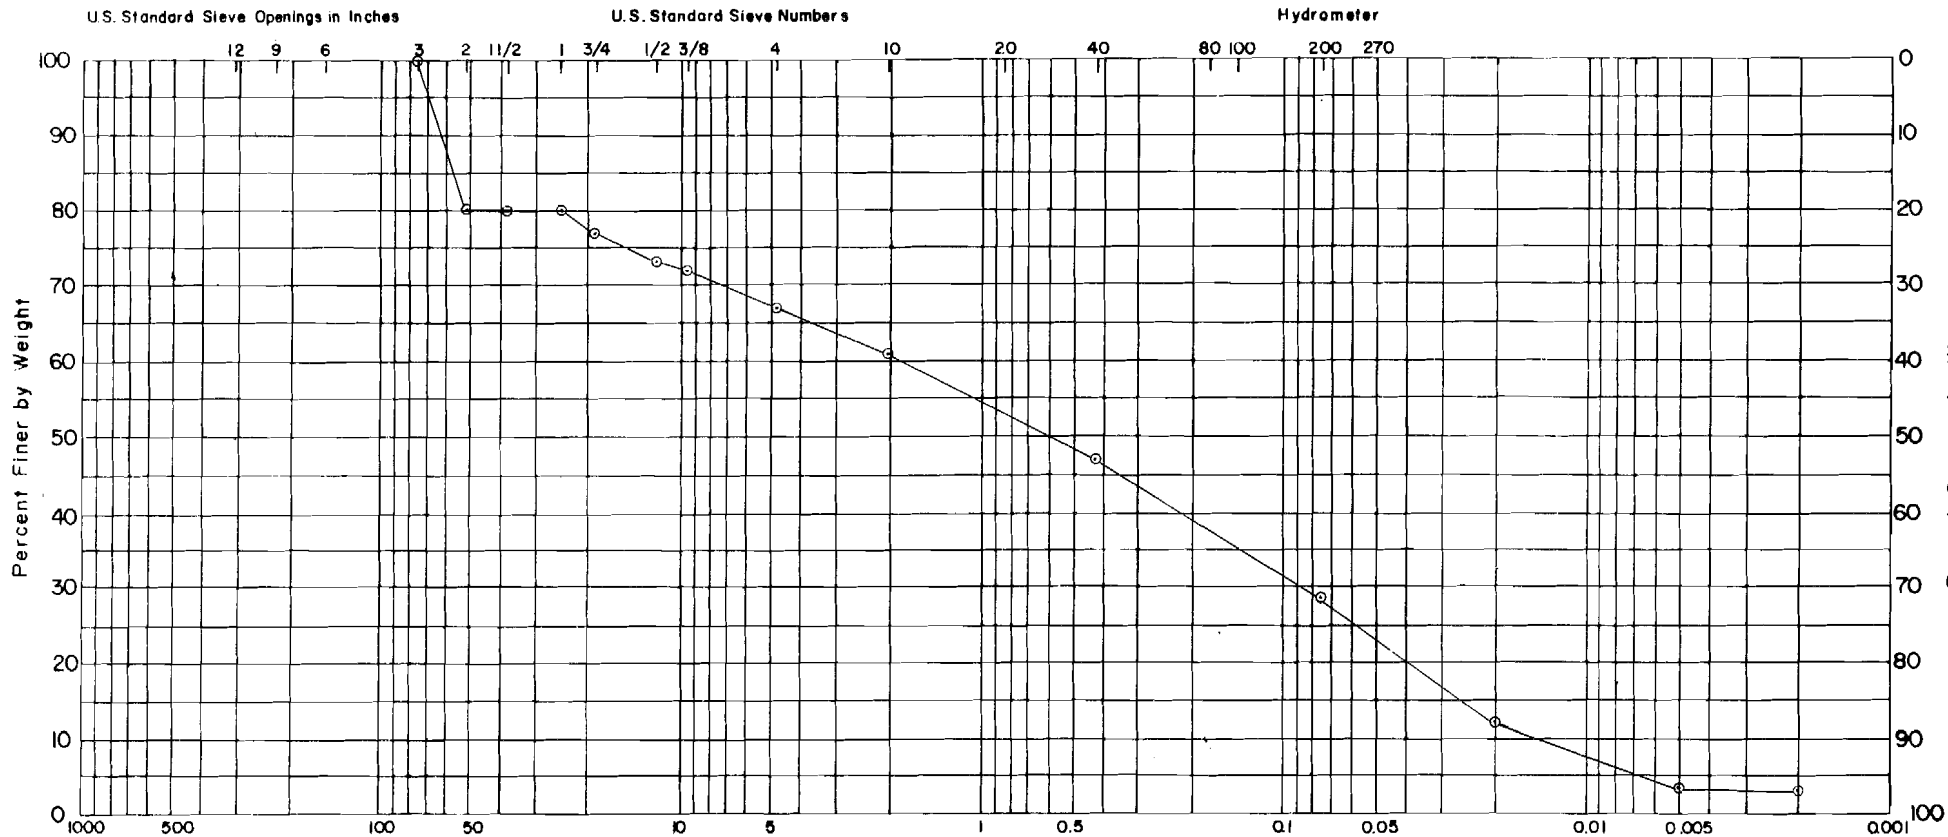
BORROW AREA D

SAMPLE NO.	MOISTURE CONTENT	DRY DENSITY	LL	PI	CLASSIFICATION & DESCRIPTION	
AH-D2-3 (1.5-3.0')	25.7%		NV	NP	SM	SILTY GRAVELLY SAND W/TRACE CLAY

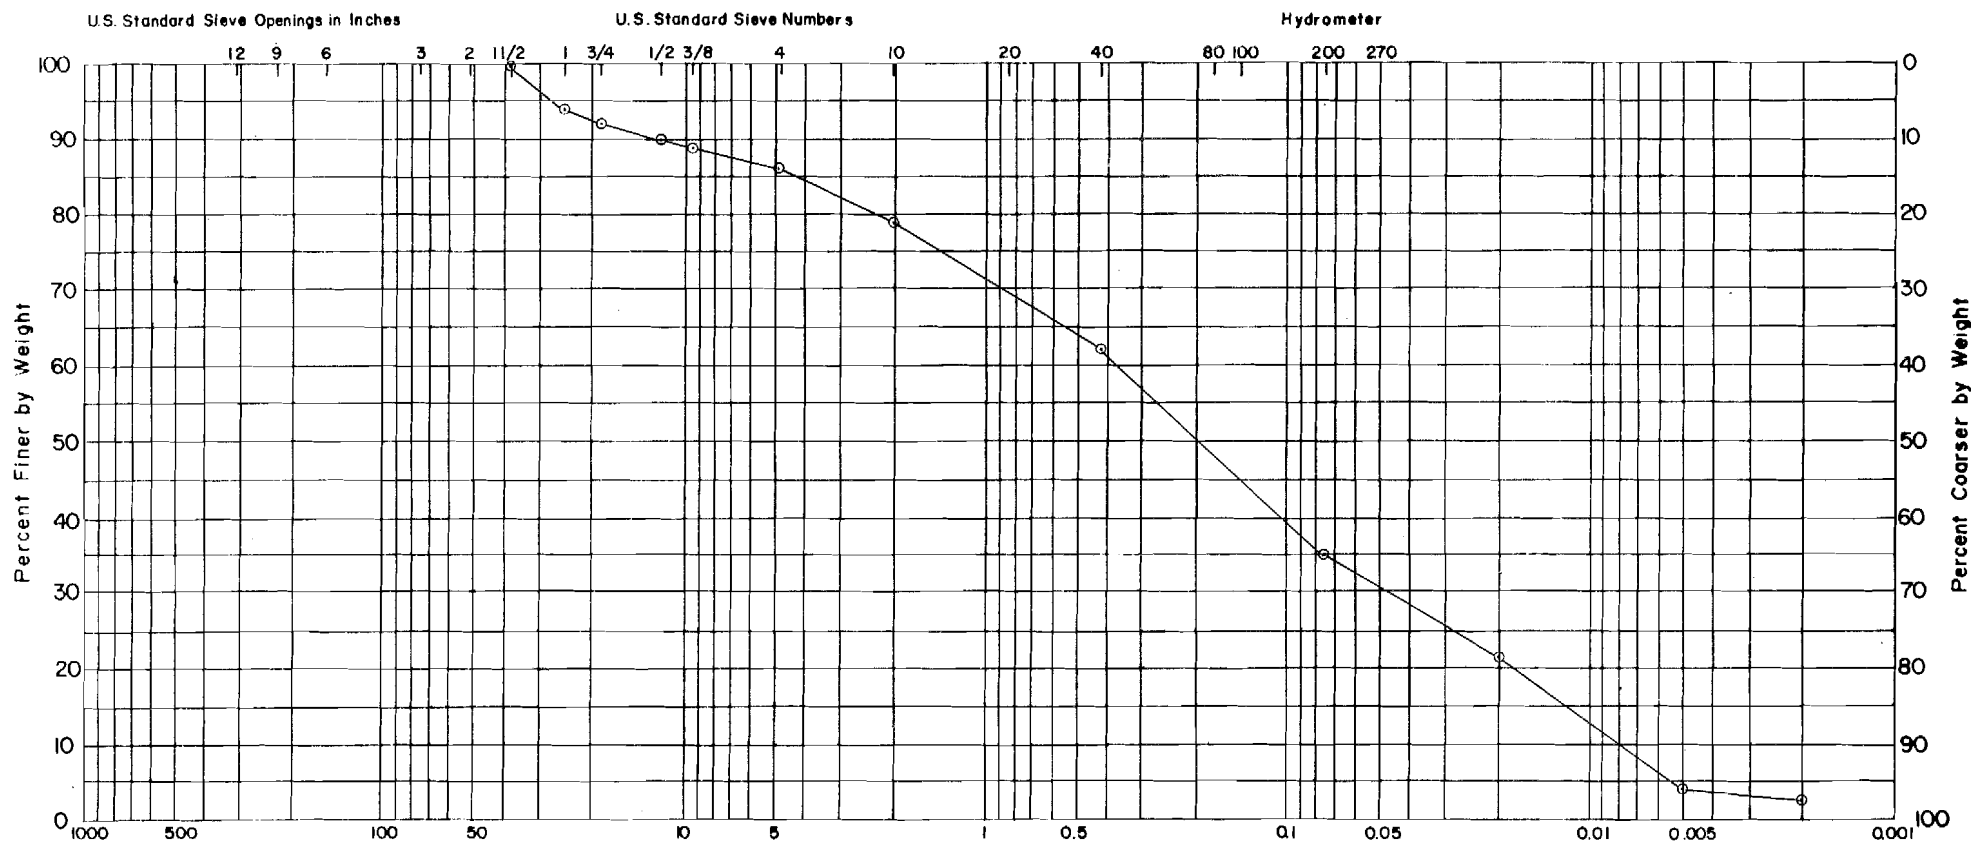
BOPROW AREA D

SAMPLE NO.	MOISTURE CONTENT	DRY DENSITY	LL	PI	CLASSIFICATION & DESCRIPTION	
AH-D2-4 (3.0-4.5')	11.4%		13.9	NP	SM	SILTY SAND WITH SOME GRAVEL, TRACE CLAY Non Plastic
