SUSITNA HYDROELECTRIC PROJECT

1980 - 81 GEOTECHNICAL REPORT

VOLUME 2
APPENDIX A-F
FINAL DRAFT

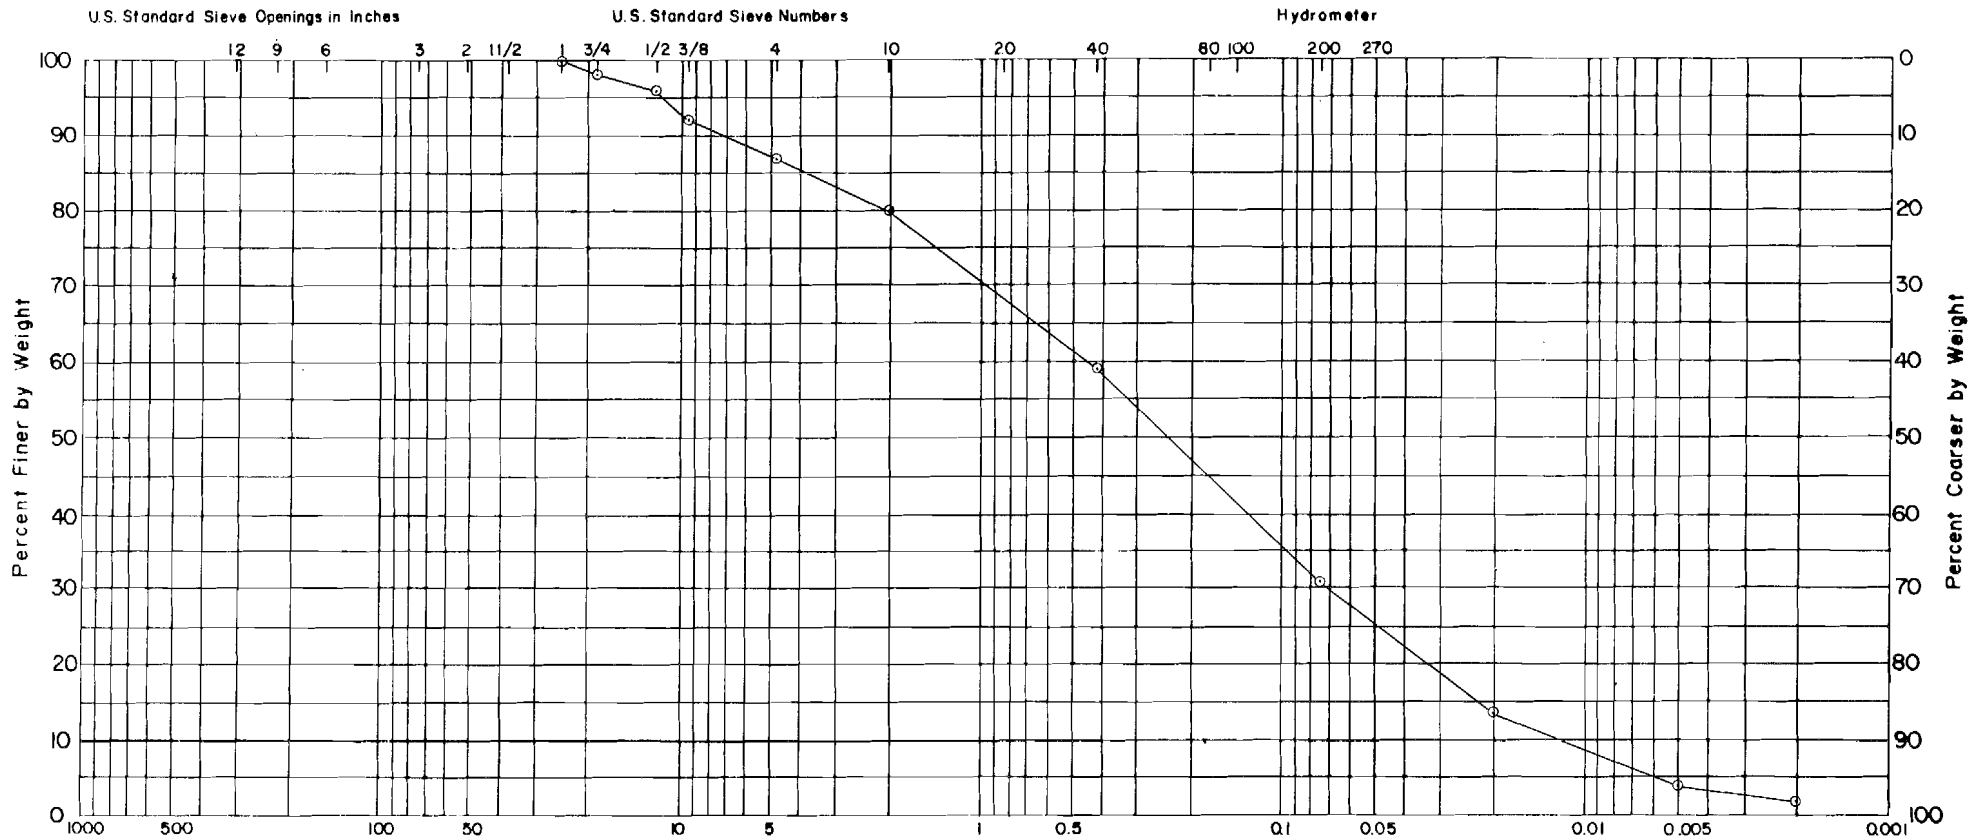
BORROW AREA D

SAMPLE NO.	MOISTURE CONTENT	DRY DENSITY	LL	PI	SM	CLASSIFICATION & DESCRIPTION
AH-D2-5 (4.5-6.0')	11.2%		NV	NP	SM	SILTY SAND WITH SOME GRAVEL, TRACE CLAY Non Viscous, Non Plastic

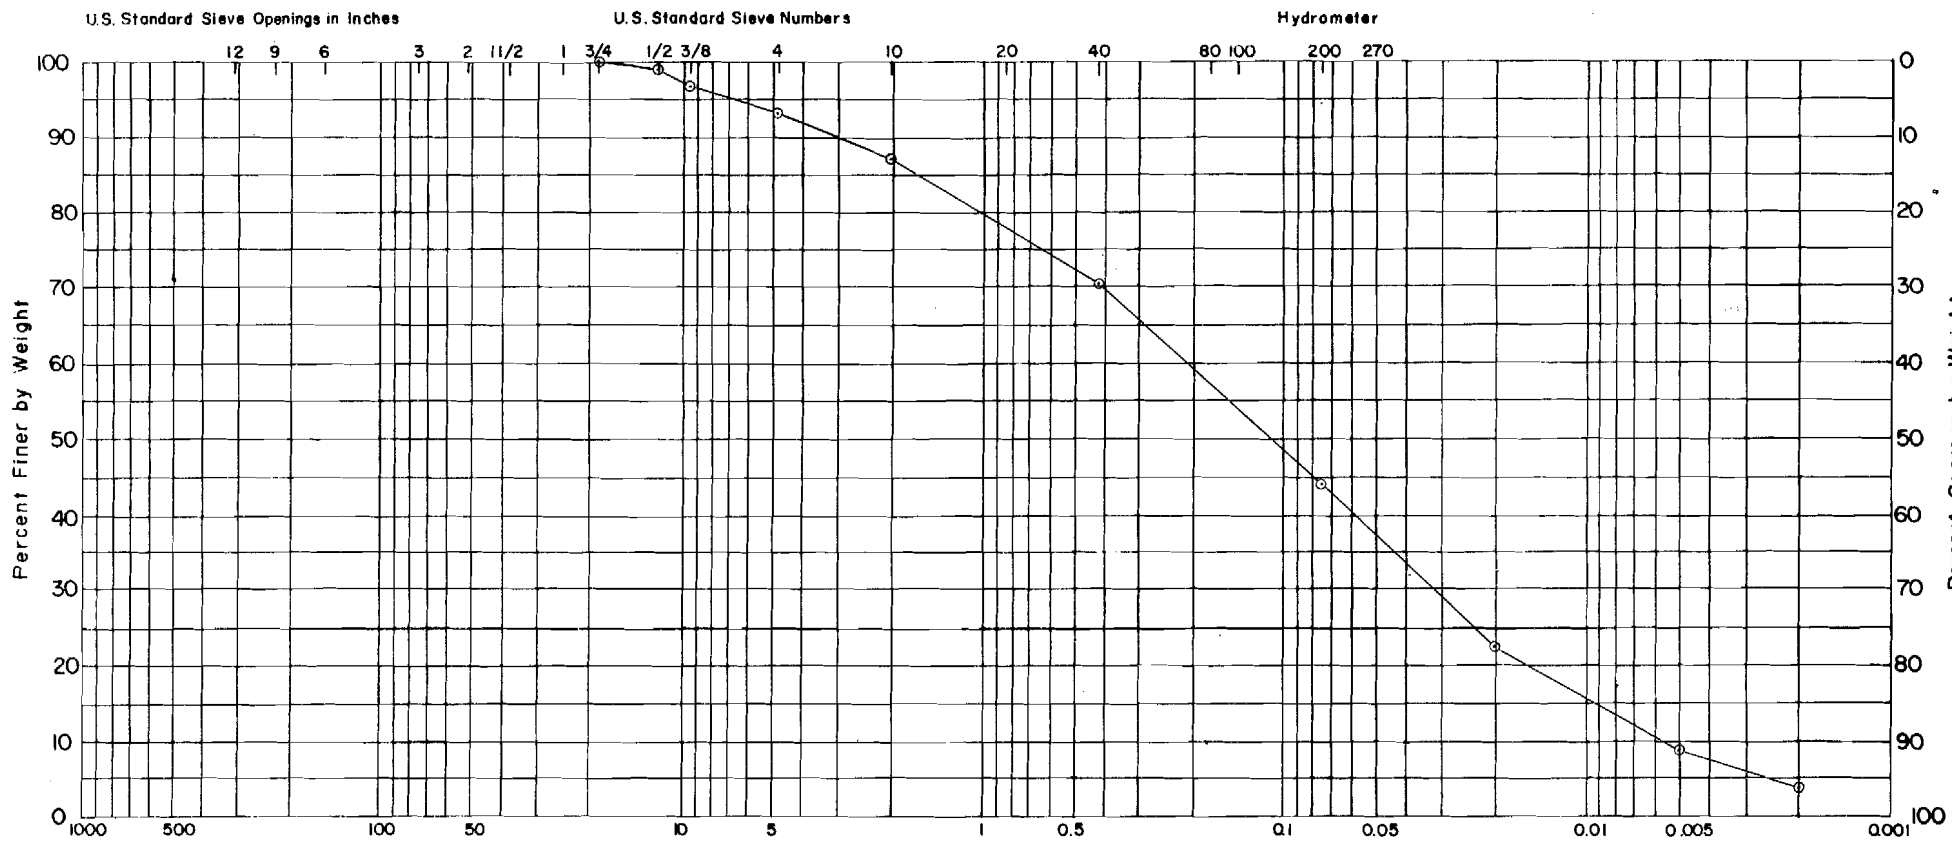
BORROW AREA D

SAMPLE NO.	MOISTURE CONTENT	DRY DENSITY	LL	PI		CLASSIFICATION & DESCRIPTION
AH-D2-8 (15.0-16.5')	11.3%		15.5	2.2	SM	SILTY SAND WITH TRACE GRAVEL, TRACE CLAY

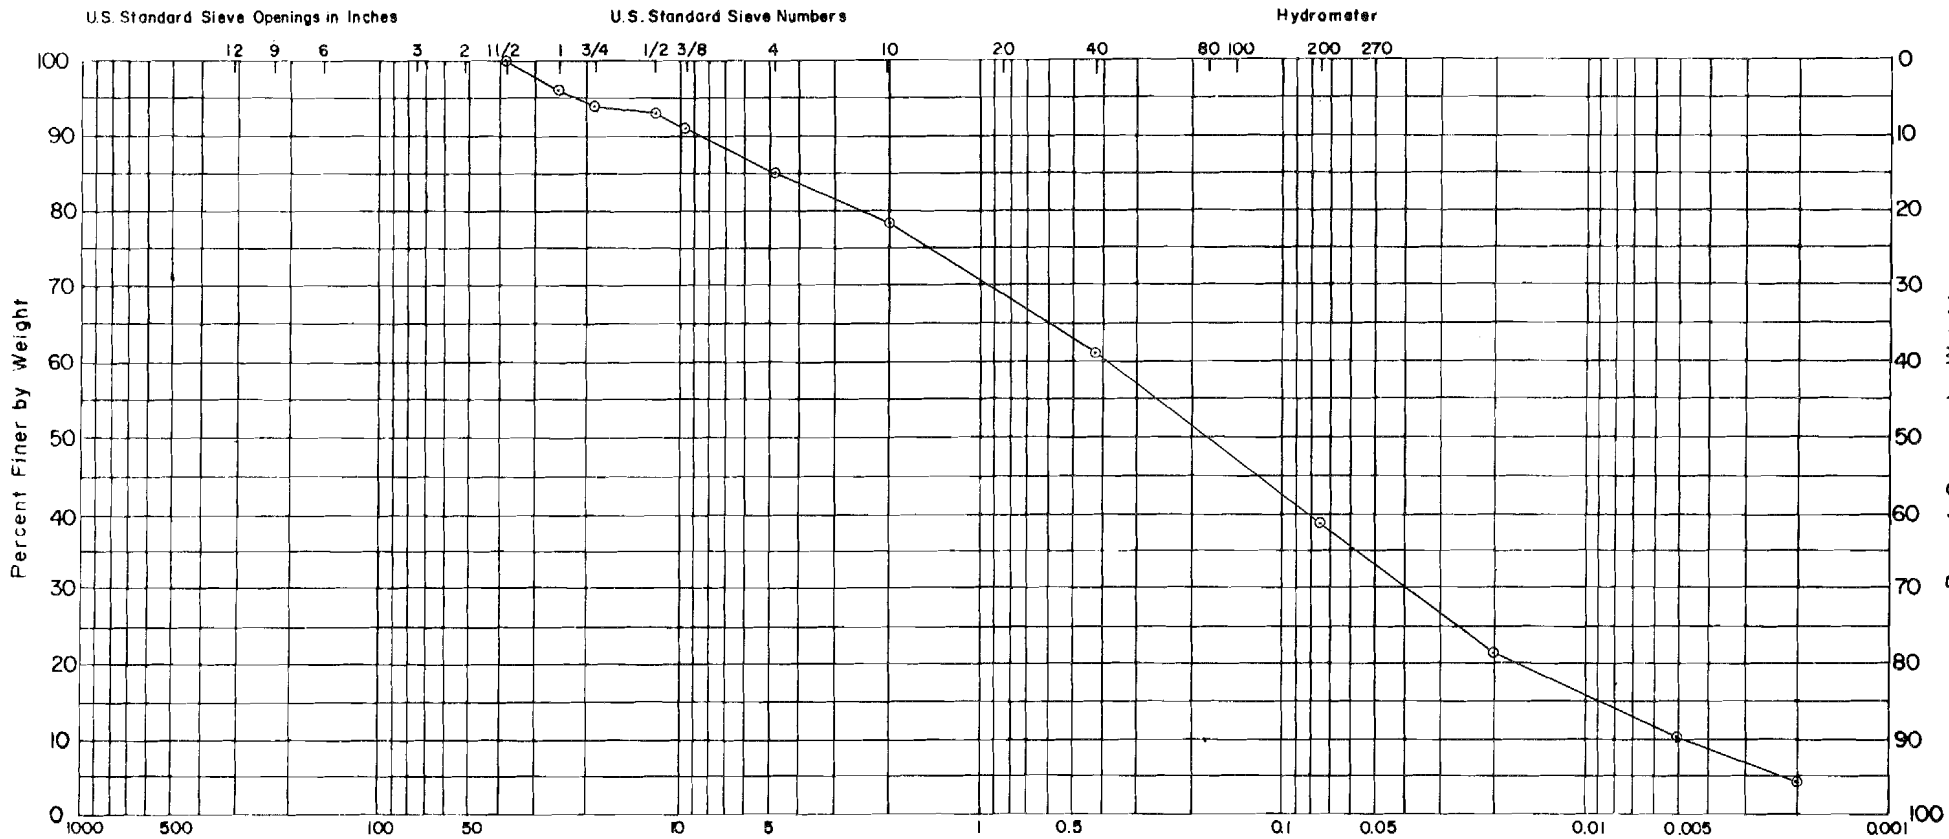
BORROW AREA D

SAMPLE NO.	MOISTURE CONTENT	DRY DENSITY	LL	PI	CLASSIFICATION & DESCRIPTION	
AH-D2-9 (20.0-21.5')	9.4%		17.5	4.2	SM	SILTY SAND WITH SOME GRAVEL, CLAY

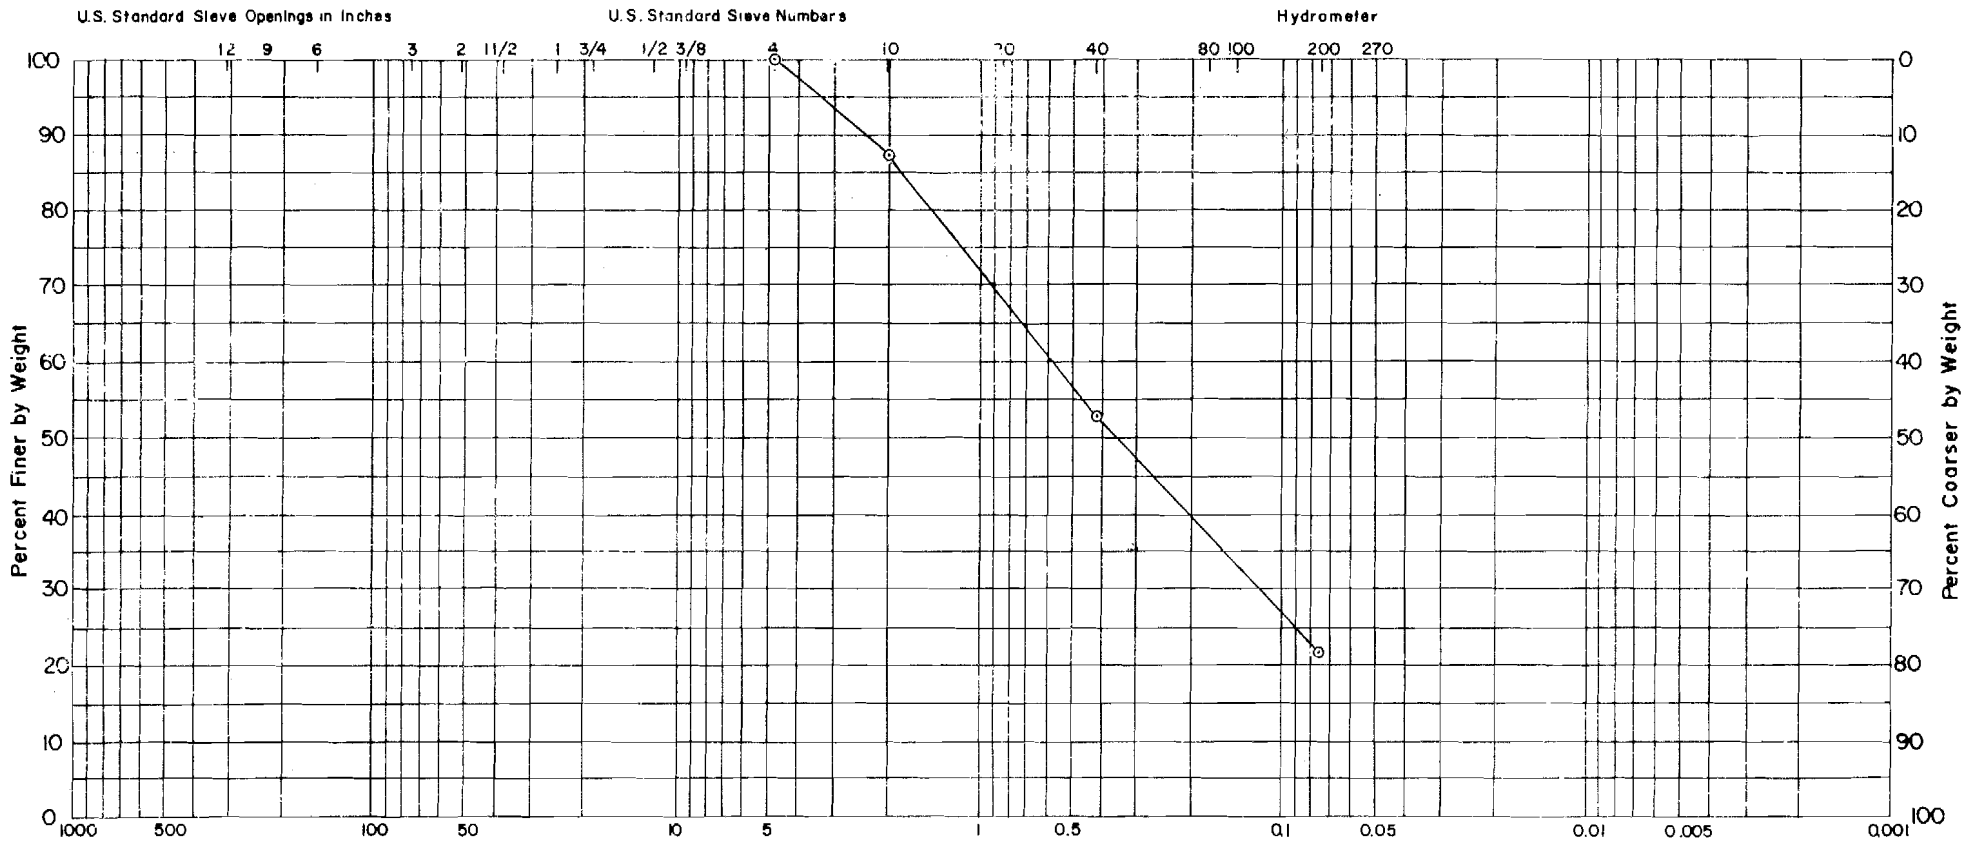
BORROW AREA D
AUGER HOLE AH-D5

SAMPLE NO.	MOISTURE CONTENT	DRY DENSITY	LL	PI	CLASS	CLASSIFICATION & DESCRIPTION
AH-D5 - 4					SM	SAND WITH SOME SILT

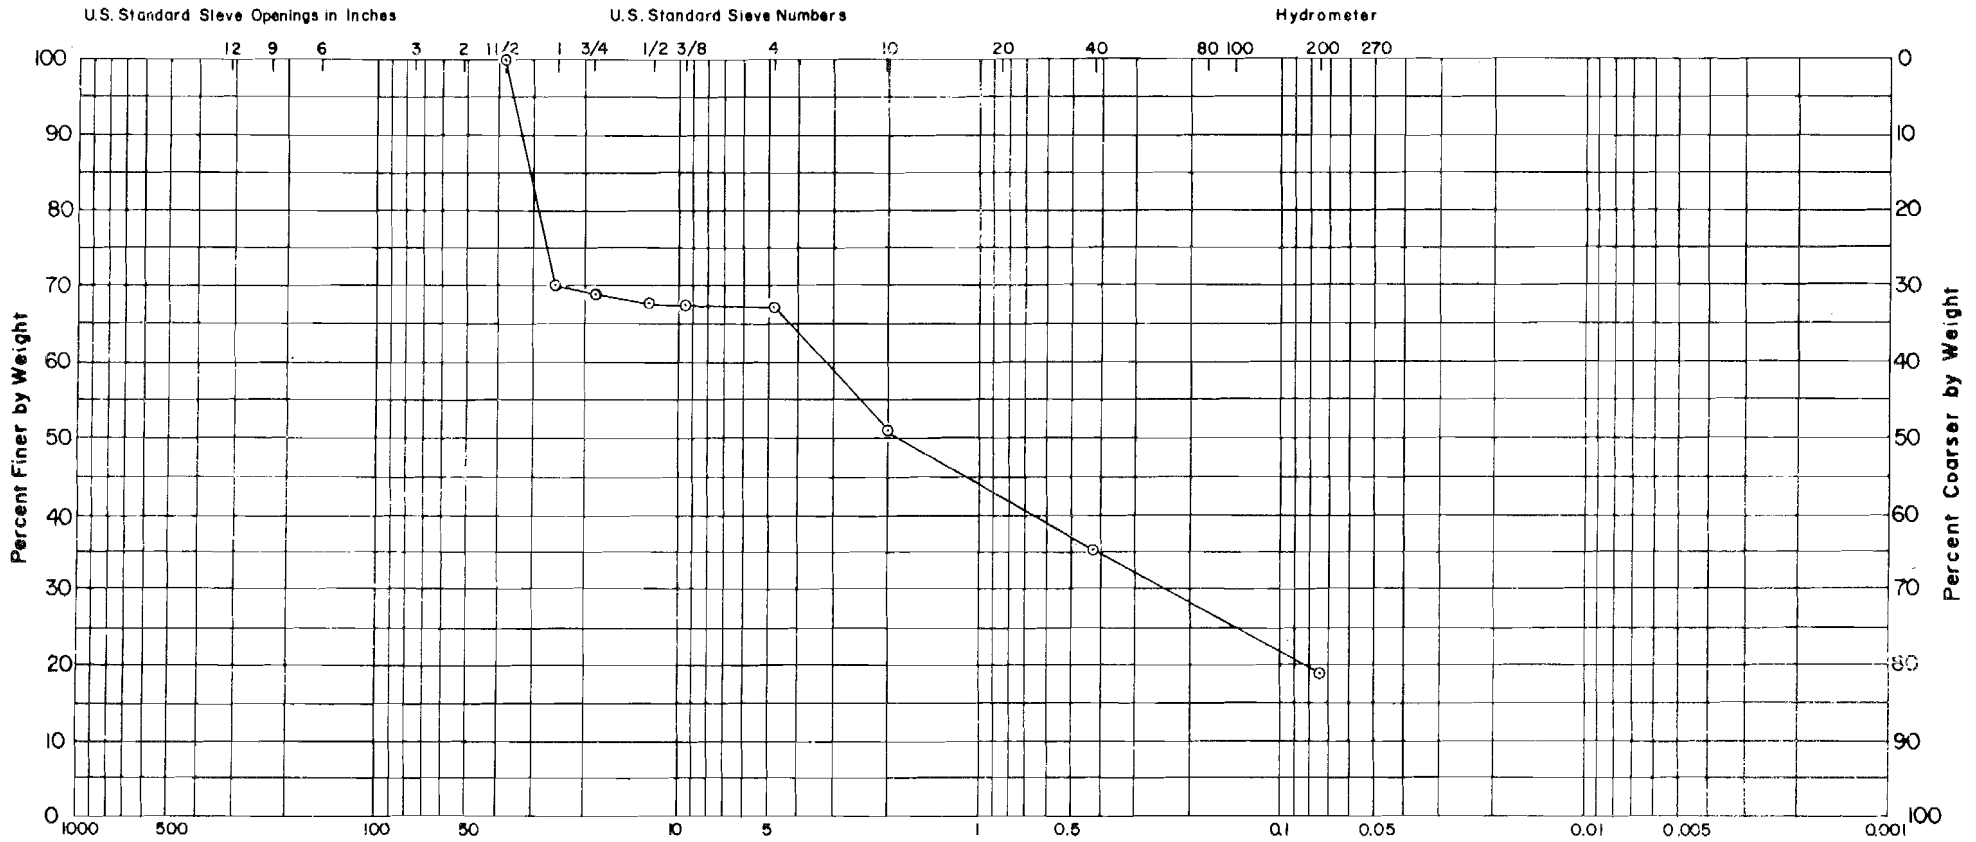
BORROW AREA D
AUGER HOLE AH-D5

SAMPLE NO.	MOISTURE CONTENT	DRY DENSITY	LL	PI	CLASS	CLASSIFICATION & DESCRIPTION
AH-D5 - 5					SM	GRAVELLY SAND WITH SOME SILT

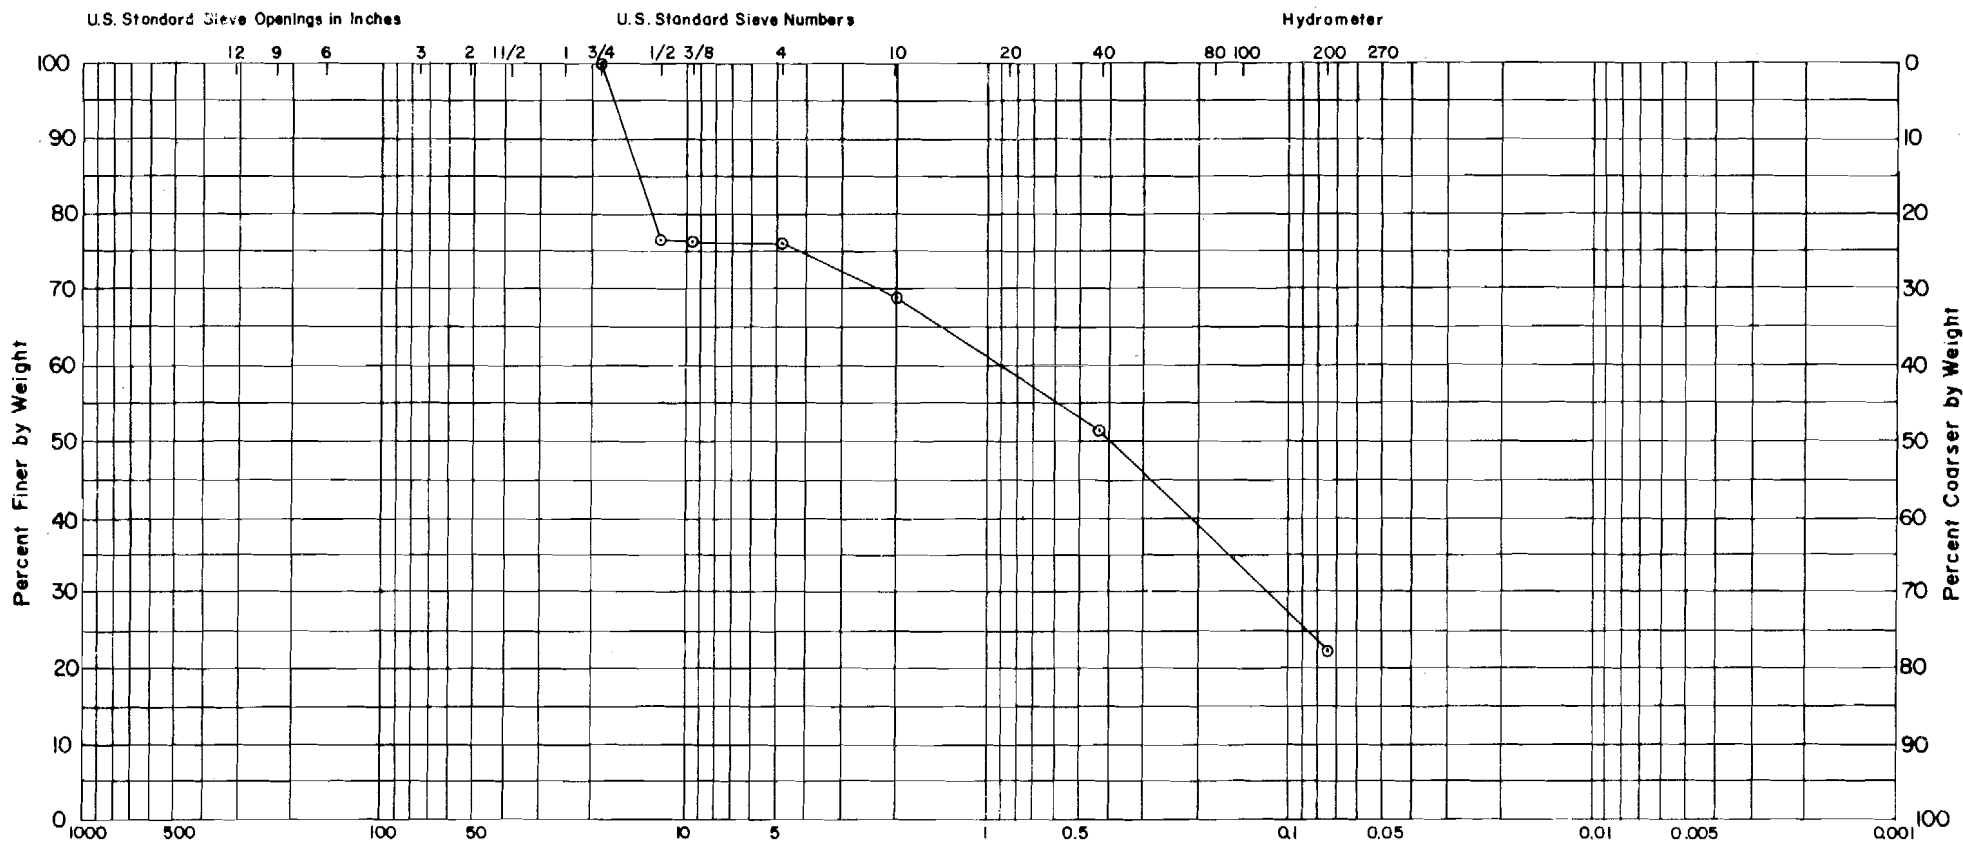
BORROW AREA D
AUGER HOLE AH-D5

SAMPLE NO.	MOTSTURE CONTENT	DRY DENSITY	LL	PI	CLASS	CLASSIFICATION & DESCRIPTION
AH-D5 - 6					SM	SAND WITH SOME GRAVEL AND SILT

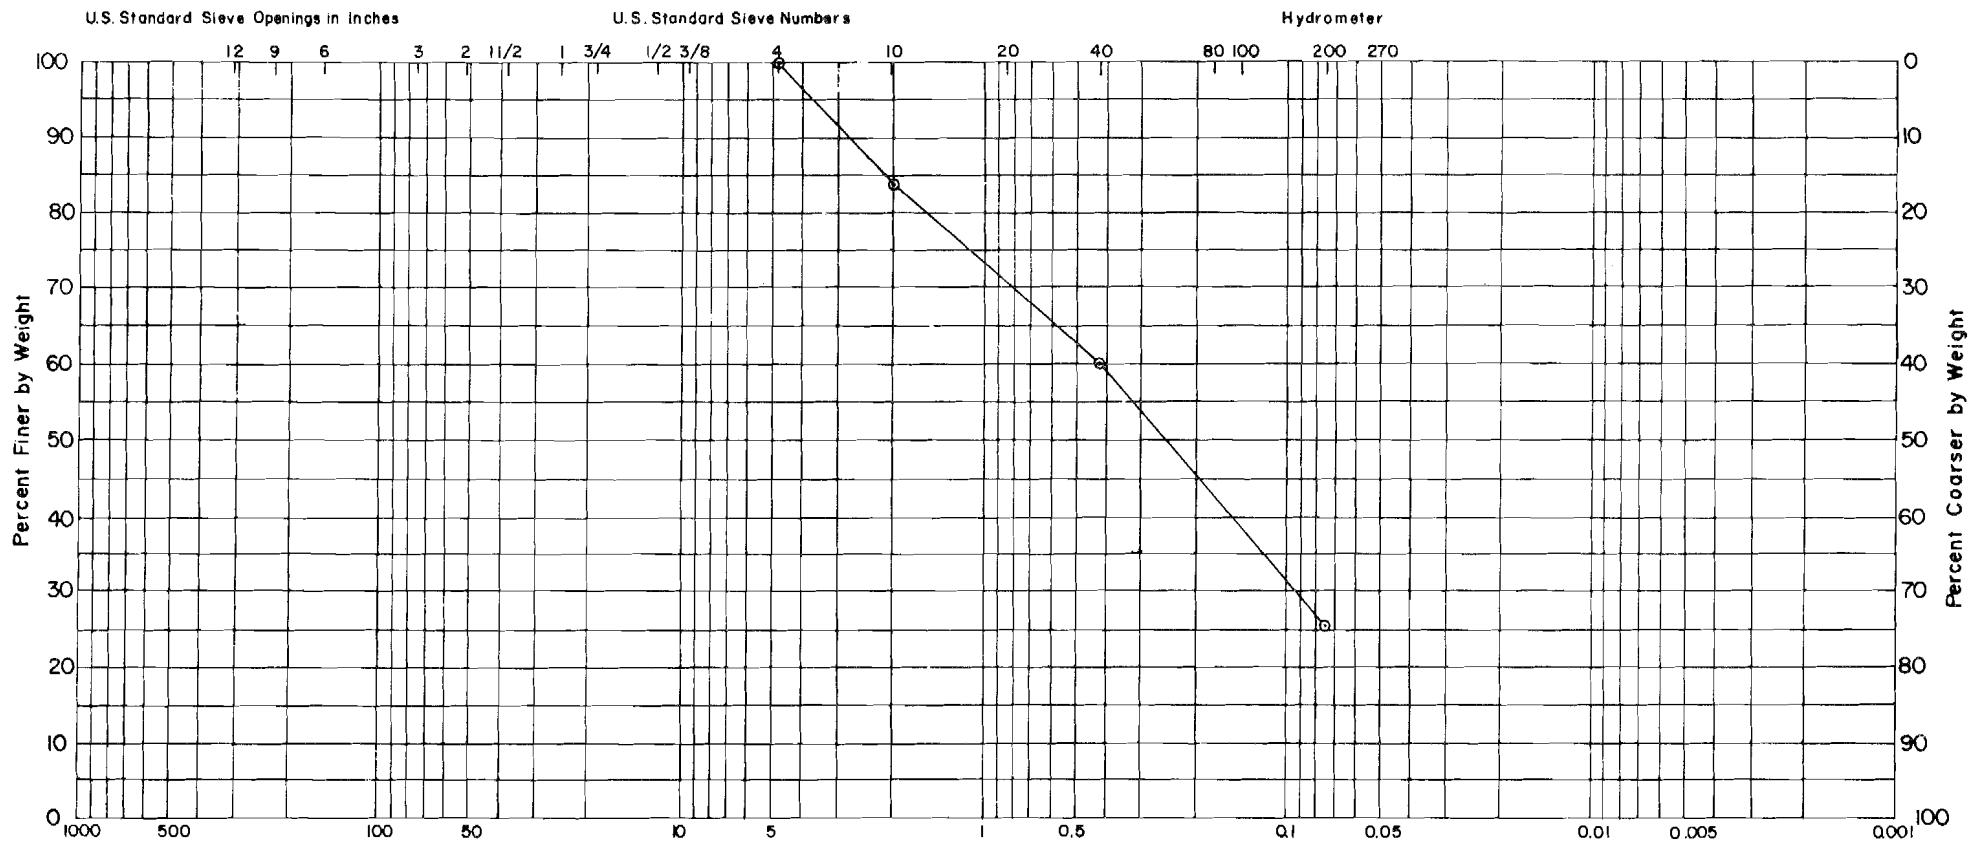
BORROW AREA D
AUGER HOLE AH-D5

SAMPLE NO.	MOISTURE CONTENT	DRY DENSITY	LL	PI	CLASS	CLASSIFICATION & DESCRIPTION
AH-D5 - 9	13		14	NP	SM	SAND WITH SOME SILT

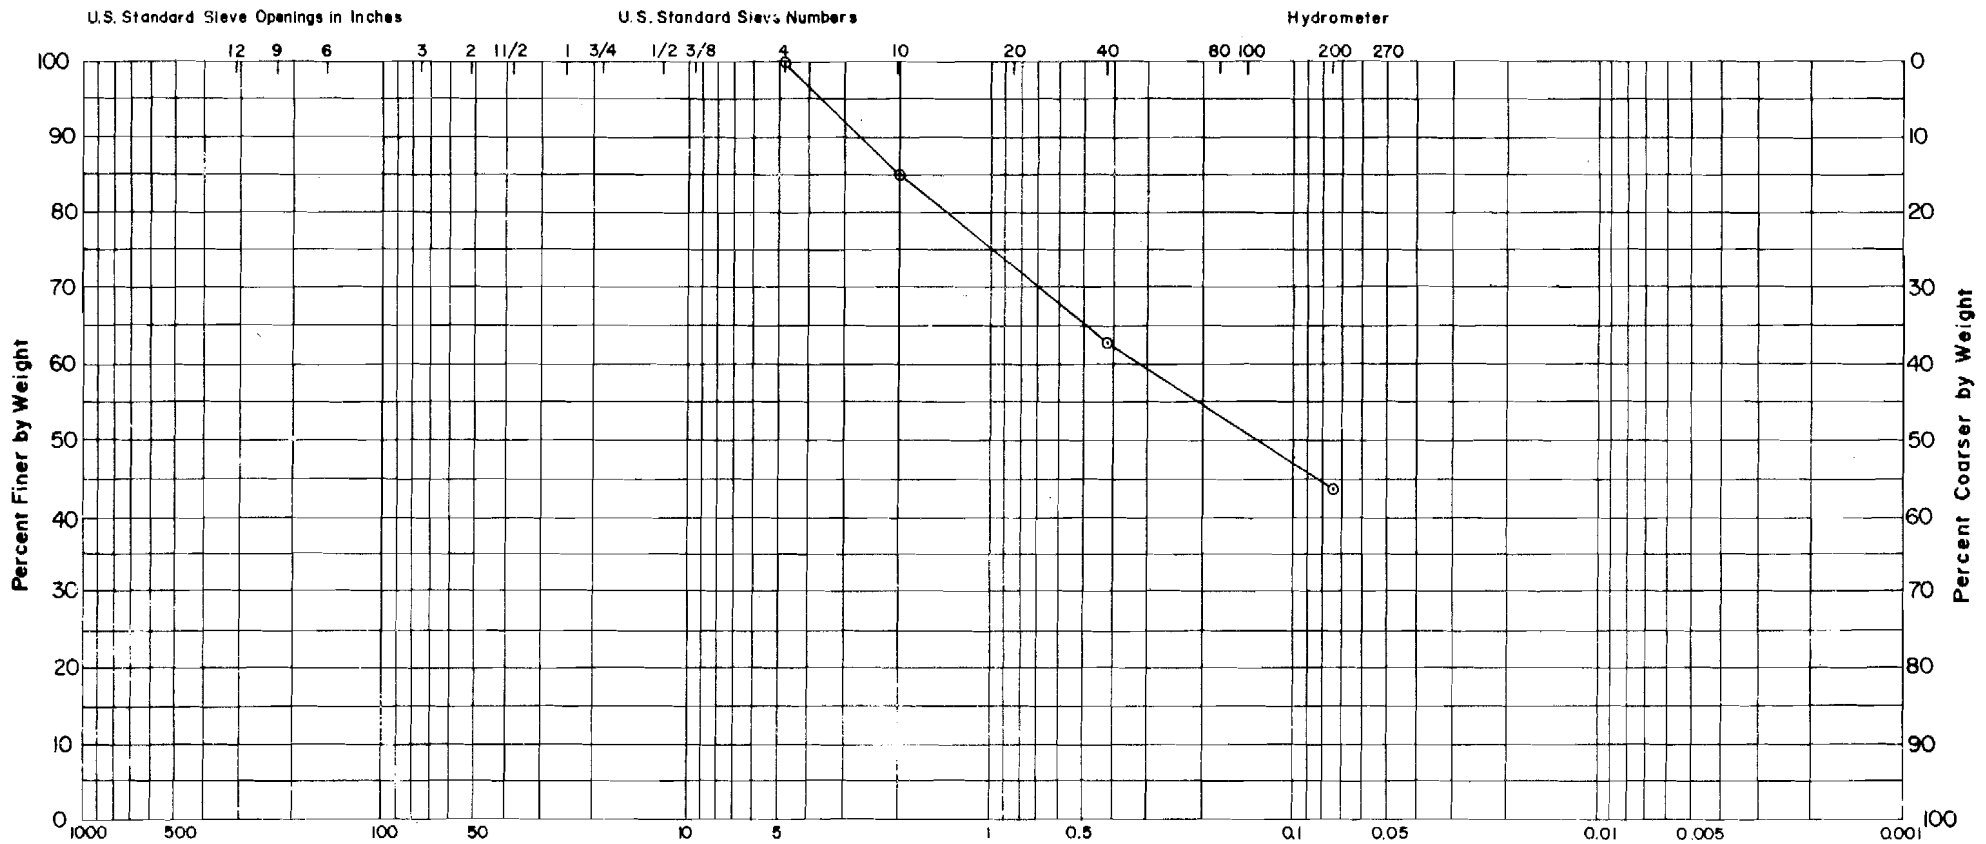
BORROW AREA D
AUGER HOLE AH-D5

SAMPLE NO.	MOISTURE CONTENT	DRY DENSITY	LL	PI	CLASS	CLASSIFICATION & DESCRIPTION
AH-D5 - 10	12		17	6	SM-SC	SILTY SAND WITH SOME TO TRACE CLAY

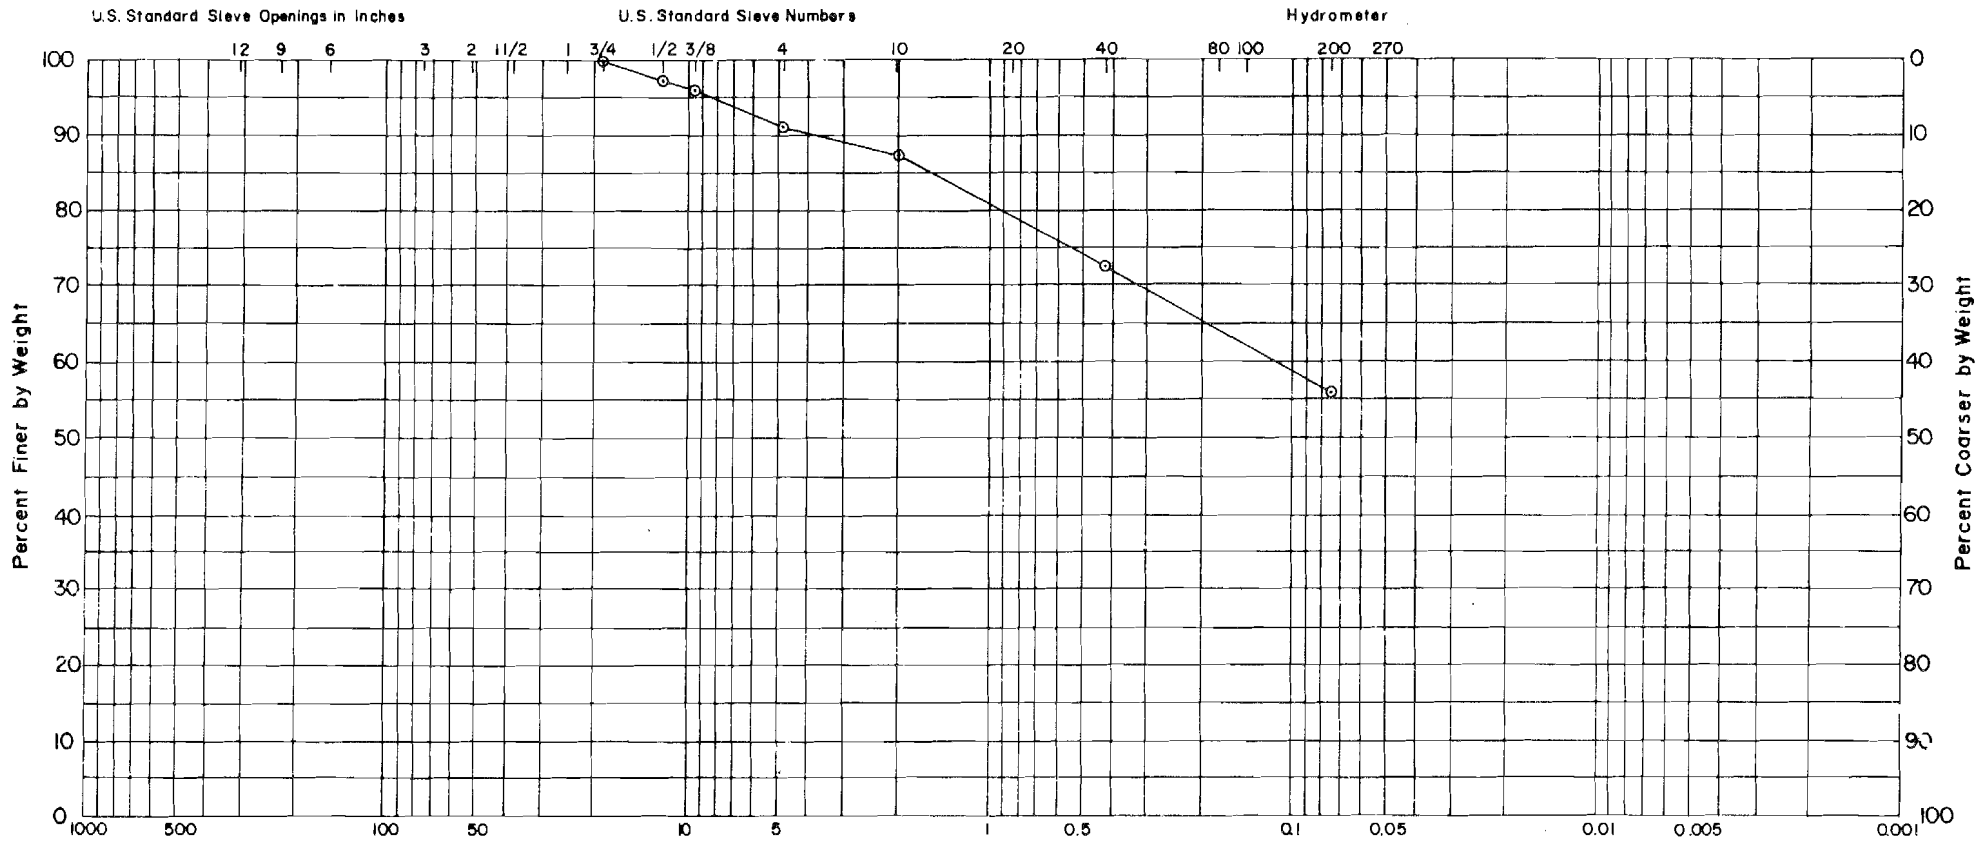
BORROW AREA D
AUGER HOLE AH-D5

SAMPLE NO.	MOTIS TURE CONTENT	DR Y DENSITY	LL	PI	CLASS	CLASSIFICATION & DESCRIPTION
AH-D5-11	12		23	14	CL	SANDY SILT WITH SOME TO TRACE CLAY AND TRACE GRAVEL

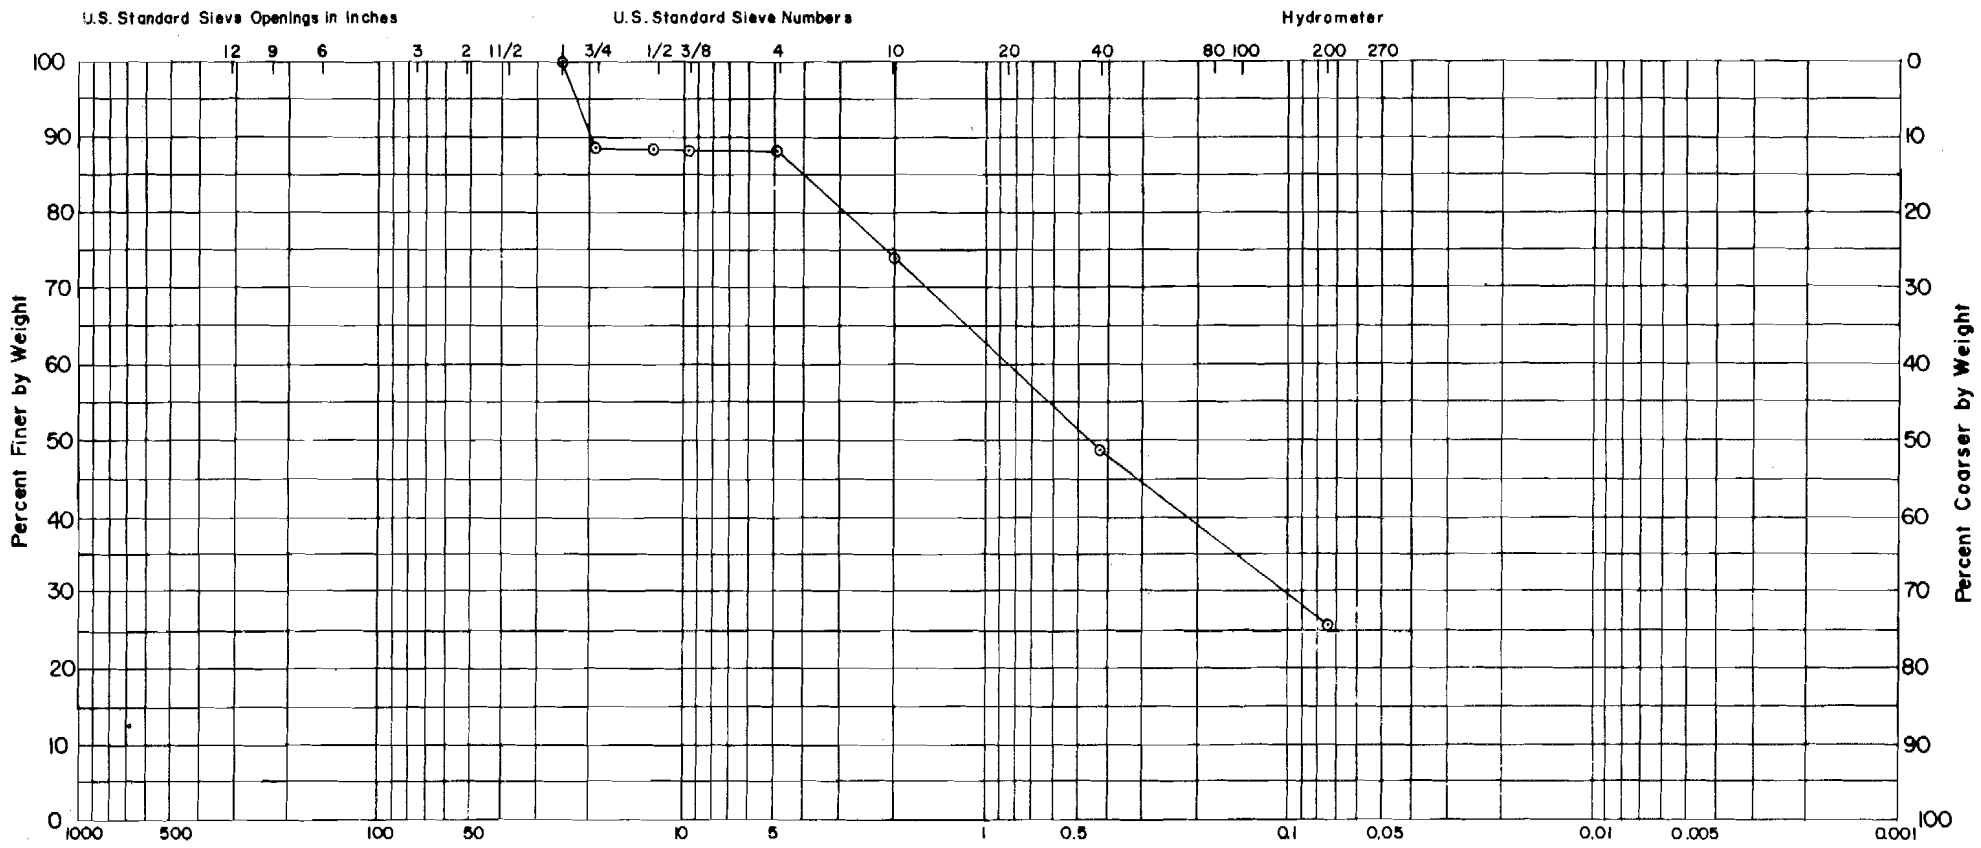
BORROW AREA D
AUGER HOLE AH-D5

SAMPLE NO.	MOISTURE CONTENT	DRY DENSITY	LL	PI	CLASS	CLASSIFICATION & DESCRIPTION
AH-D5 - 12	9		39	14	SM-SC	SAND WITH SOME GRAVEL AND SILT AND TRACE CLAY

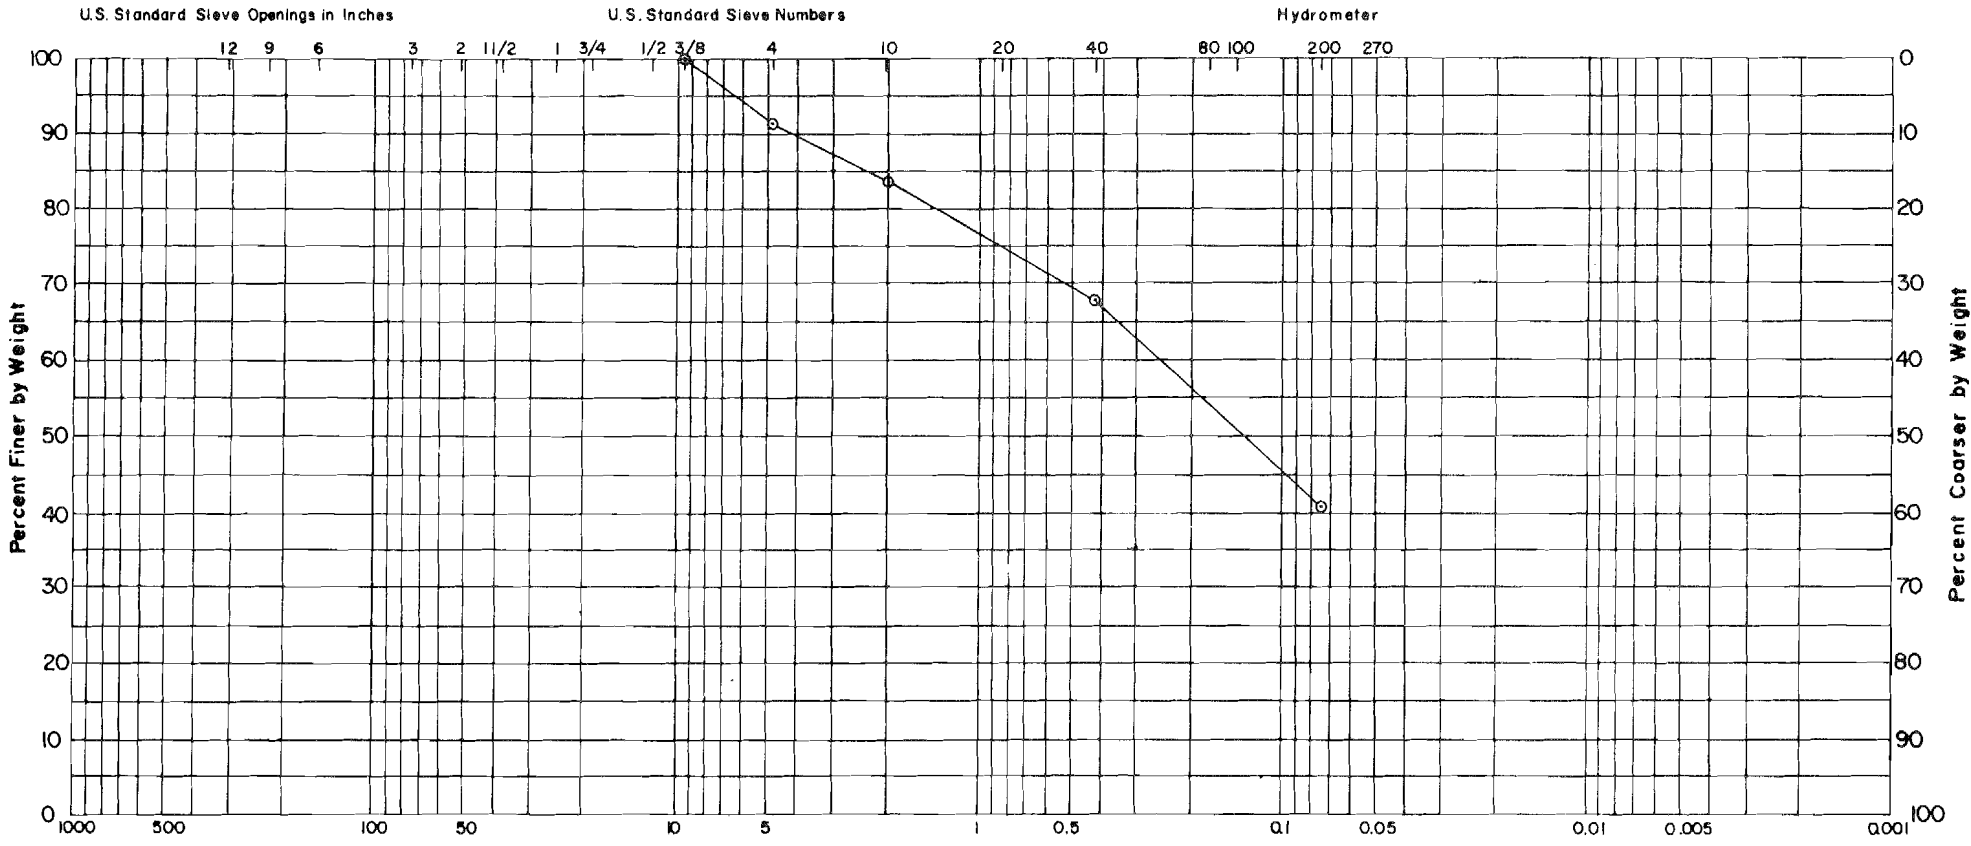
BORROW AREA D
AUGER HOLE AH-D6

SAMPLE NO.	MOISTURE CONTENT	DRY DENSITY	LL	PI	CLASS	CLASSIFICATION & DESCRIPTION
AH-D6 - 3,4,	10,8		15	NP	SM	SILTY SAND WITH TRACE GRAVEL

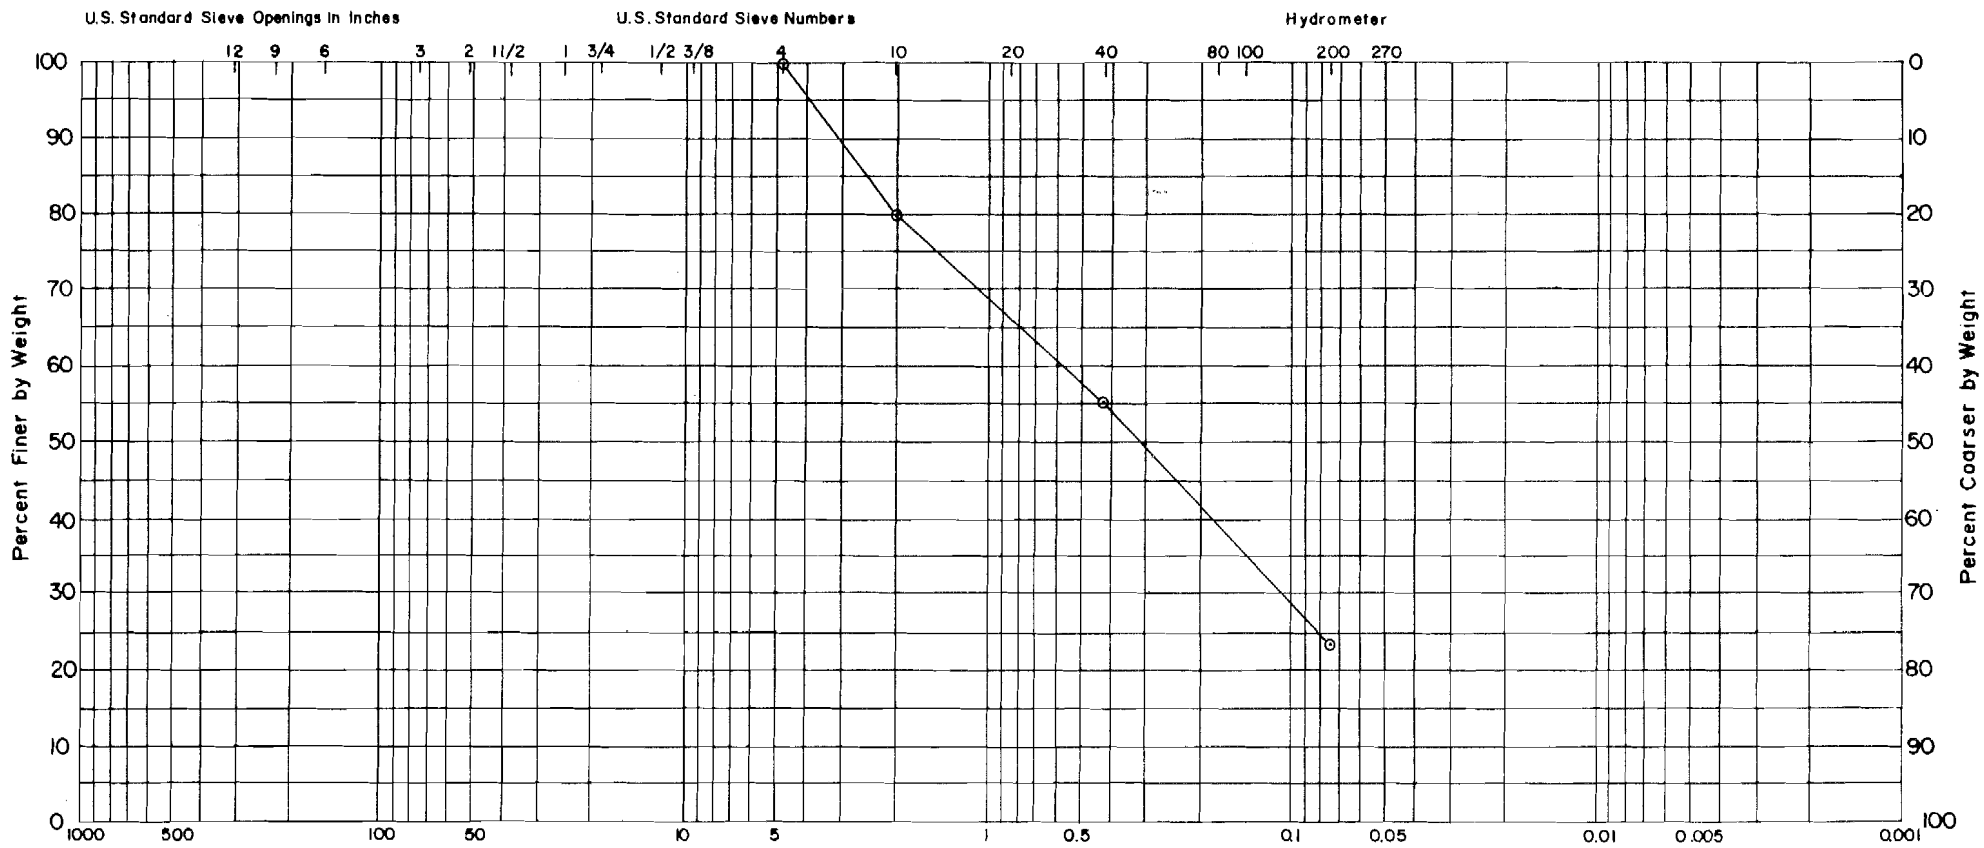
SAMPLE NO.	MOISTURE CONTENT	DRY DENSITY	LL	PI	CLASS	CLASSIFICATION & DESCRIPTION
AH-D6 - 6,7	12,11		13	NP	SM	SAND WITH SOME SILT

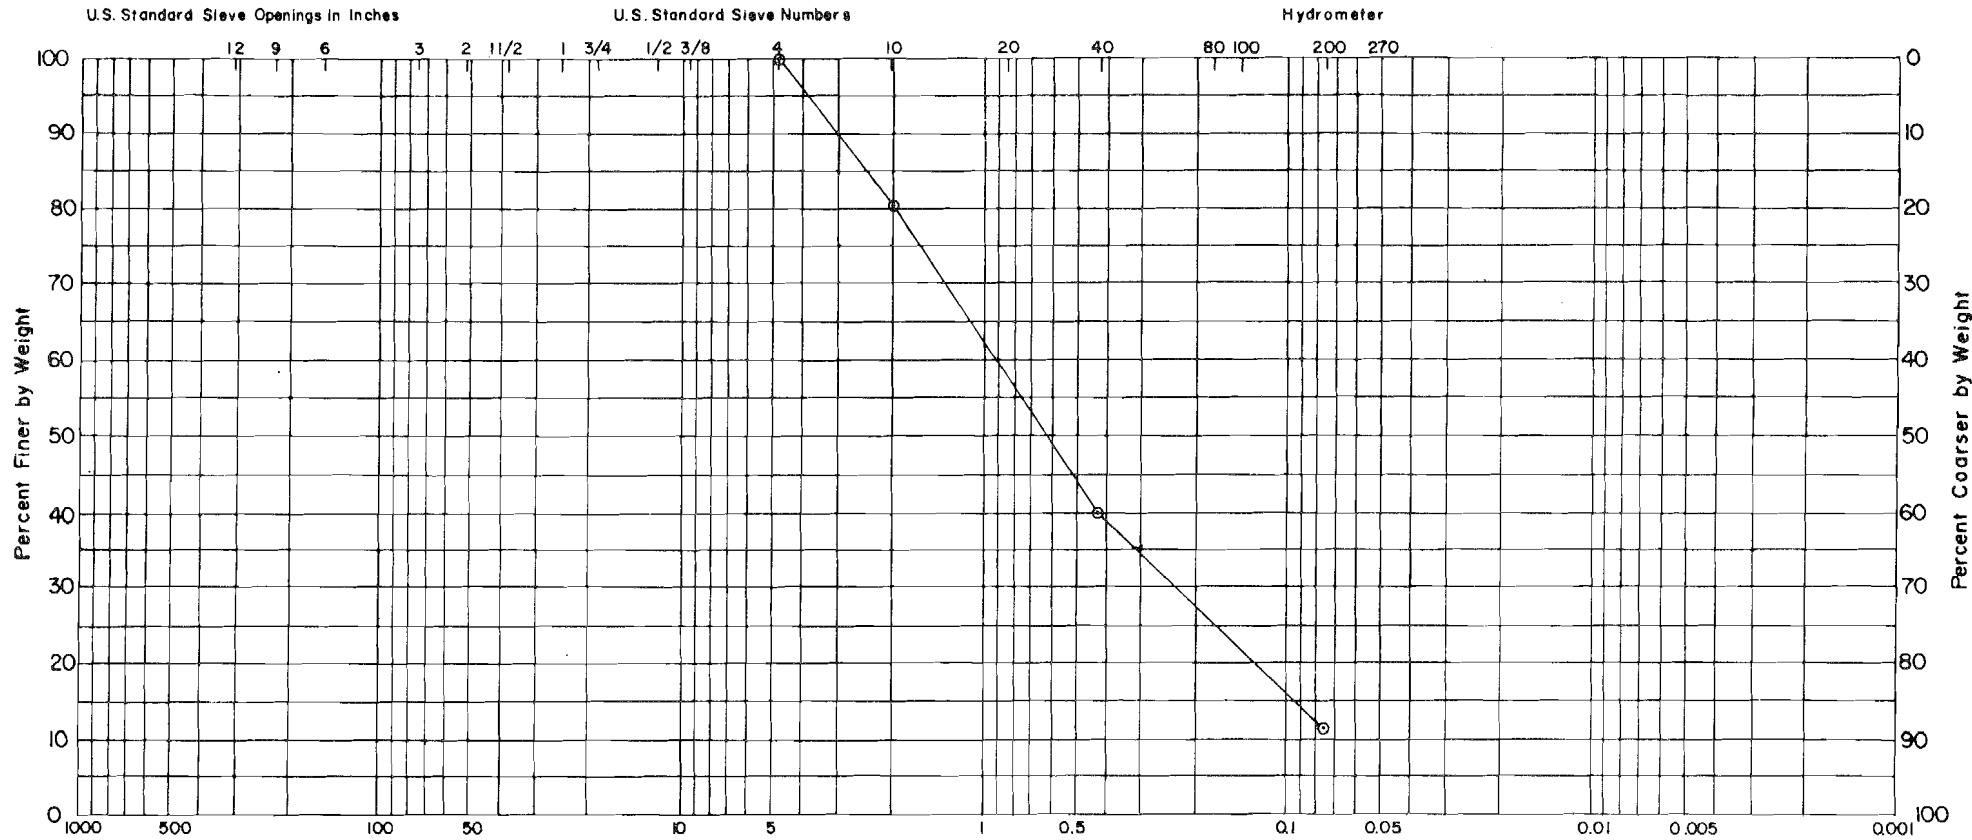
BORROW AREA D
AUGER HOLE AH-D6

SAMPLE NO.	MOISTURE CONTENT	DRY DENSITY	LL	PI	CLASS	CLASSIFICATION & DESCRIPTION
AH-D6 - 9	12		17	2	SW-SM	SAND WITH TRACE SILT
